EVALUATION OF THE GUARD RAIL ENERGY ABSORBING TERMINAL (G-R-E-A-T) IMPACT ATTENUATOR

FINAL REPORT

Research Report No. 160
Research Project No. 79-3G(B)

Conducted by
LOUISIANA DEPARTMENT OF TRANSPORTATION
AND DEVELOPMENT
Research and Development Section
In Cooperation with
U. S. Department of Transportation
FEDERAL HIGHWAY ADMINISTRATION

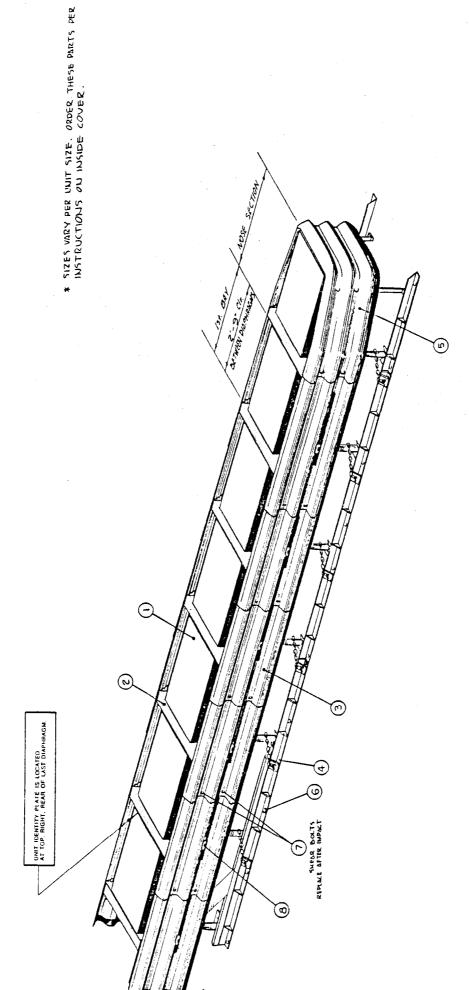
FIGURE 3

G-R-E-A-T System

The system suffered no weather damage for the first nine months. It was in June 1980 that the investigators first noticed a tear in the top of one waterproofing, plastic covering that surrounded the cardboard container of the Hi-Dri cells (Figure 3). The plastic actually had a sunburned appearance. On subsequent inspections, all cartridges exhibited tears and water penetration became excessive. By September 1981, approximately two years after installation, water penetration had deteriorated the cardboard cartridges so as to render them unsuitable to sustaining a collision. The following was a description submitted June 30, 1981.

On June 16, 1981, the principal investigator traveled to the site of installation in order to inspect the system. While the G-R-E-A-T showed no signs of being hit, it did show considerable weather damage. All plastic covers on the top of the cartridges are now gone. The cardboard boxes which are the cartridges are showing water damage. All have holes in their tops, and cartridge No. 10 is also deteriorated at the bottom so that one can see the ground looking through it. The system is still structurally sound and looks as though it will sustain a hit at present. Nevertheless, the investigator has recommended that all cartridges be replaced.

Late August or early September some of the Hi-Dri cells had slipped to the bottom of their cartridges. June 22, 1981, it was recommended that all cartridges be replaced.

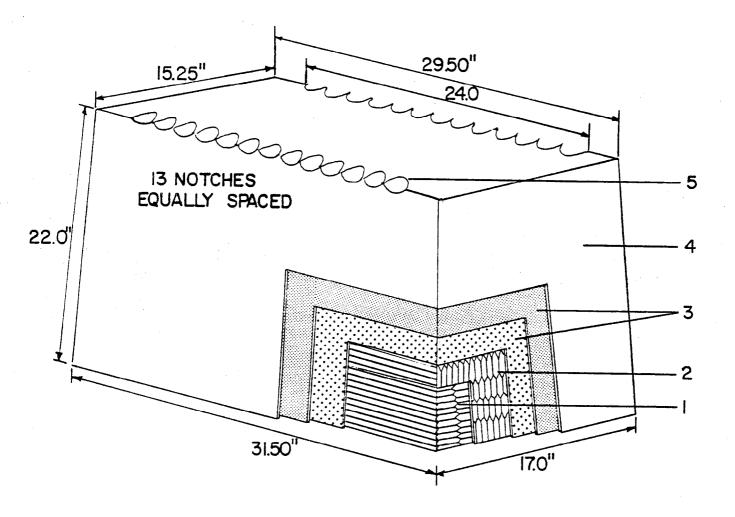
Hex-Foam Cartridge Assembly
FIGURE 5
12

The new Hex-Foam cartridge consists of the Hex-Foam material, a polyethylene bag for environmental protection, a burlap bag to contain the debris after an impact, and an outer semi-rigid container made of cross linked polyethylene. The outer container is made from the same material that has proven its weathering capability in both the G-R-E-A-T nose wrap and the Energite lid.*

Figure 5 is a drawing of the Hex-Foam cartridge.

On November 30, 1981, a district maintenance crew replaced the Hi-Dri with the new Hex-Foam cartridges, installed the cartridges' support brackets, and installed the restraining cable in one day. The maintenance crew stated that the retrofitting presented no problem; that becoming familiar with the system was the most confusing part of the whole operation. A breakdown of the crew's charges is as follows:

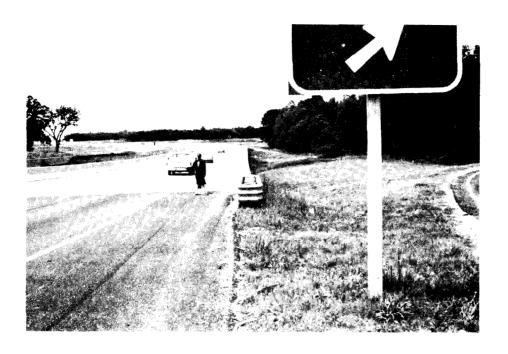
FIGURE 6

Since the installation of the new system, there has been no damage by vehicle or by the weather to the attenuator.

Distant View of G-R-E-A-T System

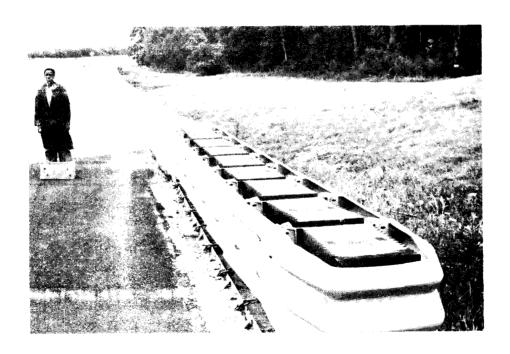
Close-up View of G-R-E-A-T System
FIGURE 7

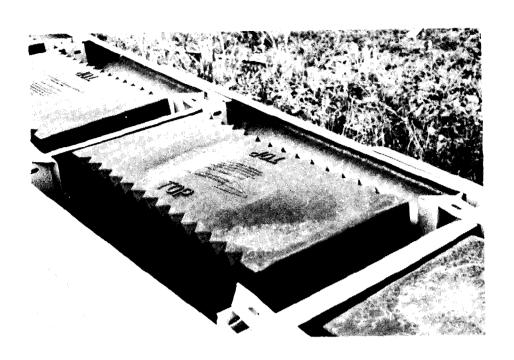
Hex-Foam Cartridge Assembly Installed FIGURE 8
