HEAT-STRAIGHTENING EFFECTS ON THE BEHAVIOR
OF FULL-SCALE SIMULATED BRIDGE GIRDERS

VOLUME 4: FIRST INTERIM REPORT OF PHASE 2

STATE PROJECT NO. 736-10-46
FEDERAL AID PROJECT NO. HPR-0010(008)
LSU PROJECT NO. 127-15-4141

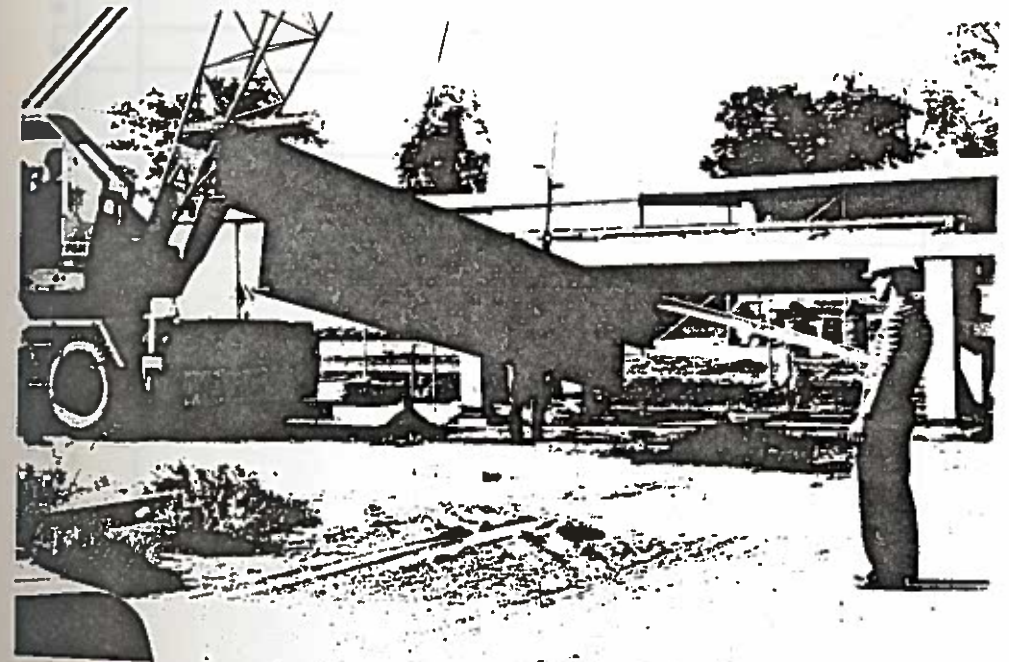
Figure 27. Deflected Shape of the Test Girder SB-3

The largest deflection occurred at the point of impact (point 11) which is located 10.1 feet from the roller support. That deflection was measured to be about 4.33 inches. The bottom flange had rotated approximately 5 degrees over its 8.99-inch width. Deflection measurements along the web revealed that the web had plastically yielded as a long, flat plate, bending about its weak axis in the longitudinal direction. That yield line occurred about 1 inch below the lower surface of the top flange. Initial deflection measurements taken along side "h" of the damaged girder are shown in Table 4. Figure 29 shows all the yield areas in this girder specimen.

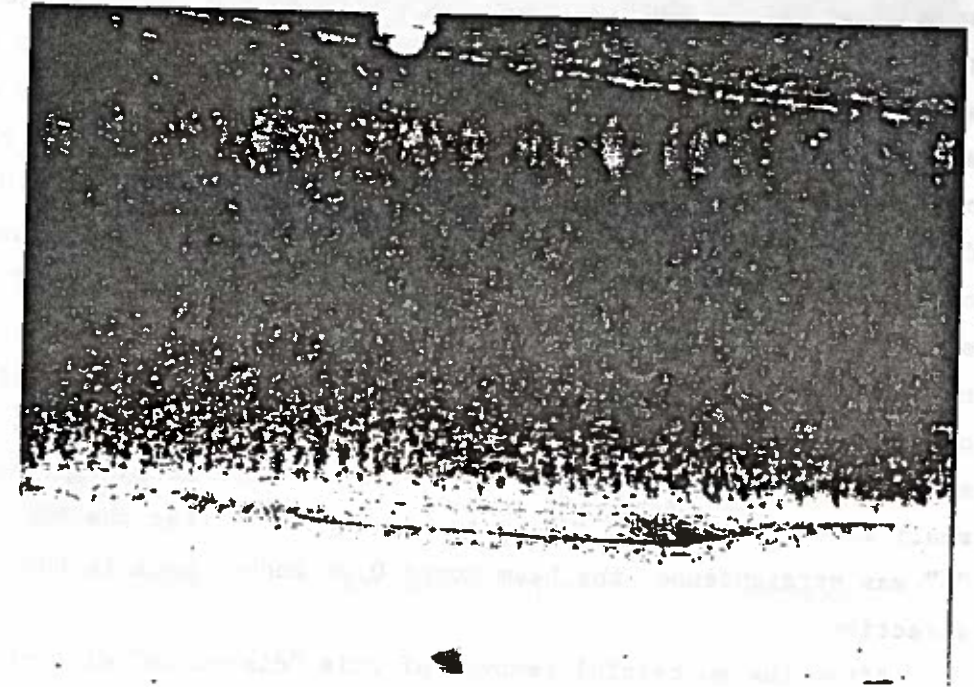
Figure 45. Close-Up View of the "Dish-Like" Distortion in Girder SB-1

After the successful heat-straightening repair of the lateral displacement of the bottom flange, two localized bulges still existed in that flange. These bulges are clearly seen in Figure 45. In order to achieve a complete restoration of the original undeformed shape of the girder, the bulges were removed in heating sequence 7. One bulge (side "d") of the bottom flange was caused by the large pressure exerted by the jacking device at the time of the damage inducement operation. The shape and location of that bulge has been previously described. The other bulge was very small. It existed on the opposite side (side "h") of the bottom flange and was caused by differential temperature variation during heating between the upper and lower surfaces of side "h" of the bottom flange. That temperature variation was caused by the repetitive heating of only the lower surface, which produced a buckle.
