1. Report No. FHWA/LA-88/210		2. Government Accession No.		3. Recipient's Catalog No.	
4. Title and Subtitle Development of Design Criteria for the Prevention of Slope Failures		5. Report Date March 1990

9. Performing Organization Name and Address Dept. of Petroleum Engineering and Geosciences Louisiana Tech University Ruston, LA 71272		10. Work Unit No.

**DEVELOPMENT OF DESIGN
CRITERIA FOR PREVENTION
OF SLOPE FAILURES**

FINAL REPORT

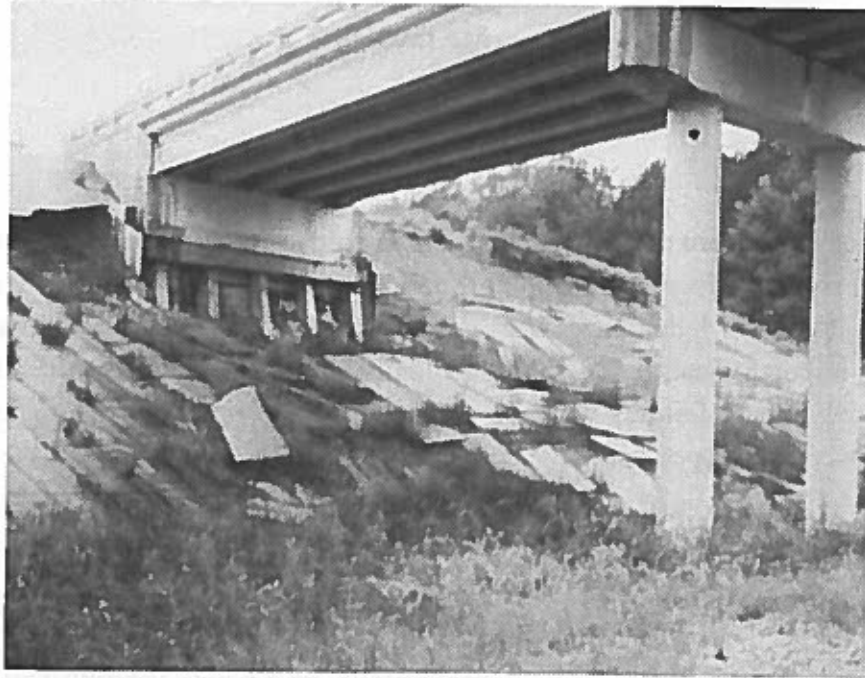
Figure 6. Slump at Locality S12, Acadia Parish, east side of overpass. The slump is 32 m wide and 21 m long. Scarp is 2.5 m high. Note the displaced sections of concrete apron.

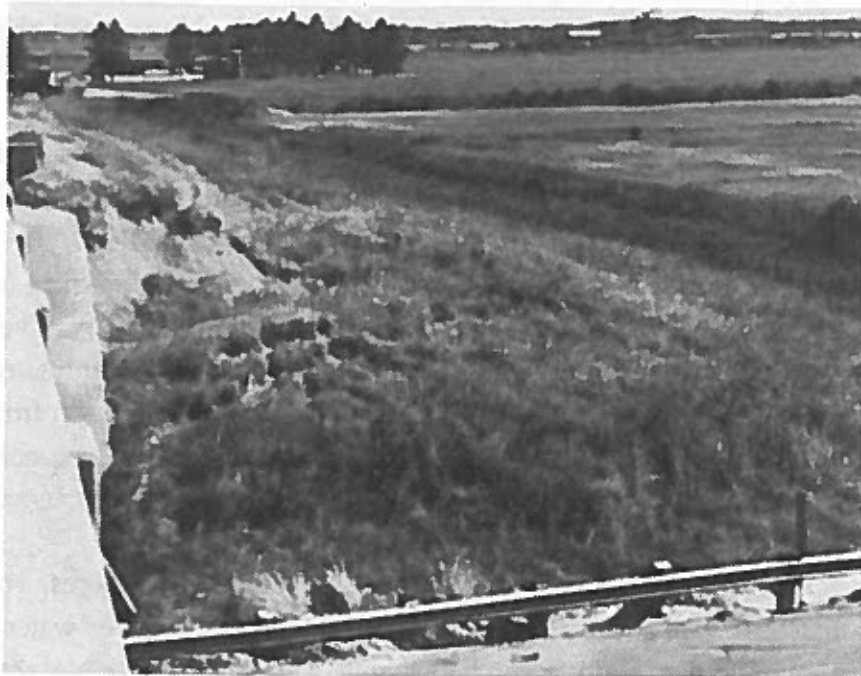
Figure 7. Slump at Locality S15, Acadia Parish, southwest quadrant. Failure morphology is well displayed: head scarp, rotated inward slump blocks, and toe above the guard rail.

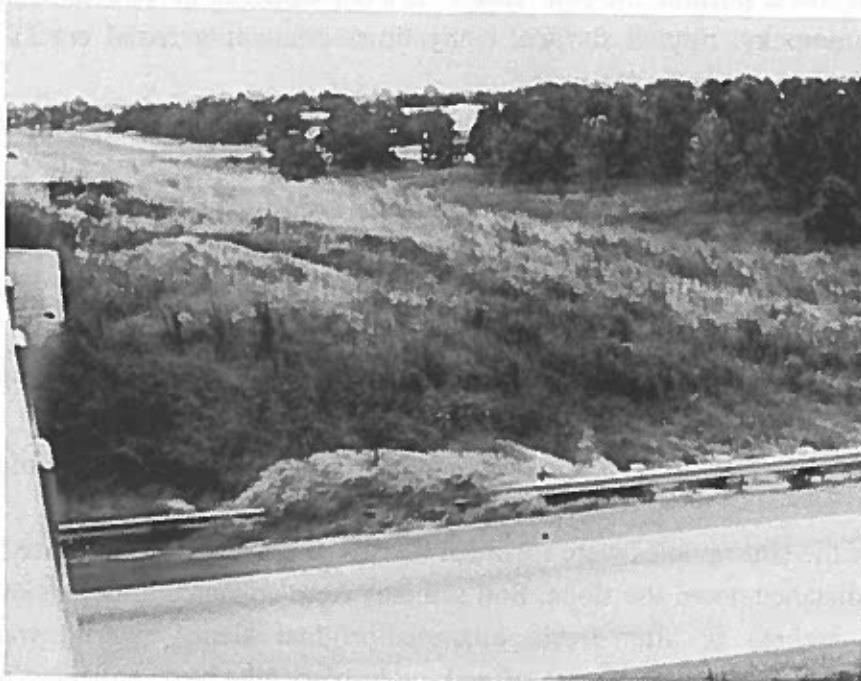
Figure 8. Slump-earthflow at Locality S17, Acadia Parish, northeast quadrant. Failed embankment material has "flowed" over guard rail onto shoulder of I-10.

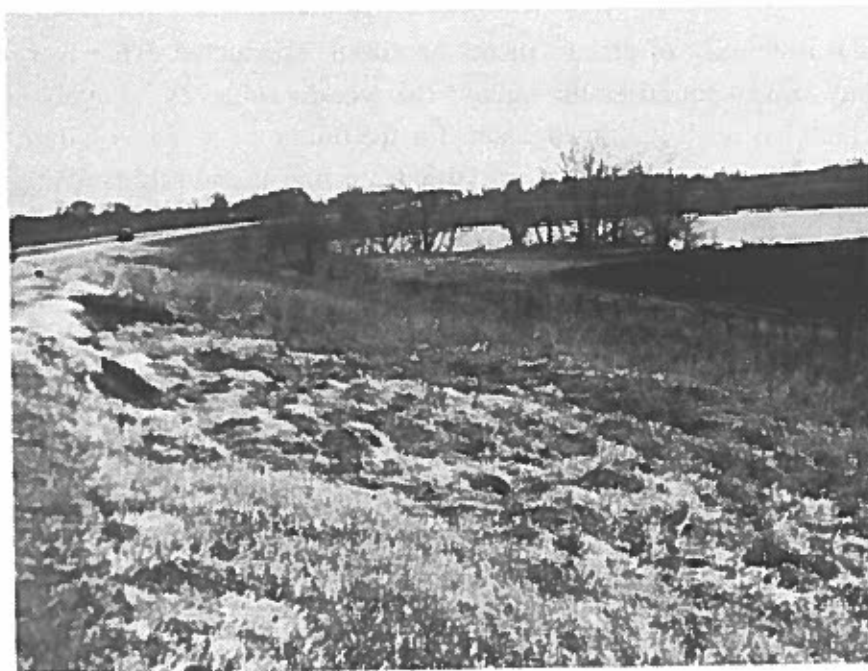
Figure 9. Water-filled borrow pit at Chicago Mill site (Locality N17), southeast quadrant, I-20 study area, Madison Parish. Note the slope failure (slump-earthflow) in foreground.

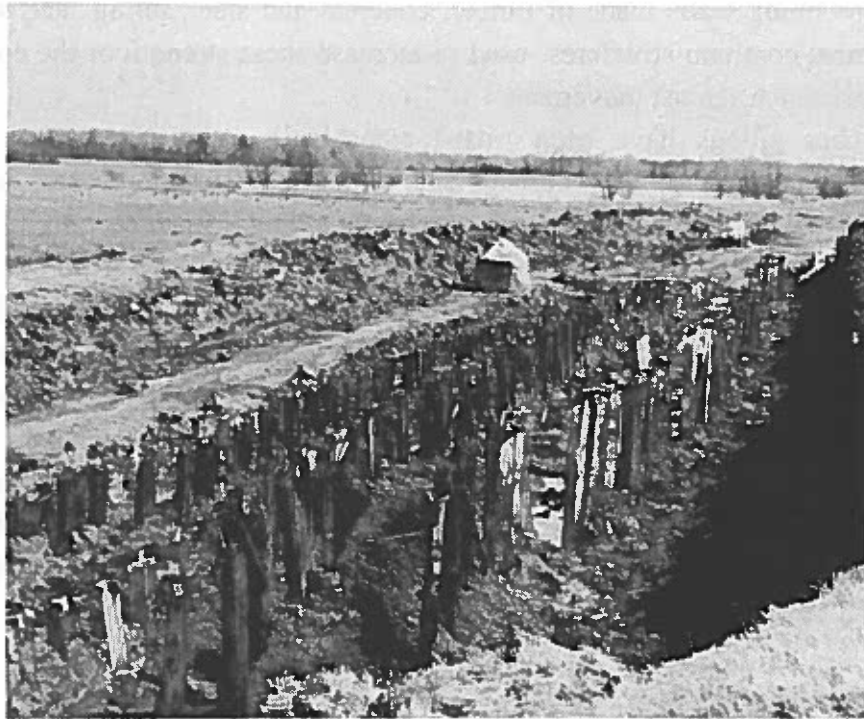
Figure 10. Unsuccessful attempt at stabilizing a failed slope by use of pilings at Chicago Mill site, Locality N17, northeast slope, Madison Parish, I-20 study area. Over 250 pilings were exposed in this one slope during repairs in 1987. The pilings do little to retard the movement of material that has a high shrink-swell clay content.

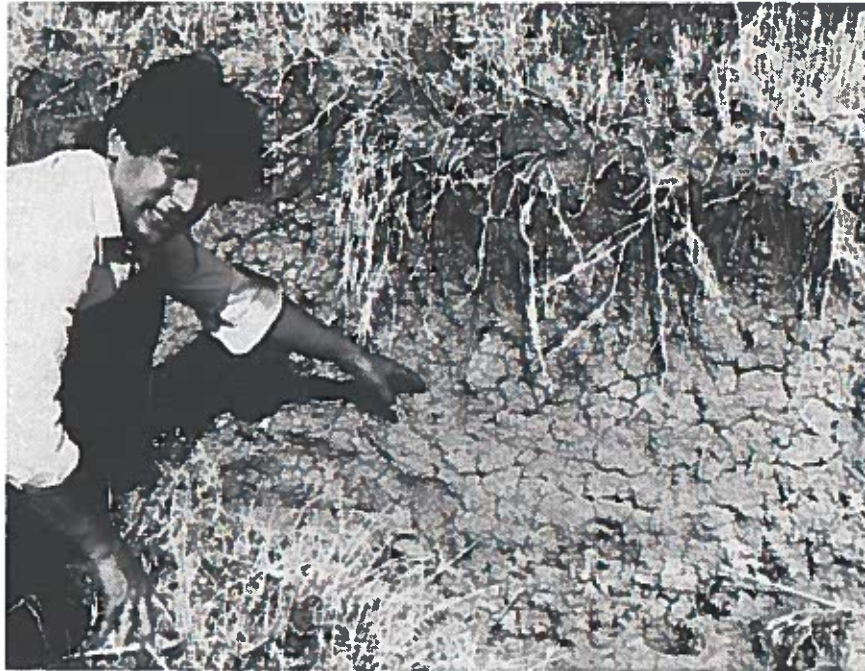
Figure 15. Polygonal cracks characteristic of high-smectite soils after dry periods. Photo taken at scarp of slump at Tendal northwest site, Locality N15, I-20 study area. The soil series is the Sharkey.

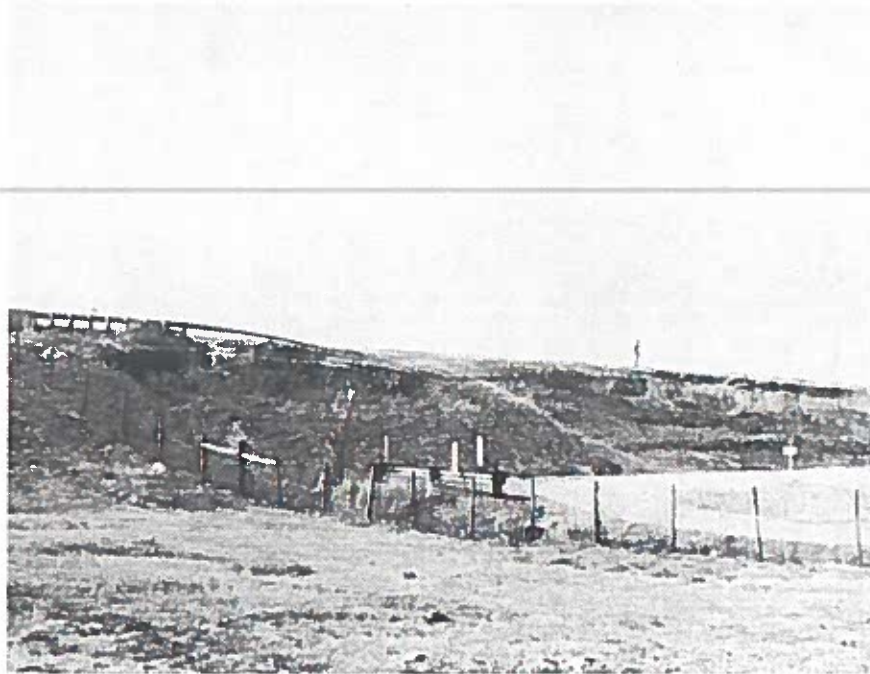
Figure 11. Failures are slump-earthflows which are separated by an earthflow. This slope is located in the I-20 study area, Tendal northeast quadrant, Locality N15, Madison Parish.

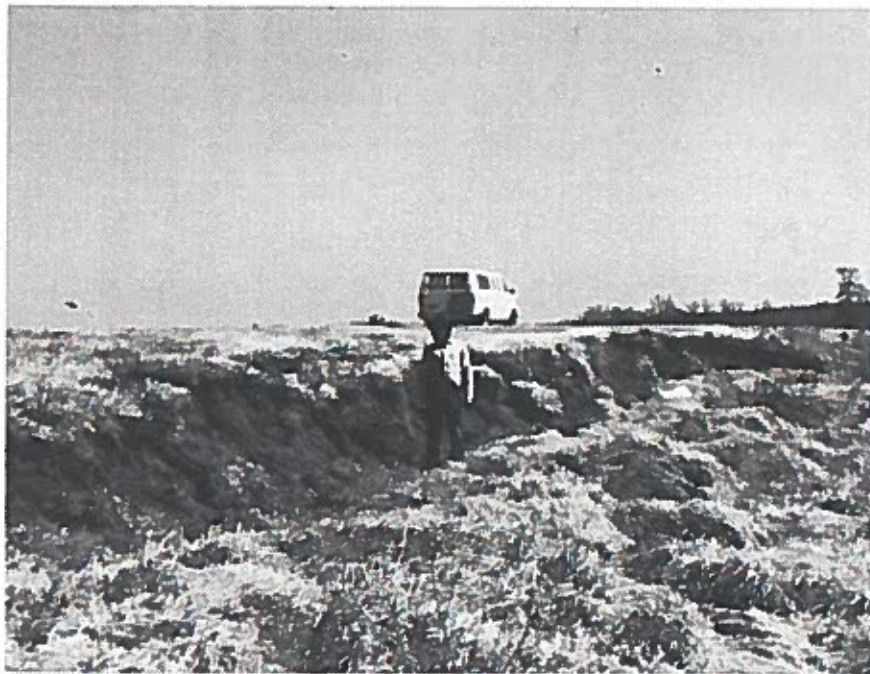
Figure 12. Prominent scarp at the head of a slump-earthflow at the Chicago Mill site, I-20 study area, Locality N17, southeast quadrant, Madison Parish.

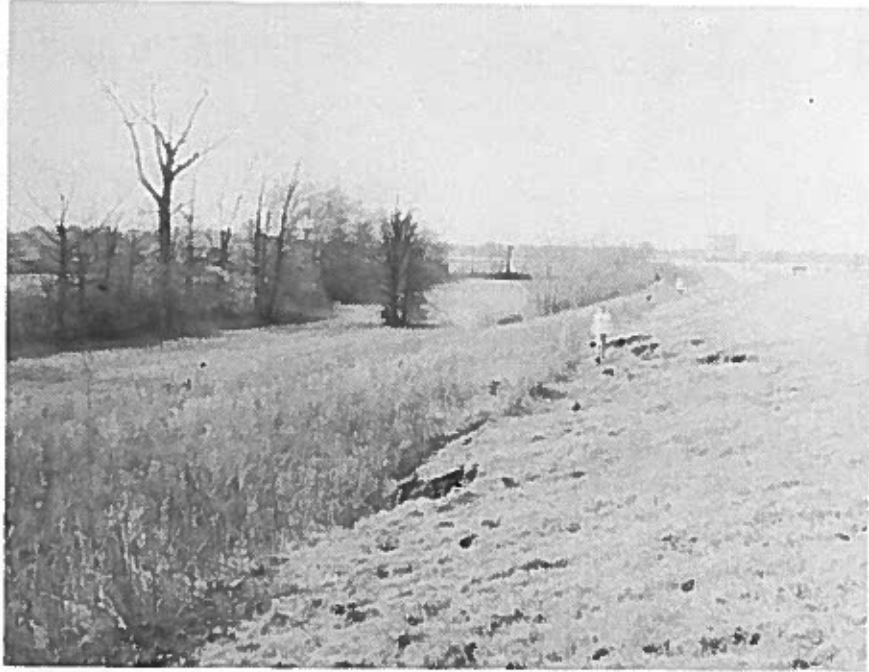
Figure 13. Slump-earthflow at Chicago Mill, southwest quadrant, Locality N17, Madison Parish, I-20 study area. The high vegetation masks the failure. This failure continued to grow throughout the duration of the study.

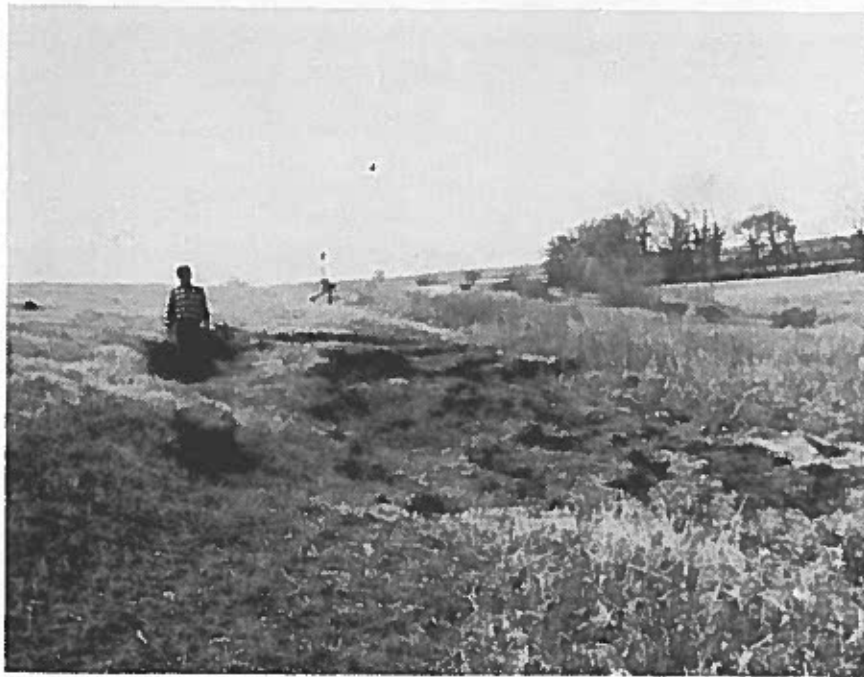
Figure 14. Slump exhibiting minor scarps caused by rotation. This failure appears on the northwest quadrant of Tallulah railroad site, Locality N18, Madison Parish, I-20 study area.

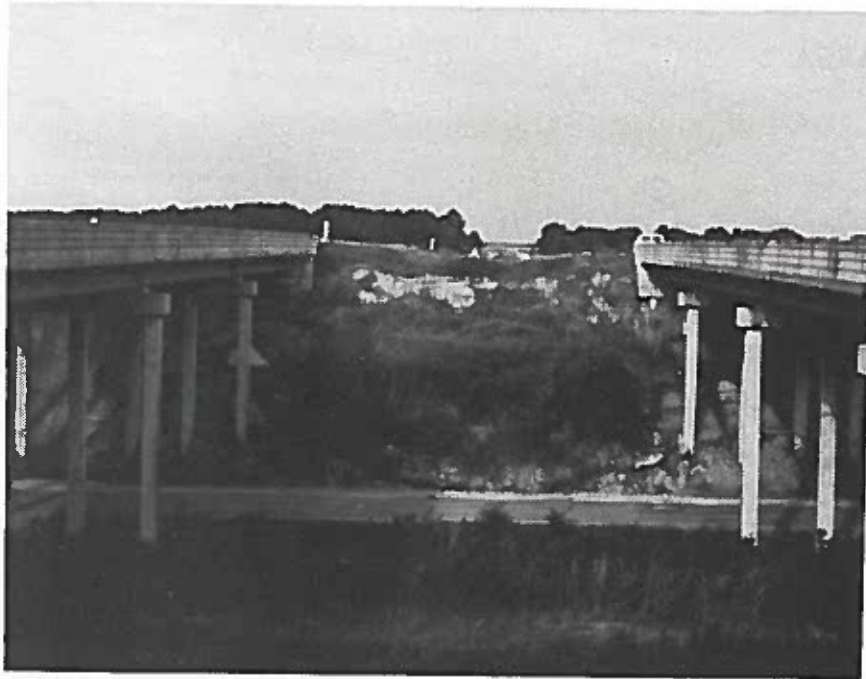
Figure 16. Slump failure between two bridges on I-10 (Locality S12, AC-Bridge, east side). Note the broken and displaced sections of concrete revetment apron.

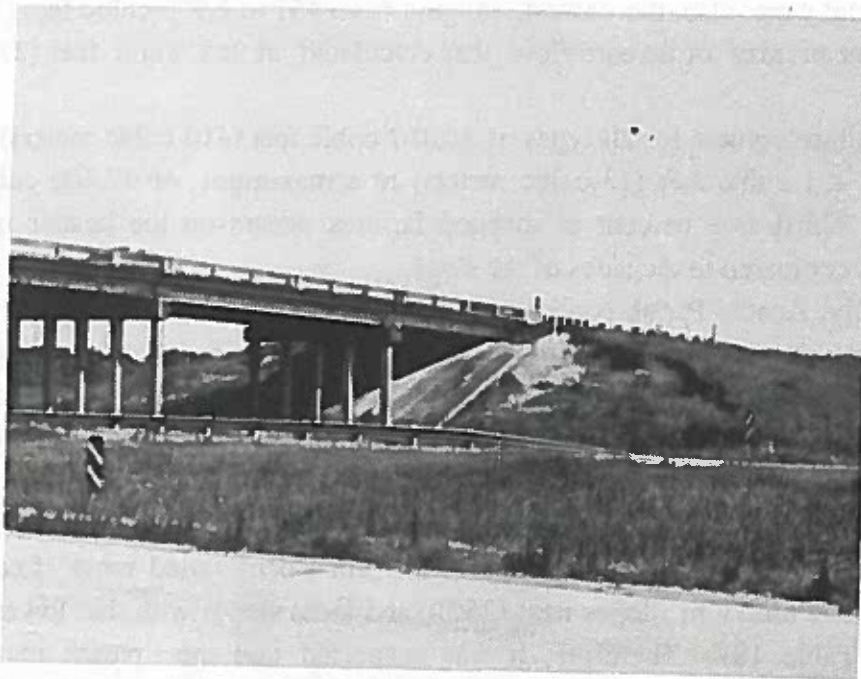
Figure 17. Slump-earthflow beginning to undermine the revetment apron at Locality S15, AC-EO1111-SW.

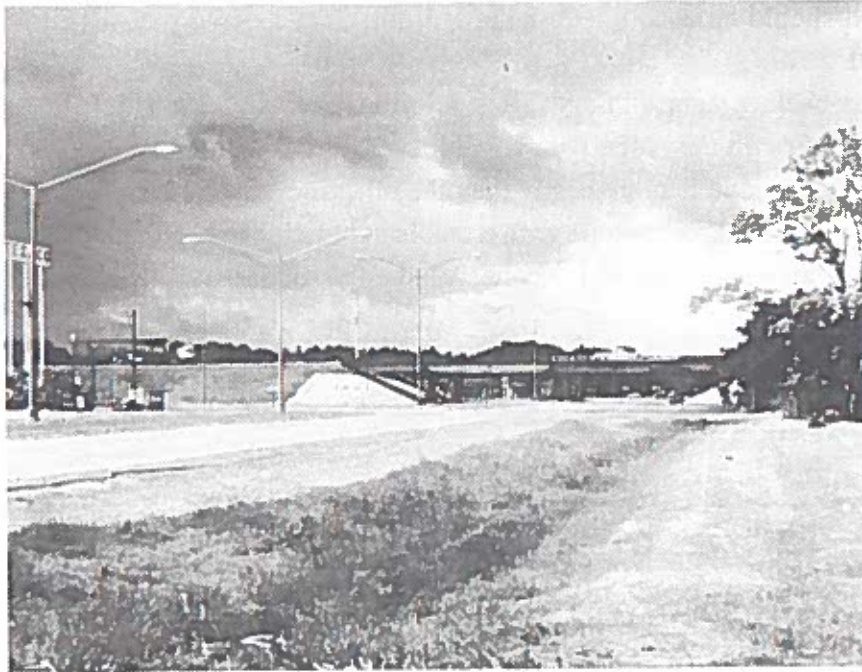
Figure 39. Revetments on the headers. This site has not failed and is located at the interchange at Rayne in the I-10 study area. This design is recommended to reduce the large number of header failures.

Control of slope stability centers around control of the shrink-swell clay in the slope soils. It is recommended to lime-stabilize the soils to inactivate the smectite clays. A map of the distribution of these clays in Louisiana is included in the report. It is not recommended to drive pilings or push the failed soil back up onto the slope. It is also recommended to have adequate drainage to control surface run-off on these slopes. It is also suggested to extend the header revetment aprons under the bridges onto the sides.
