CRASH TESTING OF LOUISIANA'S
3 1/2" DIAMETER MULTI-DIRECTIONAL,
SINGLE STEEL POST, SMALL SIGN SUPPORT

RESEARCH REPORT NO. 267
RESEARCH PROJECT NO. 93-1SS(B)

Conducted by
SAFETY DIVISION, TEXAS TRANSPORTATION INSTITUTE,
THE TEXAS A&M UNIVERSITY SYSTEM
COLLEGE STATION, TEXAS 77843
and
LOUISIANA TRANSPORTATION RESEARCH CENTER,
LOUISIANA DEPARTMENT OF TRANSPORTATION AND DEVELOPMENT
In Cooperation With
U.S. DEPARTMENT OF TRANSPORTATION
FEDERAL HIGHWAY ADMINISTRATION

March 1993

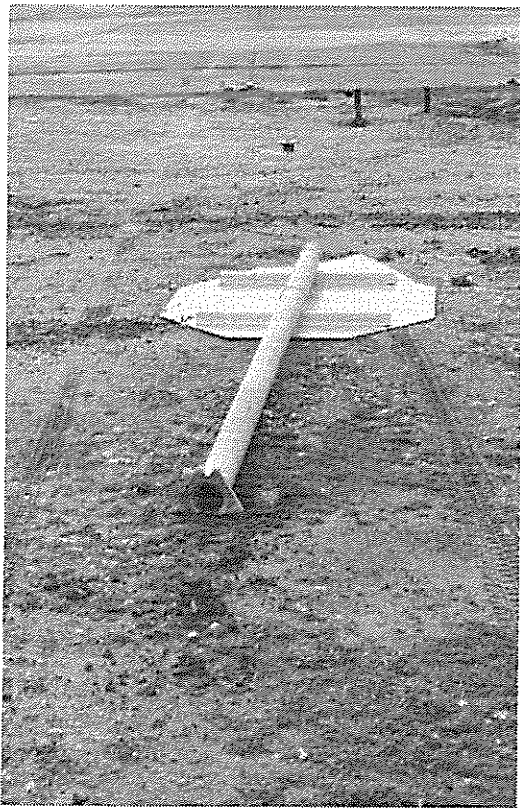
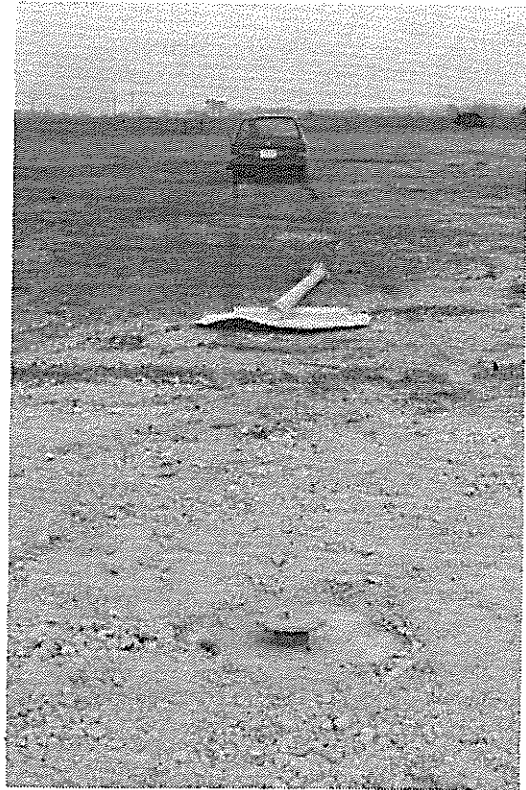
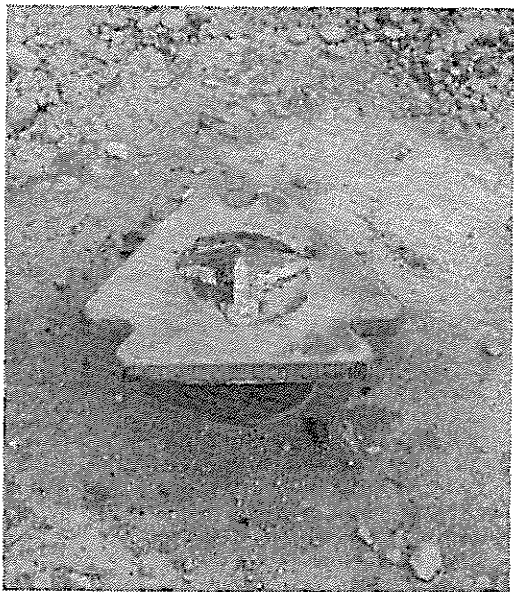
Figure 7. Sign installation after test 7222-1.

The installation yielded to the vehicle. Damage sustained to the sign installation is shown in Figure 7. The sign support came to rest 18.5 ft (5.6 m) from the point of impact. The vehicle sustained very minimal damage to the bumper and hood as shown in Figure 9. Maximum crush to the vehicle was 2.5 cm (1.0 in), located at the rear left side of the roof.

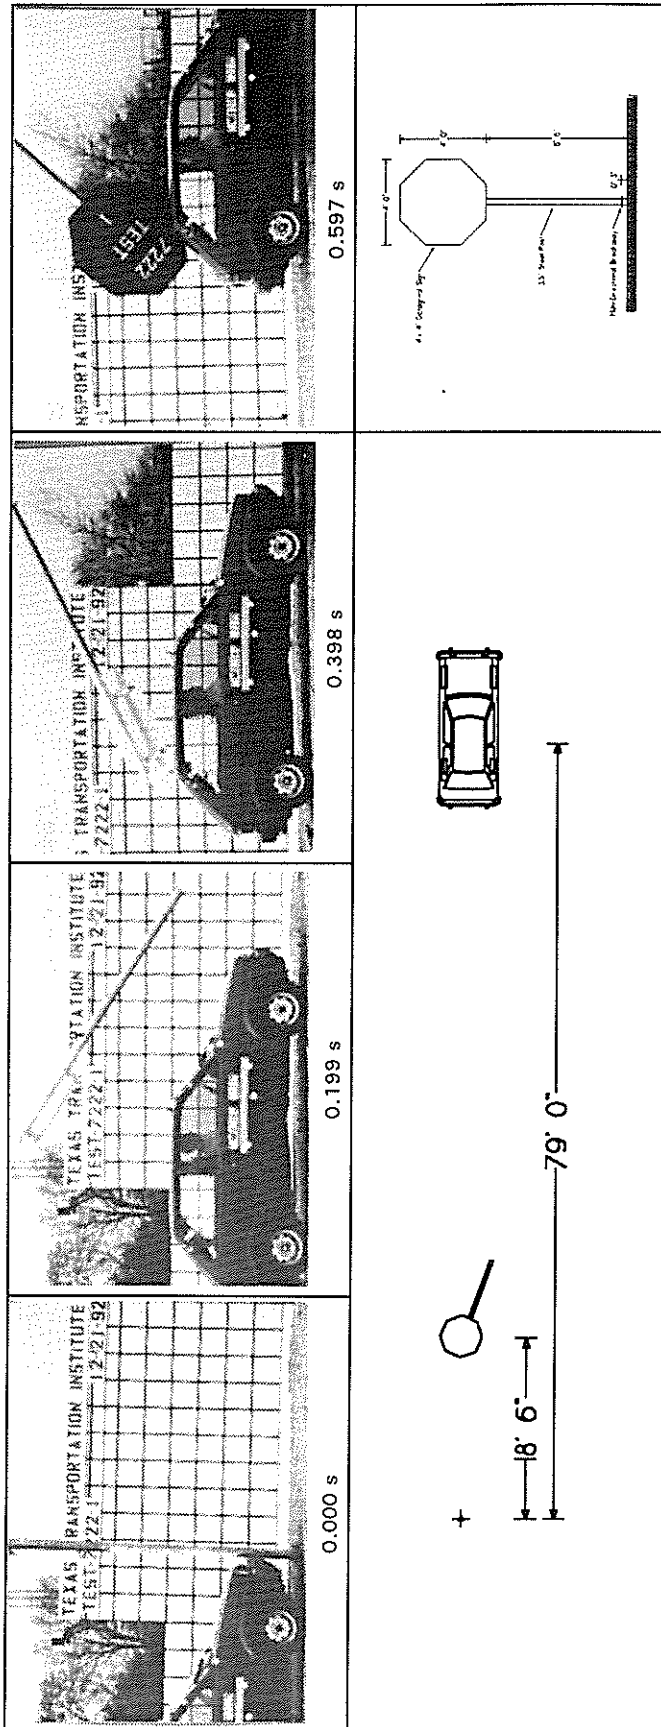
Figure 10. Data summary for test 7222-1.

A summary of the test results and other information pertinent to this test are given in Figure 10. The maximum 0.050 second average acceleration experienced by the vehicle was -0.9 g in the longitudinal direction and 0.3 g in the lateral direction. Vehicle angular displacements are plotted in Figure 11 and vehicle accelerometer traces are displayed in Figures 12 through 14. Occupant impact velocity in the longitudinal and lateral direction are not applicable to this test, as theoretical occupant displacement did not reach 0.6 m (2.0 ft) longitudinal or 0.3 m (1 ft) lateral. Occupant ridedown accelerations were not

applicable as well because theoretical occupant contact did not occur. Change in vehicle velocity was 2.8 km/h (1.7 mi/h).

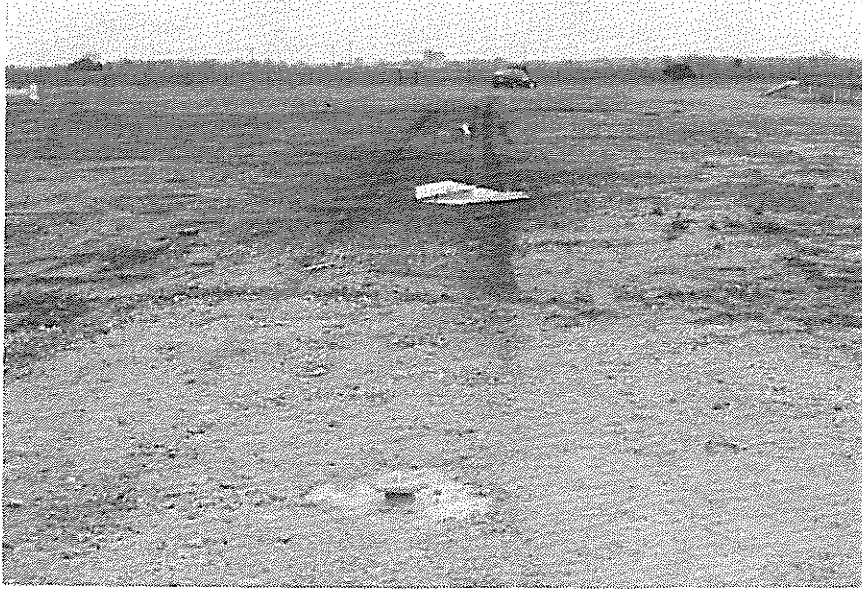
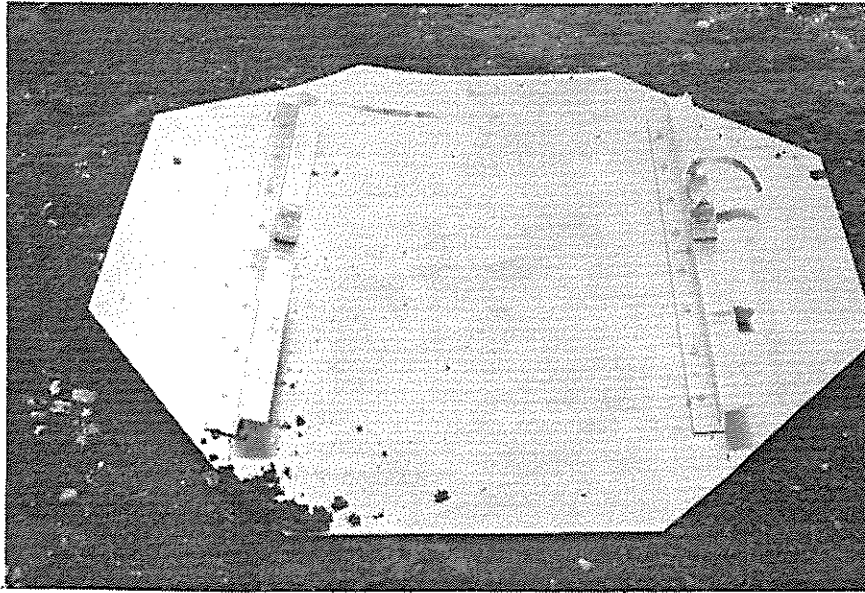
Figure 17. Sign installation after test 7222-2.

The installation yielded to the vehicle. Damage sustained to the sign installation is shown in Figure 17. The sign support came to rest 18.7 m (61.3 ft) from the point of impact and the sign panel 10.1 m (33.3 ft). The vehicle sustained moderate damage to the bumper, grill, radiator, fender and hood as shown in Figure 19. It should be noted, the extreme rearward displacement of the right front wheel is due to the lower ball joint coming out of the spindle assembly. The nut from the ball joint was found to be stripped off. It was inconclusive whether the nut was stripped off from prior fatigue or from possibly impacting the support stub. No evidence was found to conclusively support the latter. Maximum crush to the vehicle was 13.5 cm (5.3 in), located at the front right quarter of the vehicle.

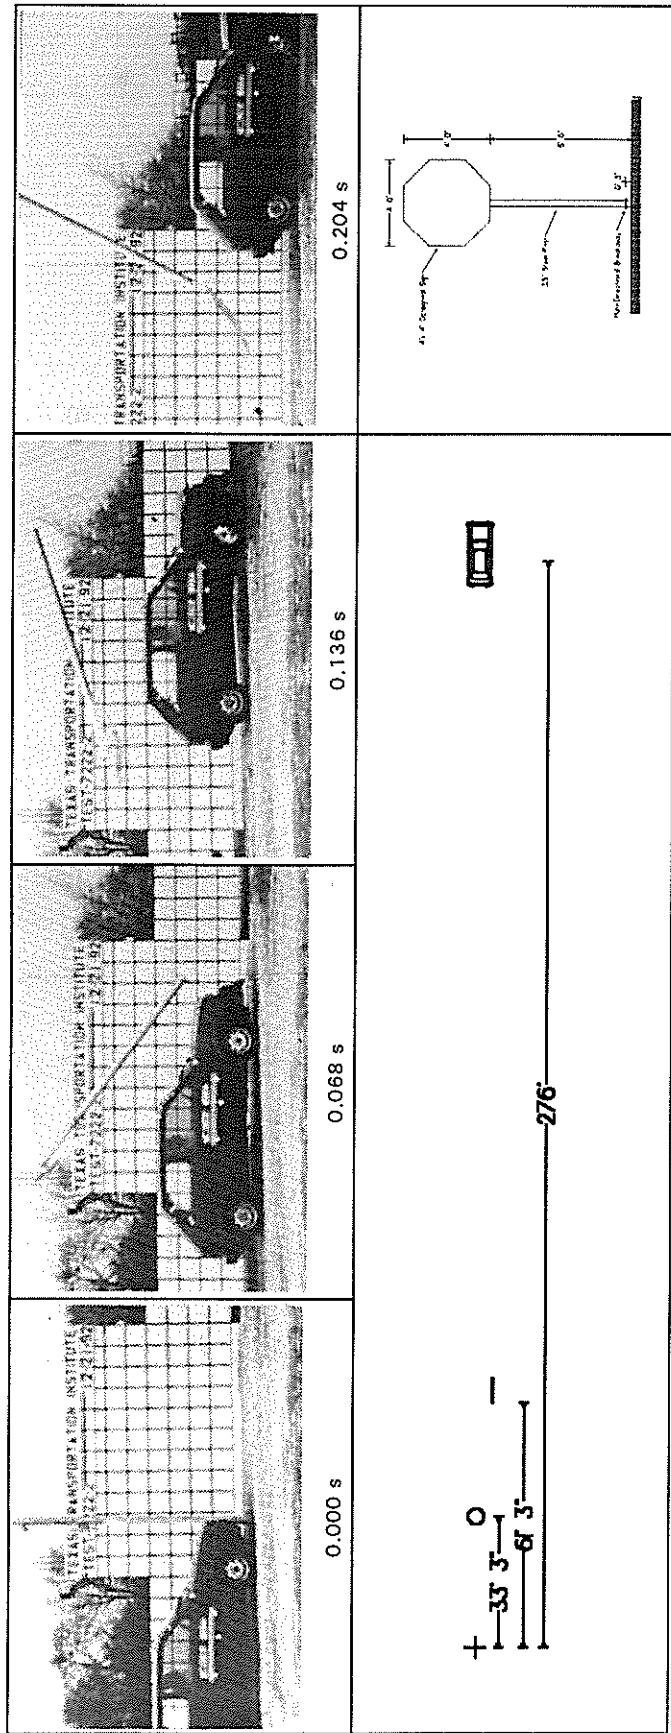
Figure 20. Data summary for test 7222-2.

A summary of the test results and other information pertinent to this test are given in Figure 20. The maximum 0.050 second average acceleration experienced by the vehicle was -2.3 g in the longitudinal direction and -0.8 g in the lateral direction. Vehicle angular displacements are plotted in Figure 21 and vehicle accelerometer traces are displayed in Figures 22 through 24. Occupant impact velocity in the longitudinal and lateral direction are not applicable to this test, as theoretical occupant displacement did not reach 0.6 m (2.0 ft) longitudinal or 0.3 m (1 ft) lateral. Occupant ridedown accelerations were not applicable as well because theoretical occupant contact did not occur. Change in vehicle velocity was 5.3 km/h (3.3 mi/h).
