1. Report No. FHWA/LA-92/287		2. Government Accession No.	3. Recipient's Catalog No.
4. Title and Subtitle Break and Seat of Jointed Reinforced Concrete Pavements		5. Report Date September 1994

BREAK AND SEAT OF JOINTED
REINFORCED CONCRETE PAVEMENTS

INTERIM CONSTRUCTION REPORT
BY

RESEARCH REPORT NO. 287

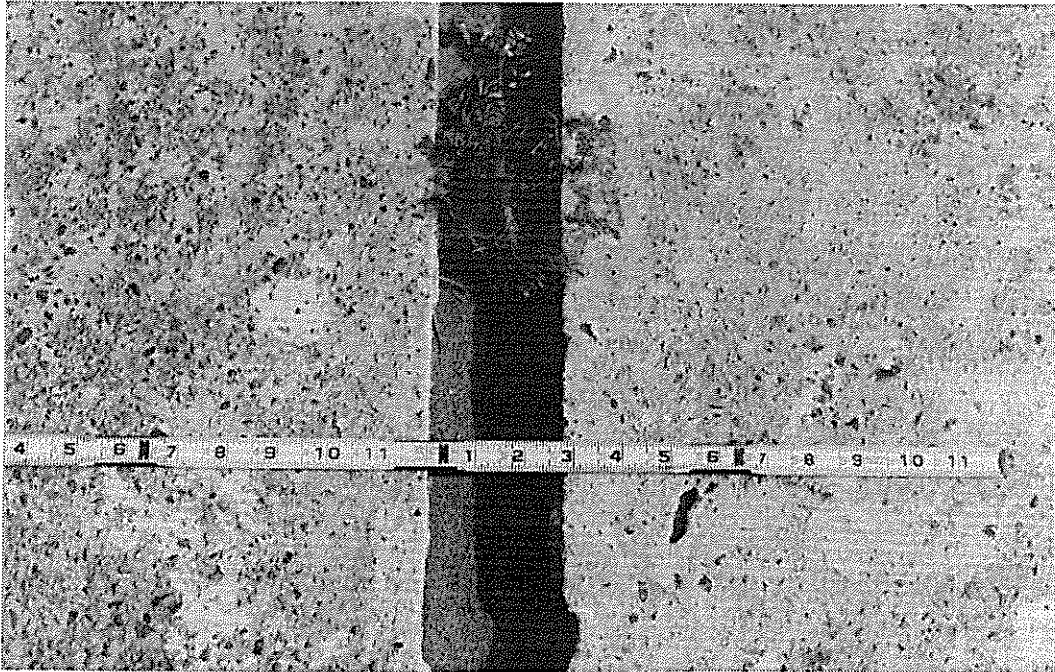
An initial visual distress survey was conducted on the SP-202 sections prior to breaking operations. Crack positions were measured and a crack map produced. In addition, a hand held videotape recording of each section was taken to permanently record the pre-rehabilitation distress for future reference. The initial distress survey for the SP-202 test sections is shown in Figure 13 of Appendix A. Figures 2 and 3 are sample photographs of the existing joint conditions.

Figure 2. Crack width of existing joint.

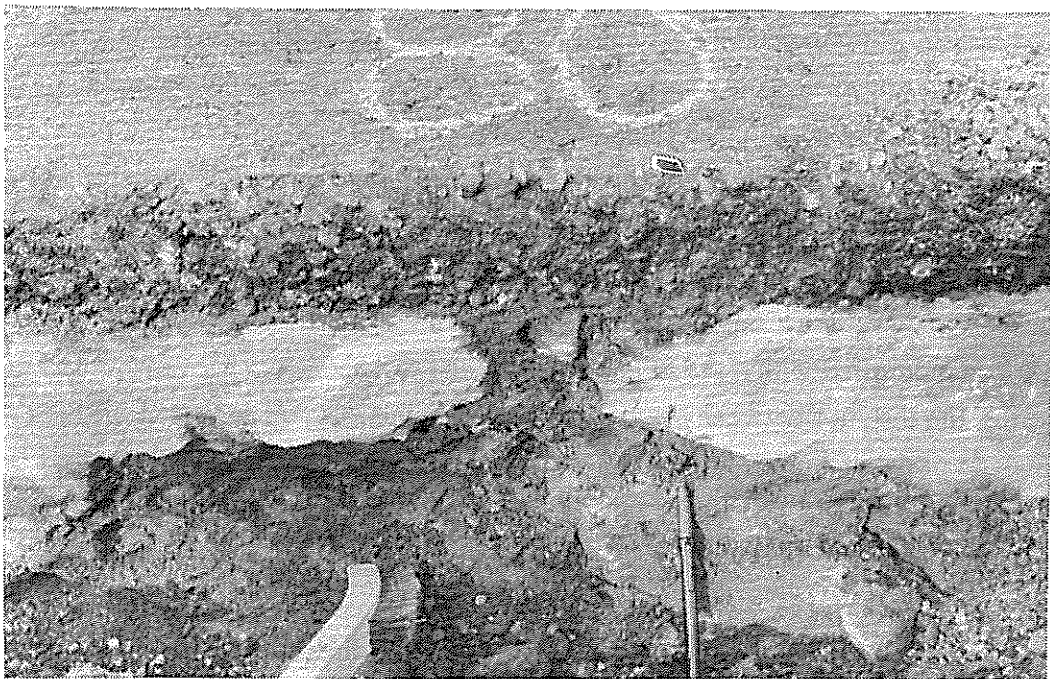
Figure 3. Condition of slab edge at the joint.

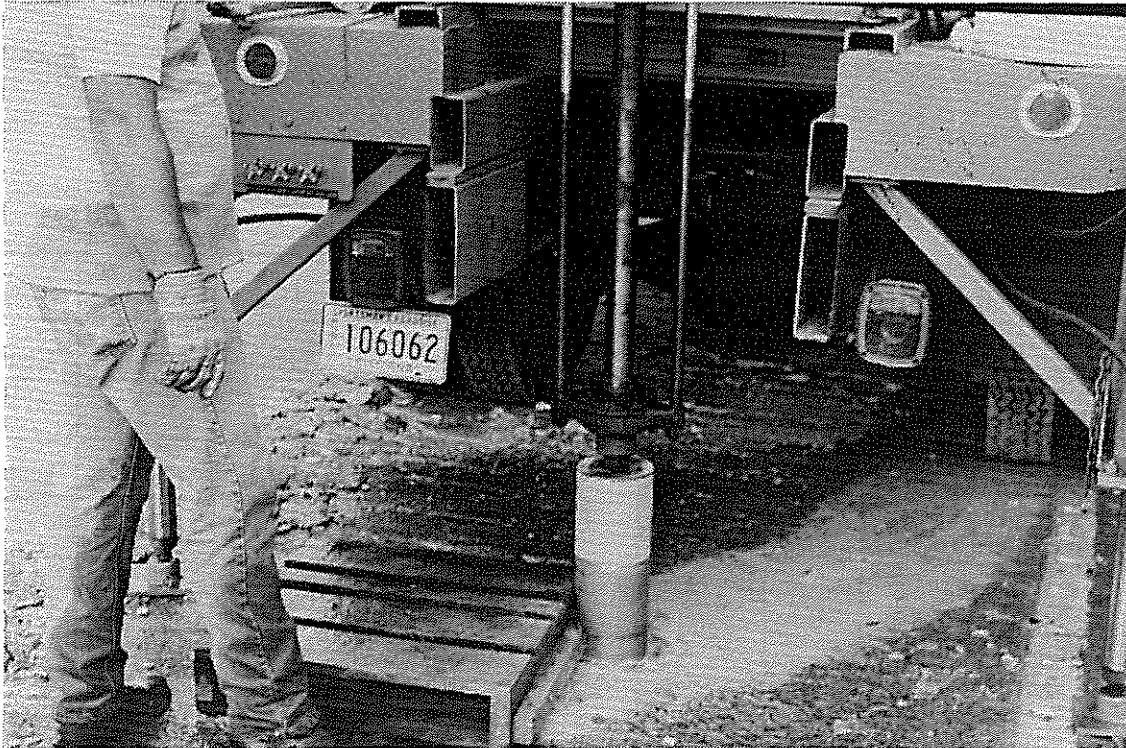
The six inch diameter cores taken within the test sections as shown in Figure 7 were to verify full depth breaks and determine the degree of debonding of the wire mesh reinforcing from the PCC. These cores were taken to coincide with selected post-break, mid-panel, FWD test locations. Information on these core locations are shown in Table 7.

Full-depth cracks were evident in each of the cores after breaking, however, in every case the steel was only partially debonded from the concrete. Coring operations and extracted cores were videotape recorded.

Figure 7. After Break Core, 6" Break Pattern.

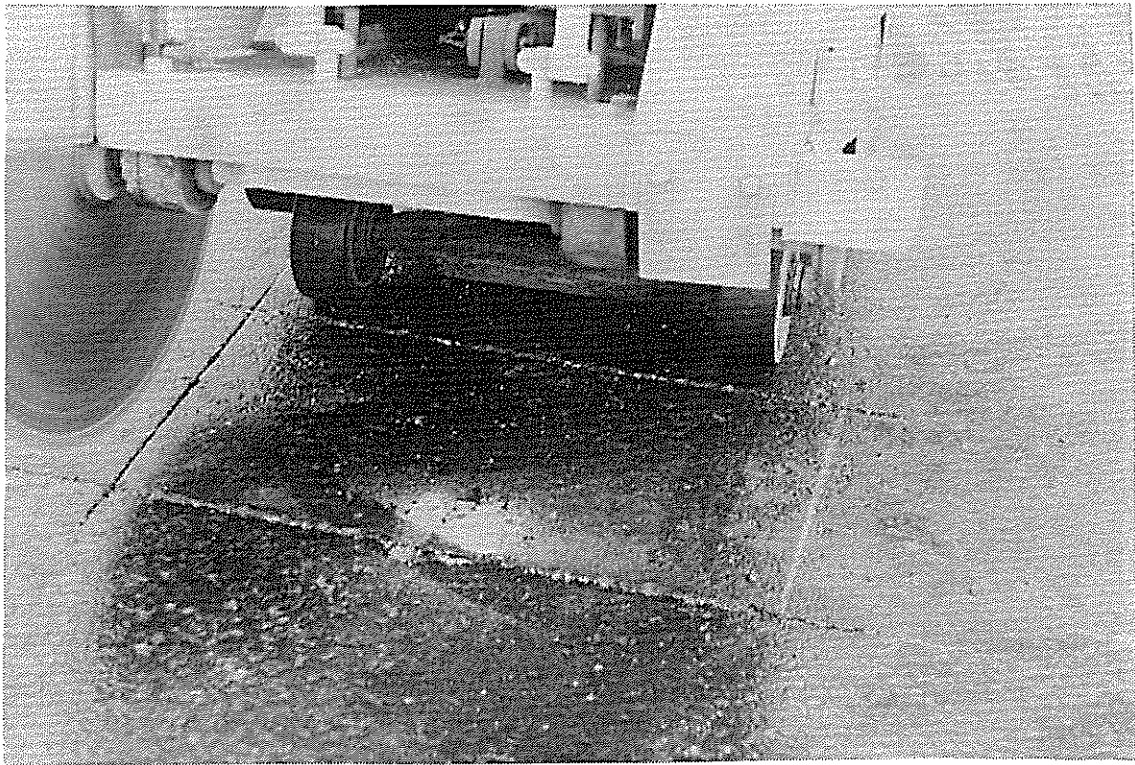
Figure 9. Saw Cut for Utility Box Installation.

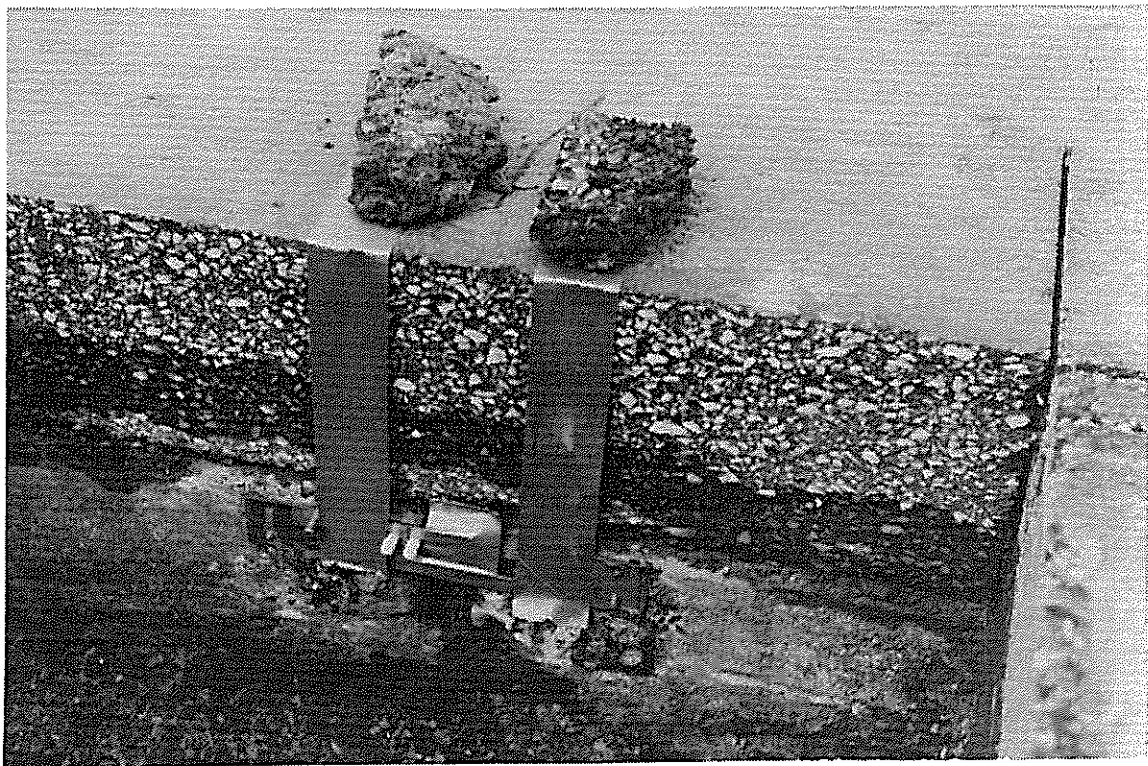
Figure 10. Installation of Monitoring Gauge.

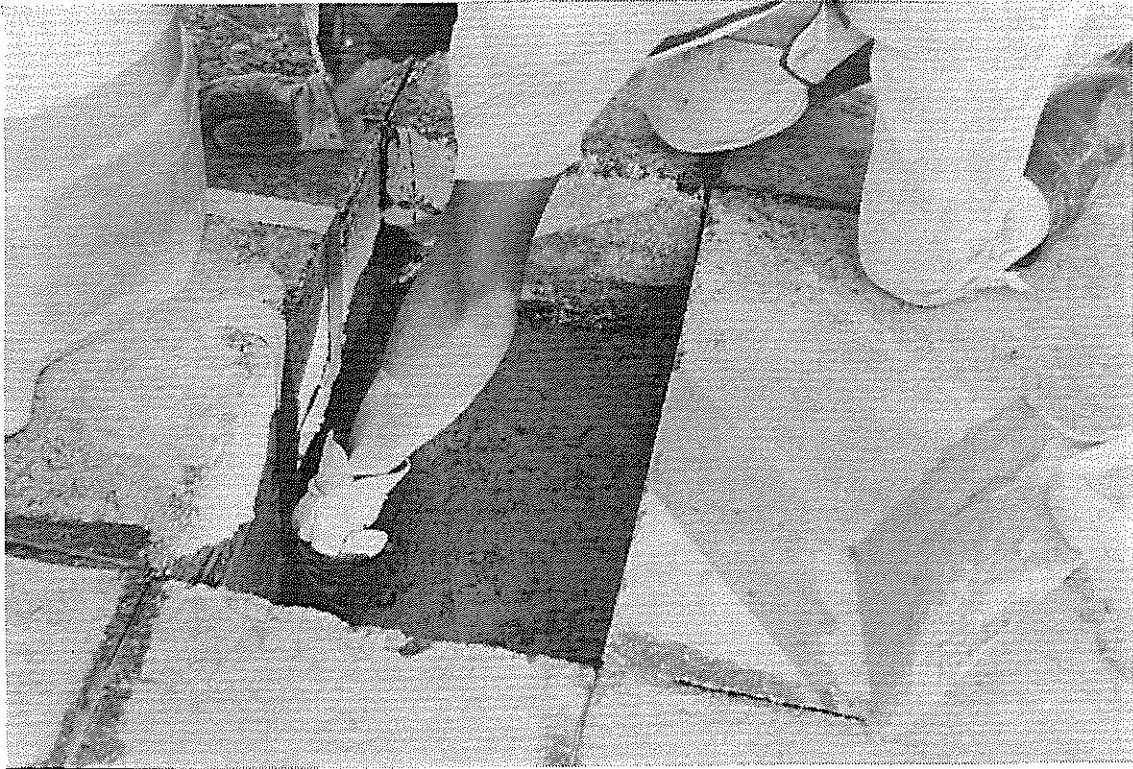
To avoid build up of water and ice around the gauges, the PCC access box support base was removed along the side of the original PCC slab within the access box. Photographs of the installation process are shown in Figures 9, 10, 11, and 12.

Figure 11. Preparing Base for Utility Box.

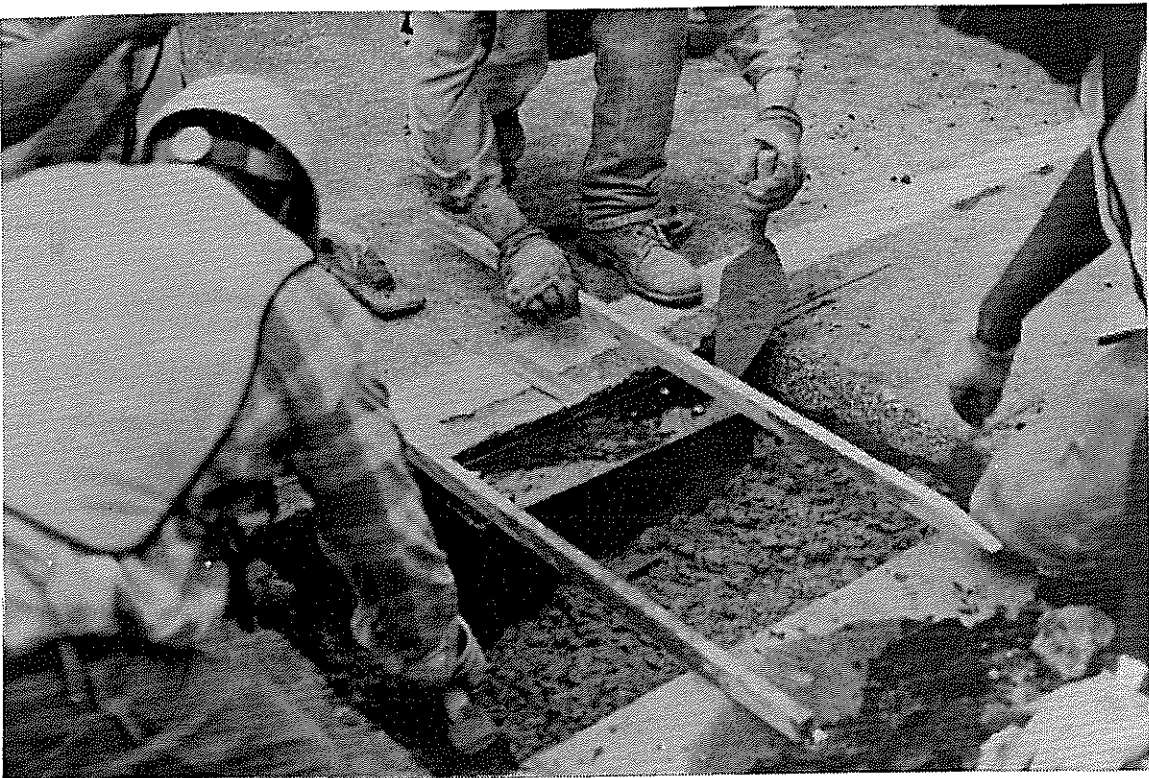
After the gauges were installed, the contractor established two directional traffic flow on the eastbound lanes. All eastbound main line traffic was partially channeled onto the outside shoulder. This new traffic pattern placed the access boxes, (which were only designed for shoulder use and to only support occasional partial wheel loads) in the outside wheel path of the main line pavement. Under this intense loading, the access boxes failed.

Figure 12. Installation of Utility Box..

Once the contractor re-established directional flow of the traffic, the state redesigned and fabricated stronger access boxes. The new boxes along with new gauges were reinstalled at the same locations during the week of 10/28/92 through 10/30/92. The gauges were set and initial (start of monitoring period) readings were taken on 11/04/94 and 11/05/92 which are discussed in Section 8 of this report.
