1. Report No. State Project Number: 736-99-0680		2. Government Accession No.	3. Recipient's Catalog No.
4. Title and Subtitle Implementation of Heat-Straightening Repairs for Louisiana Bridges		5. Report Date December 1998

**IMPLEMENTATION OF HEAT-STRAIGHTENING REPAIRS
FOR
LOUISIANA BRIDGES**

LTRC PROJECT NO. 99-1C
STATE PROJECT NO. 736-99-0680

LOUISIANA DEPARTMENT OF TRANSPORTATION AND DEVELOPMENT
LOUISIANA TRANSPORTATION RESEARCH CENTER

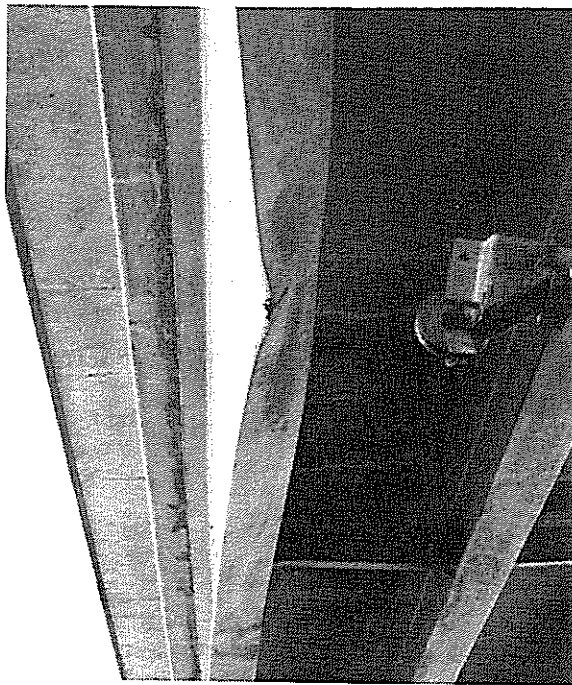
The initial inspection indicated that the bridge remained stable. The lower flange had displaced approximately 17 inches at the impact point (fig. 1). Impact occurred on the lower flange directly over the center of the right, eastbound lane (fig. 2). Located six feet to the left of diaphragm number 2, the flange had a sharp dimple where the impact occurred (fig. 3). Diaphragms 2 and 3 were partially crushed but most bolts remained intact (fig. 4). Very minor crushing was observed at diaphragm 4. No significant damage was found at the end diaphragms, 1 and 5, or at the bearing supports. The top flange had pulled out of the slot on the underside of the concrete deck and had a maximum lateral deflection of 1.5 inches (fig. 5). The concrete deck had not cracked. Since there was no immediate safety concerns and the overpass was lightly traveled by local traffic, the bridge remained open to traffic.

Figure 1
View of damaged beam at region of impact

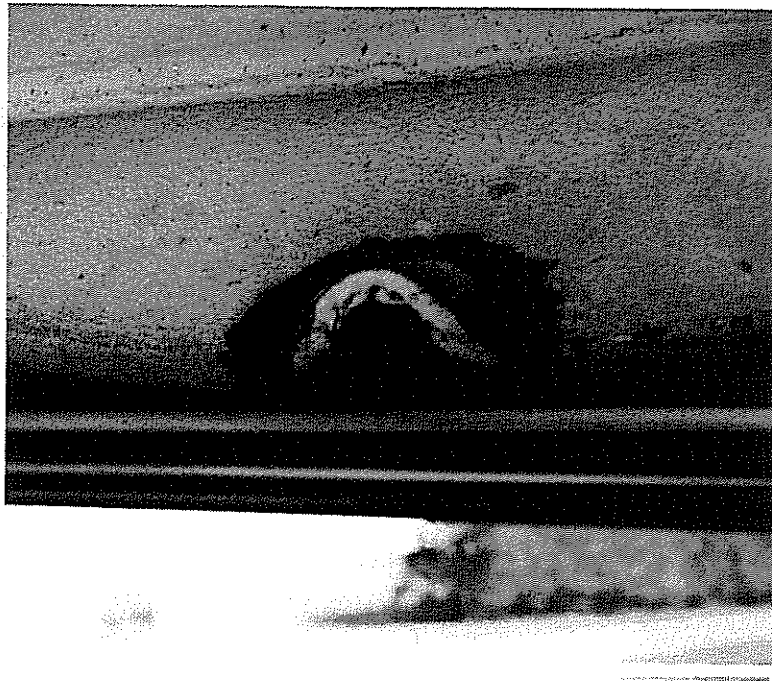
Figure 3
Point of impact

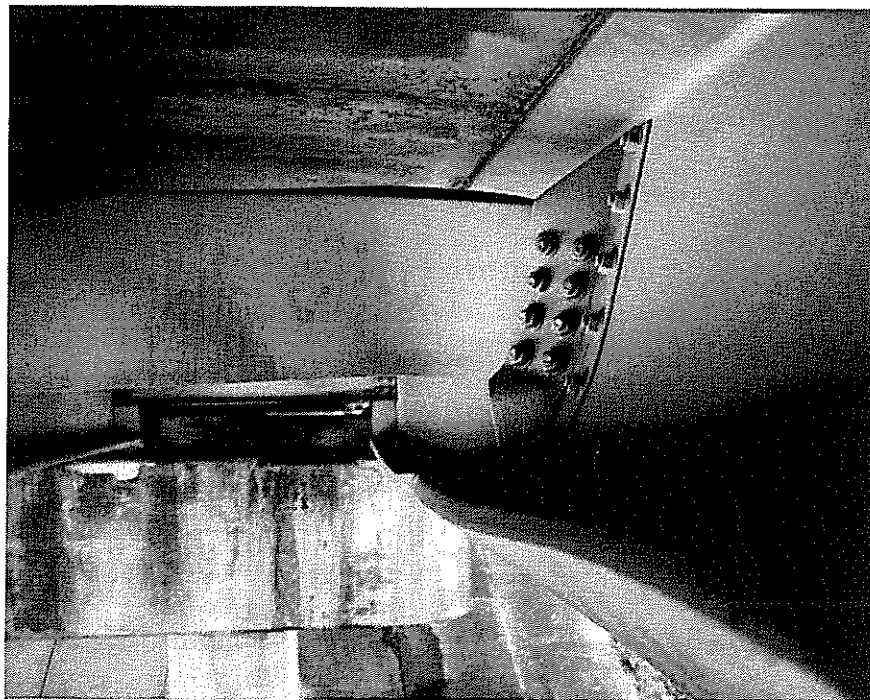
Figure 4
Damage diaphragm number two

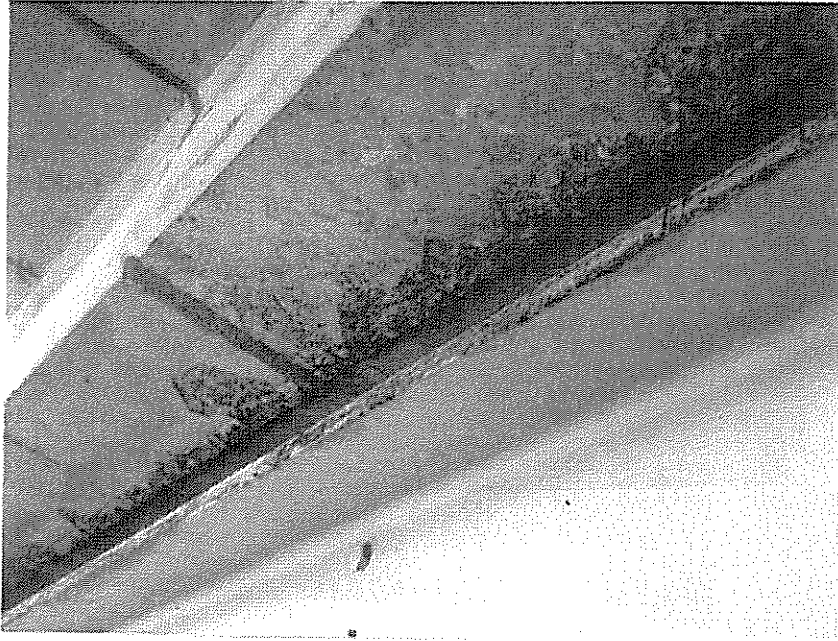
Figure 5
Top flange pulled out of slot

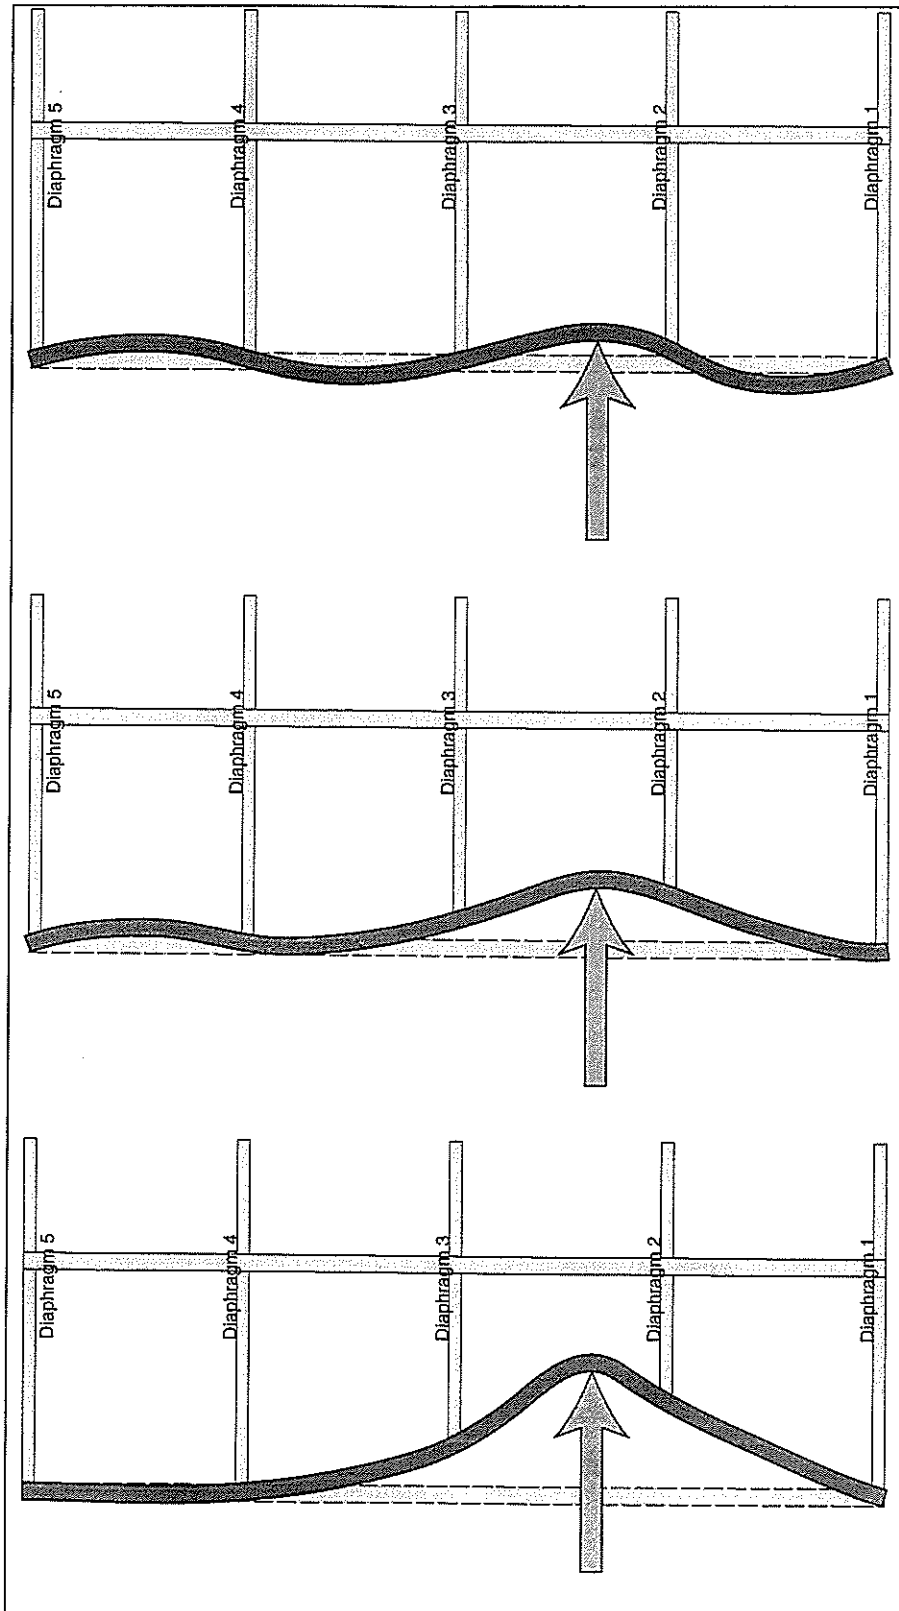
Progression of damage and primary locations. The progression of damage is illustrated in figure 6. At the impact point, the lower flange began to displace laterally with a plastic hinge forming as it translated and rotated. The lower flange behaved similarly to a beam continuous over supports, with the diaphragms acting as supports (fig. 6a). The force from

impact was translated to the adjacent diaphragms causing them to partially crush (fig. 6b).

Figure 6
Stages of lower flange movement during impact

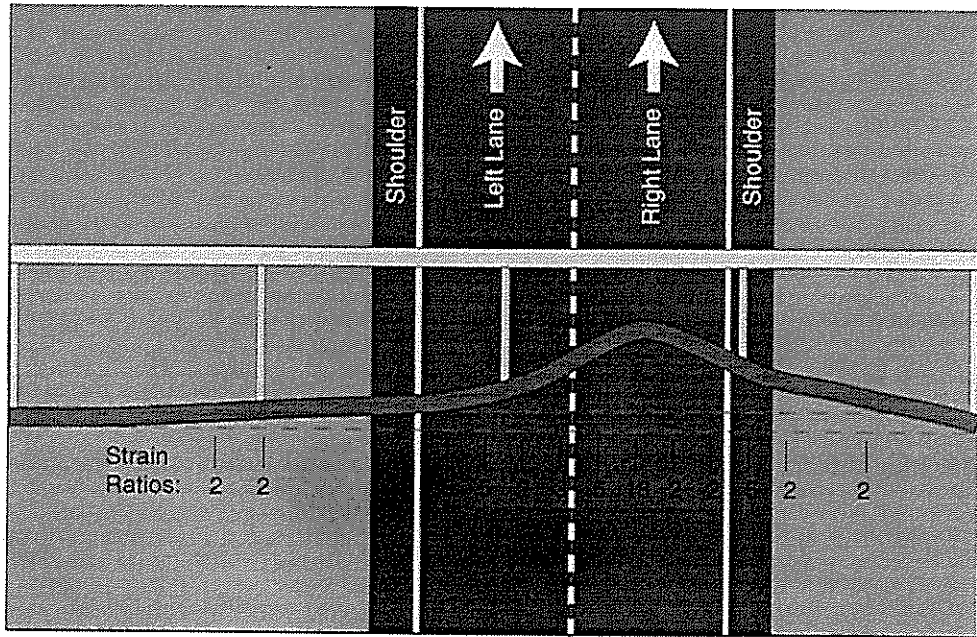
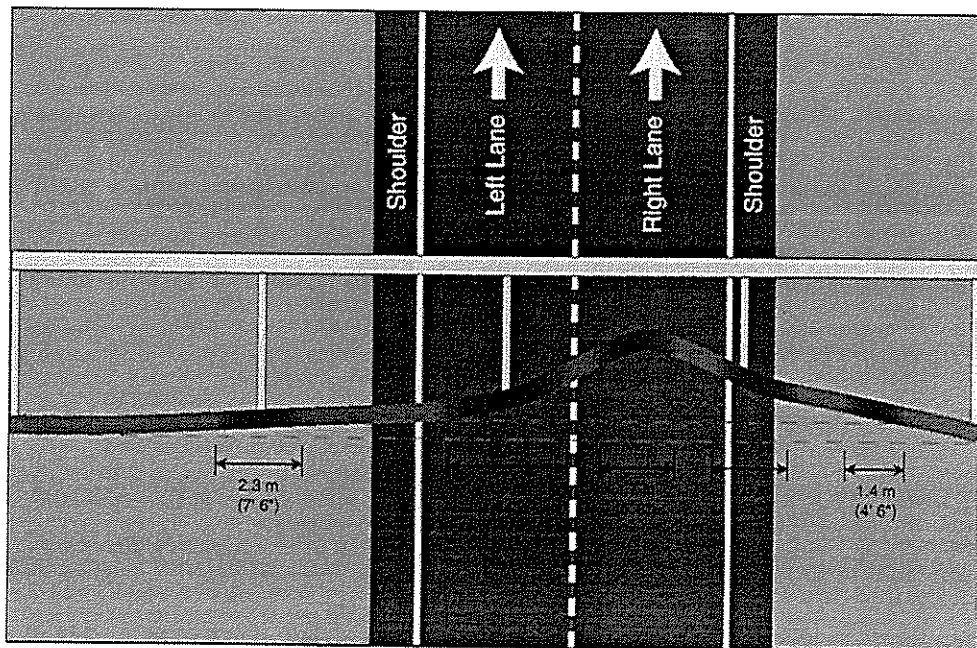
Yield zones in the lower flange occurred at diaphragms 2, 3, and 4 as well as the impact point.

Figure 7a
Strain ratios for lower flange

Figure 7b
Yield Zones for lower flange

small (five or less) except at the impact point where the actual strain exceeds the yield strain by a factor of 18. These ratios are well below 100 and are thus repairable. The degree of damage was

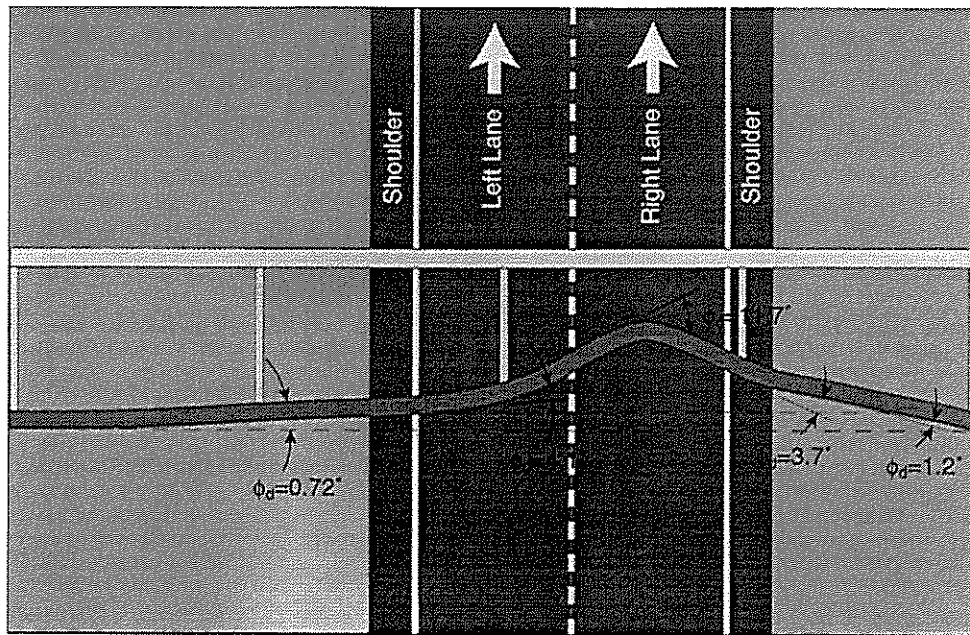
measured graphically by extending tangents from the elastic portions and measuring the angle of the tangents. At the impact region as shown in figure 8, the degree of damage is 11.7 degrees or 204 milliradians. The degree of damage at the diaphragms is considerably smaller as shown.

Figure 8
Degree of damage for each yield zone of lower flange

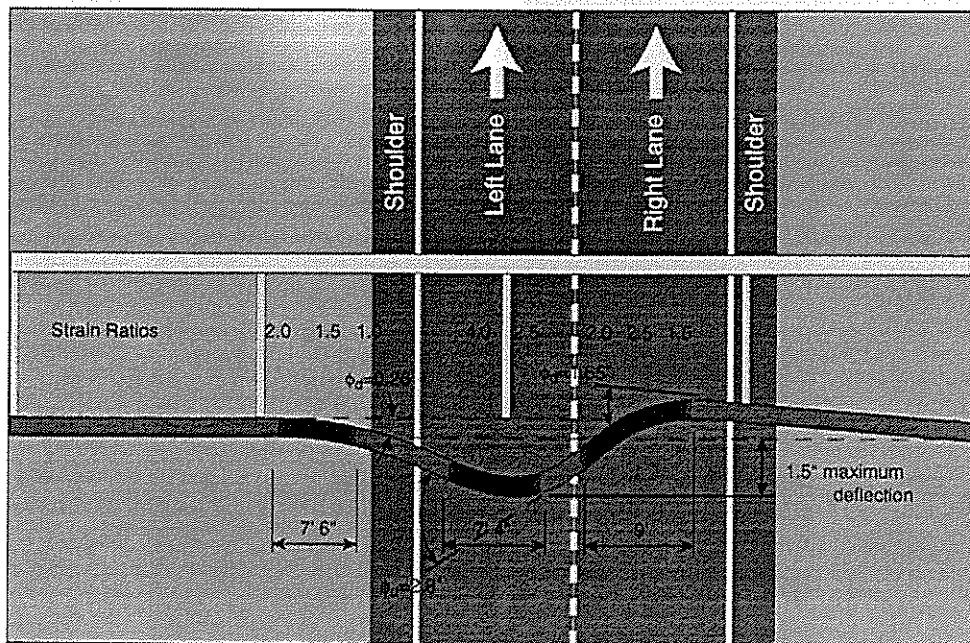
Upper flange. Similar computations were made for the upper flange where minor yielding occurred at the diaphragms. The results are shown in figure 9.

Figure 9
Degree of damage at each yield zone for lateral movement of upper flange

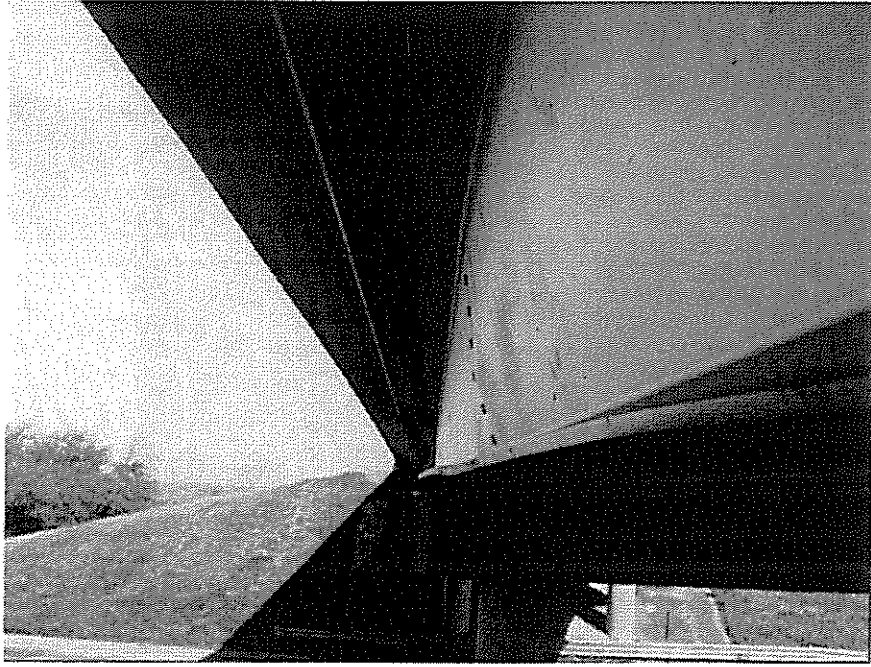
Web and flange bulges. The offset method was also used to compute the strain ratios of the web and flange bulges as shown in figure 10. The maximum strain ratios are much less than 100 and are repairable with one exception. At the impact point (fig. 11), a sharp hump was made over about a four inch length. This damage was very localized and the transitions were smooth. However, the maximum strain ratio at this hump was 394, which greatly exceeds recommended limits for heat straightening.

Figure 10
Localized web and flange damage

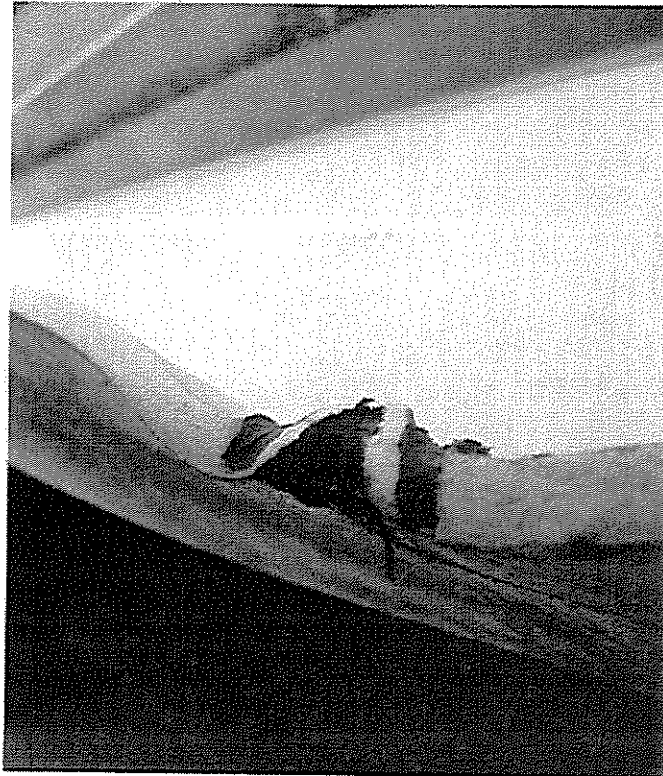
Figure 11
Deformations at lower flange impact point.

shown, the strain ratio is greatly in excess of 100. It was decided to leave this notch and grind any discontinuities smooth. The line heat pattern is shown in fig. 19.

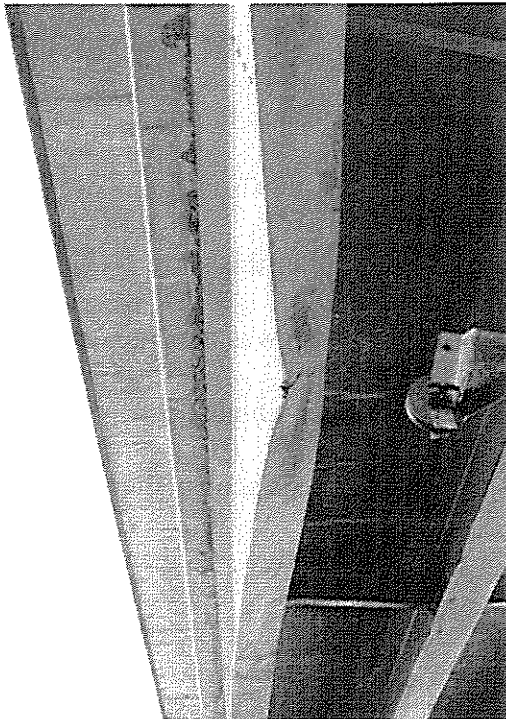
(a) Initial Damage.

Figure 22
Beam before and after repair.

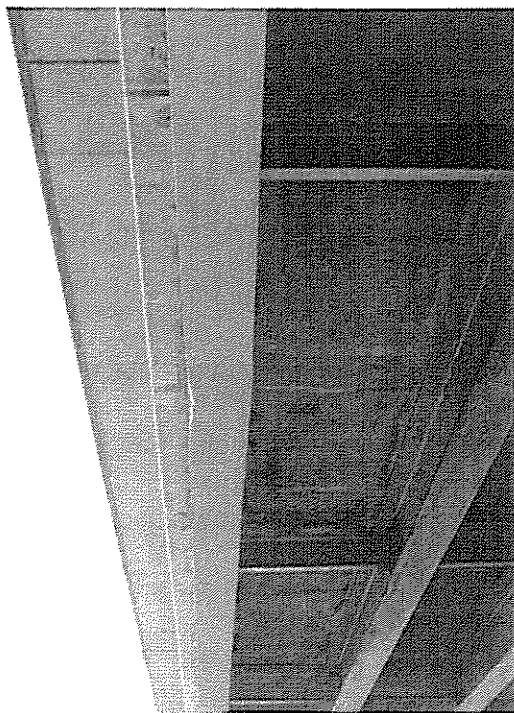
(b) Beam After Repair.

The fascia beam was successfully straightened with the exception of two aspects. First, the dimple at the impact point was not straightened because the localized damage at the impact point exceeds the recommended repair limits. Additionally, this damage was quite localized and did not significantly jeopardize the strength or function of the beam. Second, the top flange of the beam did not return completely into the deck slot. Grout is to be used to fill the remaining void areas.

Final configuration. A view of the beam, before and after repair is shown in figure 22.
