Louisiana Transportation Research Center

Technical Assistance Report 14-02TA-B

Evaluation of Rutting Distresses on I-20 Near Minden, LA

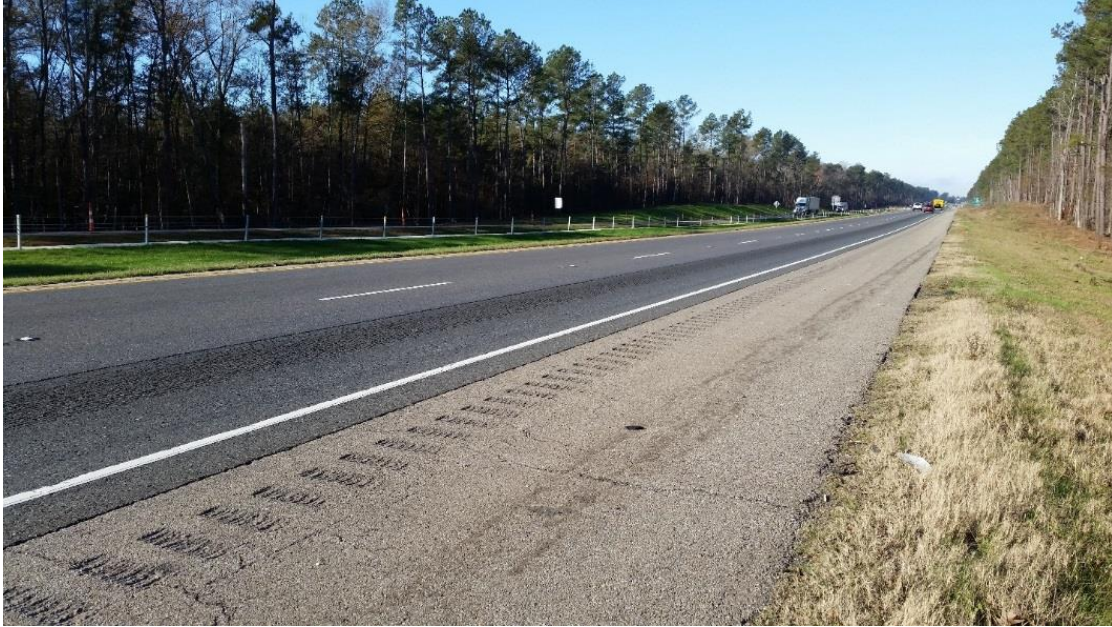
Figure 1
I-20 westbound milled outside lane

From October 2011 to March 2012 the district milled 10 miles from the same I-20 locations (State Project No. 451-03-0070) from the Webster-Bienville Parish line (log mile: 16.02) to Dixie Inn (log mile: 6.20) and placed a level 2F Superpave wearing course on the westbound inside lane with a 4.5-ft. overlap onto the outside lane. This overlay can be seen in Figure 1 where the 4.5-ft. overlap into the outside lane is noticeable.

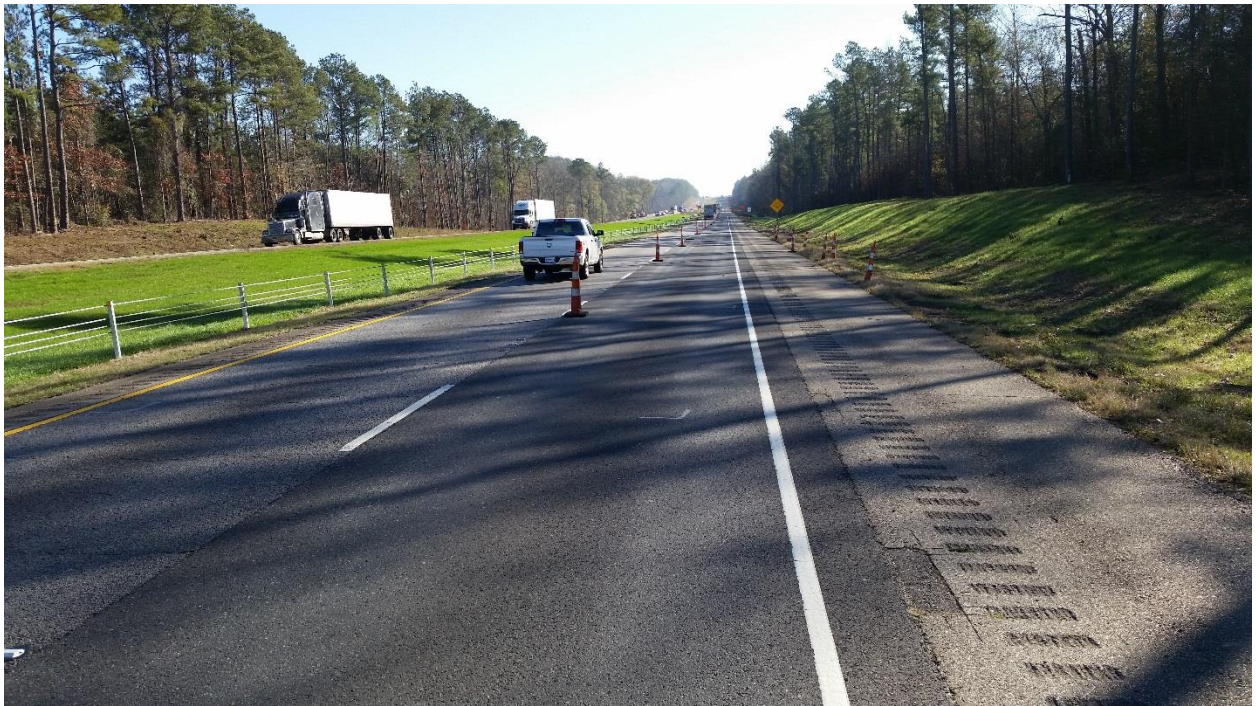
Figure 2
I-20 eastbound lane rutting

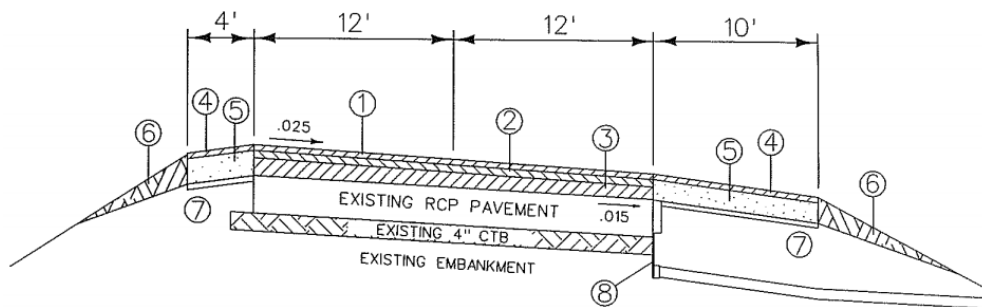
Figure 4
Typical roadway section of I-20

In a review of the original construction proposal, edge underdrains were required to relieve moisture from accumulating underneath the pavement structure. Construction documents indicate that the installed underdrain system was a thin geocomposite underdrain type system. Most states, including Louisiana, have determined the geocomposite underdrain

system to be inferior to the traditional trench underdrain system, which is the current practice used by the DOTD.

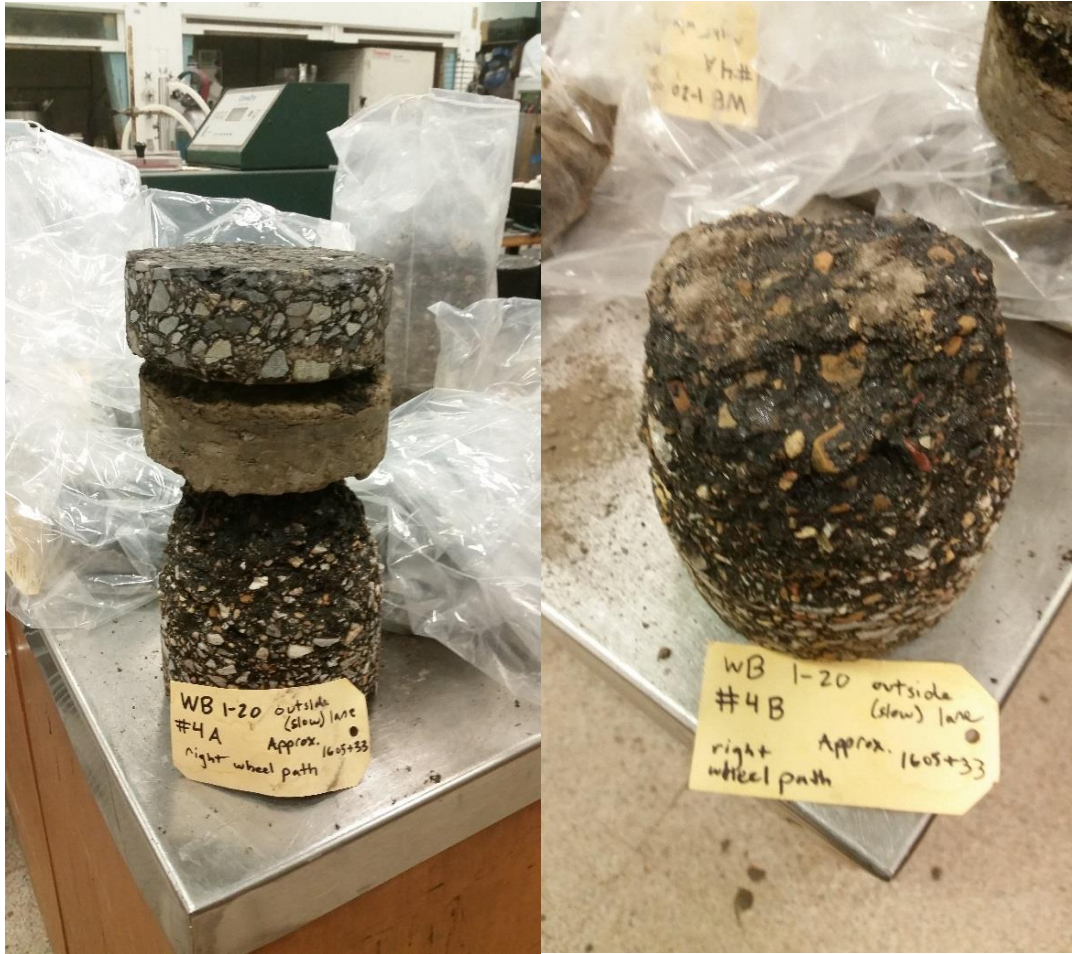
Figure 5
Roadway core #4

During coring operations, a Stone Mastic Asphalt (SMA) surface layer was observed as the wearing course on both the inside and outside lanes. This lift apparently was placed directly over the old wearing course. This was noticeable of all the cores obtained, as there was difficulty keeping them intact during drilling operations. Each core came out in two or three pieces. Figure 5a shows the typical core obtained from the field. At the locations where cores were taken, the bottom and thickest layer (approx. 4 in.) was the Type 5A base course placed in 1991. The next two lifts were the Type 3 binder (approx. 3 in.) and Type 8 wearing (approx. 2 in.) courses placed in 1991. The original wearing course was covered in a layer of clay/sands due to the drilling process, which is believed to have come from the deteriorated binder course. The top surface was the SMA wearing course, added in 2003. The SMA layer was easily distinguishable by observing the large aggregates in the mix. Damage was not observed in any of the SMA layers obtained. Although some stripping has occurred in the base course, the binder course exhibited excessive stripping throughout the layer, as seen in Figure 5b, and shows a loss of asphalt coverage on the aggregate. A considerable amount of clay, sand, and gravel was found all around the drilling site after taking the core.

Evaluation of the site and asphalt cores retrieved showed considerable deterioration of the binder course due to its moisture susceptibility and due to inadequate moisture drainage. The “pooling” and pumping of water in the underlying layers caused the loss of adhesion between the asphalt binder and aggregates. Subsequently the support structure of the road was damaged and settling occurred on the surface layers. The water was introduced from the underlying layers and forced upwards to the asphalt layers. However, the mix designs which followed the allowable specifications during the time of construction would not pass current design specifications.

Based on these findings, the authors recommend a full-depth rehabilitation of the asphalt base, binder and wearing courses. This should ensure the removal of substandard materials that were used on the original rehab project. Once the old pavement is removed, it is further recommended that additional breaking of the original JRCP pavement be conducted in areas where reflective cracking is visible at the top surface, and/or in the areas of the old test sections where the break pattern or other rehab technique was greater than 18 in. In addition, it is extremely important that the deficiencies of the underdrain system are corrected. It is recommended that the current geocomposite underdrain system be removed and replaced with the latest design for underdrain systems similar to the one shown in the Appendix.
