# ***Louisiana Transportation Research Center***

Final Report 552

## **Repair of Morganza Spillway Bridge Bent Pile Cap Using Carbon Fiber Reinforcement (CFR)**

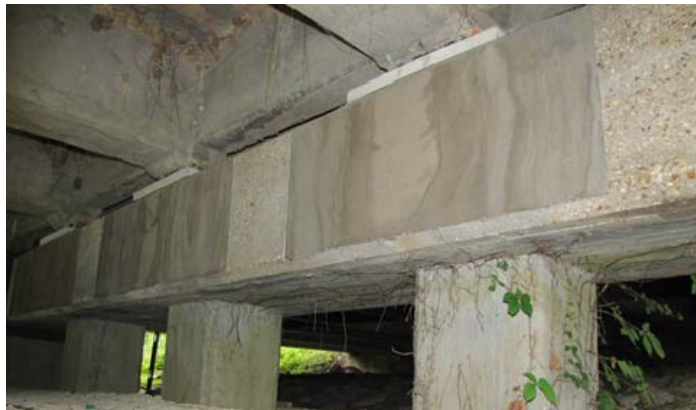
During the major-repair process, the size of the girder's bearing plate was increased to reduce the stress concentrations. The new 18-in. x 24-in. plate, shown in Figure 2, reduced the compressive (bearing) stress to 65 psi for a maximum wheel load of 28,000 lb. This value is based on the transfer of the entire wheel load to the support and an infinitely rigid plate. In practice, the actual stress will be lower than this value. Note that the stress induced by the weight of the bridge is not included because the repair material was applied after the entire bridge is in place. The actual bearing stress on concrete will be much higher.

**Figure 2**  
**View of the bent after the initial repair: Note the base plates under the beams and the repair material that replaced delaminated concrete**

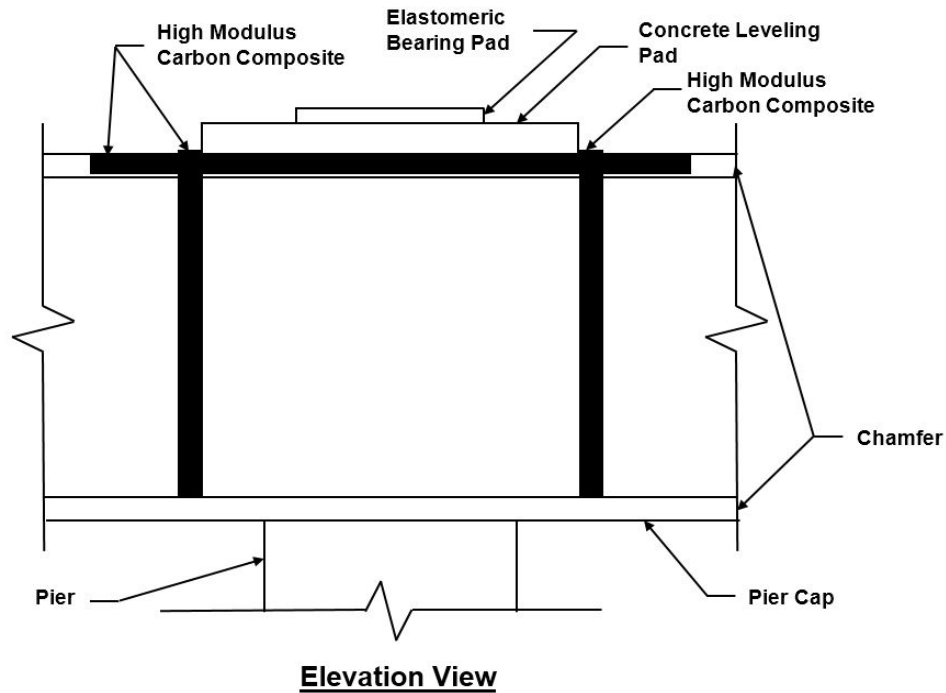
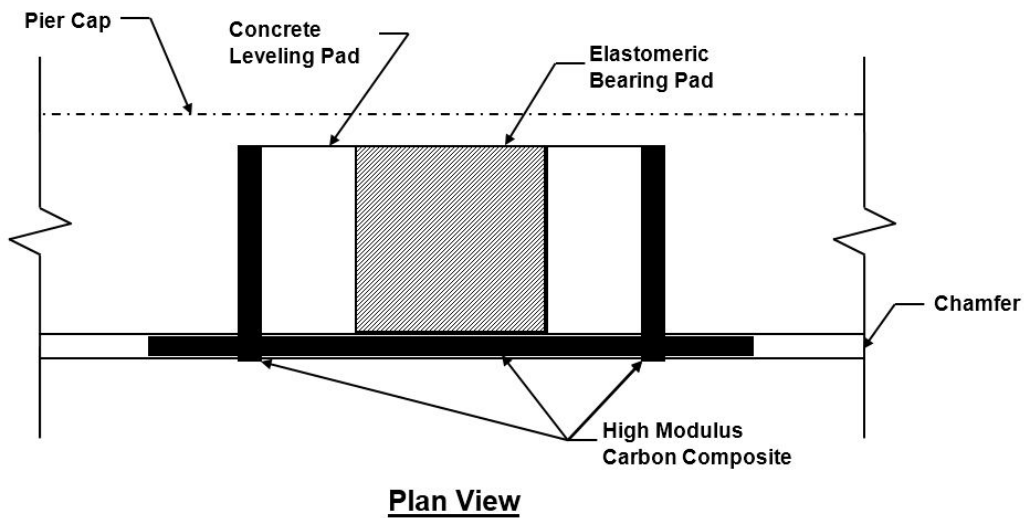
Line drawings of the system are presented in Figures 3 and 4. The original layout of placing carbon fibers at X pattern was changed to the current pattern because of the change of the support system to a larger bearing plate. The modified pattern will also provide stronger anchoring near the top, where the splitting potential is high.

**Figure 3**  
**Line drawing of the anchoring system**

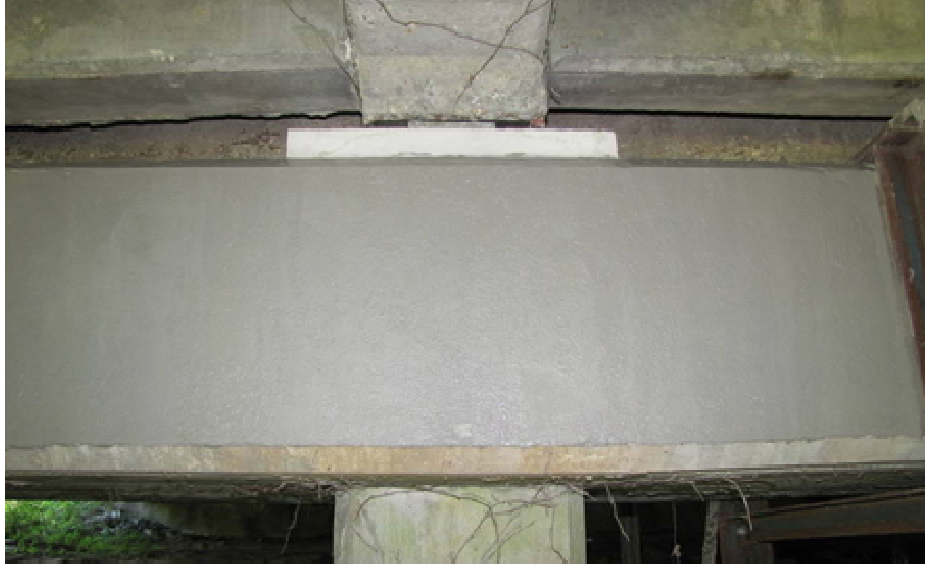
After an initial coating of short-carbon fiber composite coating, shown in Figure 9, the tows along the bearing plate was placed using the inorganic polymer, shown in Figure 10. This was followed by the placement of confining tows, shown in Figure 11. Note that the confining tows extent from bottom of the bent to the end of the bearing plate proving more than sufficient development length.

**Figure 9**  
**Initial coating with short discrete fiber reinforced composite**

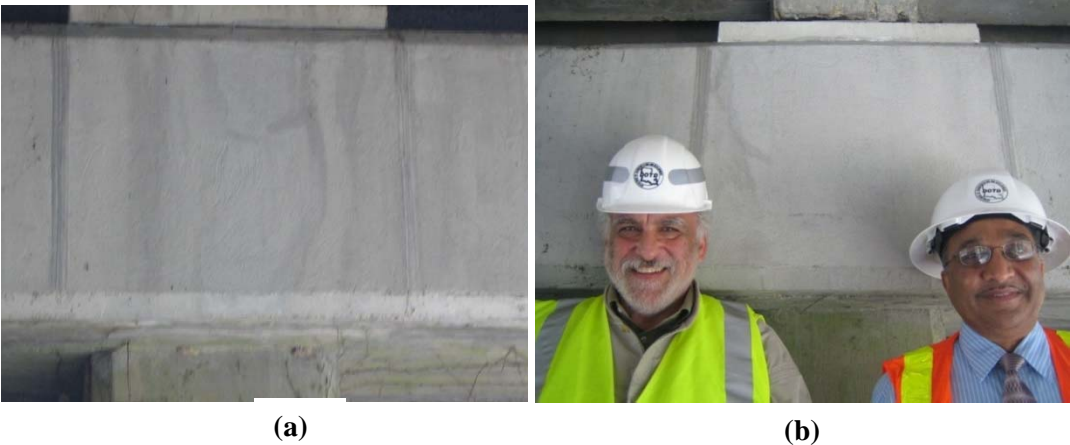
The rehabilitation work is performing well. The high modulus carbon composite used for confinement is well bonded and there is no sign of any damage or deterioration. The top fiber composite coating is also performing well. Pictures of both composites presented in Figures 22 to 25 show the status of the rehabilitation work.

**Figure 22**  
**View of high modulus confinement composite: continuous carbon tows can be seen on both sides of the bearing plate**

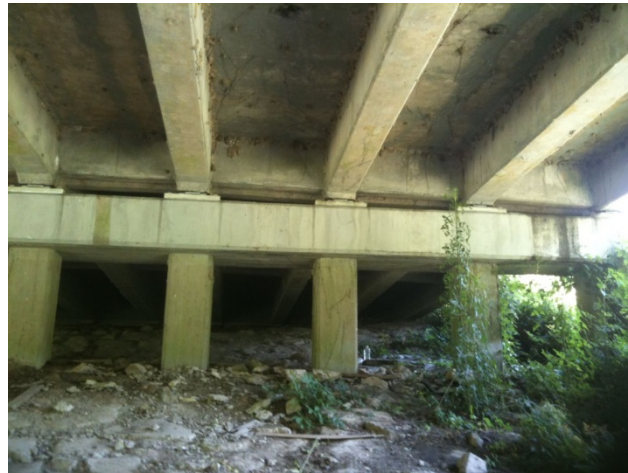
**Figure 29**  
**Overall view: Note the debris buildup on the un-coated right side of the structure**

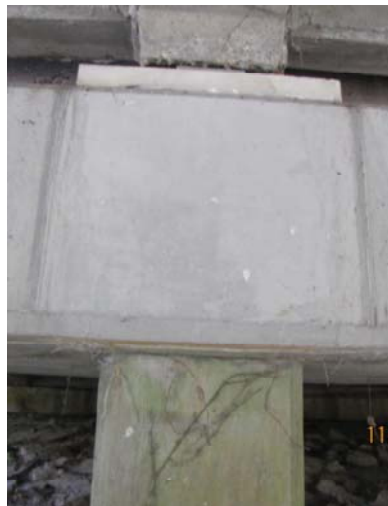
The rehabilitation work is performing well. The high modulus carbon composite used for confinement is well bonded and there is no sign of any damage or deterioration. The top fiber composite coating is also performing well. Pictures of both strengthening composite and composite-coatings, presented in Figures 31 to 34, show the status of the rehabilitation work.

**Figure 31**  
**View of high modulus confinement composite: Continuous carbon tows can be seen on both sides of the bearing plate**

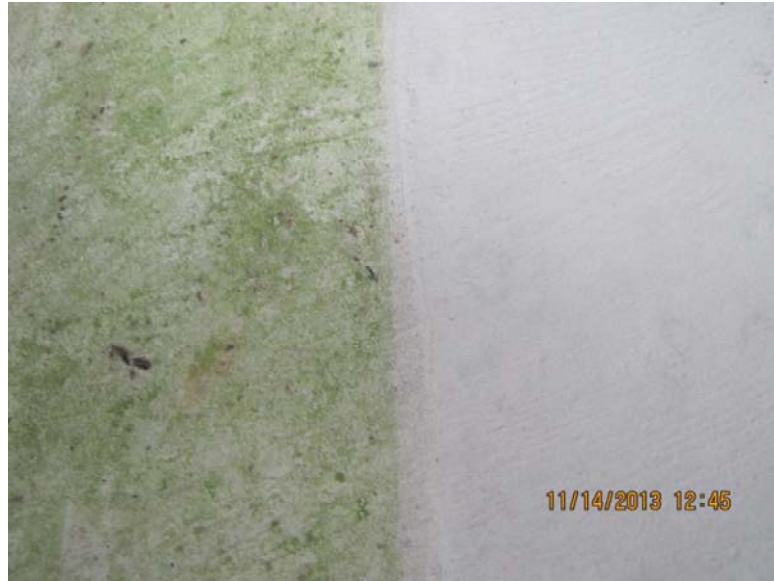
**Figure 34**  
**Self-cleaning property: close-up of coated (on right) and non-coated (on left) surface highlights self-cleaning**

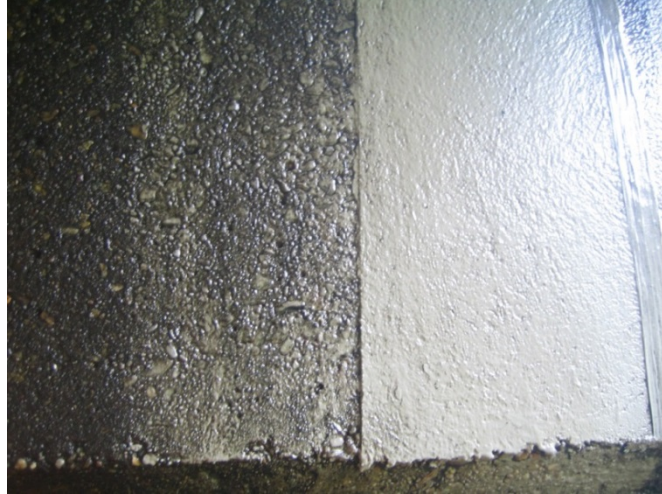
**Figure 39**  
**Self-cleaning property: Close-up of coated (on right) and non-coated (on left) surface highlights self-cleaning**
