Technical Assistance Report 15-01TA-C

**Evaluation of Cores from I-10 between
Acadian Thruway and College Drive**

Petrographic Investigation of Concrete Cores From Cracked Pavement Slabs Located on Interstate 10 in Baton Rouge, Louisiana

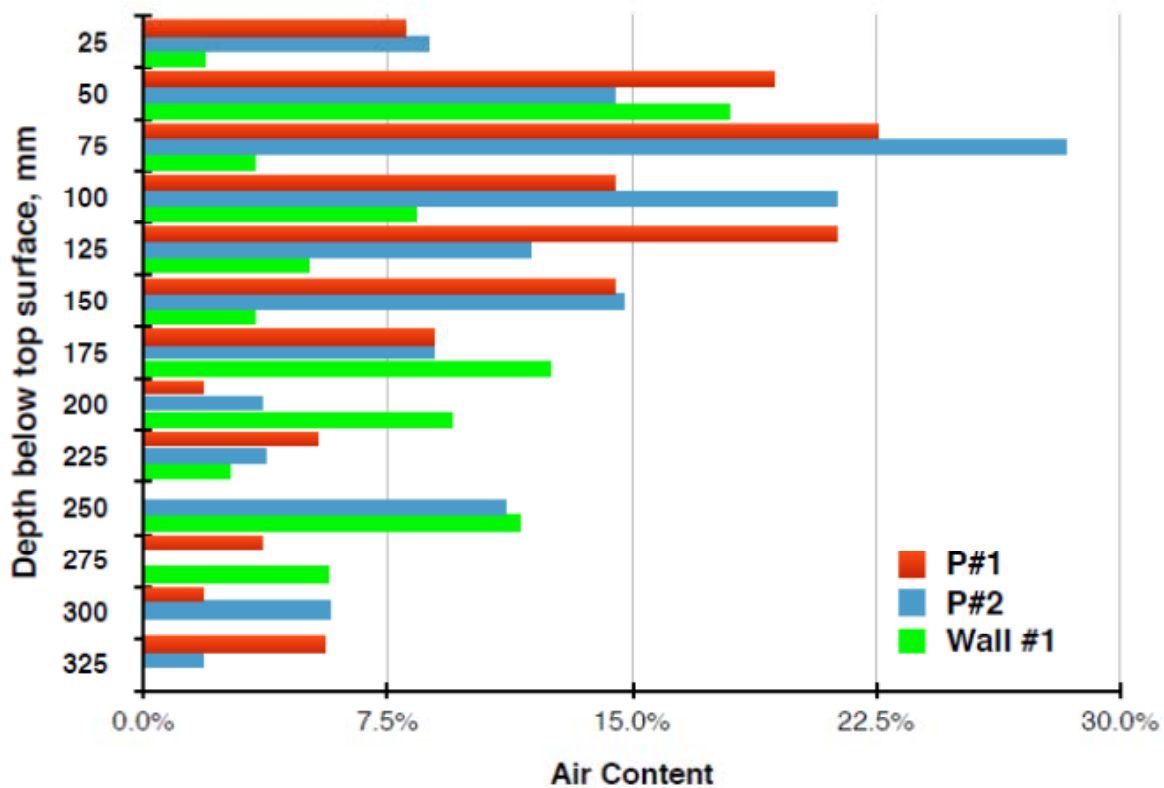
Figure 2
Distribution of air void content

The deterioration is attributed to excessive air content. The petrographic report notes that the top 3-4 inches generally average 17 percent air content with mid-slab air content in the normal range. Figure 2 shows the distribution of air void content by volume. Note that the excessive air void content exceeds 15 percent. This will make the concrete very weak and susceptible to deterioration. Figure 3 shows the same results but limits it to the top, middle, and bottom portion of the pavement.

Possible remedies for this section include partial depth patching of the affected areas, full depth patching of the affected areas, or hydroblasting the entire section to remove the top 3-4 inches and completing a bonded concrete overlay. Of the options, the most cost-effective solution is probably the full depth patching to include whole panel replacement of the affected panels.

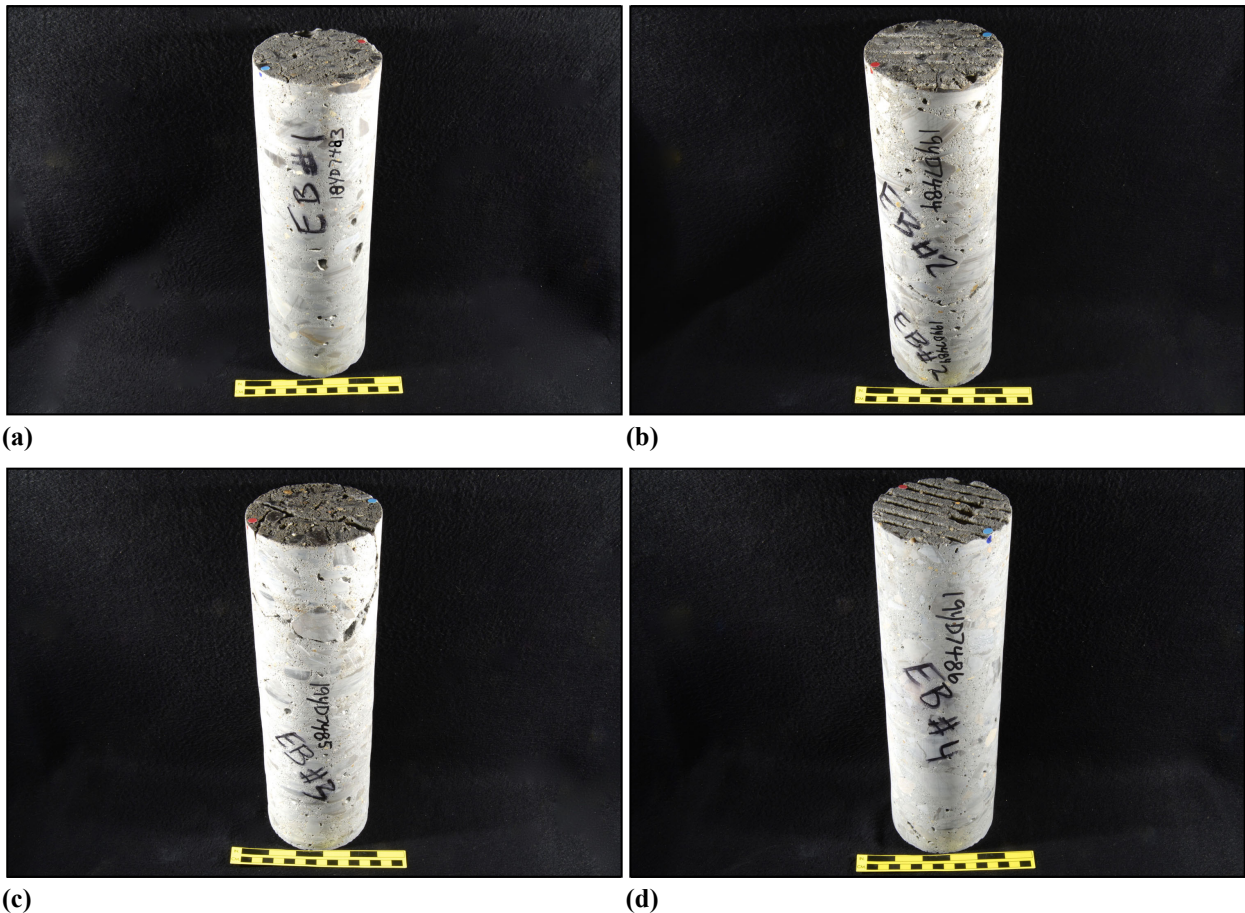
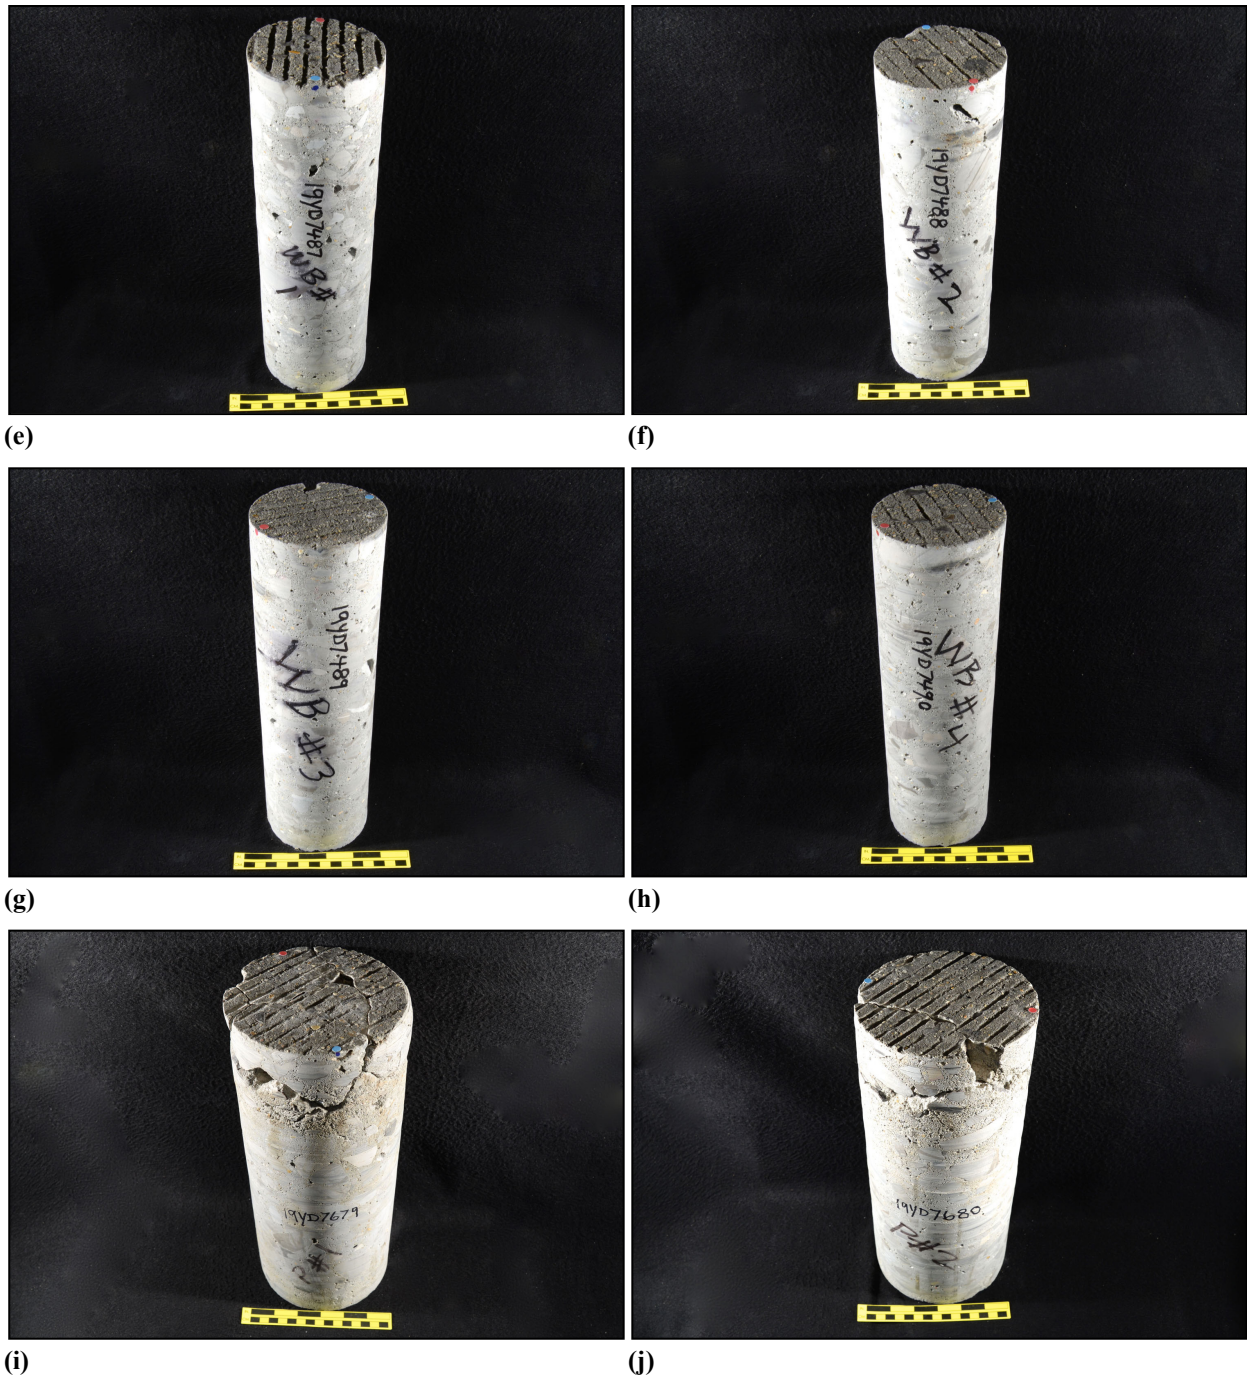
3.1 Orientation, Dimensions & As-Received Condition All the cores are vertical in orientation save the wall core, which is horizontal. The cores span from finished surfaces (or a formed surface on the wall core) to saw-cut surfaces, representing partial thicknesses of the sampled elements slabs. The first eight slab cores are 80 mm (3 1/8 in.) in diameter and ~ 325 mm (~ 13 in.) long. The last two slab cores are 100 mm (4 in.) in diameter and ~ 350 mm (14 in.) long. The wall core is 100 mm (4 in.) in diameter and 255 mm (~ 10 in.) long. The cores are hard and compact and lack embedded steel. Most of the cores showed worn top surface that exposed coarse aggregate particles.

Figure 1. Photographs showing the top and sides of the eastbound cores in their as-received condition. (a) Core EB #1. (b) Core EB #2. (c) Core EB #3. (d) Core EB #4. The yellow scale bar is ~ 150 mm (6 in.) long.

Figure 1 (cont'd). Photographs showing the top and sides of the westbound cores in their as-received condition and the other two pavement cores that showed significant delaminations. (e) Core WB #1. (f) Core WB #2. (g) Core WB #3. (h) Core WB #4. (i) Core P#1. (j) Core P#2. The yellow scale bar is ~ 150 mm (6 in.) long. See *Appendix I* for photographs of Core Wall #1 in as-received condition.

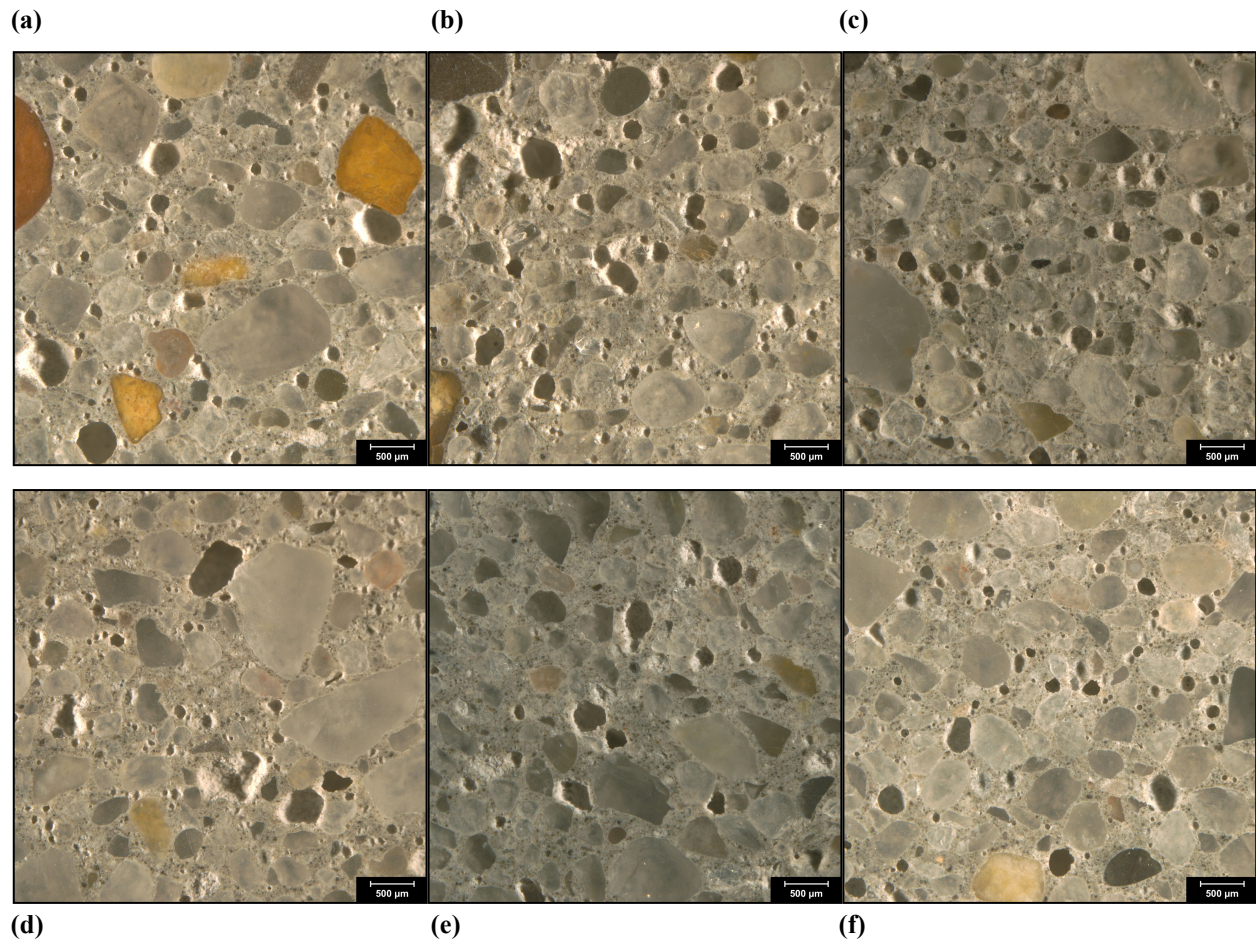
3.3 Components: Air All the cores from the first set of eight are air-entrained with air contents that ranged from an estimated 4-6% except Core EB #2 and Core EB #3, which contain an estimated 7-9% air (**Figure 3**). Note that in the first eight cores air contents were estimated visually but were not measured by point count methods as outlined in ASTM C457. Many of the cores in the first set of eight contained large voids typical of incomplete consolidation, entrapped air or water voids. In particular, Core EB #3 showed numerous large voids in the top 55 mm (2 1/8 in.) where extensive cracking and delamination of the concrete was observed, as discussed below.

Figure 3. Reflected light photomicrographs of polished slabs showing examples of entrained air voids. (a) Core EB #1. (b) Core EB #2. (c) Core EB #3. (d) Core WB #2. (e) Core WB #3. (f) Core WB #4.

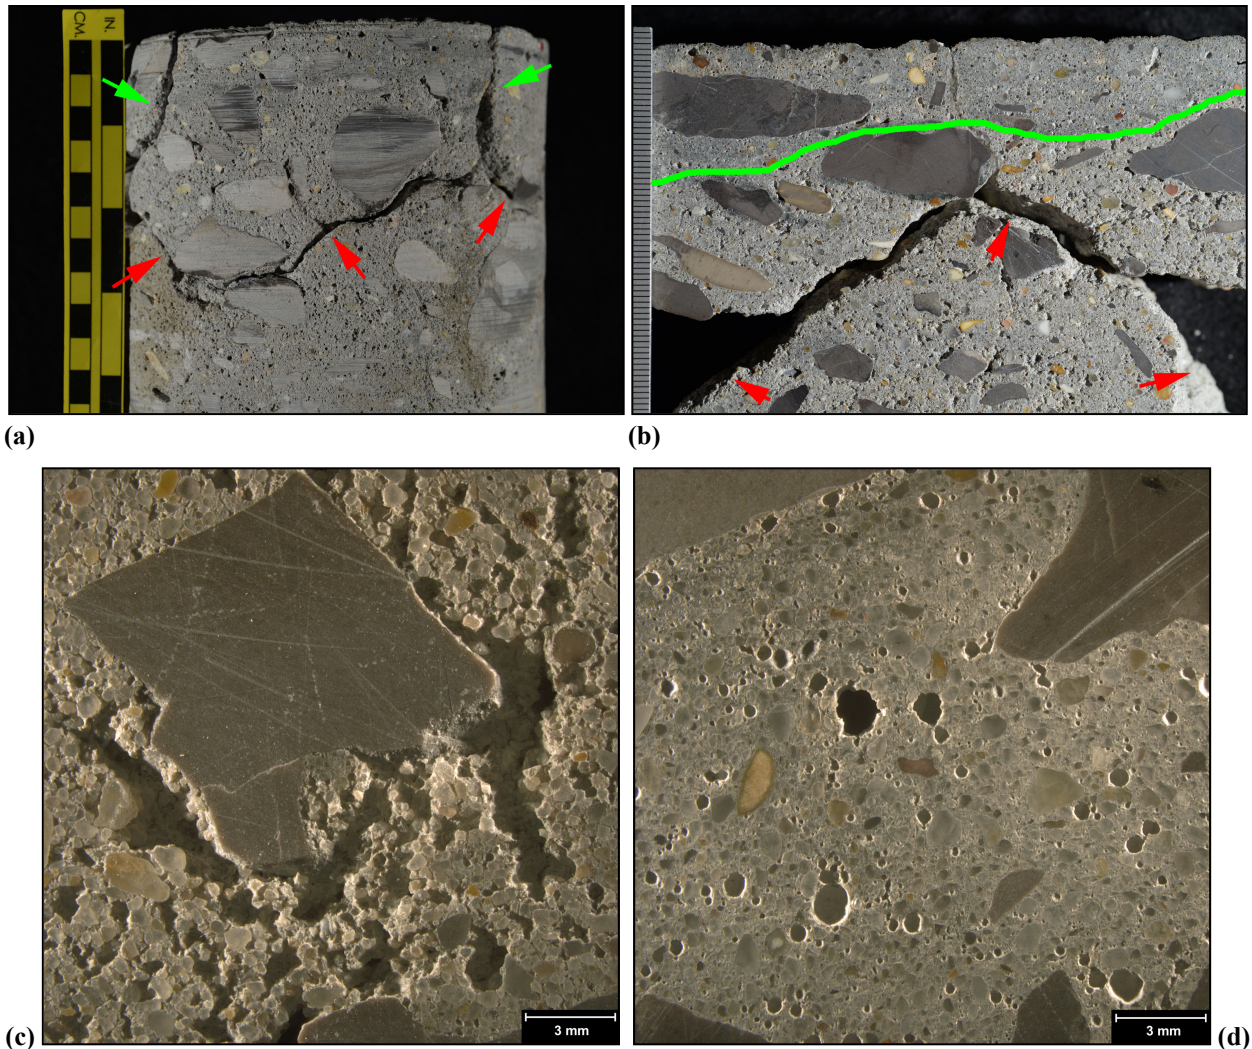
Core P#1 and Core P#2 contained zones of extremely high air (~ 17%) at the top of the cores and much lower air (4-5%) in the middle (**Figure 4**). The zones of high air coincide approximately with the depth of delaminations observed in these cores. Core Wall #1 did not show elevated air near its outer surface and was not delaminated.

Figure 4. (a) Photograph of the side of Core P#1 near the top of the core. The red arrows show sub-horizontal crack along which the core delaminated. The green arrows indicate sub-vertical cracks. (b) Photograph of the polished surface of Core P#1 showing section near the top of the core. The green line separates a zone of significantly lower air content than the zone below it; on average the concrete has ~ 17% air. The red arrows highlight the delamination crack. Reflected light photomicrographs of the polished surface of Core P#1 showing detail of voids (c) at the top and (d) in the middle of the core.

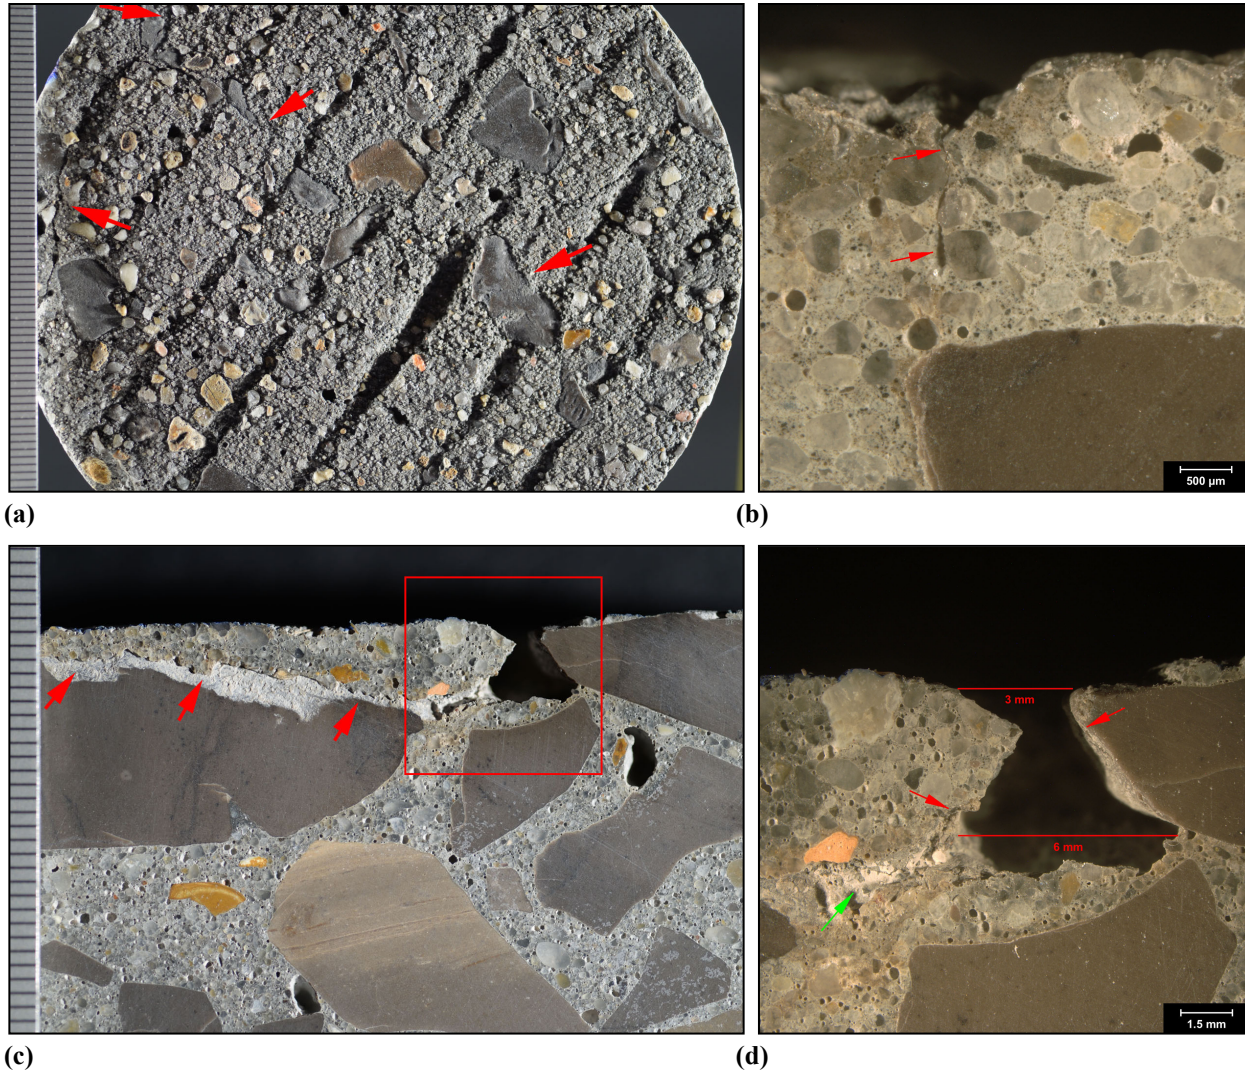
3.6 Cracking and Microcracking Most of the cores showed linear cracks on their top surfaces. The cracks are typical of drying shrinkage as they cut sub-vertically from the top surface, cutting primarily around aggregate particles and lacking significant secondary deposits save calcium carbonate (**Figure 7**). These cracks were typically 250-500 μm (10-20 mil) wide and most commonly cut to depths of ~ 9.5 mm ($\frac{3}{8}$ in.) below the top surface of the core. A few cores showed sub-vertical cracks that cut to depths of 15-25 mm ($\frac{5}{8}$ -1 in.). These also cut around aggregates and lack secondary deposits. Core EB #1 showed a sub-horizontal crack subjacent to the top surface but was not delaminated.

Figure 7. (a) Photograph of the top of Core WB #4 showing triple point hairline cracks (red arrows) on a worn tined surface. (b) Reflected light photomicrograph of polished surface of Core WB #4 showing sub-vertical microcrack (red arrows) at the top surface that represents an extension of the hairline crack observed on the top surface. (c) Photograph of the top of the polished surface of Core EB #1 showing a sub-horizontal crack (red arrows) subjacent to the top surface. The red box shows the approximate area of (b) where red arrows indicate a large void (width measured by red bars) and the green arrow shows the sub-horizontal crack.

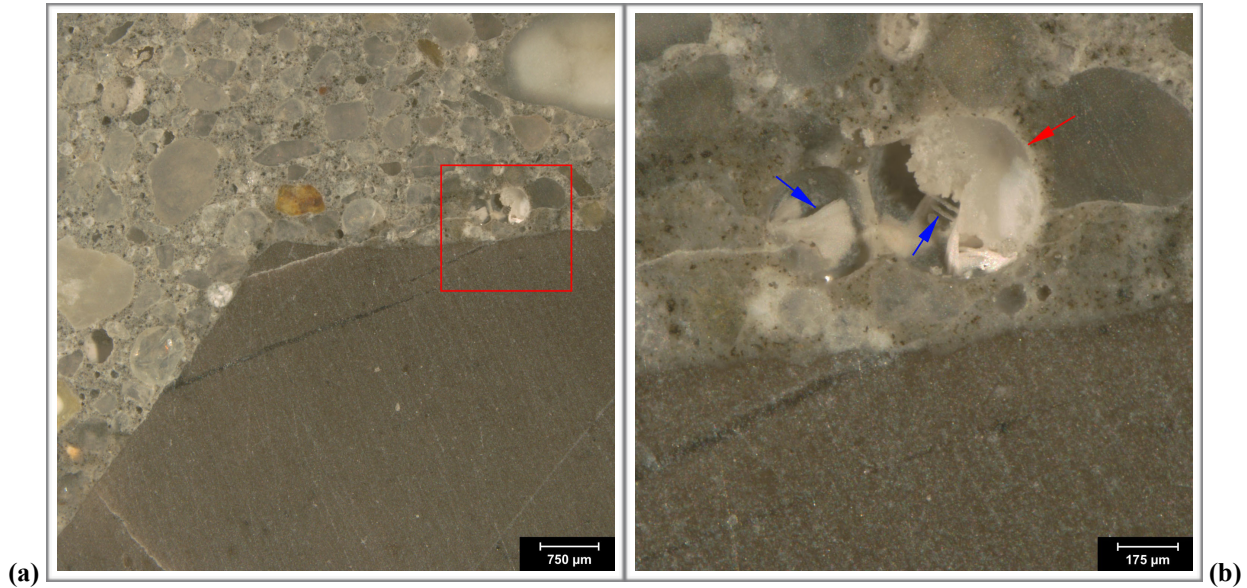
3.8 Secondary Deposits—Alkali-Silica Reaction (ASR) Seven of the eight cores examined petrographically show trace to very minor ASR; Core WB #1 is the sole core lacking deposits of gel. In all cases deposits of gel were observed in voids, most commonly adjacent to or near particles of limestone in the coarse aggregate (**Figure 10**). SEM/EDS analysis of these deposits confirm they consist of ASR gel, most commonly with calcium as the dominant cation in the gel (**Figure 11**).

Figure 10. Reflected light photomicrographs of polished surface of Core EB #1 showing (a) overview and (b) detail of gel deposits in void next to a coarse aggregate particle about 85 mm (3 3/8 in.) below the top surface. The red square in (a) shows the approximate area of (b) where the red arrow indicates a gelatinous deposit and blue arrows indicate more crystalline deposits.

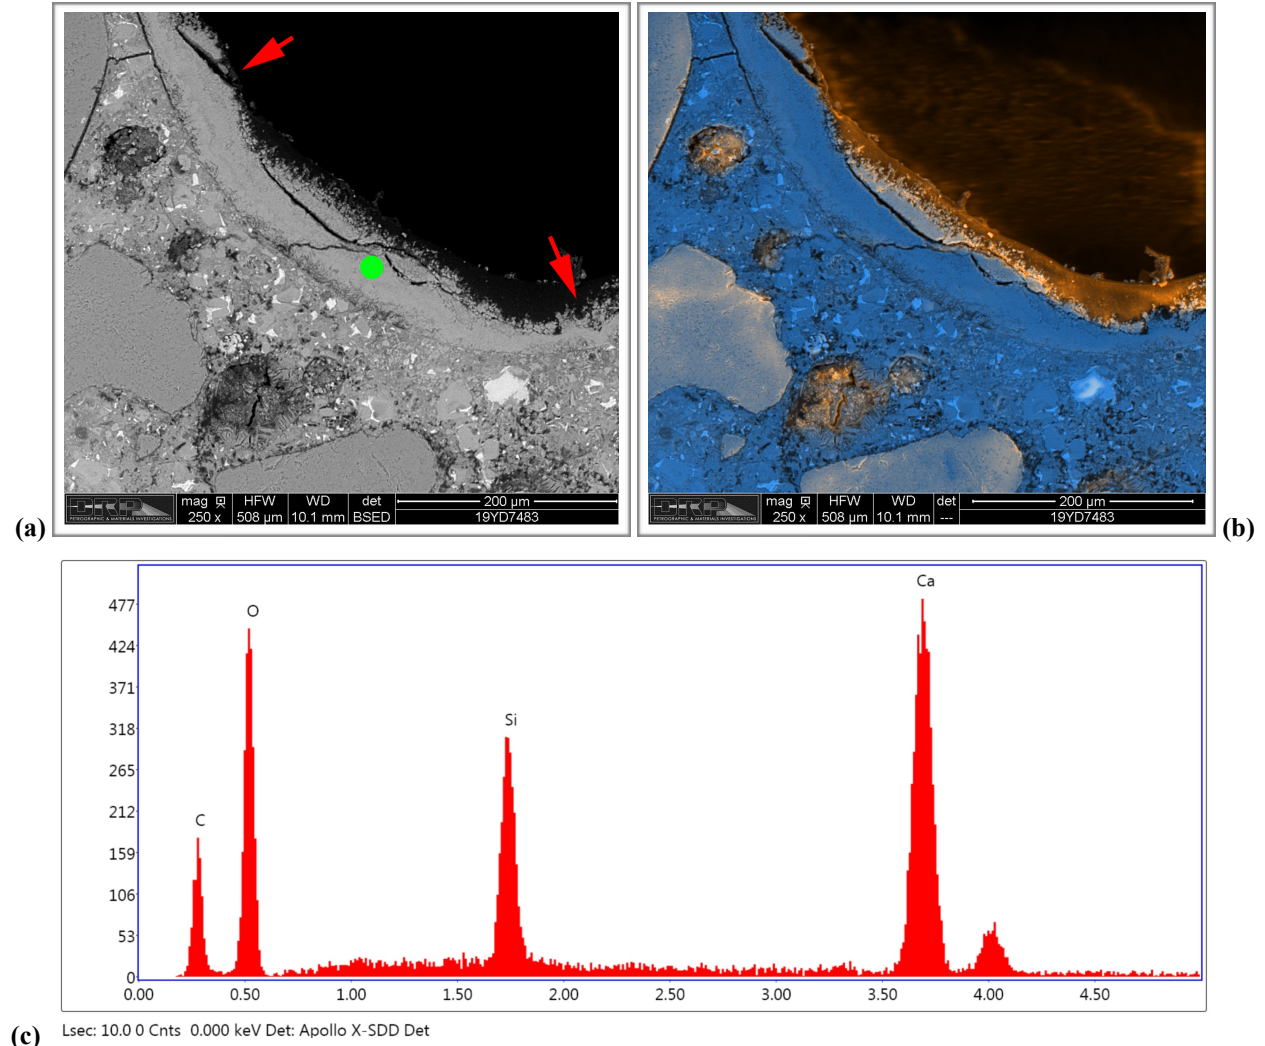
Figure 11. (a) Backscatter electron (BSE) and (b) combined backscatter/secondary electron (BSE/SE) micrograph of polished surface of Core EB #1 showing detail of void lined with gel.

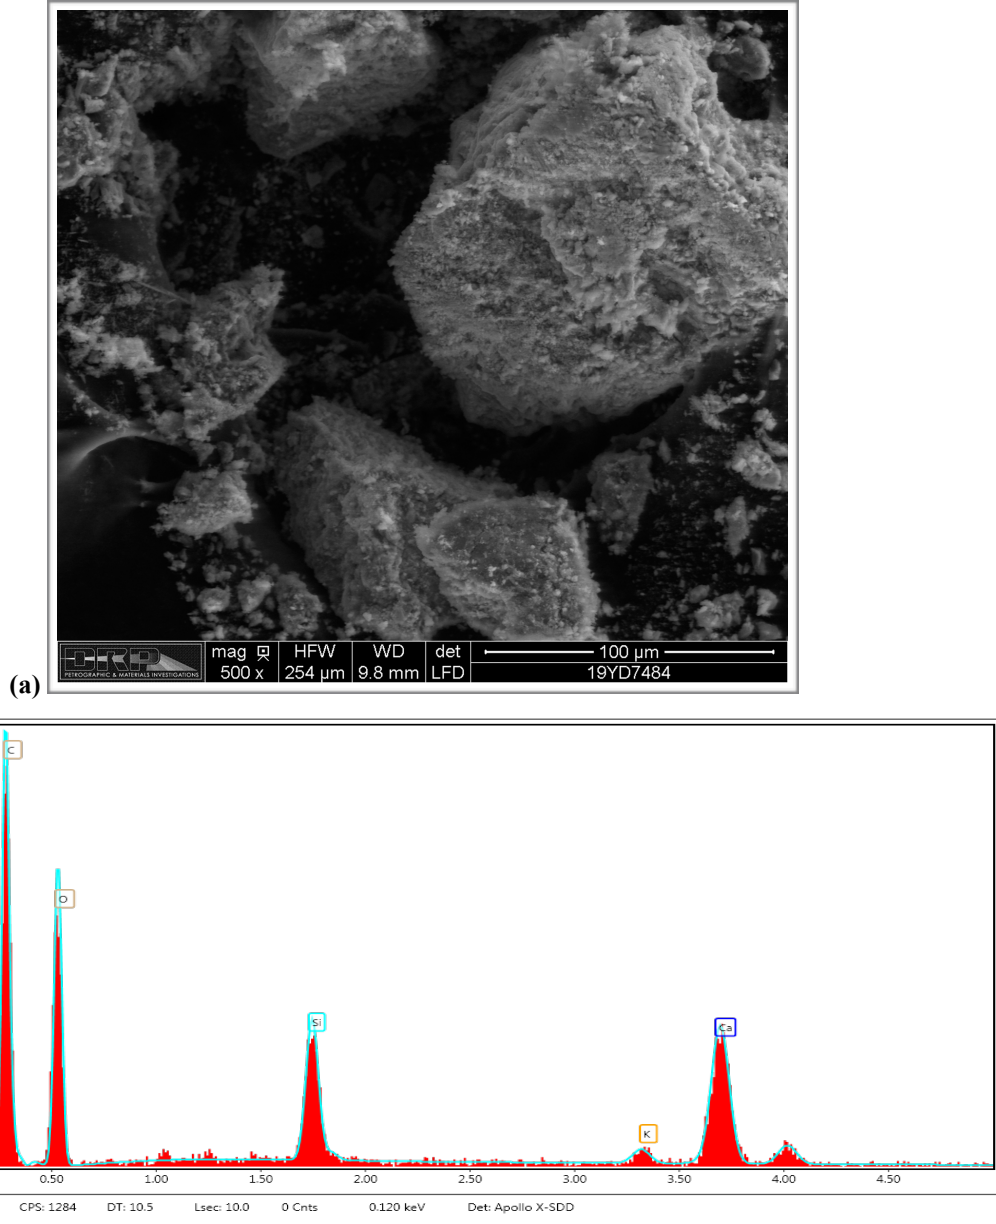
Figure B15. (a) Backscatter electron micrograph of gel deposits scraped from void shown in B13 (b) and placed on carbon tape. (b) EDS spectrum of deposit indicating composition typical of ASR gel.

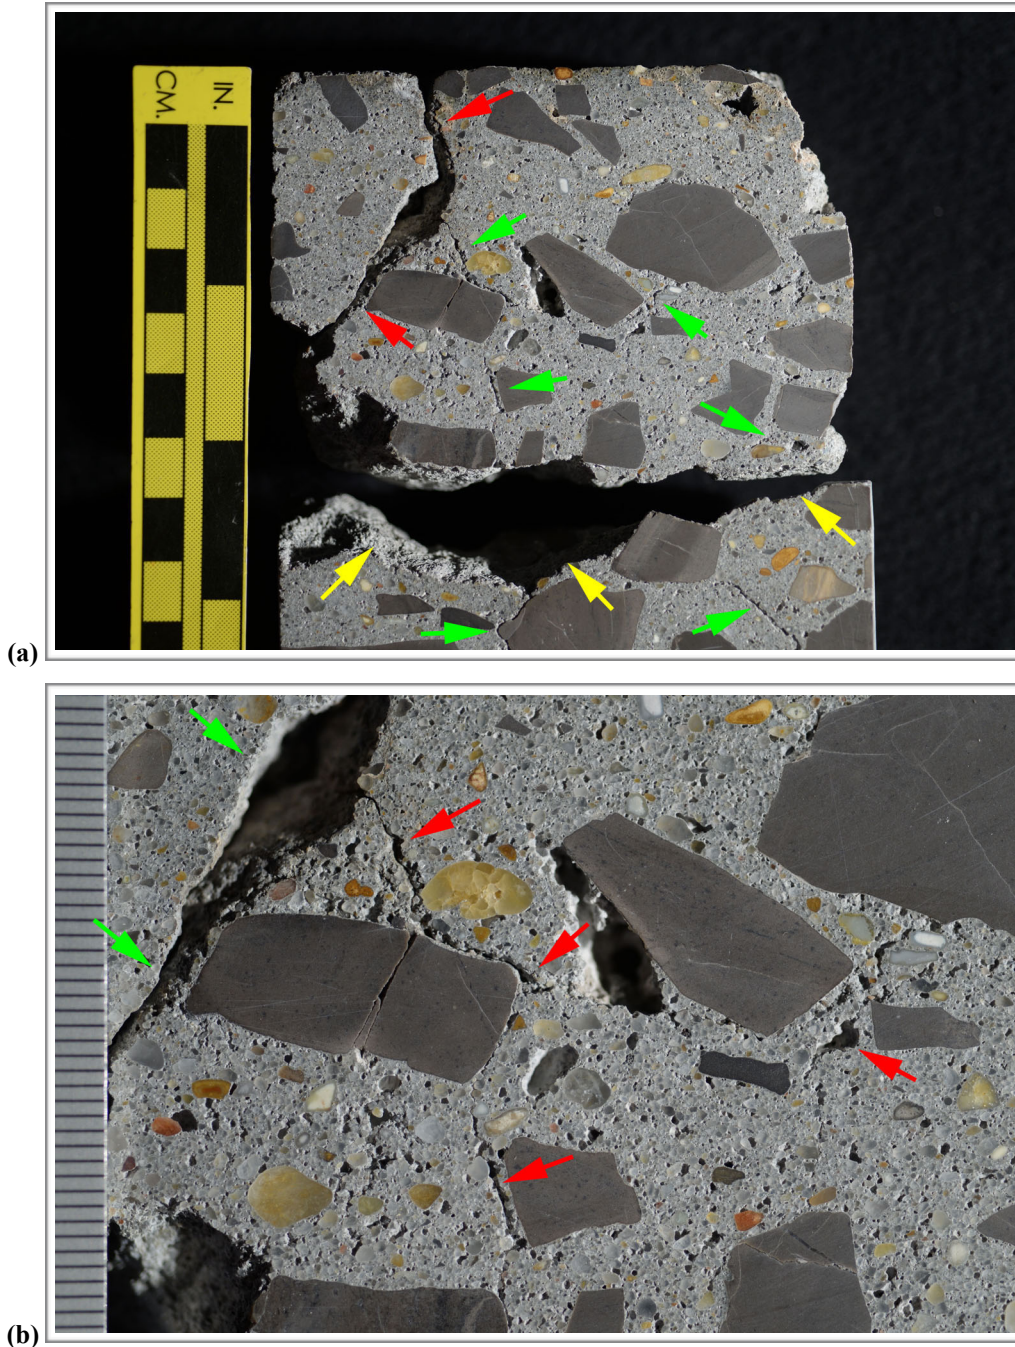
Figure C5. Photograph of the polished surface showing (a) overview and (b) detail of cracking near the top of the core. In (a) the yellow arrows indicate main horizontal crack that cut core in two and the red arrows indicate the main sub-vertical crack that cut the top piece in two pieces. The green arrows indicate smaller cracks. In (b) the green arrows indicate the main crack and the red arrows show smaller cracks. The scale is in millimeters in (b).

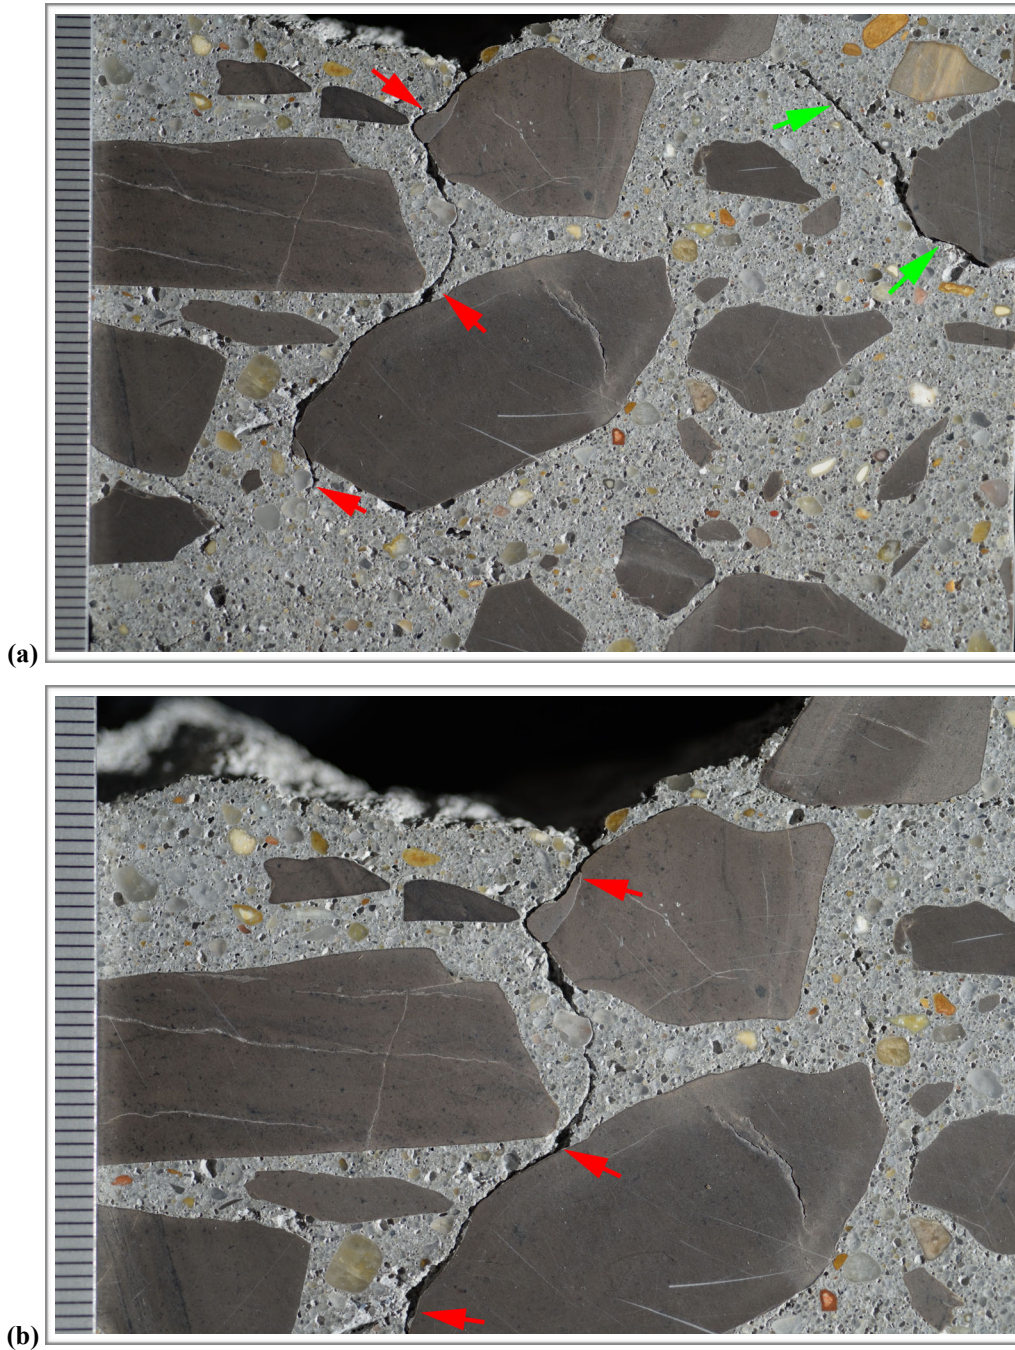
Figure C6. Photographs showing (a) overview and (b) detail of cracking below the main sub-horizontal crack about 50 mm (2 in.) below the top surface. The red arrows indicate the sub-vertical crack that from the horizontal crack. The green arrows in (a) indicate an oblique crack. The scale is in millimeters in both photos.

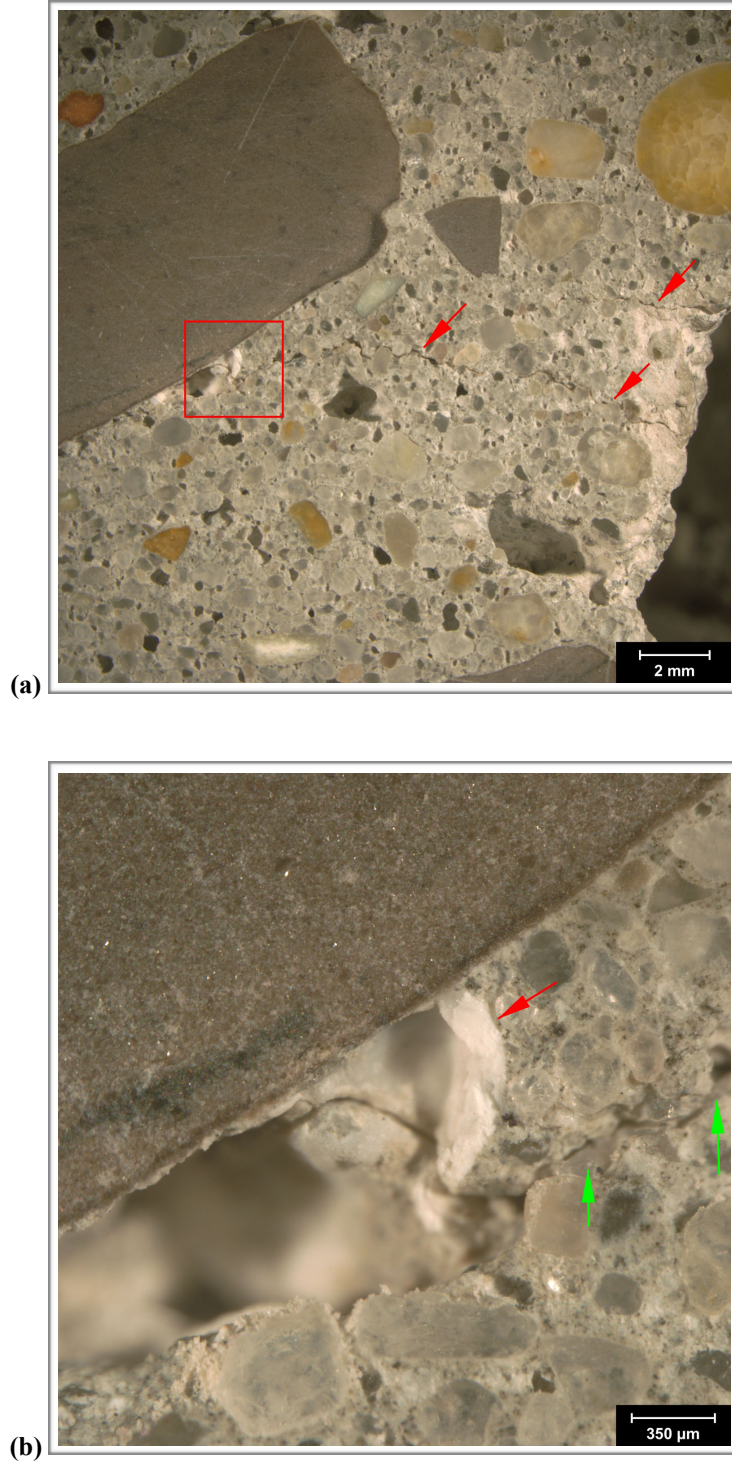
Figure C7. Reflected light photomicrographs of the polished surface showing (a) overview and (b) detail of microcracks about 38 mm (1 ½ in.) below the top surface. In (a) the red arrows indicate sub-horizontal microcracks that intersect a void next to a limestone particle that contains gelatinous deposits. The red box in (a) shows the approximate area of (b), where the red arrow indicates the deposit and the green arrows indicate a microcrack.

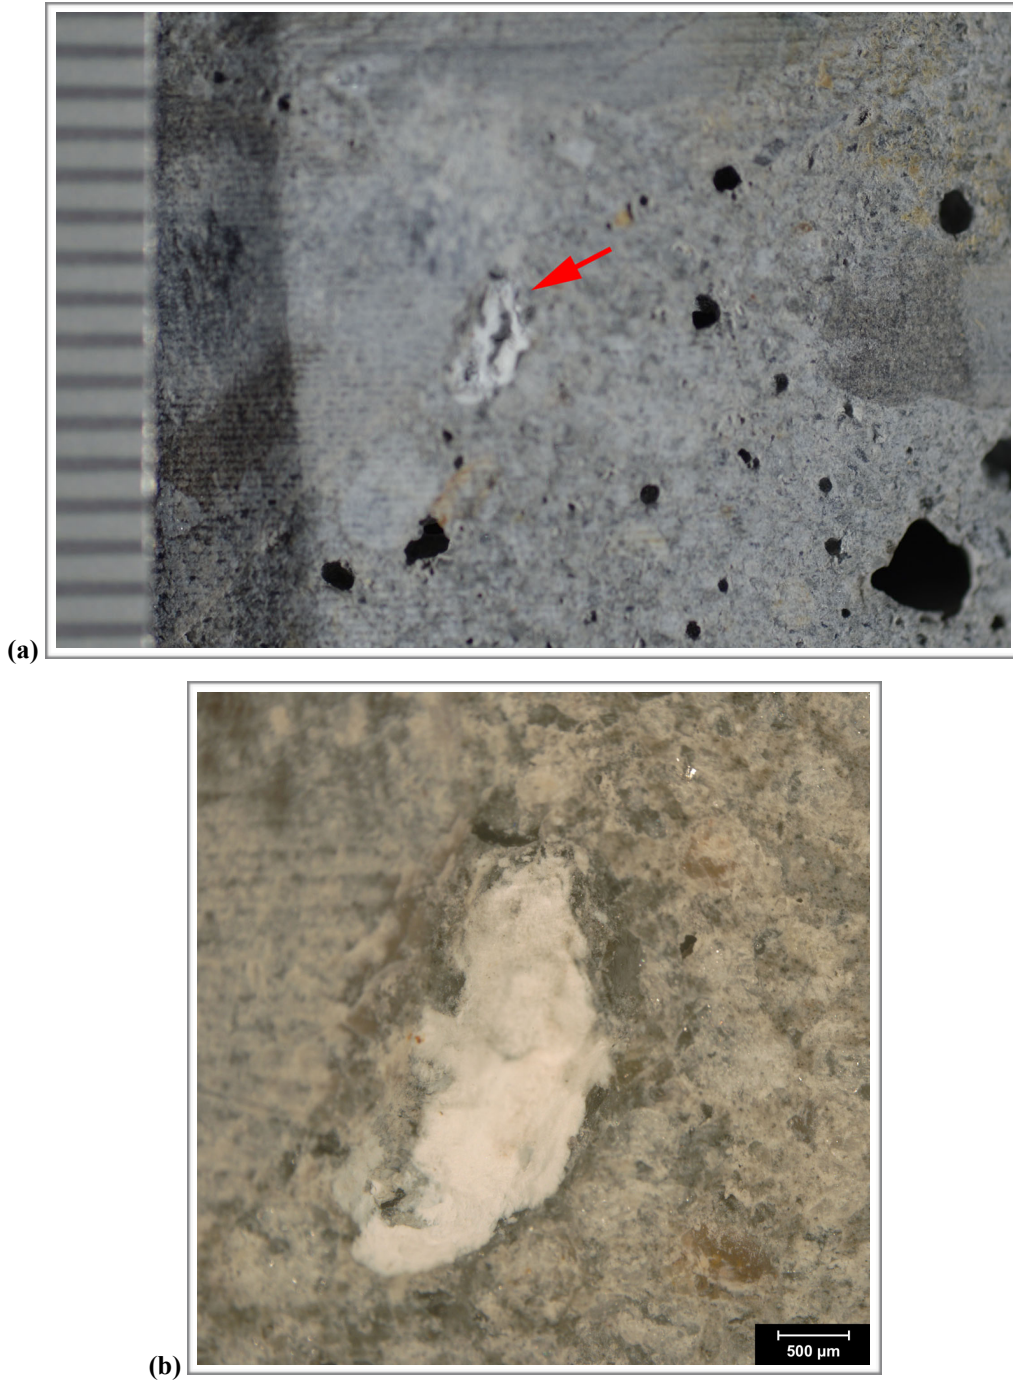
Figure D12. (a) Photograph and (b) reflected light photomicrograph of the side of the core showing a void filled with gel (red arrow in (a)). Scale in millimeters in (a).

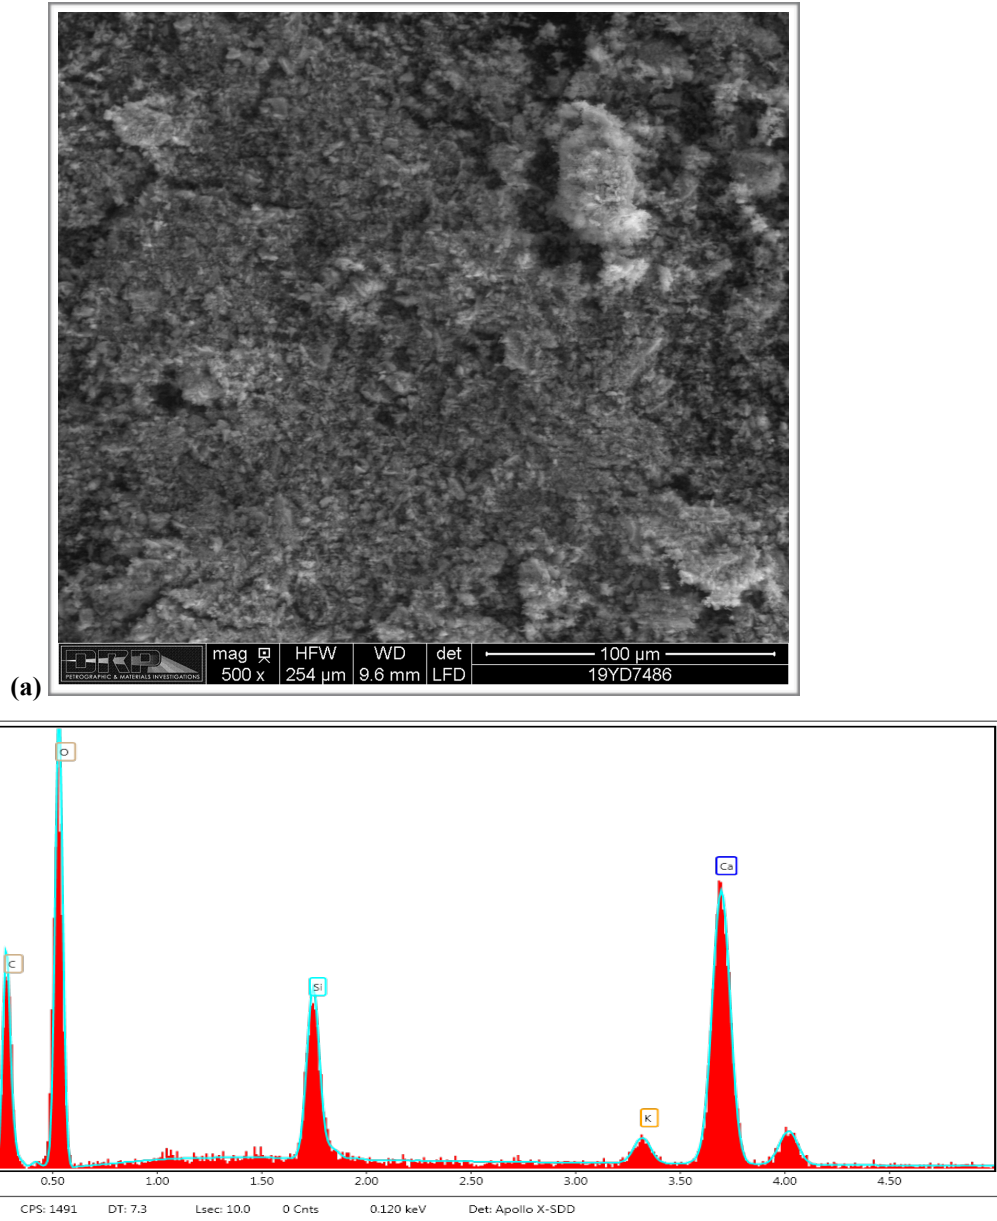
Figure D13. (a) Backscatter electron micrograph of gel deposits scraped from void shown in D12(b) and placed on carbon tape. (b) EDS spectrum of deposit indicating composition typical of ASR gel.

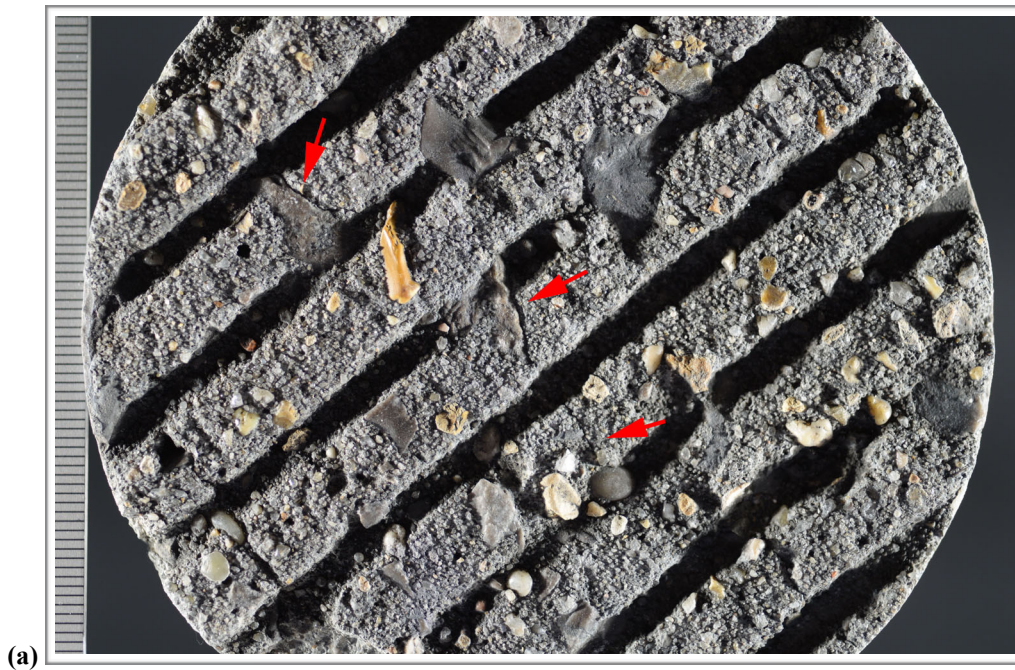
Figure E3. (a) Photograph showing crack (red arrows) on the top surface; scale in millimeters. (b) Reflected light photomicrograph showing hairline crack (red arrows) at the top of the core.

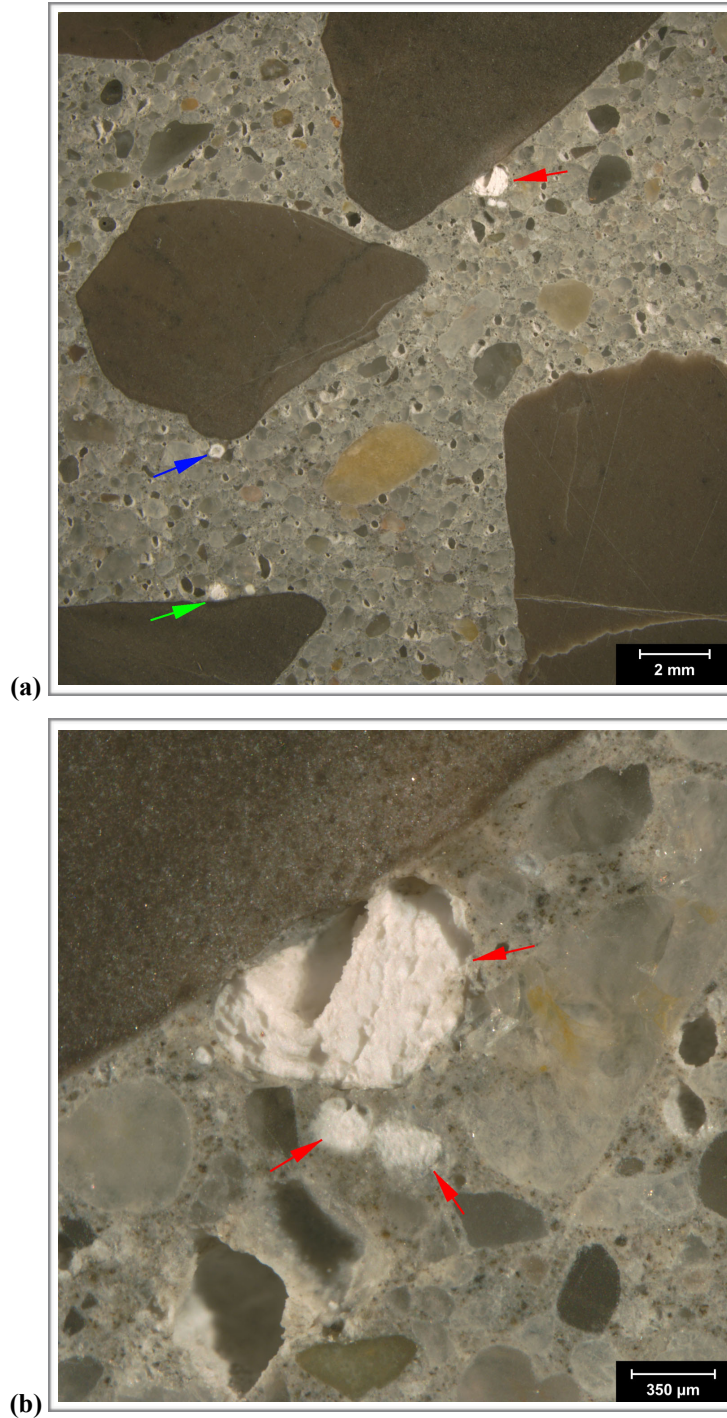
Figure G13. Reflected light photomicrographs of the polished surface showing several voids filled with ASR gel about 80 mm (3 1/8 in.) below the top surface. The red, blue and green arrows indicate voids that are shown in more detail in (b), (c) and (d), respectively.
