# Louisiana Transportation Research Center

Final Report 579

## **I-10 Girder Repair Using Post-Tensioned Steel Rods and Carbon Fiber Composite Cables (CFCC)**

Ching Tsai, Ph.D., P.E.  
Walid Alaywan, Ph.D., P.E.

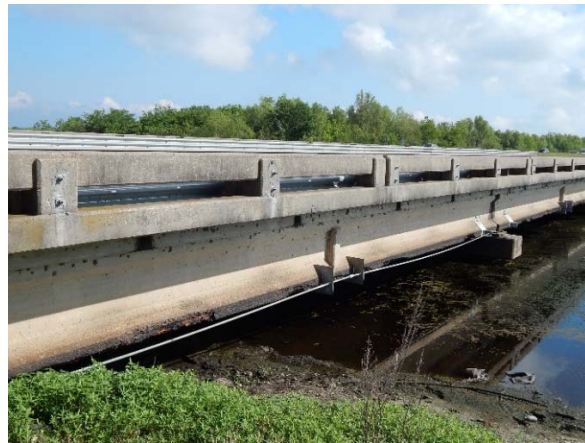
**Figure 2 (a)**  
**Distance view of the eastbound bridge**

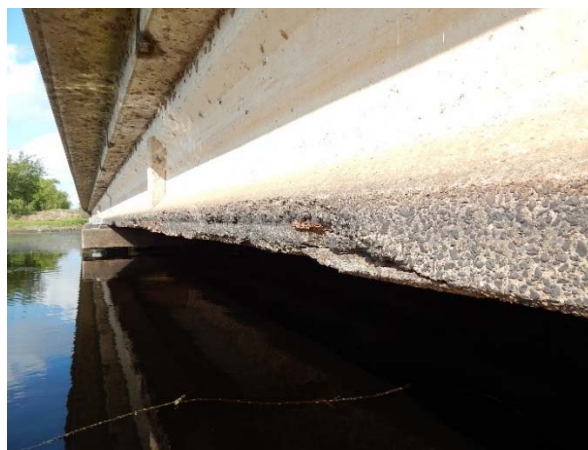
level is near the bottom of the web where severe concrete spalls and steel corrosion can be clearly seen.

**Figure 2 (b)**  
**Close view of the westbound bridge**

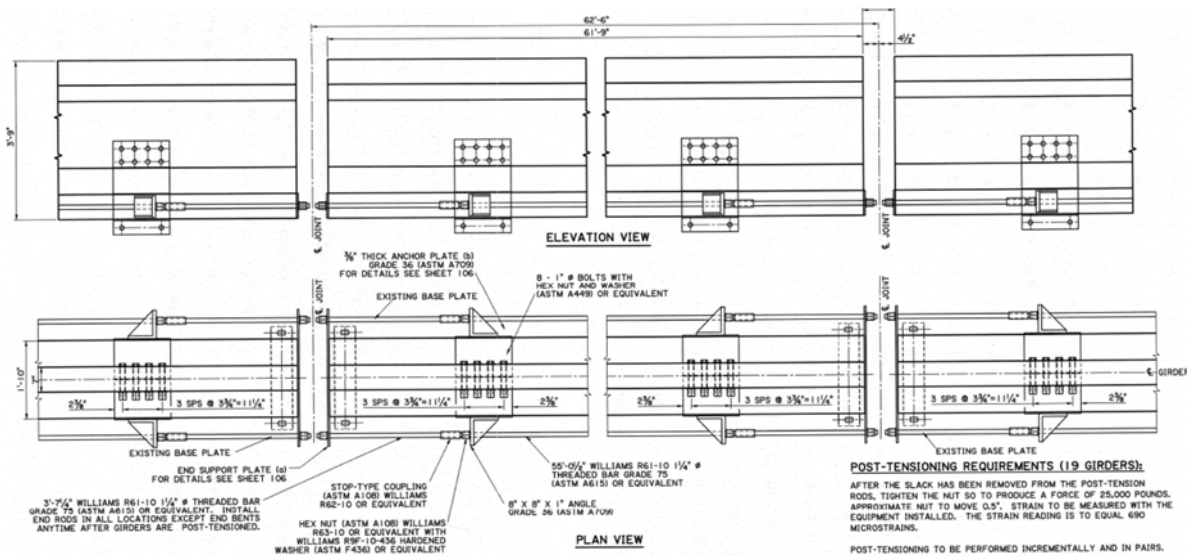
**Figure 4  
External steel reinforcement and anchor locations**

As previously stated, the bridge repair consists of patching the deteriorated concrete and installing one external reinforcement on each side of the deteriorated girders. The girders selected for repair are shown in Table 1. All except the girders at Span C of the east bound bridge were repaired using high strength steel rods. CFCCs were used for the girders at Span C of the east bound bridge. The anchoring system for the steel rods are shown in Figures 4 and 5. Figure 4 shows the locations of the anchoring points. The anchor details are shown in Figure 5. Note that the anchoring points for the steel rods are located at 3 ft. 10 in. from girder ends. The anchoring system for the CFCCs is presented in Figure 6. The locations for the anchors for the CFCC's are located at the girder ends since only one span is reinforced using CFCC and there would not be any conflict. The initial tension forces are 20 kips and 30 kips for steel rods and CFCCs, respectively.

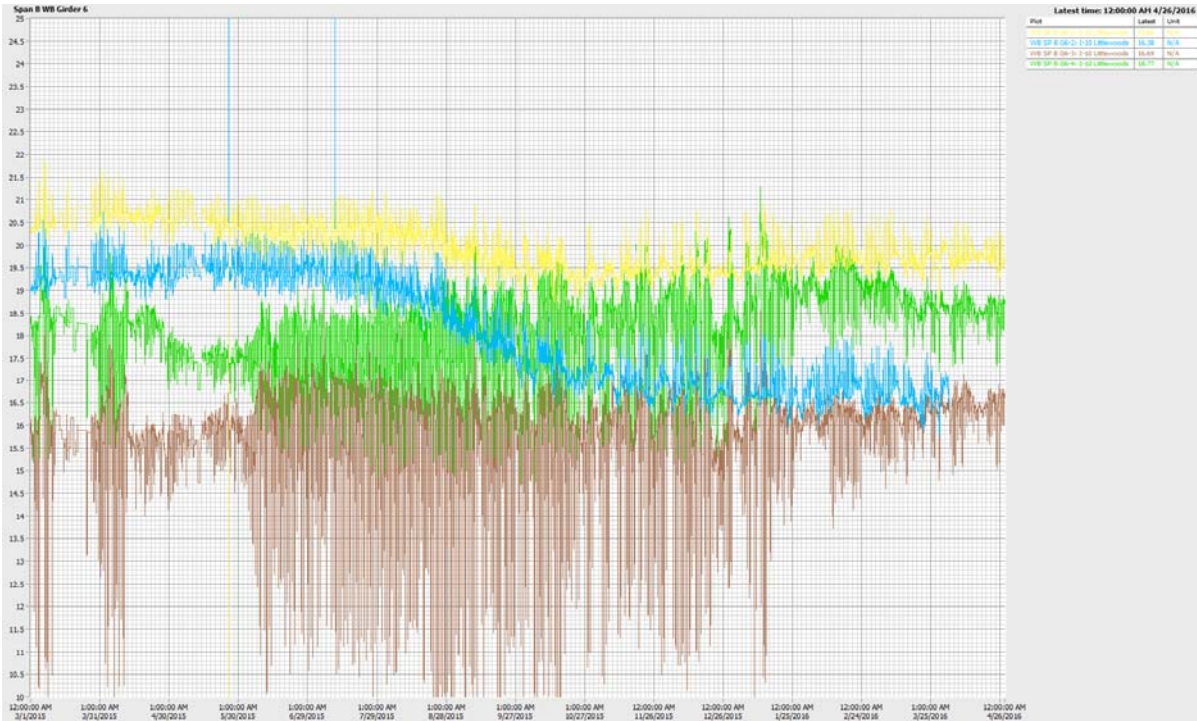
The next step is to examine the behavior of the northern most girder. Again the tension forces recorded from the external reinforcing of Girder 6 (northernmost girder) of the Span B westbound bridge are presented in Figure 18. The yellow and blue lines represent the south side reinforcing bar and the other two show the tension measurements from the reinforcing bar on the north side. Similar to the behaviors observed from Girder 1, the exposed side (in this case, north) experienced greater tension fluctuations. The magnitude of the daily tension change is about 7 kips, greater than 50% of the initial tension. Since the deck slopes at 3/16 in. per foot southward, Girder 6 is about 7 in. higher than Girder 1. As such, the north side of the reinforcing bar was mostly above water during the monitoring period except between early October 2015 and February 2016. This is evident from the much longer period of large daily tension swings recorded. It is interesting that the tension forces between the two gages on the south side of the girder diverged starting sometime in July 2015, which coincided with the low water level. The initial difference between the two gages was slightly less than 1.5 kips; by January 2016, the difference increased to about 3 kips, about 20% of the initial tension force. Note that the two gages were installed on the same reinforcing bar. In theory, these two values should be the same if no friction or bending exist. It is possible that friction resulted from the contacts between the reinforcing bar and the intermediate supports (see Figure 19) contributed to a portion of the tension differential. It is likely that

bending of the cables also caused the tension difference. It is speculated that the divergence was a result of the stress redistribution due to high temperature deviation between the inside and outside of the exterior girders causing the girder to warp slightly and resulting the increased friction between the support and external steel rods.

**Figure 18**  
**Tensions of post-tensioning rods for girder 6, Span B westbound**

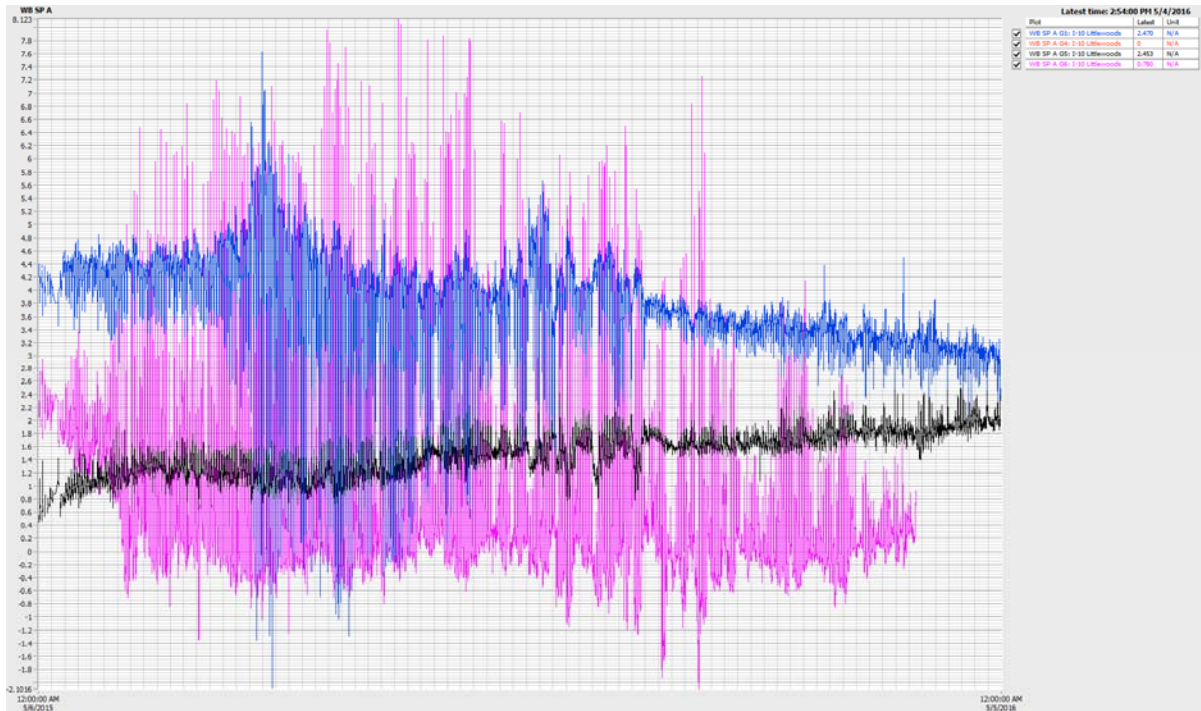
**Figure 20**

Figure 20 shows the tension difference between two sides of the same girders of the Span A of the westbound bridge. As discussed previously, the two exterior girders showed large tension fluctuations due to exposure to the ambient conditions. Both exterior girders (blue and pink lines) also show a reduction in tension differences with time. The interior girder (black line) show only minimum daily fluctuations. However, the long-term trend of the tension difference on this interior girder appears to be increasing at rate of about 1 kip/year. If the rate of deterioration remains the same, the girder should be sufficient to resist the lateral bending before the scheduled bridge replacement.

**Tension differential between the sides of girders 1, 4, 5, and 6, Span A westbound**

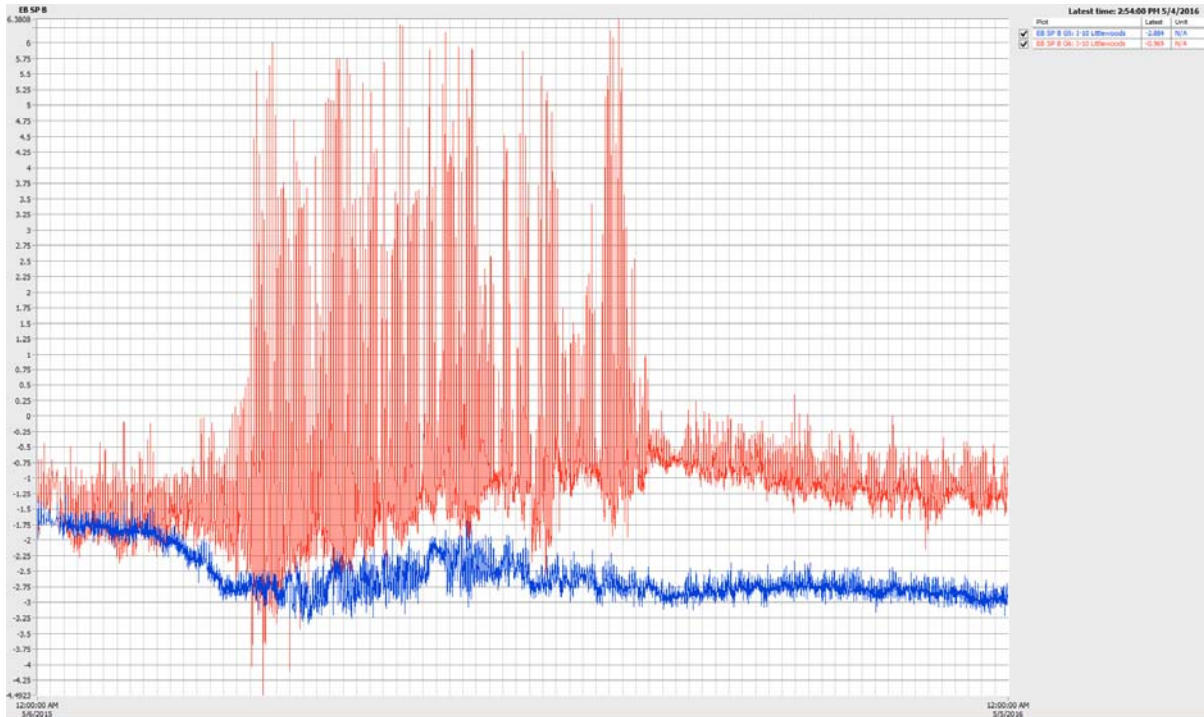
Similar behaviors have been observed from the other steel reinforced spans. For example, the tension differential of Girders 5 and 6 of the Span B eastbound bridge are shown in Figure 21. While the trends of the differentials showed slight changes, the long-term differentials are still much smaller than the daily fluctuations. This trend implies that the daily fluctuations are more critical than the long-term trend observed to date.

**Figure 21**  
**Tension differential between the sides of girders 5 and 6, Span B eastbound**

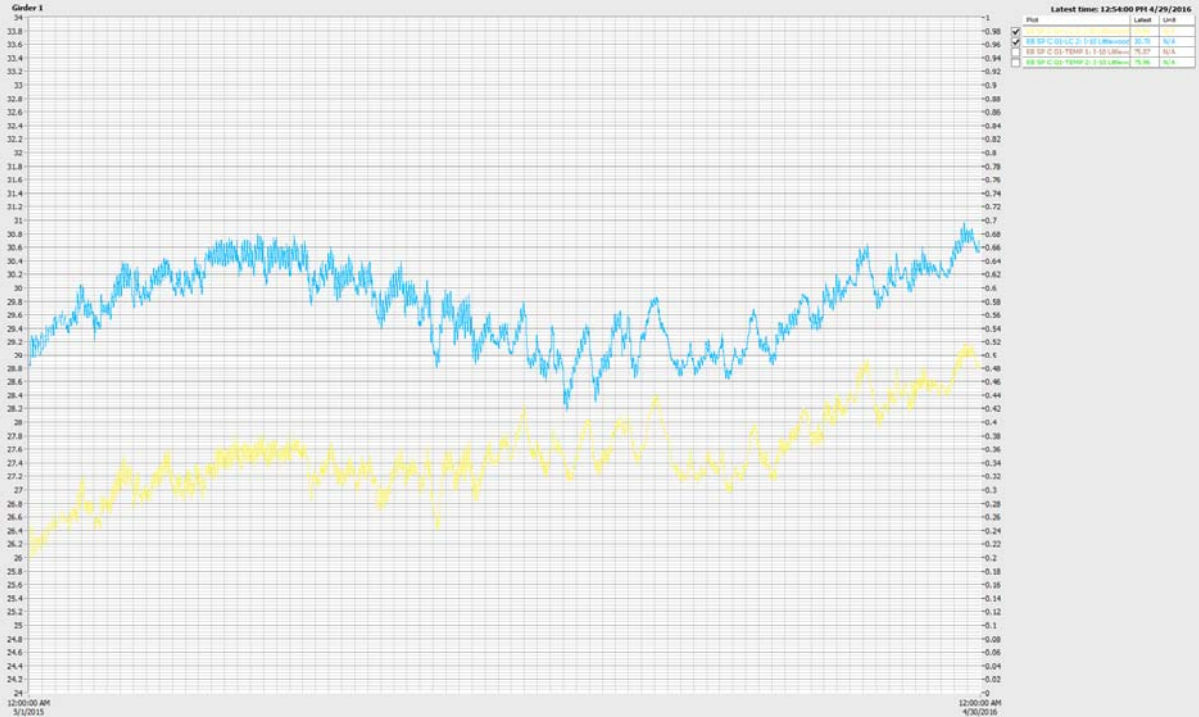
some observations. As an example, Figure 23 shows the tension forces of the CFCCs for Girder 1 of the CFCC reinforced span. It is clear that once the water level dropped to below the reinforcement level, the force in the CFCC on the exposed side (blue line) started decline. As soon as the water level recovered, the force also gradually recovered. The CFCC on the protective side appears to respond differently. The force reduction was much smaller and gap of tension forces between the two sides never recovered.

The daily maximum tension force fluctuation was only about 0.4 kips. This is in contrast to the 7 kips daily fluctuation of the steel rods. The long-term rate of tension increase on an annual basis is about 2 kips. This is very significant. The implication that the internal prestressed tendons are transferring equivalent of the 2 kips of prestress force to the external reinforcement every year. The force transferring could be the result of bonding loss of the prestressed strands due to concrete deterioration or steel corrosion.

**Figure 23**  
**Tension forces of CFCC for girder 1, Span C eastbound**

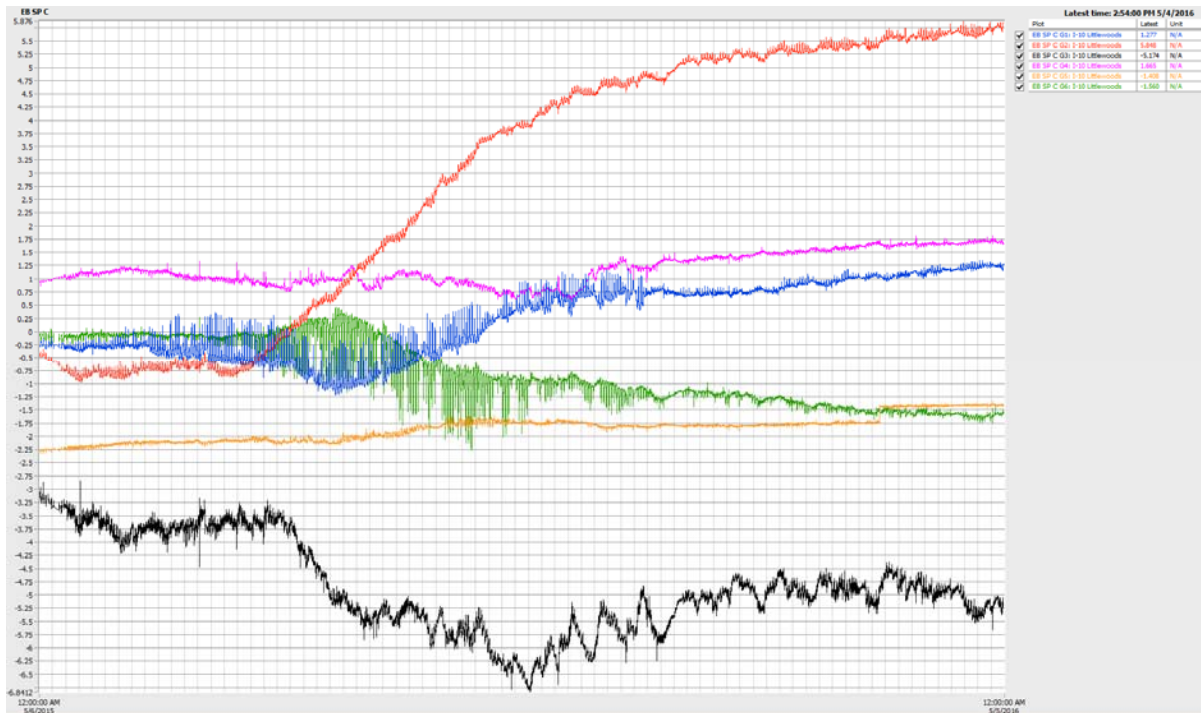
In addition to the rate of load transfer to the external reinforcement, the force differentials between two sides of the girders are also of concern since they are the symptoms of uneven deterioration. They also cause warping or bending of the girder along the weak axis. Figure 24 shows the differential forces of the CFCCs between two sides of the girders for the CFCC reinforced span. It is interesting to observe the two external girders' (blue color – Girder 1 and green color – Girder 6) behavior. They are almost mirror images of each other. Girders 4 (pink) and 5 (tan) generally remained consistent throughout the monitoring period except for an event occurred on March 20, 2016, that caused a small jump (0.3 kips) in tension differential. It is postulated that the sudden change was due to redistribution of the stress within the girder from the prior stress build up. Due to the small magnitude of the jump, it should not have any material impact on the safety of the bridge. The data from Girders 2 and 3 presented the most significant change in the girder performance. Between mid-July and early November 2015 during the period of low water level, there observed a significant change in the tension differentials between the two sides of these girders. The large change suggests the girder exposure sped up the girder deterioration. The combination of the high warping force mentioned above and the high rate of load transfer from the internal prestressed strands to the external reinforcement of Girder 3 could potentially disrupt the bridge service and reduce the potential bridge life.

**Figure 24**  
**Tension force differential of the CFCC reinforced girders**
