Louisiana Transportation Research Center

Final Report 626

Evaluating Louisiana New Continuity Detail for Girder Bridges

1. Title and Subtitle
**Evaluating Louisiana New Continuity Detail for Girder
Bridges**
2. Author(s)
Ayman M. Okeil, Ph.D., P.E. (FL)
Marco Canales, M.Sc.
3. Performing Organization Name and Address
Department of Civil and Environmental Engineering
3255 P.F. Taylor Hall
Louisiana State University
Baton Rouge, LA 70803

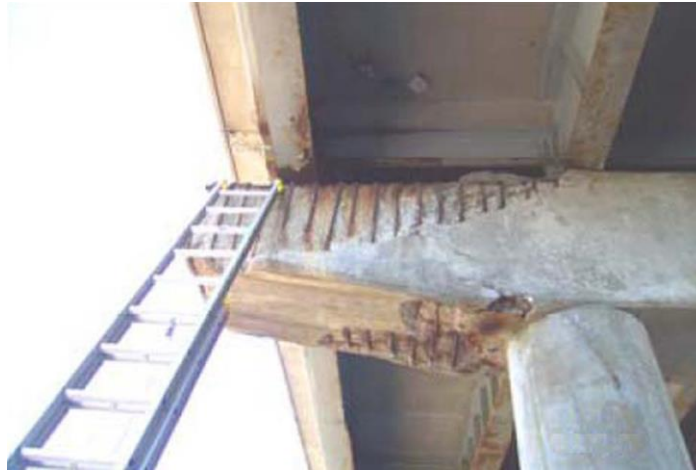
Figure 3. Corrosion damage caused by chloride-contamination leaks in bridge deck expansion joints [6]

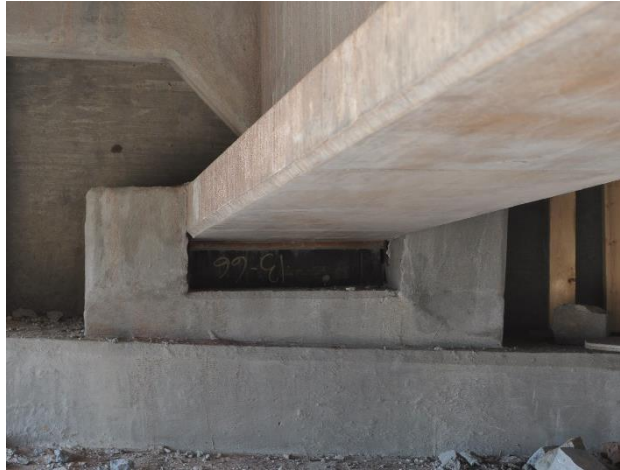
Figure 53. Conditions of the gap between the shear keys and the girder bottom flanges

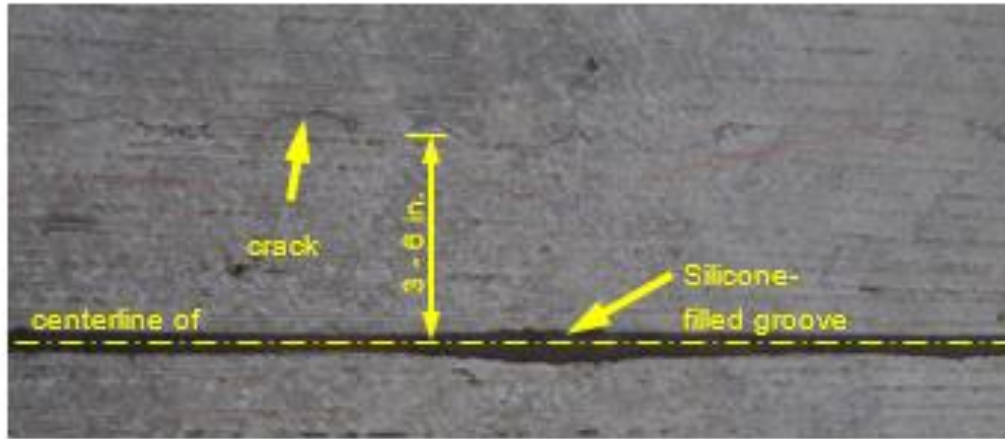
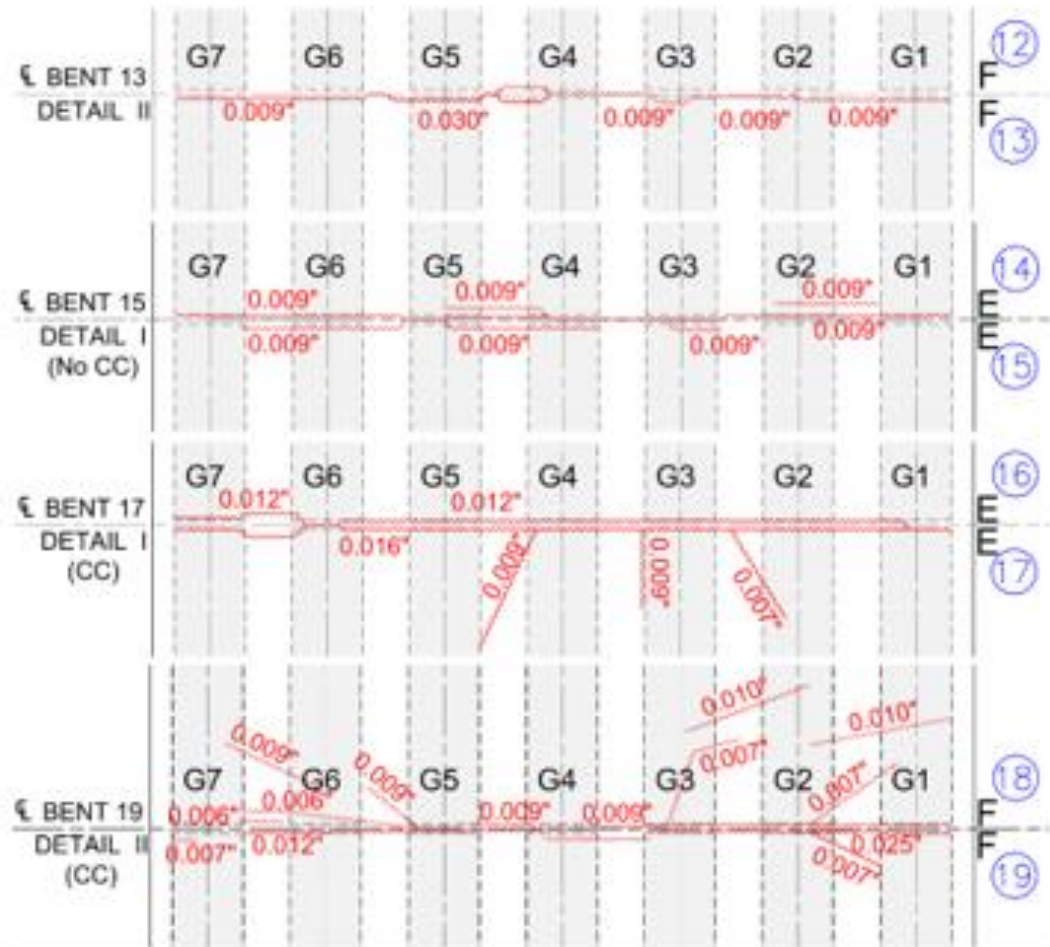
Figure 54. Top view of transverse deck cracking at sample link slab locations

2. The transverse crack control detail (groove) at the center of link slab was not effective in arresting expected transverse cracks at the joint. Therefore, it is not deemed a necessary detail, especially that the crack widths are not alarming and do not require intervention.

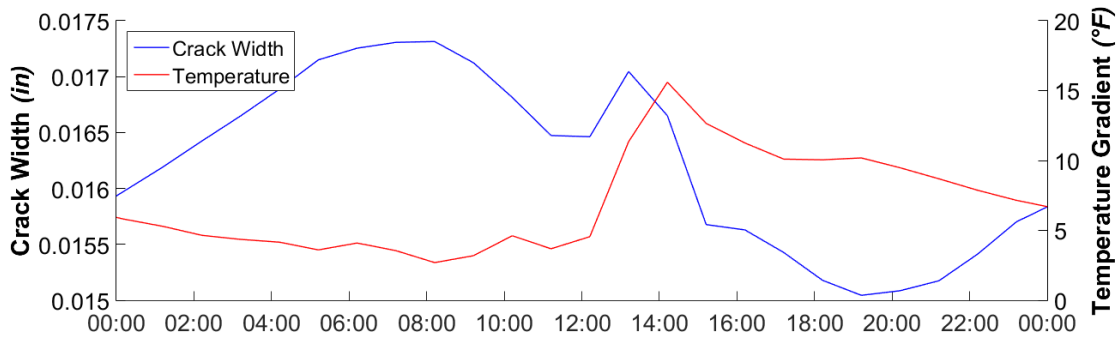
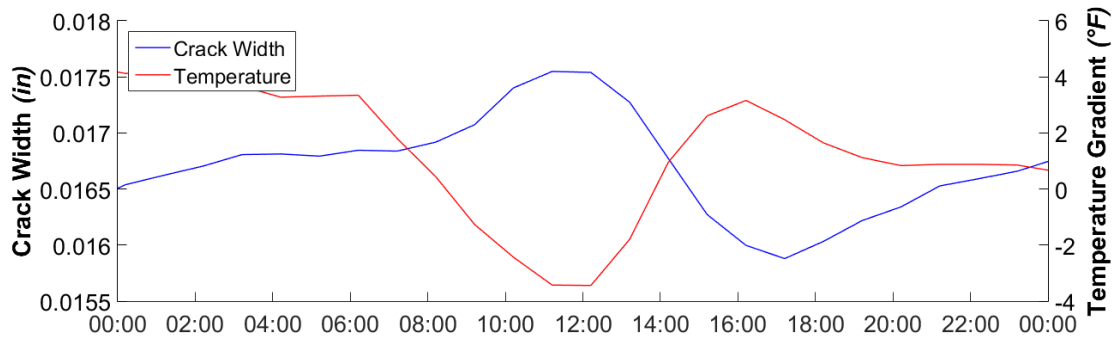
Figure 79. Crack width at Bent 19 – Girder G7 – Segment D (2-span fixed segment) over a 24-hour period in the summer

By comparing Figure 75 with Figure 79, it is possible to see the effect that a fixed support condition can have on cracking in the summer. The cracking is wider in the bent with the fixed support condition. This could likely be attributed to the increase in stiffness at the joint from the diaphragm in the fixed support. An increase in the stiffness at the joint would increase stress levels and produce wider cracks on the slab. The effect is also present in the winter, as can be observed by comparing Figure 78 with Figure 80.

From the observations in this research, an increase to support stiffness will likely widen the cracks in the corresponding bent by concentrating stresses around the joint. Conversely, an increase in continuity reduces the possibility for cracking as more restrictions exist for the crack to open. In terms of temperature, it is clear that in all the cases crack formation responds very closely to temperature gradient.

3. Anchoring diaphragms in bent caps imposes higher strains on the link slab and may lead to wider crack widths. Therefore, it is recommended that such a detail not be used in link slab construction as long as other horizontal forces (e.g., braking and seismic) could be resisted by another mechanism of the bridge structure.
