Report No. FHWA/LA.05/397		2. Government Accession No.	3. Recipient's Catalog No.
4. Title and Subtitle Evaluation of DOTD Semi-Integral Bridge and Abutment System		5. Report Date March 2005

14. Sponsoring Agency Code	
15. Supplementary Notes			
<p>16. Abstract</p> <p>The Louisiana Department of Transportation and Development (LADOTD) designed and constructed its first prototype semi-integral abutment bridge in 1989. In this design, large longitudinal movements due to expansion and contraction, creep, shrinkage, and settlement are mitigated with an annular space, or gap, constructed between the backwall and the roadway embankment. This annular space is created using a geosynthetic-reinforced embankment constructed underneath the approach slab on the roadway side. To date, DOTD has constructed six prototype semi-integral bridges. These bridges are located in the north, central, and western parts of the state. All six-prototype bridges were replacement projects in areas of the state where soil conditions are relatively good and, therefore, settlement was not a concern. The approach slab in the DOTD prototype design is cast integral with the bridge making it one continuous structure.

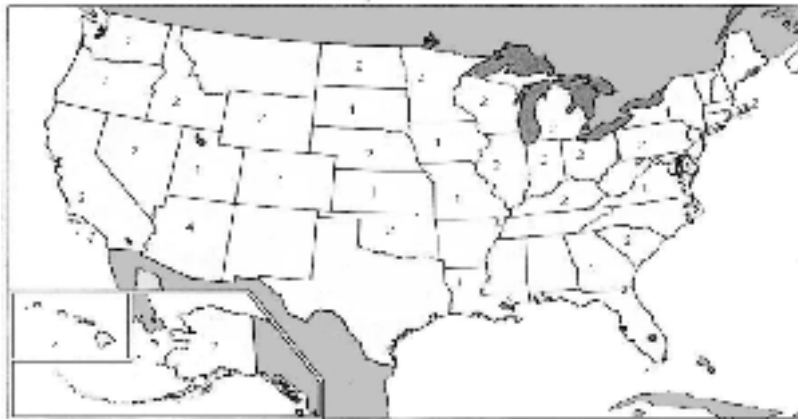
1- Very Good to Excellent 2- Satisfactory to Good 3- Poor to Fair 4- Discontinued

Figure 3
States with jointless bridges and their reported performance

As of 2001, 35 of the 50 states had constructed jointless bridges [1]. Eleven states reported their overall experience with integral bridges as either very good or excellent. Another 21 say their experience has been good to satisfactory. However, Minnesota reported poor experiences and Arizona has discontinued the use of jointless bridges. Of the 35 states, 16 say there is definitely a need for future research of jointless bridge design and construction. Figure 3 shows the states with jointless bridges and their reported experiences of bridge performance.

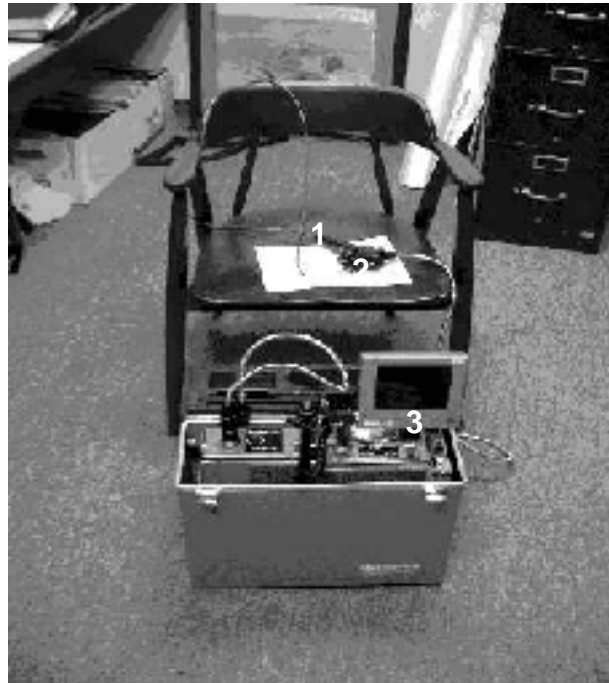
Figure 14
DOTD's baroscope

1. Camera
2. Joystick Control
3. Screen

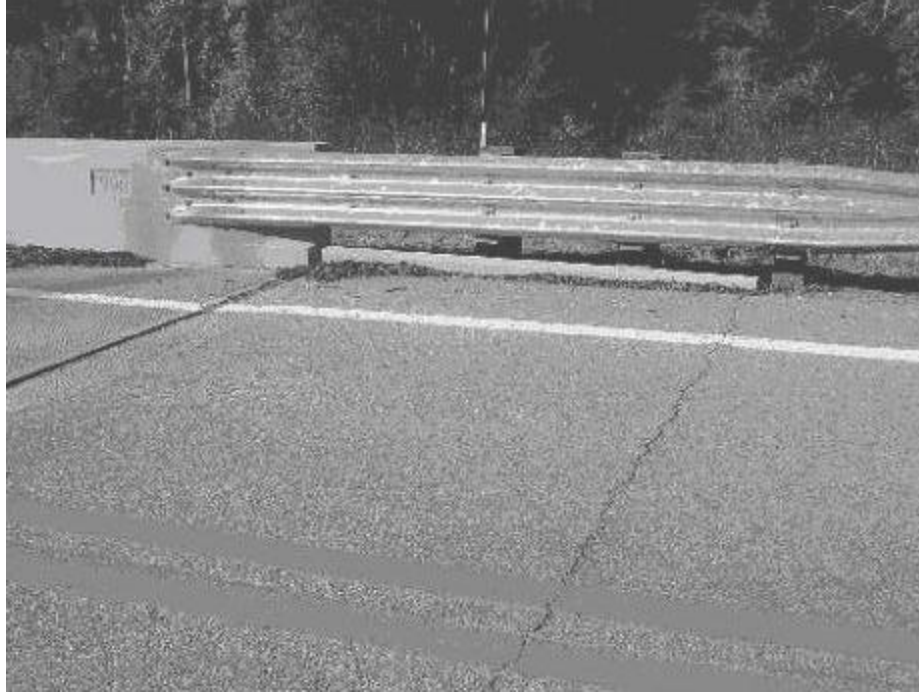
Figure 18
A crack across the approach slab of Bridge C-1

- In all four conventional bridges, rubber seal fillers along the expansion joints were either partially or fully loose, particularly in Bridge C-3.
- Several transverse and few longitudinal cracks were observed in the bridge decks, particularly in the approach slabs, as shown in figure 18.
- A camber was observed in the girders of Bridge C-1.
- In terms of rideability, all four bridges had a small bump at the interfaces between the approach slab and bridge deck and between the approach slab and roadway. The remaining joints within the bridge spans were acceptable.

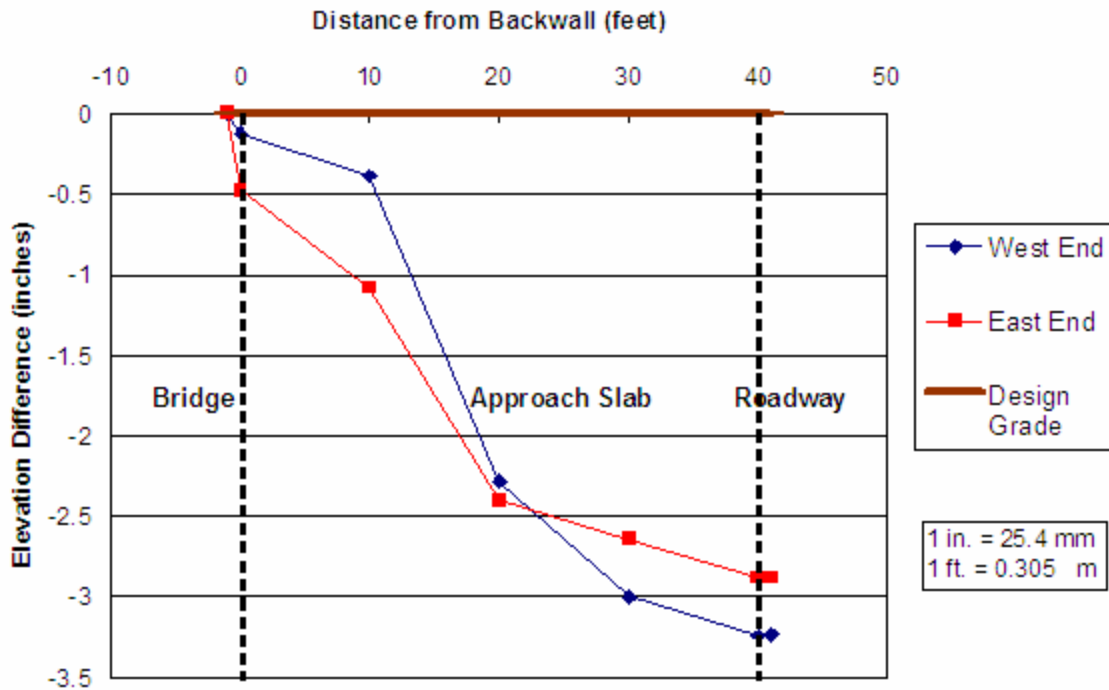
Figure 20
Longitudinal profile along Bridge I-1

The vertical gaps on both ends of the bridge were examined through the 4-inch (102 mm) diameter inspection holes drilled in the approach slab. The gap measurements indicated that an annular space existed on both ends as specified in the design drawings. However, the gap size was generally larger on the east end of the bridge than on the west end. The gap size varied between 1.6 and 4.6 inches (45 and 117 mm), as shown in figure 21. The gap was about 1.6 inches (41 mm) wide at a depth of 11 inches (0.29 m) on the west end. The size of the gap increased to 3 inches (76 mm) at a depth of 38 inches (0.97 m). The gap size decreased below this depth, it was 2.1 inches (53 mm) at a depth of 72 inches (1.83 m). On the east end, the gap was 3.5 inches (89 mm) at the 37 inch (0.94 m) depth, and then it increase to 4.6 inches (117 mm) at a depth of 72 inches (1.83 m).

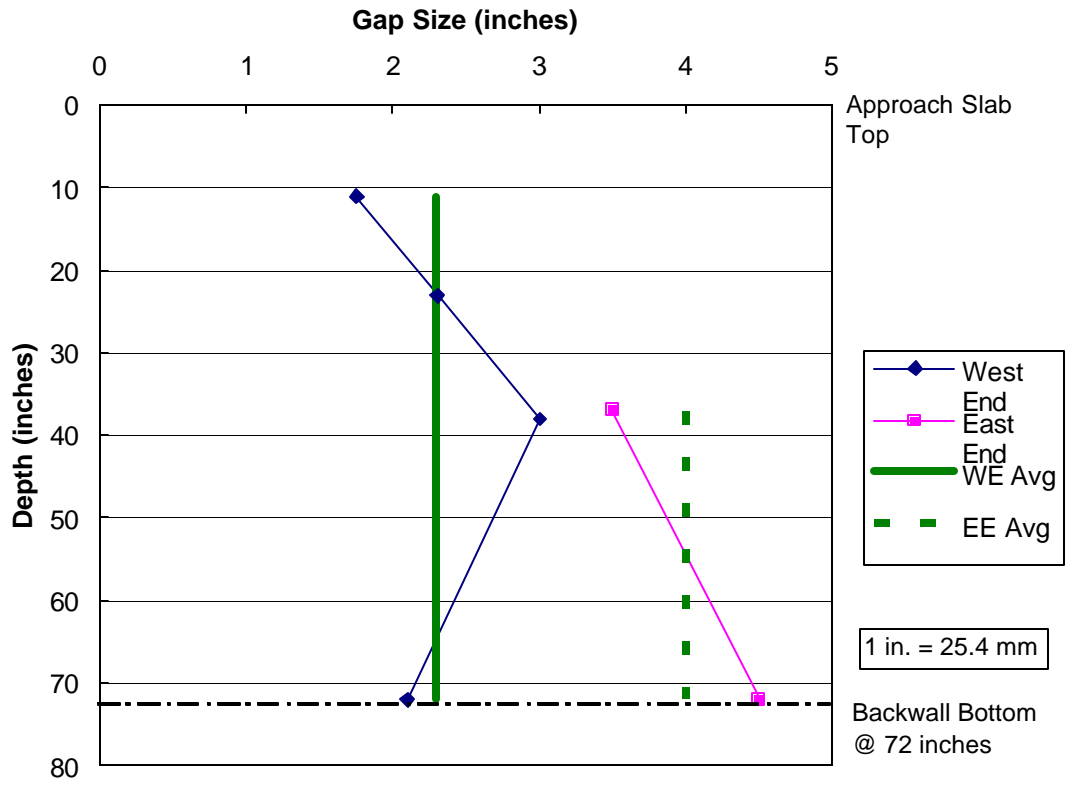
Figure 21
Variation of gap size in Bridge I-1

In this bridge, the change in gap size with temperature and time was also monitored by measurements made through the existing weep holes along the backwalls on each side of the bridge. A sketch of the measurement procedure is shown on figure 22. Each time a measurement was taken by DOTD personnel, the ambient temperature at the bridge surface was also recorded. The average daily ambient temperature was also recorded at the bridge location. An effort was made to take these measurements as often as possible. Seven readings were taken by DOTD in a four-week span. It should be noted that measuring the gap space through the weep hole is subject to human judgment and possible associated errors. The measuring scale used should be entered at the same exact location each time a measurement is made, but this is not possible with different personnel taking the measurements. For example, a 0.5-inch (13 mm) change at the measurement location could result from personnel touching the geogrid face or penetrating into the actual soil surface within the embankment. A geogrid could be also damaged or cut at a given location, which could result in 1-inch (25 mm) error. In figure 23 the view of the gap through the weep hole of Bridge I-1 indicates a cut in the geogrid. This was the only bridge with a cut on the geogrid.

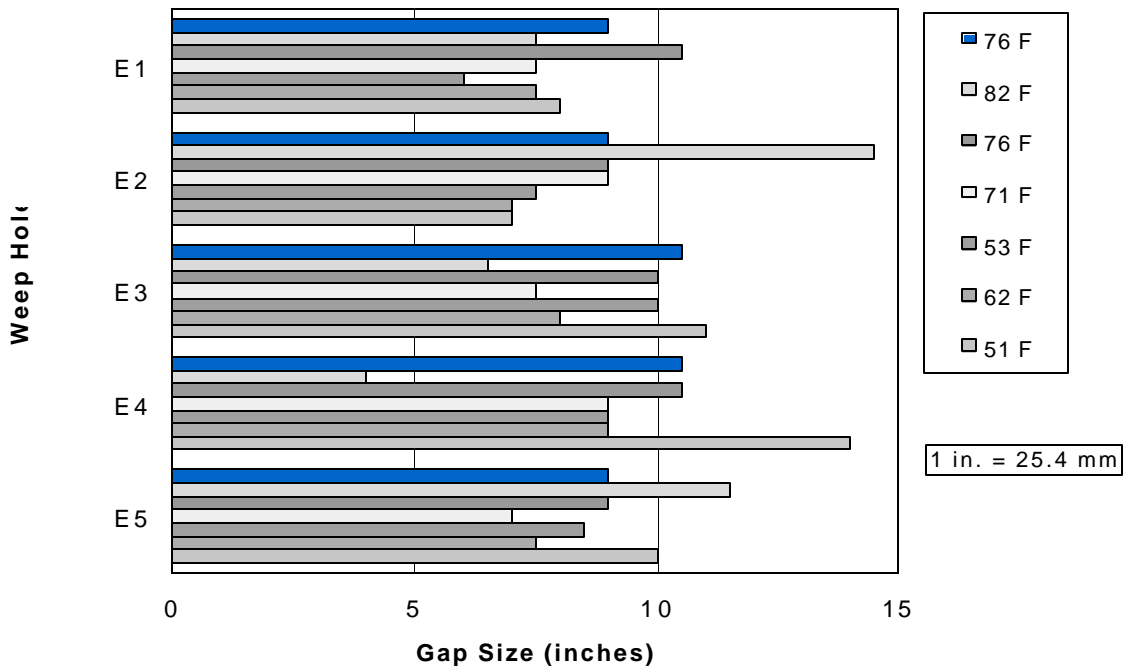
Figure 26
Variation of gap size (east wall) with temperature in Bridge I-1

Figures 26 and 27 show the change in the gap size with the ambient temperature recorded at the time of measurement. These temperatures may not accurately represent the actual ambient conditions since they were taken over the bridge at the time of the reading and may not represent the extreme conditions during a given day or a given month. Other conditions such as humidity and rain could have also affected the measurements.

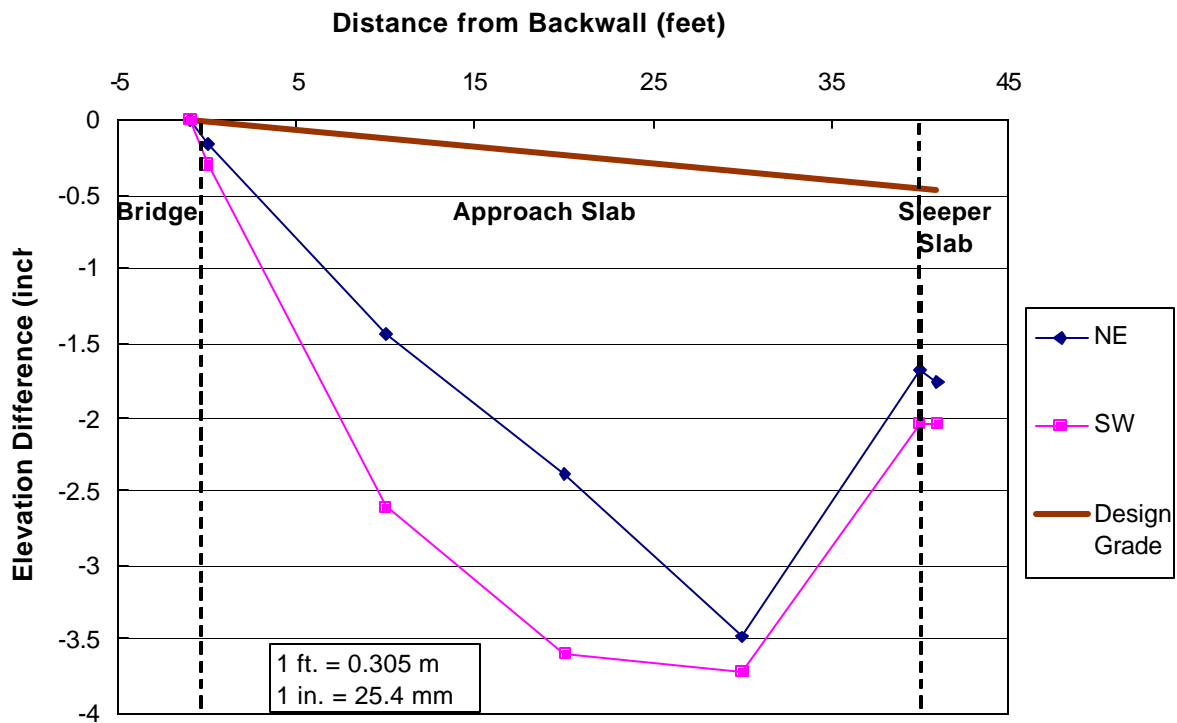
Figure 30
Longitudinal profile along Bridge I-2

This 725 feet (221 m) long bridge is the longest integral bridge built to date in Louisiana. Geodetic survey results showed differences between the edge of the bridge and the sleeper slab of about 1.73 inches (44 mm) on the northeast (NE) end and 2 inches (51 mm) on the southwest (SW) end, as shown in figure 30. On this approach slab and at about 30 feet (9.14 m) from the bridge deck, the southwest end exhibits a relatively high elevation difference from the deck of 3.7 in (94 mm). This difference decreases significantly to about 2 inches (51 mm) at the sleeper slab joint on the northeast end. According to the grade profile, it is clear that the approach slab did not have any significant settlement on the first 30 feet (9 m). However, a difference of 3.3 inches (85 mm) was observed at the approach slab roadway interface. This difference could be the result of either a construction error or a local high grade at the survey point.

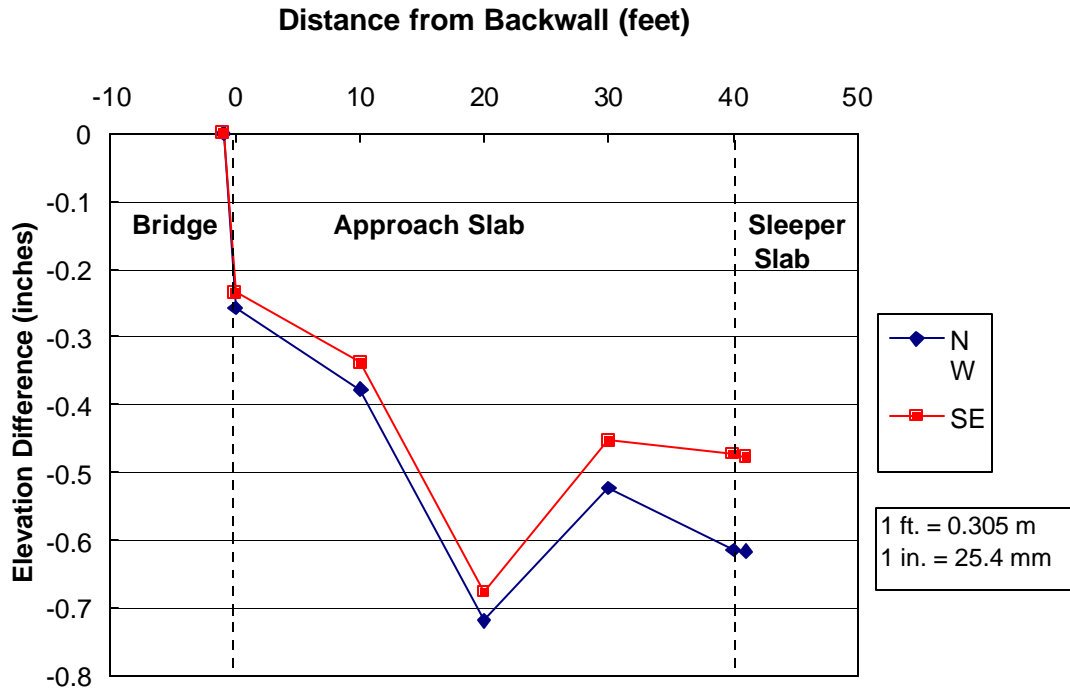
Figure 35
Longitudinal profile along Bridge I-6

Figure 35 indicates a difference in relative elevation of about 0.48 to 0.62 inch (12 to 16 mm) between the end of the bridge and edge of the sleeper slab. At the middle of the approach slab, the maximum difference in elevation is about 0.7 inch (18 mm). The design grade profile was not available on the design plans. The width of the gap between the backwall and the geosynthetic-reinforced embankment was measured on the southeast end of the bridge. The gap size varied between 4 and 6 inches (102 and 152 mm), as shown in figure 36. The figure shows that the gap size decreases with depth.

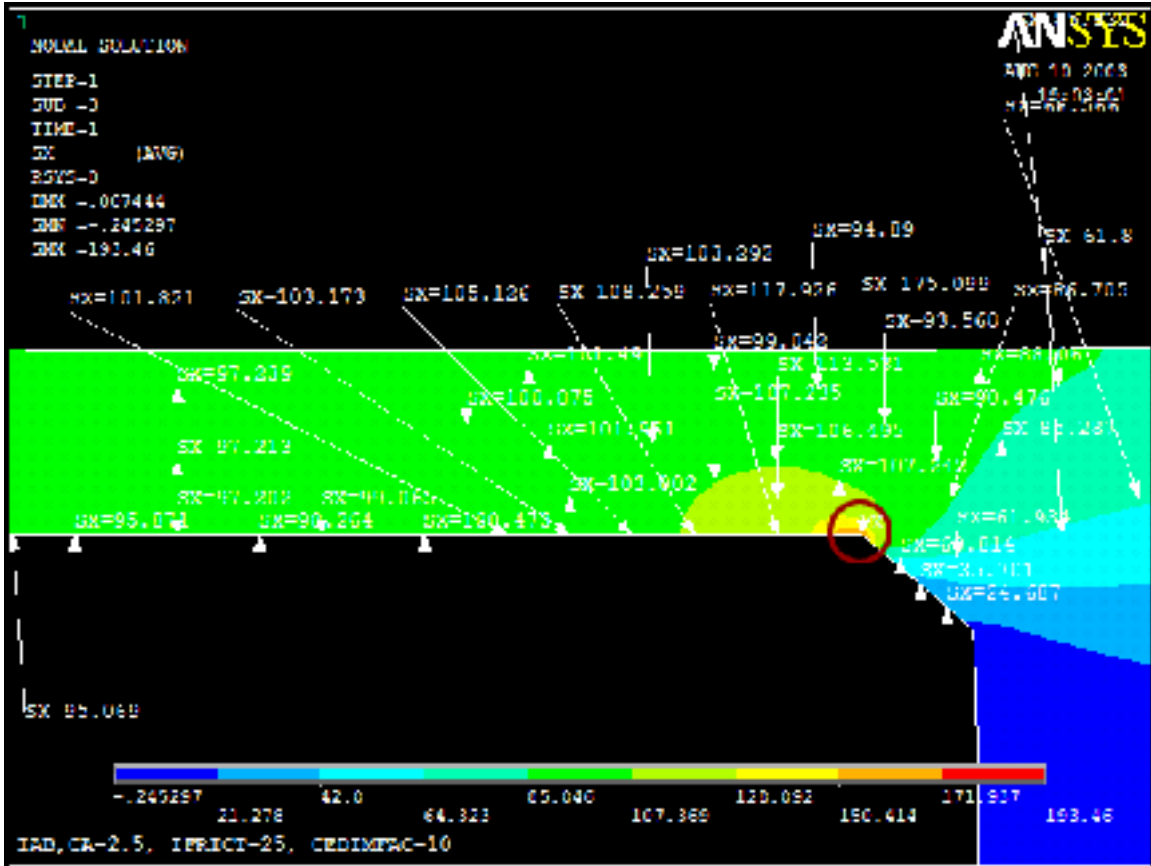
Figure 69
Stress distribution with CEDIMFAC=10, Ca = 2.5 psi & IFRUCTION = 25

A typical stress distribution resulting from the finite element analysis is presented in figure 69 for illustrative purposes. An analysis with a CEDIMFAC = 10, Ca = 2.5 psi, and IFRUCTION = 25, revealed the following stress distribution (note that the stresses are expected to be 20 percent higher in the fully converged case). All stresses are in psi units. A parametric study was performed to determine the effect of changing the haunch angle. The results are shown in table 25. Note that for small values of the haunch angle, the critical stress point is moved to the backwall. A few of the initial cases show cracks in the system and stress redistribution (CEDIMFAC=12, ca=3, IFRUCTION=2.5). Figures 70 and 71 are examples of such cases. The circle in figure 71 indicates locations of cracking.
