EVALUATION OF EXPERIMENTAL RAILROAD-  
HIGHWAY GRADE CROSSINGS IN LOUISIANA

INTERIM REPORT NO. 5

Research Report No. 140

Conducted by  
LOUISIANA DEPARTMENT OF TRANSPORTATION AND DEVELOPMENT  
Research and Development Section

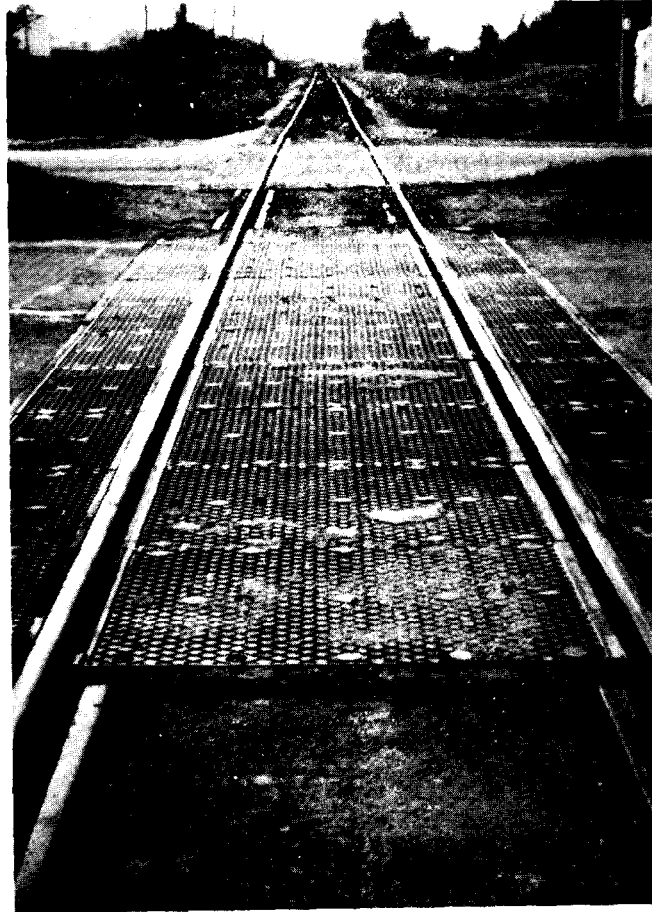
FIGURE 4

The November, 1979, inspection revealed that many problems associated with the 1973 accident still existed. There were warped pads, loose bolts, uneven panels and some broken welds which caused the overall performance to be rated as only fair (Figure 4). Since the first inspection report had revealed an excellent performance until the

time of the derailment, it can be concluded that the November, 1979, performance rating of "fair" is primarily due to the 1973 derailment damages and also due to subsequent deterioration which was caused by lack of proper and timely repairs to correct those damages.

*Goodyear rubber crossing at Baton Rouge  
after approximately 17 years of service*

*(NOTE: 1973 derailment damage was partially repaired in late 1977)*

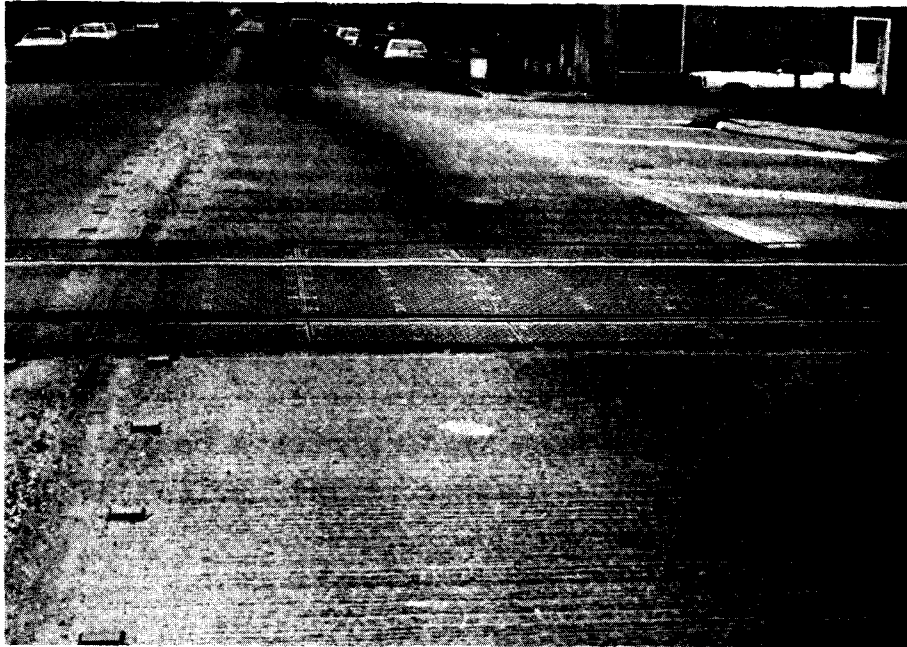
FIGURE 5

The most recent inspection, in November, 1979, revealed that the crossing was in excellent overall condition (Figures 5 and 6). However, it should be noted that the relief joints between the field-side rubber panels and the portland cement concrete pavement on either side of the crossing were apparently filled with inferior and uncompacted asphaltic material which had sunk and broken out in several spots creating a bump effect at the crossing. Addition of an asphaltic filler mix to the relief joints should remedy the problem and result in a much smoother ride over the crossing.

*Overall view of Goodyear rubber crossing at Welsh  
after approximately 3 years of service*

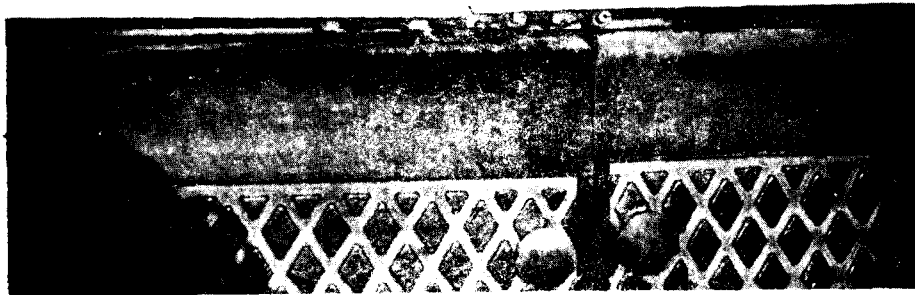
*Close up view of bridge crossing at Bossier City  
showing unspalled concrete at the highway median*

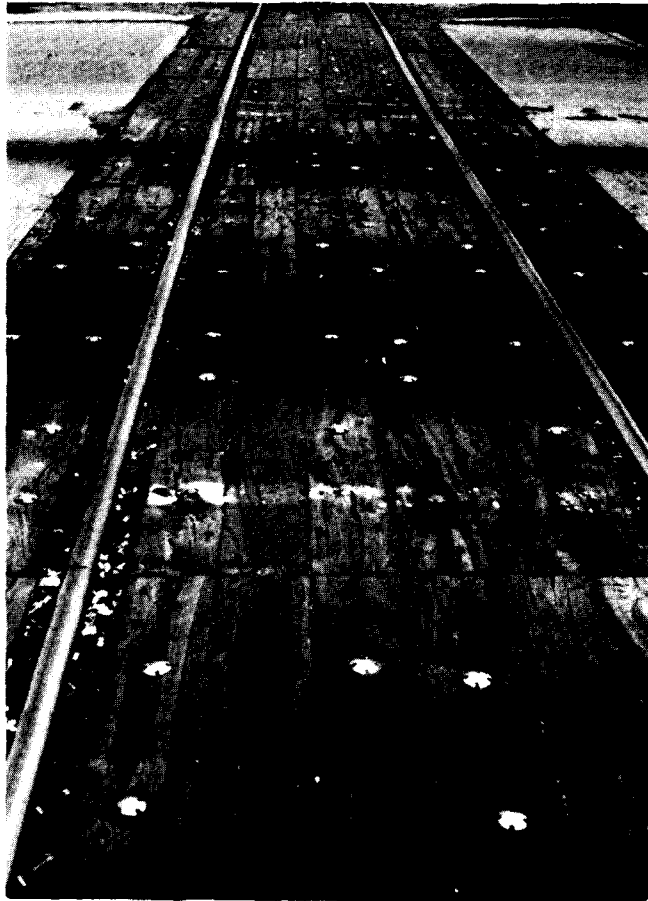
FIGURE 9

Crossing No. 4a is a sectional treated timber crossing (Figure 9) which has been included in the study for comparison purposes. It has performed well to date primarily due to a well drained and a well compacted subgrade. There is one loose rail which needs to be tightened.

*Overall view of sectional treated timber Crossing at Bossier City  
after approximately 4 years of service*

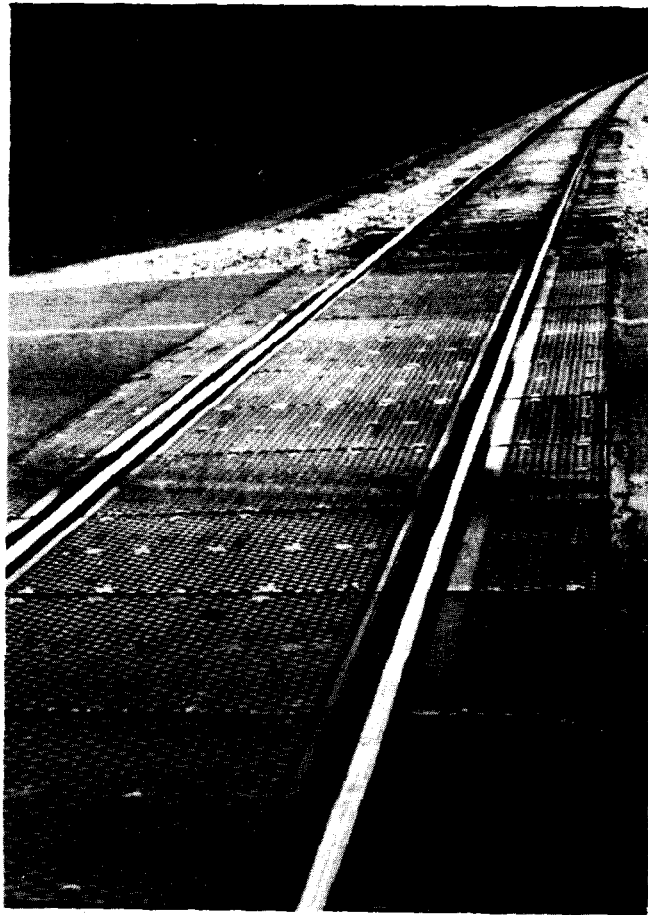
FIGURE 10

This single-track, rural crossing is part of a main line which serves eight (8) freight trains per day at an estimated rail speed of 35 mph. The crossing utilizes Goodyear rubber panels and was installed in December, 1975. With the exception of slight deterioration of the asphalt filler at the header boards (Figure 10), the crossing has performed very well, and its performance can be rated as good to excellent. Ride quality over the crossing is also very satisfactory.

*Goodyear rubber crossing at Pickering  
after 4 years of service*

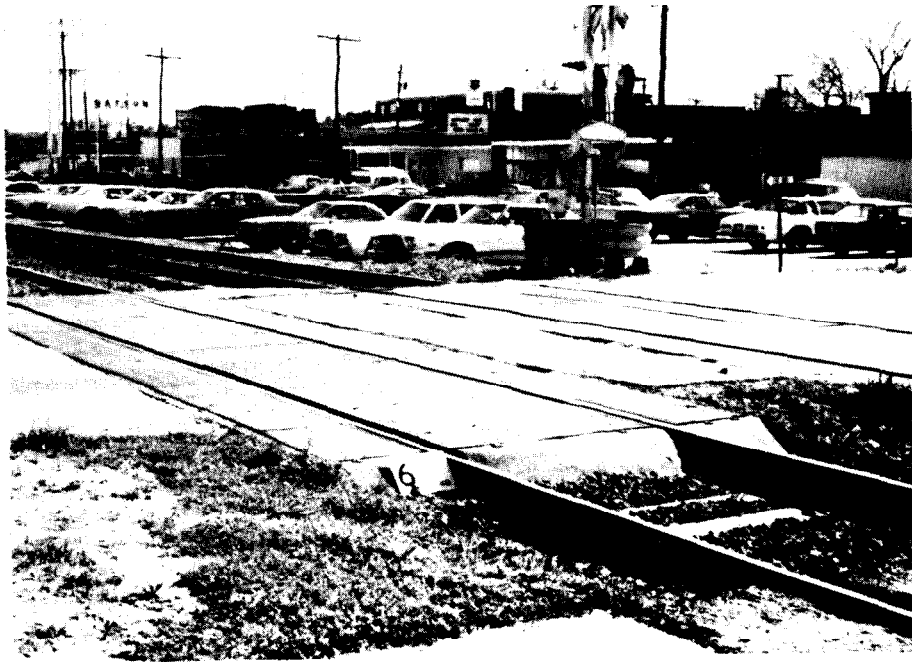
FIGURE 11

The tracks at the subject location are part of main lines which serve fifteen (15) rail movements per day at an estimated rail speed of 30 mph. The crossing was constructed in the fall of 1974 using Goodyear rubber panels. With the exception of minor equipment damage to the skid plates, a loose rail and uneven relief joints, the experimental installation remains in good-to-excellent condition and exhibits smooth riding quality for vehicular traffic (Figures 11 and 12).

*Double-track Goodyear rubber crossing at Hammond  
after more than five years of service*

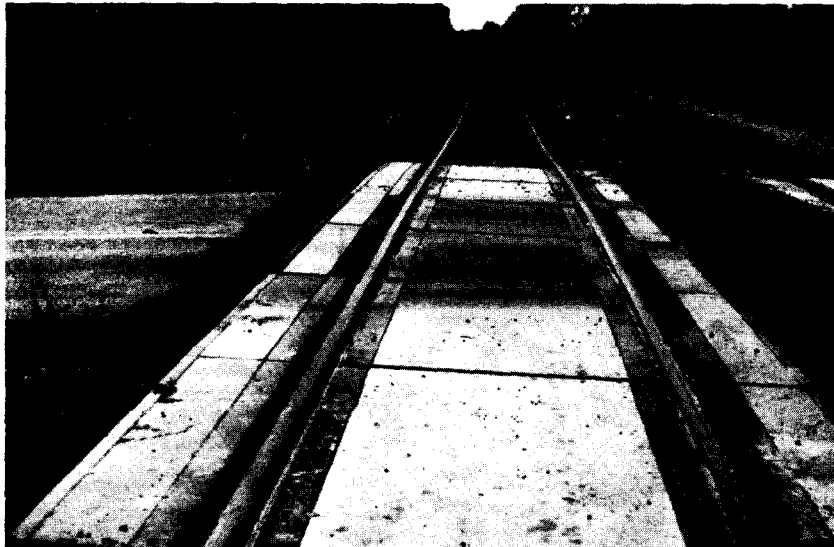
FIGURE 13a

The crossings at the subject location are part of a mainline which serves six (6) rail movements per day at an estimated maximum rail speed of 40 mph. Both crossings were constructed in December, 1974, using a new type of prefabricated reinforced-concrete crossing manufactured by Szarka Enterprises, Inc. of Livonia, Michigan, having the trade name FAB-RA-CAST (Figure 13a).

*General view of precast concrete crossing  
FAB-RA-CAST in Burnside*

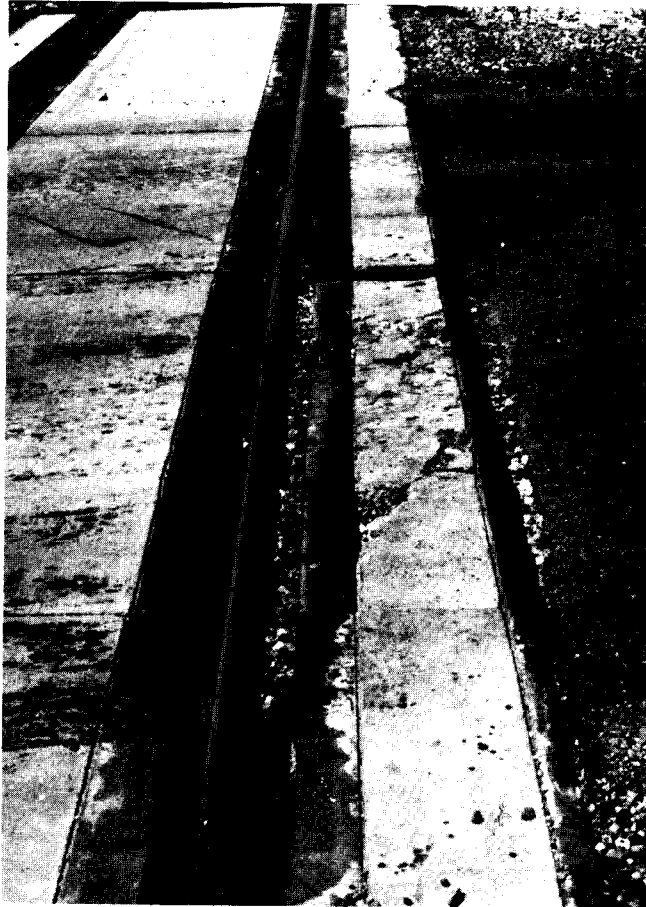
*FIGURE 13c*

*FAB-RA-CAS® slab began deteriorating  
soon after installation*

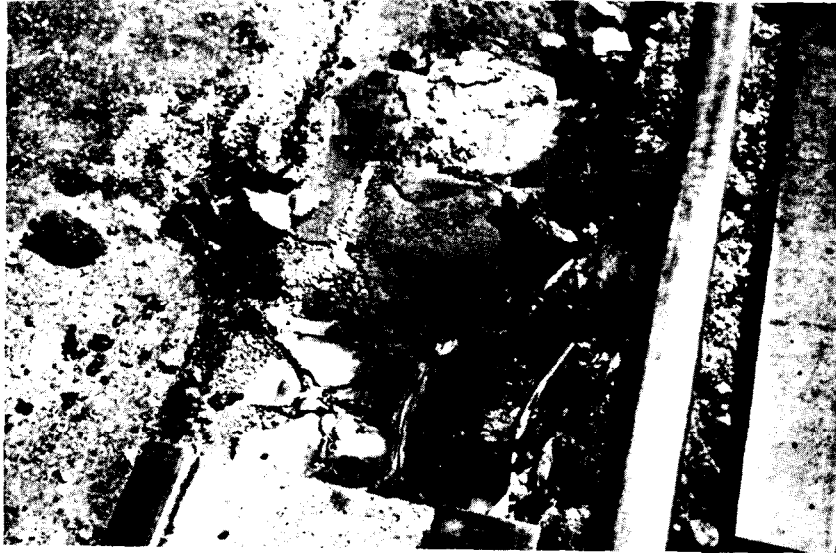
*FIGURE 13d*

*FAB-RA-CAST slab disintegrated under traffic load*

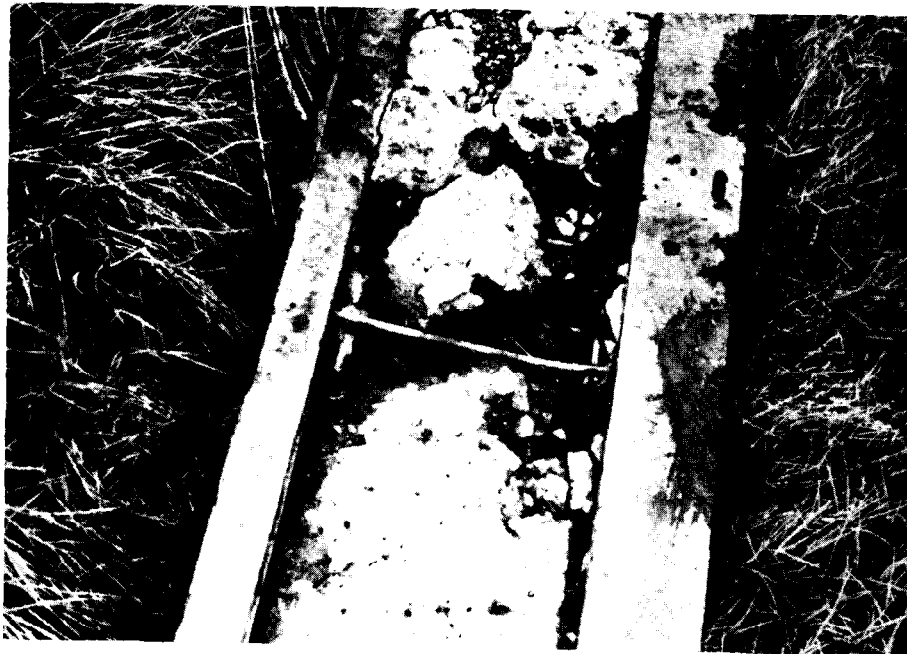
*FIGURE 13e*

*Badly deteriorated FAB-RA-CAST slab  
has been removed to be replaced by a new panel*

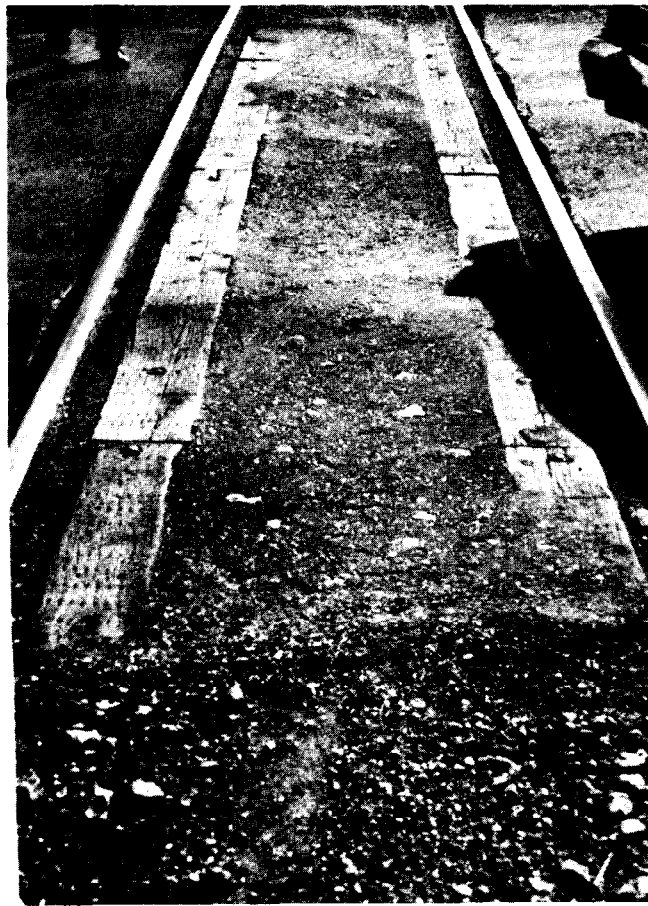
FIGURE 14

In June, 1977, two field-side panels had cracked and other pads had begun rocking. By 1979, the crossings had experienced complete failure, again, and they had to be removed and replaced by temporary timber-asphalt crossings (Figure 14). Rubber-panel crossings will be installed at this location in the near future.

*1979 view of temporary timber-asphalt crossing at Burnside  
after FAB-RA-CAST slabs had failed again and  
required removal and replacement*

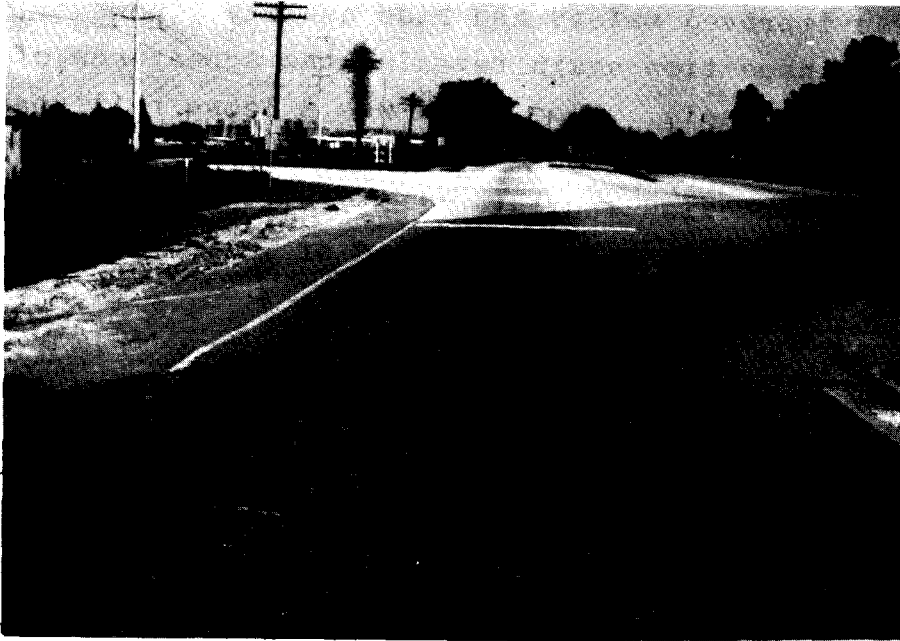
*FIGURE 15a*

*General view of True Temper crossing near L.S.U. Campus  
in Baton Rouge after 4 1/2 years of service  
(NOTE: In May, 1978 all broken panels were removed and replaced.)*

Periodic inspections of this installation have revealed that the performance of this crossing is at best marginal to poor. Development of surface failures such as cracking, spalling, break-outs, and wavy and out-of-alignment panels have become a common occurrence. Several pads have completely failed, and large pieces have broken out under the action of the traffic.

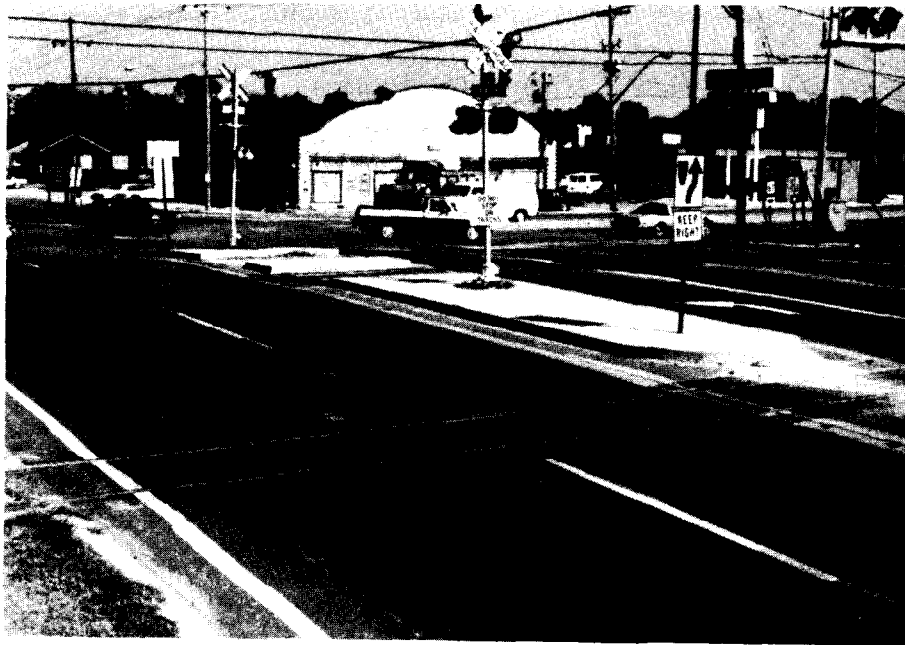
FIGURE 23

There are three sets of tracks at this crossing (Figure 23). The main and passing lines intersect the street at right angles while the spur line crosses it at an slight curvature. The tracks serve a total of nine (9) freight trains per day at an estimated maximum rail speed of 20 mph.

*General view of triple track  
Goodyear rubber crossing at Kenner*

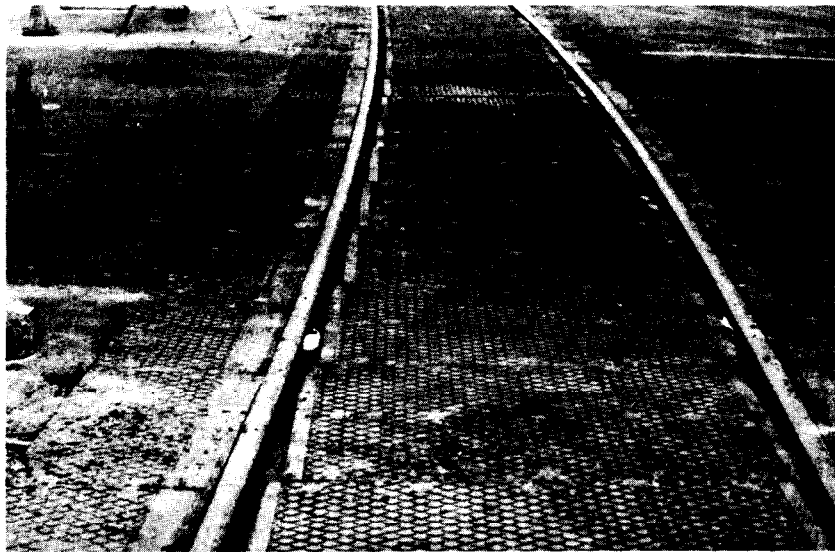
FIGURE 24

The installation was completed in March, 1977, utilizing Goodyear's Super Cushion rubber panels. There were no major construction problems observed or reported. It should be noted that the "saw tooth" pattern on the west end of the spur line (Figure 24) is a result of the use of standard rectangular rubber panels on a set of tracks with slight curvature.

*Saw tooth pattern on the west end of curving spur line at Kenner produced by the use of standard rectangular Goodyear rubber panels*

Our 1979 inspection reveals that there are some loose panels which need to be tightened; otherwise, the crossing exhibits a good riding quality and an overall good physical condition.

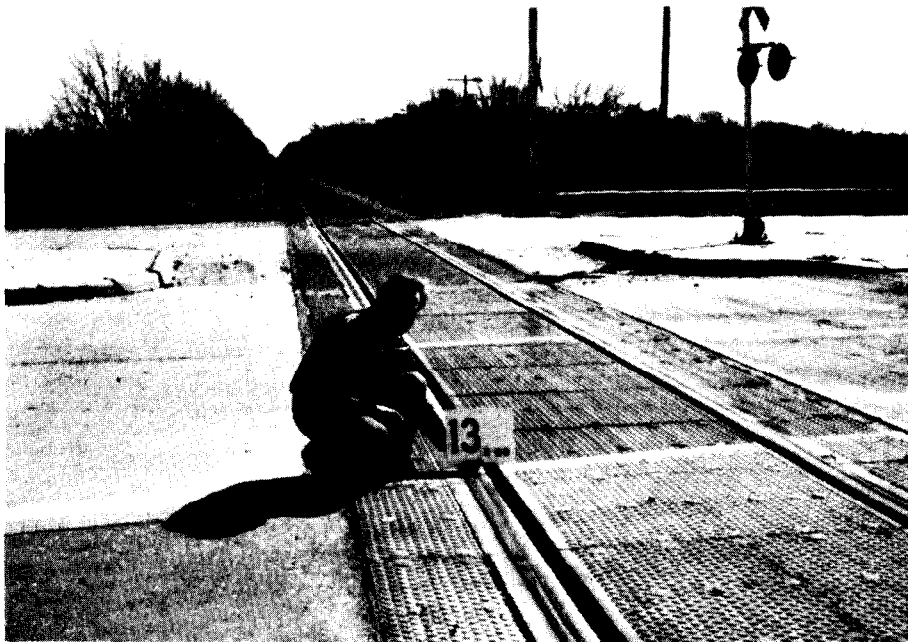
FIGURE 25

This single track crossing is 99 feet long, perpendicular to the centerline, and continues through the median of the highway (Figure 25). It was completed in February, 1978, with Goodyear's Super Cushion rubber panels. The tracks on this crossing are part of a main line which serves six (6) freight trains per day at an estimated maximum rail speed of fifty (50) mph.

*General view of Goodyear rubber crossing at Shreveport after two years of service. The crossing remains in good condition with excellent rideability.*

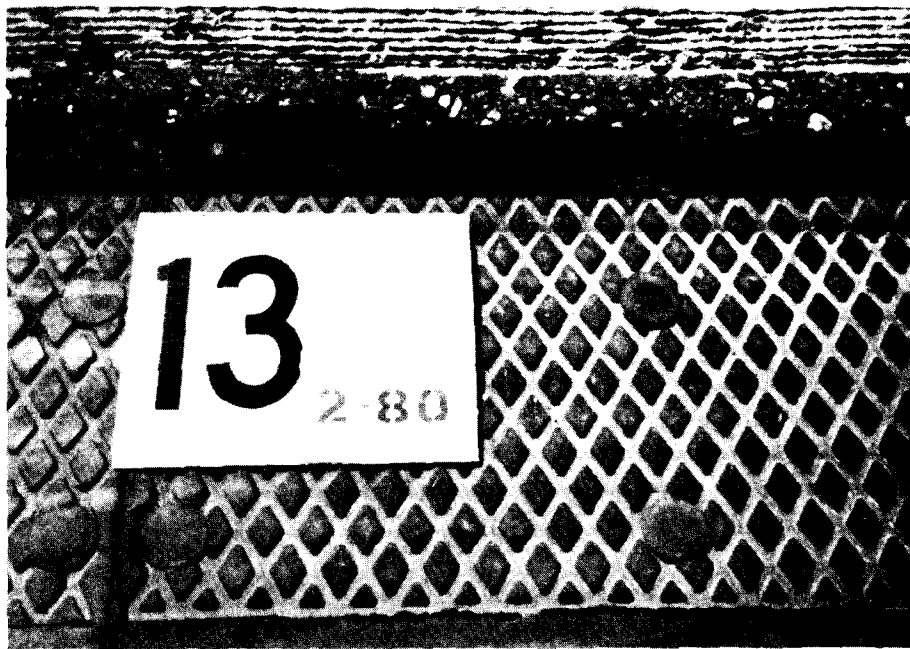
FIGURE 26

After two years of service, the crossing is in good general physical condition with excellent rideability. The only problem observed was at the header boards and the relief joints between the field-side panels and the approaching concrete pavement (Figure 26). The asphaltic filler material had sunk approximately one (1) inch and broken out in some areas. Rehabilitation of the aforementioned relief joints should remedy the problem.

*Close up view of relief joint at the juncture of field-side rubber panels and the approaching concrete pavement  
Note the damaged and sunken header board.*

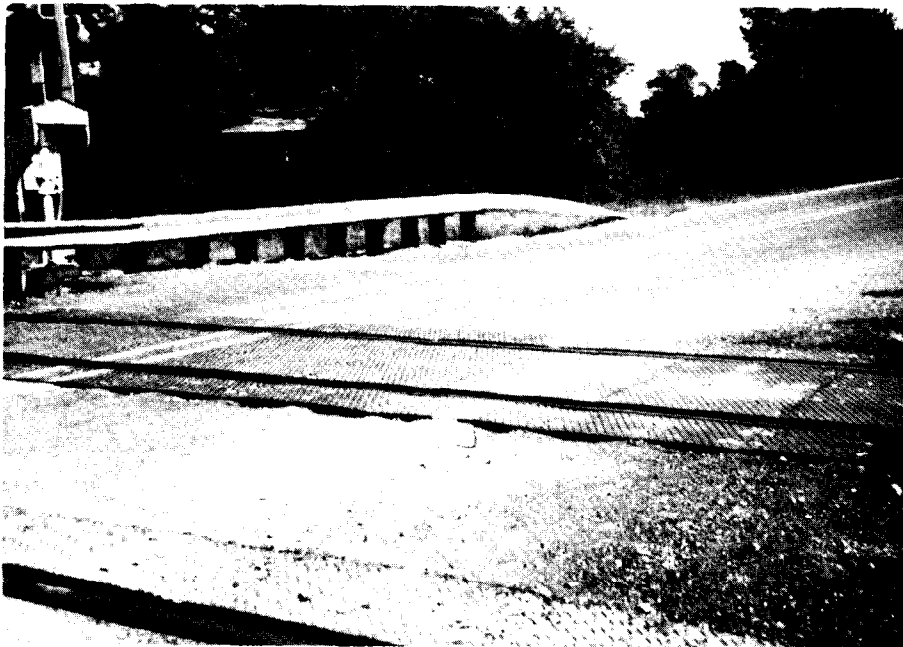
FIGURE 32

*True Temper, T-Core, crossing in Walker  
Note the deteriorating asphalt mix adjacent  
to the field-side panels.*

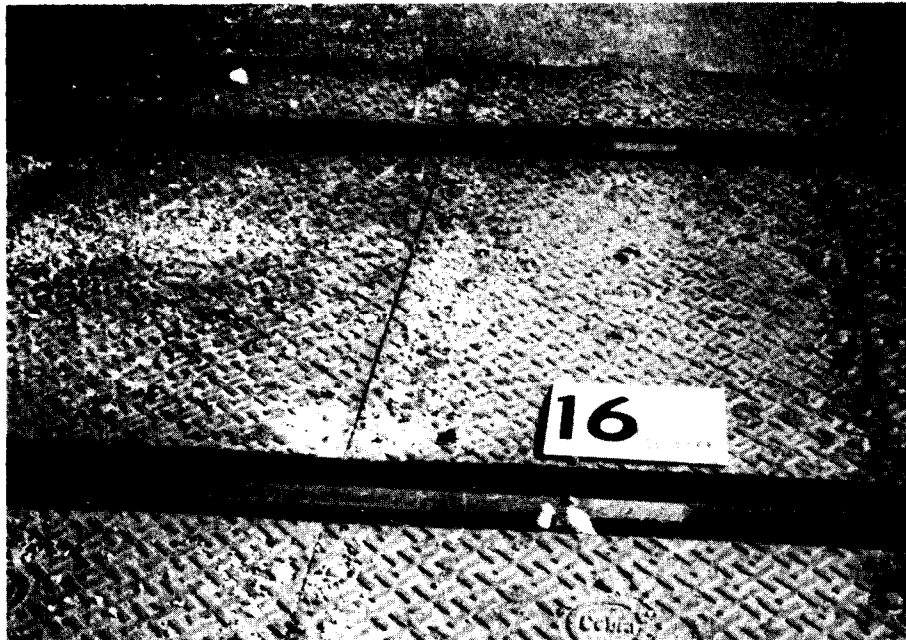
FIGURE 34

After one year of service, the performance of the True Temper, T-Core and the Cobra crossings located on this low-traffic, rural road were rated as good and excellent, respectively (Figures 33 and 34). Annual inspection of the crossing will continue.

*Close up view of Cobra crossing in Walker*

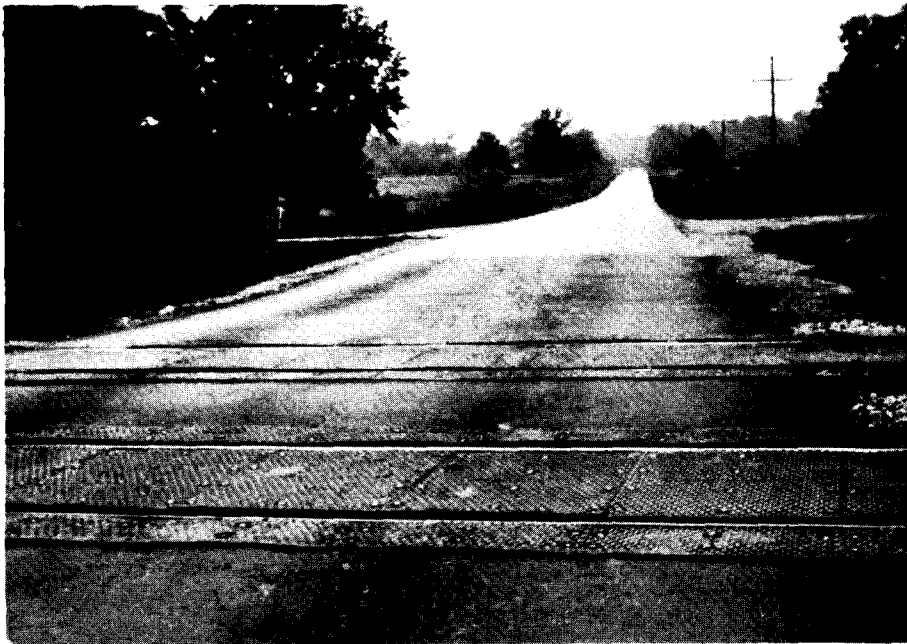
FIGURE 35

This double-track crossing (Figure 35) is located on La. 1054, approximately 0.2 mile east of La. 51, at Greenlaw, Louisiana. At this location, La. 1054 is a rural road carrying two lanes of opposing traffic at a posted maximum speed of 55 mph and an estimated 1979 ADT of 550, including 10% trucks.

*True Temper, T-Core crossing (foreground) and  
Cobra crossing (background) in Greenlaw*

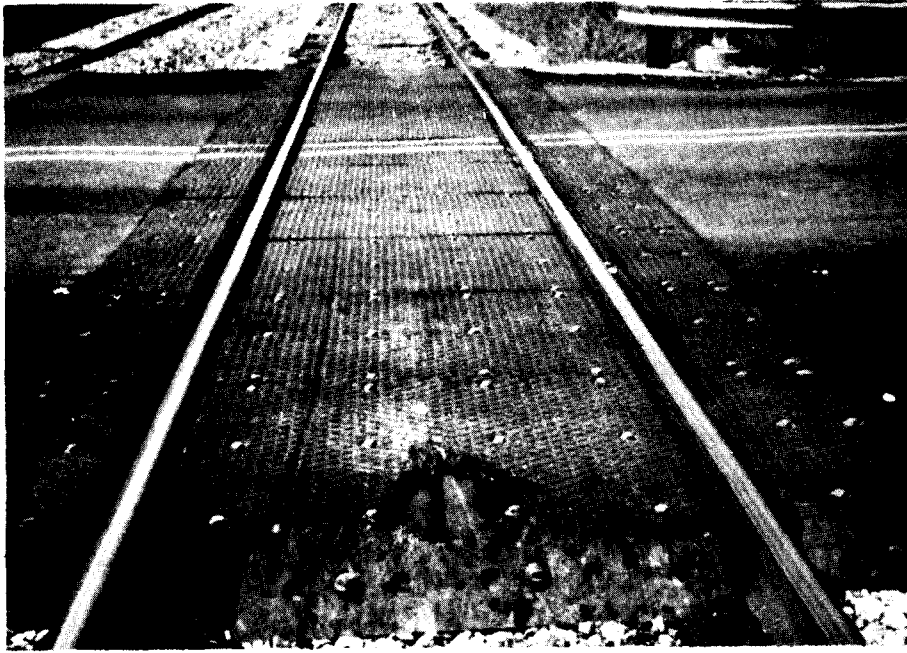
FIGURE 36

After two (2) years of service, the general physical condition and the rideability of both T-Core and Cobra grade crossings located on this low-traffic, rural road were rated as good and excellent, respectively. Periodic evaluation of the crossing will continue.

*True Temper, T-Core crossing in Greenlaw  
after two years of service*

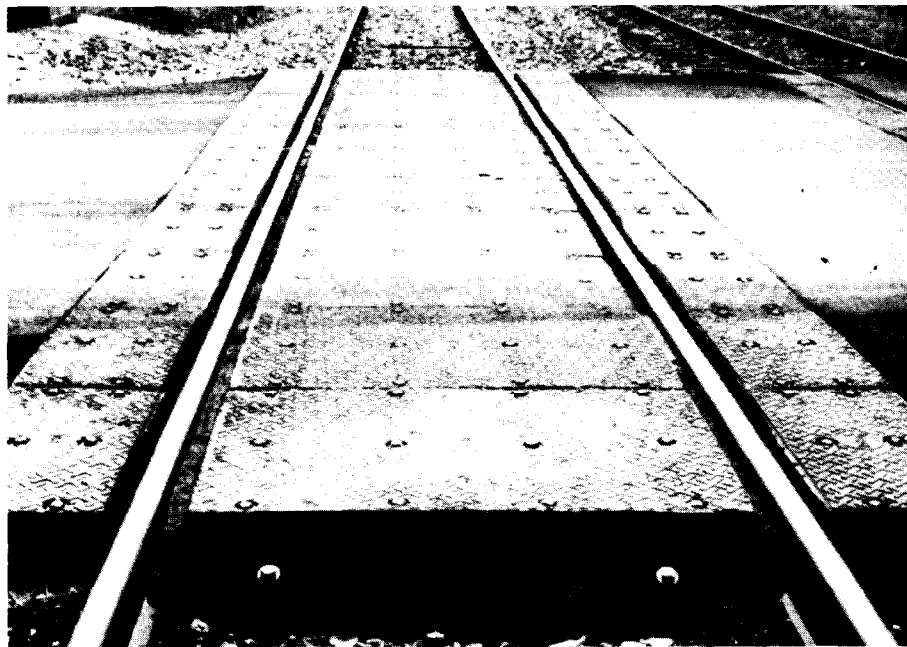
FIGURE 37

*Cobra crossing in Greenlaw after two years of service*

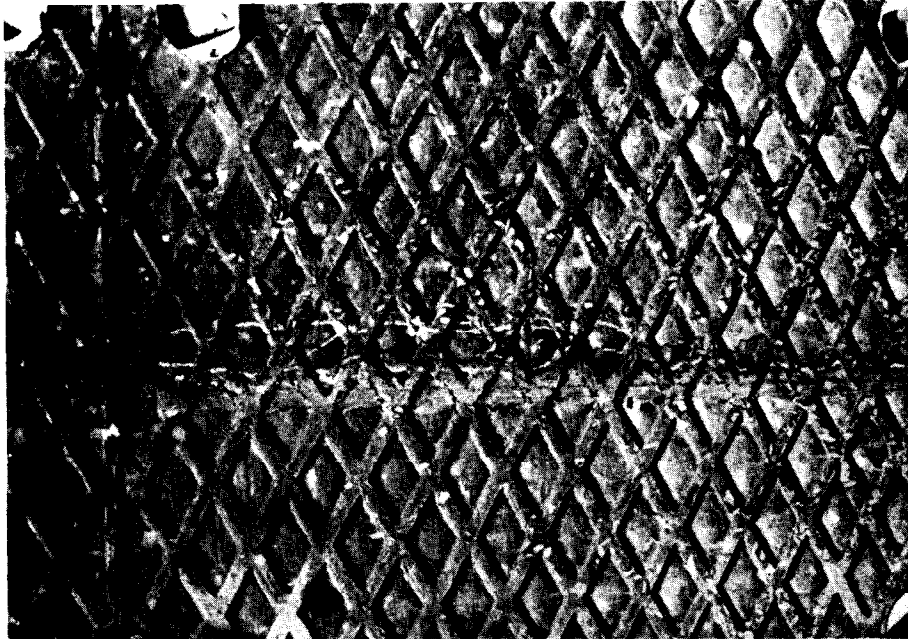
FIGURE 38

The November, 1979, inspection revealed some hairline cracks in the T-Core modules (Figure 38), additionally, some panels and skid plates sustained damage caused by dragging railroad equipment. There were also some loose T-Core panels which required tightening. There were no major problems noted at the Cobra crossing site except for minor sinking of the asphalt mix along the flangeways.

*Close up view of True Temper, T-Core crossing  
in Greenland showing cracked polyethylene modules*

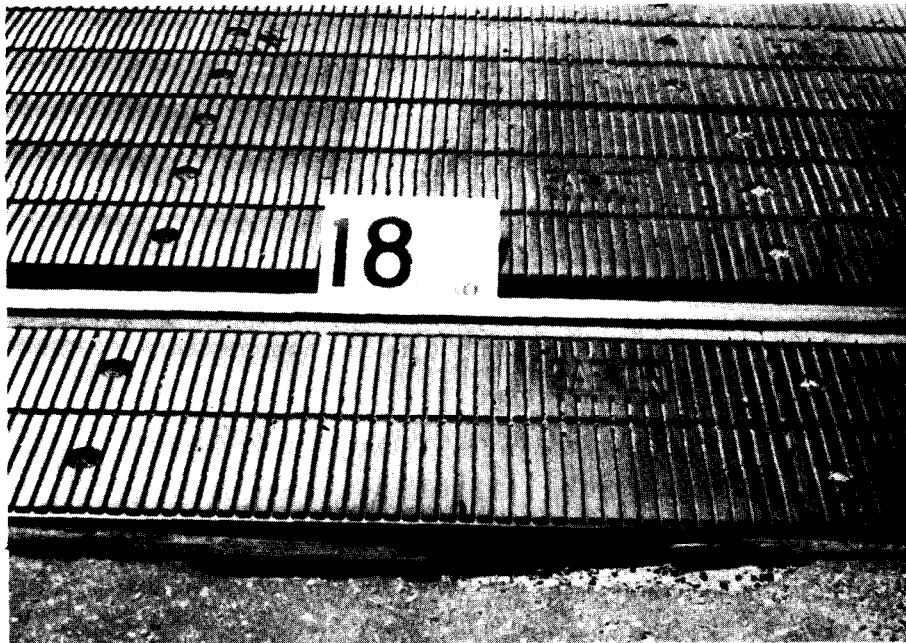
FIGURE 42

*SAF & DRI rubber crossing in Natalbany  
remains in excellent physical condition after one and half years of service*

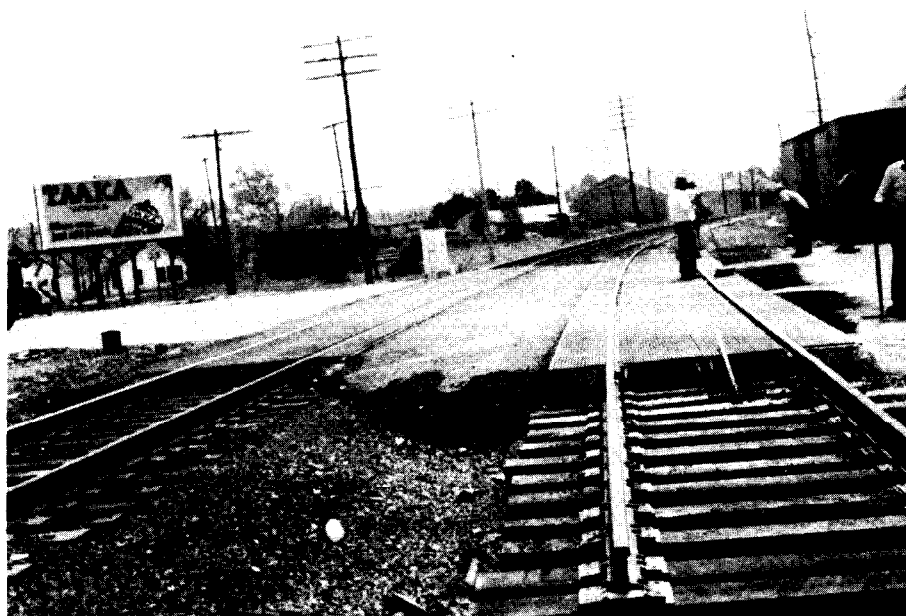
FIGURE 46

The crossing (Figure 46) includes one main and one side line; it serves one (1) passenger and fourteen (14) freight trains per day at an estimated maximum railroad speed of 25 mph.

*Double-track Parkco rubber crossing  
under construction in Lafayette*

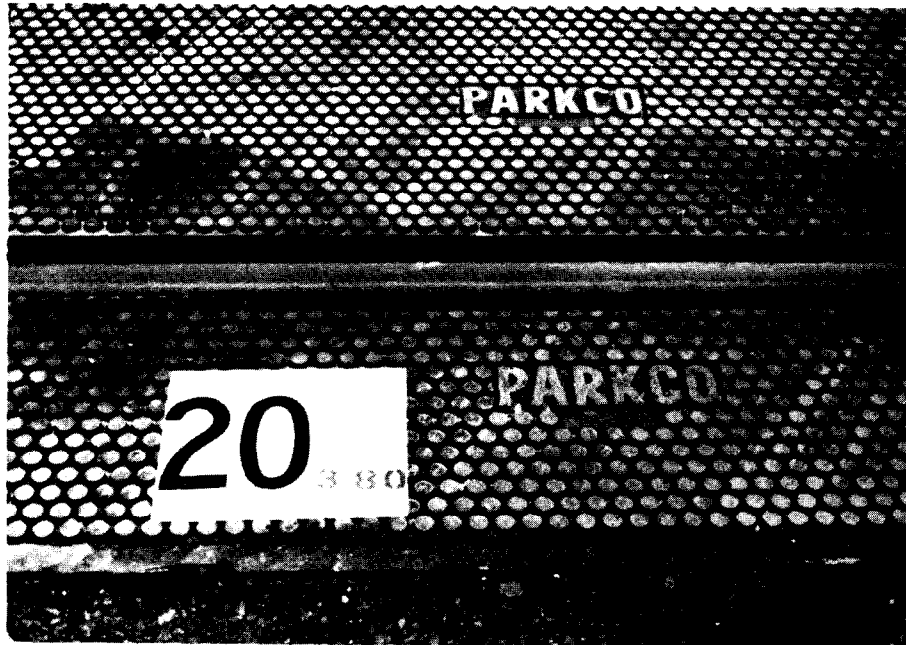
FIGURE 47

Each crossing in this double-track installation is eighty-four (84) feet long and was completed in March, 1980, using steel reinforced rubber panels with the trade name Parkco (Figure 47), manufactured and distributed by Park Rubber Company of Lake Zurich, Illinois. The Parkco crossing material has the unique features of arched steel reinforcement plate in each panel and the fact that the panels are not individually fastened to the wooden shims or the crossties underneath. Instead, the panels are held together by means of eight (8) post-tensioned steel rods which pass through precast longitudinal channels, two (2) per panel (Figure 48).

*Close up view of Parkco rubber panel crossing  
under construction in Lafayette*

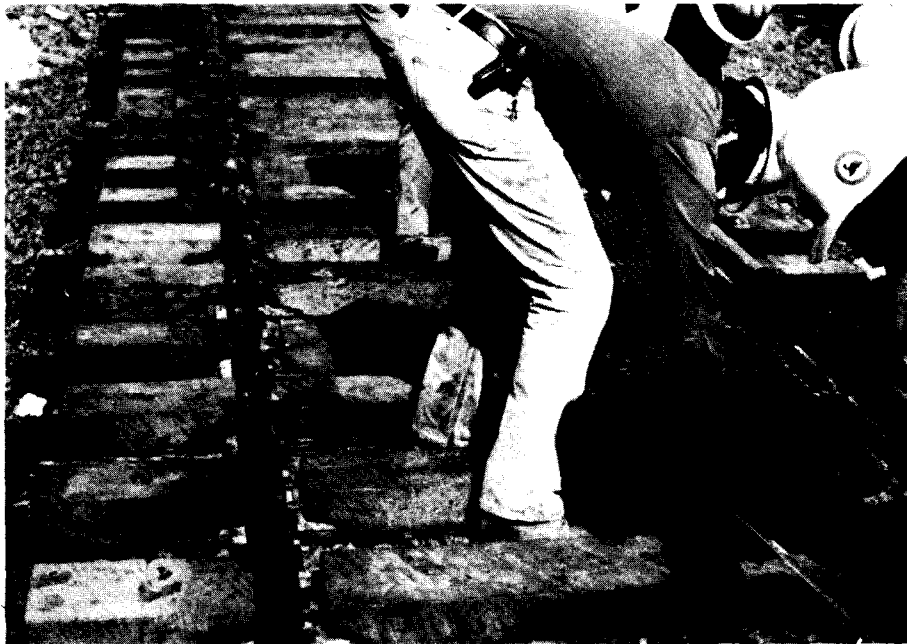
FIGURE 48

The installation of the Parkco pads was very quick and simple. There were no major problems encountered during construction except that the wooden shims were not all installed level and, therefore, there were gaps between the bottom of the panels and the top surface of the shims (Figure 49). The problem was brought to the attention of the manufacturer's representative at the site who said that the Parkco system had been designed to act as a bridge, and panels did not have to be in full contact with the individual supporting wooden shims. Also, the creosoted pine header boards adjacent to the field-side panels were slightly damaged by the steel wheel roller during subsequent asphalt patching operation.

*Parkco rubber crossing installation in Lafayette showing the positioning of a panel on wooden shims.*
