EVALUATION OF GRADED LIMESTONE BASE COURSE  
ON A LOW VOLUME ROAD

Final Report

Research Report No. 175

Conducted by  
LOUISIANA DEPARTMENT OF TRANSPORTATION  
AND DEVELOPMENT  
Research and Development Section  
In Cooperation with  
U. S. Department of Transportation  
FEDERAL HIGHWAY ADMINISTRATION

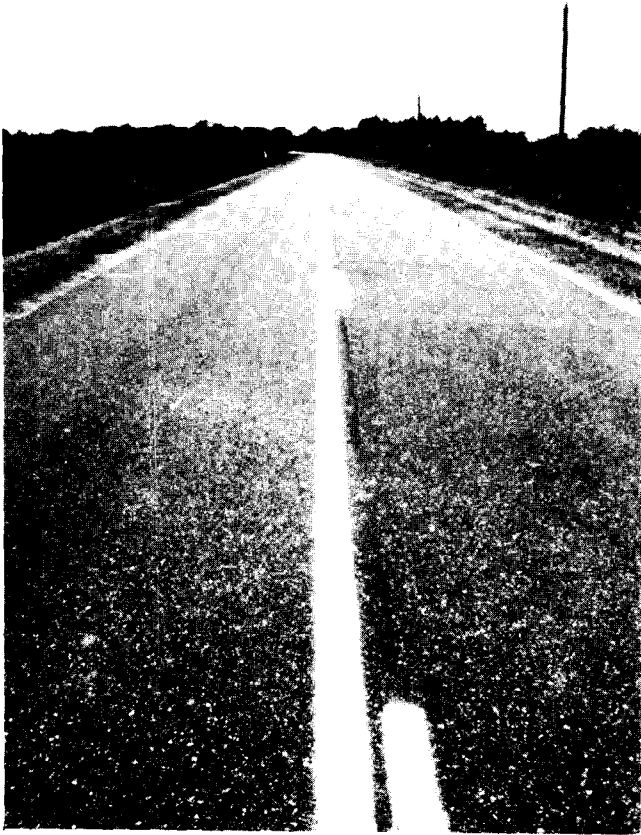
*Figure 6*

*Overall View - Limestone East Section*

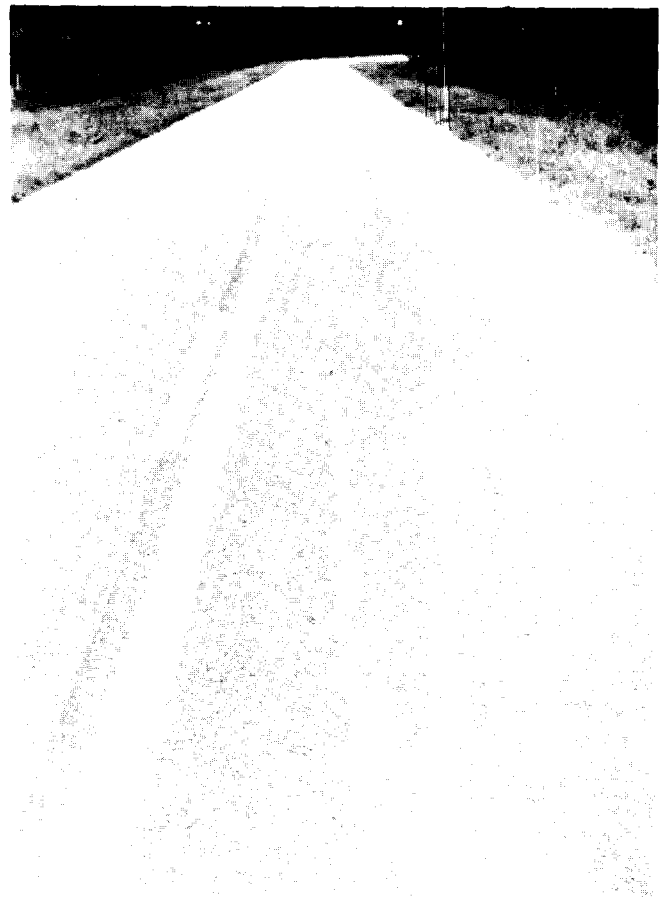
*Figure 7*

*Overall View - Soil Cement West Section*

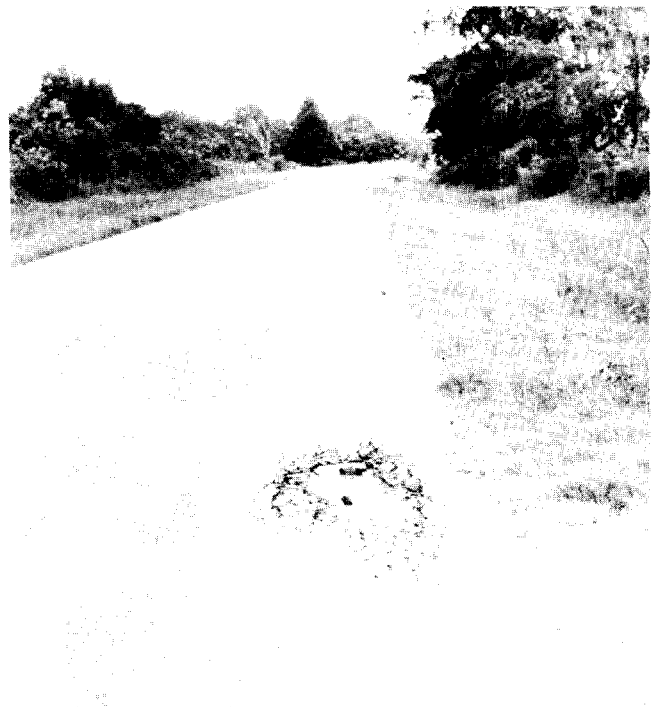
*Figure 9*

Approximately seven months after completion of the paving operations, reflected shrinkage cracks began to appear in both of the soil cement "control" sections. These block type cracks presently extend over 100% of the pavement surface. The longitudinal edges of the block cracking typically coincide with the inside and outside wheel paths of each lane. Two years after surfacing, two areas of base failure were observed in the soil cement west section. A year later two additional areas of base failure were observed adjacent to the first two. This is an isolated area located at the entrance to a farm haul road.

*Unpatched Base Failure -  
Soil Cement West Section*

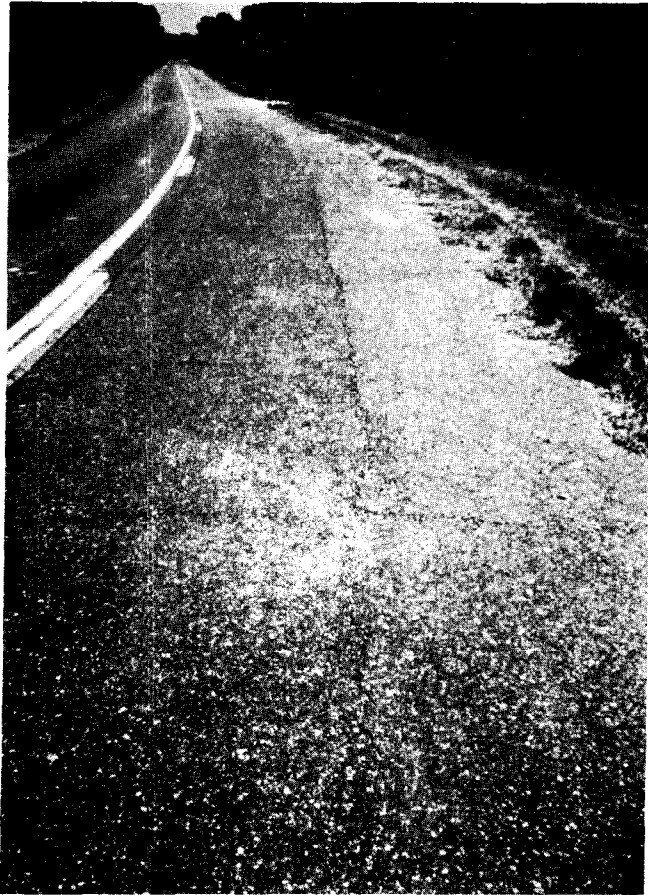
*Figure 10*

6. The soil cement sections developed block type shrinkage cracking within a year of construction. The longitudinal edges of the block cracking have surfaced in the wheel paths indicating the influence of traffic loads on the location of shrinkage crack development. Several isolated pothole-type failures have occurred, primarily adjacent to a farm haul road. Wheel path rutting is minimal, 0.1 inches on the

*Block Cracking -  
Soil Cement East Section*
