A-83/165	2. Government Accession No.	3. Recipient's Catalog No.	
Subtitle TION OF EXPERIMENTAL RAILROAD-HIGHWAY CROSSINGS IN LOUISIANA		5. Report Date AUGUST 1983	6. Performing Organization Code
G. BOKUN AND ALFRED F. MOORE		8. Performing Organization Report No.	
Organization Name and Address Louisiana Department of Transportation & Dev. Research and Development Section Box 44245, Capitol Station Shreveport, Louisiana 70804		10. Work Unit No.	11. Contract or Grant No. LA 80-1SS
Agency Name and Address Louisiana Department of Transportation & Dev. Research and Development Section Box 44245, Capitol Station Shreveport, Louisiana 70804		13. Type of Report and Period Covered Interim Report No. 6 Period 1970 to 1983	
Supplementary Notes Prepared in cooperation with the U.S. Department of Transportation, Highway Administration		14. Sponsoring Agency Code

ABSTRACT

This interim report was prepared to provide a review of the performance of thirty railroad-highway grade crossings installed experimentally in Louisiana between 1970 and 1983. They were constructed of rubber, high-density polyethylene (HDPE) or pre-cast concrete panels that were installed under the Federal Highway Administrati

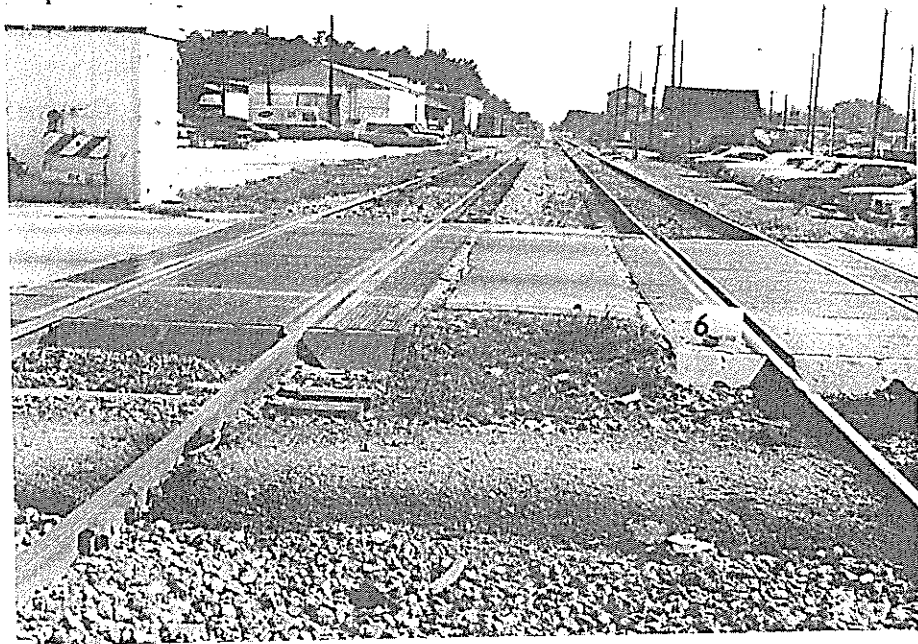
Figure 3

Deterioration of wooden header boards
at the pavement relief juncture.

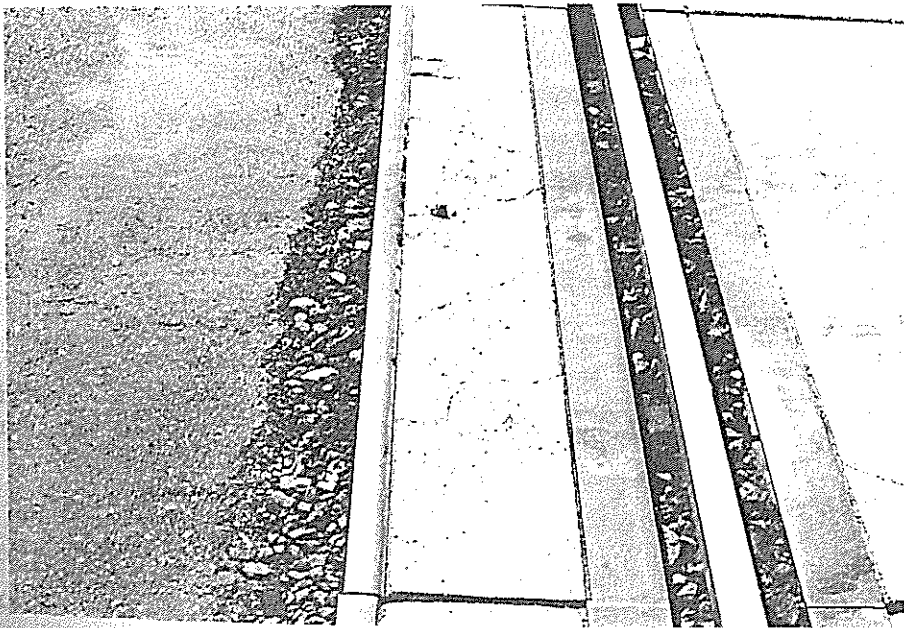
Figure 4

As detailed in Research Report No. 140, performance evaluations were formally discontinued on this prefabricated reinforced-concrete crossing (proprietary name FAB-RA-CAST, manufactured by Szarka Enterprises, Inc., of Livonia, Michigan) in 1979 after their complete failure on several occasions. Initially installed in December 1974, the pre-cast concrete panels began cracking and subsiding almost immediately (Figure 4).

Preliminary cracking of the field-side pre-cast concrete panels three months after initial installation in 1974.

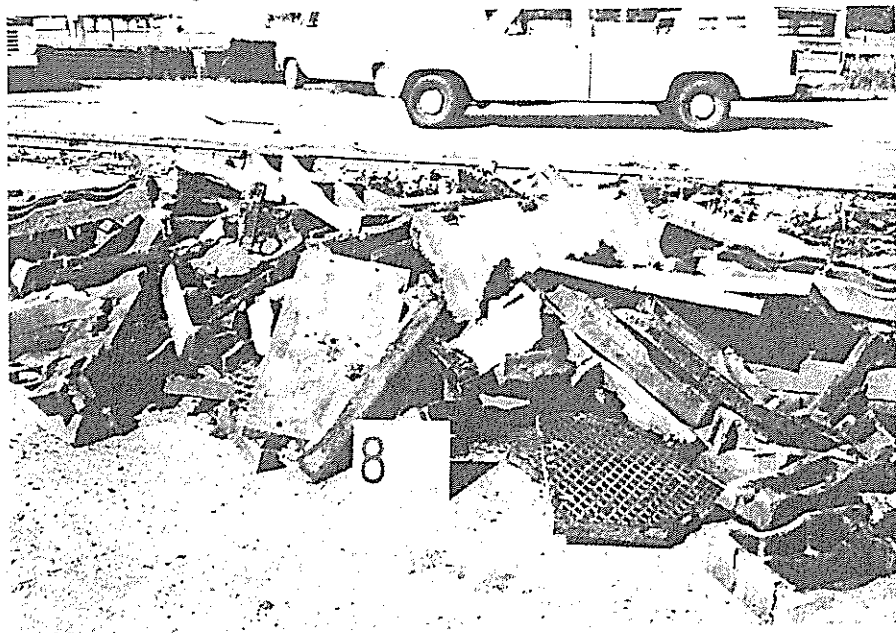
Figure 11

View of the failed structural foam panels just prior to disposition.

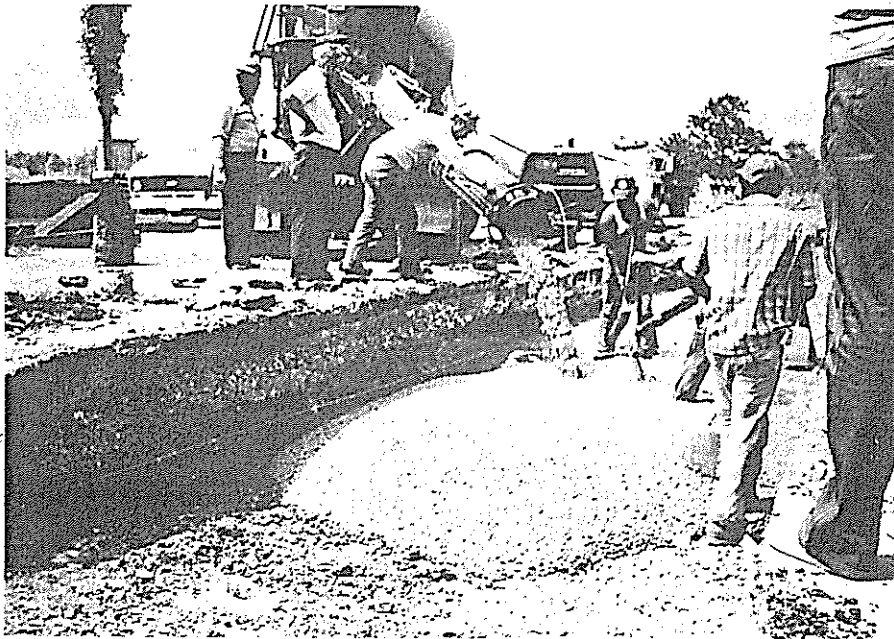
Figure 13

is was followed by pouring portland cement concrete with calcium chloride additive to a depth of 12 in. with a 6 in. in 100 ft drop towards the low side to provide for adequate drainage (Figure 13). This additive permits work to progress with minimal disruption whereas conventional methods would require a seven to fourteen day delay pending acceptance through normal compressive strength criteria for PCC cylinders.

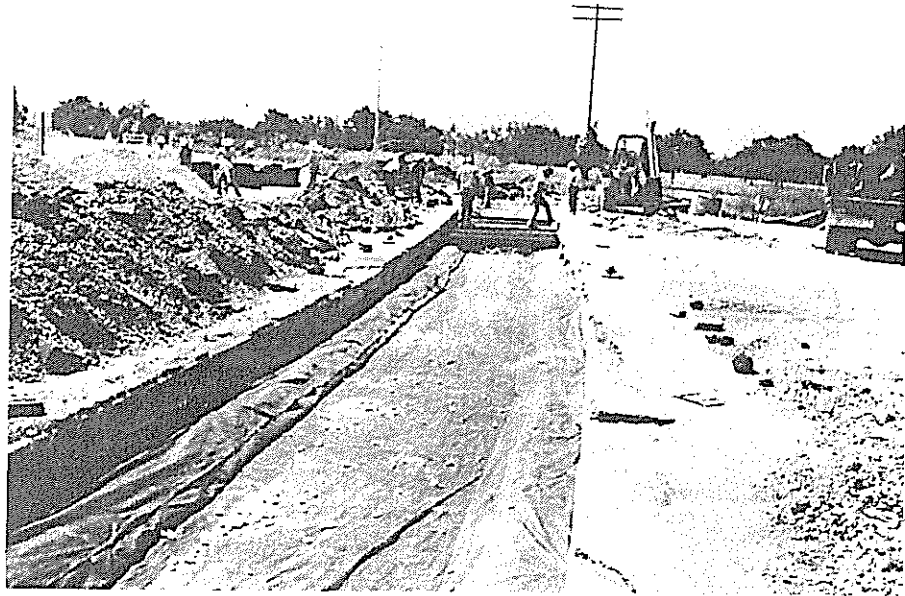
Figure 14

Within 24 hours, engineering grade fabric filter cloth lined the excavation and encapsulated fresh, coarse ballast to form french drains on either side (Figure 14).

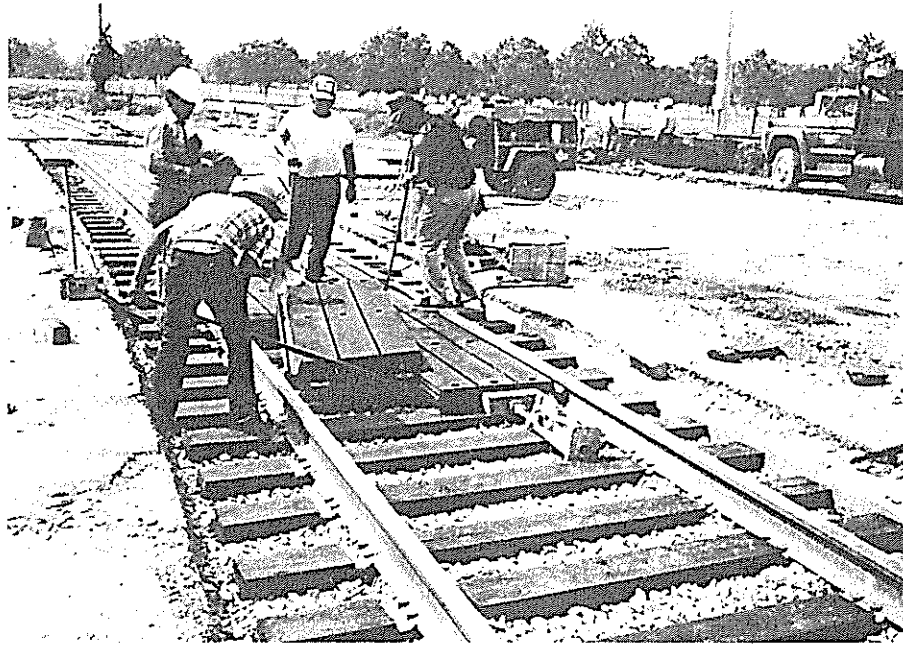
Figure 17

The railway roadbed, thus prepared, posed no problem at all with installation of a competitive rubber panel then on the QPL (Figure 17). After over eighteen months, this crossing has not shown the slightest inclination towards subsidence, panel looseness or rocking.

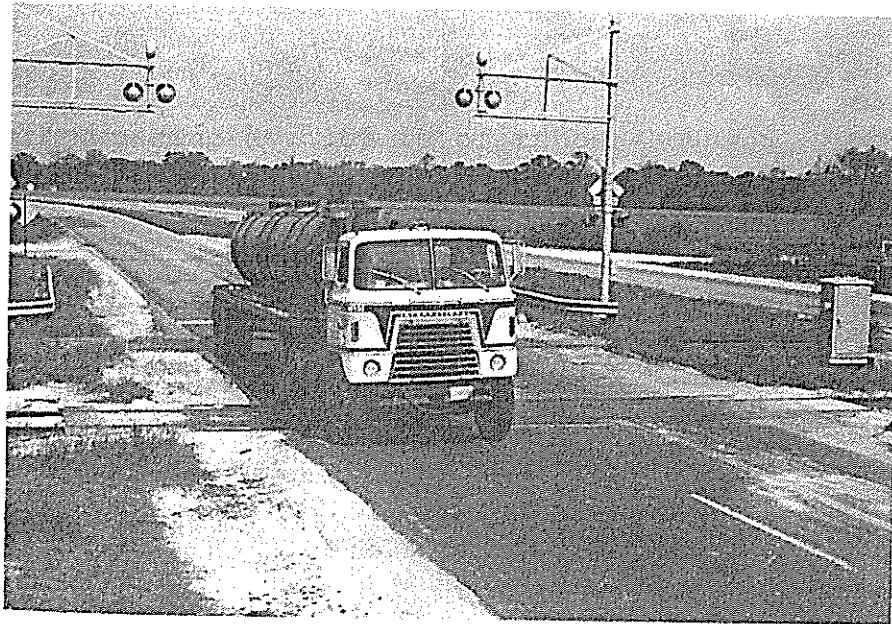
Figure 18

At the subject location, La. 3089 is a four-lane, divided rural highway with an estimated 1979 ADT of 5610 with 20% trucks. The True Temper T-Core high-density polyethylene (HDP or structural foam) panels were installed in September 1976, on an industrial spur hosting two rail movements per day. After this installation failed in a manner similar to Experimental Crossing No. 8, but at an accelerated rate due to the high truck volume, it was replaced during 1978 with a Goodyear Super Cushion rubber panel crossing (Figure 18).

Typical truck traffic that contributed to the rapid failure of the True Temper T-Core HDP panels within two years.

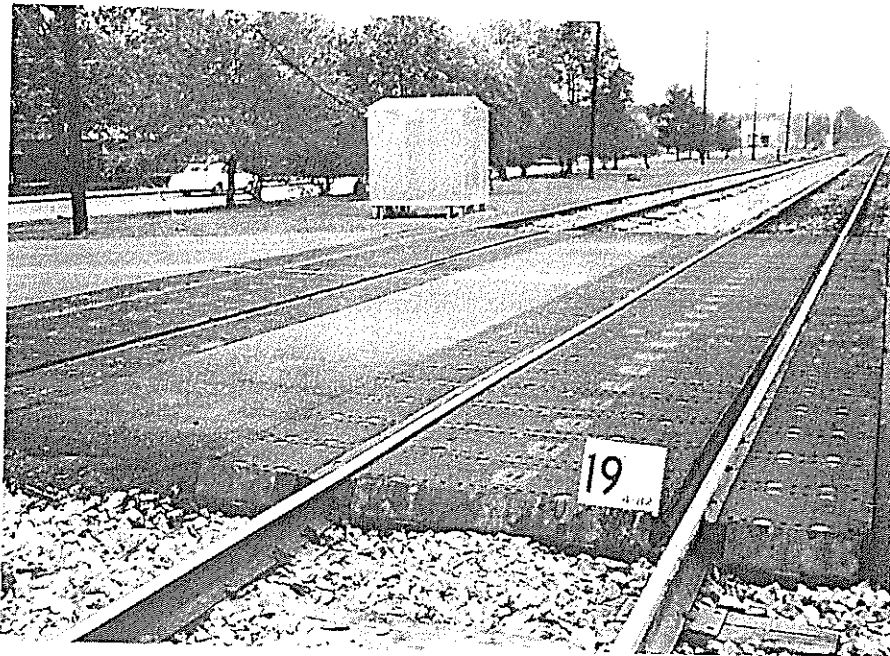
Figure 32
Gen-Trac Rubber Panel Crossing at Independence
after five years of satisfactory performance.

Performance evaluations of these crossings were terminated after five years of satisfactory performance. While these narrow (18 in.) rubber panels have been noted to exhibit premature loosening or rocking at some locations, the excellent subbase at this site can be cited as a major contributory factor in eliminating this condition. Being full depth rubber panels, Gen-Trac crossings do not require conventional header boards. There is no evidence of failure at the pavement joints which lends support to this design feature. This crossing continues to perform in a very satisfactory manner after five years of evaluation.

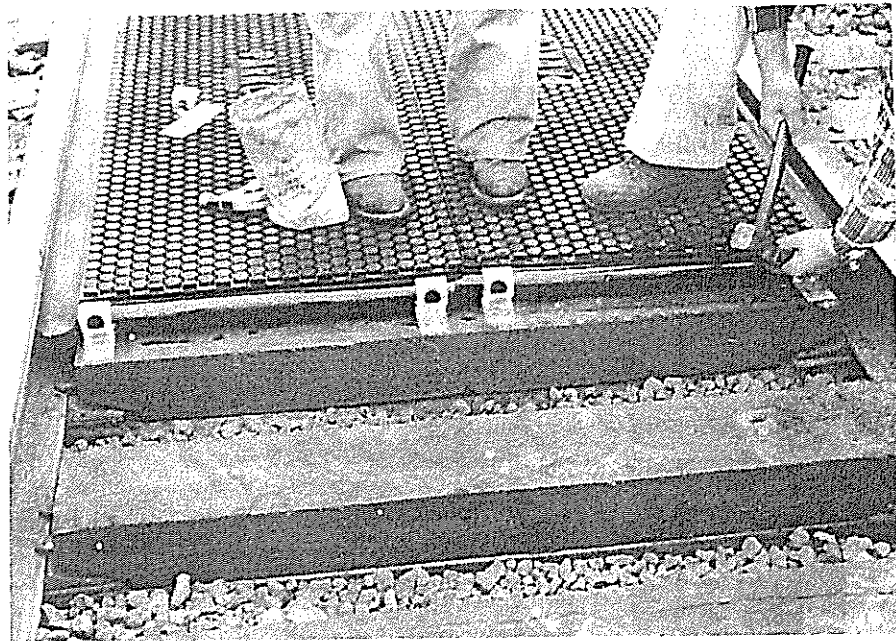
Figure 34

Completed in March 1980, each of these eighty-four foot long crossings feature steel reinforced rubber panels manufactured by the Park Rubber Company of Lake Zurich, Illinois and designated PARKCO. The unique features of these seventy-two inch long rubber panels are the arched steel plate reinforcement, cast in longitudinally, and the method of securing the panels to the crossing. Utilizing conventional shims, the rubber panels are popped into place and interlocked by built-in tongue-and groove construction. Since the heaviest component is only 300 pounds, this is readily handled by two people. After all the panels are in place, held temporarily with stabilizer clips (Figure 34), 5/8 in. threaded steel cables are inserted longitudinally through channels cast into the panels.

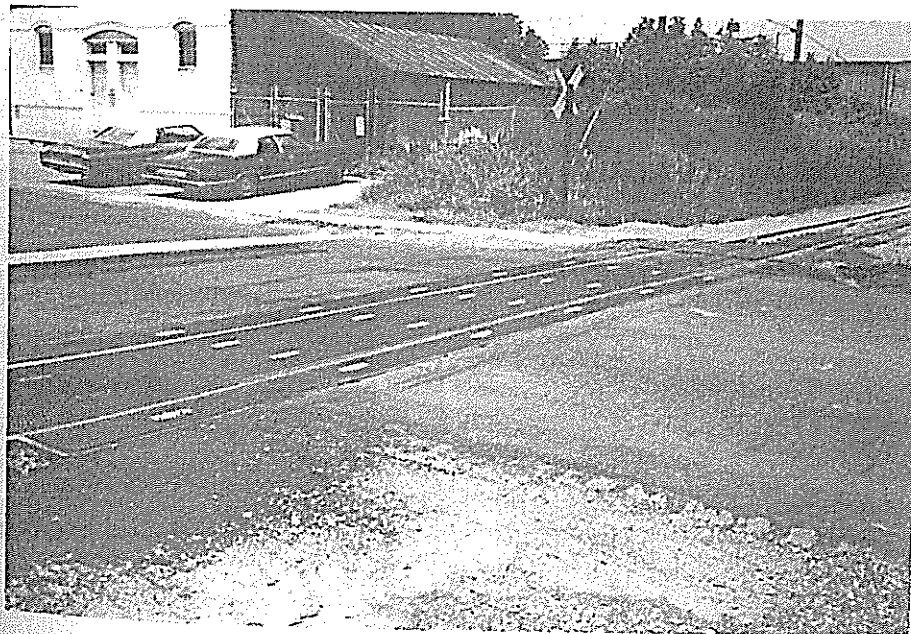
Figure 45

The above captioned projects are located on two two-lane, one-way city streets in Bastrop, Louisiana (Figure 45) with a posted maximum speed of 40 mph. The estimated 1982 ADT at this location is 12,750 vpd with 6% trucks. Serving the Arkansas and Louisiana, Missouri (A & LM) Railroad, there are four freight trains per day at an estimated 10 mph rail speed. Crossing No. 24C is a spur line serving International Paper Company and handles four switching rail movements per day at an estimated rail speed of 4 mph.

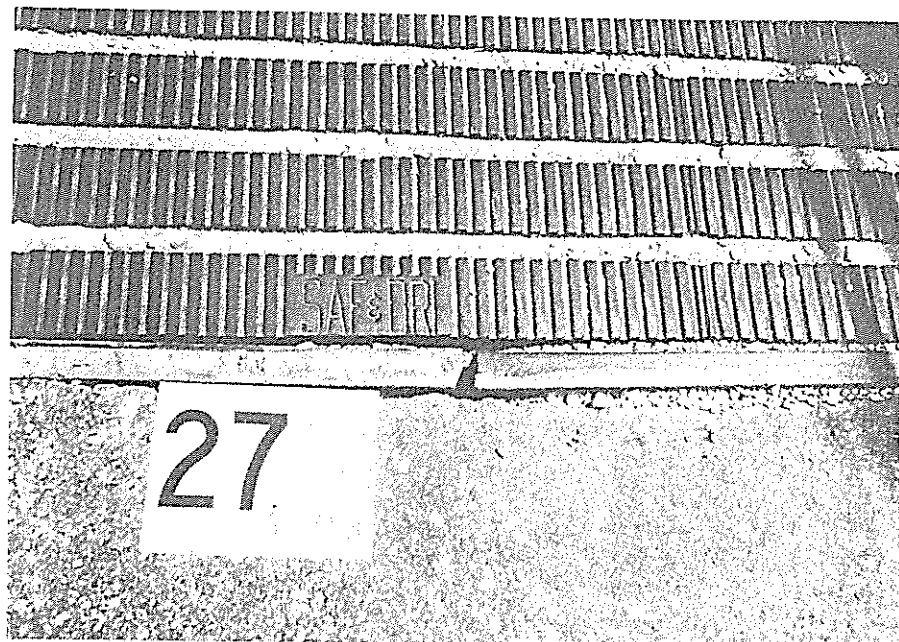
Figure 53

Although relatively new, having been installed only a year ago, the rubber panels are performing in an excellent manner. Exception must be taken, however, with the header boards. It seems that these one and one-half inch thick, eight inch deep rigid header boards are unsuitable because of this rigidity or perhaps brittleness. During construction, it was impossible to penetrate the dense mass in order to affix the header boards to the ties or shims. Consequently, they were set in place and restrained only by the wedging action of the asphalt juncture filler material (Figure 53).

Thick, rigid polymeric header boards

Within six months, one of the boards popped out due to vibration caused by rail and vehicular traffic (Figure 54). Rigidity or brittleness is also apparently responsible for the further breaking of the panels into large chunks. While the remaining boards are performing their intended function, researchers conclude that the polymeric material is too dense and brittle to absorb the abuse of traffic.

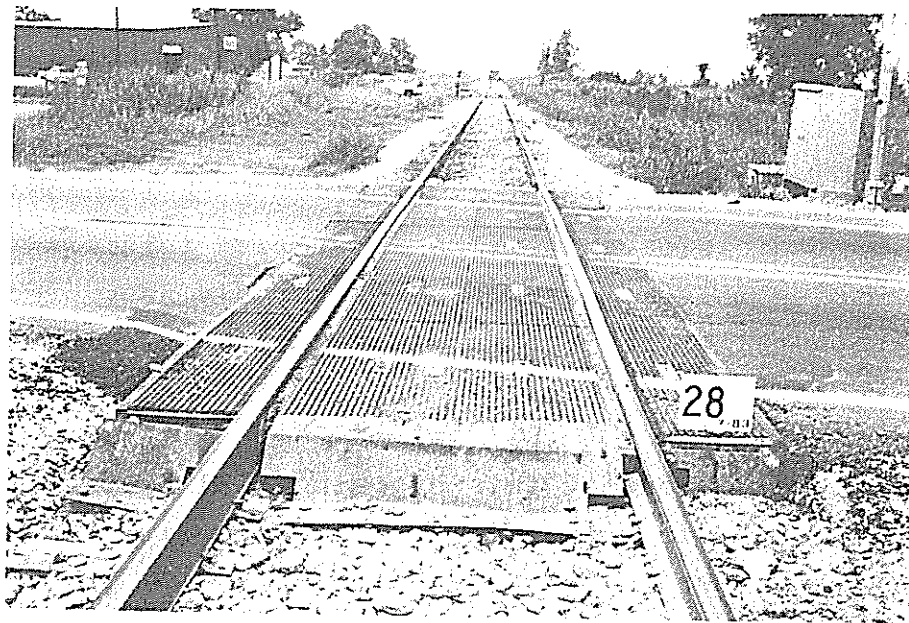
Figure 55

PARKCO rubber panel crossing at St. Gabriel. Note poor condition of missing and battered steel skid plates caused by dragging rail equipment.

The proprietary feature of this thirty foot crossing installed in August 1982 is the latest design of PARKCO rubber panel construction (Figure 55). ...Cited previously, the recent changes are mostly cosmetic in nature. They include white rubber for the PARKCO name brand embossed in the center of each panel, reduction in height of the two rows of rubber "buttons" nearest the rail on the field side panels (which would eventually be abraded off by the train wheels anyhow) and high-tensile strength steel header board bolts molded in. These bolts replace the earlier practice of using common threaded steel rod pieces, which fatigued easily and broke off almost immediately. The bolt head now provides a base for securely welding it to the steel reinforcing prior to encapsulating in molded rubber.

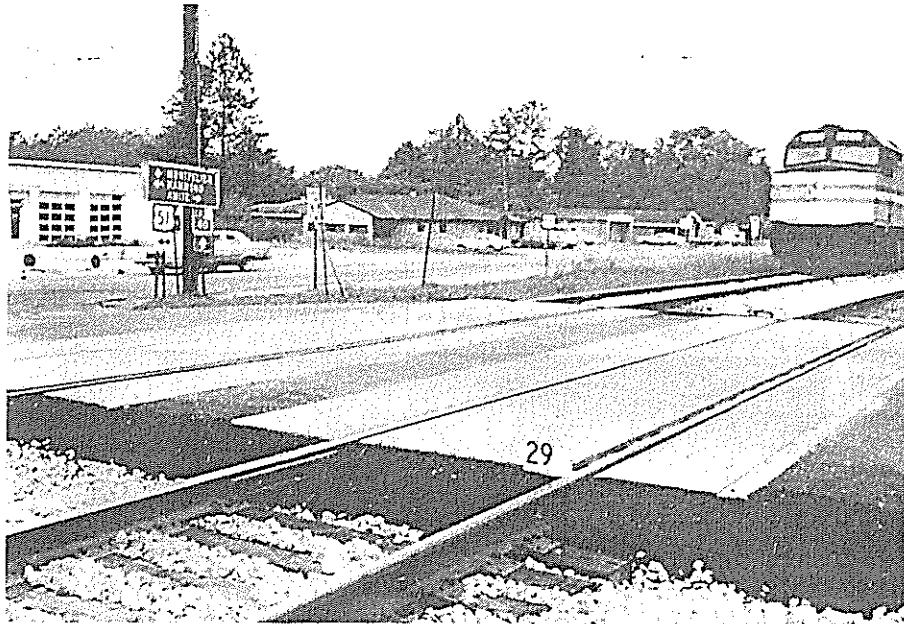
Figure 58

They concluded that this condition was due to the fact that only rubber wedges are utilized to affix the pre-cast panels in place. Vehicular and rail traffic vibrations were cited as the primary cause of this condition. Immediate corrective measures were taken by jacking panels back into original position and restraining them with HMAC bolsters at each end (Figure 58).

HMAC bolsters added to restrain the panels that are otherwise affixed only with rubber wedges.

This interim measure has proven very satisfactory and these crossings are in excellent overall condition after one year. Evaluation of these crossings will continue as scheduled.
