1. Report No. FHWA/LA-91/238		2. Government Accession No.		3. Recipient's Catalog No.	
4. Title and Subtitle Feasibility of Applying Cathodic Protection to Underground Culverts			5. Report Date June 1991

**FEASIBILITY OF APPLYING CATHODIC PROTECTION
TO UNDERGROUND CULVERTS**

INTERIM REPORT

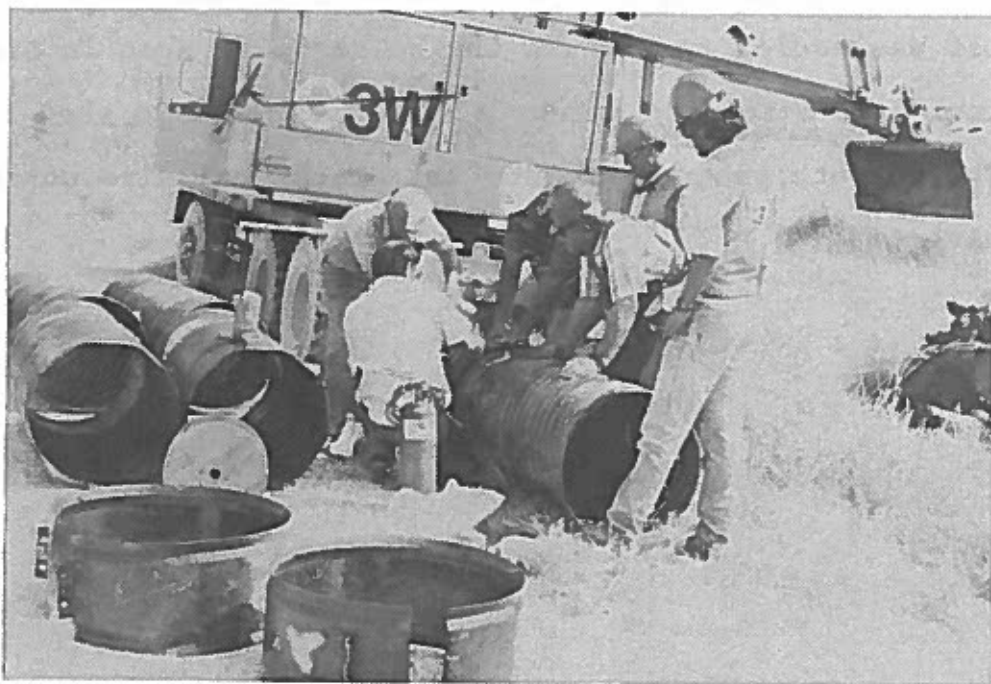
Figure 5. This is a culvert being prepared for installation.

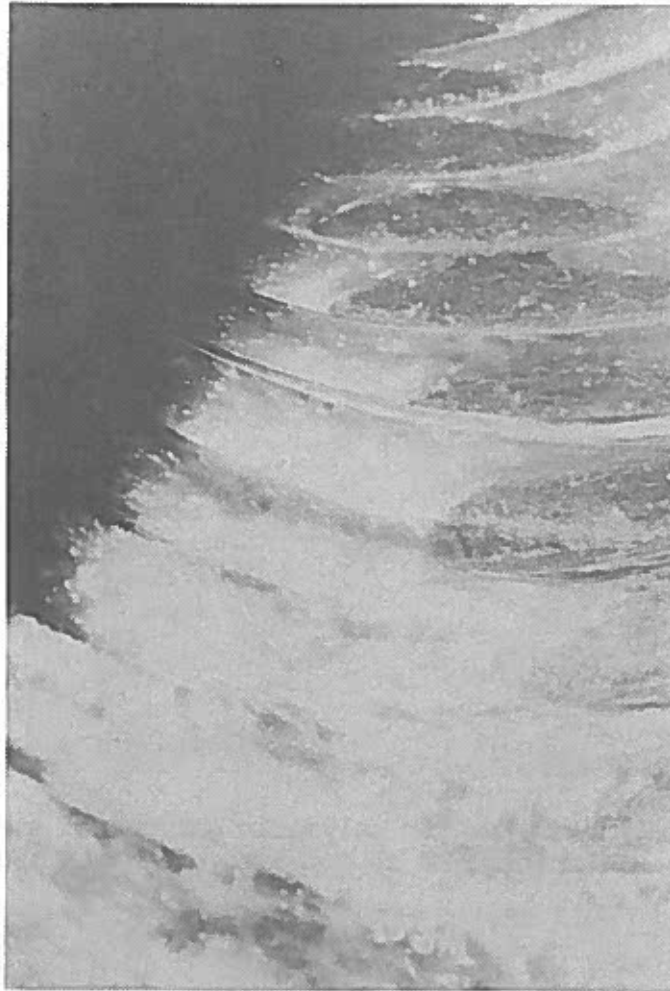
Figure G-13. This view shows a close-up of the deposits on the inside of the culvert.

3) Polymeric Galvanized Steel (Supplier 1). Figures 10-13 in Appendix G show the condition of this culvert immediately after testing. There is only a small amount of white scale which suggests that the polymer coating was effective. A close-up view of the inside of this culvert shows some rust at the bottom of the ridges. The rust appears to be superficial, perhaps from steel particles on the surface.

There appears to be some corrosion occurring under the coating, especially around the edges. In general, the coating is held tightly. The outside of the culvert is in very good condition. Overall rating on this coating is 7.0.

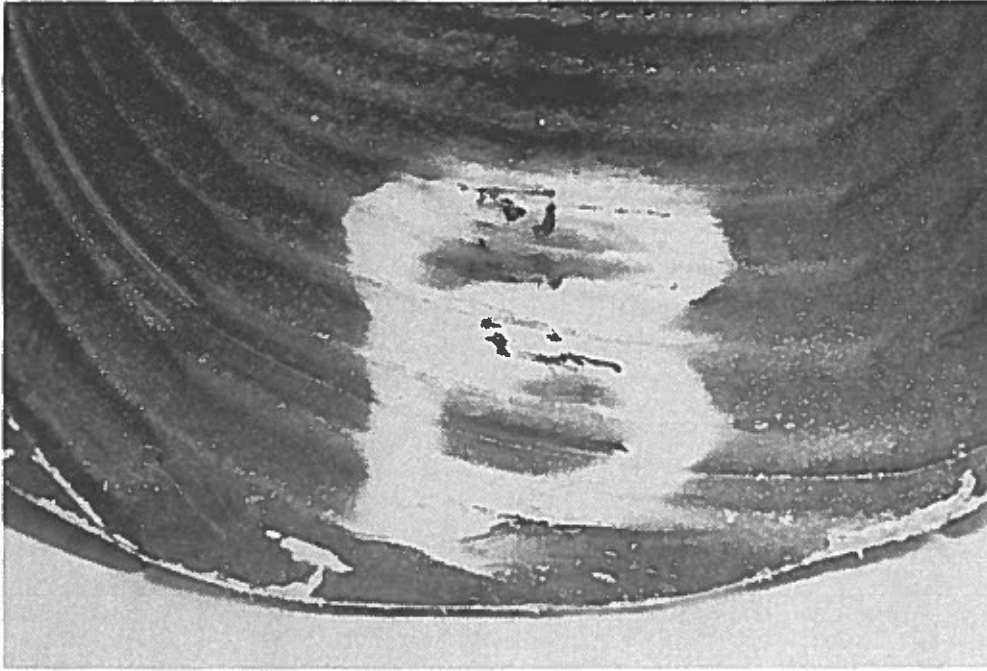
Figure G-26. The inside of this culvert shows a large number of rust spots.

The inside of the culvert is seen to contain a large number of rust spots.

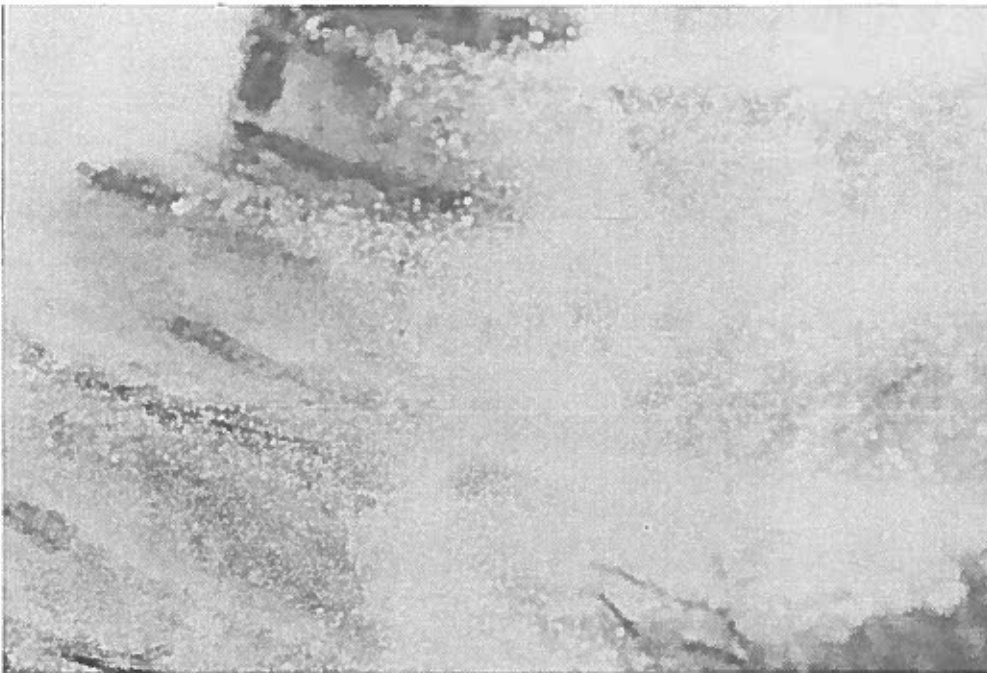
Figure G-27. This is a close-up view of the inside of this culvert which shows corrosion attack.

Generally, there is some rusting, especially where the culvert has been cut. Overall the culvert condition is a 7.0. 8) Aluminized Type II. Figures 29-32 in Appendix G show this culvert after the one month of testing. There is some external attack. An inside view of the culvert shows that there is a small amount of attack.
