**ASSESSMENT  
OF  
MITIGATING EMBANKMENT SETTLEMENT  
WITH  
PILE-SUPPORTED APPROACH SLABS**

Final Report

LTRC PROJECT NO. 97-4GT  
STATE PROJECT NO. 736-99-0454

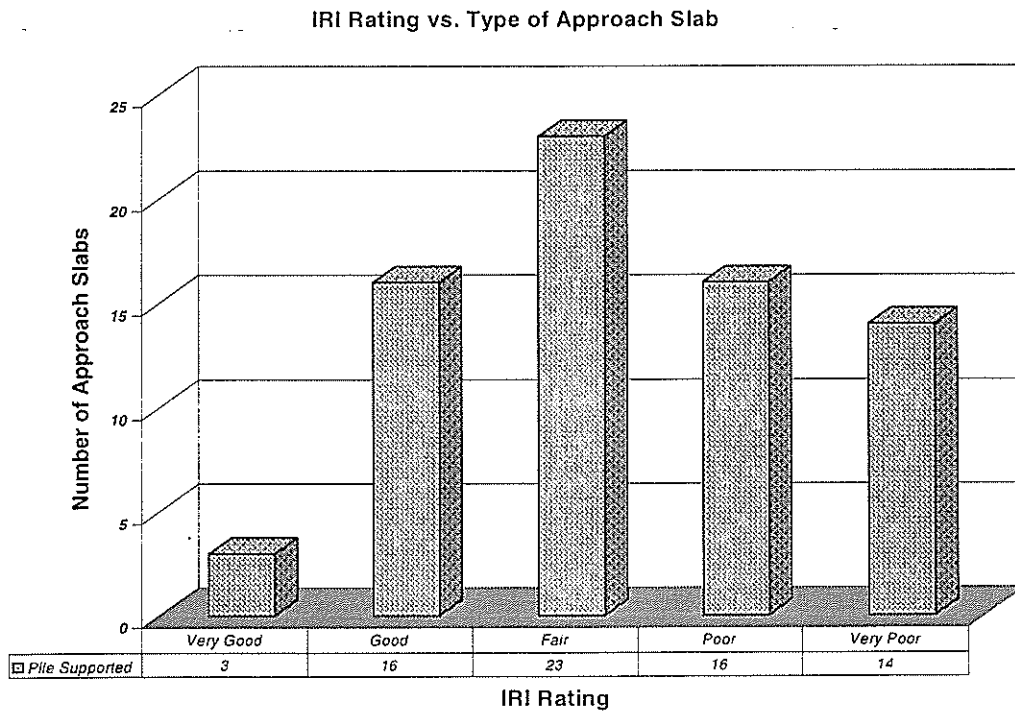
**Figure 9**  
Effect of approach slab type

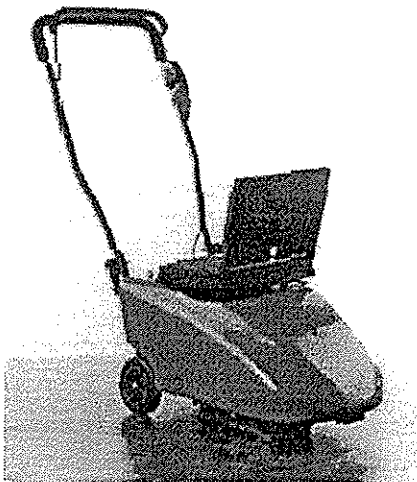
**Figure 11a**  
ARRB Walking Profiler

The equipment used for this test is the Australian Road Research Board (ARRB) Walking Profiler (Model APR1) shown in Figure 11a. This is a high quality precision instrument which provides efficient collection and presentation of continuous paved surface information, including distance, profile and grade. Figure 11b shows a walking profiler being used at one of the representative test sites. LTRC was responsible for this field test. Measurements were made along the same established survey lines. This test was performed in all test sites except Site 7.

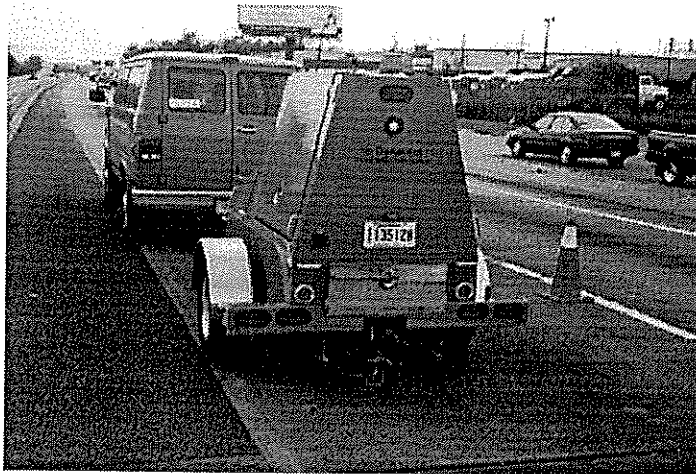
**Figure 12**  
A FWD machine working at a test site

A testing machine commonly known as a falling-weight deflectometer (FWD) was used for non-destructive testing of pavement sections at the selected representative sites. The FWD is an impulse-type testing device which imparts a transient load upon the pavement surface. Both the duration and magnitude of the force are representative of the load pulse induced by a truck tire moving at moderate speeds. The load is generated by dropping a set of masses from selected heights onto a system of rubber buffers. Both the duration of the load

pulse and magnitude of the maximum load can be varied based on the drop height and buffer configuration. The loading mechanism is housed in a trailer pulled by a special vehicle which is also used for power generation and data acquisition. The test is static when measurements are made at a given location and then the vehicle is moved to the next measuring station. These stations were located at the same survey points established earlier on the roadway. Machines that are suitable for highway pavement testing typically can generate maximum load pulses in the range of 1500 lbf (680.4 kg) to 25,000 lbf (11340 kg). The tests were performed at load pulses of approximately 16,750 lbf (7597.8 kg). Figure 12 shows a FWD test at a representative test site. These tests were all performed by LTRC.

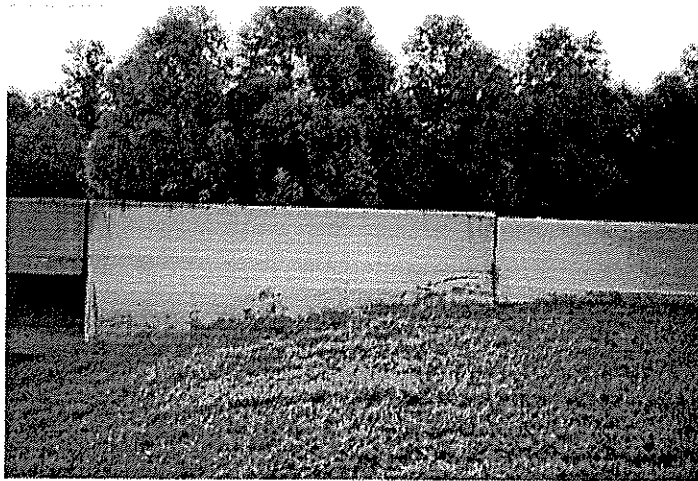
**Figure 20**  
View of northbound bridge of Site 1

Based on a visual inspection, it appears that the approach slab at Site 1 has performed poorly. There is significant differential settlement along the approach slab. At the joint between the bridge and the approach slab there is also noticeable differential settlement. A view of the northbound slab and abutment is shown in Figure 20.

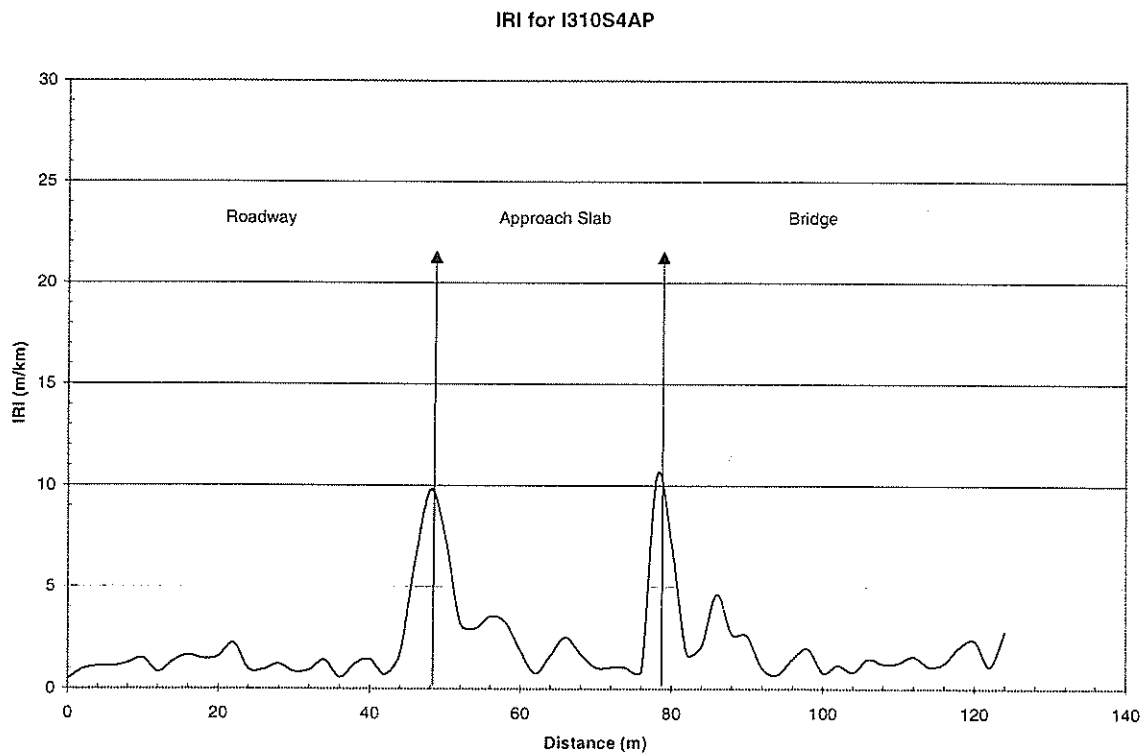
The IRIs for Site 4 were determined using a laser profiler and are shown in Figure 34.

**Figure 34**  
IRIs for Site 4

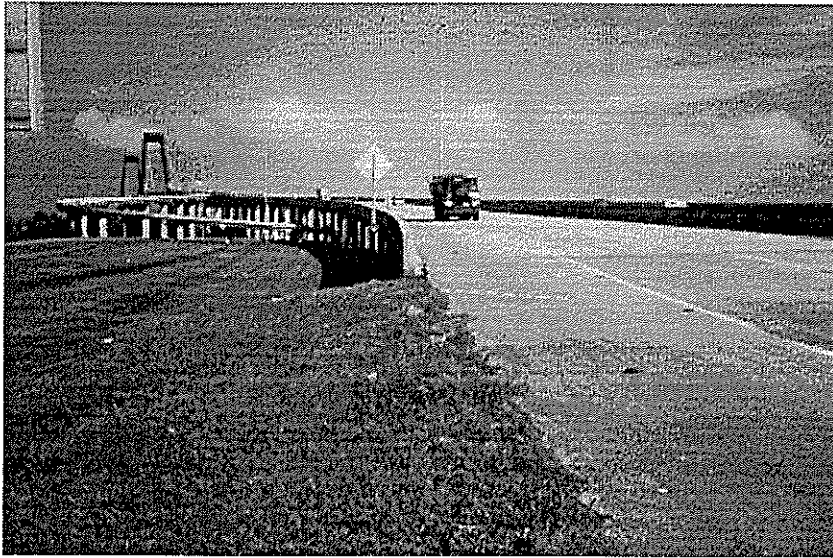
**Figure 35**  
Site 5: Hale Boggs bridge south approach

Site 5 is the south approach to the Hale Boggs (Luling) Bridge and includes the southbound and northbound lanes (see fig. 10a for map location). Figure 35 shows a view of this site looking in the north direction from the southbound approach.

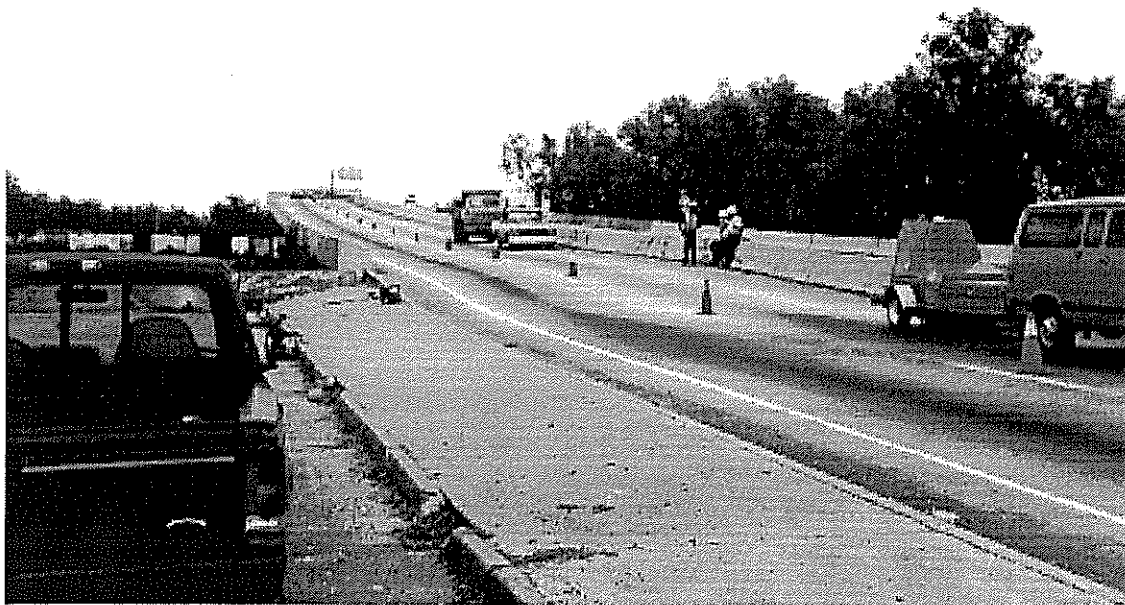
**Figure 41**

Site 7 is the westbound west approach of the Jefferson/Orleans parish line bridge (see Figure 10b for map location). Figure 41 shows a view of this site looking in the east direction. As shown in Figure 41, a serious bump has developed at the start of the approach slab on the bridge side. A void can be seen under the slab in this area, which indicates that the soil under the approach slab has significantly settled and accordingly no contact is present between the slab and the foundation soil.

Site 7: LA 3139 parish line bridge westbound west approach

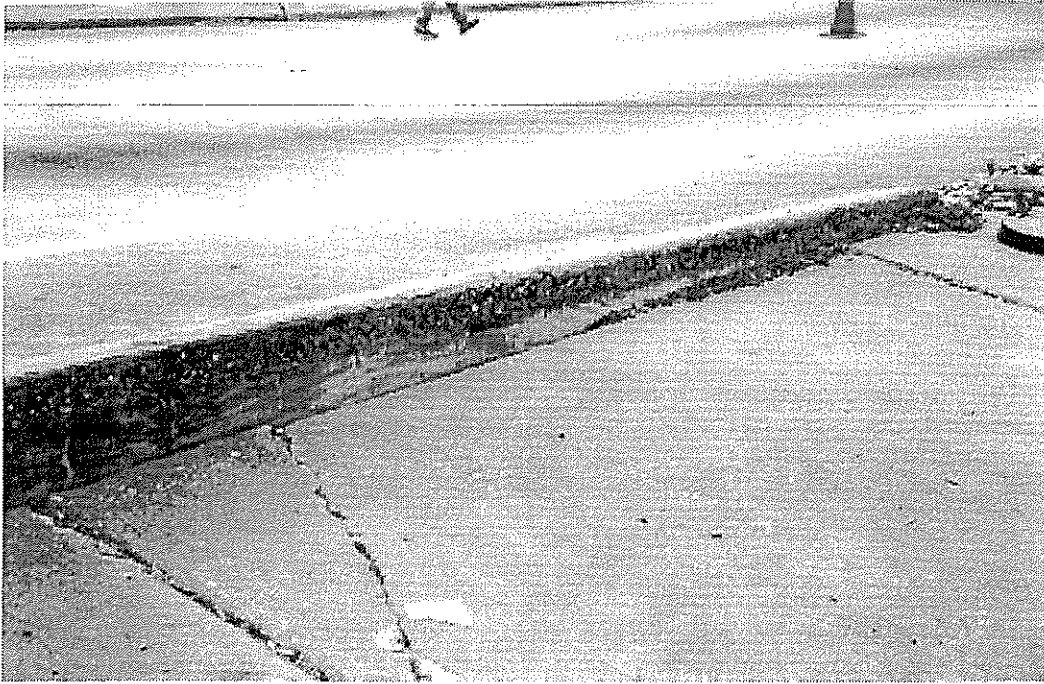
**Figure 42**  
Longitudinal differential settlement between approach slab and its adjacent side shoulder pavement

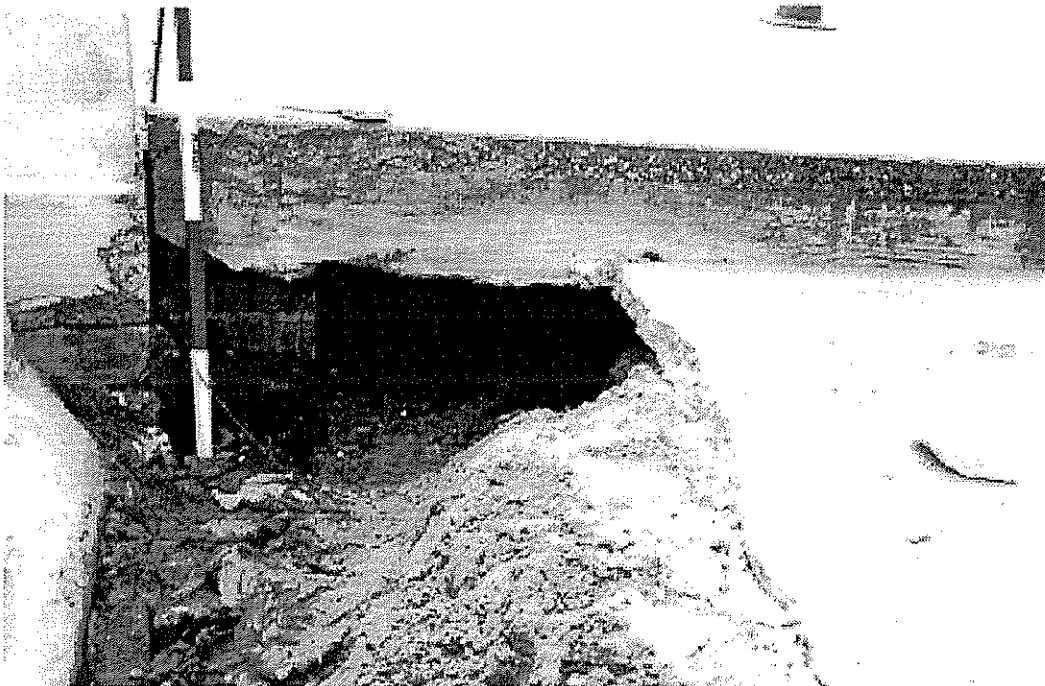
**Figure 43**  
View of embankment under approach slab
