1. Report No. FHWA/LA.11/478		2. Government Accession No.	3. Recipient's Catalog No.
4. Title and Subtitle Cost Effective Prevention of Reflective Cracking of Composite Pavement		5. Report Date September 2011

Cost Effective Prevention of Reflective Cracking in Composite Pavements

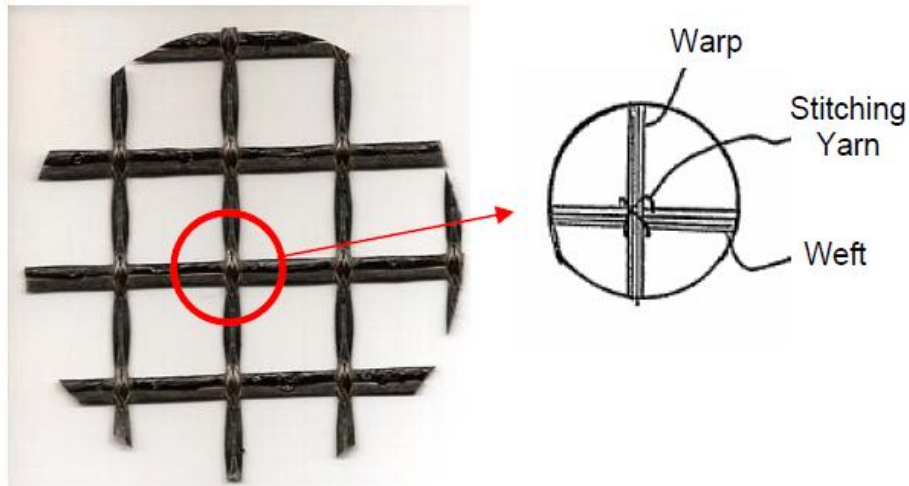
Figure 4
Structure of a fiber-glass grid [26]

Fiber-Glass Grid. Marks presented the performance of fiber-glass grid in delaying reflective cracking in four test sections in Iowa [25]. The fiber-glass grid was installed on I-35 in which two 1.5-in. lifts of binder course were placed followed by a 1.5-in. wearing surface. Performance was monitored annually for five years by determining the number of cracks that reflected through the layer and by comparing the reinforced sections to the control segments. In one section, the fiber-glass grid was placed directly on top of the concrete pavement while in the three other sections, it was placed between lifts of asphalt mixture. Results of this monitoring showed that the best performer was the section in which the fiber-glass grid was placed directly on top of the concrete pavement, with 43 percent of the joints reflecting after five years. The poorest performer was one section with fiber-glass grid placed between lifts of asphalt concrete with 80 percent of the joints reflecting after five years. Conclusion of this study indicated that the use of fiber-glass grid yields a small reduction in reflective cracking but does not justify the cost of this interlayer system. Figure 4 describes the general structure of a fiber-glass grid.

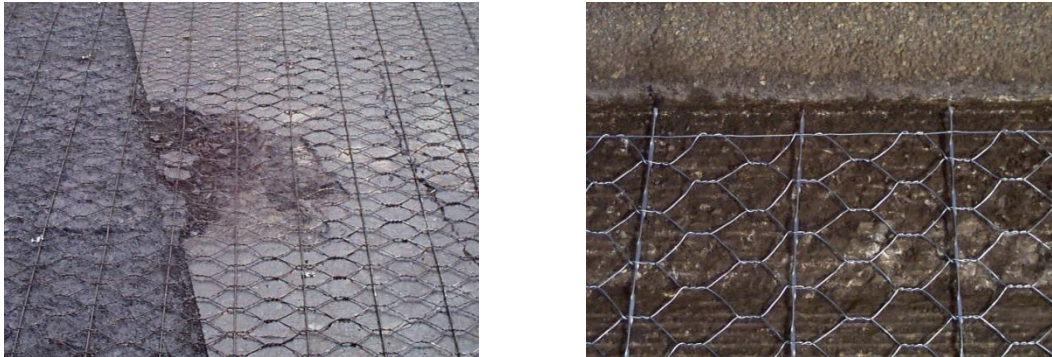
Figure 5
General configurations of two types of steel reinforcement [37]

Evaluation of the new class of steel reinforcement showed that the performance of the overlay was enhanced if slab-fracturing techniques were used to reduce vertical movements at the joints prior to placement of the overlay. It was also concluded that overlay thickness still remains the major factor controlling pavement performance. Among the evaluated test sites was a project in Mont-Saint-Aubert. This site consisted of a highly deteriorated rigid pavement structure with a traffic pattern classified as light to medium; see Figure 6(a). In 1989, steel reinforcement was installed after minor repairs to the existing pavement structure.

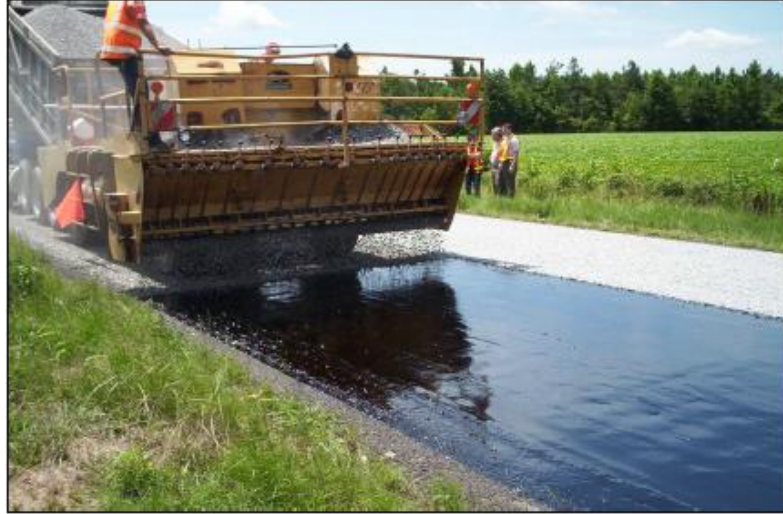
Figure 7
Application of a stress absorbing membrane interlayer [41]

Stress Absorbing Membrane Interlayer. SAMI is constructed by placing a seal coat made of rubber asphalt binder (80 percent asphalt cement and 20 percent ground tire rubber) on the surface of the old pavement and then rolling in coarse aggregate chips as shown in Figure 7. This layer may be used as a stress-relief interlayer. The main role of the SAMI is to retard crack propagation and improve the tensile strength at the bottom of the overlay due to the presence of the rubber asphalt binder. It is thought that this interlayer will cause the overlay to behave independently from the underlying structure. If this hypothesis is correct, higher tensile strains will occur in the overlay, but no reflective cracking will take place. Most of the reviewed literature agreed on the effectiveness of this interlayer to retard reflective cracking [8].

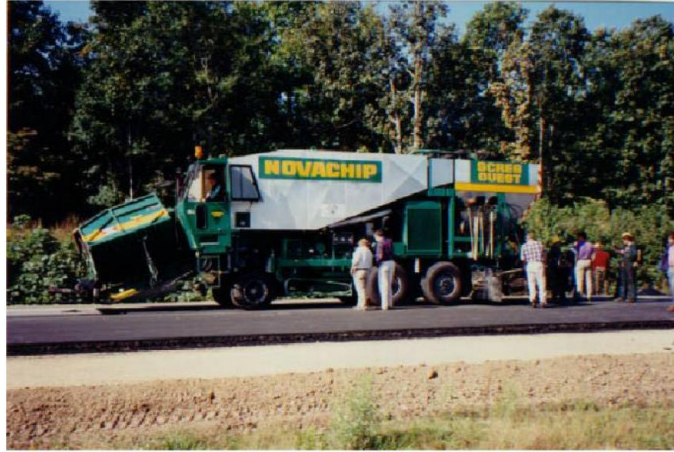
Figure 9
Novachip paver [47]

NovaChip[®]. NovaChip[®] consists of a thin (3/8 to 3/4 in.) gap graded HMA layer placed on top of a Novabond[®] membrane, which is a polymer modified asphalt emulsion. This product, which was originally developed in France, is manufactured by SemMaterials in the US. It was originally introduced as a surface treatment for weathered and cracked pavements in order to address the rough texture and the potential for flying chips encountered with chip seal. The application of NovaChip[®] requires the use of specially designed equipment that places both the Novabond[®] and the NovaChip[®] in a single pass. Thin gap-graded hot mix asphalt is placed on a relatively thick polymer modified asphalt emulsion tack coat as shown in Figure 9. Good adhesion, rapid application, and reduced noises were found to be significant advantages of this material [47]. A nominal aggregate size of 0.5 in. or less is used in this mix [48]. Field performance of NovaChip[®] in Washington State has been positive when used on top of a deteriorated flexible pavement [49]. After six years in service, while the extent of reflective cracking gradually increased over the years, the cracks remained tight. The manufacturer of this system expects a service life ranging from 10 to 12 years. In a report published by National Center for Asphalt Technology (NCAT), Hanson stated that projects in Bucks County and Montgomery County of Pennsylvania reported minor reflective cracks on the surface of the roadway where NovaChip[®] was used. Similar conclusions were made from projects with NovaChip[®] in Alabama. Pretreatment of existing joints before application of NovaChip[®] is strongly recommended. Any cracks greater than 0.25 in. should be cleaned routed and sealed [50].

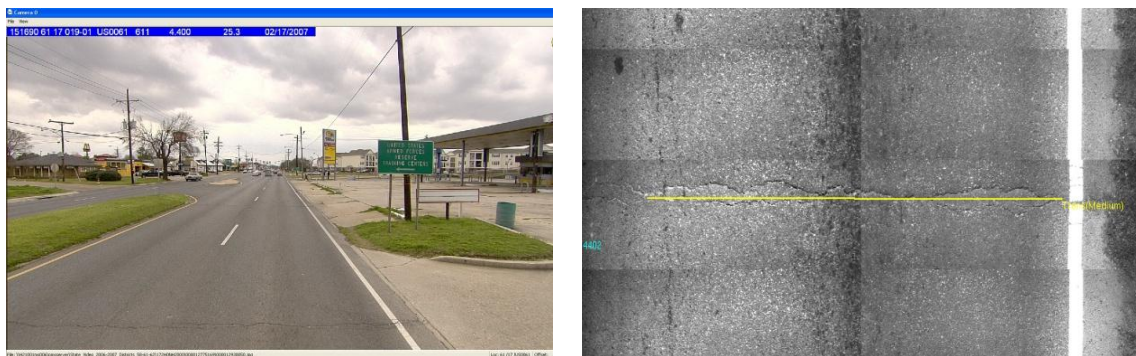
Figure 12
Pavement imaging and the detection of reflective cracking

Videos of the roadway sections are stored in the server and are classified by districts. To determine the number of joints that reflected on a specific road segment, video crack surveys were reviewed, using the Visidata software. This software links video pavement imaging with global positioning and performance data. To ensure that only reflected cracks are counted and that other transversely manifested cracks are not included, the first joint location

RCI represents the percentage of joints that reflect the pavement surface. This parameter was calculated by counting the number of reflected cracks at the joints. The Visidata software developed by Roadware, Inc., was instrumental in the analysis of the pavement sections in order to calculate the RCI as it provided various digital views of the pavement structure, see Figure 12. Videos were available on different servers for all the districts. Unfortunately, the server holding videos for years 2000, 2003, and 2005 crashed after analyzing the fiber-glass grid projects. This incident only allowed the calculation of RCI for the years 2007 and 2009 for the remaining projects in other treatment categories.

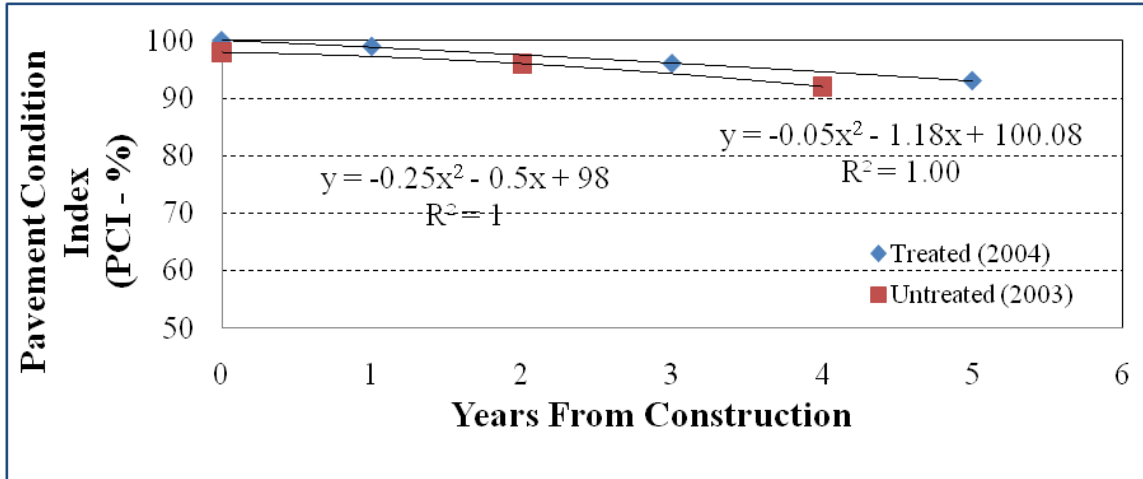
Figure 17

Typical variation of the pavement condition index during the monitored period

Various trigger values were used depending on the functional classification of the roadway, see Table 6. Poor condition was considered to be the rehabilitation trigger point for all road types. The value of “x” was the year at which pavement performance falls below the trigger value. That particular value of “x” was considered to be the service life of the pavement. A similar procedure was followed for all pavement sections for both treated and untreated segments. This analysis used the estimated service life values to establish a performance comparison analysis between treated and untreated sections. The difference between the predicted service life of the treated section and the respective untreated section was calculated. If the difference was positive, the treatment is expected to result in a positive effect in performance for that particular pavement section. In order to identify a conclusive trend for each treatment in terms of performance, a sufficient number of projects were analyzed under each category. However, only a few numbers of projects were available to satisfy the selection requirements for a detailed analysis in the STRATA[®], SAMI, and paving fabrics categories.

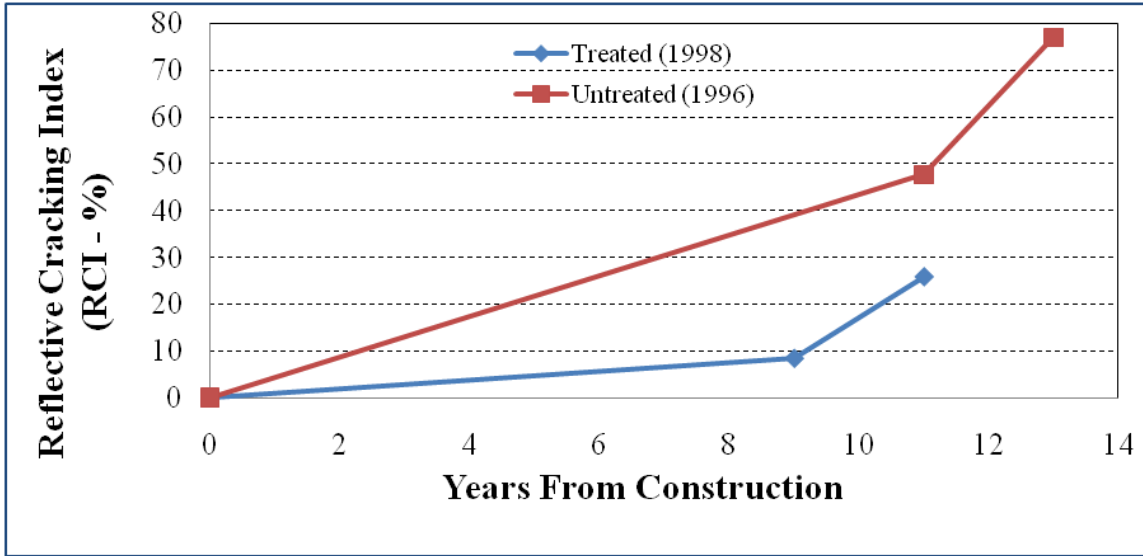
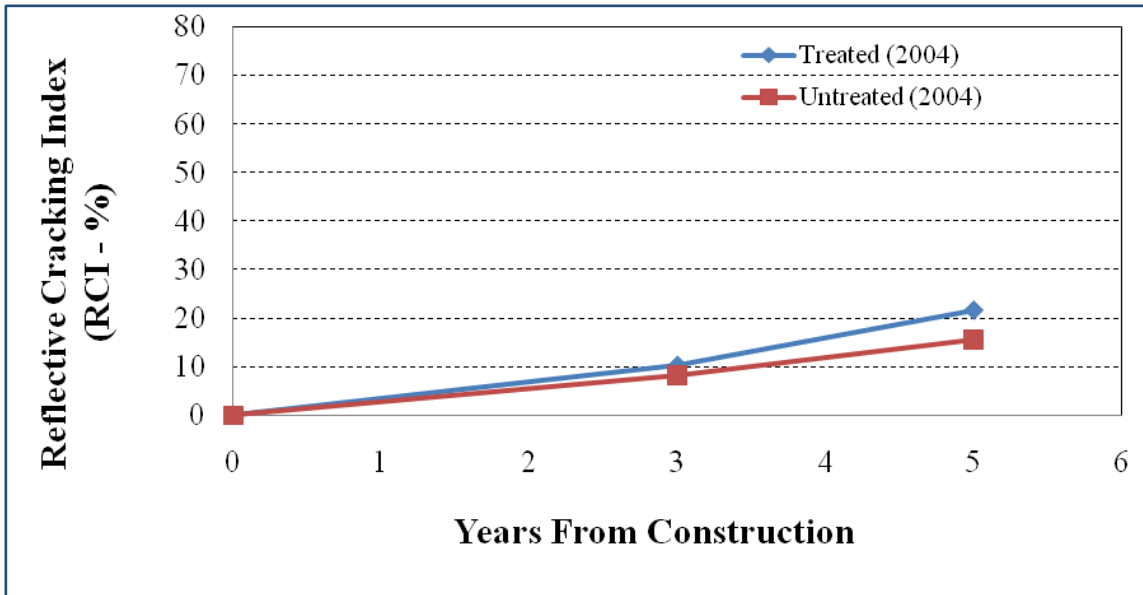
Figure 19
RCI plots for selected projects in chip seal category

RCI graphs were created for all selected projects in which treatments were used, except for saw and seal. In saw and seal projects, sealed cracks were surveyed to identify double cracking. As previously mentioned, projects with fiber-glass grid had data from the year 2000, while the rest of the projects contained data for years 2007 and 2009 only. RCI calculated and assessed pavement performance against reflective cracking, while PCI predicted the average service life. Examples of RCI trends for different treatment methods are presented in Figures 19 to 23. Figure 19 (a) and (b) presents two projects in which chip seal was applied as an interlayer treatment. Figure 19 (a) presents a site in which the application of chip seal as an interlayer improved the performance against reflective cracking. In contrast, Figure 19 (b) demonstrates that the RCI was higher in the treated section than in the untreated section. Similarly, Figure 20 (a) and (b) presents two sites in which a fiber-glass grid was used; in one of the sites, the performance of the treated section was comparable to the performance of the untreated section, while the other site showed that the RCI was higher in the treated section than in the untreated section. Similarly, Figures 21, 22, and 23 represent sites in which SAMI (Stress Absorbing Membrane Interlayer), paving fabrics, and STRATA[®] were used. In general, results of the RCI were mixed for the different treatment methods; therefore, these results were not used to draw conclusions as to the effectiveness of each treatment method.

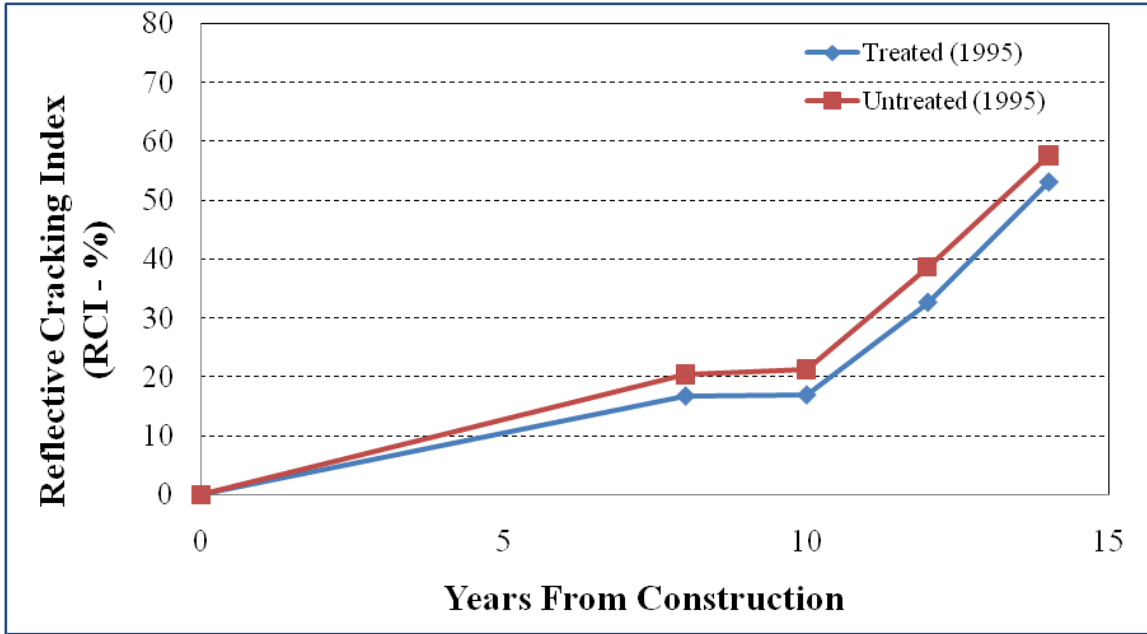
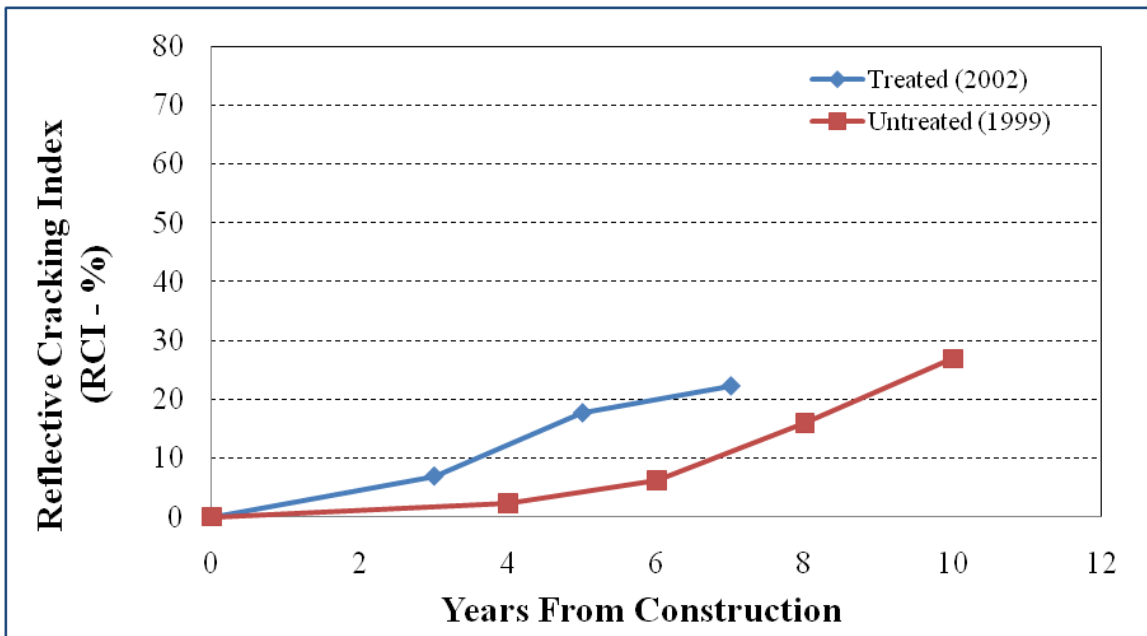
Figure 20
RCI plots for selected projects in fiber-glass grid category

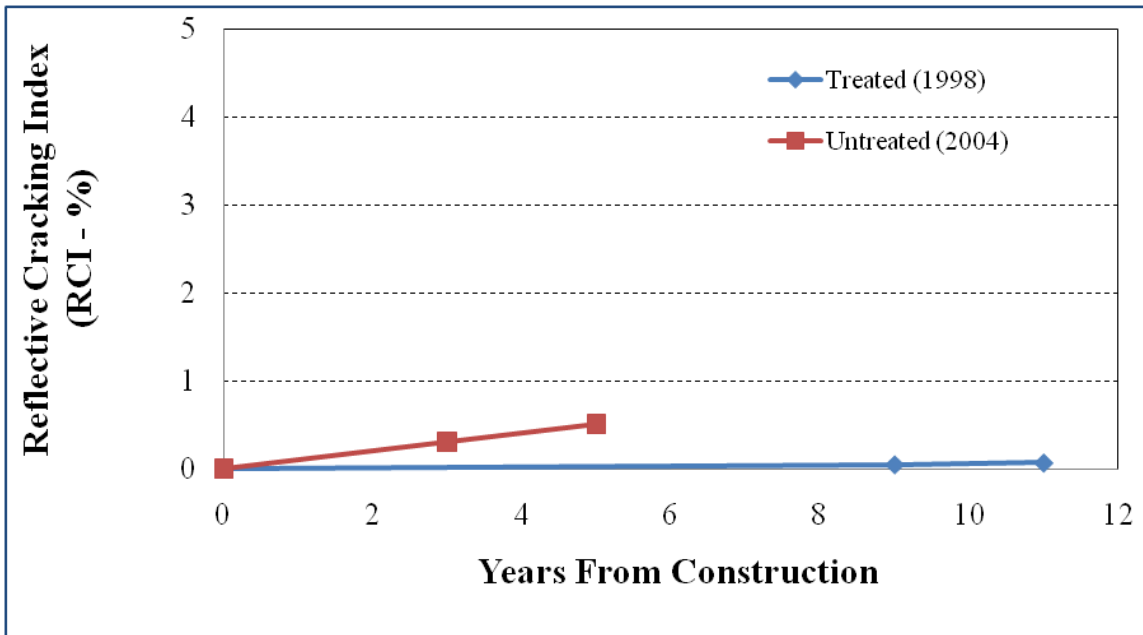
Figure 22
RCI plot for a paving fabric project

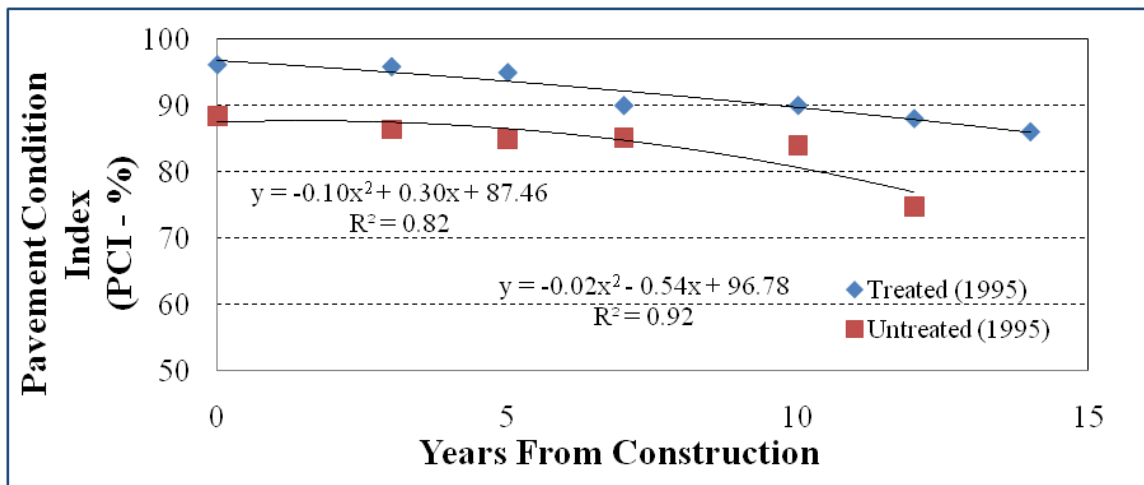
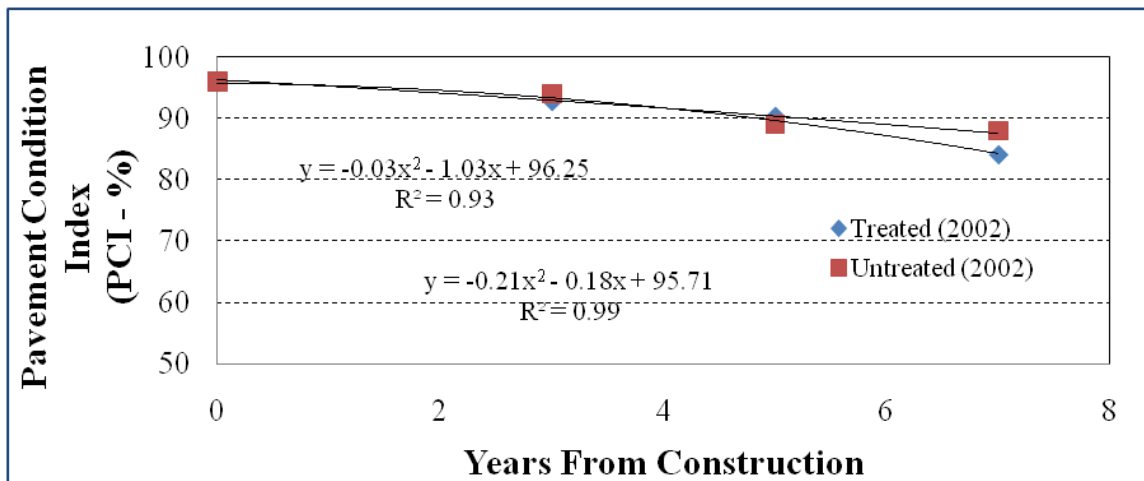
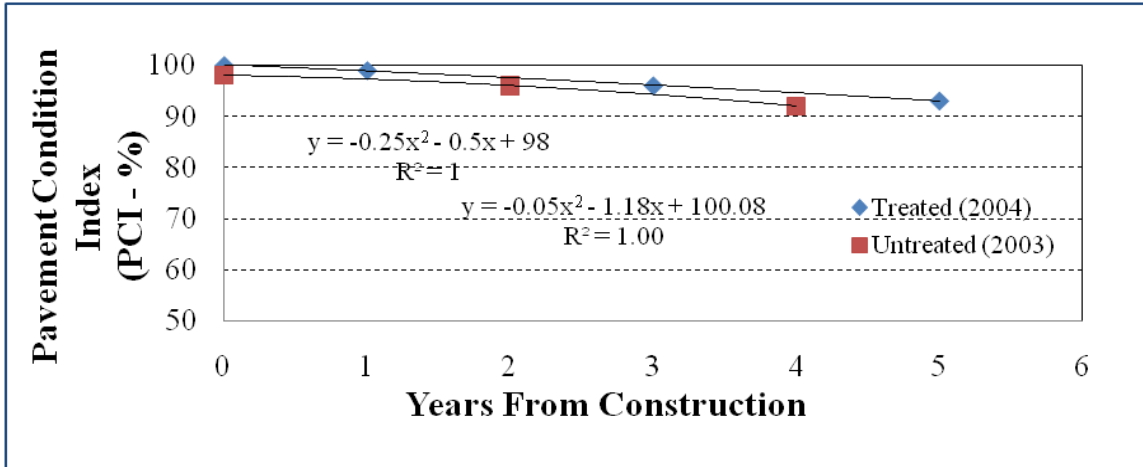
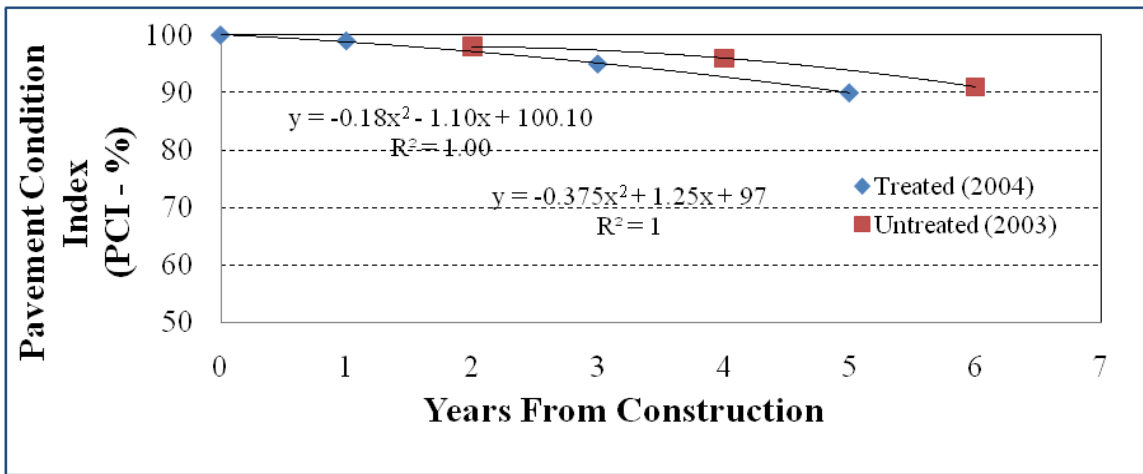
Figure 24 shows PCI trends for a number of sections illustrating the different treatment categories. Figure 24 (a) and (b) presents PCI plots for two of the sites, which were sawed and sealed; similarly, Figure 24 (c) and (d) presents plots for sites treated with chip seal. Figure 24 (e) and (f) presents plots for sites treated with fiber-glass grid; Figure 24 (g) and (h) represents plots for sites treated with SAMI; Figure 24 (i) presents a plot for sites treated with paving fabrics; and Figure 24 (j) presents a plot for sites treated with STRATA[®]. Similar graphs were plotted for all the projects selected for detailed analysis.

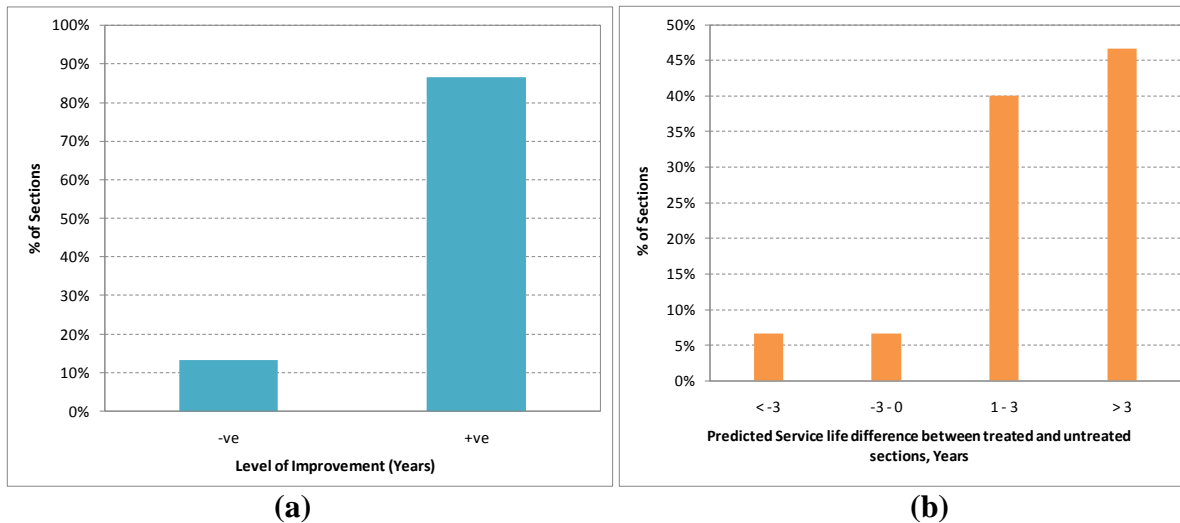
Figure 25
Contribution of saw and seal to the predicted pavement service lives

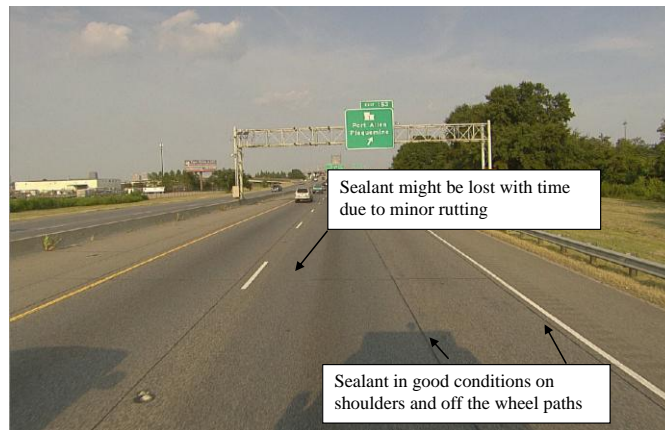
Figure 26
(a) Dislocated joints and double cracking, (b) sealant condition under high traffic loading

decrease the serviceability of the pavement structure. While the analysis showed that this treatment method was more effective in sections with low to medium traffic volumes, contact with project engineers across the state indicated that the performance of this treatment was similar for low, medium, and high traffic volumes. Therefore, additional analysis is needed to determine the exact influence of traffic volumes on saw and seal.

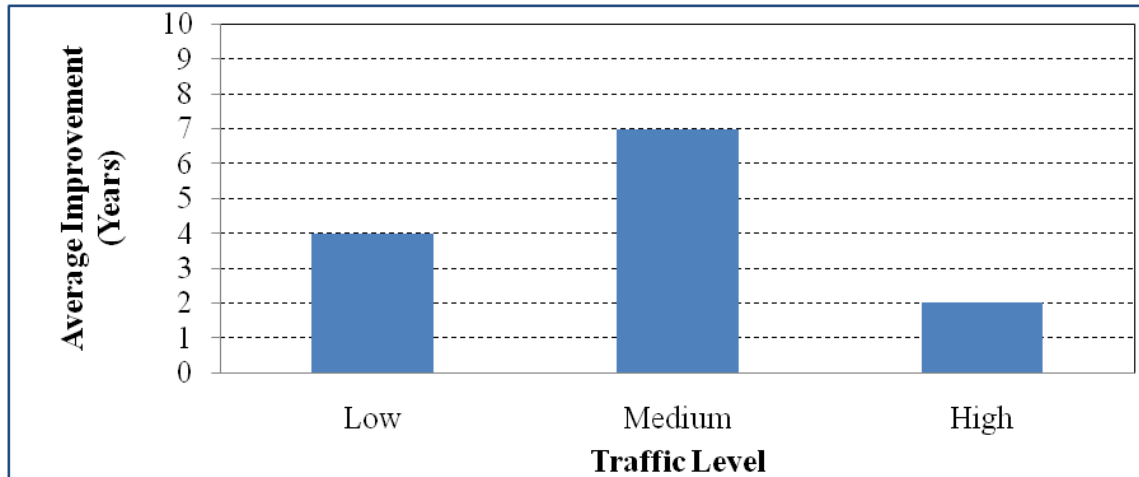
Figure 27
Effects of traffic levels on performance of saw and seal

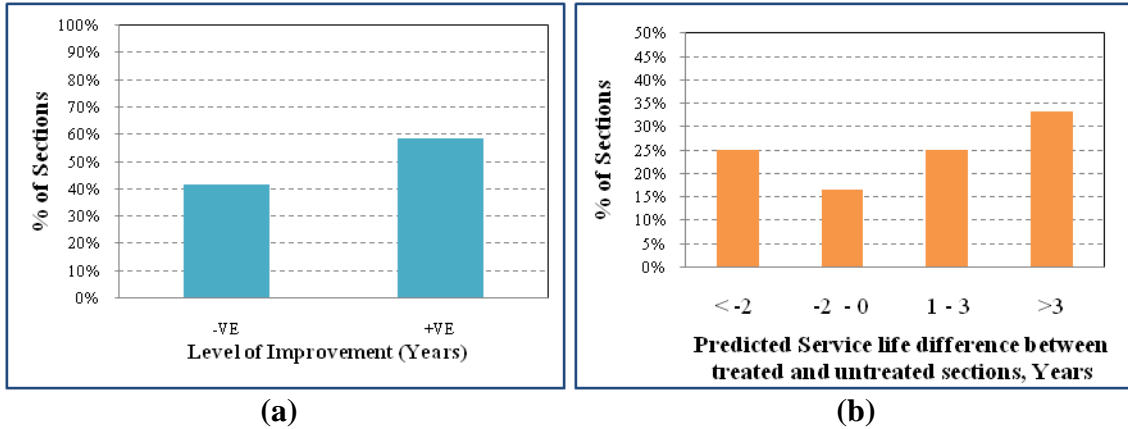
Figure 28
Contribution of chip seal to the predicted pavement service lives

Twelve different pavement sections were analyzed in which chip seal was used as a treatment for reflective cracking relief. The project locations were presented in Figure 11. Table 9 illustrates the predicted service lives for the treated and untreated sections. In order to identify the general trends in the tabulated results, Figure 28 groups the different projects into classes exhibiting similar levels of contribution from chip seal. It is noted that two sites showed similar performance levels when compared to their respective untreated segments. These sites were considered in the negative category since there was no improvement in service life. As shown by these results, 58 percent of the sites showed a positive improvement ranging from 2 to 10 years, while the remaining 42 percent of the sites showed a negative contribution, i.e., no improvement due to the treatment. Twenty-five percent of the sections showed an improvement from 1 to 3 years and 33 percent of the evaluated sections showed an improvement ranging from 4 to 10 years. Two of the sites showed neither improvement nor disimprovement due to the application of chip seal as a reflective crack relief interlayer. The average level of improvement to the pavement service life was about 2 years.

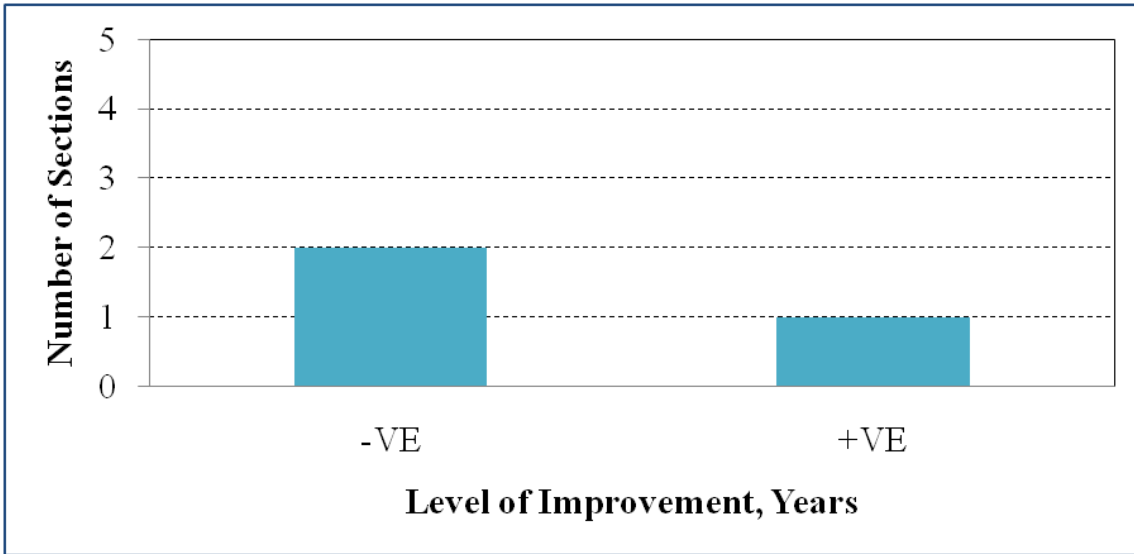
Figure 30
Contribution of SAMI to pavement service lives

SAMI consists of a single application of surface treatment coupled with an asphalt rubber binder. Only three projects offered sufficient data for a detailed performance analysis. Table 11 illustrates the predicted service lives for the treated and untreated sections. In order to identify the general trends reflected by this table, Figure 30 categorizes the level of improvement or disimprovement due to the use of SAMI into a structured histogram. As shown by these results, one section showed a positive improvement of about 10 years while the remaining two sections showed a negative contribution. Only one section showed an improvement of about 10 years and the other two evaluated sections showed negative improvement in the range of 3 to 5 years.

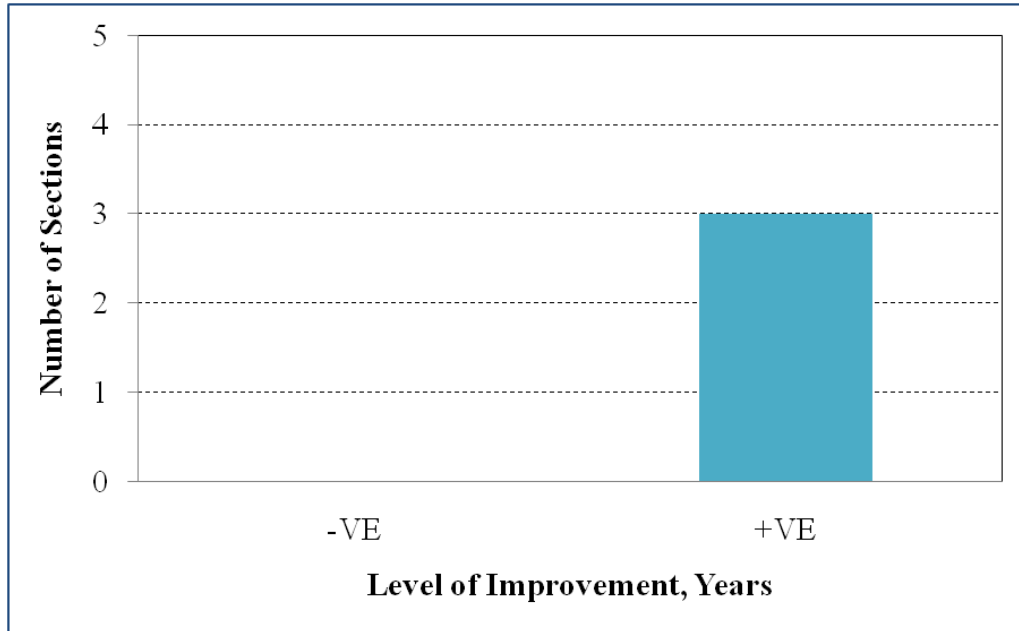
Figure 31
Contribution of paving fabrics to pavement service lives

This study analyzed only three projects in the paving fabric category. All the projects where paving fabric was used showed a positive performance by improving the service life over untreated sections. Table 11 illustrates the predicted service lives for the treated and untreated sections. To identify the general trends in the tabulated results, Figure 31 categorizes the level of improvement or disimprovement, due to the use of paving fabric into a structured histogram. As shown by these results, 100 percent of the sites showed a positive improvement ranging from 4 to 5 years, while no sections showed a negative contribution or improvement, due to the treatment. The three sections collectively showed an improvement from 4 to 5 years; two of the sections showed an improvement of about 4 years, and one section showed an improvement of 5 years.

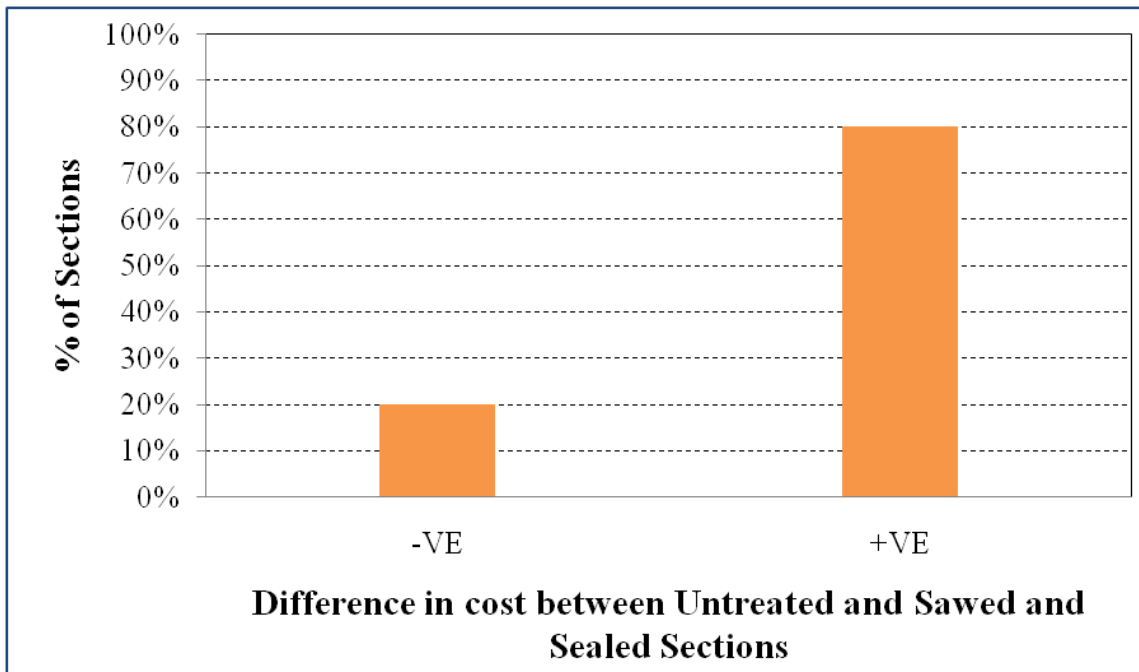
Figure 34
Cost effectiveness of saw and seal treatment method

Figure 34 compares the cost of regular HMA overlays to the cost of treated HMA overlays, based on the TAC concept presented in equation (6). A positive cost difference (+VE) indicates that the use of saw and seal is found to be economical while a negative cost (-VE) difference indicates that the treatment method is not cost-effective compared to regular HMA overlays. As shown in this figure, the majority of the sections (80 percent) indicate that saw and seal is cost-effective, compared to regular HMA overlays. Based on these results, this study determined that this treatment method is cost-effective compared to regular HMA overlays. However, the effectiveness of this treatment method strongly depends on the success of the construction process in applying the treatment to the exact joint locations.

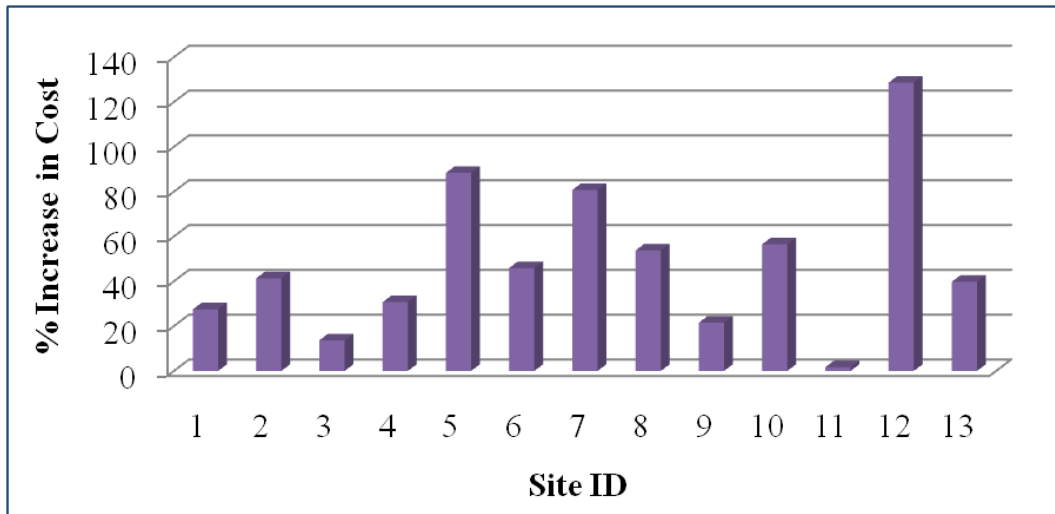
Figure 37
Increase in cost of the HMA overlay due to fiber-glass grid

Cost data for the road way reinforcement mesh as well as HMA overlays were obtained from actual bid items for each project. Figure 37 presents the percentage increase in the cost of the HMA overlay, due to the fiber-glass grid treatment. The increase in cost ranged from 1.6 to 128 percent averaging 48 percent of the HMA overlay cost.

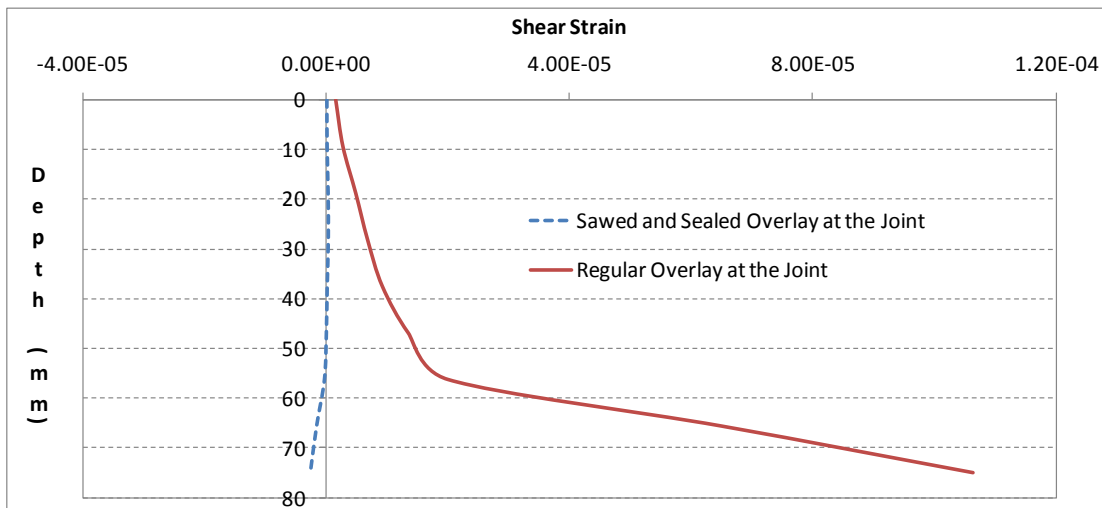
The high strain levels at the bottom of the HMA overlay constructed without the saw and seal method will result in crack initiation at the bottom of the overlay and crack propagation with load repetitions. The transverse and shear strain distributions away from the joint were similar with and without saw and seal while being slightly greater when saw and seal was used. It is determined from these results that the constructed joints in the HMA overlay allow it to move with the underlying layer and to dissipate the energy generated due to expansion and contraction in the concrete layer and wheel loading without cracking.
