TECHSUMMARY *September 2018*

SIO No. 30000154 / LTRC Project No. 09-2ST

Performance and Analysis of Concrete Bridge Railing using Conventional and Composite Reinforcement Materials

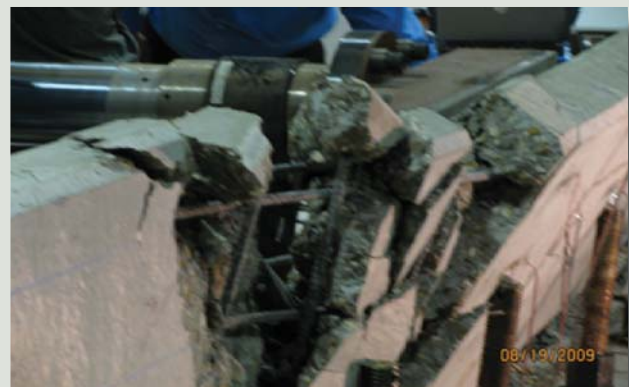
Figure 2
Barrier after failure

- The measured load-to-failure of the precast barrier agreed with the predicted section capacity of the barrier obtained from the analytical analysis.
- Anchorage of the tested barrier were strong enough that cracks initiated in the wall portion of the barrier and not the slab.
- The barrier test specimen failed in two different subsequent modes: torsion and breakout of anchorage detail.

The barrier failed at the middle region, and as such, testing the end region could not be performed. Based on that and until additional work is done to assess the capacity of the section at the end region, it can be concluded that the precast concrete barriers similar to the one tested in this study are not TL3 compliant and their use should be limited to conditions that qualify for TL2.
