| Rehabilitation of Deteriorated Timber Piles using Fiber Reinforced Polymer (FRP) Composites | FHWA/LA.21/653 |
| Hota Gangarao (PI), Drew Damich, Mark Skidmore, and John Harper | March 2022 |
| WVU Constructed Facilities Center | LTRC Project Number: 15-3ST |
| Louisiana Department of Transportation and Development | November 2015-April 2021 |

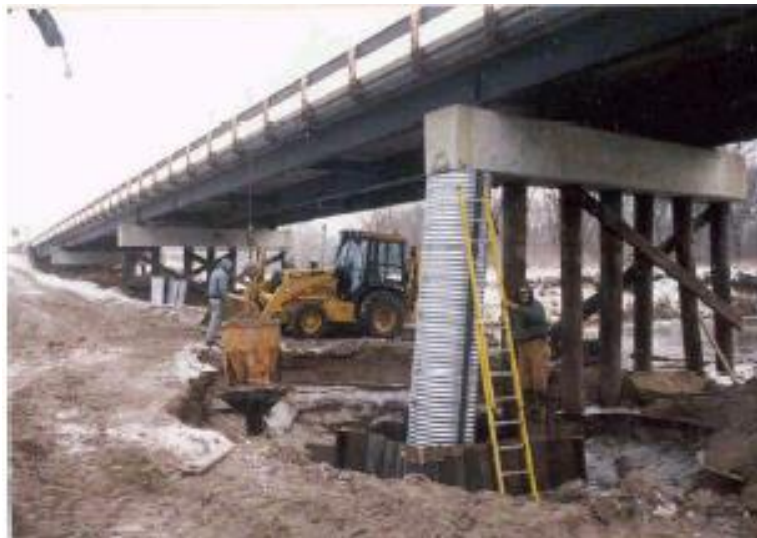
Figure 2. Concrete jacketing installation

Should the concrete crack, the encased timber will continue to deteriorate. The ability to transfer load between the timber and concrete is considered questionable [11]. In confined spaces, placement of the rebar and jacketing can be challenging [10]. A cheaper version of this repair was reported as being \$20 per linear foot not including labor cost [11].

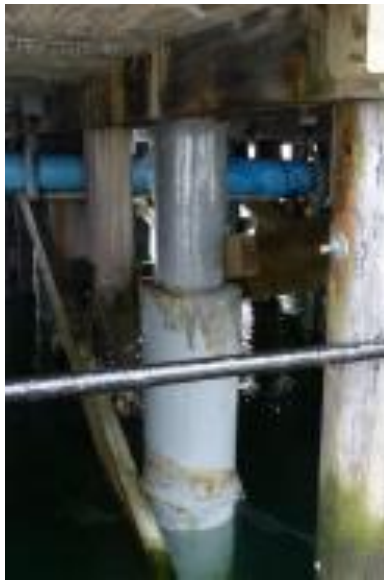
Figure 7. FRP shell with filler

In a study in Nova Scotia at Halifax Cable Wharf, marine timber piles experiencing severe deterioration from freeze/thaw cycling and marine borers were rehabilitated using glass FRP prefabricated shells (Figure 7). The prefabricated shell consisted of multiple laminates of Tyfo® SHE-51 (E-glass unidirectional laminates) in vertical and horizontal orientations, wherein glass laminates were used to repair the sections with the most damage. The prefabricated FRP shells were placed around the piles and underwater grout was pumped into the shell. The prefabricated shells with grout provide local compressive strength [15].

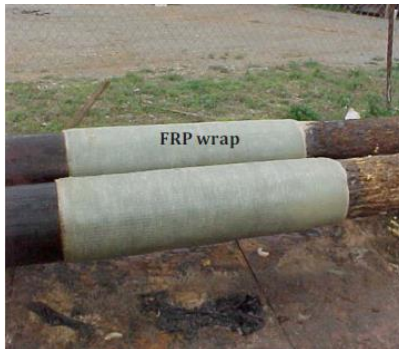
Figure 17. Electrical poles with FRP wraps

Electrical poles up to 30 years old were repaired with epoxy/E-glass FRP wraps in tandem with off the shelf wood fillers as shown in Figure 17. The Tyfo S fluid epoxy was used to impregnate the FRP and as a primer on the timbers. Tyfo SHE-51A fabric was used with three 0° unidirectional layers in the axial direction and one 90° layer in the hoop direction. More wraps in the axial direction provided more stiffness under bending loads. Bending tests indicated that the repaired poles returned to approximately 85% of their original capacity. The report recommended for flexural strengthening that 80% of reinforcement should be orientated in the axial direction with the remaining 20% used for confinement. Additionally, the report recommended the length of wrap to be the full length of the damaged area plus one diameter of the pole on either side [22].

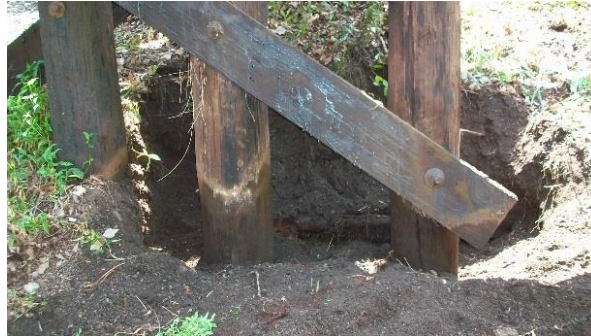
Figure 18. Pile excavation

Debris and soil around the base of above ground portion of piles must be removed to allow for load transfer between the sound pile section underneath and the damaged section as shown in Figure 18. If the pile is submerged, a cofferdam or some other method for diverting water should be used (Figure 19). When the pile is exposed, it should be dried with a portable heater but at a low enough temperature to avoid creosote ignition (<130 °F).

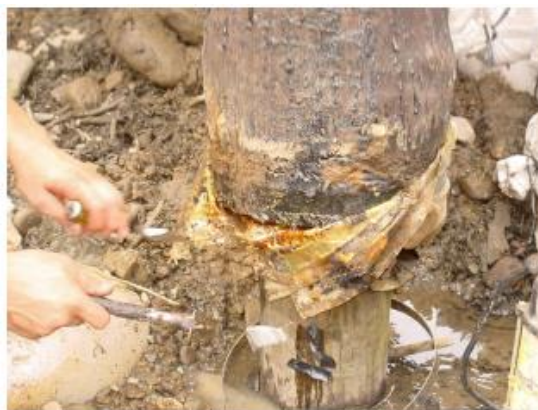
Figure 20. Removal of decay

Once the area around a distressed pile is clear and dried, the decayed portions of the pile should be removed and discarded (Figure 20).

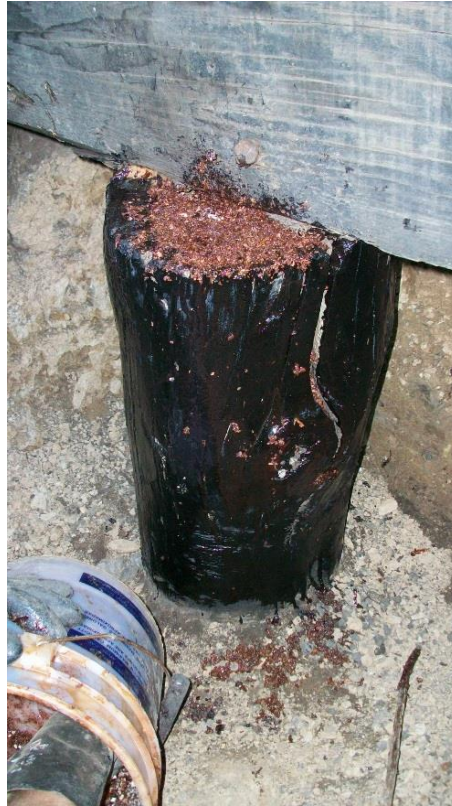
Figure 22. Primed and filled pile section

Any gaps, checks, or heart rot were filled with a sawdust/resin mixture (Figure 22). Depending on the consistency desired, the sawdust content could vary from 20% - 50%, which is determined by adding sawdust until the mixture is as thick as possible while still being able to be poured into the pile (roughly the consistency of honey). As resin flow depends on temperature, the amount of sawdust must be adjusted based on-site conditions.

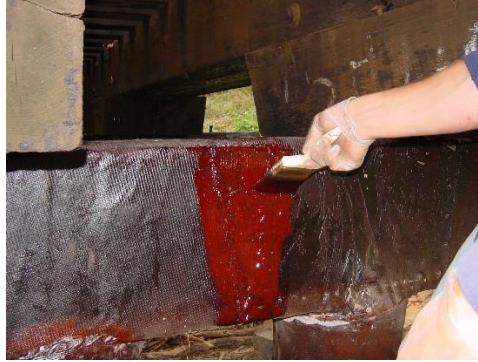
Figure 23. Sealing with phenolic

After wrapping, a phenolic-based adhesive was applied to the exterior of the wrap and around the edges to seal the surface and protect the bond from moisture (Figure 23).

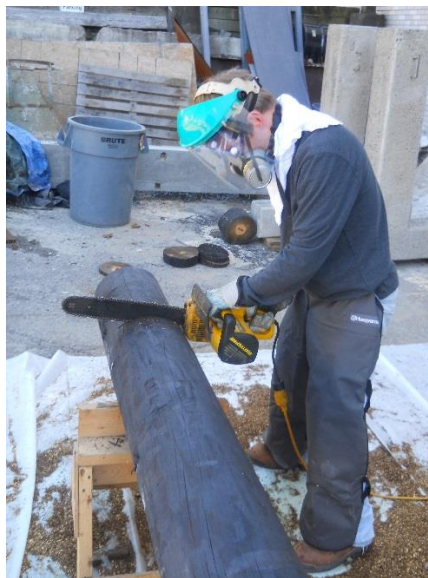
Figure 25. Cutting timber specimens

Timber specimens were used in bond evaluations, pull-off testing, and full-scale simulated rehabilitation. Testing was conducted on new timber piles to provide a uniform result. New timbers were selected due the variability present in deteriorated piles from the field that would influence the test results. Timber piles were provided in 8-ft. lengths and treated with creosote before shipping. Pile diameters varied from 10 in. to 12 in. A chain saw was used to cut the piles into the required portions for each tests as shown in Figure 25. While effective at cutting the pile into appropriate lengths, the hand held saw made it difficult to create straight cuts consistently. Therefore, on many of the timber specimens, surfaces are often non-parallel, which created small, amounts of eccentricities during testing resulting small amounts for column bending induced stresses. Any influences from these eccentricities are covered in the test discussions.

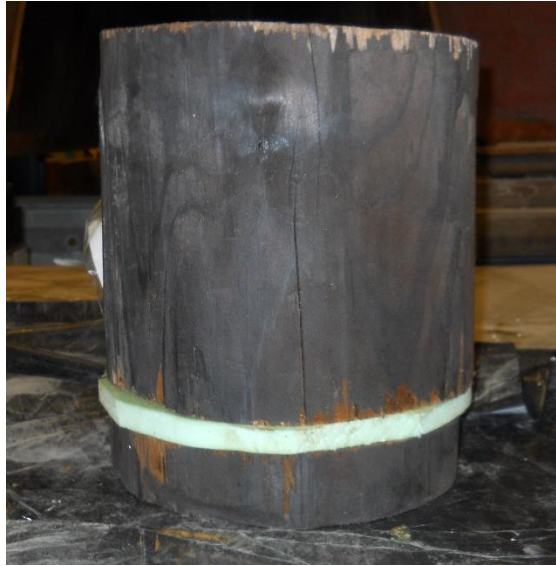
Figure 27. Unwrapped timber bond specimen

For the 6-in. bond length specimens, timber was cut at 10 in. with a 2-in. base portion. For the 12-in. bond length specimens, timber was cut at 16 in. with a 2-in. thick bottom. After cutting, the bond specimens were assembled with the 1/2-in. thick insulation sandwiched between the top (bond section) and bottom (2 in.) timber portions then screwed together with 3-in. screws. Insulation was later trimmed to match the circumference of the timber (shown in Figure 27) and putty was applied to fill any voids created during the trimming of the insulation.

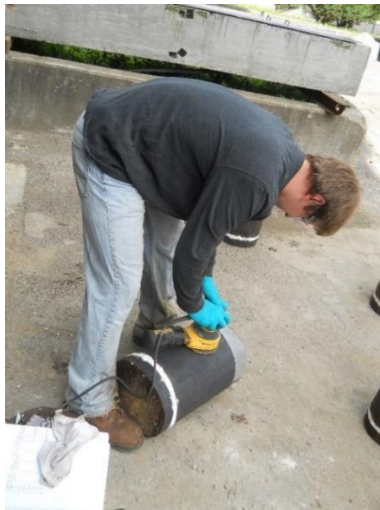
Figure 28. Sanding of bond specimens

Samples were then sanded on the surface with an electric palm sander to remove some of the creosote clogging the pores of the timbers to allow for resin penetration, which would improve the bond strength as shown in Figure 28. Wax paper was installed at the top of the specimen to provide a bond breaking material that ensured a consistent bond length during wrapping and ensured that the testing would apply load only to the timber.

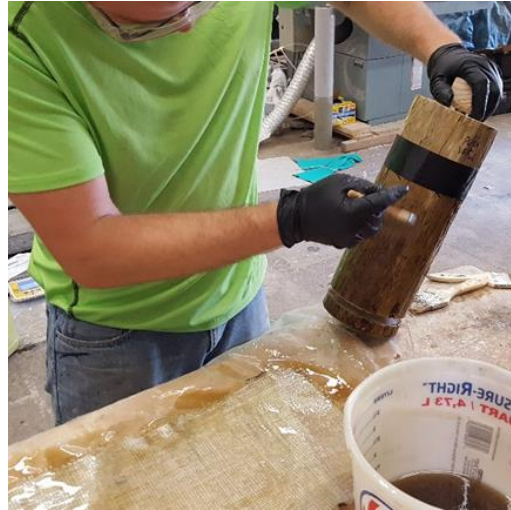
Figure 29. Apply primer to smaller mock up sample

Samples were wrapped after sanding and the installation of the bond breaker. First, primer consisting of the saturating resin used was applied to the surface of the pile for the Fyfe, Sika, and Phenolic systems (Figure 29). Aquawrap did not provide a primer, but used water to activate the process; therefore, the piles were sprayed with a layer of water instead of applying a primer. Next, wraps with the dimensions shown in Table 17 were saturated by hand with the saturate resin (Figure 30) until the surface of the fibers were just beginning to show a coating of resin but not completely submerged with resin. The exception to this process was the Aquawrap, whose wraps were sprayed with water before applying them to the piles (shown in Figure 31). Once saturated (activating the prepreg resin) the wraps were wrapped tightly around the timber samples as shown in Figure 32 and secured in place with stricture wrap (shrink-wrap) to provide uniform pressure during curing. The stricture wrap was originally provided for the Aquawrap. It was also used for the other systems to provide consistent pressure application for each system. The pressure was critical in producing a strong bond between the timber and the wrap.

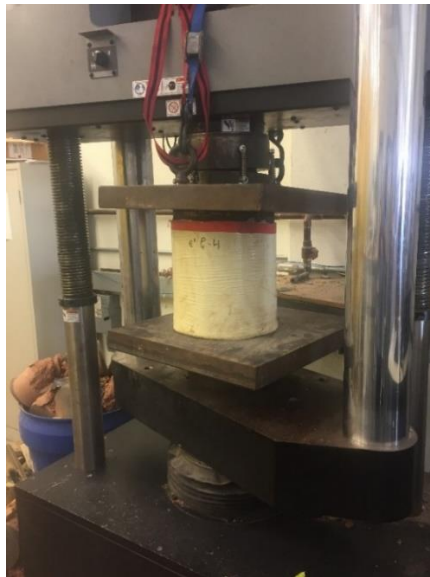
Figure 34. Testing configuration for bond test

Specimens were evaluated under compression on WVU-CFC's Instron 1000HDX universal testing machine at a loading rate of 10,000 lbf per minute. To provide a large enough bearing surface for the 10-in. to 12-in. diameter piles, 2-in. thick steel plates were attached to the machines. The configuration for the test is shown in Figure 33. A typical bond test is shown in Figure 34.

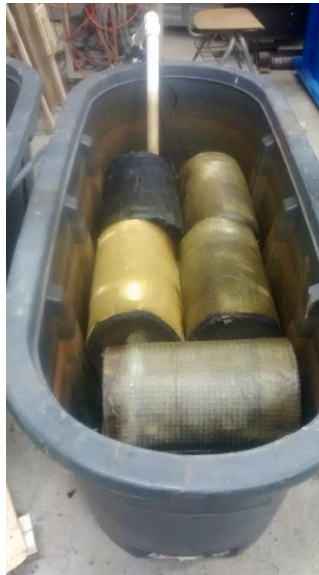
Figure 37. Aging specimens in tanks

Aging tests were conducted to evaluate the effects of moisture through wet/dry cycles on bond strength and pile load capacity. Two 12-in. bond samples of each wrap system were prepared in the same manner as the bond testing and evaluated using two tanks. The samples were divided between the two tanks, and one of the tanks was filled with domestic water. Every 6 hours, a timer turned on a sump pump, which cycled the water to the other tank. Thus, half of the samples were submerged for 6 hours while the other half were dry. This process was conducted constantly for four months, from September 15, 2017, to January 15, 2018. Figure 37 shows the specimens in an empty tank after the aging simulation was complete. Figure 38 shows the specimens underwater during the saturated phase of the cycle.

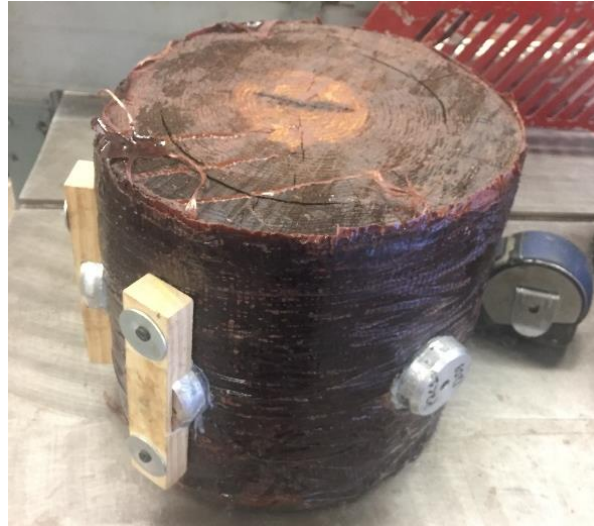
Figure 40. Pull-off puck attachment technique

After curing for at least 7 days, specimens were prepared for pull-off testing. First, the composite was drilled with a 2-1/8 in. composite hole-saw through the FRP. Next a 2-1/8 in. wood hole saw completed the cut 1/4 to 1/2 in. into the timber. This was done to ensure a localized bond strength was being tested and to prevent contributions from the rest of the bond area. Consistent cutting was ensured by a small wooden plate with a hole that matched the hole-saw diameter attached with screws as shown in Figure 39. The plate allowed the saw to cut in the same location on the specimen without any misalignment. After the holes were drilled and the plate removed, aluminum pull-off pucks with 2 in. diameters were attached to the composite with 2500-psi fast setting epoxy and secured by timber sheaths as shown in Figure 40.

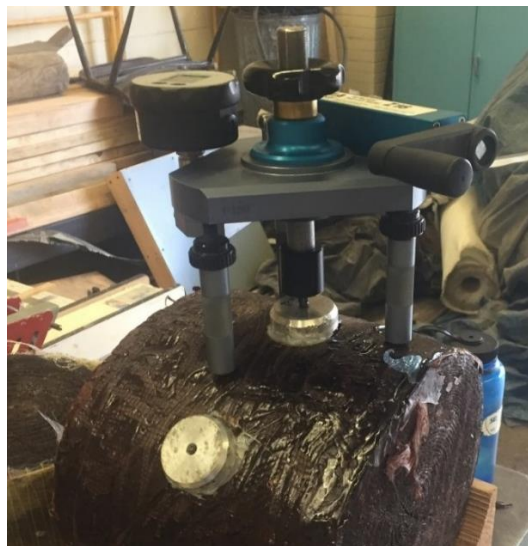
Figure 41. Dyna Proceq Z16 pull-off tester

A Dyna Proceq Z16 pull-off tester was used to remove the pucks from the specimens. The apparatus consisted of three adjustable legs with a single testing shaft attached to the pucks, adjusted by a hand crank as seen in Figure 41. Tests were considered completed when the pull-off pucks achieved a peak load resulting from the FRP bond failing or exceeding the tensile strength of wood fibers along the specimen length.

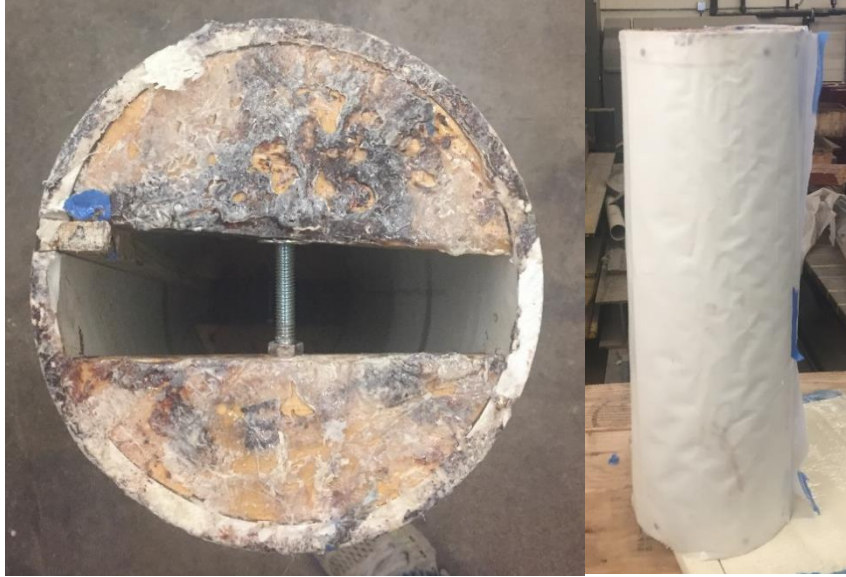
Figure 42. PVC mold for compression testing

Manufacturing methods for creating the shells were also developed through experimentation. Initially, specimens were found to be sticking to the PVC pipes used as molds after curing, and mold release agents were not found to be effective for full size samples although they were effective for smaller samples. As a solution, two layers of 3-mm plastic sheeting were placed around the molds allowing the shell to bond to one of the plastic layers while sliding off of the second layer underneath. Additionally, initial shells were found to shrink onto the molds as they cured, requiring over 20,000 lbf to remove the mold from inside the shells. To address these issues, PVC pipes were split lengthwise. The top of the molds were held open by set screws that were used to expand the molds and insert a ½-in. wide wood strip into the lengthwise cut in the pipe, thus expanding the diameter of the PVC pipe as shown in Figure 42. After the FRP was wrapped and cured on the mold, the wooden strips were removed and PVC mold snapped back to its original shape, allowing for easy removal. After these adjustments, successful shells for compression testing could be produced.

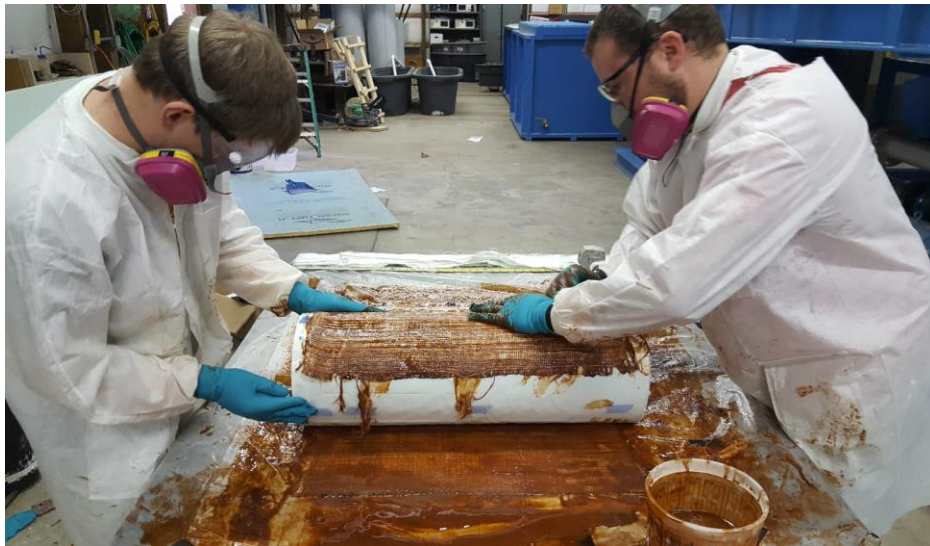
Figure 44. Wrapping of compression test tubes

To evaluate compression, wet layup tube specimens were manufactured consisting of both three and five layers (three of each tube type). The tubes were manufactured on PVC molds to have a diameter of roughly 9 in. and height of 24 in. For Fyfe, Sika, Phenolic, and Simpson Strong-Tie, fabric was cut to 30 in. (transverse) by 24 in. (longitudinal) for a single layer. During wrapping, the resins were prepared as per the specifications and applied to fabric in order to saturate them fully as shown in Figure 43. For unidirectional Fyfe, Sika, and Simpson Strong-Tie fabric systems, the layers were oriented with the majority of fibers in the longitudinal directions in a (0/90/0) orientation for three layers and (0/90/0/90/0) for five layers of wrap. For the bidirectional fabric systems (Aquawrap and Phenolic), the wraps were simply wrapped with three and five layers as necessary. See Figure 44 for an example of wrapping shells.

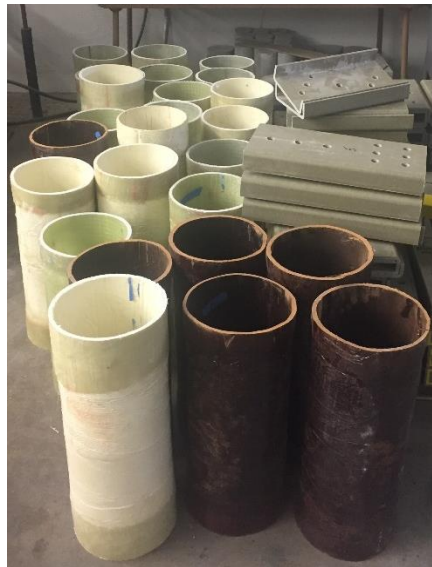
Figure 45. FRP shell specimens

To prevent fiber crushing on top and bottom of the shells during compression testing, additional strips were placed on the top and bottom with a width varying from 4 in. to 6 in. After applying the extra reinforcement, the specimens were wrapped with stricture wrap to ensure proper bonding between layers and to keep the specimens from slipping off the forms. Specimens were wrapped and cured above 70°F. After curing the specimens, the ends of the specimens were cut with a commercial band saw to provide a reasonably square, smooth bearing specimen for uniform load distribution, preventing stress concentrations. However, this cutting method still leaves some undulations and out-of-square given saw blade wobble and operator errors. Many of the completed shells are shown in Figure 45.

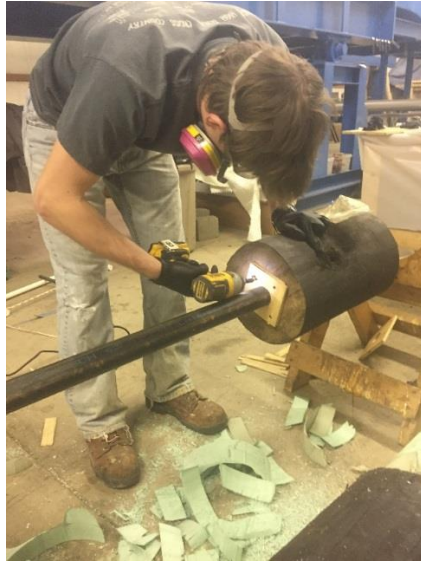
Figure 47. Setting timber for rehabilitation

To ensure the timber samples remained parallel to each other during testing, a steel pipe was used for alignment and to aid in handling. The two 16-in. portions of timber pile were drilled with a 2-1/4-in. vertical hole to place it on the 2-in. steel pipe. The ends were secured with plywood plates with 2-in. diameter holes to adjust the alignment of the two timber samples to account for drilling and cutting errors as shown in Figure 47.

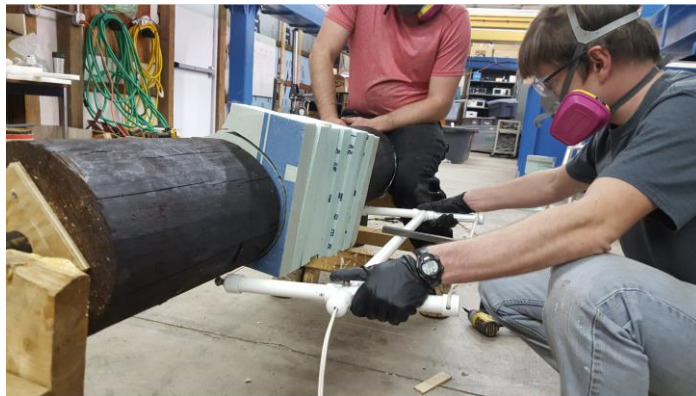
Figure 48. Trimming insulation for simulated rehabilitation

The two portions were separated by an 18-in. gap created by 9 pieces of 12-in. x 12-in. x 2-in. extruded insulation. The insulation was then trimmed with a hot wire to match the shape of the timber as shown in Figure 48. Figure 49 shows a sample ready to be wrapped.

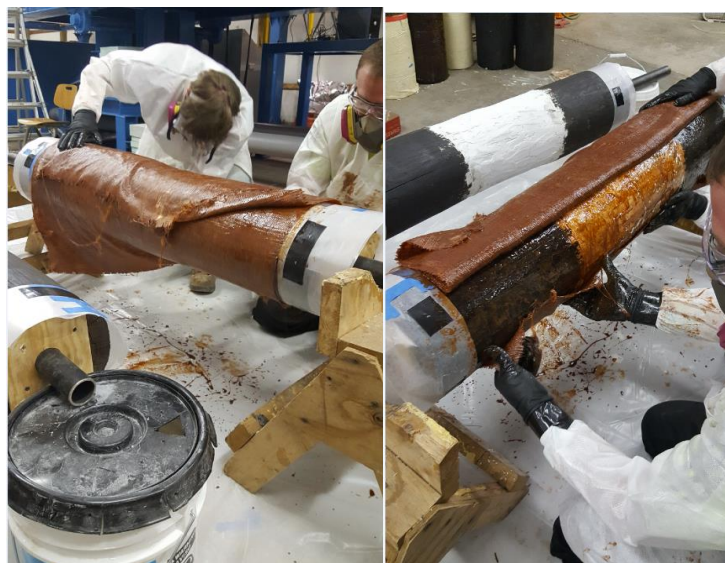
Figure 50. Wrapping of rehabilitation specimens

Dry wall compound was utilized to fill any voids developed during the trimming process and provide a uniform wrapping surface. The timber specimens were then wrapped with the FRP wraps as shown in Figure 50. For the hand lay-up specimens, fabrics were cut to 42 in. (longitudinal) by 38 in. (transversely). After curing for 7 days, the pipes were removed from the specimens, and the insulation was melted away with acetone to produce a hollow core between the timber pieces.

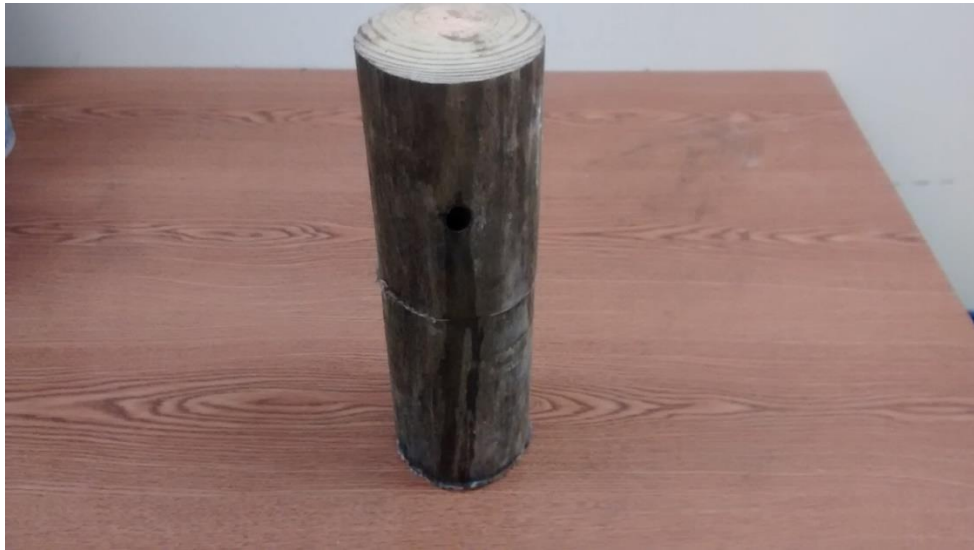
Figure 55. Bulk filler specimen

To test the ability of bulk fillers to fill heart rot, 2 pieces of 4 in. nominal diameter, 6-in. long fence posts were hollowed out to a depth of 2 in. in the same manner as the crack filler samples (except without any cuts or holes in the walls). The actual diameter of the fence posts varied but averaged 3-3/4 in. Two different bits were used with a 1-15/16-in. diameter bit, resulting in 26% cross section loss. A 3-in. diameter bit was used to simulate 64% cross section loss, which was the largest section loss possible while leaving enough wall thickness on the smallest samples to avoid breaking during cutting and provide a glue surface for later fabrication. Two specimens were glued together with the voided areas abutting to create a 4-in. long void as shown in Figure 55. Silicone caulk was used to attach and seal the two sections together. To pour the resin into the void, a 1/2-in. diameter filling hole was drilled at a 30° angle into the top of the void. Similarly, a 1/4-in. diameter hole was drilled at a 45° angle to allow air to escape, with the air hole coming out higher on the outside of the wood. A total of 9 samples were made for each filler material with 3 at 25% voided and 6 at 56% voided. Three 25% voided samples and 3 of the 56% voided samples were filled with only resin, while the remaining 3 samples at 56% void were filled with a mixture of resin and sand. The

The samples were filled using a funnel and allowed to cure for 24 hours. To assess the amount of fill, the samples were cut open and the amount of voided area was measured by determining the depth of the filler to the nearest 1/16th of an inch and multiplying this by the diameter of the void.

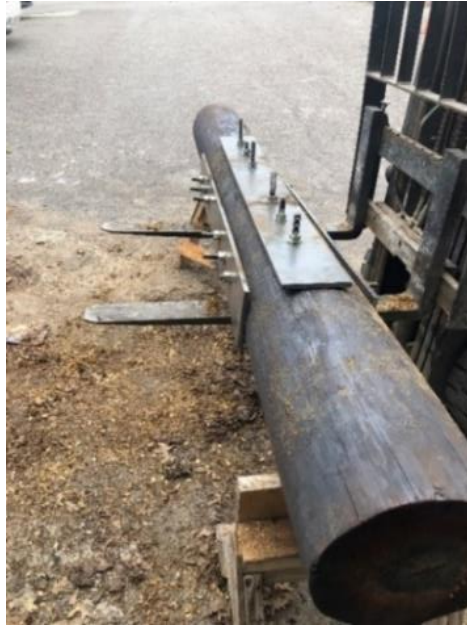
Figure 59. Steel splice specimen constructed in WVU CFC lab

The cut pile pieces were joined together with steel plates as shown in Figure 57. The steel plate and C-channel splicing methods used 18-in. long bolts of $\frac{3}{4}$ in. diameter (Grade B61). The wooden plate method used 24-in. long bolts of $\frac{3}{4}$ in. diameter (Grade B61) to accommodate approximately 3-in. thick timber splices. All joints were spliced with 54-in. long plates that were 5.5-in. and 6-in. in width for timber and steel plate splices, respectively. However, the C-channel splicing mechanism also included an 8-in. wide steel channel. Steel plate schematics are provided in Figure 58. An image of an assembled pile prepared for shear testing, using the steel plate splicing method is provided in Figure 59.

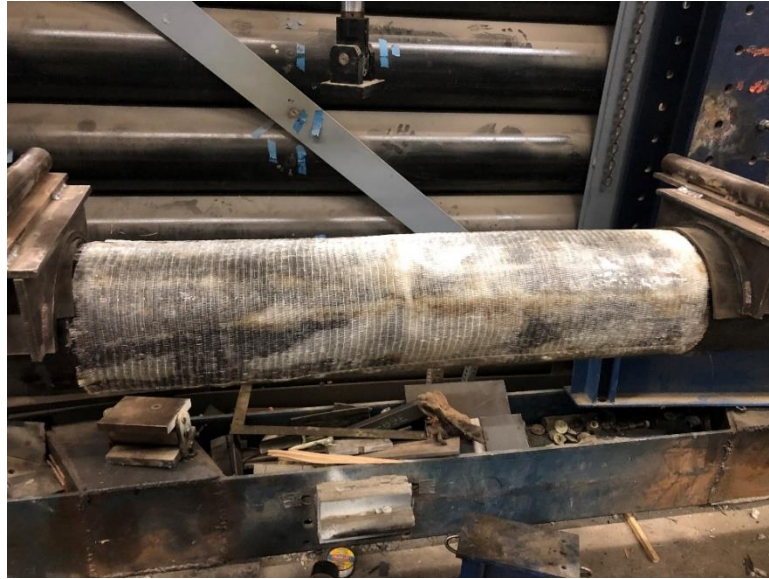
Figure 61. Completed fiber reinforced polymer splice

Piles were cut to the desired length for each test, i.e., 16 ft. for bending, 8 ft. for shear, and 5 ft. for axial testing. The piles were cut in half before splicing with FRP wraps. Only three piles of each length were needed for this portion of testing to remain consistent with testing performed on piles with traditional splicing methods. The sections of each pile were nailed together to prevent pile separation or movement during wrapping. Sheets of fabric were cut to 4 ft. in length, creating a rectangular sheet of fiber with dimensions 48 x 51 in., where 51 in. was the width of the glass fabric roll supplied by Sika. The resin was prepared by mixing part A with part B as per the manufacturer's instructions. The contents were mixed using a mixer drill bit for five minutes. After thorough mixing of the resin, it was used to prime the pile and saturate the glass fabric sheets. Each pile tested was wrapped with three layers around its circumference. The pile was primed by thoroughly brushing the primer (resin) onto the surface of the pile and subsequently prepared by rolling resin onto both sides of the fabric, ensuring that the entire sheet was fully saturated. After the pile was primed, the fabrics were then applied (wrapped around) to the pile. The fabrics were stapled at the ends and pressed. While the fabric was wrapped around the pile, the resin saturated fabric was wiped and pressed by hand to remove voids and ensure a tight, void free wrap. After both sheets were applied to the pile, it was set aside to cure for at least three days before testing. An image of a finished FRP splice is provided in Figure 61.

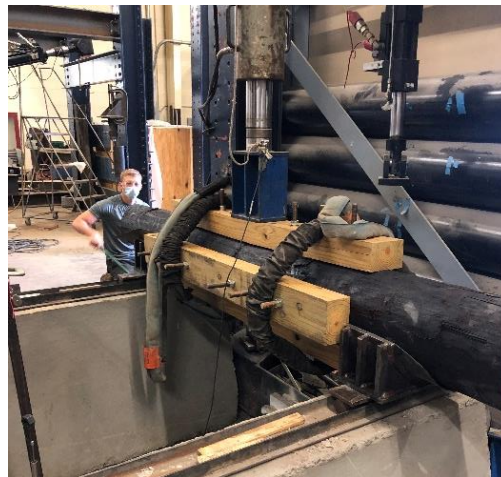
Figure 63. Shear test setup with wooden splice

An 8-ft. long pile was placed on steel saddles following splicing of the test specimen at the center of the span of the refurbished pile (Figure 62). A concentrated load was applied using a hydraulic actuator. The load was transferred from the actuator to a load cell that was placed on top of a spacer on the pile specimen. The load cell records the amount of force applied to the pile from the actuator. A linear variable differential transformer (LVDT) was placed at the center span to measure deflection. A shear test setup with wood plate splicing overlapping the pile joint is shown in Figure 63.

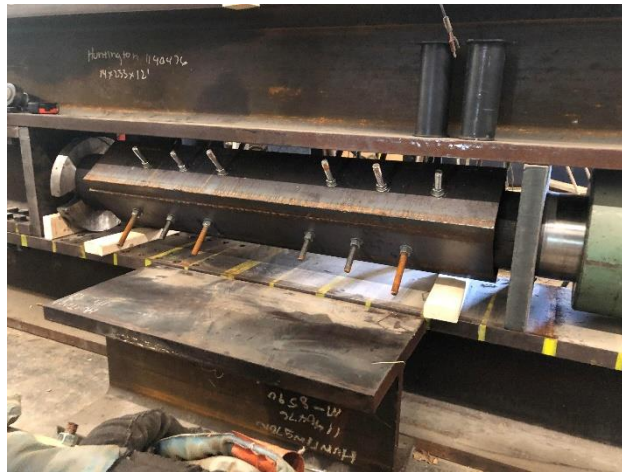
Figure 67. Axial test setup with C-channel splice

The axial compression test was performed by placing the 5 ft. long pile sections in a compression test frame, which had a load capacity of 750 kips. Load was applied using a hydraulic jack applying load to a 16 x 16-in. steel plate, which in turn exerts axial force on the pile cross section. A LVDT was used to measure longitudinal displacement under compression. Figure 66 was a schematic of the axial compression test. Figure 67 provides an image of axial testing performed with C-channel splicing.

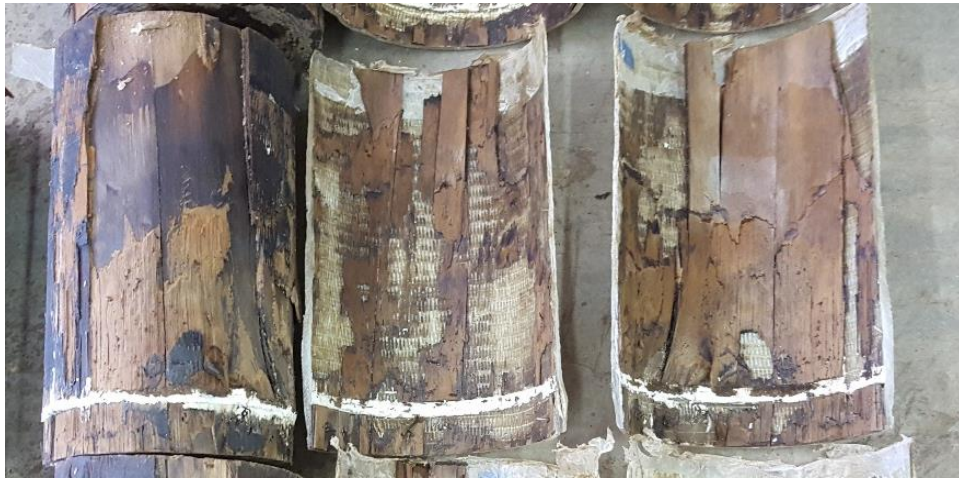
Figure 68. Retained timber on Fyfe bond tests

As shown in Figure 68, delaminated wraps contained large portions of timber ranging from 1/4 in. to 1/2 in. in thickness. Such behavior was indicative of failure in the timber substrate and not the resin used in the FRP system. From this visual evaluation, failure in timber was assumed to be the controlling failure mode for the majority of the specimens bonded with Fyfe resin. This indicates the epoxy resin was able to bond sufficiently to the creosote-treated pile and obtain a small degree of penetration into the timber.

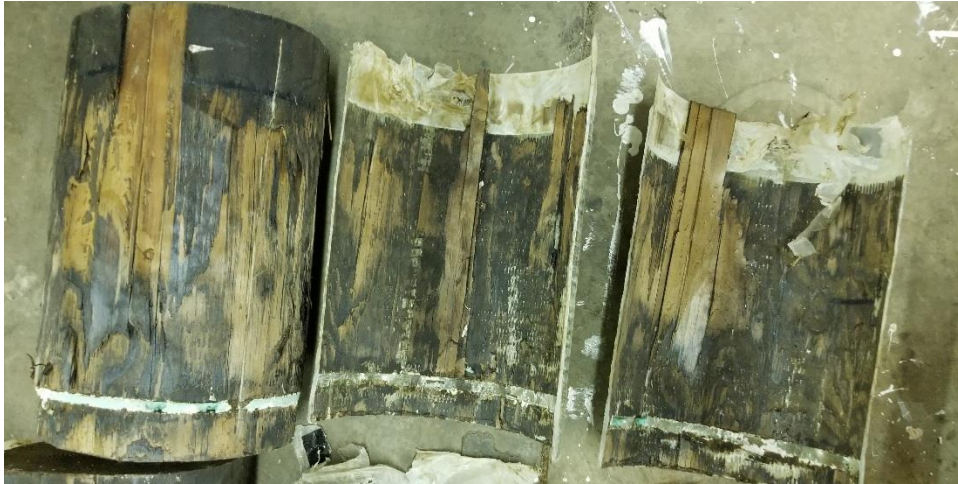
Figure 70. Retained timber on Sika bond tests

Visual inspection of the Sika samples showed the same timber failure mode as the Fyfe samples, as shown in Figure 70. This indicates the epoxy resin was able to bond sufficiently well to the creosote-treated pile and obtain the required degree of penetration into the timber, to prevent debonding at the glue line.

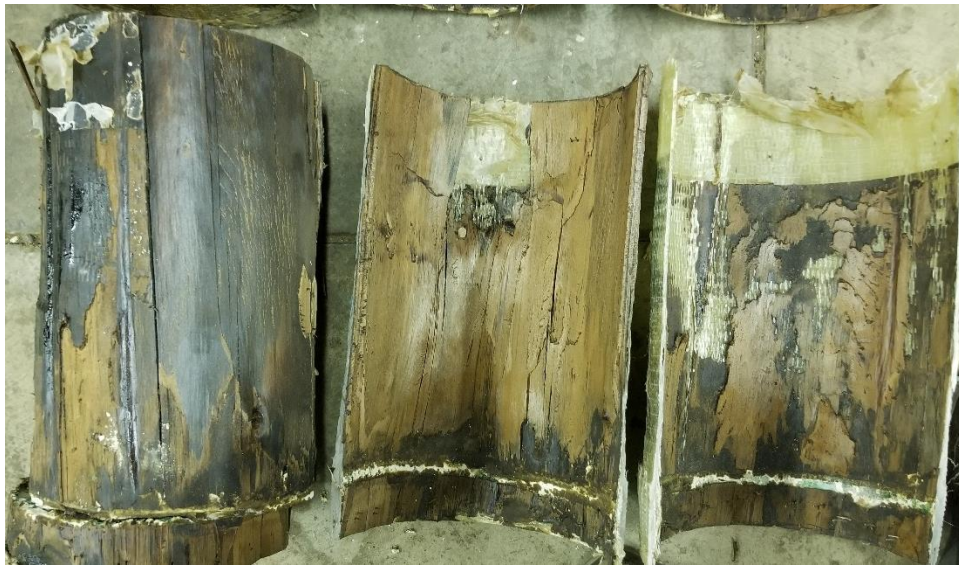
Figure 72. Retained timber on Simpson Strong Tie bond test

Visual inspection of bond strength failure modes of Simpson Strong-Tie with timber substrate were similar to the Fyfe and Sika samples, with a large amount of timber still bonded to the wrap and the failure occurring in the timber itself. This indicates the epoxy resin was able to bond sufficiently to the creosote-treated pile and obtain a small degree of penetration into the timber.

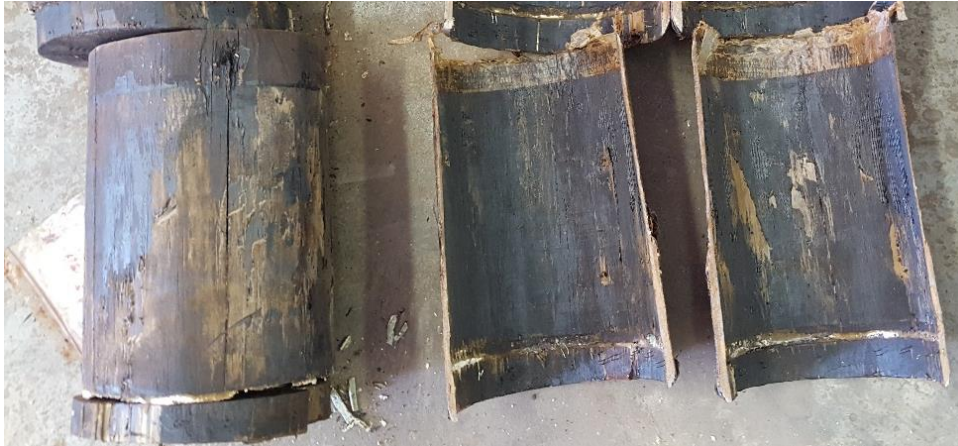
Figure 74. Superficial retained timber on phenolic wraps

After unwrapping the glass fabric bonded with phenolic resin, it was found that no timber substrate adhered to the FRP. On the other hand, the creosote layer had been pulled off as shown in Figure 74. The few pieces of timber retained were superficial. This indicates that the phenolic resin was unable to make a sufficient bond beyond the outer layer of creosote.

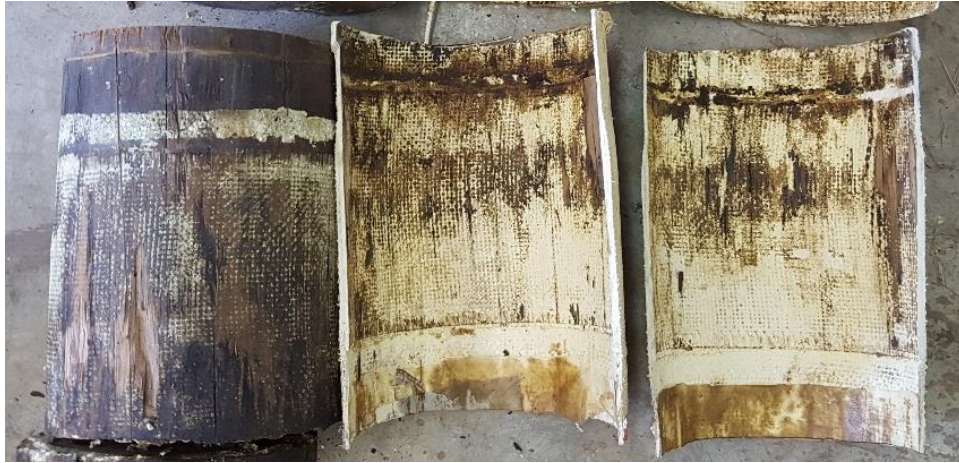
Figure 76. Limited retained timber on Aquawrap 6 in. and 12-in. bond specimens

Evaluating the wraps after bond testing revealed that no timber remained as shown in Figure 76 on the wrap, suggesting that failures occurred in the bond line and not the wood. Failure in the bond line indicates a poor bond strength.

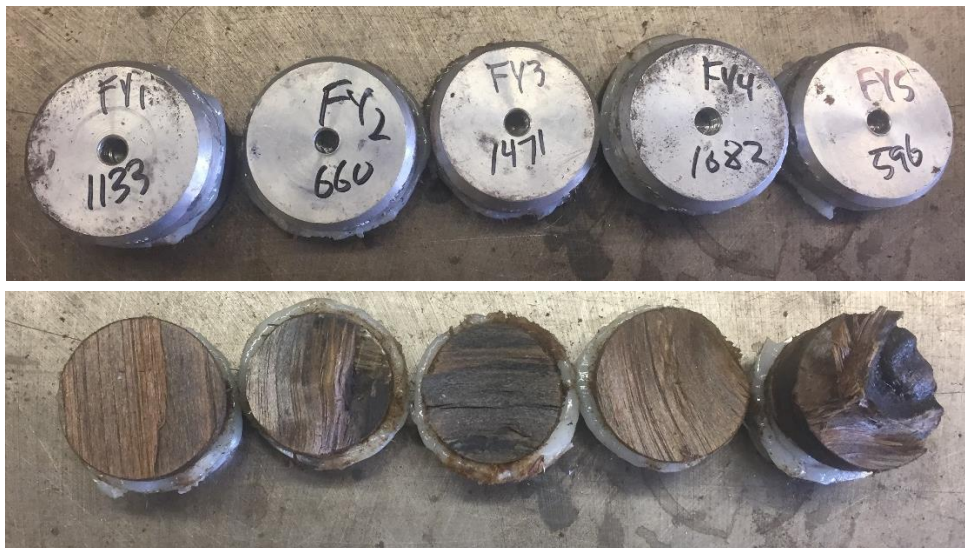
Figure 79. Fyfe pull-off carriers (timber failure)

Fyfe bond pull-off specimens failed in the timber with large thicknesses of timber attached to the wrap, as shown in Figure 79, thus showing that the FRP to timber bond in tension exceeds that of the underlying wood. The average pull-off strength was ~353 psi as shown in Table 31. The wood fibers for these tests displayed a large amount of variability (knots, grain changes) which contributed to the large variation between pull-off tensile strengths.

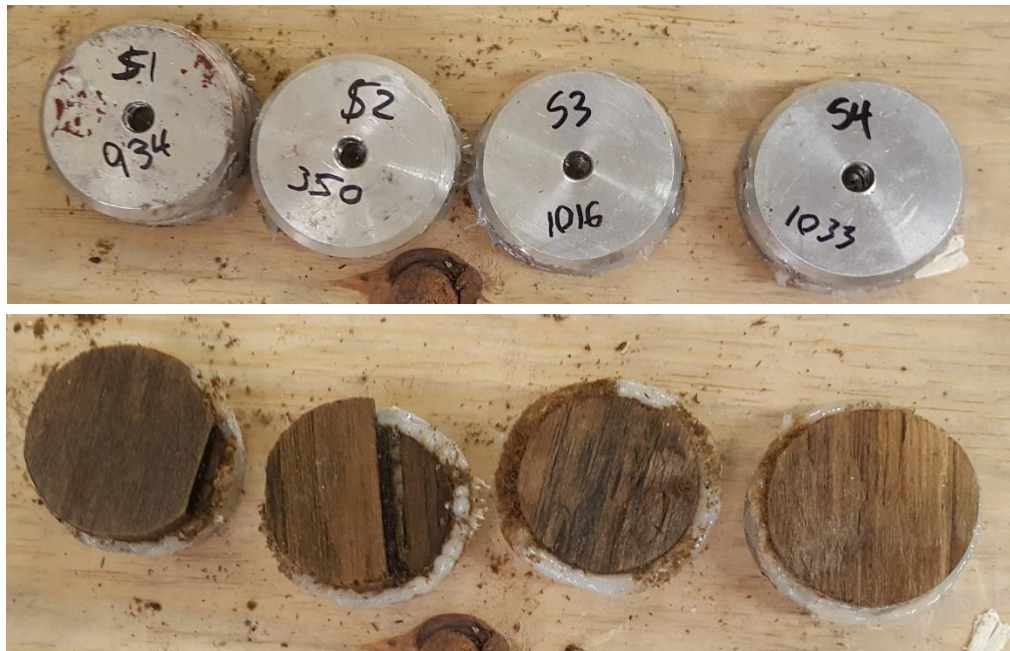
Figure 80. Sika pull-off carriers (timber failure)

Similar to the Fyfe bond pull-off specimens, Sika pull-off samples all failed in the timber with large thicknesses of retained timber as shown in Figure 80. Again, the strength of the FRP to timber bond in tension exceeded that of the underlying wood. Sika 2 is not included in the analysis as the sample was taken over a crack in the timber, which resulted in a very low strength. Sika 5 failed in the glue line between the dolly and the FRP, which is attributed to failure of the test procedure and is not presented in Table 32. The average pull-off strength was 316 psi as shown in Table 32.

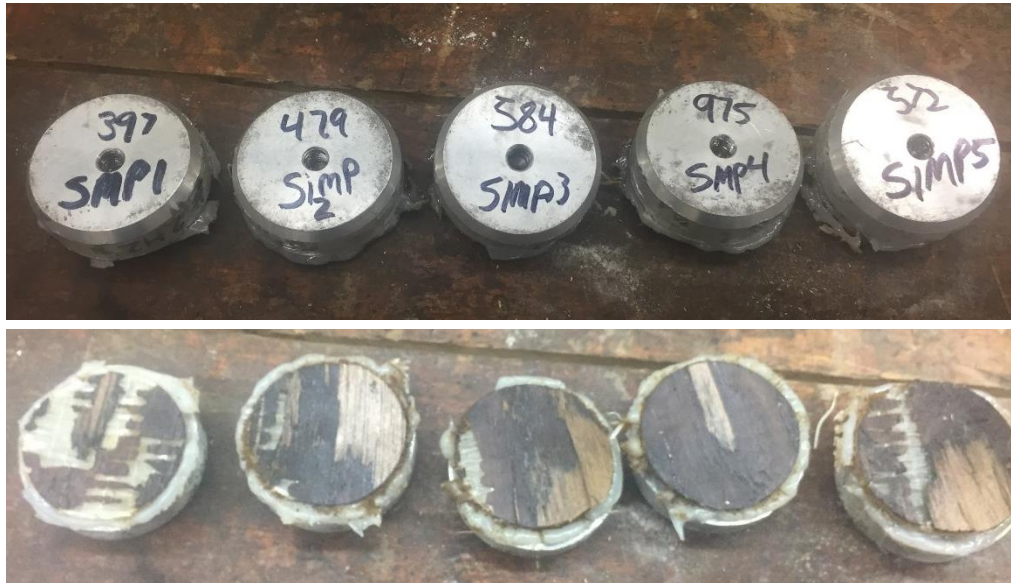
Figure 81. Simpson Strong-Tie pull-off carriers (timber failure)

Simpson Strong-Tie bond pull-off specimens all failed in the timber, but as shown in Figure 81, the amount of timber retained was less than the amount of timber retained in previous tests. This was attributed to a shallow drilling depth used in these tests. Since the failure was in the timber, the FRP to timber bond in tension exceeds that of the underlying wood. The average pull-off strength was 191 psi as shown in Table 33.

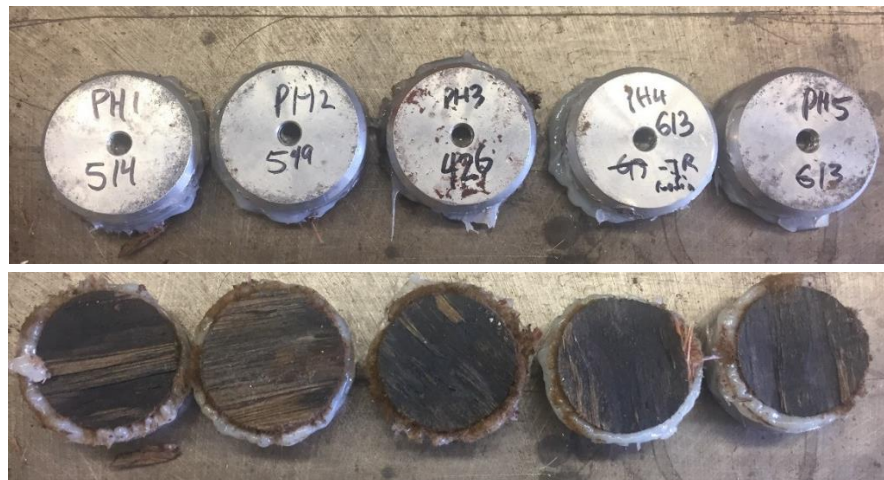
Figure 82. Phenolic pull-off pucks (timber)

Phenolic pull-off specimens exhibited timber failures, as shown in Figure 82, with a thin layer of timber retained on the FRP wrap. This failure shows that the FRP to timber bond in tension was greater than that of underlying timber, but that the resin did not penetrate deeply into the timber. Average pull-off strength was 173 psi as shown in Table 34.

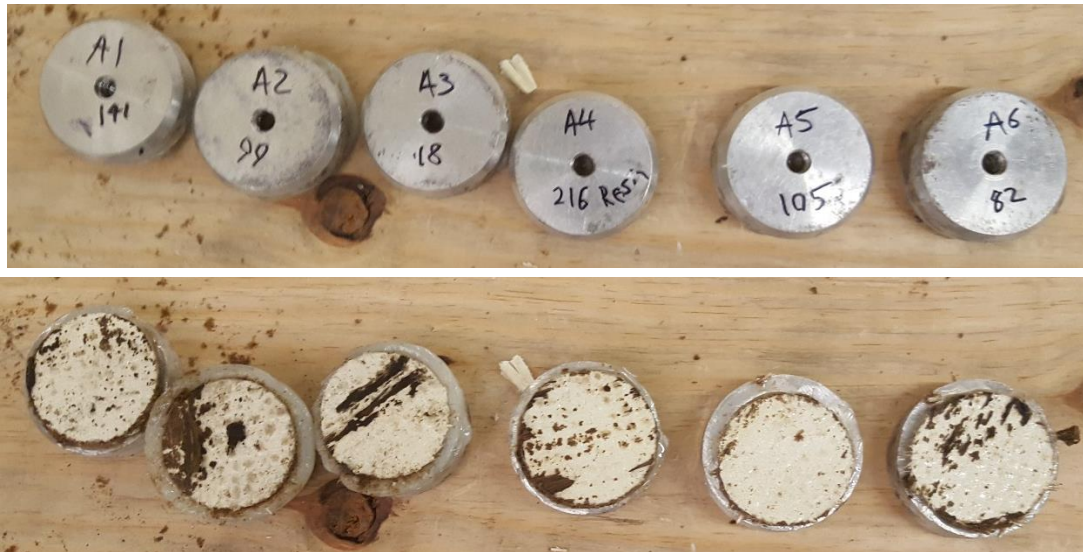
Figure 83. Aquawrap pull-off carriers (bond line)

The pull-off tests for the Aquawrap displayed failure in the bond line indicating poor resin penetration into the wood substrate (Figure 83). Aquawrap 3 is excluded from the average as the load was below the acceptable range of the test fixture, and Aquawrap 4 is excluded as excessive epoxy adhered to the pile beyond the 2-in. pull off puck invalidating the test. The average pull-off strength was 34 psi as shown in Table 35.

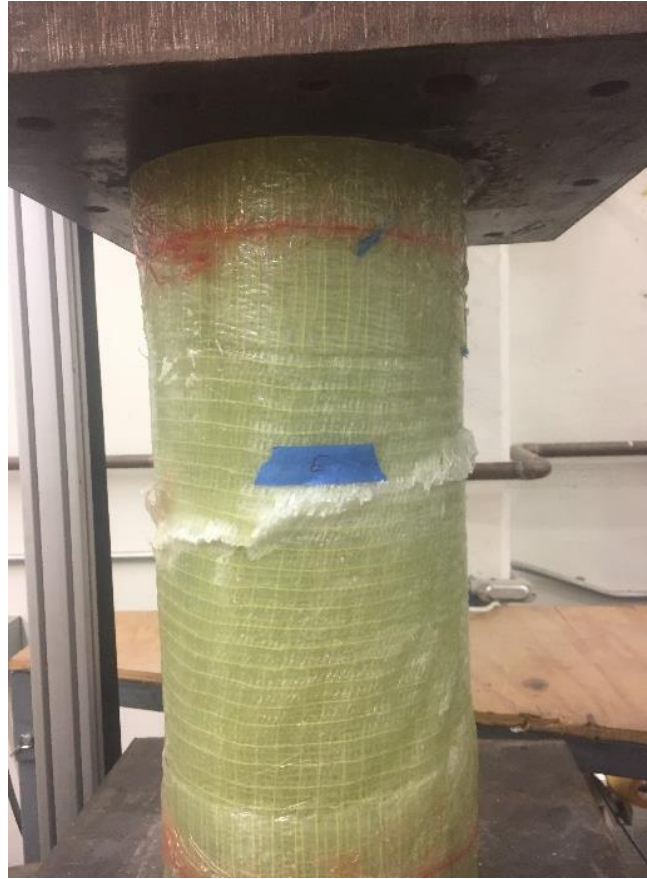
Figure 84. Typical Fyfe compression failure (Fyfe E)

The Fyfe specimens generally failed in compression initiated by layer separation leading to highly localized buckling of the fabric as shown in Figure 84. The white areas in Figure 84 show areas of matrix failure wherein delamination between fabric layers was noted. Once the matrix fails, the fibers lose lateral support and buckle on a fiber-by-fiber basis, further tearing away from the matrix. The matrix failure rapidly spreads around the entire circumference of the member. This is a typical compression failure mechanism of thin walled composite members and results in permanent, irreversible damage to the sample, which is readily visible as a white cloud.

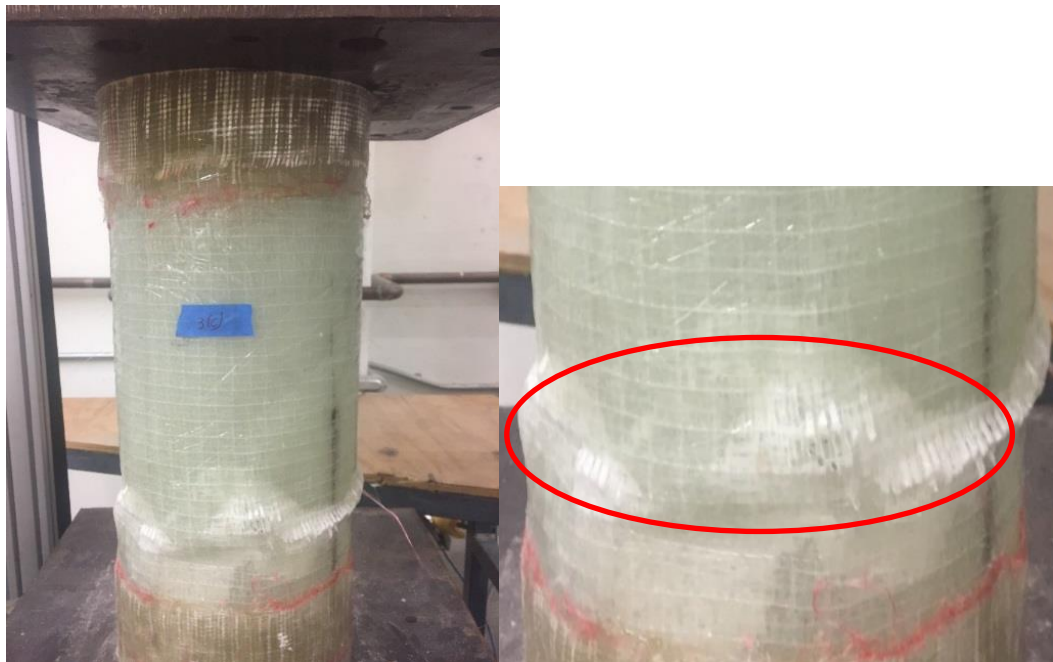
Figure 86. Typical compressive failure of sika system (Sika C) in the fibers

The Sika wraps also failed due to micro buckling in the fibers after resin failure, similar to the Fyfe system, as seen in Figure 86. The maximum compressive loads and stresses of the Sika shells are presented in Table 41 for three layers wrap and Table 42 for five layers of wrap. The maximum average stress was 13,809 psi and 14,096 psi for three and five layers, respectively. The ends of Sika B were not cut perfectly parallel, which resulted in bending forces being induced during the testing, Therefore Sika B was excluded from the analysis.

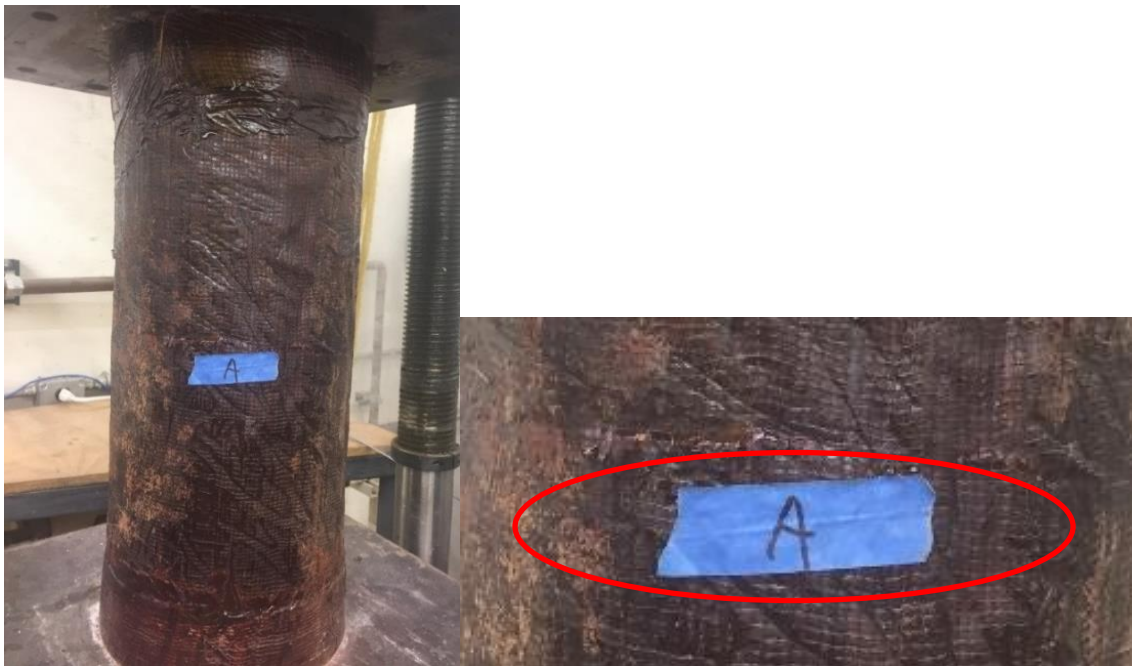
Figure 89. Typical compressive failure mode in the phenolic shell (Phenolic A)

Phenolic wraps all failed in a different manner than the epoxy systems. The vertical fibers appear to have torn as the layers separated, with minimal lateral movement of the fibers as shown in Figure 89. The lack of visual damage was attributed to the lower energy at failure due to the small failure loads (~30% of the epoxy systems). The maximum compressive loads and stresses of the phenolic shells are presented in Table 45 for three layers of wrap and Table 46 for five layers of wrap. The maximum average stress for three layers was 4,716 psi and 7,660 psi for five layers.
