| Rehabilitation of Deteriorated Timber Piles using Fiber Reinforced Polymer (FRP) Composites | FHWA/LA.21/653 |
| Hota Gangarao (PI), Drew Damich, Mark Skidmore, and John Harper | March 2022 |
| WVU Constructed Facilities Center | LTRC Project Number: 15-3ST |
| Louisiana Department of Transportation and Development | November 2015-April 2021 |

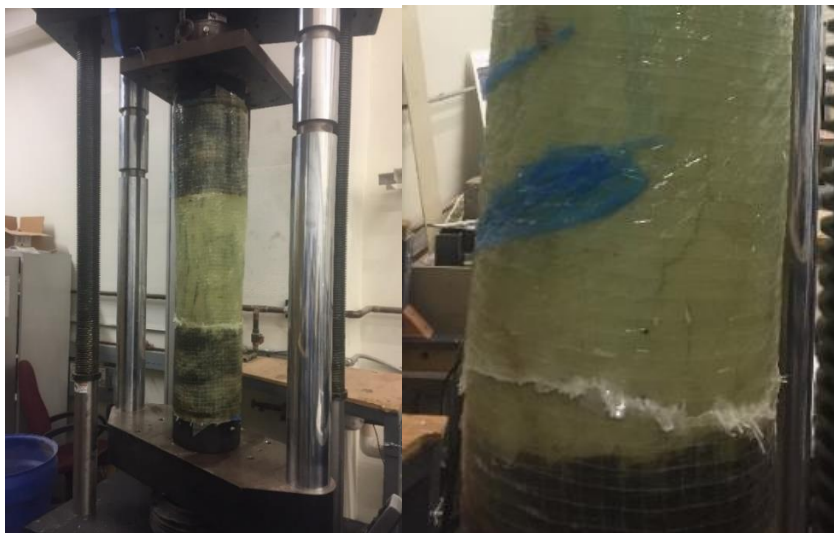
Figure 95. Typical simulated rehab failure

The simulated rehabilitation testing suggests that the individual compression and bond tests are suitable test methods to replicate the field conditions. The individual tests are much easier to prepare than the simulated rehabilitation tests, resulting in fewer experimental errors. In addition, the individual tests use less material and thus are more economical to conduct additional tests.

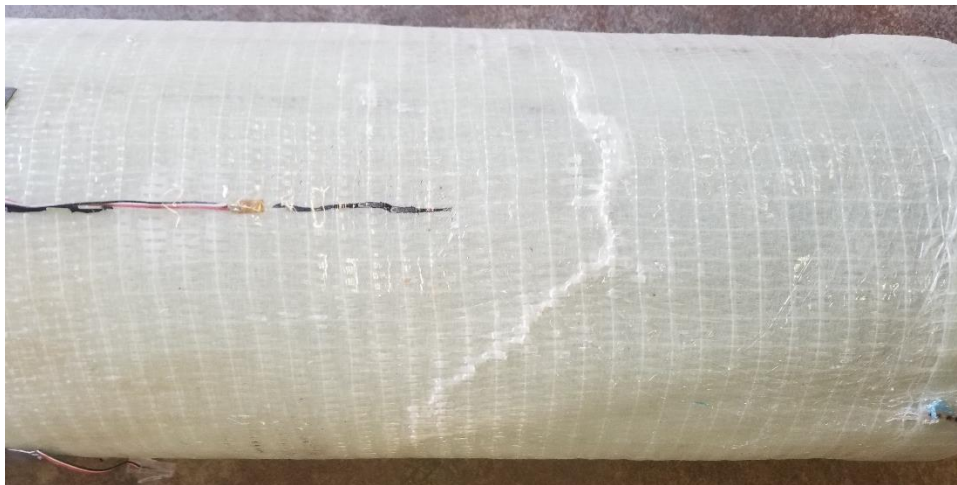
Figure 96. Failure of combined axial and bending

Side load was applied to samples 1 and 3 to generate bending forces. As shown in Table 53, flexural behavior was observed as the bottom strain gage recorded higher compressive strains due to the combined axial and flexural compressive stresses. The top strain gage recorded lower compressive strains due to the combined axial and tensile compressive stresses. However, the middle gage located at the neutral axis should have not changed in strain values, but instead saw larger reductions in compressive strain than the top gages. Failure of both samples was due to local crushing of the sample at the edge of the curved saddle used to apply the side load. Additional details of failure under combined loads can be seen in Figure 96, which was not indicative of a typical flexural failure. Thus, no inferences on the combined axial and bending can be made using the work carried out herein. Future testing should use longer samples to induce greater flexural moments.

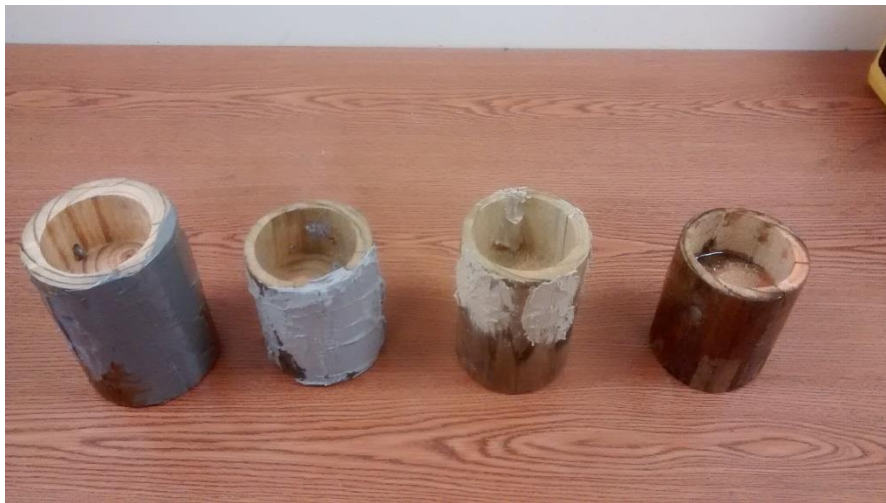
Figure 97. Prepared crack filler specimens

Crack fillers were evaluated for their ability to fill cracks and external voids to prevent internal fillers from leaking out. The crack filler was applied with a putty knife onto the timber samples and allowed to cure. The Sikadur and Simpson Strong-Tie fillers hardened within a couple hours, while the Elmer's took a full day to cure. After 24 hours, the specimens were filled with 10W-30 motor oil, which simulates the flow properties of many bulk fillers. The specimens were observed for three hours. At that time, the oil level in each sample dropped by a maximum of 1/4 in., no leaks were present, and no oil was observed on the pan underneath the samples. This indicates the oil was soaking into the wood and all of the fillers were performing as intended. After three hours, the bulk fillers would have gelled, meaning that the crack fillers were sufficient for the task. It was important to apply the fillers in a manner that deeply fill the holes and cracks.

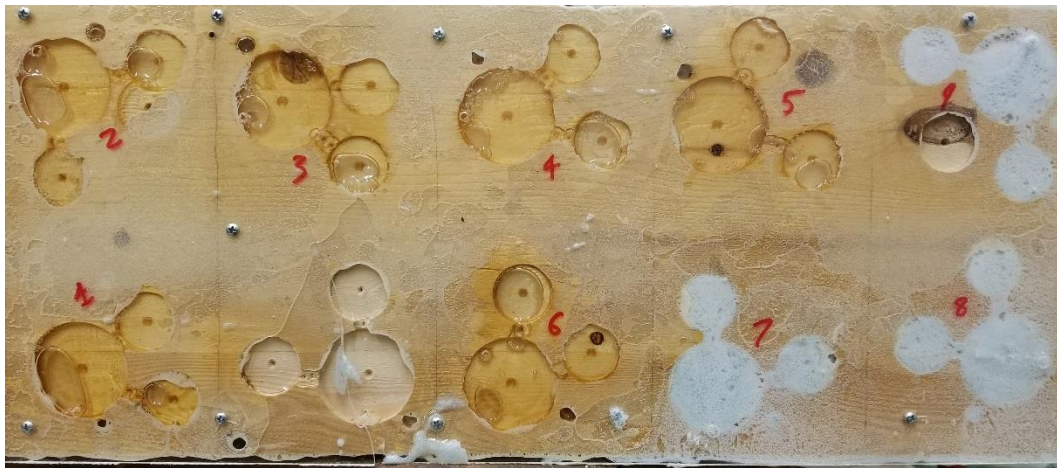
Figure 100. Large interconnected voids

Figure 98 shows the small voids, Figure 99 shows the medium voids, and Figure 100 shows the large interconnected voids. In each photo, the tests were labeled 1-9 with 1-3 referring to Sikadur Crack Fix injected with a caulk gun, Sikadur 35 injected with a syringe in samples 4 through 6, and the blue Simpson Strong-Tie foam in tests 7 through 9. Overall, the Simpson Strong-Tie polyurethane did an excellent job filling the voids in every test, with the foam expanding into every hole in the larger, interconnected void tests. However, the foam was quite soft upon curing, thus it was not clear if this would create false positives during later inspections. The Sikadur resins performed similarly regardless of the applicator wherein there was always a small air bubble left up to 1/2 in. diameter. These air bubbles were a consequence of the need to have a filling hole which the resin flows back after being pumped in (the samples were filled in the vertical position to replicate a repaired pile). However, the voids were smaller than the typical nonconforming void area (2 in²), so this is not considered a failure of the filler. The syringe had a smaller tip than the caulk gun, which did not fit in the predrilled holes as tightly. Thus, they could not be pumped under pressure into the smallest holes in the large interconnected test with the syringe (tests 4-6), while the pressure applied with the caulk gun filled the small holes in tests 2 and 3.

Overall, the Simpson Strong-Tie foam had the best filling ability, but the soft nature of the cured foam might hinder later inspections by creating false positives. The Sikadur resins performed well, though the caulk gun injection allowed for more pressure to be applied resulting in better filling of smaller voids.

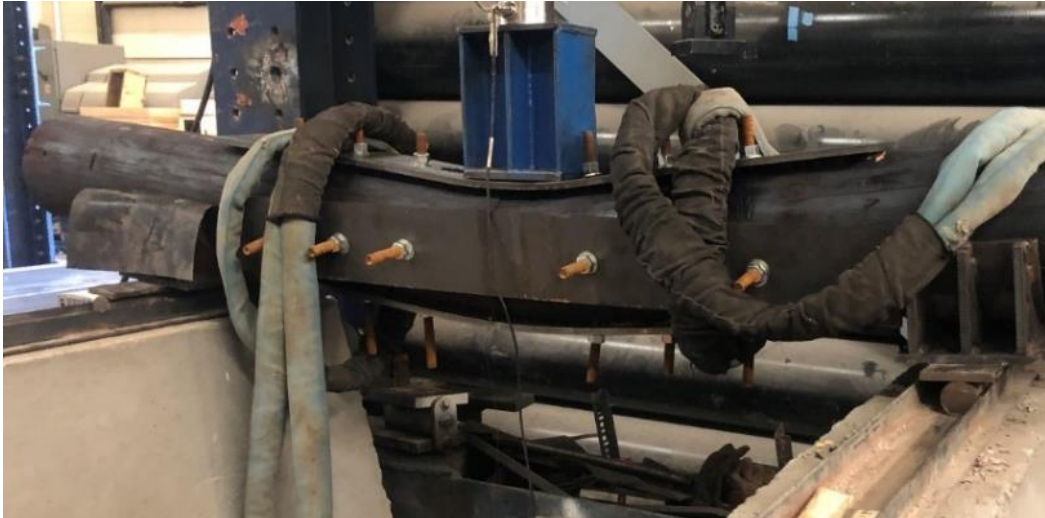
Figure 108. Yielding of top and bottom plates in steel splicing

While this test data was helpful in terms of understanding the strengths of different splicing methods, it was important to keep multiple variables in mind. For example, what is to be considered a “failure?” Ultimate stress as found in this testing can be misleading at times. Visual signs of failure are observed before a pile reached its ultimate strength. Multiple signs of visual failure were observed during testing. For the steel plate and C-channel splicing methods, it was observed that the steel plate at the surface yielded significantly. The plates on the side of the pile would not yield but it was observed that the bolts would bend and yield internally. When a specimen cannot carry any more load while deflection is increasing under load application, it is determined failure took place and testing is terminated. These two forms of visual failure can be seen in the images provided in Figure 108 and Figure 109. In the case of the wood splicing method, indentation from the applied load as well as cracking

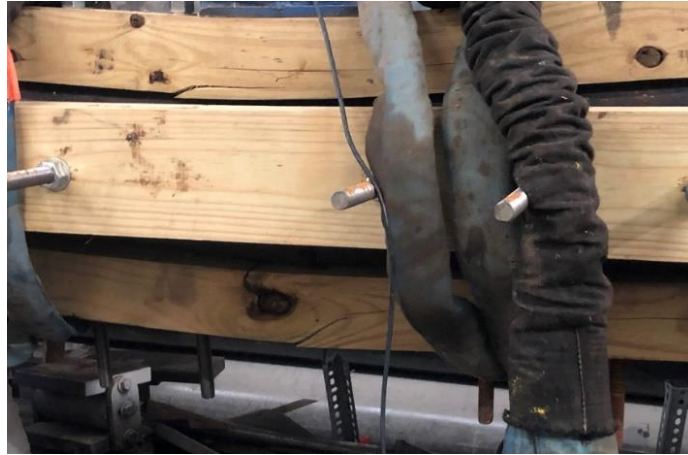
Figure 110. Cracking of top and bottom plates in wood splicing

on the top and bottom plates were observed. This visual failure mode can be seen in Figure 110.

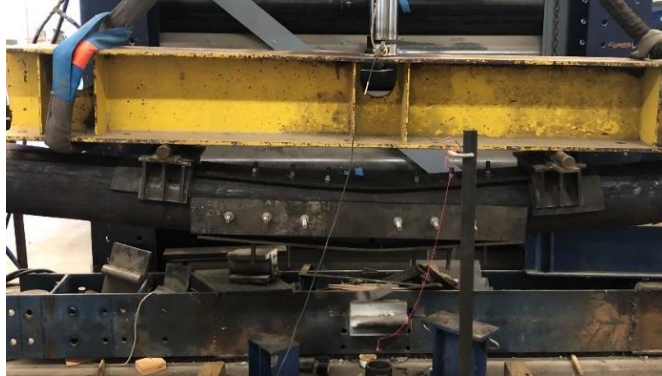
Figure 114. Steel splice yielding during bending test

The steel plate and C-channel splicing bowed a significant amount before yielding of the top and bottom plates. An image of the steel plate splice yielding is provided in Figure 114. When using the steel plate splicing method, a pile cracked along its entire span during one of the tests. This signifies that the pile split from the localized force exerted by bolts onto the timber pile at small locations. An image of this failure is shown in Figure 115. As identified in Figure 116, failure in the wooden plate splicing method left cracks along the top and bottom plates, similar to those in the shear test method.

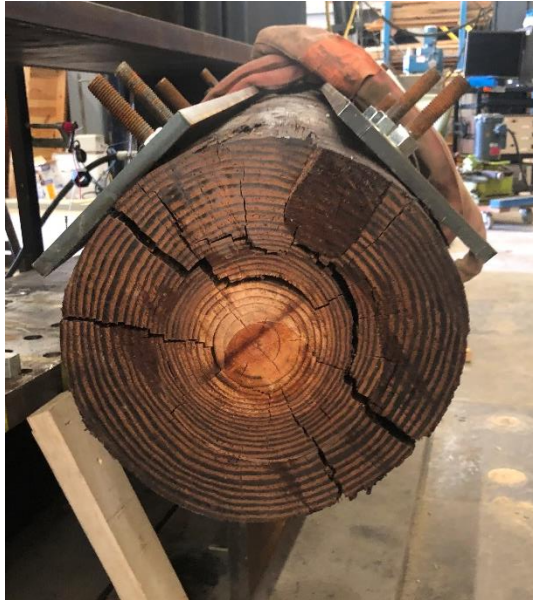
Figure 120. Cracking of steel splice pile at contact surface

A common visual failure observed in majority of the tests was the cracking of the pile cross section at both ends where the pile was in contact with the steel plates. This is indicative of the influence of Poisson’s effect in which failure occurs at higher axial loads due to the weak tensile resistance of wood along the cross section of the pile. A photograph of this failure mode is shown in Figure 120. Another observed failure was localized buckling along the pile near the contact surfaces. A photograph of this failure mode is shown in Figure 121.

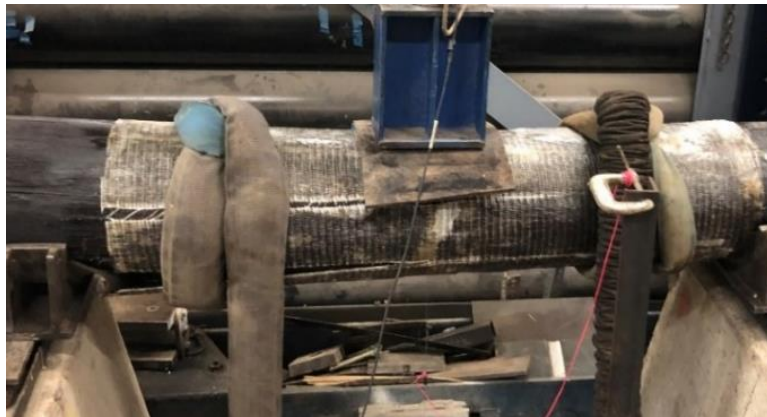
Figure 123. Hoop failure in shear test

FRP splicing ruptures longitudinally near the neutral axis of the pile FRP wrap splitting between fibers running longitudinally along the pile are noted from the center of the tested specimens, because of maximum shear stress induced at the mid-depth of the test specimens. Furthermore, the failure mode revealed that the failure occurred in the hoop direction of fibers. This was to be expected as there are few fibers resisting forces in the hoop direction. Upon initial loading of each pile, it was observed that there was cracking at the contact surface of the applied load. This implied local buckling occurred from the compressive force induced under applied load. During testing and also during load retrieval, buckling related cracking was observed in the center of the splice (Figure 124).

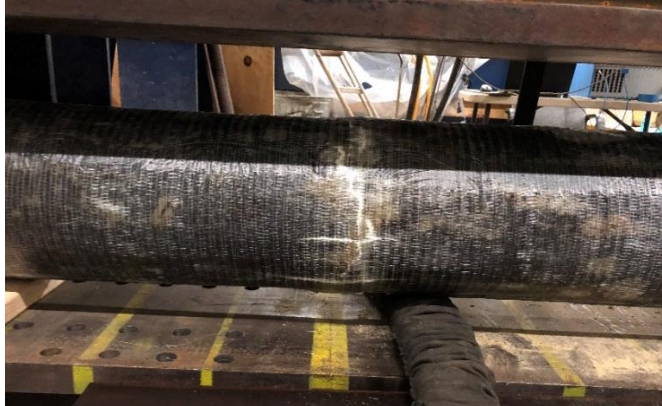
Figure 129. Bulging in FRP splice during compression testing

Due to the gap between the two halves of the pile specimen, bulging of fiber in the FRP wrap at the center is noticed. This occurred in each of the three specimens tested. Adding a layer of high strength caulking in the gap between pile’s halves can help prevent bulging. In this test, bulging fibers were split in the hoop direction but remained intact in the longitudinal direction along the pile (Figure 129). Adding an additional layer of fibers, reinforcing the hoop direction can prevent splitting. As opposed to traditional methods, buckling effects were negligible at the end of these tested piles. Bolts were not used in this method, i.e., no internal forces are acting on the pile causing it to crack, and no high stress concentration is induced from bolting at the connector locations as in legacy connections. Each of the piles failed similarly as shown in (Figure 130).

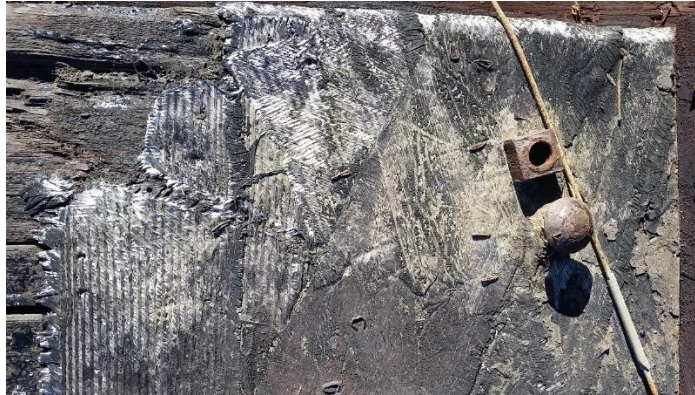
Figure 132. UV degradation of FRP wrap

Discoloration can be a sign of UV degradation, fire exposure, excessive strain, voids or moisture infiltration. The original color of the FRP wrap should be noted in the inventory reports so that color changes over time can be noted as FRP wraps vary in color from off-white (Aquawrap) to dark brown (phenolic). Typically, damage resulting in discoloration results in the composite turning white as the glass fibers are exposed, as shown in Figure 132.

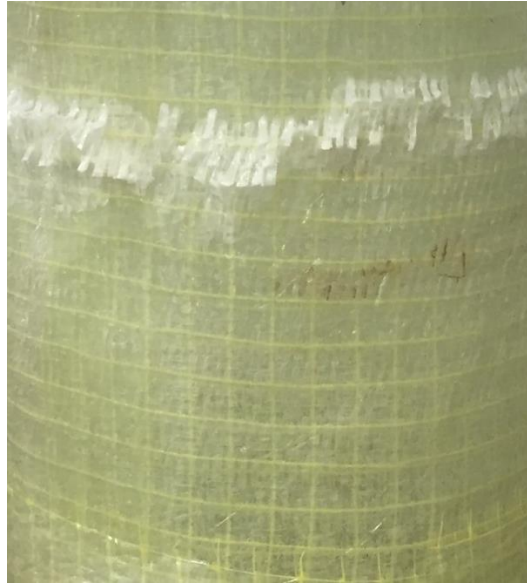
Figure 134. Cracks in FRP wrap

Cracks are the most critical inspection item as this testing program illustrated, i.e., a cracked FRP wrap has significantly reduced strength. Cracks often have discoloration around the crack, and broken fibers are typically visible. Cracked wraps should be assumed to have zero remaining strength.

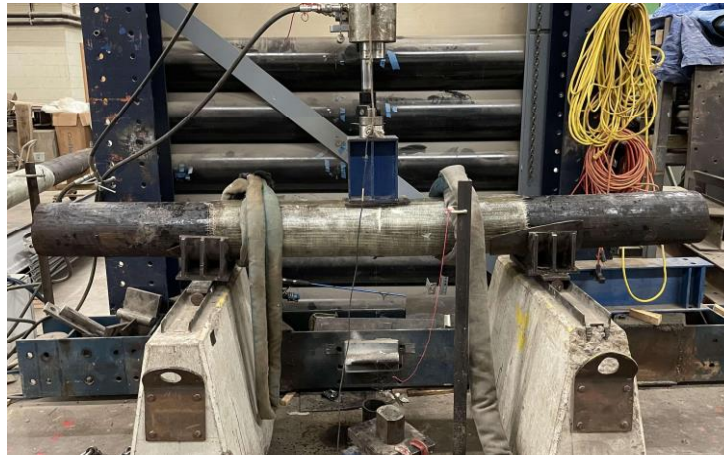
Figure A-2 – Six-layer FRP splice shear test

where the stress versus deflection plot was getting to be nonlinear. Deflection at failure of this six-layer FRP rehab specimen compared well with the three-layer FRP splice specimens, i.e., differences in deflection is about 10%. Failure mode was ductile as it failed in a more conventional manner than the three-layer FRP splice mechanism. In the pristine six-layer FRP composite wrap specimen, lateral compression of fiber was noted at the center of the splice (Figure A-3), unlike the unzipping in the original three-layer design. This failure is expected as the compressive strength of Sika Glass/Epoxy composite is slightly lower than its tensile strength. No unzipping of fabric occurred in the six-layer wrap test, indicating hoop direction reinforcement was sufficient to provide adequate confinement strength.

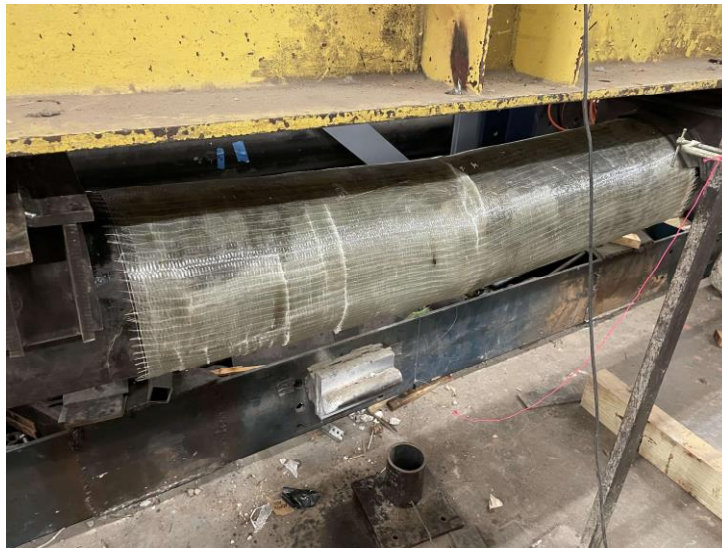
Figure A-6 – Splitting of fabric in re-wrap test

the remaining and already failed original splice did not contribute any bending resistance to the system. This means that nominal increase in bending capacity has been attained due to confinement from hoop direction fibers. Visual failure modes observed during the testing of the re-wrapped specimen supports this conclusion. The visual failure mode observed was the splitting of fabric between fibers in the hoop direction, lacking adequate reinforcement in the longitudinal direction of the pile (Figure A-6), and the nominal strength increase is attributed to confinement of the pile through hoop direction fibers.
