Louisiana Transportation Research Center

Final Report 658

**Retrofit of Existing Statewide Louisiana Safety
Walk Bridge Barrier Railing Systems**

Texas A&M Transportation Institute

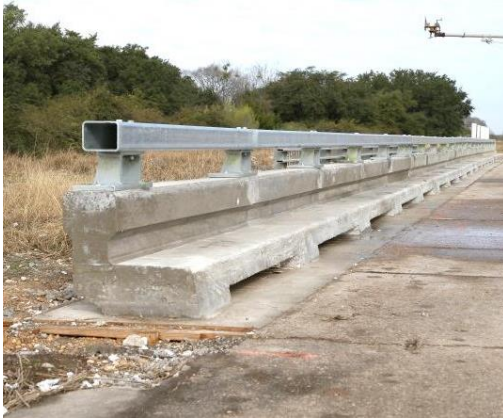
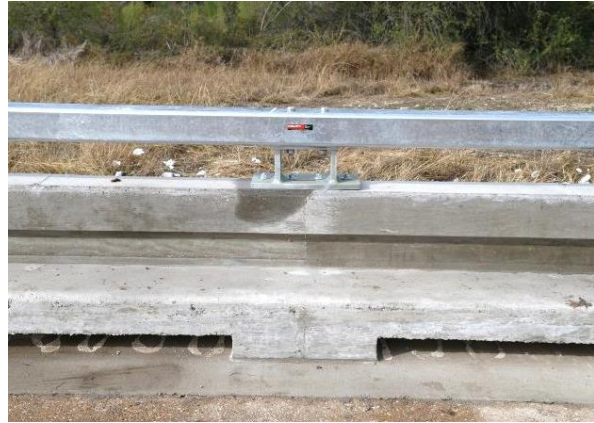
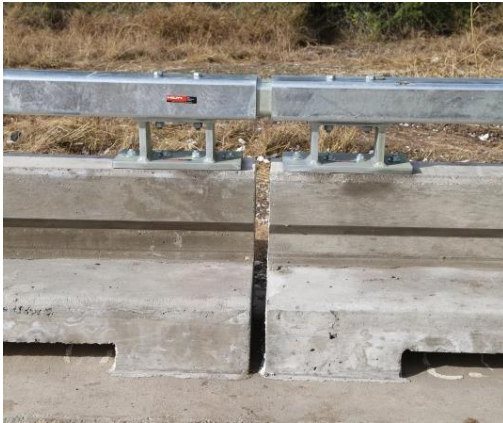
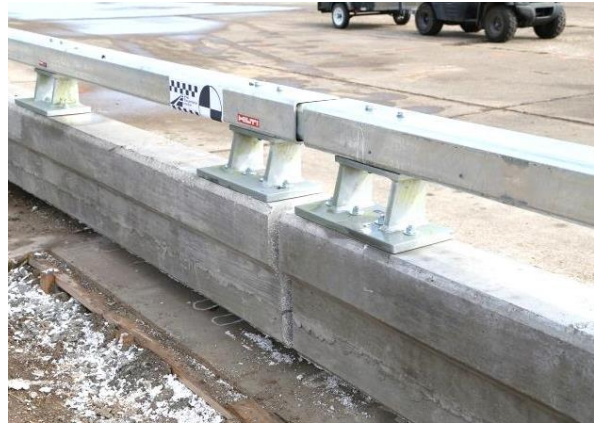
Figure 3. Photos of full-scale test installation

(a) Traffic face of bridge rail

(b) Steel post

(c) Joint

(d) Field side of bridge rail

of the design are shown in Figure 2. A picture of the pre-test installation of the Option A bridge rail design can be found in Figure 3.

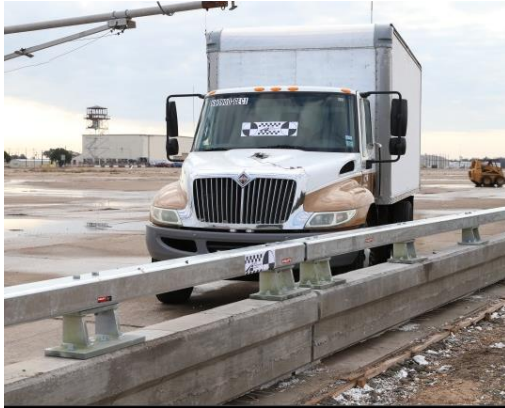
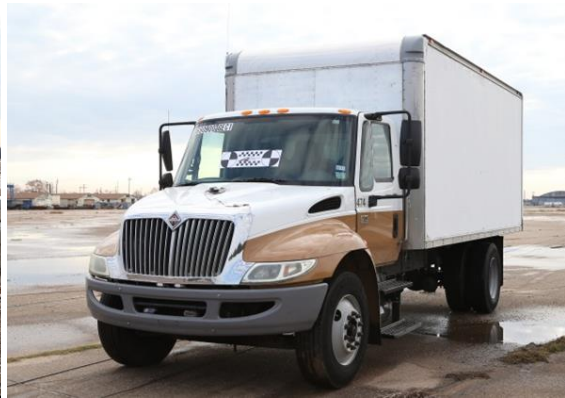
Figure 4. Bridge rail and test vehicle before MASH Test 4-12

(a) Test vehicle at target impact point

(b) 1000S test vehicle

Three crash tests were required to evaluate the bridge rail's performance for TL-4 of MASH [1]. These tests involved a 10000S vehicle (22,000-lb. single unit truck), a 2270P vehicle (a 5000-lb. (1/2-ton) quad cab pickup), and a smaller 1100C vehicle (2420-lb. small car). Figure 4 through Figure 12 show the conditions of each of the cars before and after each respective test, as well as the bridge rail damage after each test. Table 1 through Table 3 provide a summary of the MASH criteria evaluation of each individual test.

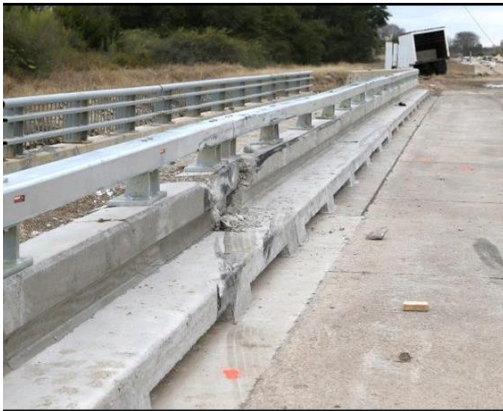
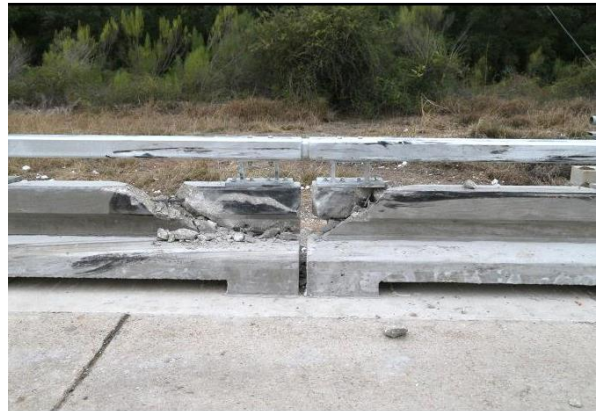
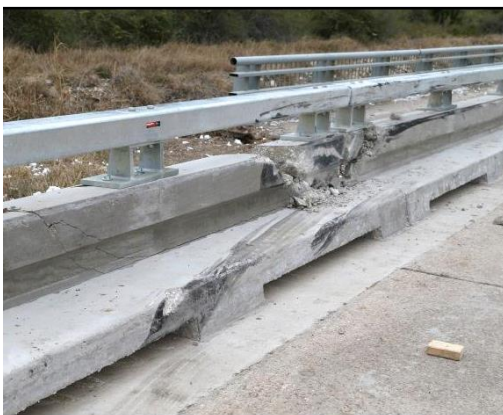
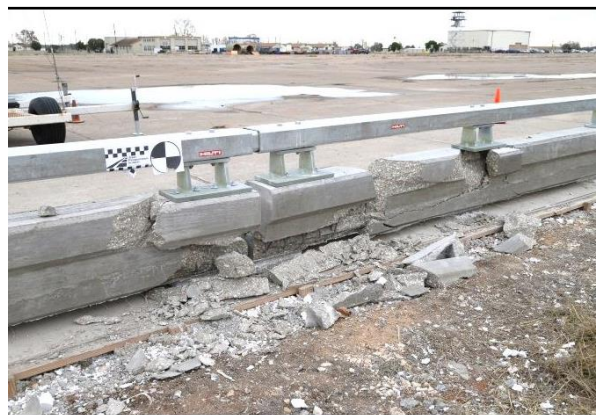
Figure 5. Bridge rail after MASH Test 4-12

(a) Traffic face of bridge rail

(b) Joint

(c) Impact point

(d) Field side of bridge rail

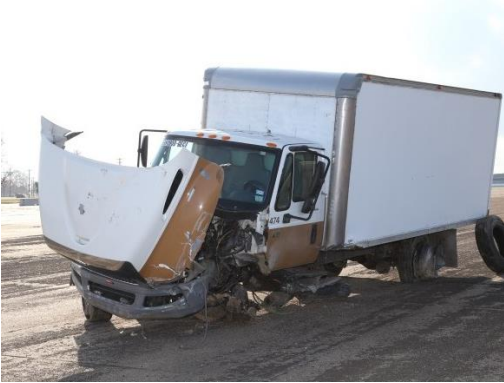
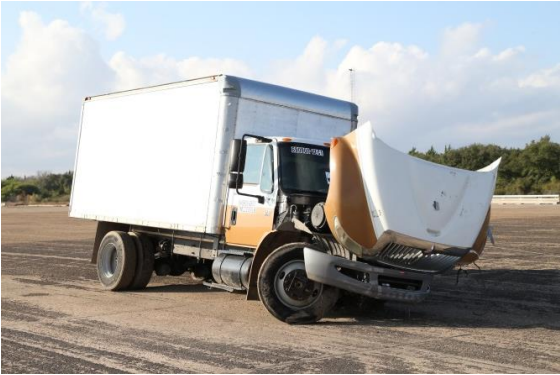
Figure 6. Test vehicle after MASH Test 4-12

(a) Damage to left side of test vehicle

(b) Damage to right side of test vehicle

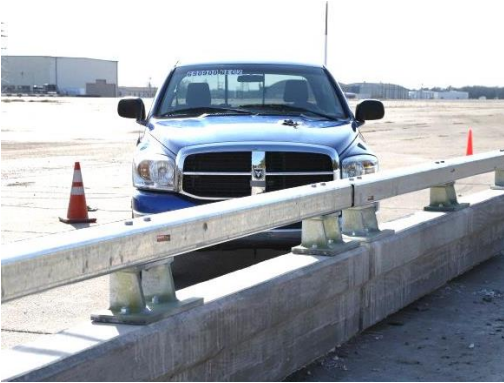
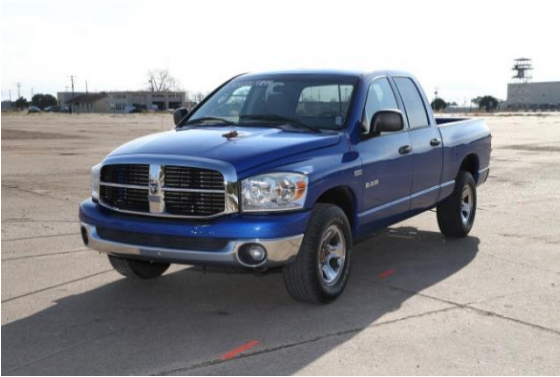
Figure 7. Bridge rail and test vehicle before MASH Test 4-11

(a) Test vehicle at target impact point

(b) 2270P test vehicle

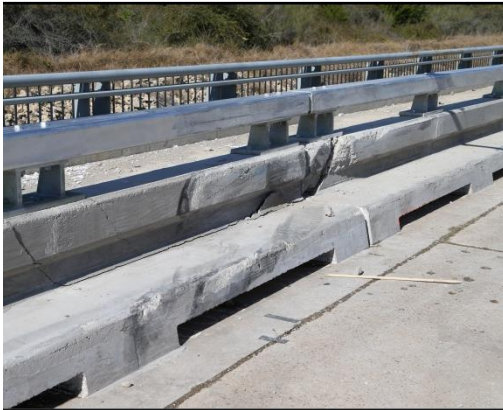
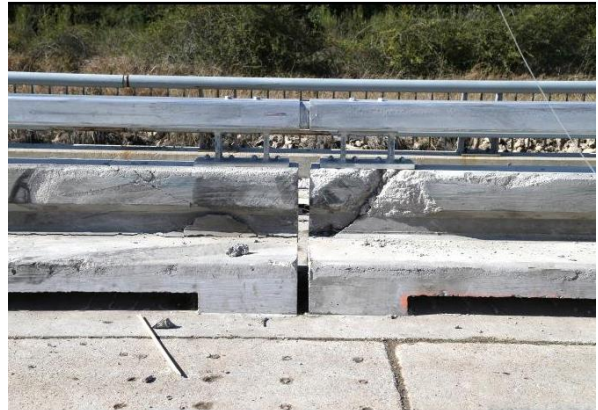
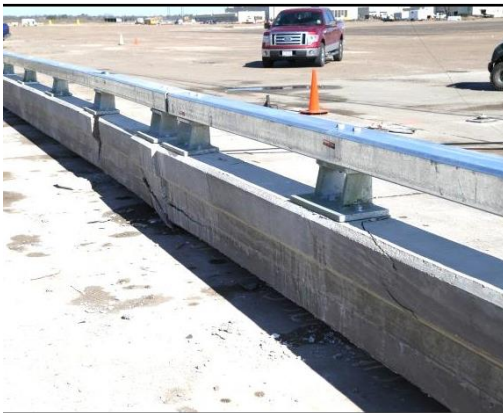
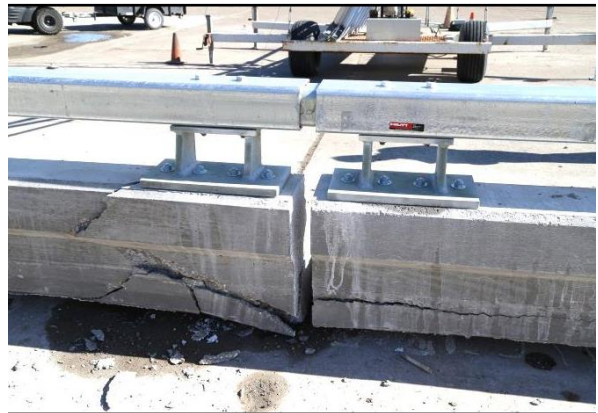
Figure 8. Bridge rail after MASH Test 4-11

(a) Traffic face of bridge rail

(b) Traffic side of joint

(c) Field side of bridge rail

(d) Field side of joint

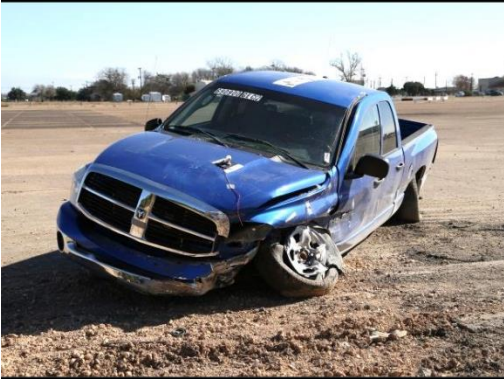
Figure 9. Test vehicle after MASH Test 4-11

(a) Damage to left side of test vehicle

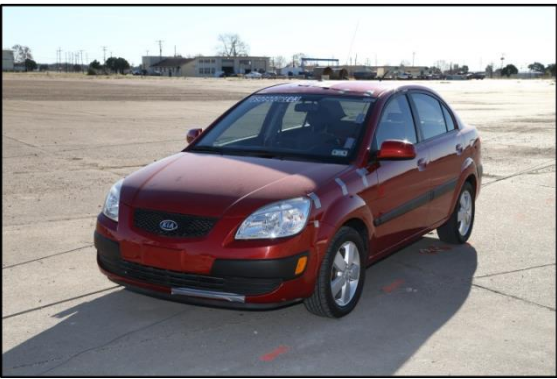
(b) 1100C test vehicle

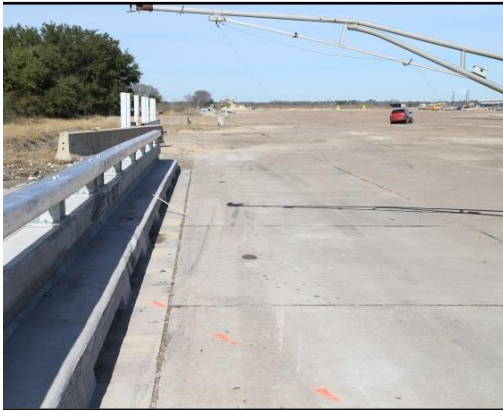
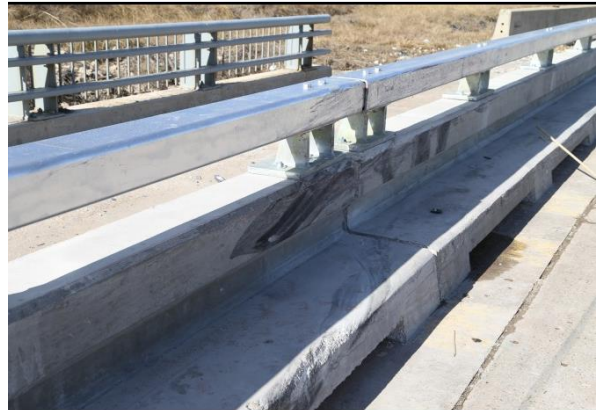
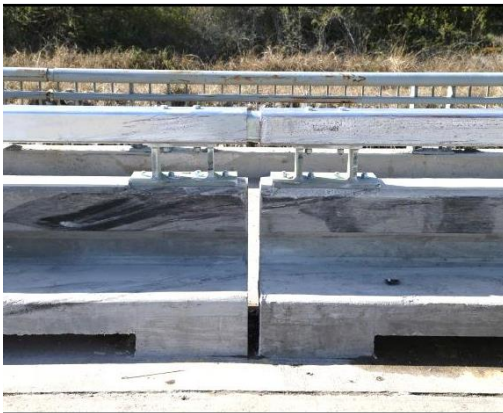
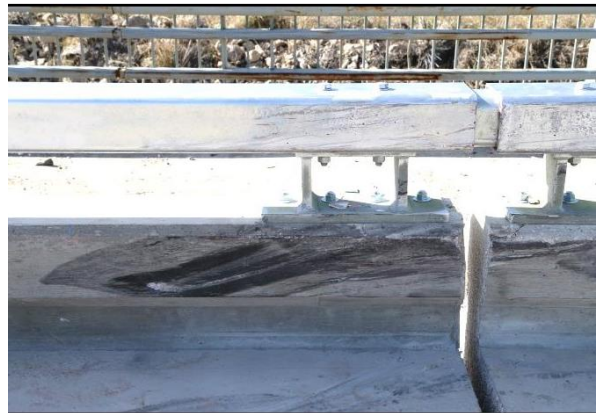
Figure 11. Bridge rail after MASH Test 4-10

(a) Traffic side of bridge rail

(b) Impact point

(c) Joint

(d) Post

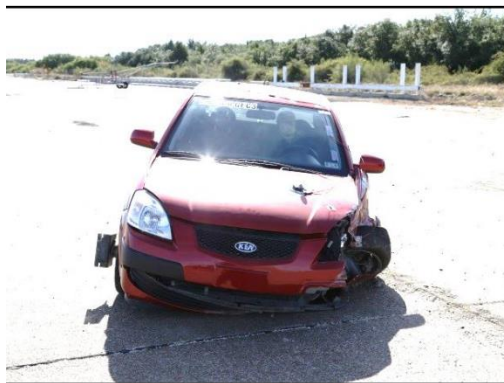
Figure 12. Test vehicle after MASH Test 4-10

(a) Damage to front of test vehicle

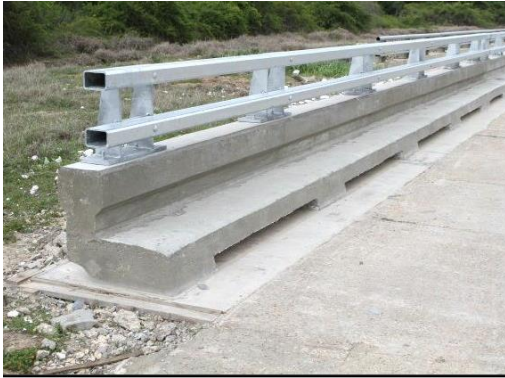
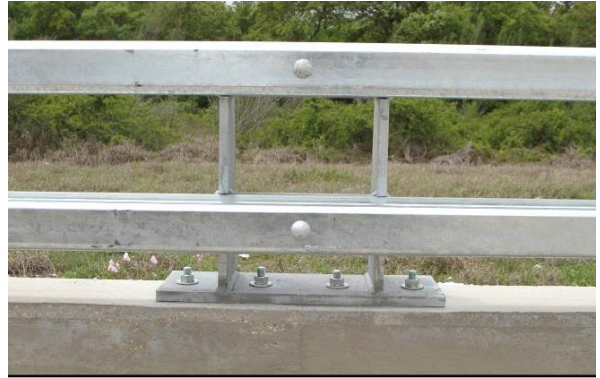
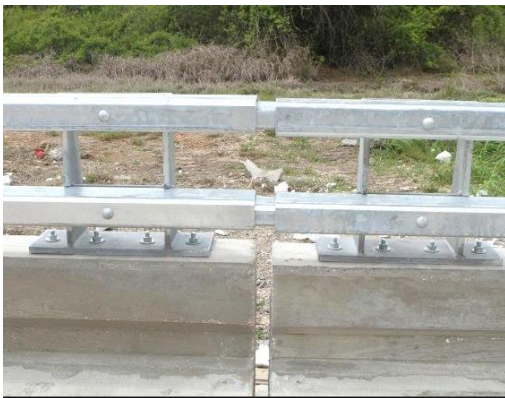
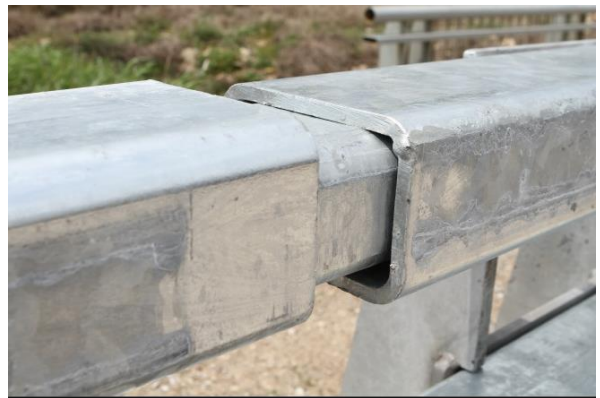
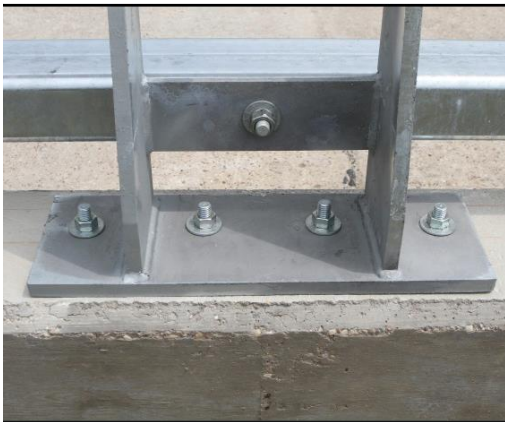
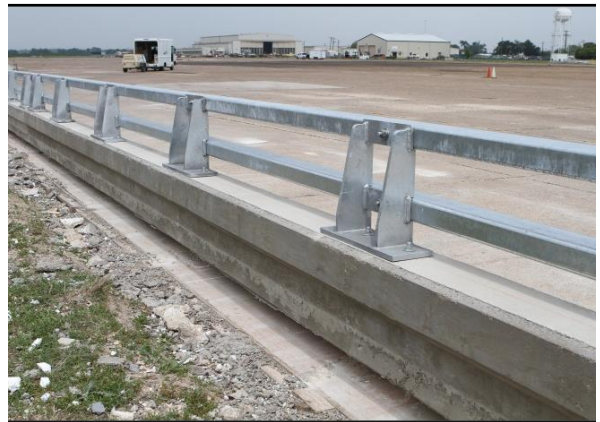
Figure 14. Design Option B1 before testing

(a) Traffic face of bridge rail

(b) Steel post

(c) Joint

(d) Metal joint and sleeve

(e) Field side of post connection

(f) Field side of bridge rail

Figure 14 shows photographs of the installation before full-scale crash testing. Figure 15 through Figure 29 show photographs (before and after) for MASH Test 4-12. Figure 30 through Figure 33 show photographs (before and after) for MASH Test 4-10. Figure 34 through Figure 40 show photographs (before and after) for MASH Test 4-11. These photos show the conditions of the rail installation and test vehicles before and after tests 690900-GEC7, GEC7a, GEC8, and GEC9, as well as damage to the bridge rail after each test. Table 4 through Table 7 provide a summary of the MASH criteria evaluation of each individual test.

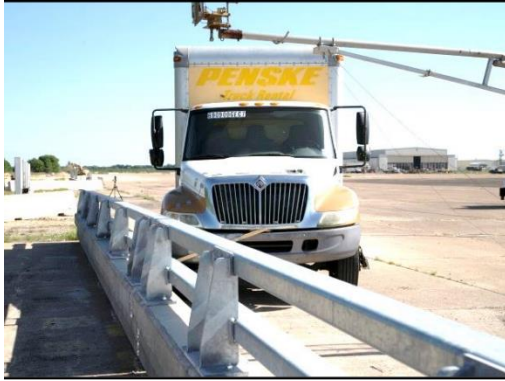
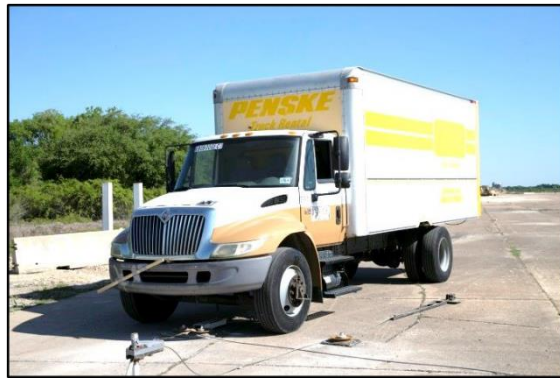
Figure 15. Test vehicle before Test No. 690900-GEC7

(a) 10000S test vehicle at impact point

(b) Left side of 10000S test vehicle

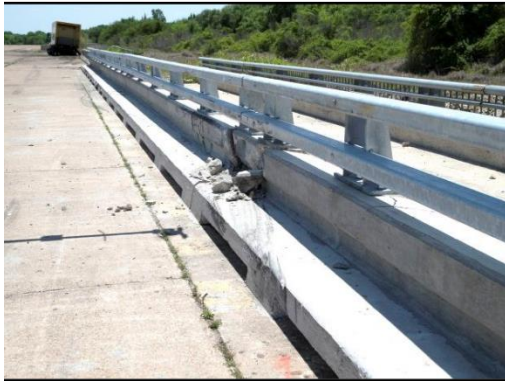
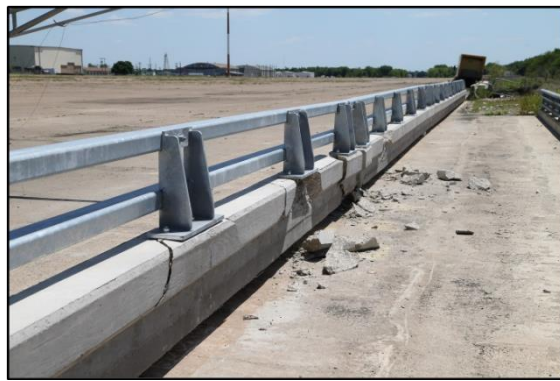
Figure 16. Rail option B1 after Test No. 690900-GEC7

(a) Traffic Side

(b) Field Side

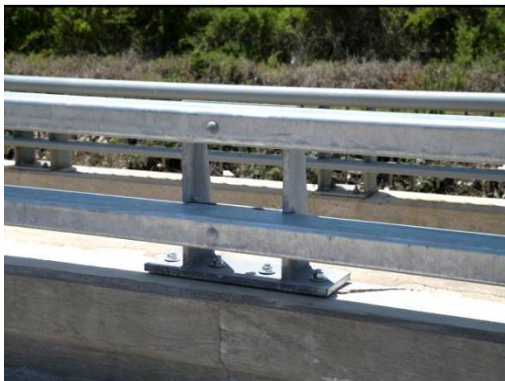
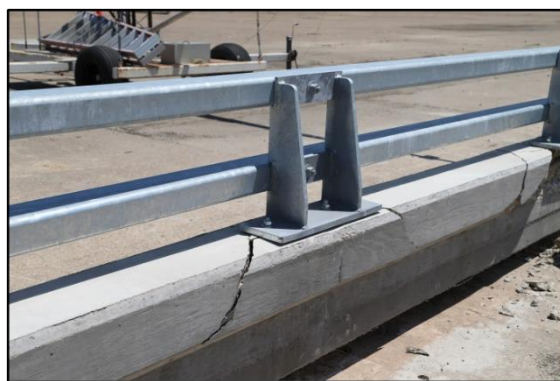
Figure 17. Post 4 after Test No. 690900-GEC7

(a) Traffic side

(b) Field side

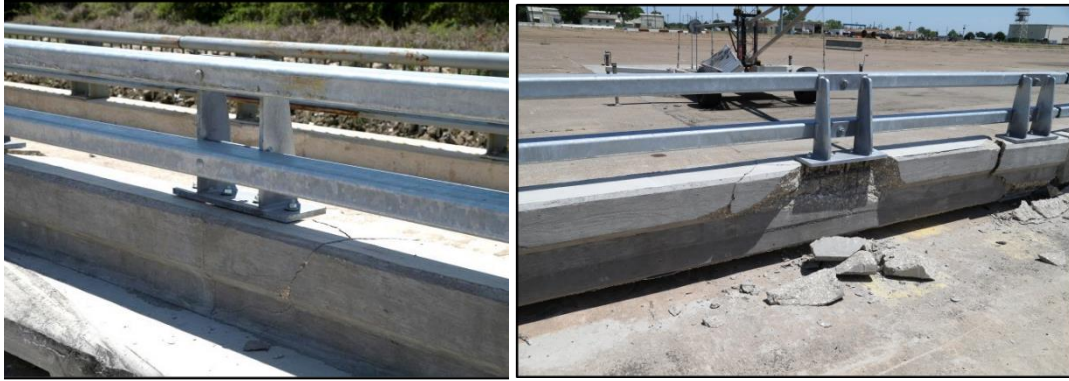
Figure 18. Post 5 after Test No. 690900-GEC7

(a) Traffic side

(b) Field side

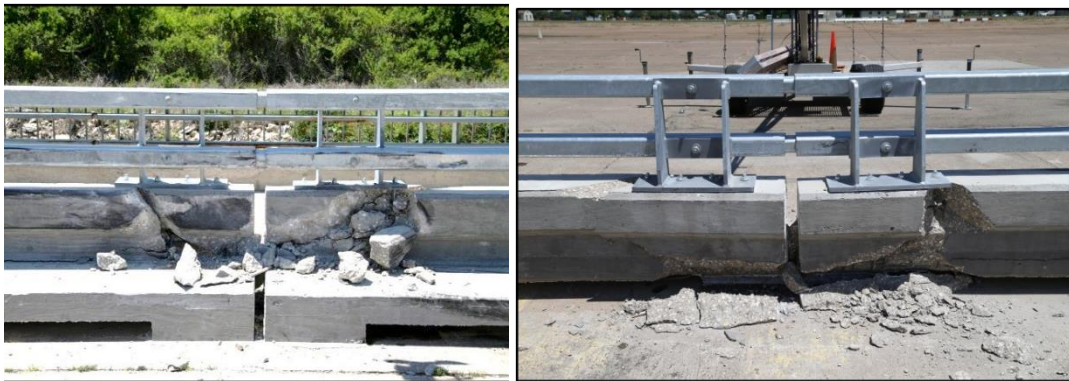
Figure 19. Post 6 and 7 after Test No. 690900-GEC7

(a) Traffic side

(b) Field side

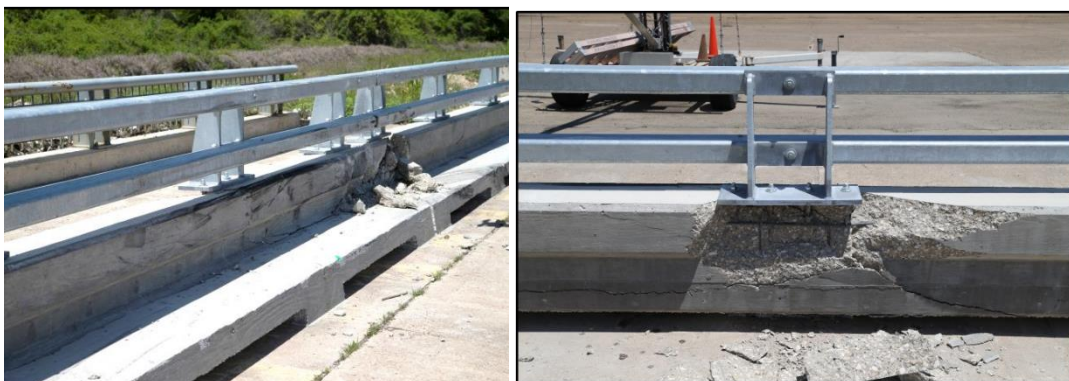
Figure 20. Post 8 after Test No. 690900-GEC7

(a) Traffic side

(b) Field side

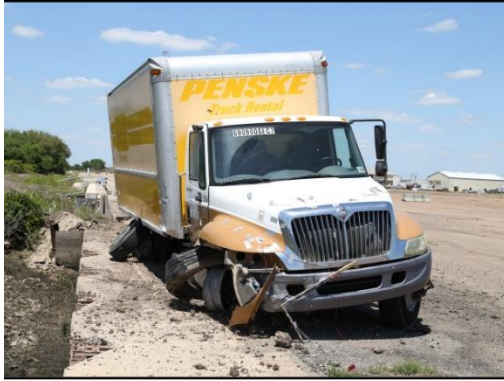
Figure 21. Test vehicle after Test No. 690900-GEC7

(a) Damage to right side of test vehicle

(b) Damage to right front tire

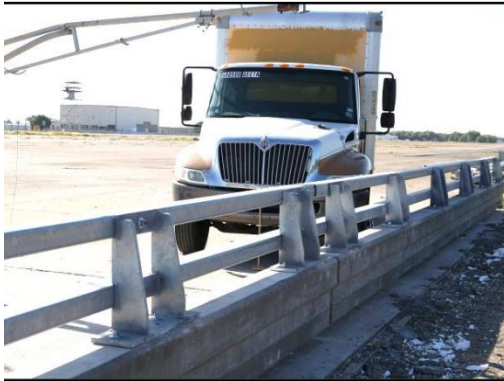
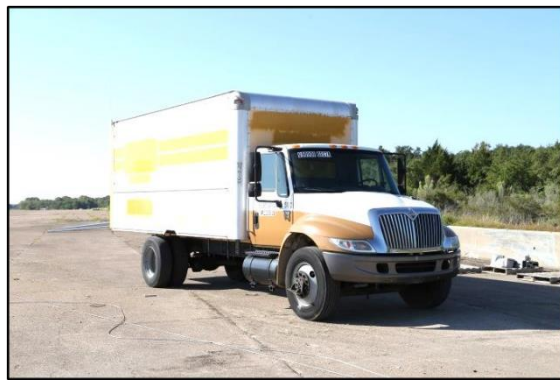
Figure 22. Test vehicle before Test No. 690900-GEC7a

(a) 10000S test vehicle and bridge rail

(b) Right side of 10000S test vehicle

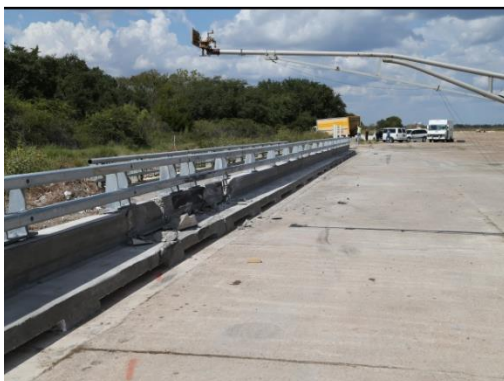
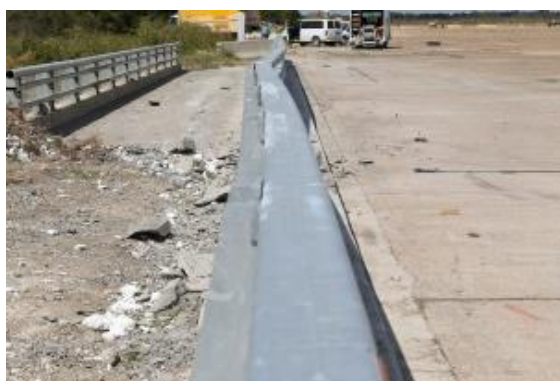
Figure 23. Rail Option B1 positions after Test No. 690900-GEC7a

(a) Traffic side of bridge rail

(b) Parallel with bridge rail

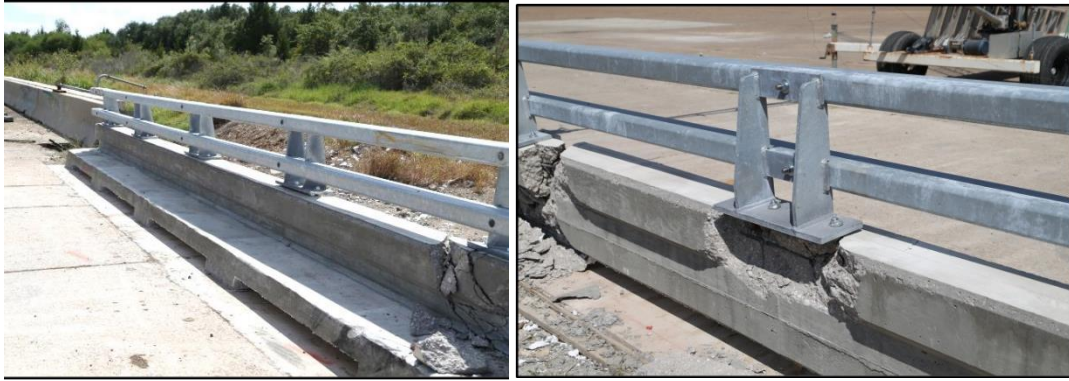
Figure 24. Posts 1 through 5 and rear of post 4 after Test No. GEC7a

(a) Traffic side

(b) Field side of post 4

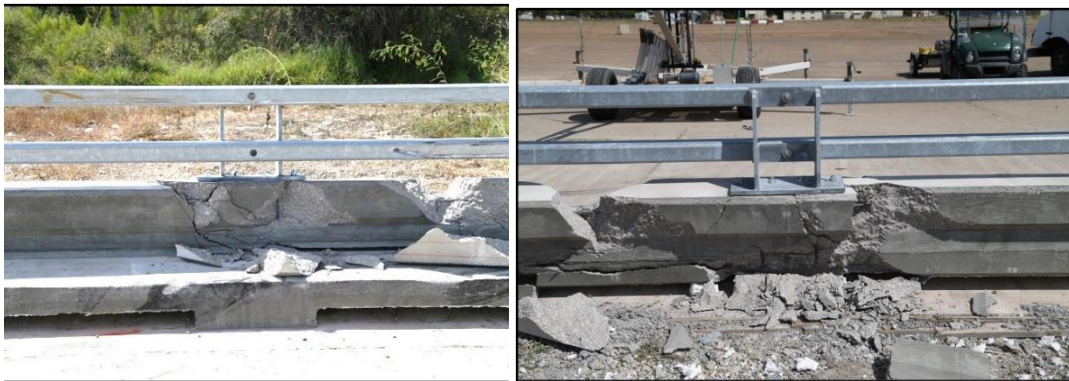
Figure 25. Post 5 after Test No. 690900-GEC7a

(a) Traffic side

(b) Field side

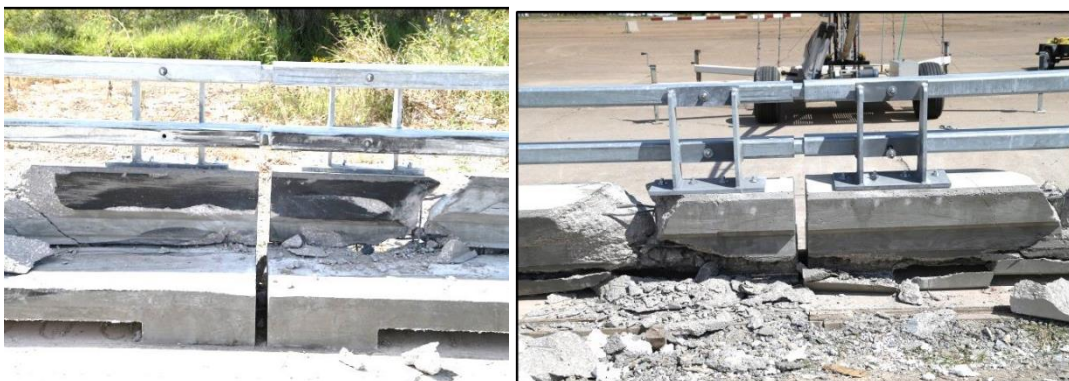
Figure 26. Post 6 and 7 after Test No. 690900-GEC7a

(a) Post 6

(b) Post 7

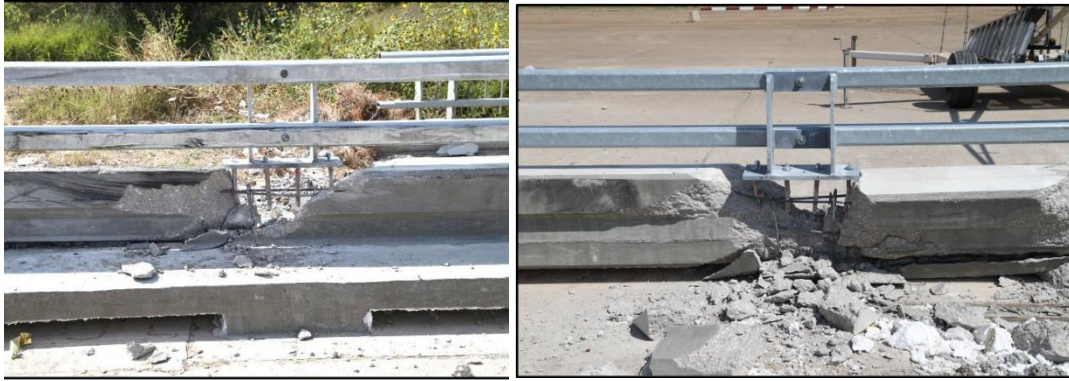
Figure 27. Post 8 after Test No. 690900-GEC7a

(a) Traffic side

(b) Field side

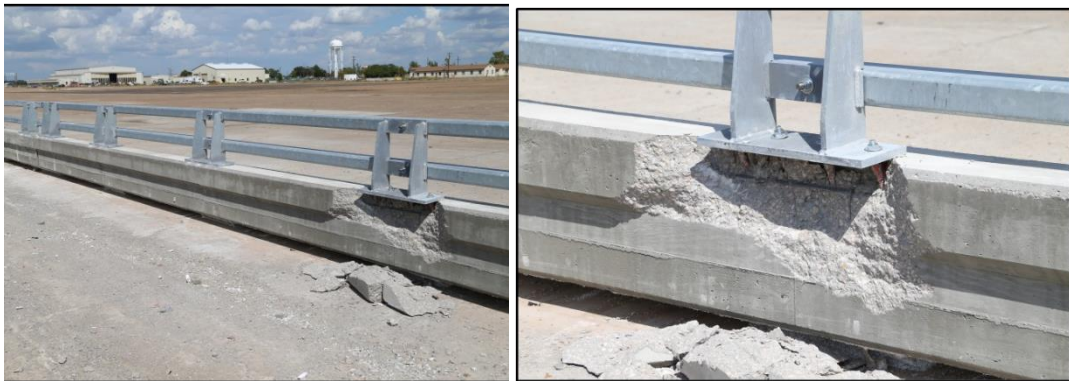
Figure 28. Post 9 through 14 after Test No. 690900-GEC7a

(a) Field side of bridge rail

(b) Damage at post 9

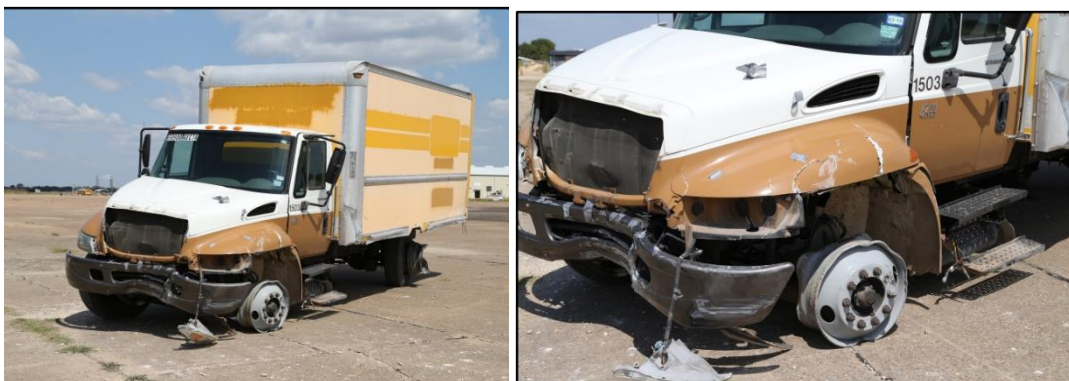
Figure 29. Test vehicle after Test No. 690900-GEC7a

(a) Damage to left side of test vehicle

(b) Damage to left front tire

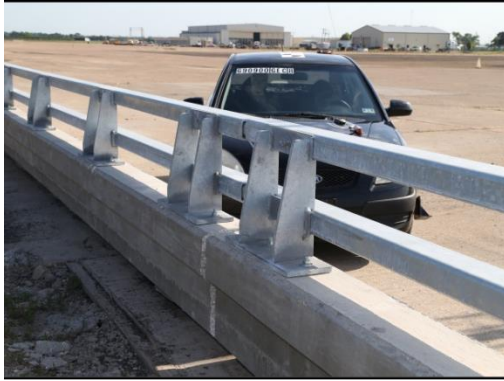
Figure 30. Test vehicle before Test No. 690900-GEC8

(a) 1100C test vehicle and bridge rail

(b) 1100C test vehicle

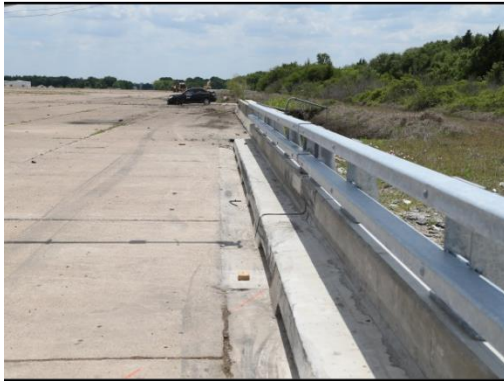
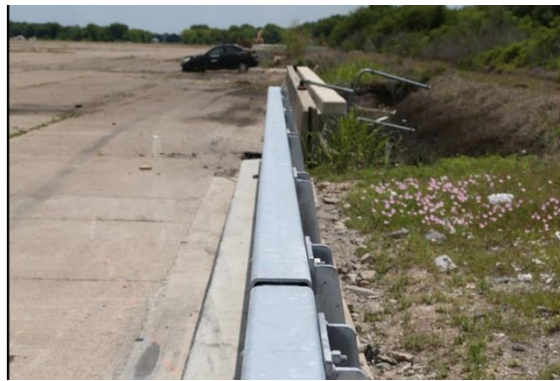
Figure 31. Rail Option B1 after Test No. 690900-GEC8

(a) Traffic side

(b) Parallel with bridge rail

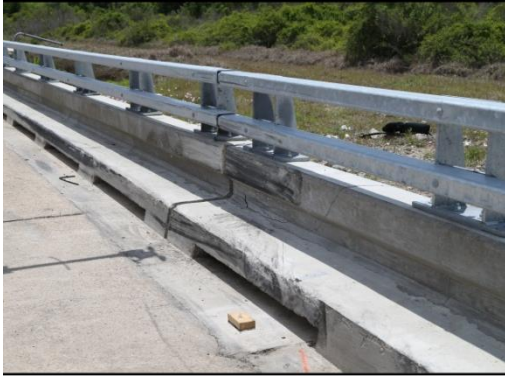
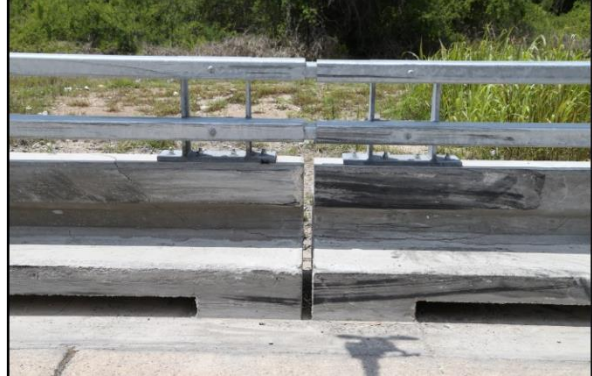
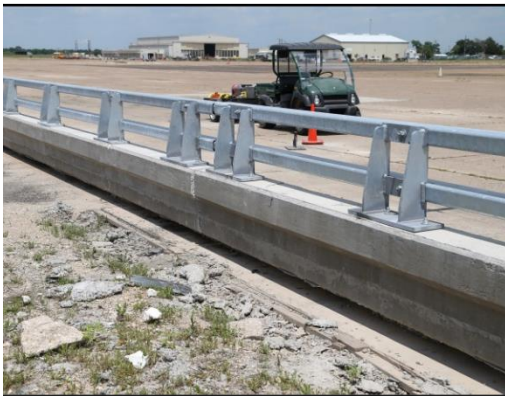
Figure 32. Installation after Test No. 690900-GEC8

(a) Traffic face of bridge rail

(b) Joint

(c) Field side of bridge rail

(d) Crack in concrete curb

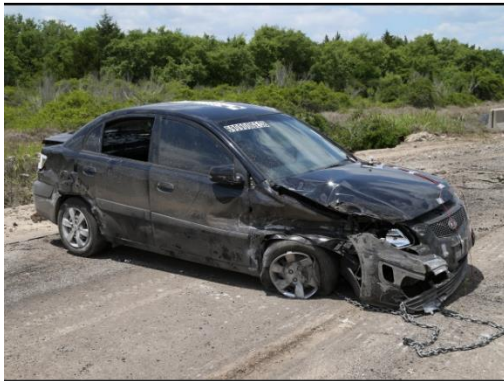
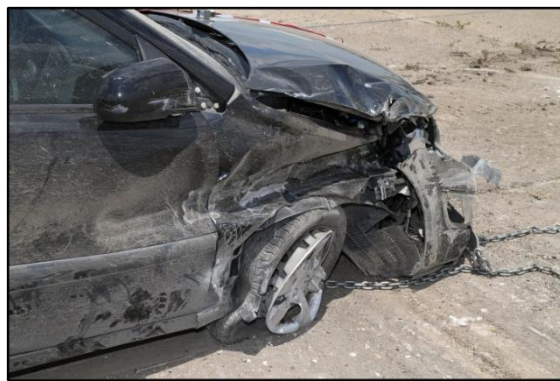
Figure 33. Test vehicle after Test No. 690900-GEC8

(a) Damage to right side

(b) Damage to right front tire

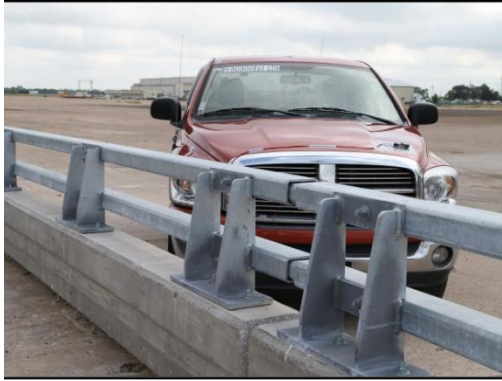
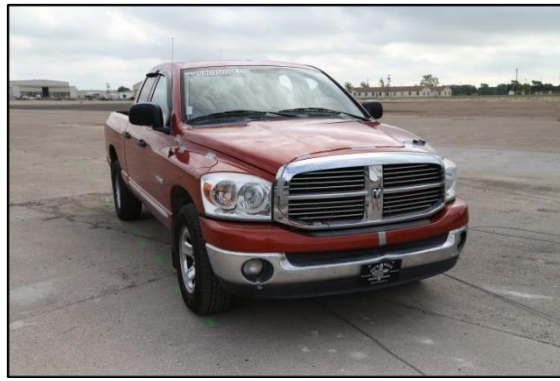
Figure 34. Test vehicle before Test No. 690900-GEC9

(a) 2270P test vehicle and bridge rail

(b) 2270P test vehicle

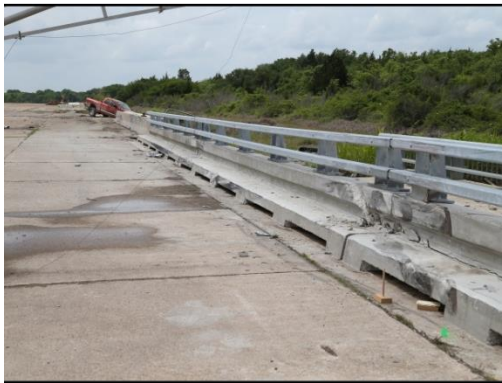
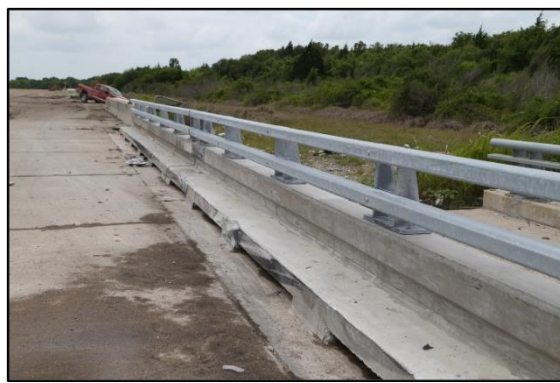
Figure 35. Position of vehicle/installation after Test No. 690900-GEC9

(a) Traffic side

(b) Along traffic face of bridge rail

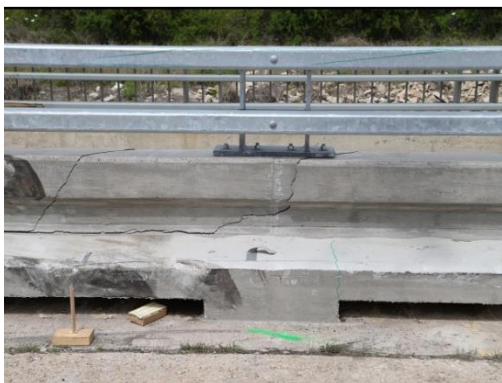
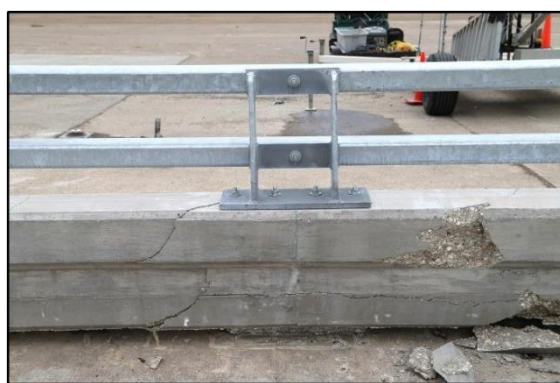
Figure 36. Post 11 after Test No. 690900-GEC9

(a) Traffic side

(b) Field side

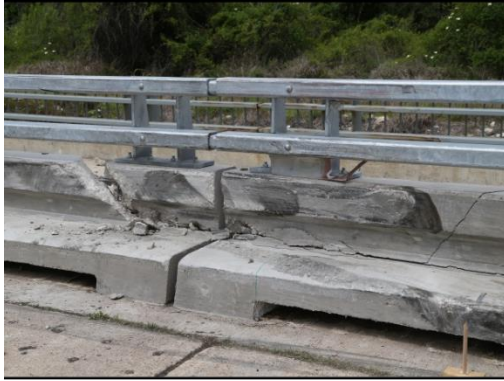
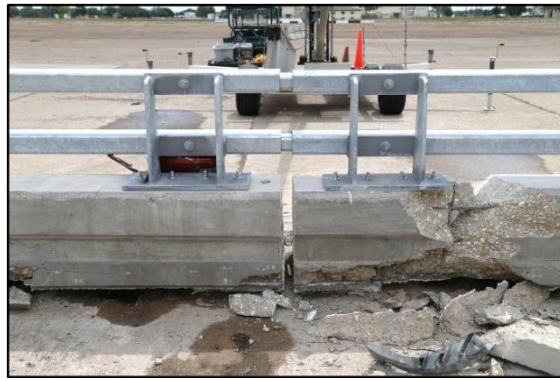
Figure 37. Post 12 and 13 after Test No. 690900-GEC9

(a) Traffic side impact area damage test

(b) Field side damage

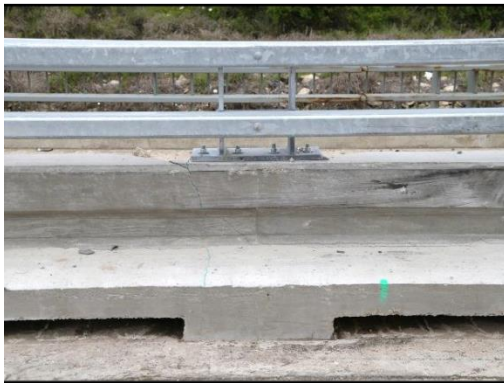
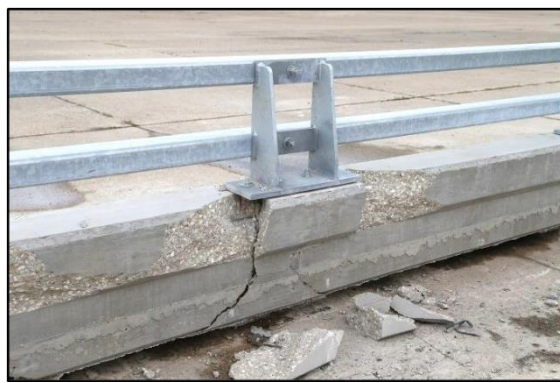
Figure 38. Photos after Test No. 690900-GEC9

(a) Traffic side

(b) Field side

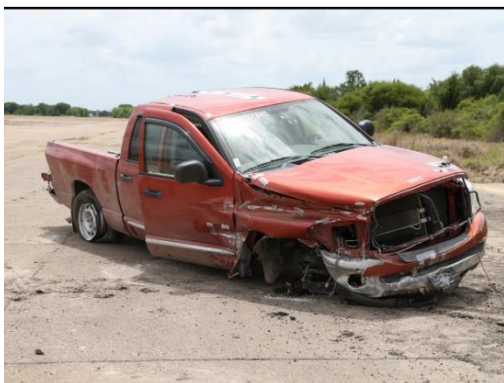
Figure 39. Test vehicle after Test No. 690900-GEC9

(a) Damage to right side

(b) Damage to right front wheel assembly

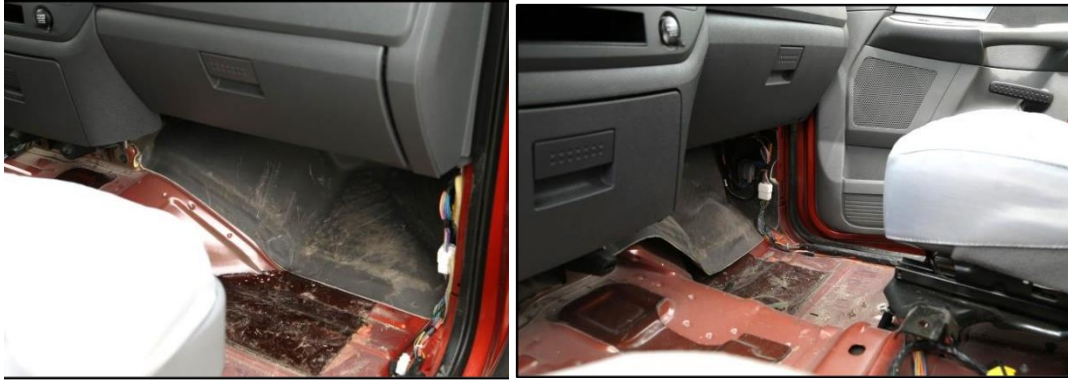
Figure 40. Interior of test vehicle for Test No. 690900-GEC9

(a) Before test

(b) After test

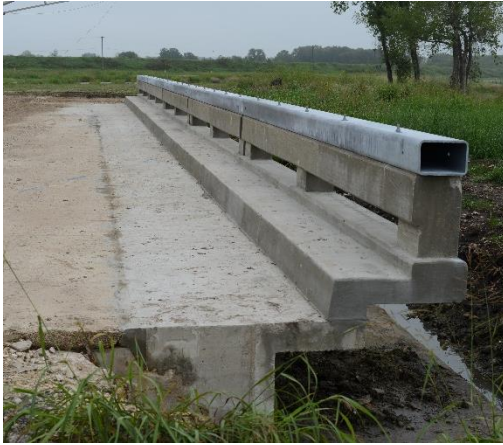
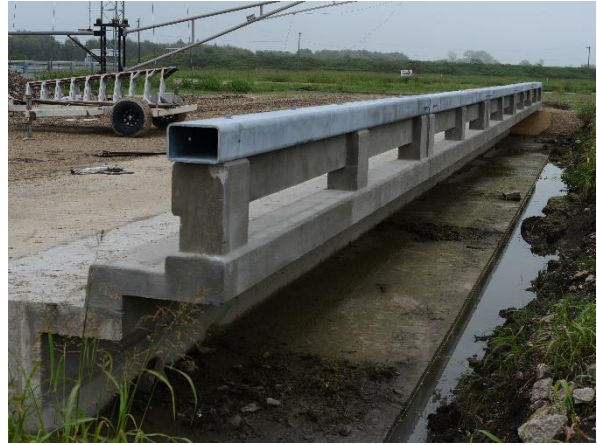
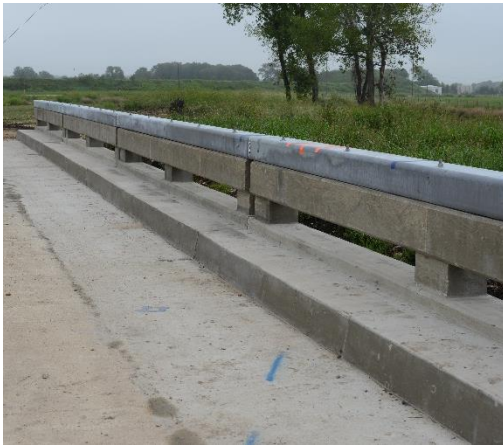
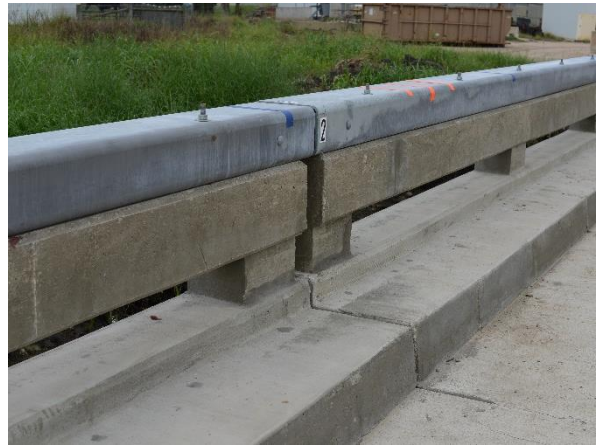
Figure 47. Louisiana Retrofit Post and Beam Bridge Rail with Safety Walk Option 1 prior to testing

(a) Traffic face of bridge rail

(b) Field side of bridge rail

(c) Upstream of joint

(d) Downstream of joint

Appendix B presents the drawings and information on the Louisiana Retrofit post and beam bridge rail with safety walk Option 1, and Figure 47 through Figure 49 provide photographs of the completed installation.

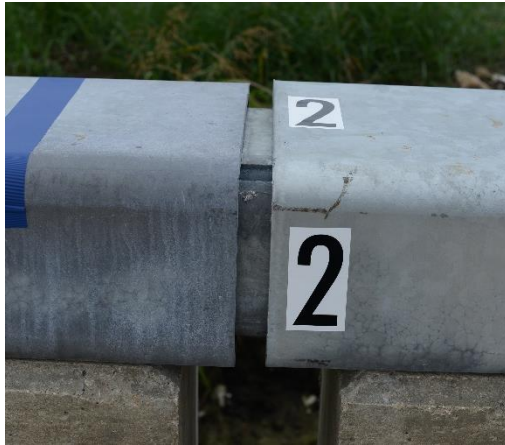
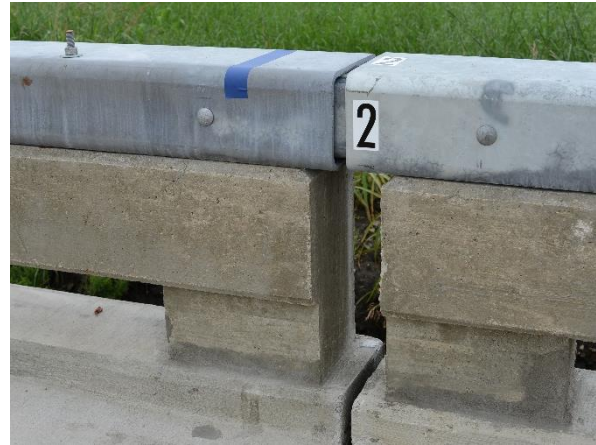
Figure 48. Joint 2 of Louisiana Retrofit Post and Beam Bridge Rail with Safety Walk Option 1 prior to testing

(a) Metal rail element at joint 2

(b) Concrete parapet at joint 2

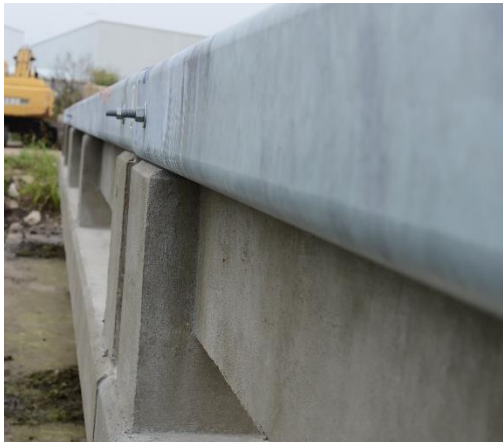
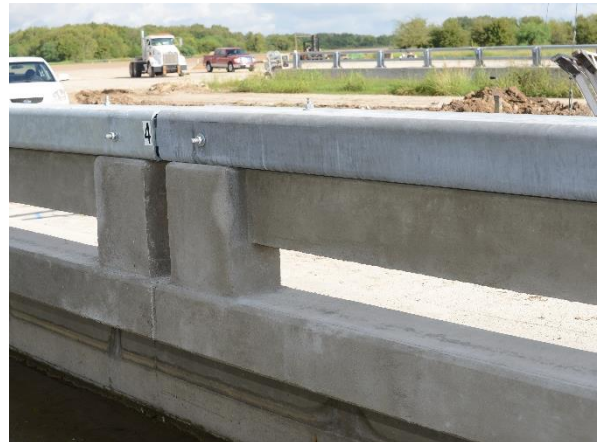
Figure 49. Field side of Louisiana Retrofit Post and Beam Bridge Rail with Safety Walk Option 1 prior to testing

(a) Field side of joint 2

(b) Field side of joint 4

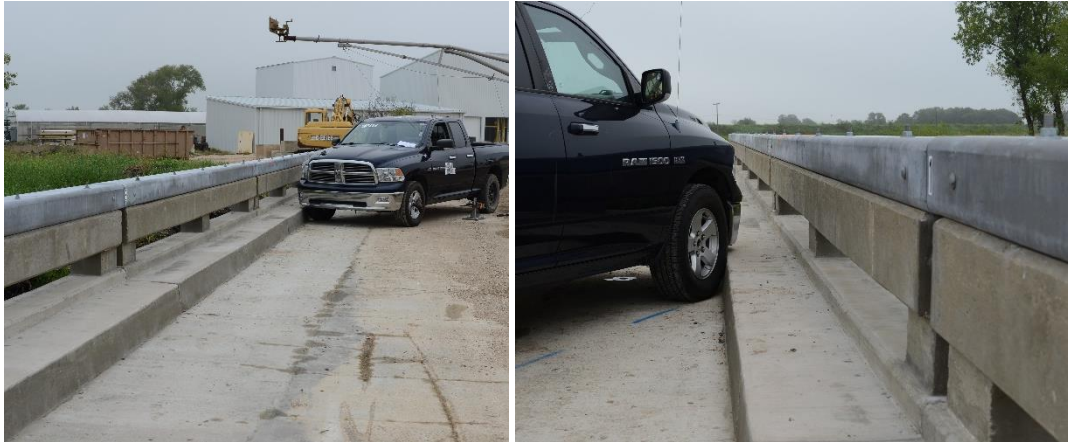
Figure 50. Test vehicle/bridge rail geometrics for Test No. 606861-1

(a) Frontal view of 2270P test vehicle at target impact point

(b) Rear view of 2270P test vehicle at target impact point

centerline of the second open joint in the concrete deck/beam. Figure 44 and Figure 50 depict the target CIP.

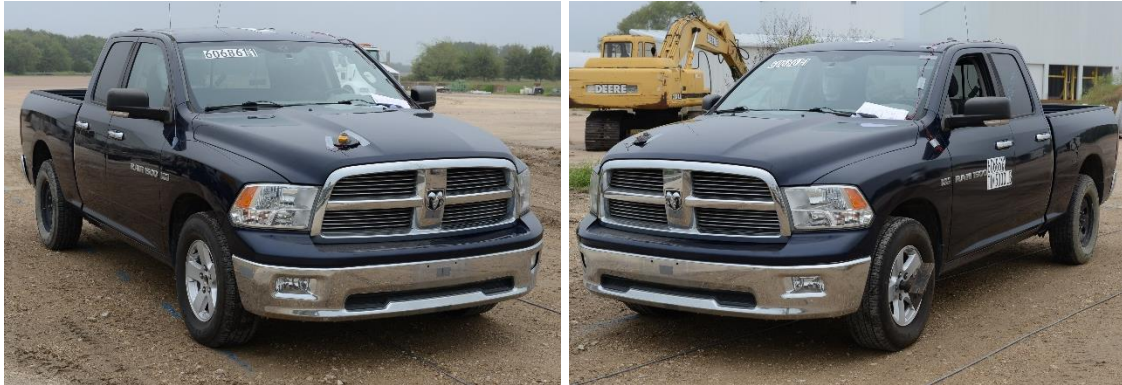
Figure 51. Test vehicle prior to Test No. 606861-1

(a) Right side of 2270P test vehicle

(b) Left side of 2270P test vehicle

Figure 51 shows the 2012 RAM 1500 pickup truck used for the crash test. The vehicle's test inertia weight was 5015 lbs, and its gross static weight was 5180 lbs. The height to the lower edge of the vehicle bumper was 11.75 in., and the height to the upper edge of the bumper was 27.0 in. The height to the vehicle's center of gravity was 28.5 in. Figure 106 and Figure 107 in Appendix D give additional dimensions and information on the vehicle. The vehicle was directed into the installation using a cable reverse tow and

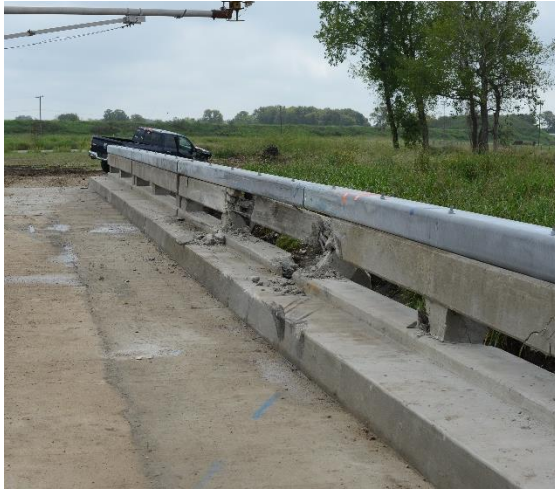
Figure 52. Option 1 bridge rail after Test No. 606861-1

(a) Bridge rail/test vehicle after test

Figure 52 through Figure 55 show the damage to the Option 1 bridge rail. The concrete at both posts at joint 2, and the middle post in section 3, failed with rebar exposed. Numerous cracks were observed in the beam and middle post of section 2 and along the beam of section 3, ending 30 in. upstream of the downstream end of section 3. The rear of the deck was broken out at the middle post of section 2, the end posts at the second joint,

and the middle post of section 3. Working width⁹ was 22.1 in., and height of the working width was 42.6 in.. Maximum dynamic deflection during the test was 10.0 in., and maximum permanent deformation was 7.25 in.

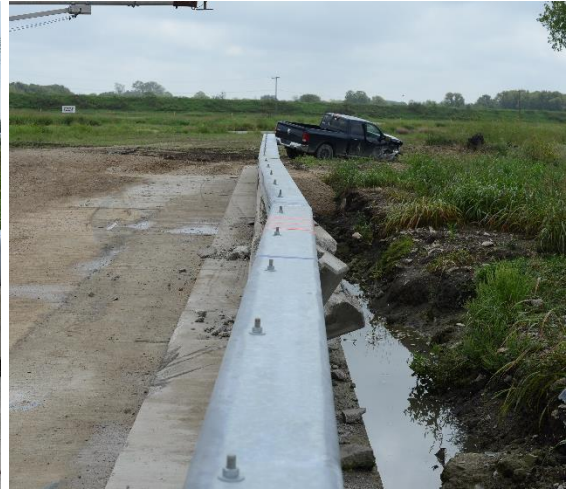
Figure 53. Damage at joint 2 after Test No. 606861-1

(b) Permanent deformation of bridge rail
