Louisiana Transportation Research Center

Final Report 658

**Retrofit of Existing Statewide Louisiana Safety
Walk Bridge Barrier Railing Systems**

Texas A&M Transportation Institute

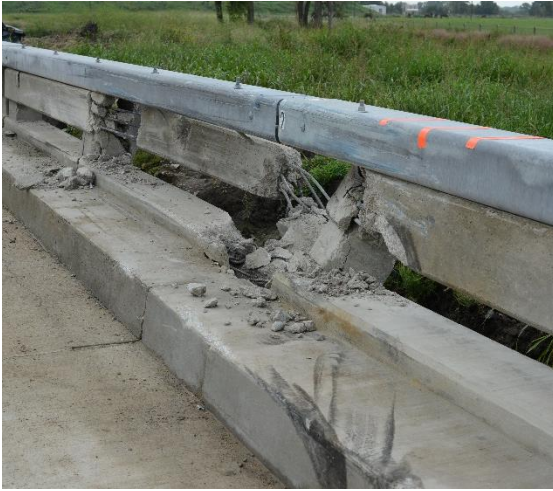
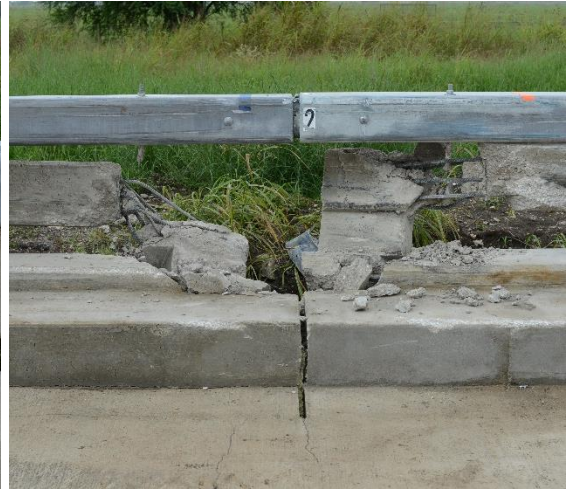
Figure 53. Damage at joint 2 after Test No. 606861-1

(a) Damage to curb and beam

(b) Damage at joint 2

Figure 52 through Figure 55 show the damage to the Option 1 bridge rail. The concrete at both posts at joint 2, and the middle post in section 3, failed with rebar exposed. Numerous cracks were observed in the beam and middle post of section 2 and along the beam of section 3, ending 30 in. upstream of the downstream end of section 3. The rear of the deck was broken out at the middle post of section 2, the end posts at the second joint,

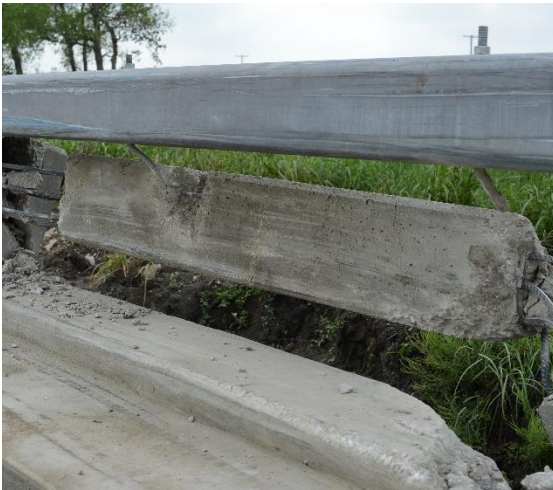
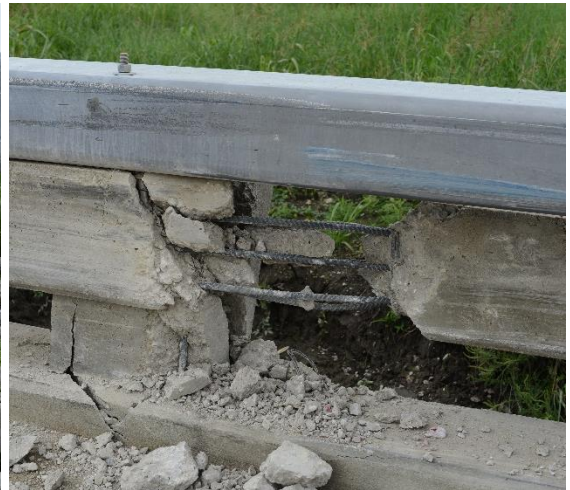
Figure 54. Damage at section 3 after Test No. 606861-1

(a) Section 3 just downstream of joint 2

(b) Middle post of section 3

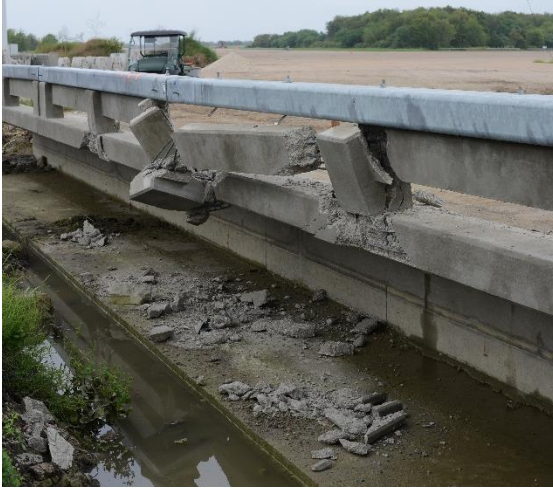
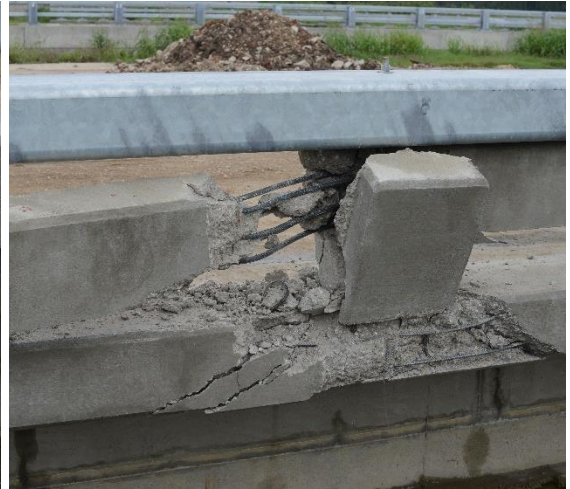
Figure 55. Damage on field side of bridge rail after Test No. 606861-1

(a) Field side of section 2

(c) Field side of end posts at joint 2

(d) Field side of middle post of section 3

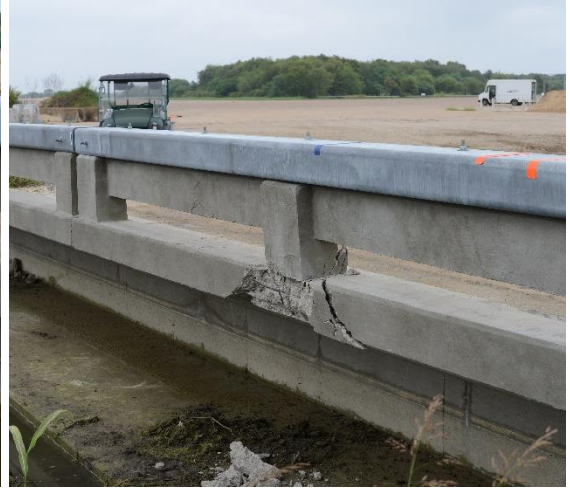
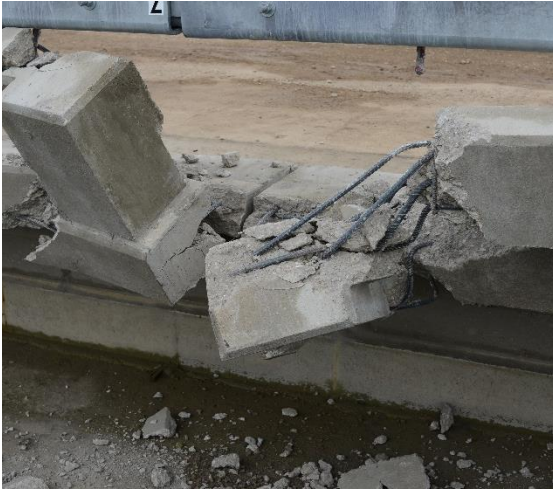
(b) Field side of middle post of section 2

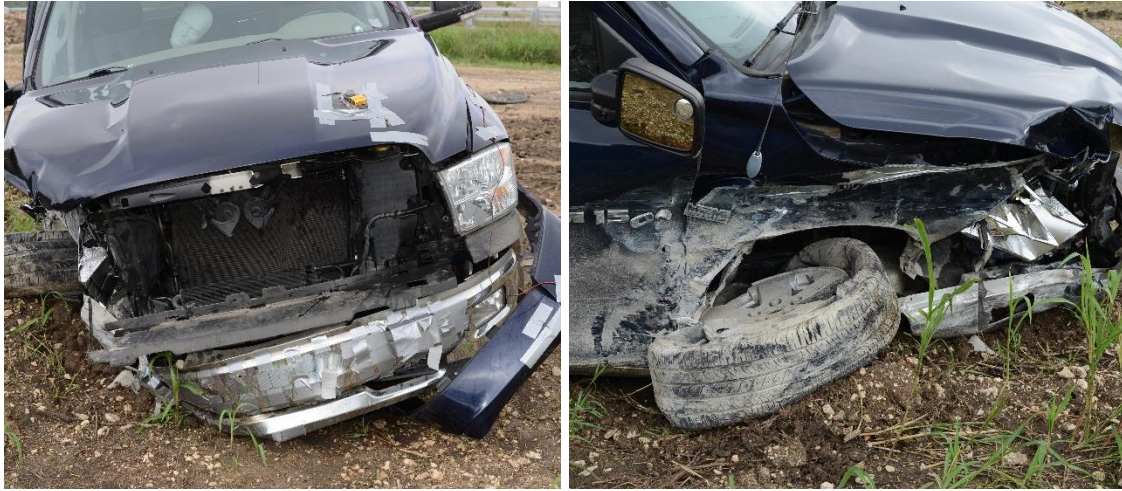
Figure 56. Test vehicle after Test No. 606861-1

(a) Front of 2270P test vehicle after test

(b) Right front of 2270P test vehicle

Figure 56 shows the damage sustained by the vehicle. The front bumper, grill, hood, right front fender, right front upper and lower ball joints, right front tire and rim, right frame rail, right front door, right rear tire, and rear bumper were damaged. Maximum exterior crush to the vehicle was 16.0 in. in the front plane at the right front corner at bumper height. Maximum occupant compartment deformation was 2.0 in. in the right firewall. Figure 57 shows the interior of the vehicle. Figure 111 and Figure 112 in Appendix D provide exterior crush and occupant compartment measurements.

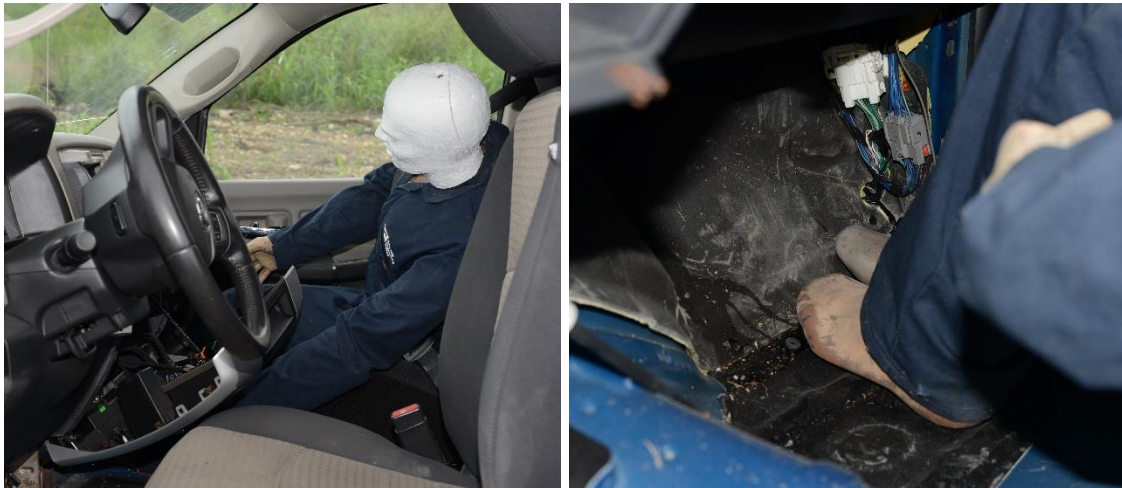
Figure 57. Interior of test vehicle after Test No. 606861-1

(a) Interior of cab of 2270P test vehicle

(a) Right front floor pan of 2270P test vehicle

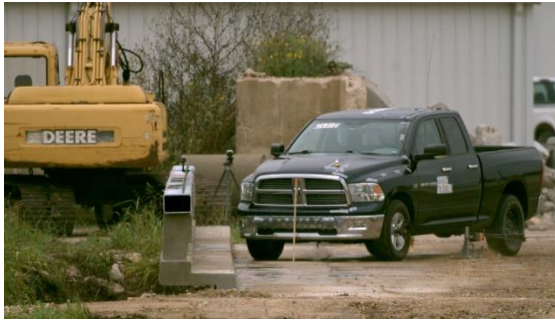
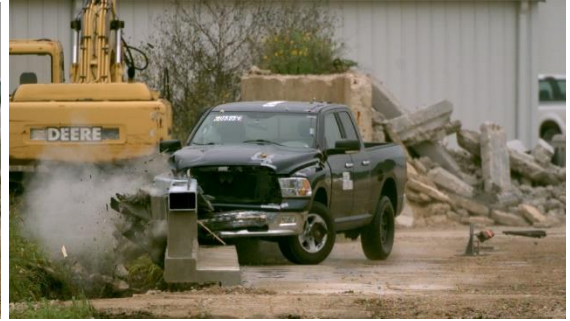
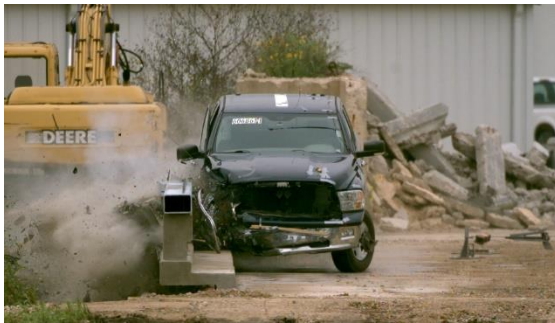
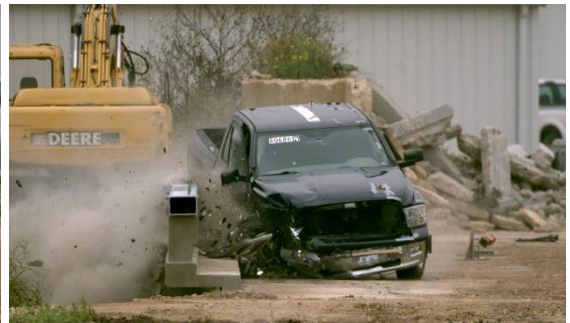
Figure 58. Summary of results for MASH Test 3-11 on Louisiana Retrofit Post and Beam Bridge Rail with Safety Walk Option 1

(a) 0.000 s

(b) 0.200 s

(c) 0.400 s

(d) 0.600 s

Data from the accelerometer, located at the vehicle center of gravity, were digitized for evaluation of occupant risk and results are shown in Table 11. Figure 58, Table 12, and Table 13 summarize these data and other pertinent information from the test. Figure 113 in Appendix D shows the vehicle angular displacements, and Figure 114 through Figure 116 in Appendix D show acceleration versus time traces.

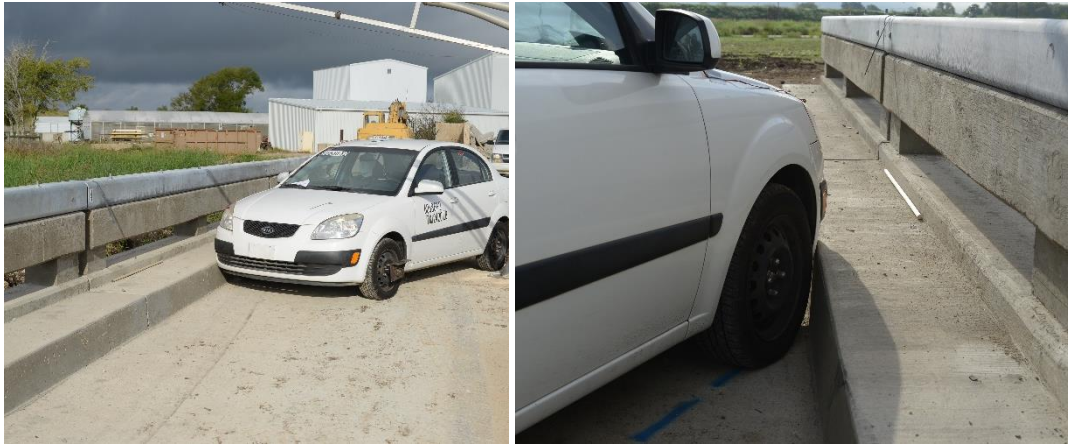
Figure 59. Test vehicle/bridge rail geometrics for Test No. 606861-2

(a) Frontal view of 1100C test vehicle at target impact point

(b) Rear view of 1100C test vehicle at target impact point

MASH Test 3-10 involves an 1100C vehicle weighing 2420 lbs \pm 55 lbs impacting the CIP of the bridge barrier at an impact speed of 62 mi/h \pm 2.5 mi/h and an angle of 25 degrees \pm 1.5 degrees. The CIP for MASH Test 3-10 on the Louisiana Retrofit post and beam bridge rail with safety walk Option 1 was 3.6 ft. \pm 1 ft. upstream of the centerline of the fourth open joint in the concrete deck/beam. Figure 44 and Figure 59 depict the target impact point.

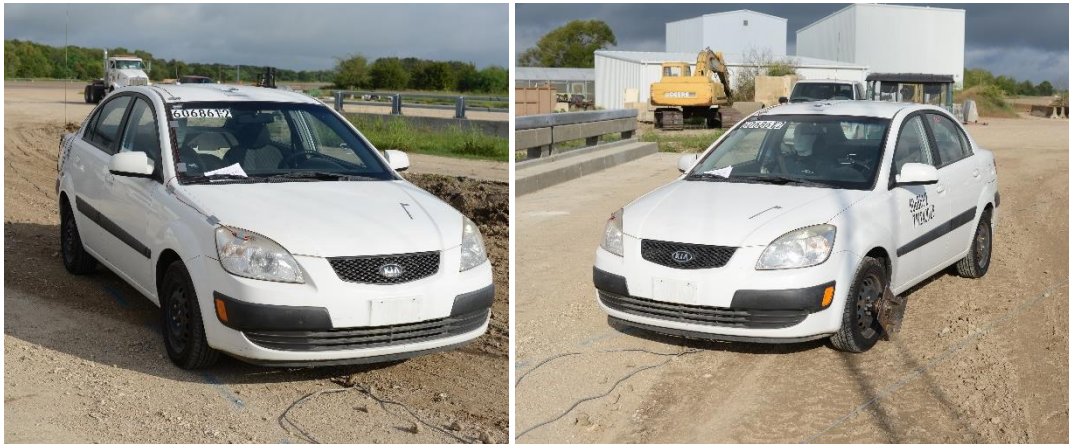
Figure 60. Test vehicle before Test No. 606861-2

(a) Right side of 1100C test vehicle

(b) Left side of 1100C test vehicle

Figure 60 shows the 2009 Kia Rio¹⁰ used for the crash test. The vehicle's test inertia weight was 2425 lbs, and its gross static weight was 2590 lbs. The height to the lower edge of the vehicle bumper was 7.75 in., and the height to the upper edge of the bumper was 21.5 in. Figure 117 in Appendix E gives additional dimensions and information on the vehicle. The vehicle was directed into the installation using a cable reverse tow and guidance system, and was released to be freewheeling and unrestrained just prior to impact.

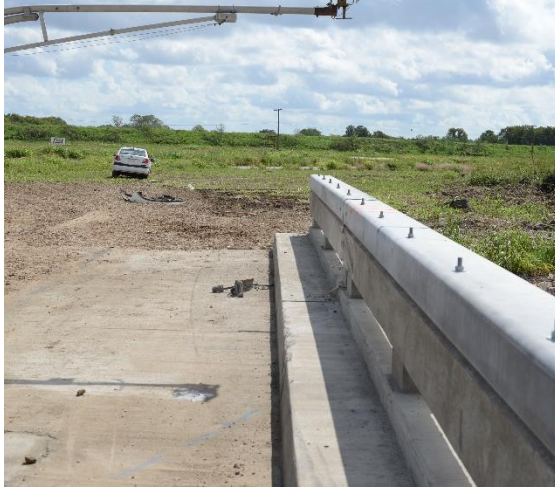
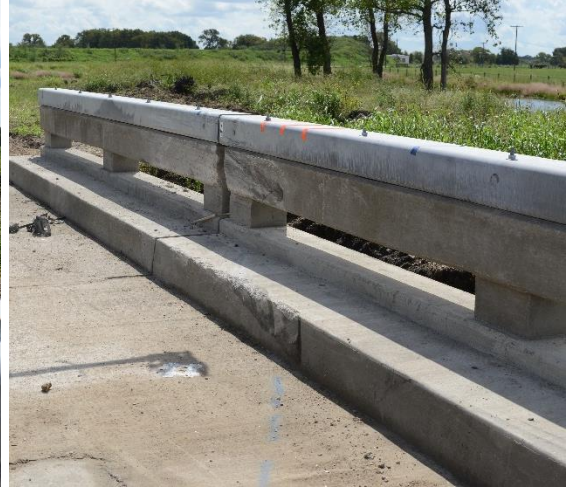
Figure 61. Option 1 bridge rail after Test No. 606861-2

(a) Bridge rail/test vehicle after test

(b) Traffic side of bridge rail at impact

Figure 61 through Figure 63 show the damage to the Option 1 bridge rail. The concrete curb was cracked through on the upstream side of the post on the downstream end of section 4, and a small crack in the curb was observed on the downstream side. The metal rail element was scuffed and scratched. Working width¹¹ was 12.7 in., and height of

working width was 42.6 in. Maximum dynamic deflection during the test was 0.7 in., and there was no measurable permanent deformation.

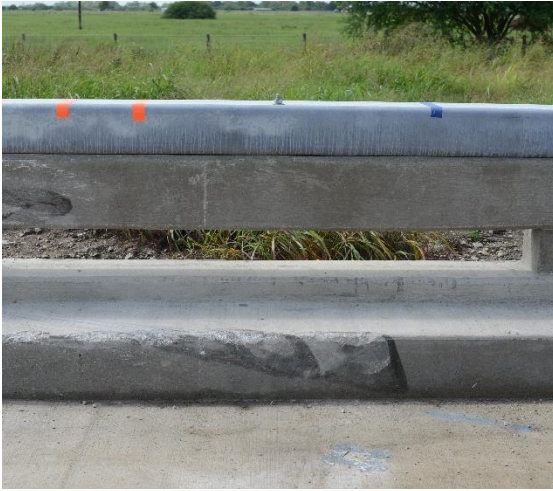
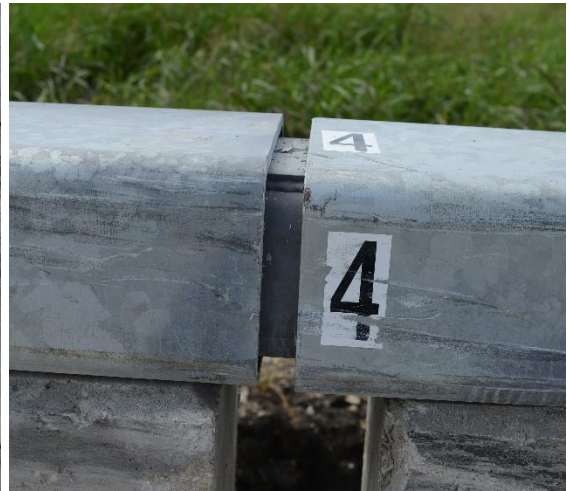
Figure 62. Damage to traffic face of bridge rail after Test No. 606861-2

(a) Traffic side at impact point

(c) Traffic side of posts at joint 4

(d) Traffic side of metal rail at joint 4

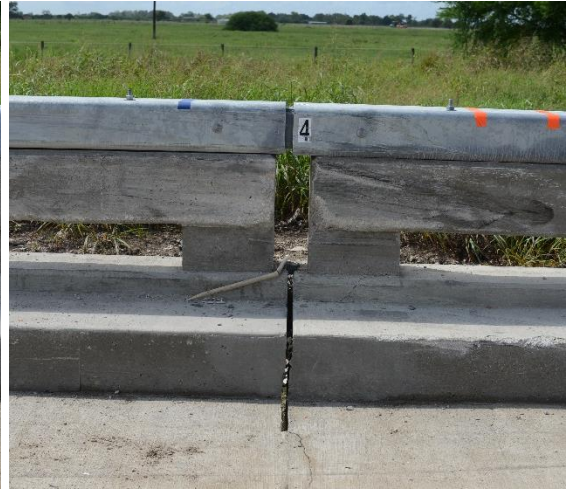
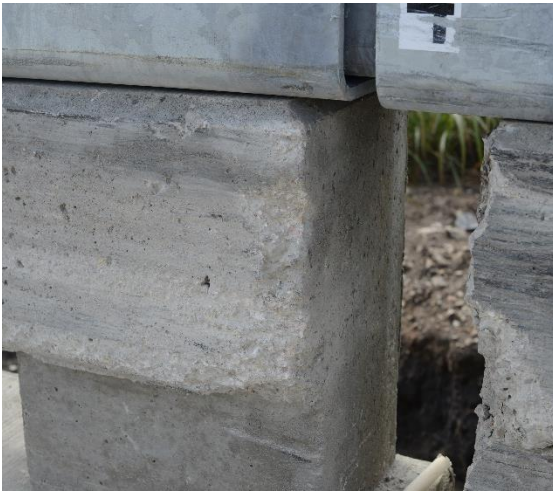
(b) Traffic side of joint 4

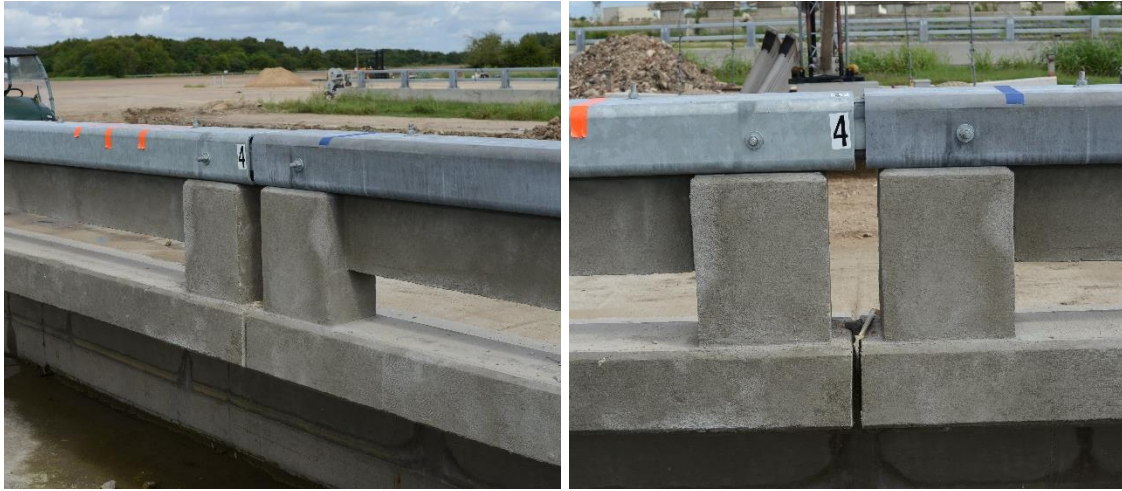
Figure 63. Damage on field side of bridge rail after Test No. 606861-2

(a) Field side of joint 4

(b) Close up view of field side of joint 4

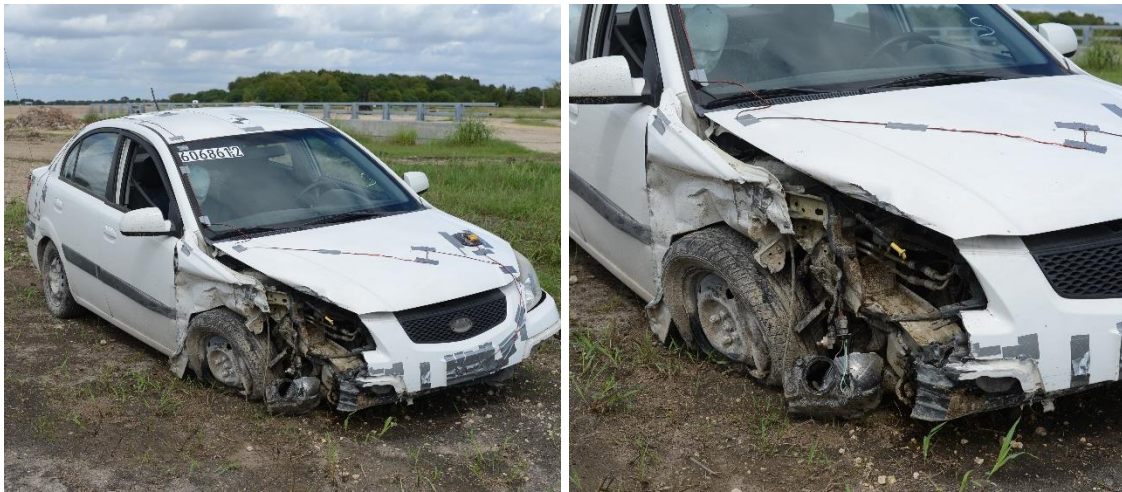
Figure 64. Test vehicle after Test No. 606861-2

(a) Front of 1100C test vehicle after test

(b) Right front of 1100C test vehicle

Figure 64 shows the damage sustained by the vehicle. The front bumper, grill, hood, radiator and support, right front tire and rim, right front strut and strut tower, right front fender, right front door and window glass, right rear quarter panel, right rear rim, and rear bumper were damaged. Maximum exterior crush to the vehicle was 9.0 in. in the side plane at the right front corner at bumper height. Maximum occupant compartment deformation was 1.5 in. in the right firewall area. Figure 65 shows the interior of the vehicle. Figure 121 and Figure 122 in Appendix E provide exterior crush and occupant compartment measurements.

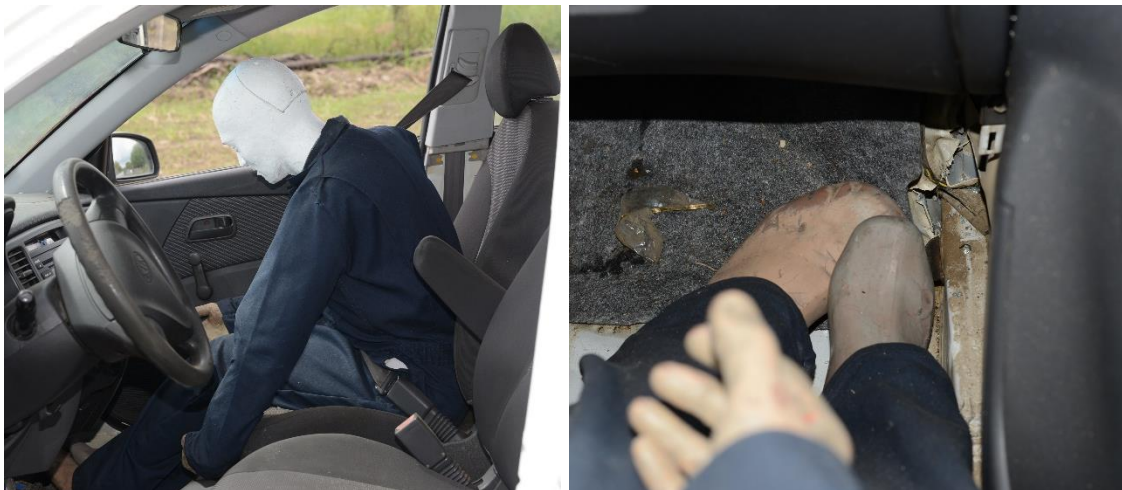
Figure 65. Interior of test vehicle after Test No. 606861-2

(a) Interior of cab of 1100C test vehicle

(b) Right front floor pan

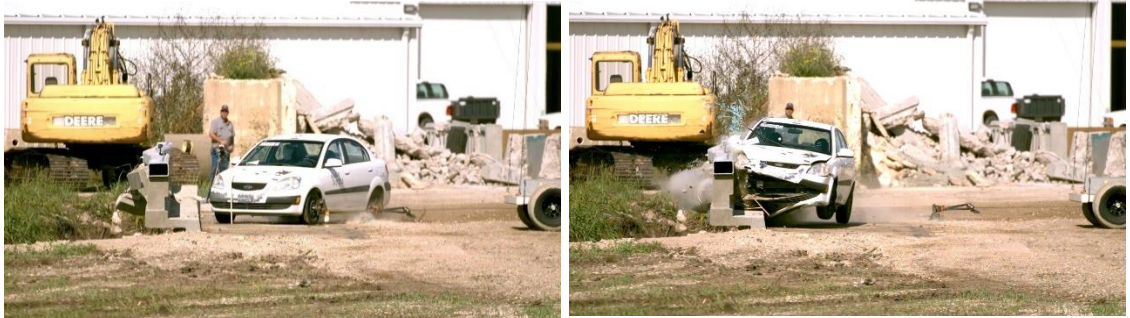
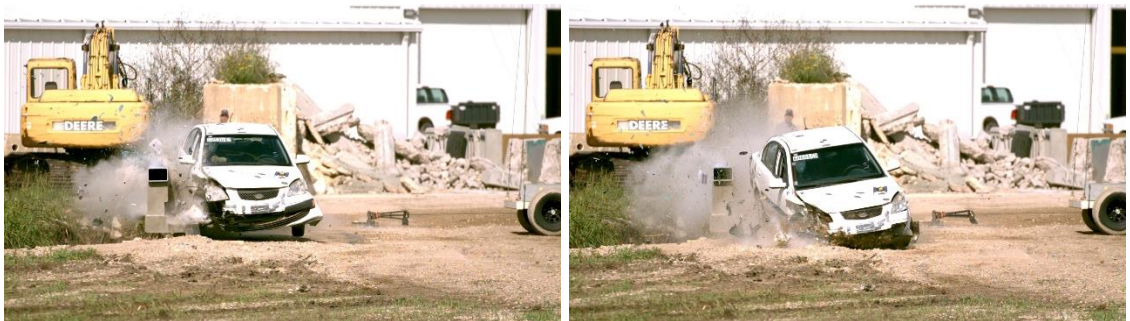
Figure 66. Summary of results for MASH Test 3-10 on Louisiana Retrofit Post and Beam Bridge Rail with Safety Walk Option 1

(a) 0.000 s

(b) 0.200 s

(c) 0.400 s

(d) 0.600 s

Data from the accelerometer, located at the vehicle center of gravity, were digitized for evaluation of occupant risk and results are shown in Table 15. Figure 66, Table 16, and Table 17 summarize these data and other pertinent information from the test. Figure 123 in Appendix E shows the vehicle angular displacements, and Figure 124 through Figure 126 in Appendix E show acceleration versus time traces.

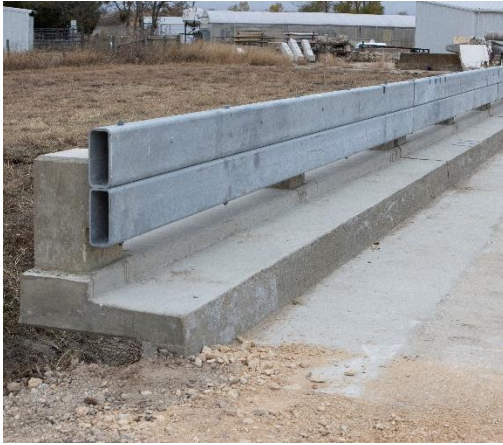
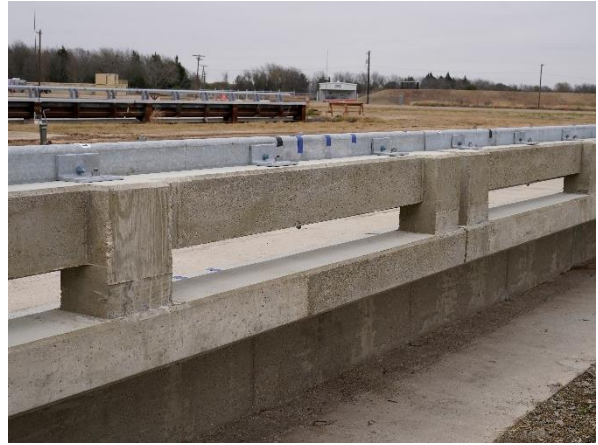
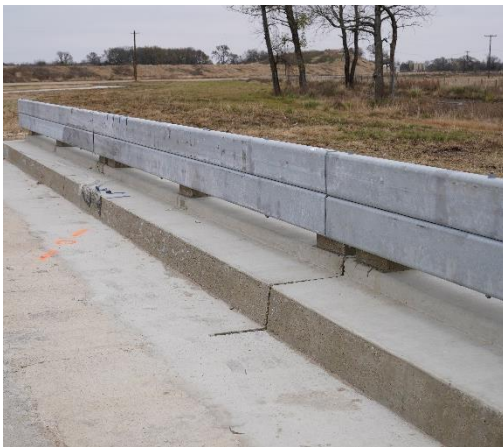
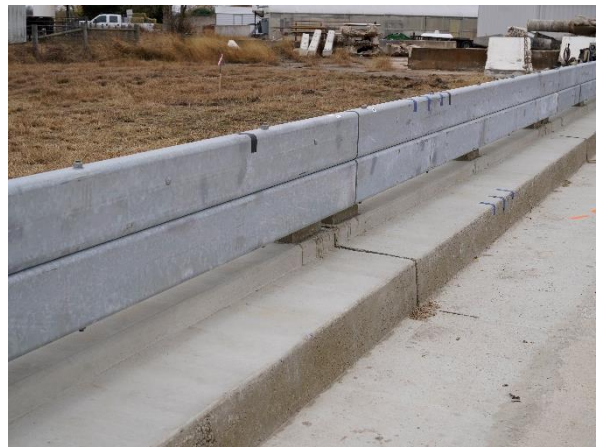
Figure 73. Louisiana Retrofit Post and Beam Bridge Rail with Safety Walk Option 2 prior to testing

(a) Traffic face of bridge rail

(b) Field side of bridge rail

(c) Upstream of joint

(d) Downstream of joint

Appendix G presents the drawings and information on the Louisiana Retrofit post and beam bridge rail with safety walk Option 2, and Figure 73 and Figure 74 provides photographs of the completed installation.

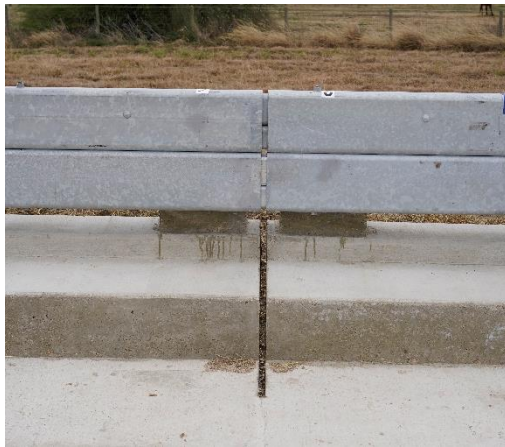
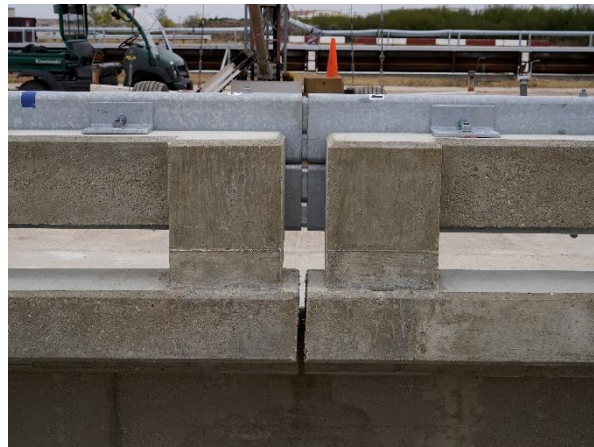
Figure 74. Joint of Louisiana Retrofit Post and Beam Bridge Rail with Safety Walk Option 2 prior to testing

(a) Traffic face at joint

(b) Field side at joint

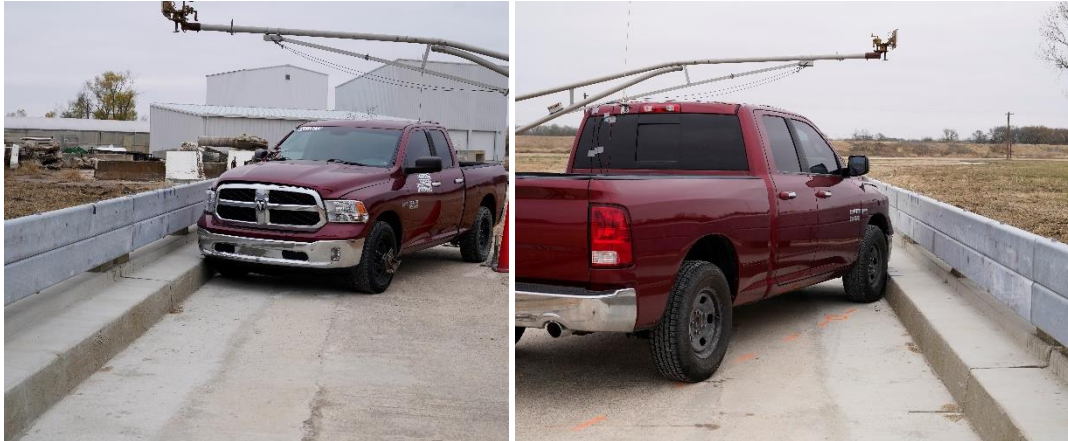
Figure 75. Test vehicle/bridge rail geometrics for Test No. 606861-3

(a) Frontal view of 2270P test vehicle at target impact point

(b) Rear view of 2270P test vehicle at target impact point

MASH Test 3-11 involved a 2270P vehicle weighing 5000 lbs \pm 110 lbs impacting the CIP of the bridge barrier at an impact speed of 62 mi/h \pm 2.5 mi/h and an angle of 25 degrees \pm 1.5 degrees. The CIP for MASH Test 3-11 on the Louisiana Retrofit post and beam bridge rail with safety walk Option 2 was determined to be 4.3 ft. upstream of the centerline of the second open joint in the deck/beam. Figure 46 and Figure 75 depict the target CIP.

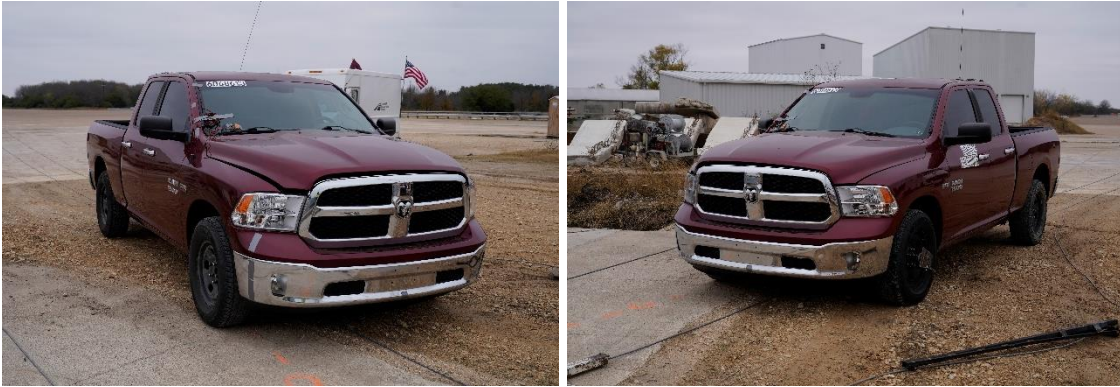
Figure 76. Test vehicle prior to Test No. 606861-3

(a) Right side of 2270P test vehicle

(b) Left side of 2270P test vehicle

Figure 76 shows the 2014 RAM 1500 pickup truck used for the crash test. The vehicle's test inertia weight was 5056 lbs, and its gross static weight was 5221 lbs. The height to the lower edge of the vehicle bumper was 11.75 in., and the height to the upper edge of the bumper was 27.0 in. The height to the vehicle's center of gravity was 28.5 in. Figure 127 and Figure 128 in Appendix J give additional dimensions and information on the vehicle. The vehicle was directed into the installation using a cable reverse tow and guidance system, and was released to be freewheeling and unrestrained just prior to impact.

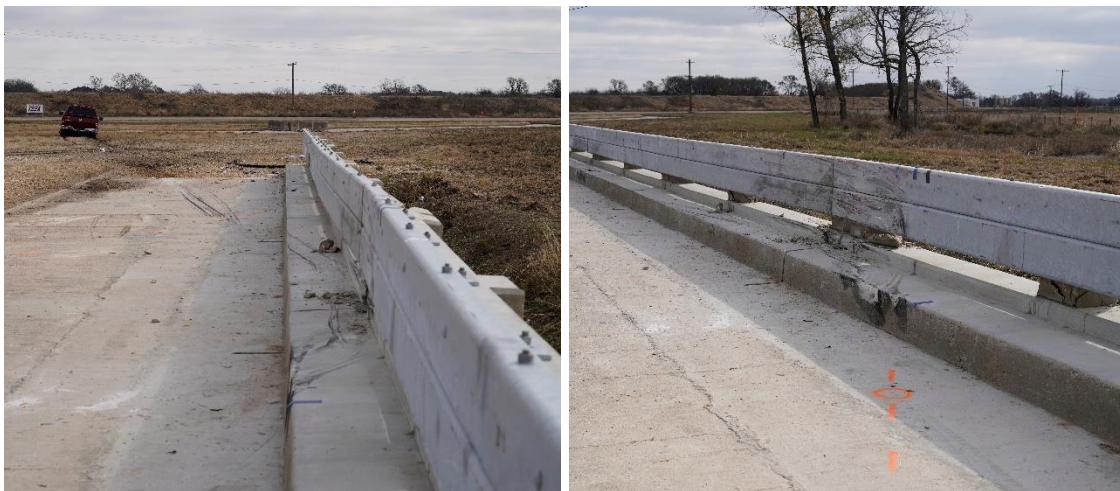
Figure 77. Option 2 bridge rail after Test No. 606861-3

(a) Bridge rail/test vehicle after test

(b) Traffic side of bridge rail at impact

Figure 77 through Figure 79 show the damage to the Option 2 bridge rail. There was some gouging and scuffing of the sidewalk at impact. The concrete deck and posts had significant damage at posts 5, 6, 7, and 8, with exposed rebar at posts 6, 7, and 8. There were several large cracks at the top of posts 6 and 7. There was also some scuffing on the metal rail element. Working width¹⁴ was 38.7 in., and height of the working width was 28.0 in. Maximum dynamic deflection during the test was 6.8 in., and maximum permanent deformation was 3.4 in.

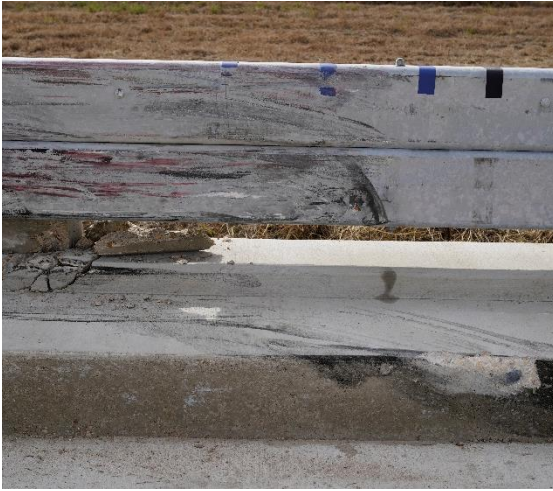
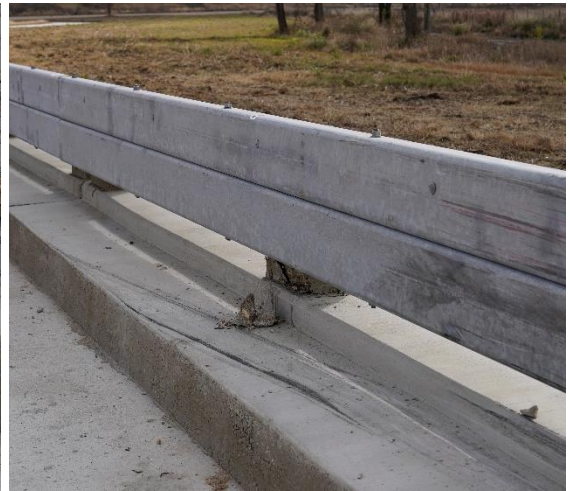
Figure 78. Damage to traffic face of bridge rail after Test No. 606861-3

(a) Traffic side at impact point

(c) Traffic side of posts at joint

(d) Traffic side loss of contact

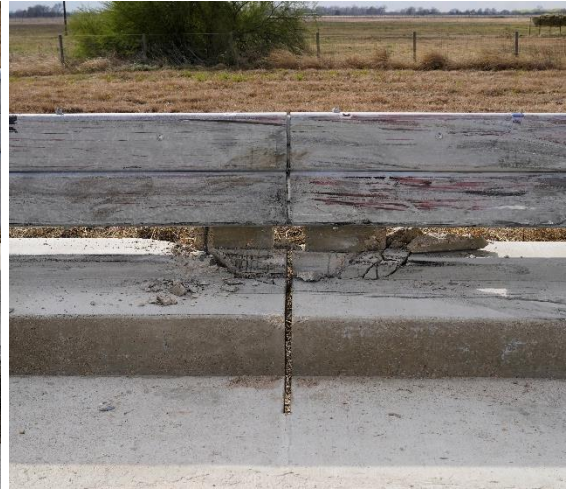
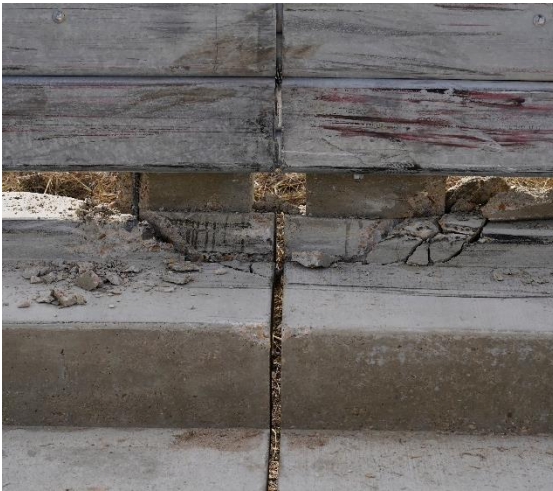
(b) Traffic side of joint

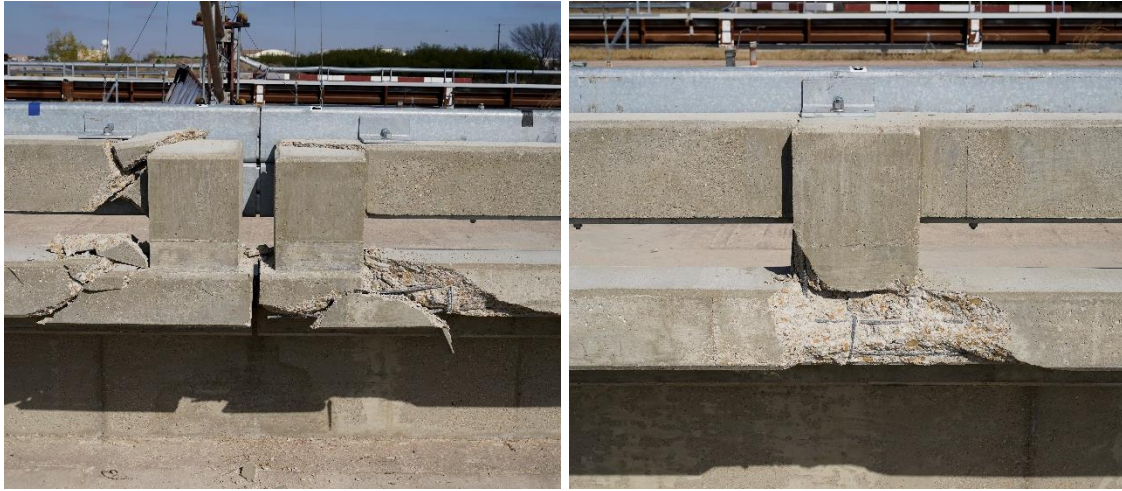
Figure 79. Damage on field side of bridge rail after Test No. 606861-3

(a) Field side of joint

(b) Field side of middle post

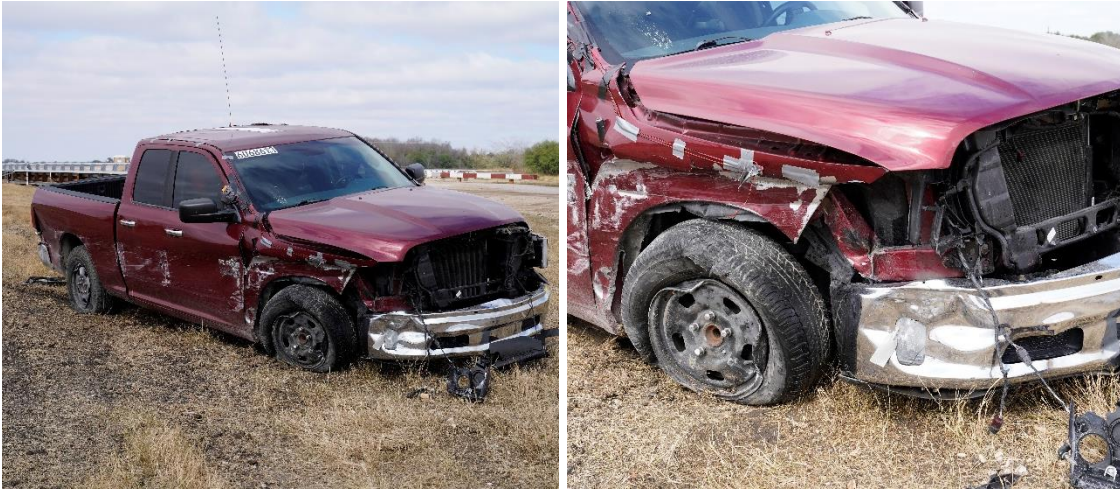
Figure 80. Test vehicle after Test No. 606861-3

(a) Front of 2270P test vehicle after test

(b) Right front of 2270P test vehicle

Figure 80 shows the damage sustained by the vehicle. The front bumper, grill, hood, radiator and support, right front fender, right front tire and rim, right front and rear doors, right rear cab corner, right rear exterior bed, right rear tire, and rear bumper were damaged. Maximum exterior crush to the vehicle was 11.0 in. in the front plane at the right front corner at bumper height. No occupant compartment deformation was observed. Figure 81 shows the interior of the vehicle. Figure 132 and Figure 133 in Appendix J provide exterior crush and occupant compartment measurements.

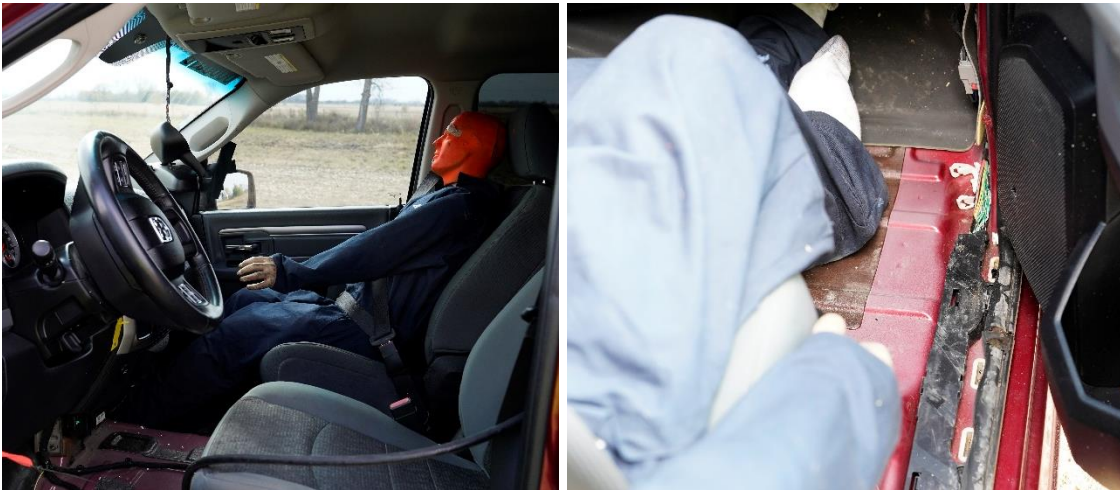
Figure 81. Interior of test vehicle after Test No. 606861-3

(b) Interior of cab of 2270P test vehicle

(a) Right front floor pan of 2270P test vehicle

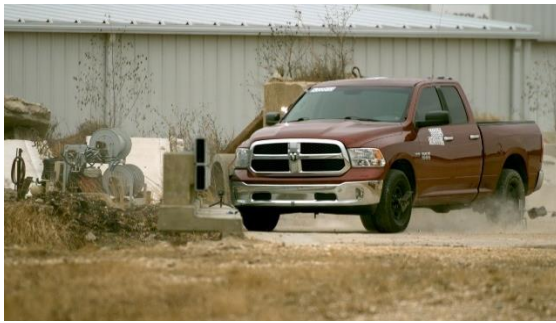
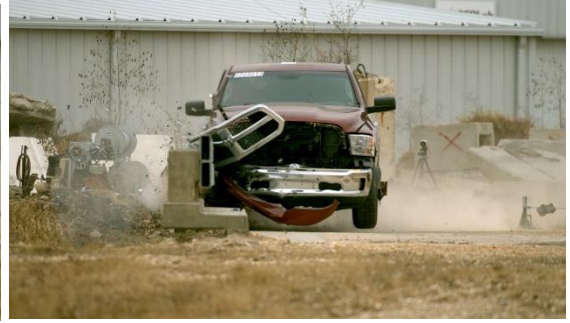
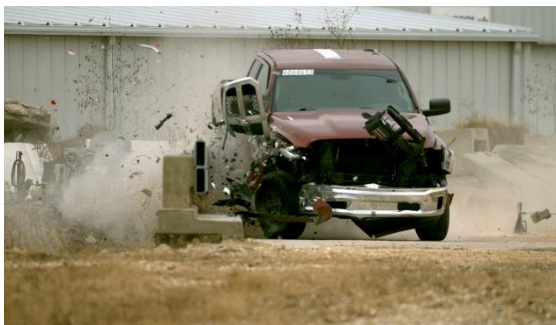
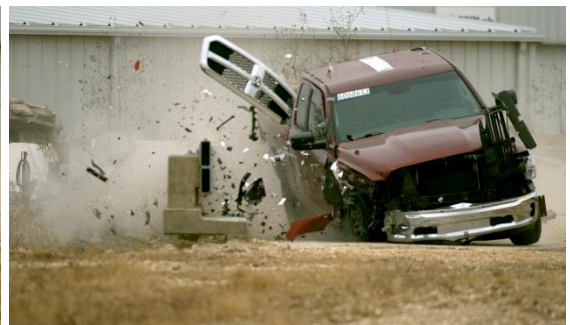
Figure 82. Summary of results for MASH Test 3-11 On Louisiana Retrofit Post and Beam Bridge Rail with Safety Walk Option 2

(a) 0.000 s

(b) 0.200 s

(c) 0.400 s

(d) 0.600 s

Data from the accelerometer, located at the vehicle center of gravity, were digitized for evaluation of occupant risk and results are shown in Table 21. Figure 82, Table 22, and Table 23 summarize these data and other pertinent information from the test. Figure 134 in Appendix J shows the vehicle angular displacements, and Figure 135 through Figure 137 in Appendix J show acceleration versus time traces.

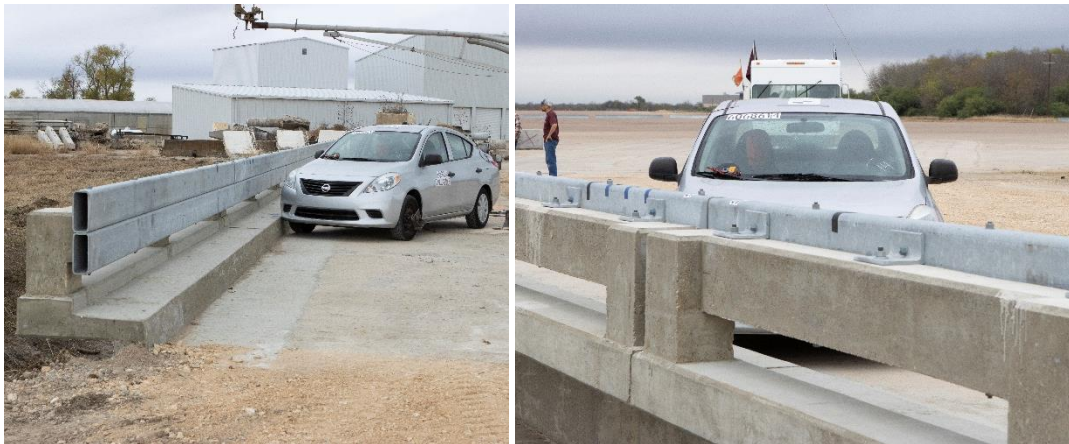
Figure 83. Test vehicle/bridge rail geometrics for Test No. 606861-4

(a) Frontal view of 1100C test vehicle at target impact point

(b) Field side view of 1100C test vehicle at target impact point

MASH Test 3-10 involves an 1100C vehicle weighing 2420 lbs \pm 55 lbs impacting the CIP of the bridge barrier at an impact speed of 62 mi/h \pm 2.5 mi/h and an angle of 25 degrees \pm 1.5 degrees. The CIP for MASH Test 3-10 on the Louisiana Retrofit post and beam bridge rail with safety walk Option 2 was 3.6 ft. \pm 1 ft. upstream of the centerline of the fourth open joint in the deck/beam. Figure 45 and Figure 83 depict the target impact point.

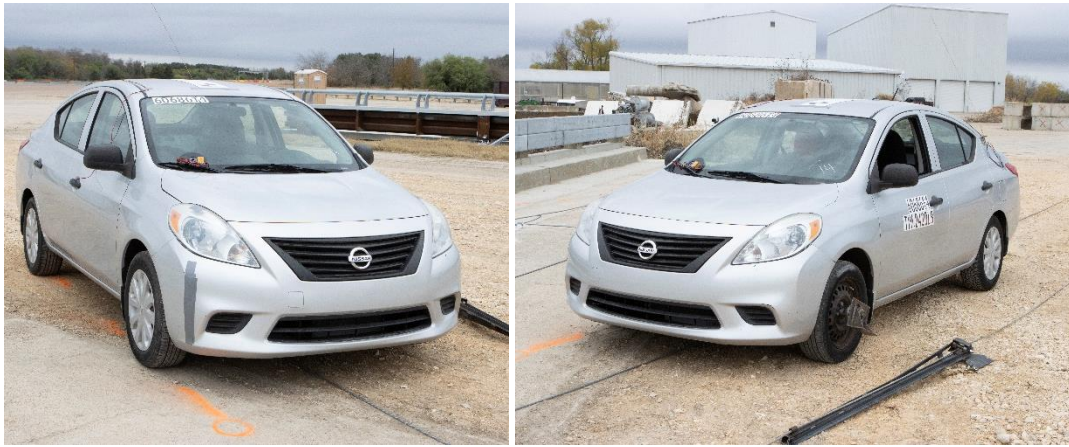
Figure 84. Test vehicle before Test No. 606861-4

(a) Right side of 1100C test vehicle

(b) Left side of 1100C test vehicle

Figure 84 shows the 2014 Nissan Versa used for the crash test. The vehicle's test inertia weight was 2404 lbs, and its gross static weight was 2569 lbs. The height to the lower edge of the vehicle bumper was 7.0 in., and the height to the upper edge of the bumper was 22.25 in. Figure 138 in Appendix K gives additional dimensions and information on the vehicle. The vehicle was directed into the installation using a cable reverse tow and guidance system, and was released to be freewheeling and unrestrained just prior to impact.

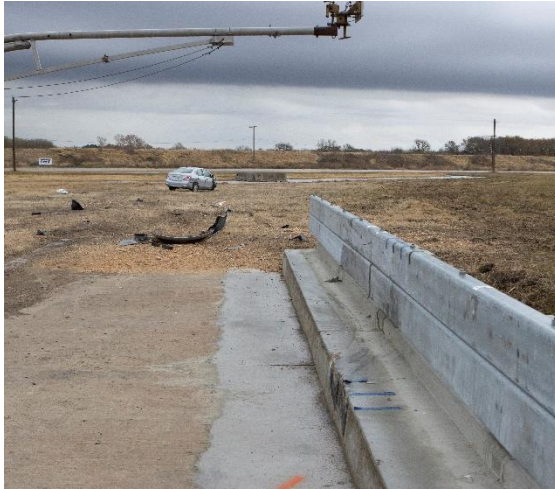
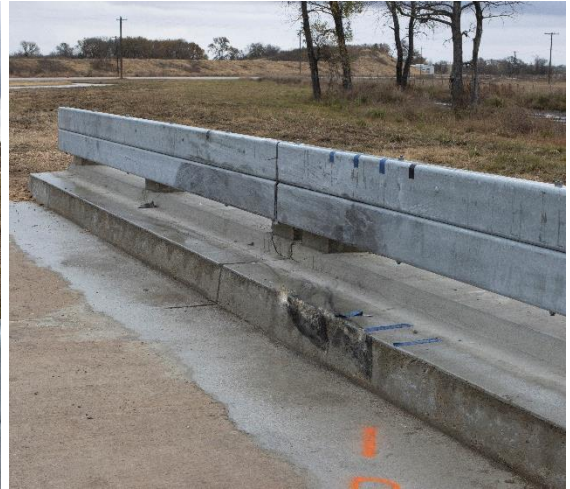
Figure 85. Option 2 ridge rail after Test No. 606861-4

(a) Bridge rail/test vehicle after test

(b) Traffic side of bridge rail at impact

Figure 85 through Figure 87 show the damage to the Option 2 bridge rail. There was some gouging and scuffing of the sidewalk at the point of impact, and the curb cracked at posts 12, 13, and 14. The cracks at posts 12 and 13 extended from the traffic side of the curb to the field side, and under the deck 11 in. at post 12 and 9 in. at post 13. The posts were also cracked at posts 12 and 13. At post 14, the curb and post were cracked on the field side. There was also some scuffing on the rail. Working width¹⁵ was 33.0 in., and

height of working width was 4.6 in. Maximum dynamic deflection during the test was 1.8 in., and maximum permanent deformation was 0.6 in.

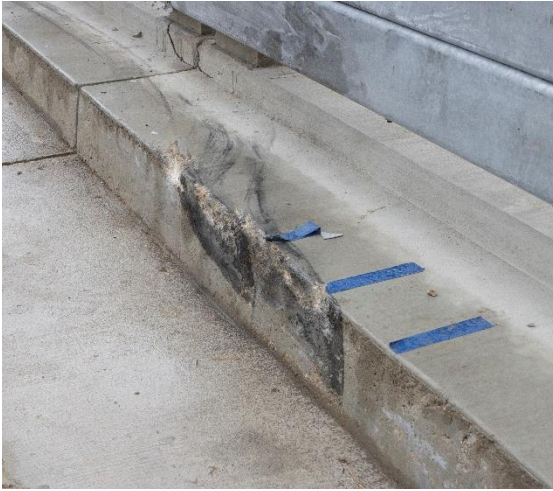
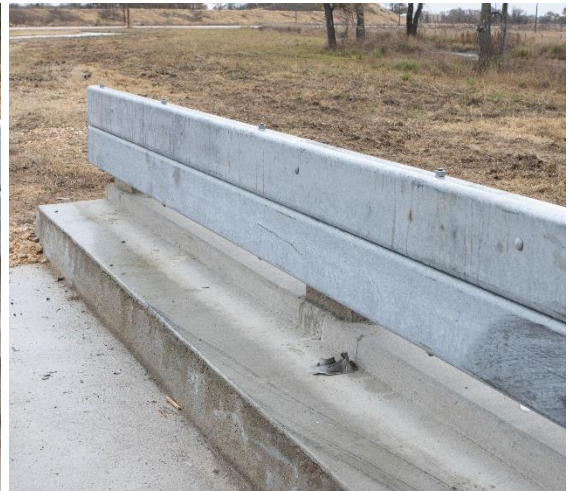
Figure 86. Damage to traffic face of bridge rail after Test No. 606861-4

(a) Traffic side at impact point

(c) Traffic side of posts at joint

(d) Traffic side loss of contact

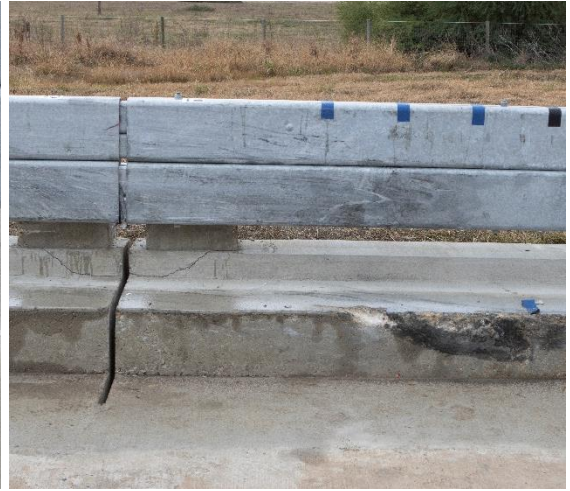
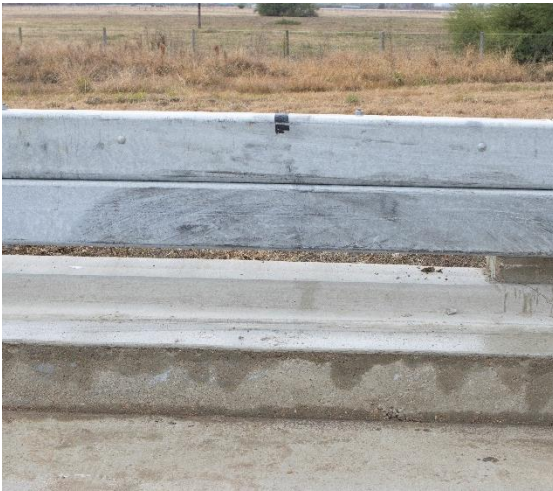
(b) Traffic side of joint

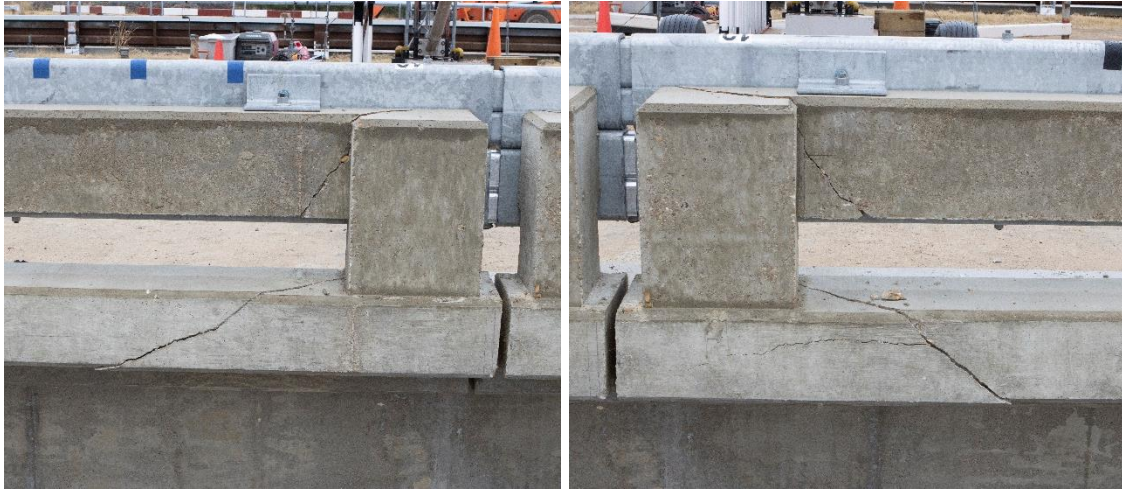
Figure 87. Damage on field side of bridge rail after Test No. 606861-4

(a) Field side upstream of joint

(b) Field side downstream of joint

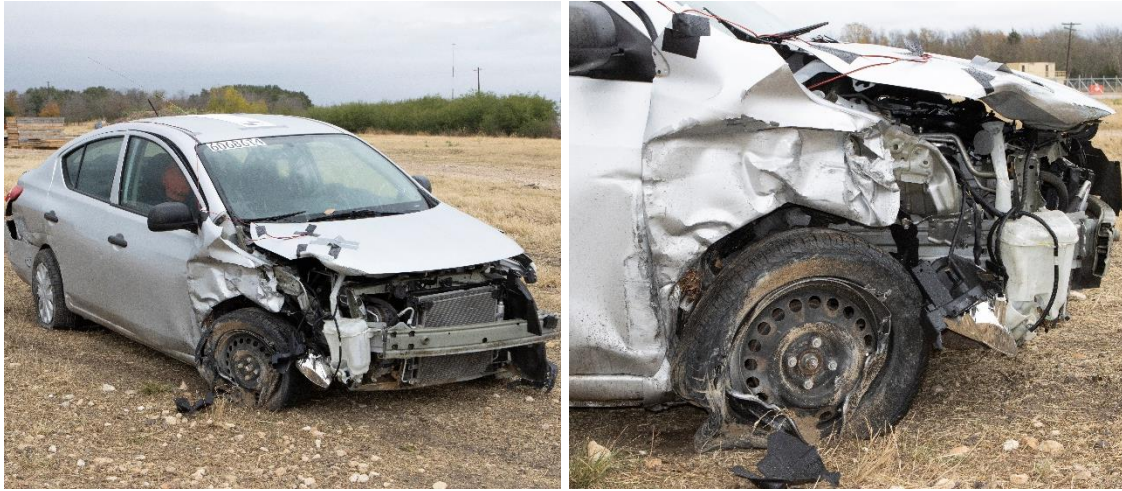
Figure 88. Test vehicle after Test No. 606861-4

(a) Front of 1100C test vehicle after test

(b) Right front of 1100C test vehicle

Figure 88 shows the damage sustained by the vehicle. The front bumper, grill, hood, radiator and support, right front fender, right front tire and rim, right strut and tower, right front and rear doors, right rear quarter panel, right rear tire and rim, and rear bumper were damaged. Maximum exterior crush to the vehicle was 9.0 in. in the front plane at the right front corner at bumper height. Maximum occupant compartment deformation was 0.5 in. in the right front floor pan and right front kick panel area. Figure 89 shows the interior of the vehicle. Figure 142 and Figure 143 in Appendix K provide exterior crush and occupant compartment measurements.
