Louisiana Transportation Research Center

Final Report 658

**Retrofit of Existing Statewide Louisiana Safety
Walk Bridge Barrier Railing Systems**

Texas A&M Transportation Institute

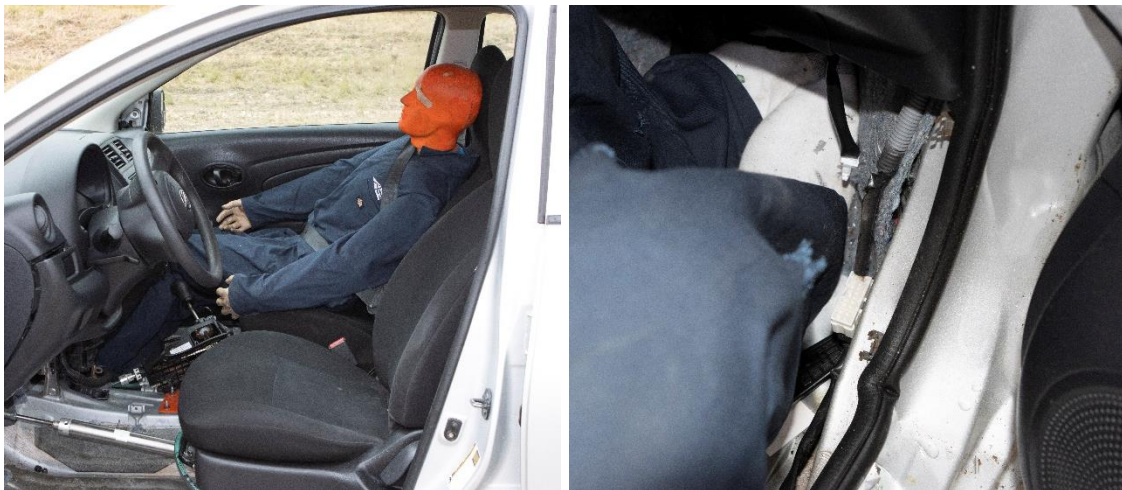
Figure 89. Interior of test vehicle after Test No. 606861-4

(c) Interior of cab of 1100C

(a) Right front floor pan of 1100C test vehicle

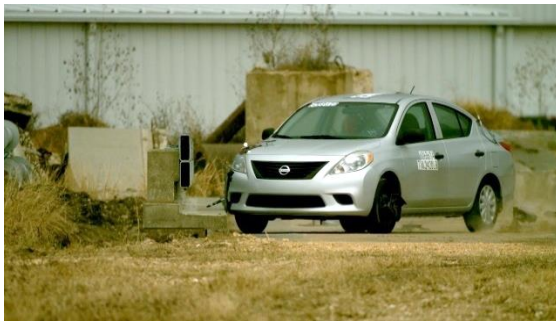
Figure 90. Summary of results for MASH Test 3-10 on Louisiana Retrofit Post and Beam Bridge Rail with Safety walk Option 2

(a) 0.000 s

Data from the accelerometer, located at the vehicle center of gravity, were digitized for evaluation of occupant risk and results are shown in Table 25. Figure 90, Table 26, and Table 27 summarize these data and other pertinent information from the test. Figure 144 in Appendix K shows the vehicle angular displacements, and Figure 145 through Figure 147 in Appendix K show acceleration versus time traces.

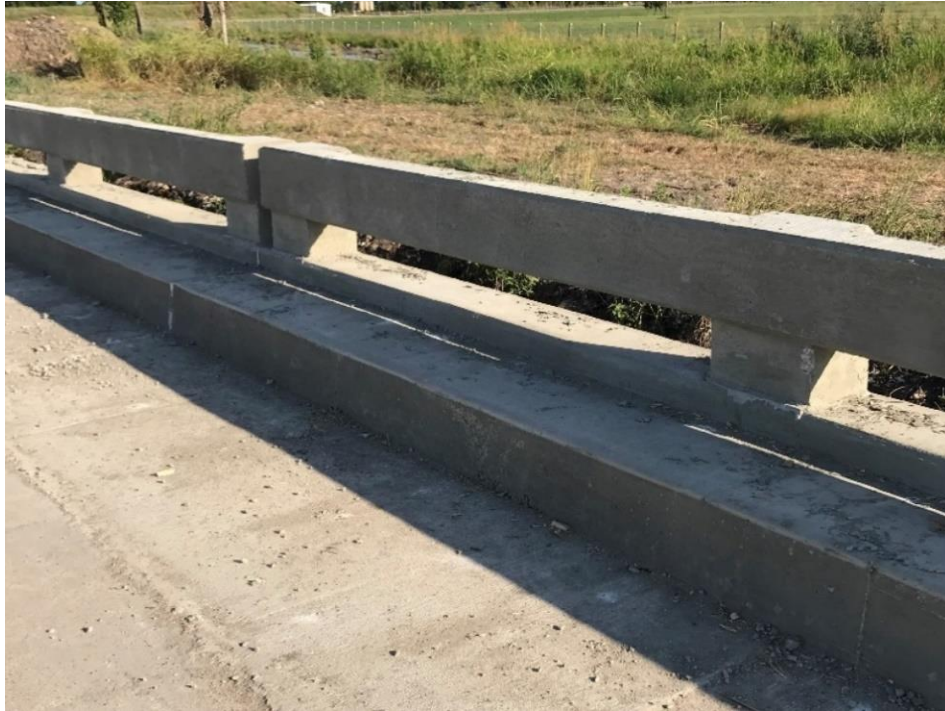
Figure 91. Safety walk barrier with concrete post and beam bridge rail

1. Figure 91 shows a view of the simulated Louisiana safety walk bridge barrier railing system with concrete deck cantilever (TTI simulated crash test installation) without the retrofit bridge rail.

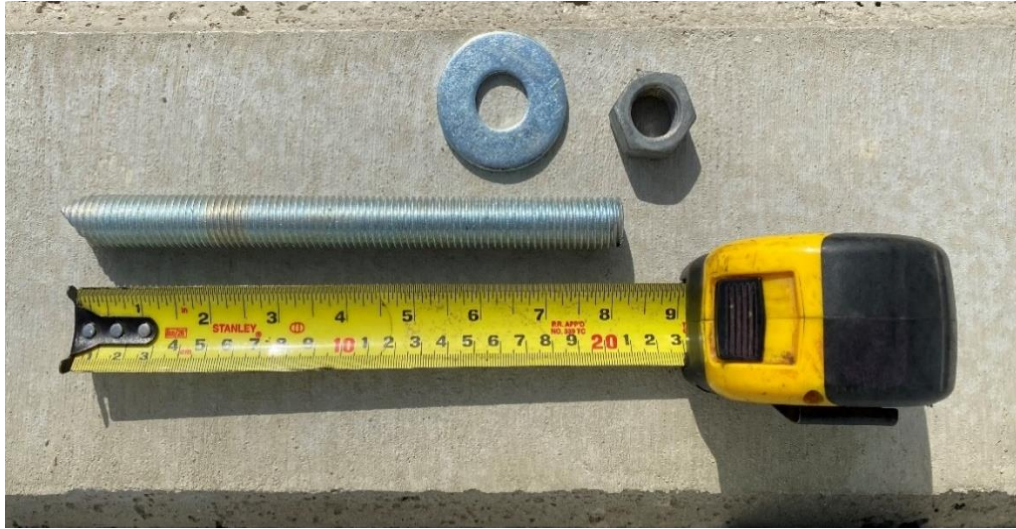
Figure 92. Hot dipped A193 B7 ¾-in. diameter Hilti threaded rod

2. Drill and install adhesive anchors for L6×4×½ angle support brackets on top of concrete bridge rail. These holes shall be drilled and the anchors installed as per the manufacturer's specifications. Hilti RE500-V3 adhesive shall be used for these ¾-in. diameter by 8 in. long anchors. The anchors shall be embedded 6 in. minimum. These anchors shall be A193-B7 galvanized threaded rods installed typically using 52 in. maximum spacing on the top of the barrier as shown in the drawings provided herein. For the solid concrete parapet design Option shown in Figures 70 to 72, the anchors shall be embedded 10 in. minimum. Photographs of the adhesive anchoring system used for this project and recommended for use for this retrofit design are provided in Figure 92 and Figure 93.

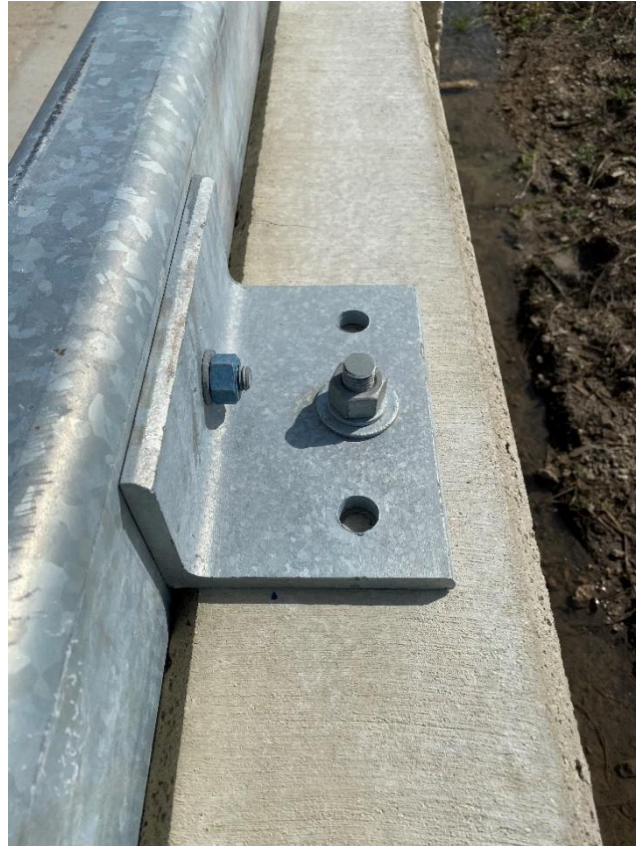
Figure 94. Installed L6×4×½ angle support bracket with ¾-in. A193 B7 galvanized threaded rod with Hilti RE500-V3 adhesive

3. Install L6×4×½ angle brackets and allow complete cure time as per Hilti HIT-RE500-V3 specifications. Figure 94 shows the bracket installed. The bracket shall be installed with the 4-in. angle face flush (even) with the face of the existing concrete barrier as shown in the photos and drawings. Please note, the concrete bridge rail is flush with the face of the support angle to provide a good uniform bearing surface for the new retrofit bridge rail. Also note, two additional holes

were provided in the L6×4×½ angle. These holes can be used if rebar is encountered in the drilling operation using the center hole in the angle.

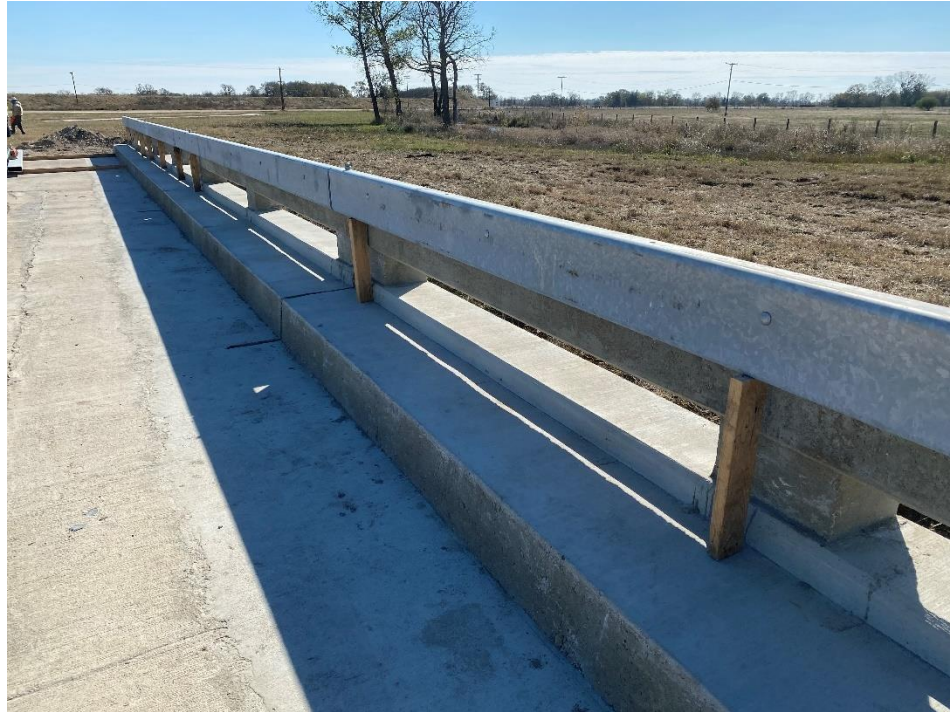
Figure 95. Installation of first/top rail element with temporary shoring support

4. Install/connect the top HSS10×4×¾ rail to the L6×4×½ angle support brackets. At each bracket location, the top rail element is attached to the bracket using a single round head 5/8-in. diameter x 5 ½ in. long bolt. Some temporary shoring support might be required to bolt this top rail element to the L6×4×½ angle support bracket. Figure 95 shows the top rail installed with the temporary shoring. Installation of the top rail should progress from one end of the bridge installation to the other adding bridge rail splices and additional rail elements as you proceed toward the opposite end of the bridge.

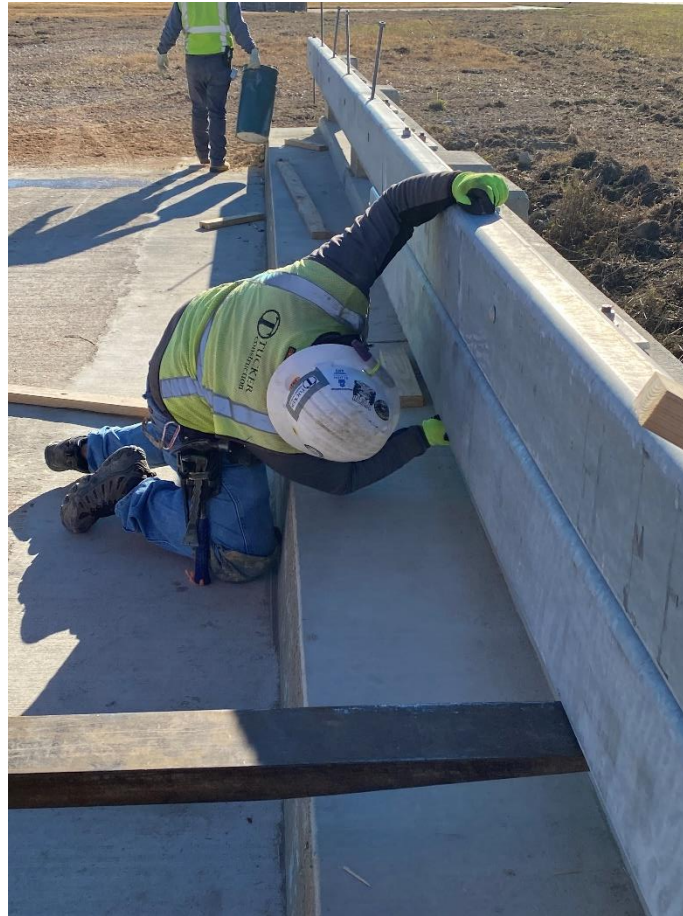
Figure 96. Installation of lower HSS10×4× $\frac{3}{8}$ rail and bolting to top rail with $\frac{5}{8}$ -in. diameter B7 threaded rods

5. Install lower HSS10×4× $\frac{3}{8}$ rail element by connecting lower element to top rail element using $\frac{5}{8}$ -in. × 22 in. long B7 threaded rods with F436 washers and two hex nuts. Figure 96 shows the lower rail installation.

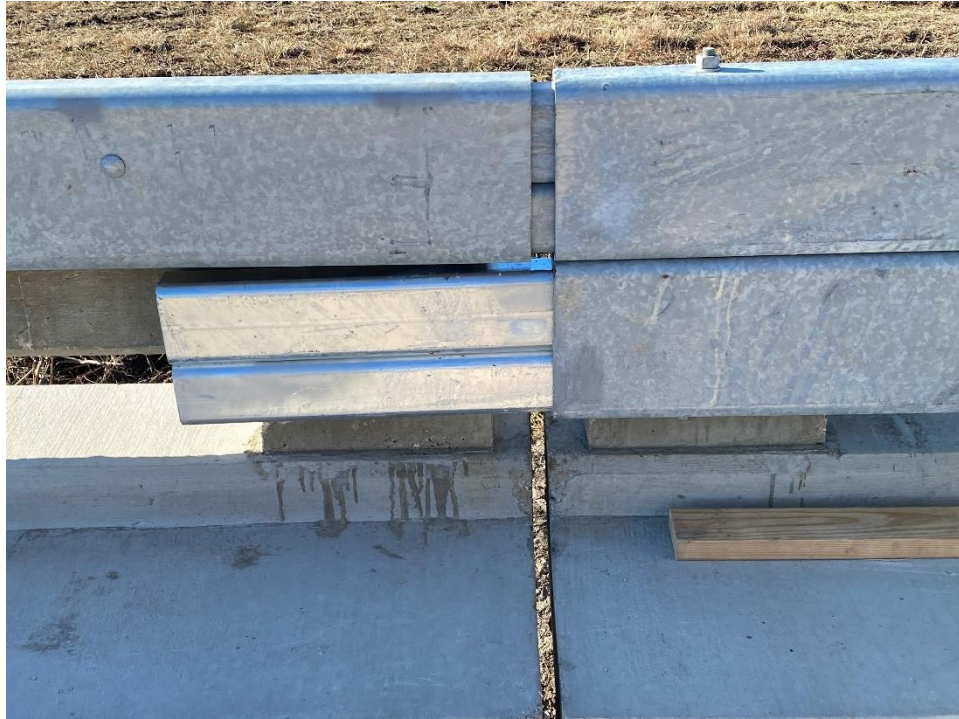
Figure 97. Typical splice assembly of rail prior to adding adjacent rail section

Figure 97 shows the installation of a typical splice joint assembly as installation of the rail progresses from one end of the installation (bridge) to the other. Photos of the completed rail section are shown in Figure 98 through Figure 100. From start to finish (after curing of the adhesive anchors), installation of the bridge rail installation was completed within 3 hours.

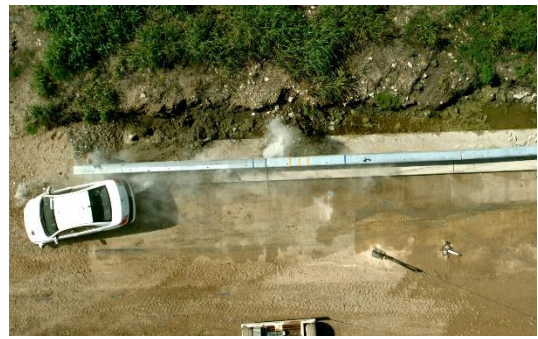
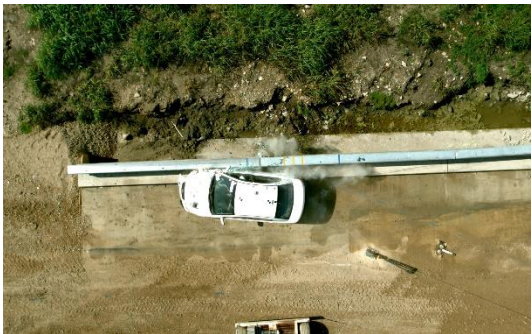
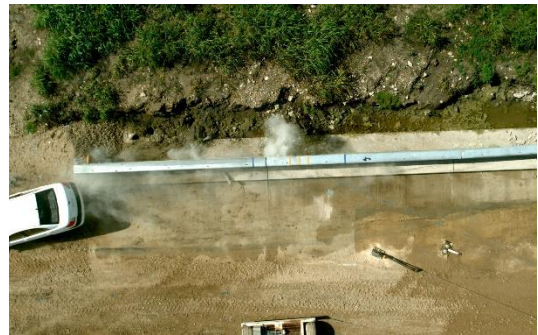
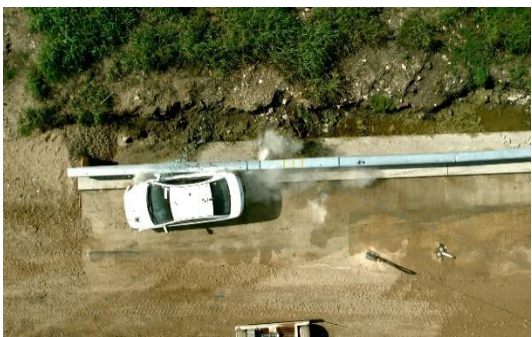
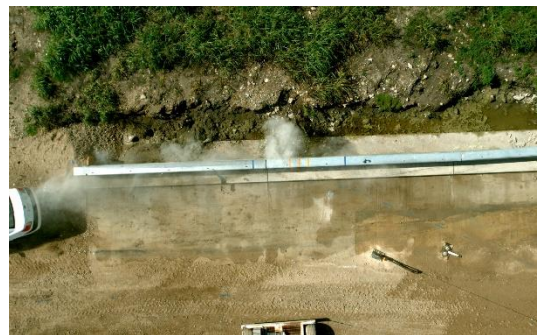
Figure 119. Sequential photographs for Test No. 606861-2 (frontal view).

Table 14 lists events that occurred during Test No. 606861-2. Figure 118 through Figure 120 in Appendix E present sequential photographs during the test.

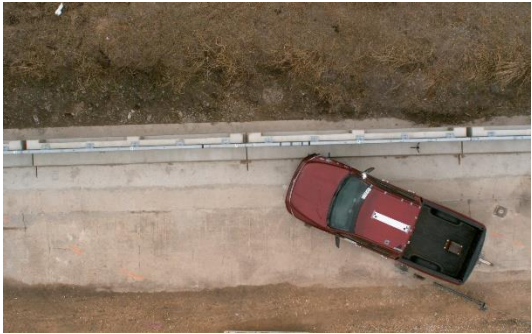
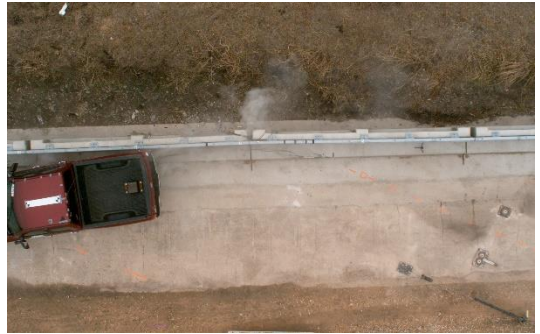
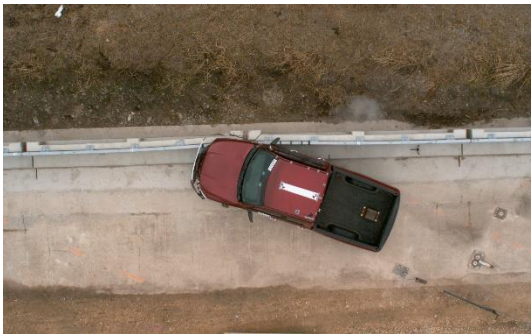
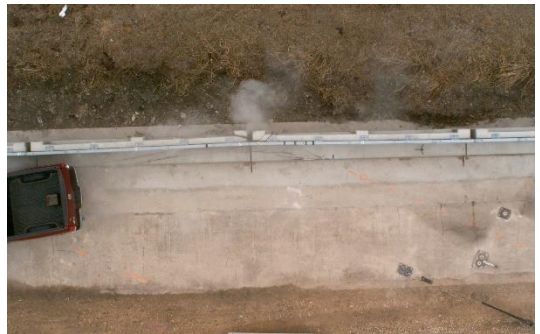
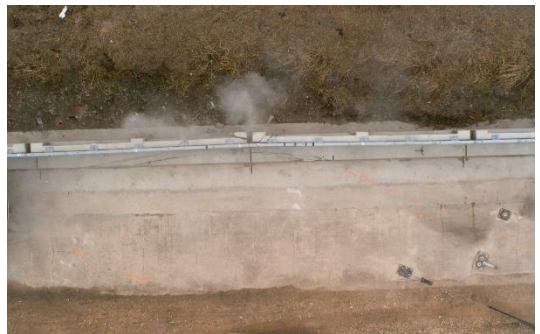
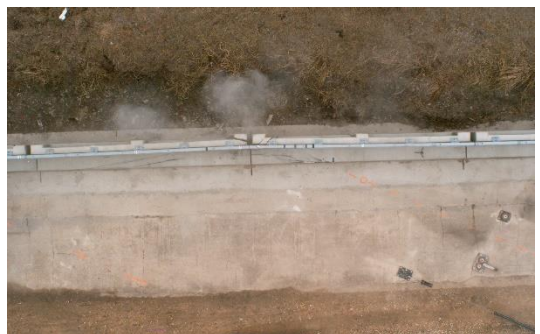
Figure 130. Sequential photographs for Test No. 606861-3 (frontal view).

Table 20 lists times and significant events that occurred during Test No. 606861-3. Figure 129 through Figure 131 in Appendix J present sequential photographs during the test.

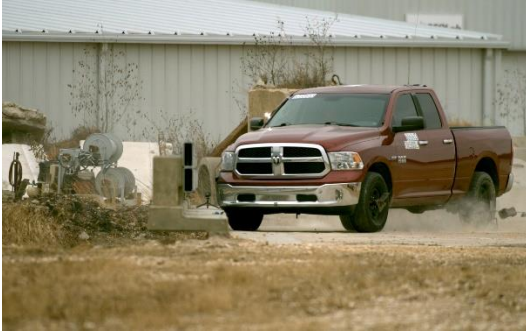
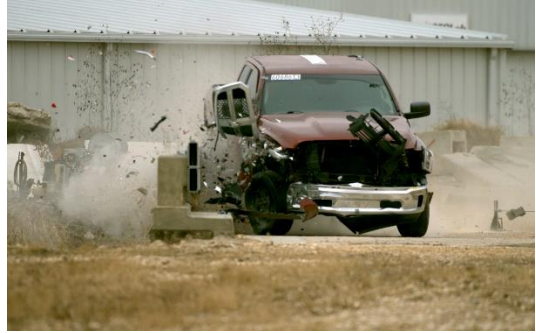
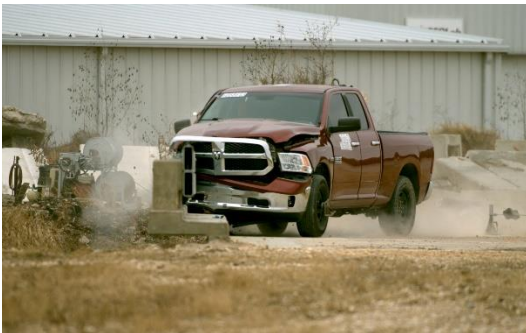
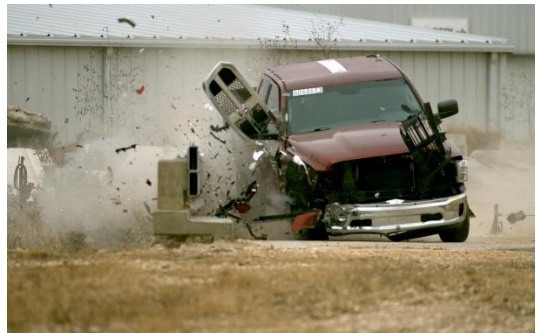
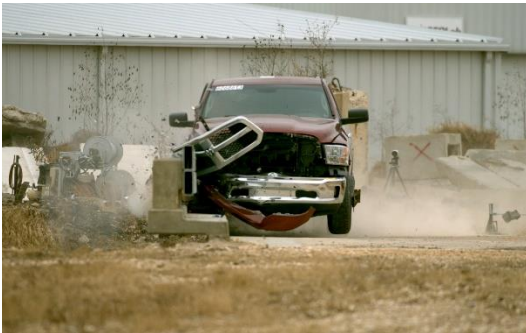
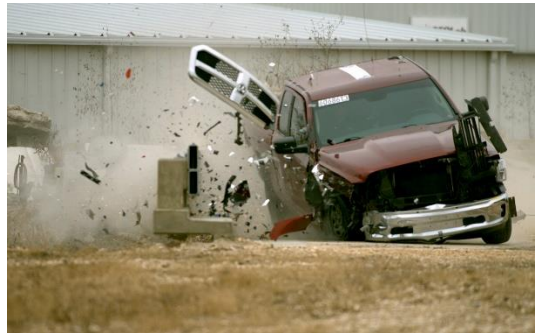
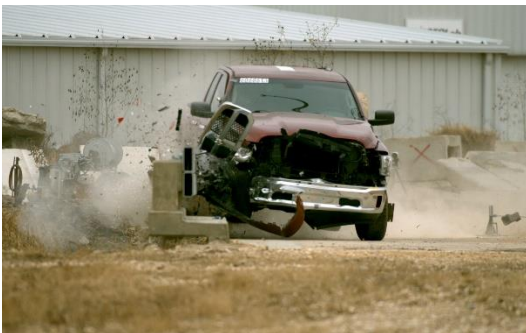
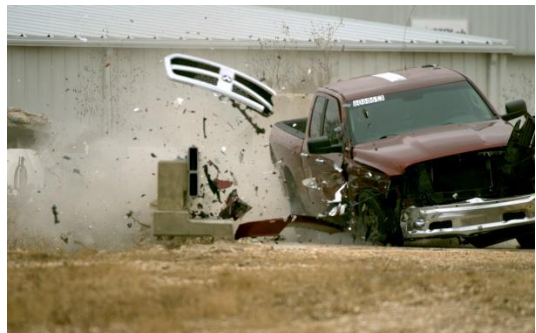
Figure 131. Sequential photographs for Test No. 606861-3 (rear view).
