HEAT-STRAIGHTENING EFFECTS ON THE BEHAVIOR
OF FULL-SCALE SIMULATED BRIDGE GIRDERS

VOLUME 4: FIRST INTERIM REPORT OF PHASE 2

STATE PROJECT NO. 736-10-46
FEDERAL AID PROJECT NO. HPR-0010(008)
LSU PROJECT NO. 127-15-4141

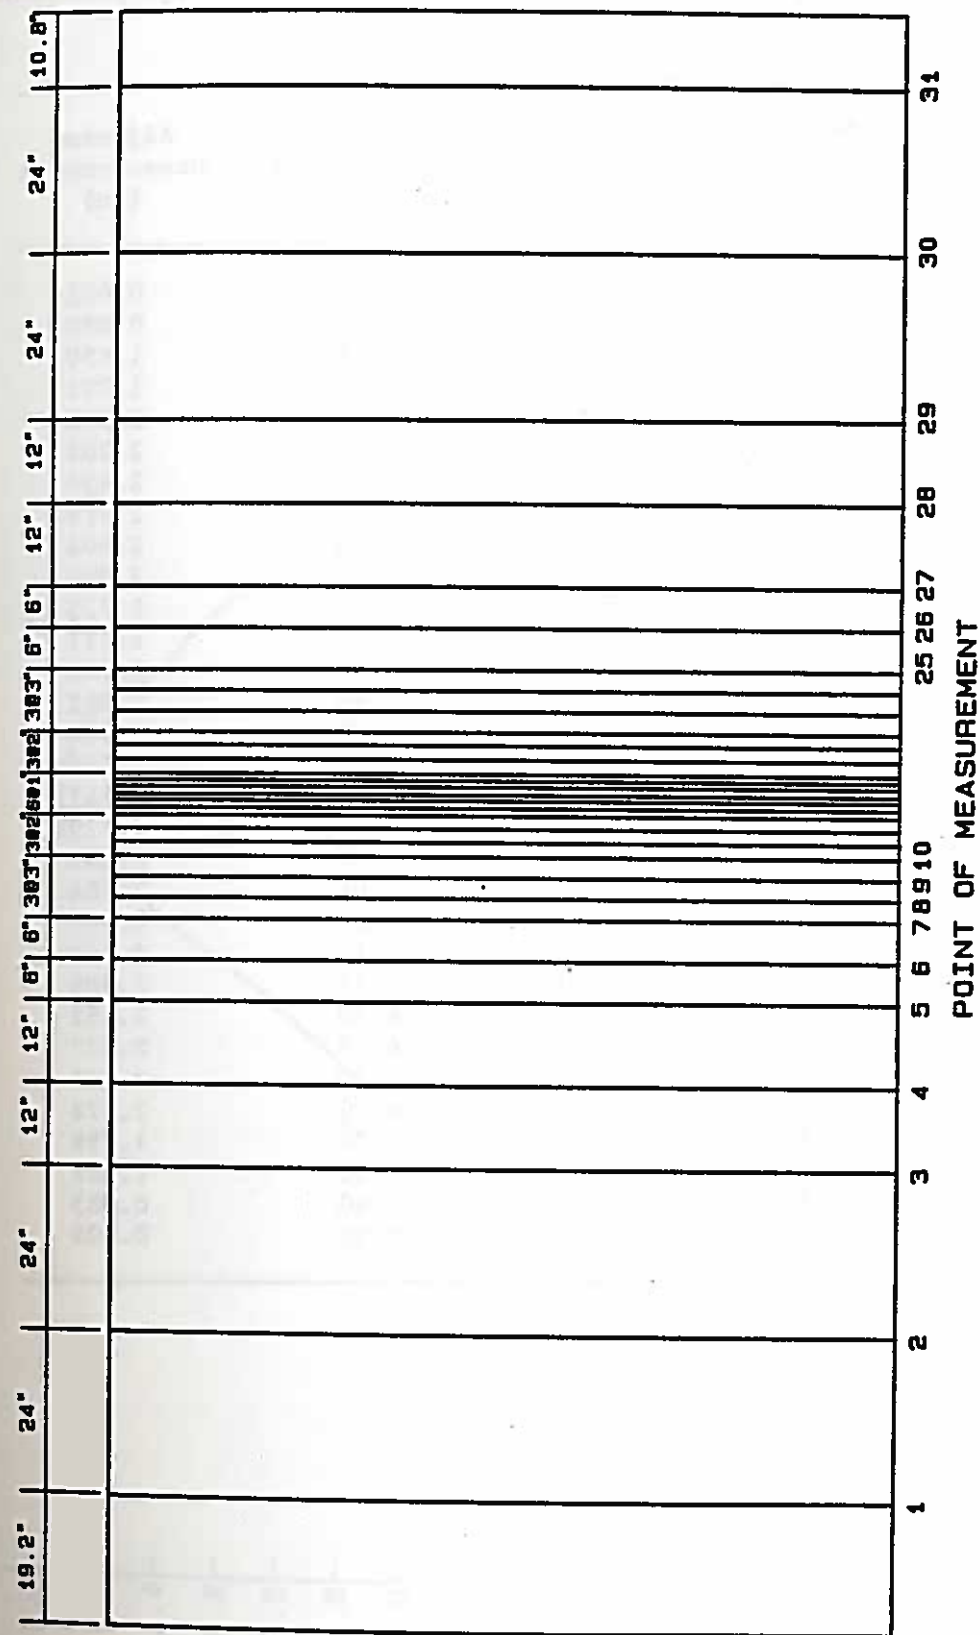
Figure 20. Measuring point layout for girder SB-1.

cross section of the girder, as was shown in Figure 10. The center of the damage, which was located at 10.1 feet away from the left support, corresponded to the central set of measuring point set 16 on Figure 20. The other sets of measuring points were symmetrically placed on both sides of that point. Figure 20 provides a schematic illustration of the layout of the sets of measuring points and their locations along the test girder.

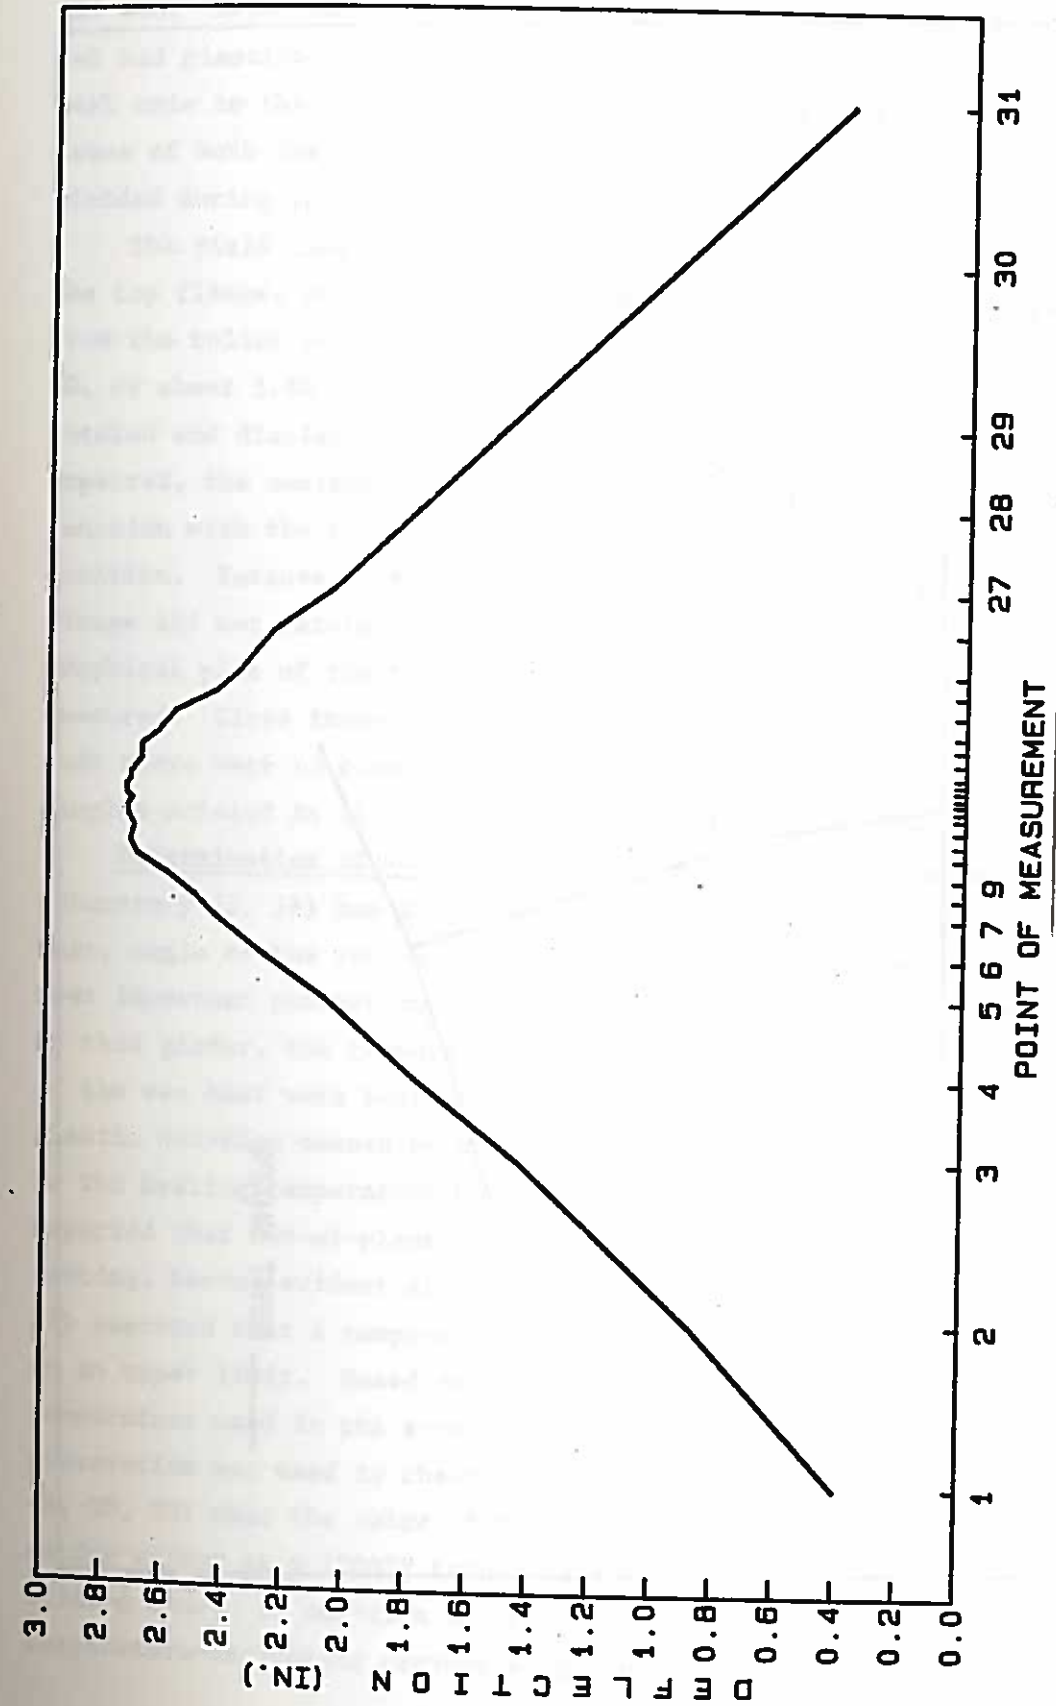
Figure 21. Initial damage assessment deflection measurements along point 'h' of girder SB-1.

The damage assessment displacements were taken at all 31 sets of measuring points along the entire girder span of 19.5 feet. Initial measurements taken along the convex side (side "h") of the bottom flange are shown in Table 2. Column 3 of the table shows the raw measurements as taken in the field with respect to the U-shaped measuring reference frame. Column 4 of the same table shows the adjusted values of the deflection with respect to the end supports which did not deform. Figure 21 provides a plot of these adjusted values showing the actual deflected shape of the girder specimen. Figure 22 shows a cross section view of the deflected shape of the girder at point 16.

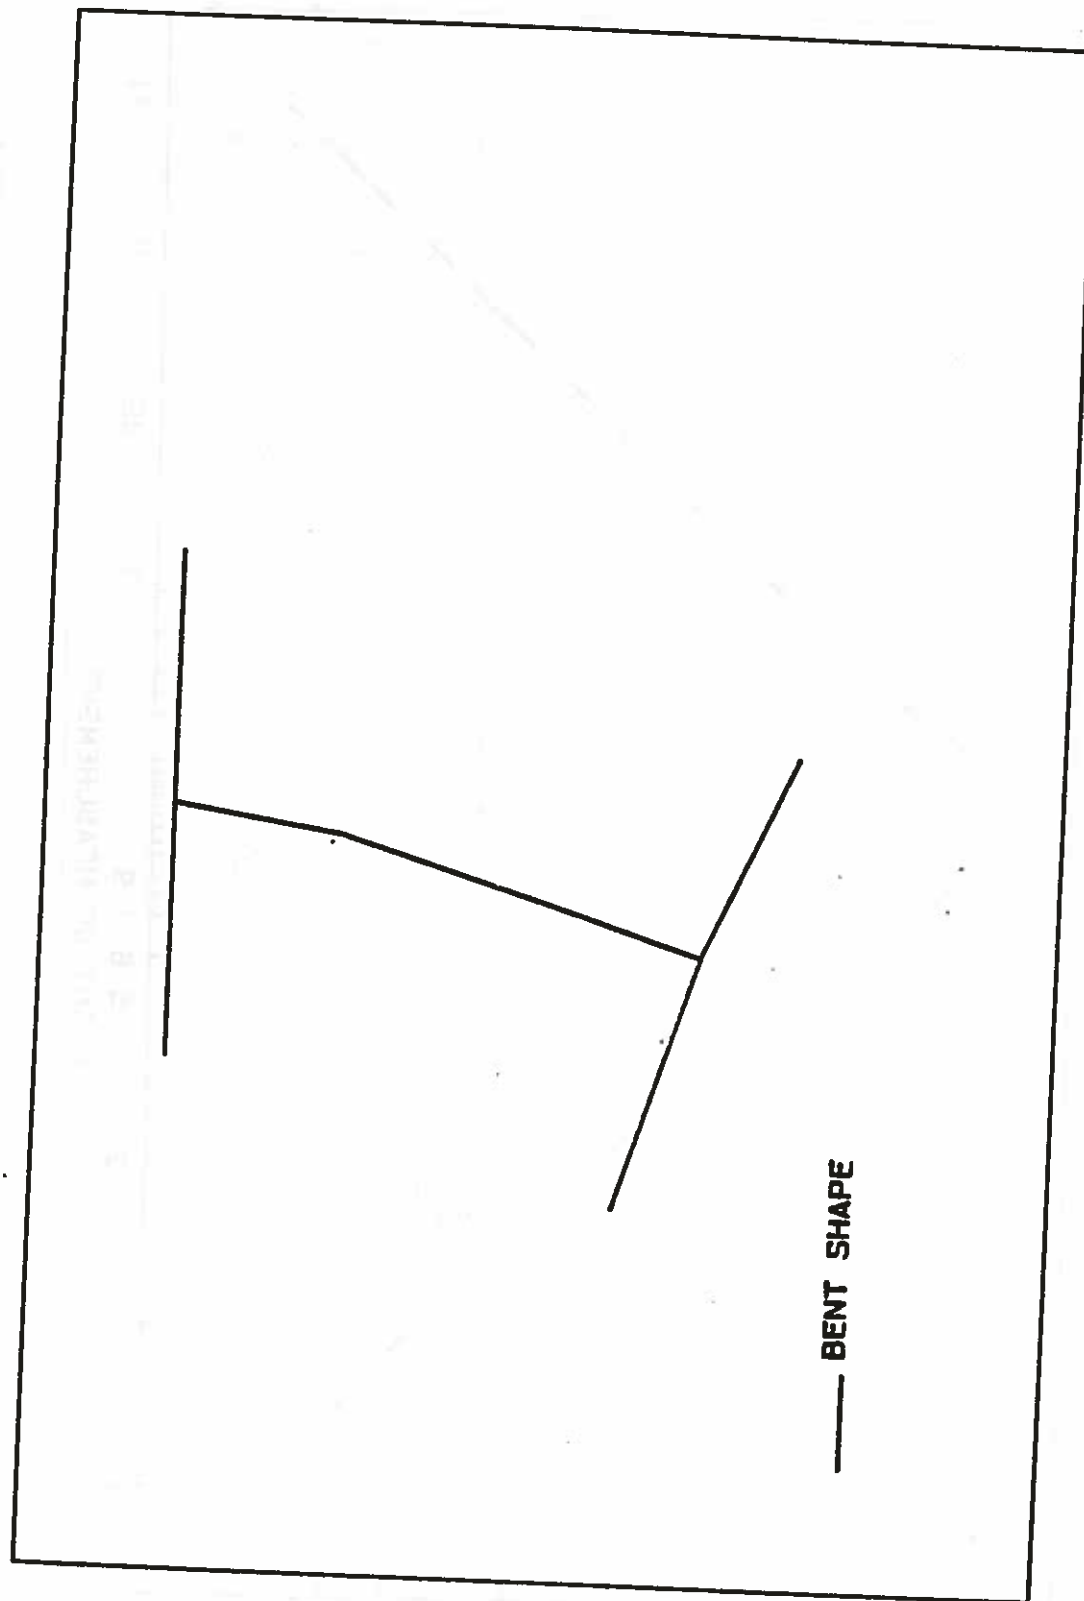
Figure 22. Deflected shape of the damaged girder SB-1 at pont 16.

Moberg (20) and Shanafelt and Horn (28) presented a set of standard procedures for inspection and assessment of damage. Those procedures were followed in this project to inspect and assess the damage induced on the test girder. The measurement of the actual plastic deformations induced in the girder specimen revealed that most of the damage in the bottom flange was confined to a 21-inch length. At the center point of the damage, the concave side of the bottom flange (in direction "d") was displaced 3.18 inches in the transverse direction and rotated, leaving its edge 1.44 inches below its original position (direction "e"). At the same point, the lateral displacement of the convex side of the same flange (direction "h") was measured to be 2.75 inches, while its vertical movement was found to be 1.64 inches upward (direction "g"). This damage assessment revealed that the bottom flange had yielded as a long flat plate in bending about its strong axis. In addition, it yielded about its weak axis along two horizontal lines through points 12 and 20 and along the junction of the bottom flange and the web between these two points, producing a "dish-like" distortion. However, the back side of the flange at this location remained relatively perpendicular to

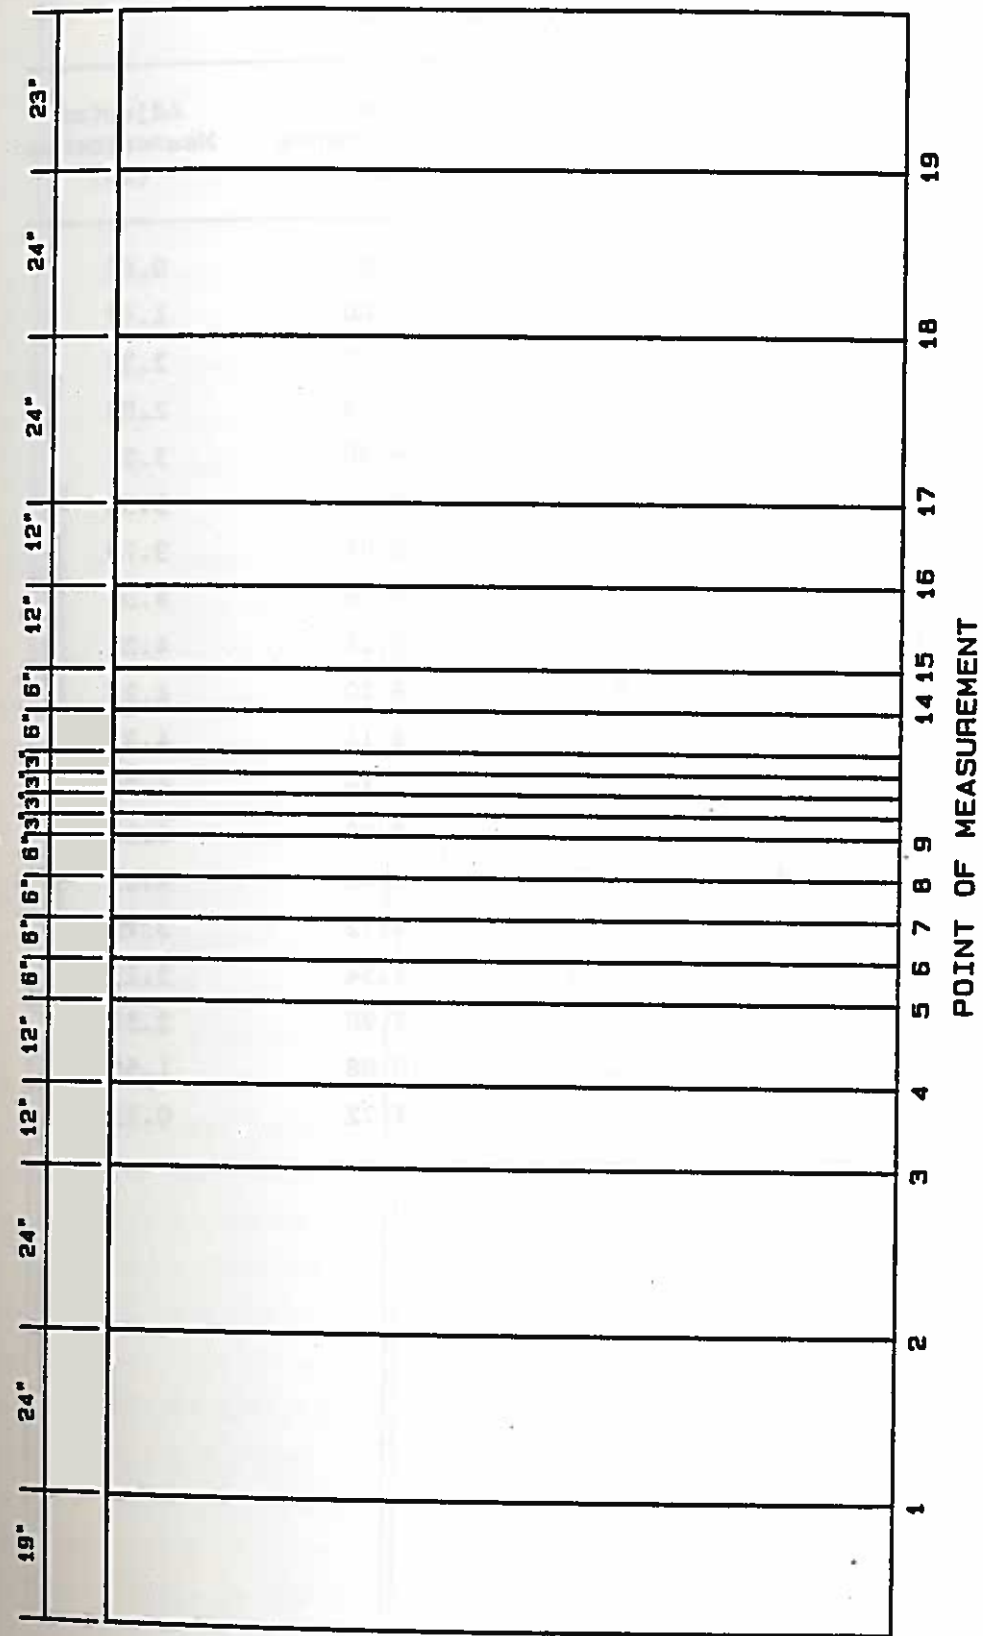
Figure 28. Measuring point layout for SB-3.

The largest deflection occurred at the point of impact (point 11) which is located 10.1 feet from the roller support. That deflection was measured to be about 4.33 inches. The bottom flange had rotated approximately 5 degrees over its 8.99-inch width. Deflection measurements along the web revealed that the web had plastically yielded as a long, flat plate, bending about its weak axis in the longitudinal direction. That yield line occurred about 1 inch below the lower surface of the top flange. Initial deflection measurements taken along side "h" of the damaged girder are shown in Table 4. Figure 29 shows all the yield areas in this girder specimen.

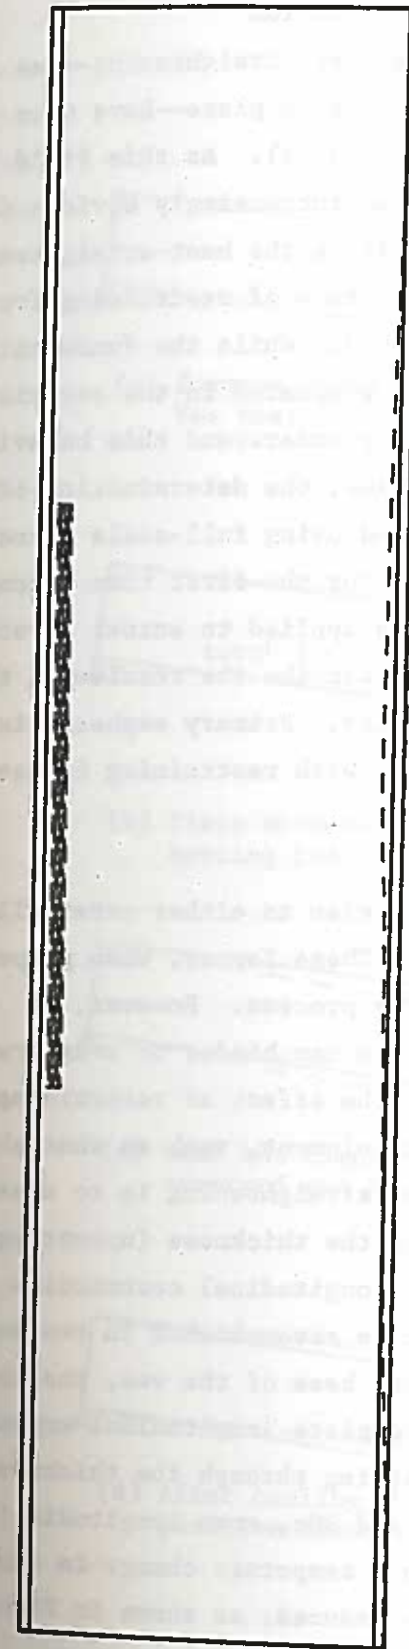
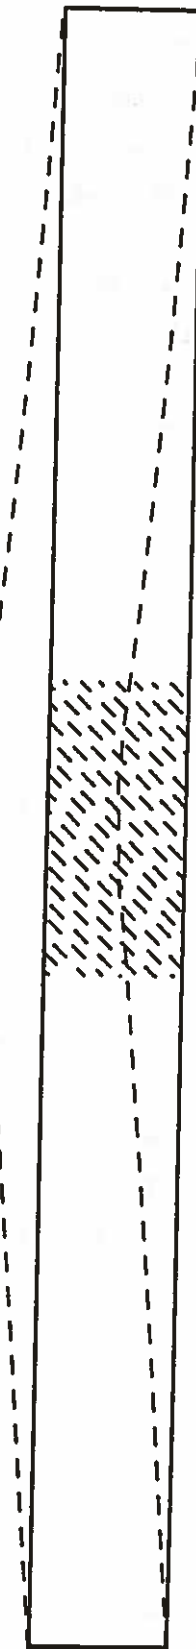
Figure 29. Identification of the yield zones in the damaged girder SB-3.

Dashed areas of Figure 29 identify all the yield zones in the W 24 x 76 composite girder.

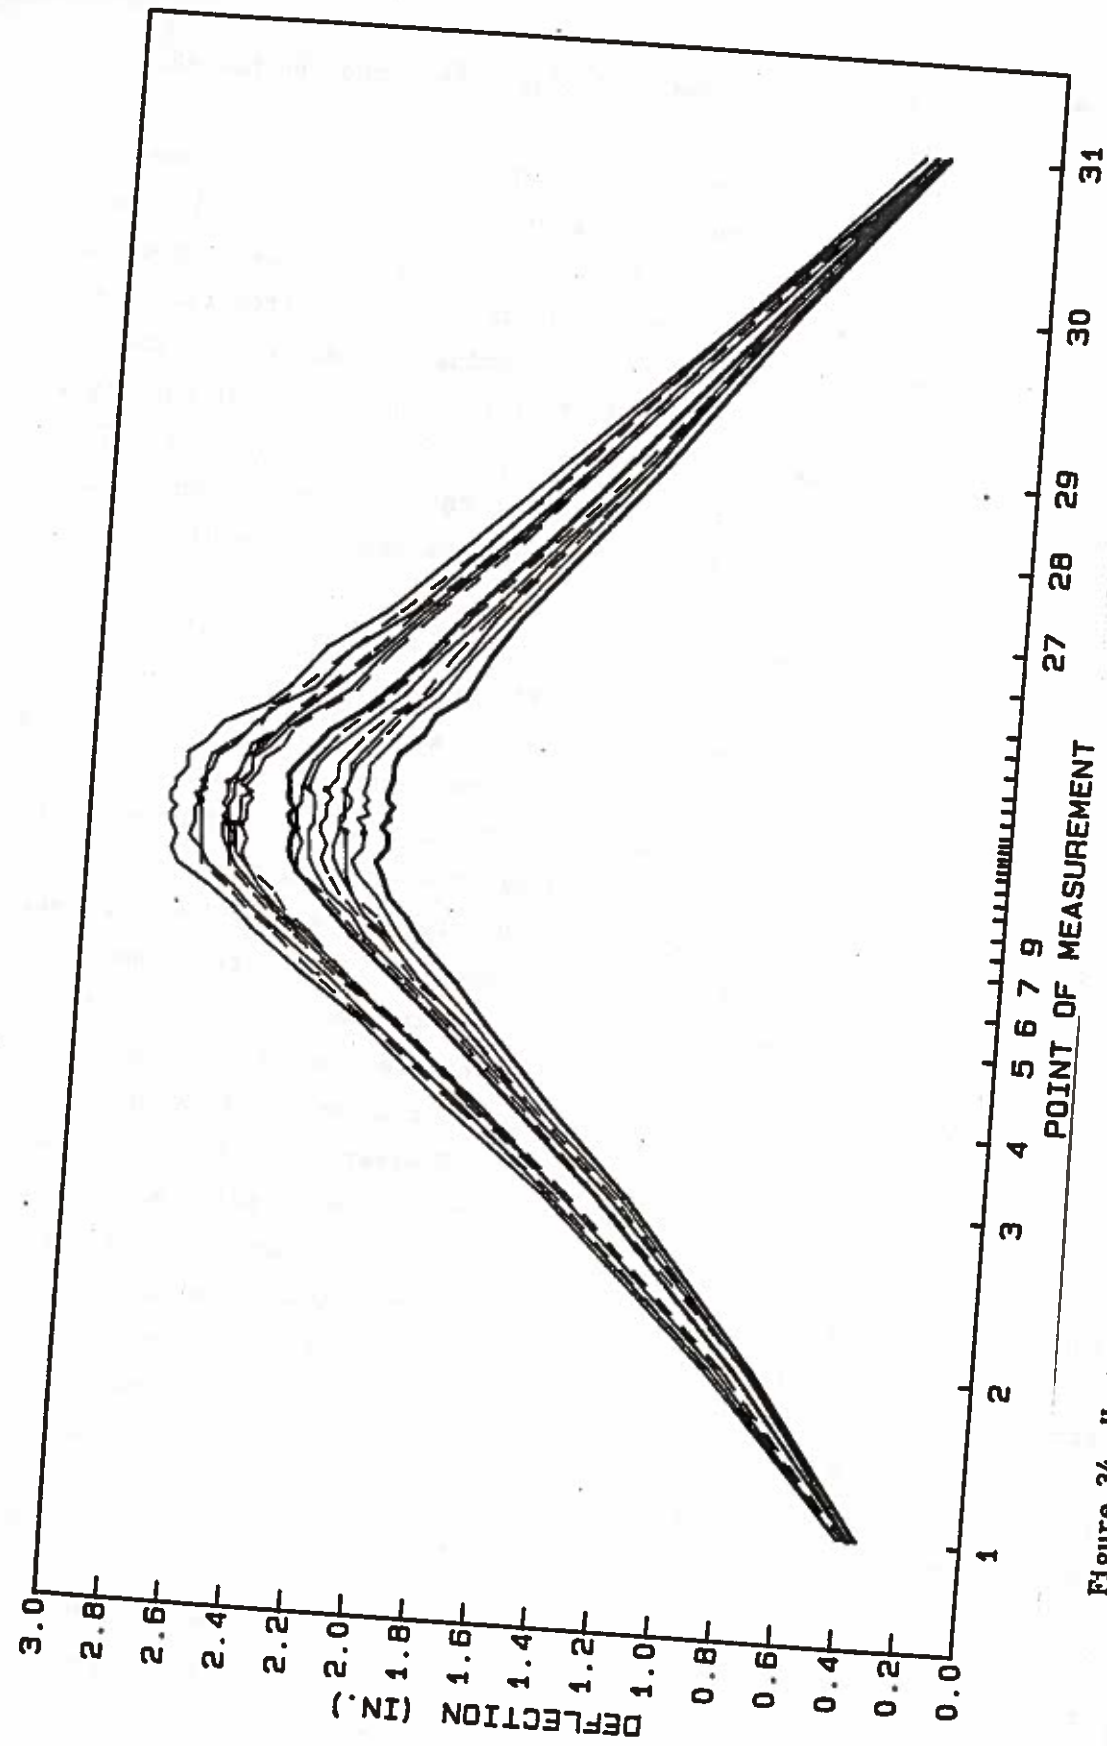
Figure 34. Heat-straightening progression for the damaged girder SB-1 through heating sequence two (15 total heating cycles).

As in the first sequence, movements were relatively small, and only a slight rate of increase occurred after the application of the second heating pattern. Since the web had yielded about its weak axis along a longitudinal line, it was concluded that the stresses acting on the yield line provided an additional restraint in the bottom flange of the girder. However, this additional restraint was acting in the wrong direction and resisted the action of the external jacking forces, thus reducing the thermal contraction of the member. In the third heating sequence, a line heat was used along the entire length of the yield zone in the web, in addition to applying the vee heat and the 112 percent auxiliary jacking force. As will be shown, the line heat by itself does not cause any straightening effect. However, it reduces the yield stress along the line so that the resistance to web straightening would be less when the vee heat is applied to the lower flange. In effect, the web yield line was straightened by hot mechanical straightening, with the flange applying the mechanical force as it was heat-straightened. This technique is frequently used by practitioners. Figure 35 shows a photograph of the actual application of this heating sequence. Two people and two single-orifice torches were required to perform this heating sequence. The line heat was applied to the convex crest of the web, starting from points 3 and 29 moving toward the middle in a direction parallel to the top flange. Each person started heating from one end of the yield line, moving progressively toward the middle of the girder. Just before getting to the middle portion, one of the

The second heating sequence was identical to the first, except that the restraining force was doubled to produce a load ratio of 112 percent. Eight cycles were applied to the damaged girder (heating cycles 8-15). Figure 34 shows the movement obtained in the bottom flange after the completion of each of the first 15 heating cycles. Again, the maximum amount of movement occurred after the application of the eighth heating cycle, which is the first heat applied in this sequence. The maximum plastic rotation angle obtained in this heating sequence was 0.00281 radians. Tables 5 and 6 summarize the measured results of this sequence.

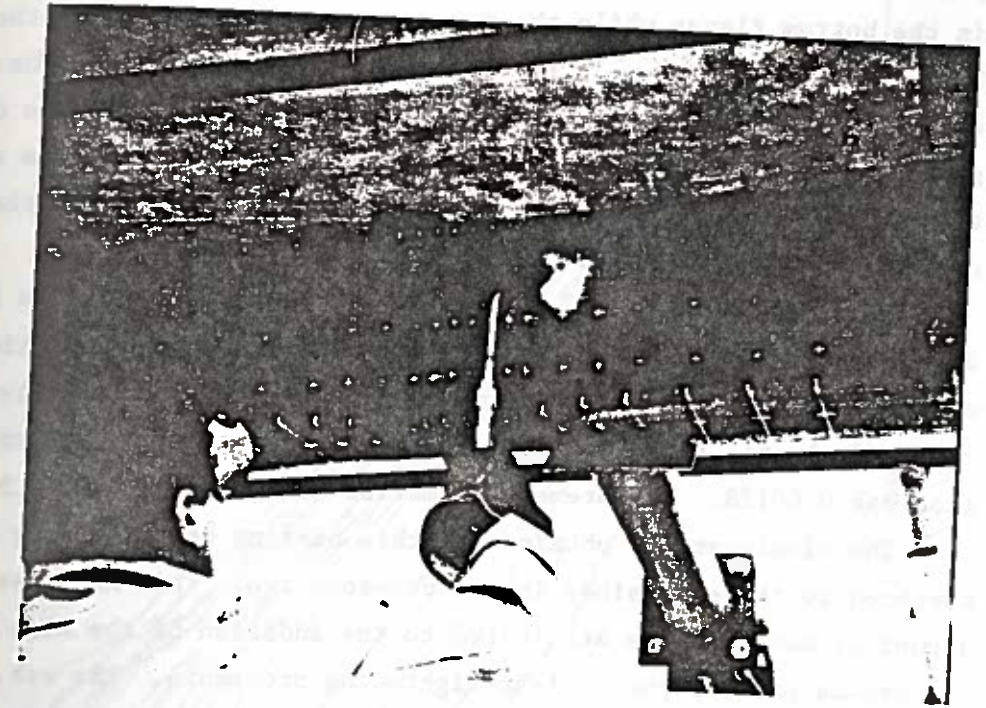
Figure 35. Line Heat in Progress

practitioners stopped heating the web and started heating the vee area in the bottom flange while the other practitioner continued the line heat. This procedure allowed both practitioners to finish the heating cycle simultaneously. The heated areas in the middle portion of the girder, both in the web and in the flange, were thus near the same temperature. Figure 36 provides a view of the girder after the application of one of these heating cycles.

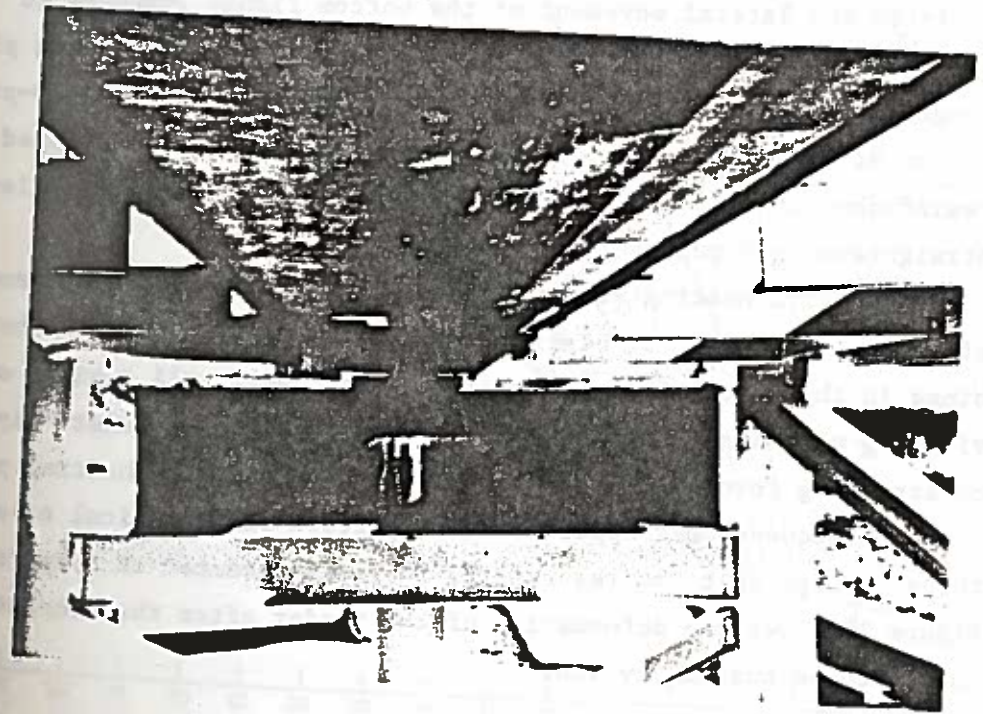
Figure 36. Curvature of the Test Girder SB-1 after the Application of Seventeen Heating Cycles.

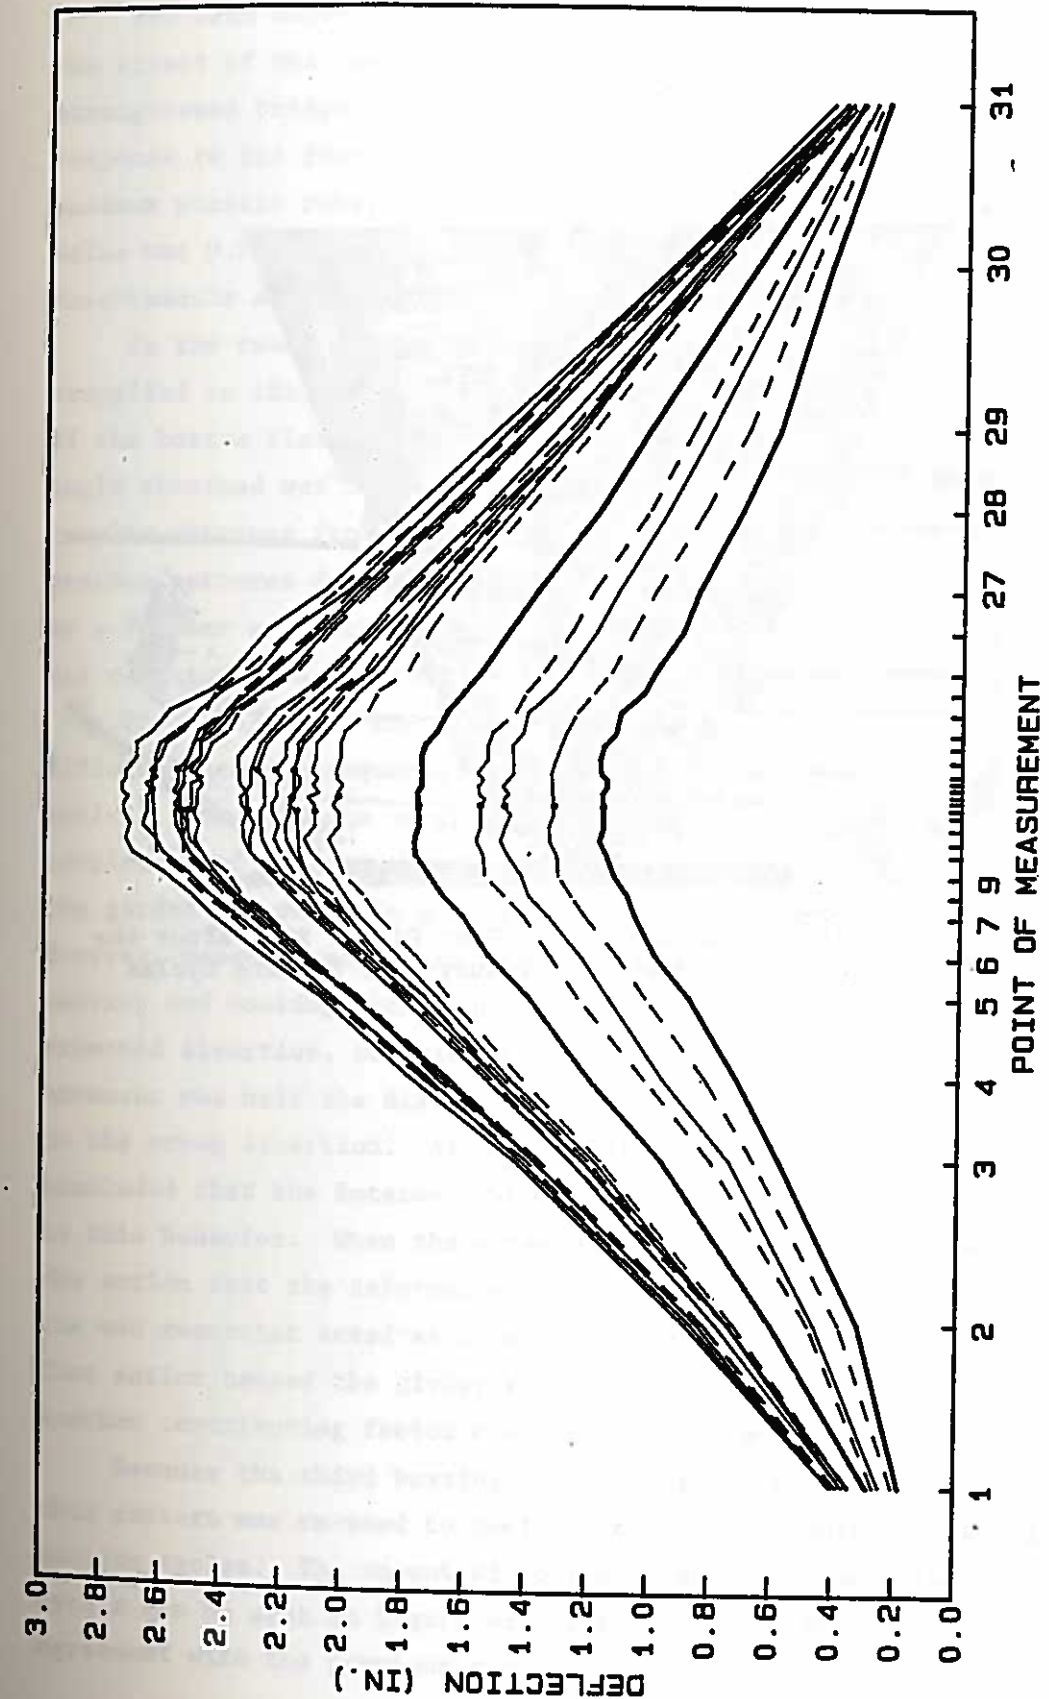
The third heating sequence produced the most consistent and effective movement. By heating both the web yield line and the plastic hinge in the bottom flange during the same cycle, all regions of initial yielding were heated simultaneously. In addition, a relatively high constraining force was used. To further evaluate the heating patterns, a fourth sequence was applied. This pattern was identical to sequence three, except that the restraining force was reduced to 56 percent. Figure 38 shows the deformation of the girder after the completion of one of these heating cycles.

Figure 37. Heat-straightening progression for the damaged girder SB-1 through heating sequence three (20 total heating cycles).

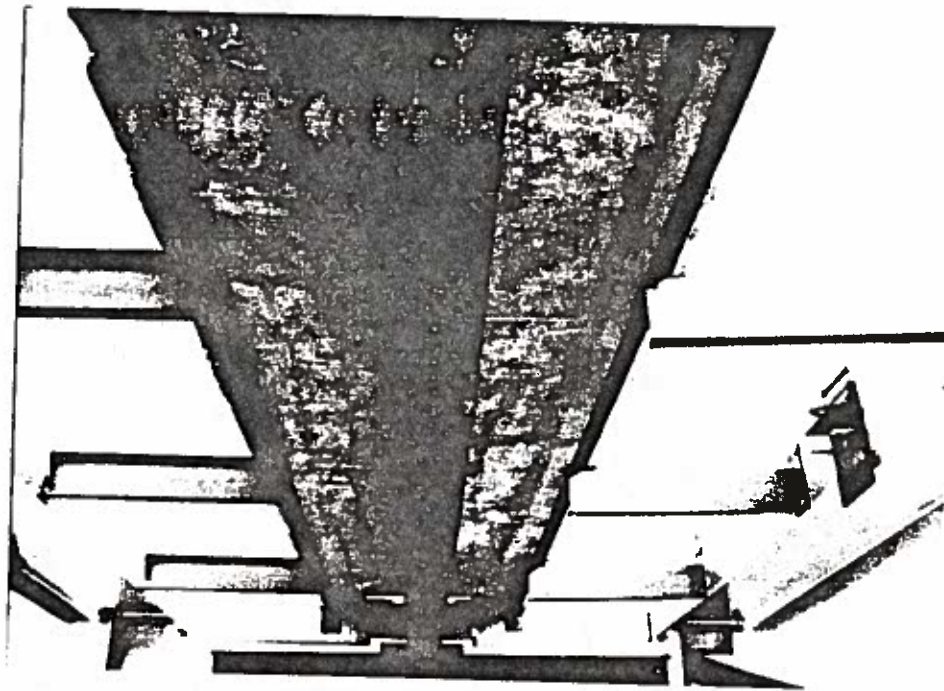
Figure 38. Curvature of the Test Girder SB-1 after the Application of Twenty-Four Heating Cycles

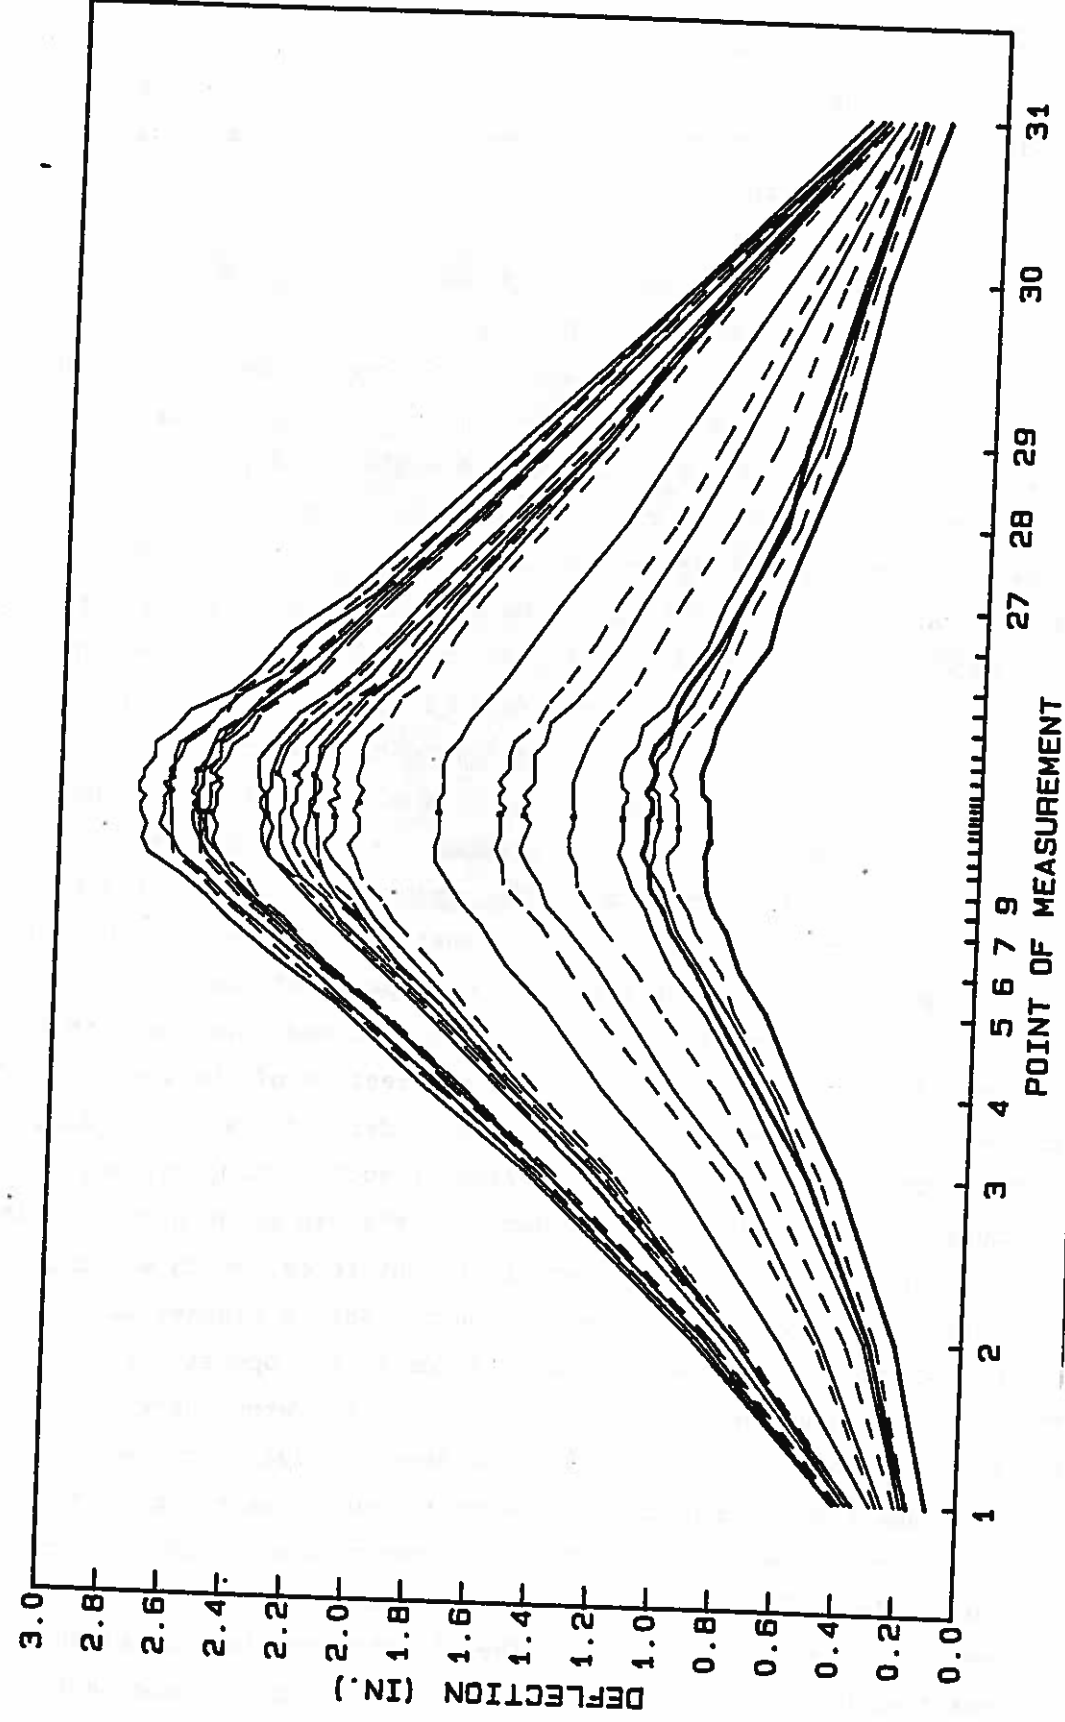
The main objective of applying this heating sequence was to study the effect of the restraining force on the behavior of the heat-straightened bridge girder. The movement of the bottom flange in response to the fourth heating sequence can be seen in Figure 39. The maximum plastic rotation obtained was 0.00175 radians, while its average value was 0.00132 radians, with a standard deviation of 0.00052. Measurements are summarized in Tables 5 and 6.

Figure 39. Heat-straightening progression for the damaged girder SB-1 through heating sequence four (24 total heating cycles).

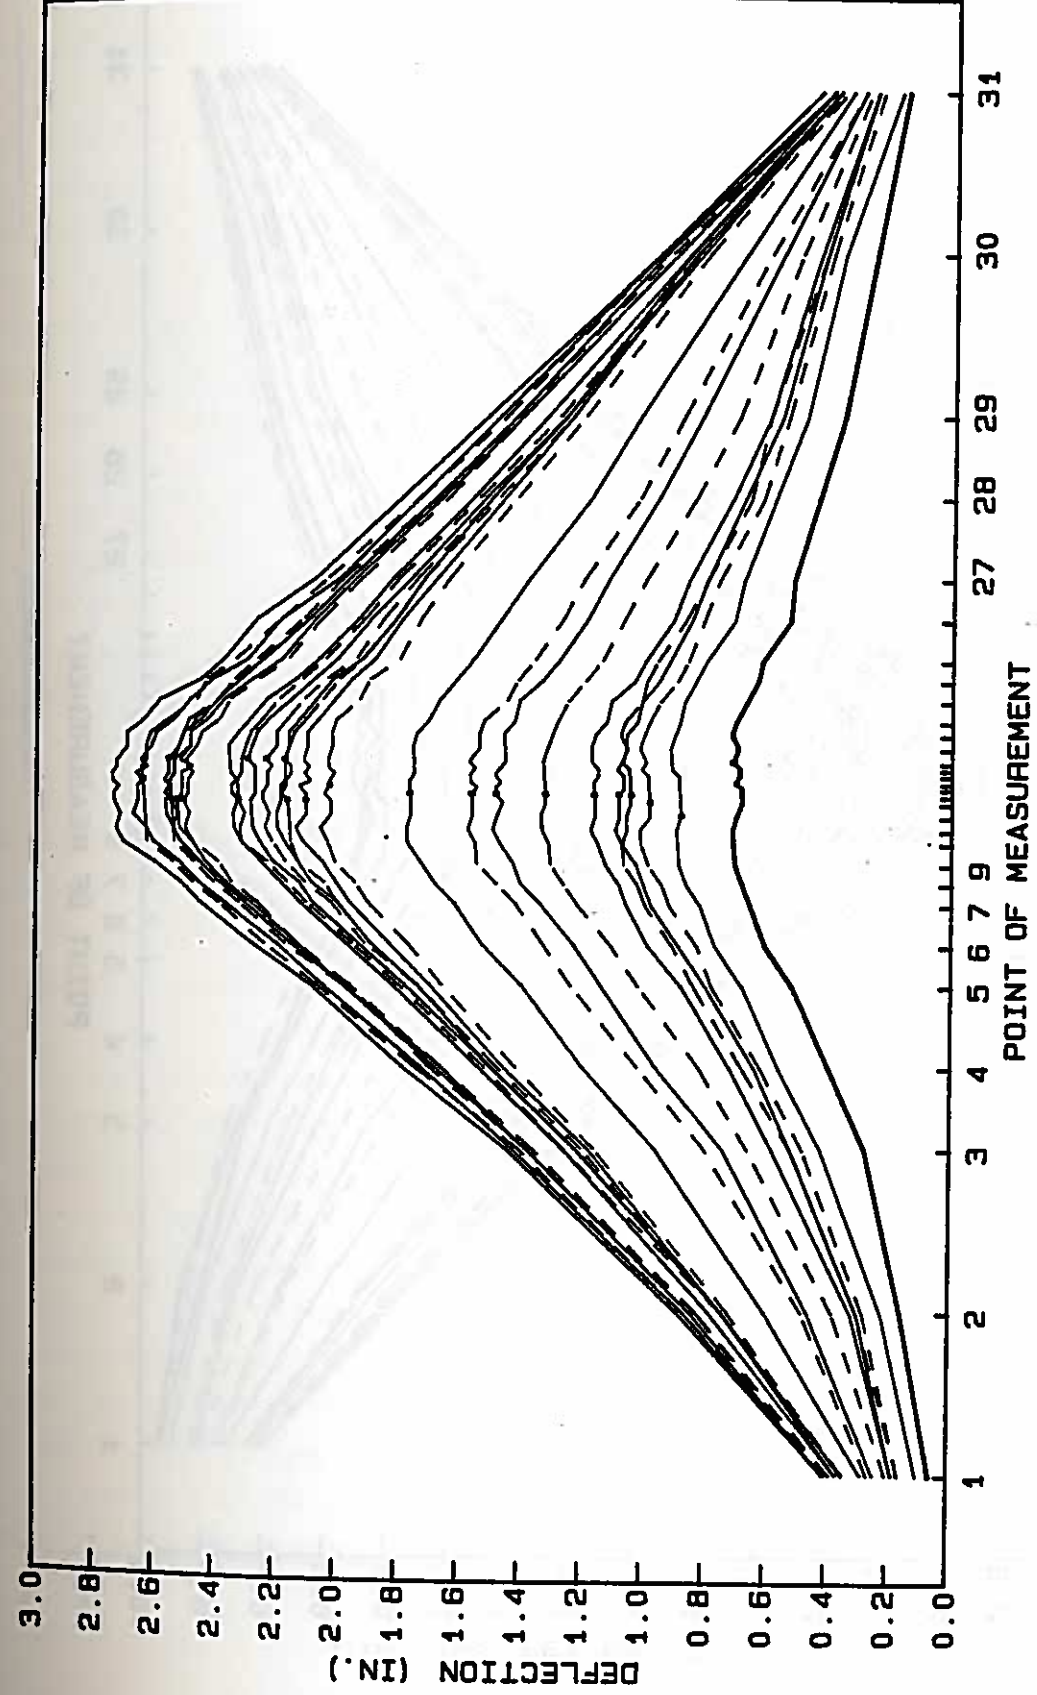
In the twenty-fifth heating cycle, heating sequence three was reapplied to the girder. The last curve in Figure 40 shows the movement of the bottom flange due to this heating cycle. The plastic rotation angle obtained was 0.00351 radians, which is in agreement with the results obtained from heating cycles 17 to 21. Thus, intermixing heating patterns did not decrease the effectiveness of pattern three. As a further evaluation of the restraining force, heating sequence three was repeated with the load ratio reduced to zero.

Figure 40. Heat-straightening progression for the damaged girder SB-1 repeating heating sequence three (25 total heating cycles).

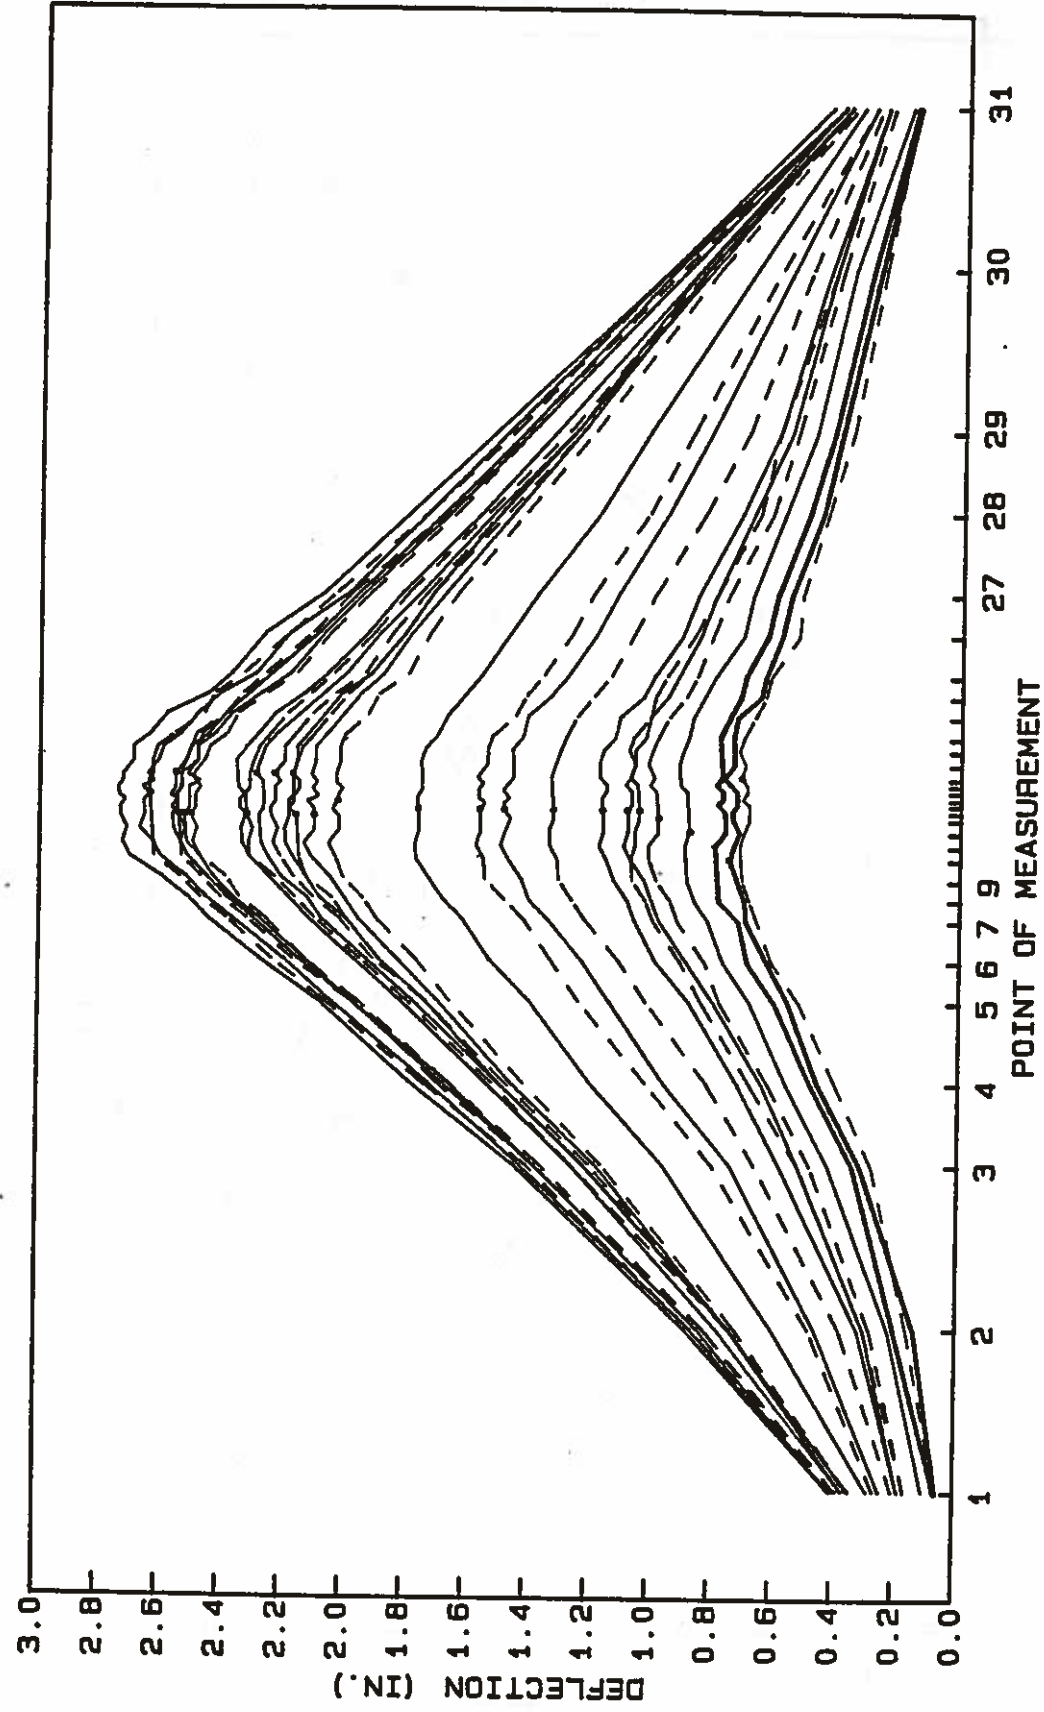
Figure 41 shows the displacements obtained during this fifth different heating sequence, in addition to all the subsequent heating cycles. Measurements of the movements of the bottom flange upon the completion of the twenty-sixth heating and cooling cycle revealed that the girder had moved in a direction opposite to the vee heat direction. However, measurements taken after the completion of the twenty-seventh heating and cooling cycle show that the girder had moved back in the expected direction, coinciding with the direction of the vee heat. That movement was half the distance that the girder had previously displaced in the wrong direction. After a review of both heating cycles, it was concluded that the internal redundancy of the web might have contributed to this behavior. When the external jacking force, which was opposing the action that the deformed web had on the bottom flange, was removed, the web restraint acted as a jacking force in the opposite direction. That action caused the girder to displace in the wrong direction. Another contributing factor could have been residual stresses.

Figure 41. Heat-straightening progression for the damaged girder SB-1 through heating sequence five (27 total heating cycles).
