HEAT-STRAIGHTENING EFFECTS ON THE BEHAVIOR
OF FULL-SCALE SIMULATED BRIDGE GIRDERS

VOLUME 4: FIRST INTERIM REPORT OF PHASE 2

STATE PROJECT NO. 736-10-46
FEDERAL AID PROJECT NO. HPR-0010(008)
LSU PROJECT NO. 127-15-4141

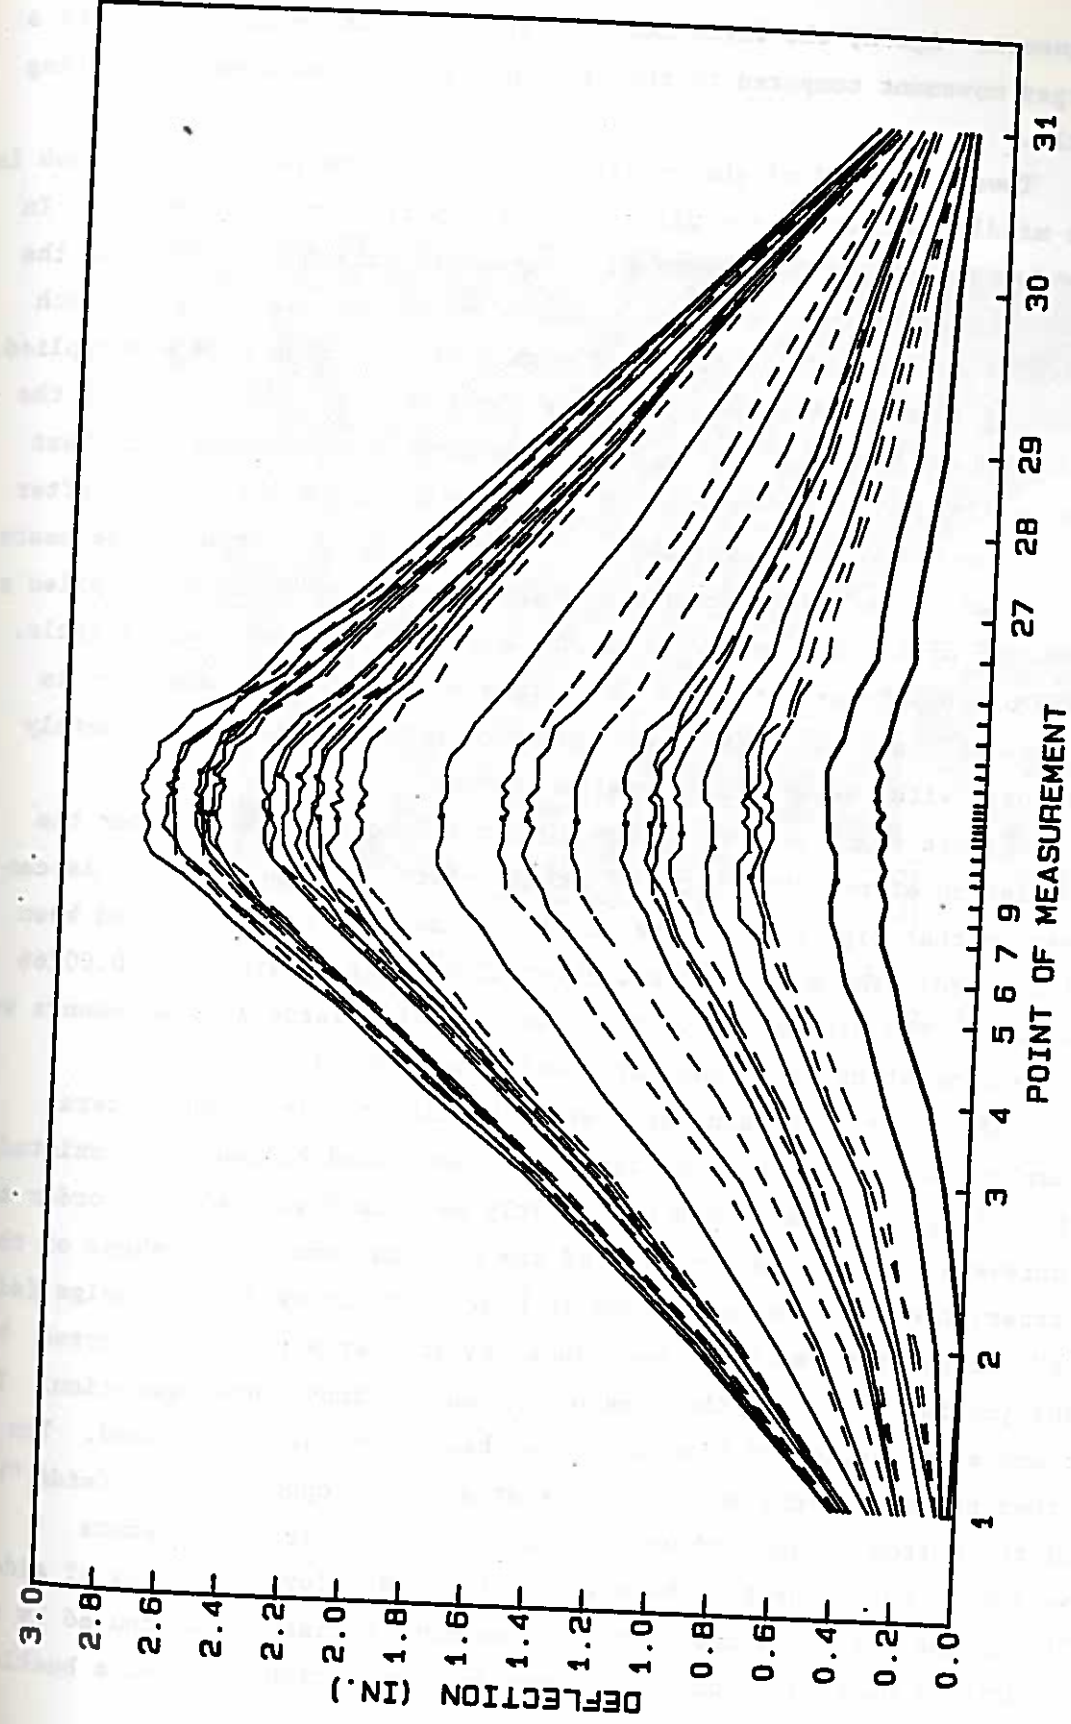
Because the third heating sequence proved to be the most effective, this pattern was re-used to perform the twenty-eighth and twenty-ninth heating cycles. The amount of movement caused by these two heating cycles can be seen in Figure 42. The plastic rotations obtained were in agreement with the previous results obtained using the same heating

Figure 42. Heat-straightening progression for the damaged girder SB-1 repeating heating sequence three (29 total heating cycles).

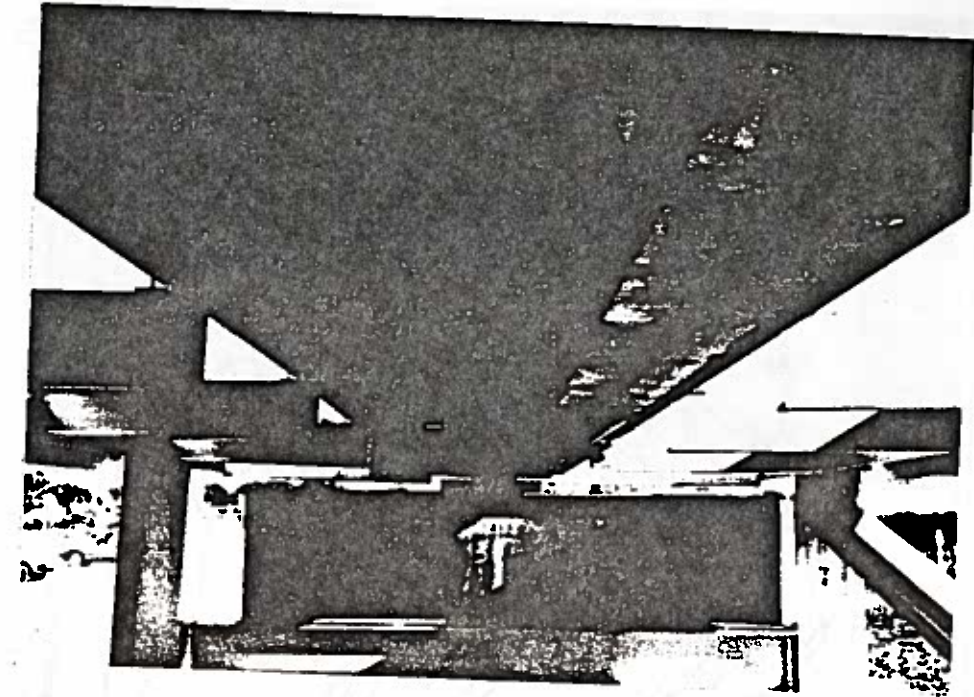
Toward the end of the repair work, it was observed that the web in the middle portion of the girder has been perfectly straightened. In heating sequence six, to prevent an overstraightening of the web, the web was not heated in sections where no curvature was present. Each practitioner heated one side of the girder. One line heat was applied, starting from point 3 and continuing through point 8, after which the vee area was heated at point 8. At the same time, another line heat was applied, starting from point 29 and going through point 21, after which another vee area was heated at point 21 also. Thus, 2 vee heats were used in this sequence. A 112 percent jacking force was applied at point 16 of the bottom flange at the beginning of each heating cycle. A view of the girder after the completion of this heating sequence is shown in Figure 43. The figure shows that the girder was completely restored with respect to lateral deformation.

Figure 43.. Curvature of the Test Girder SB-1 after the Application of Thirty-One Heating Cycles

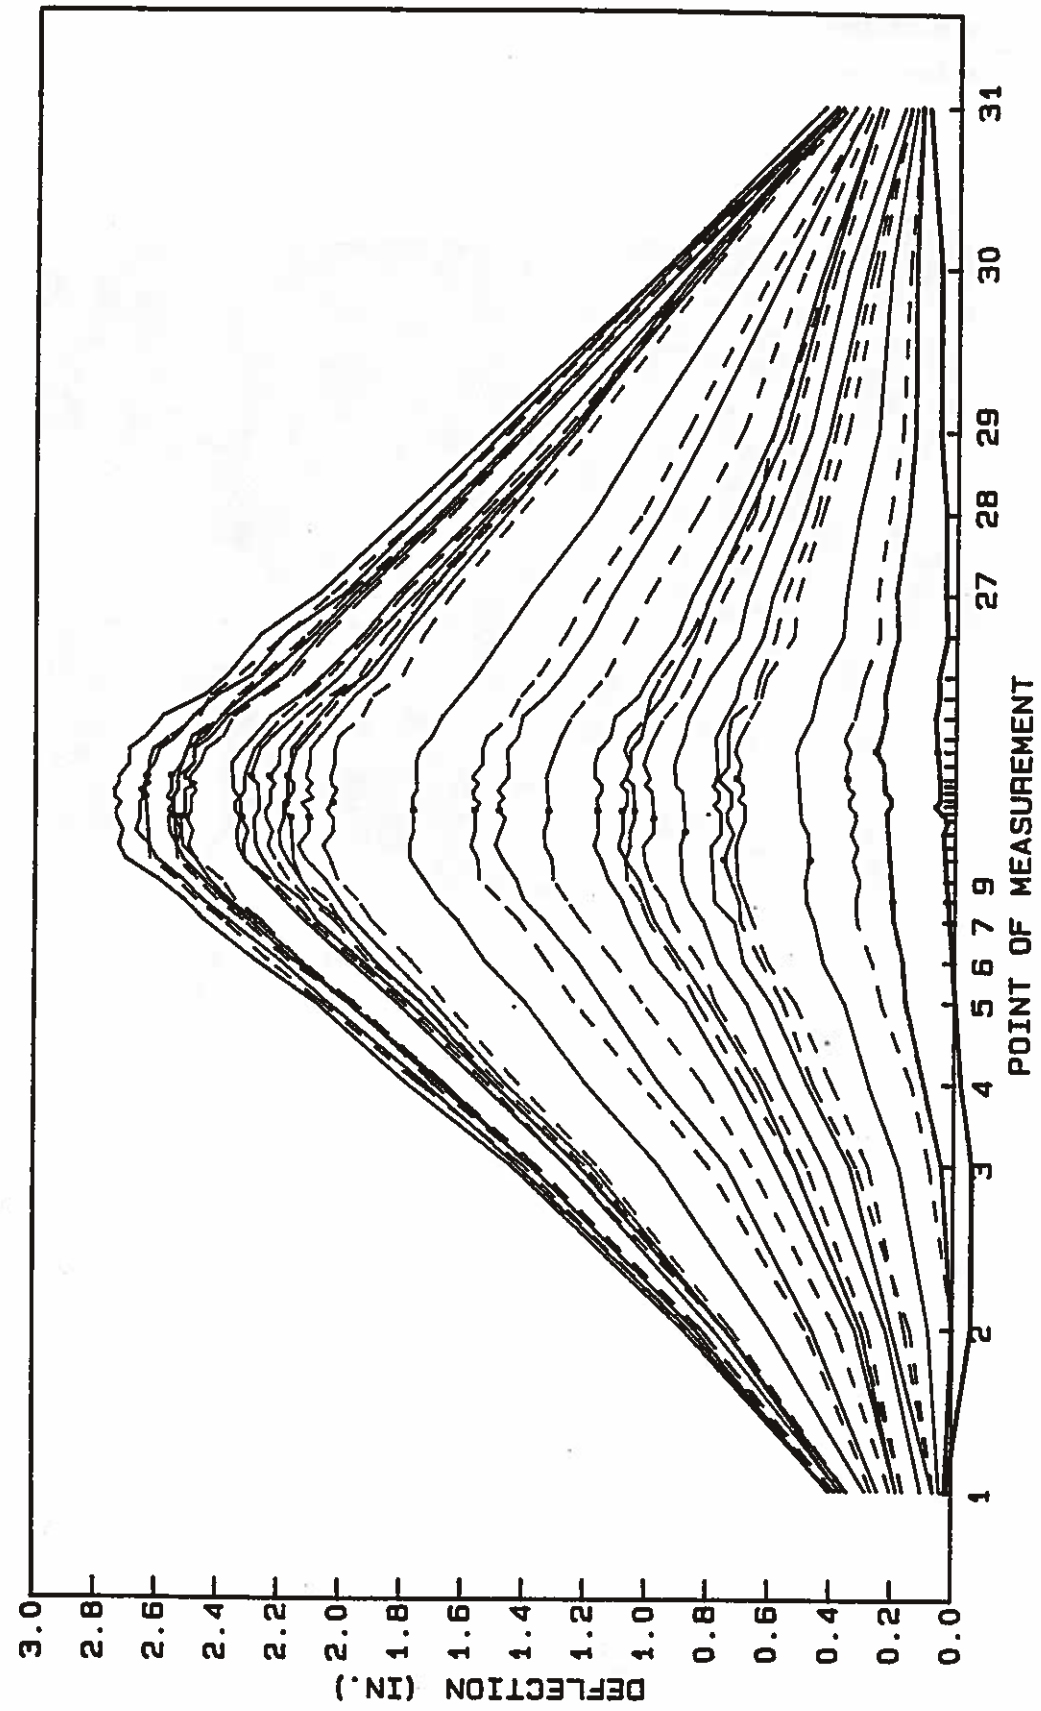
Figure 44 shows the deformation in the bottom flange after the completion of the thirtieth and thirty-first heating cycles. As can be seen in that figure, the lateral displacement of the girder had been eliminated. The average plastic rotation angle obtained was 0.00266 radians. The standard deviation was 0.00076. These last movements were quite consistent with those of heating sequence 3.

Figure 44. Heat-straightening progression for the damaged girder SB-1 through heating sequence six (31 total heating cycles).

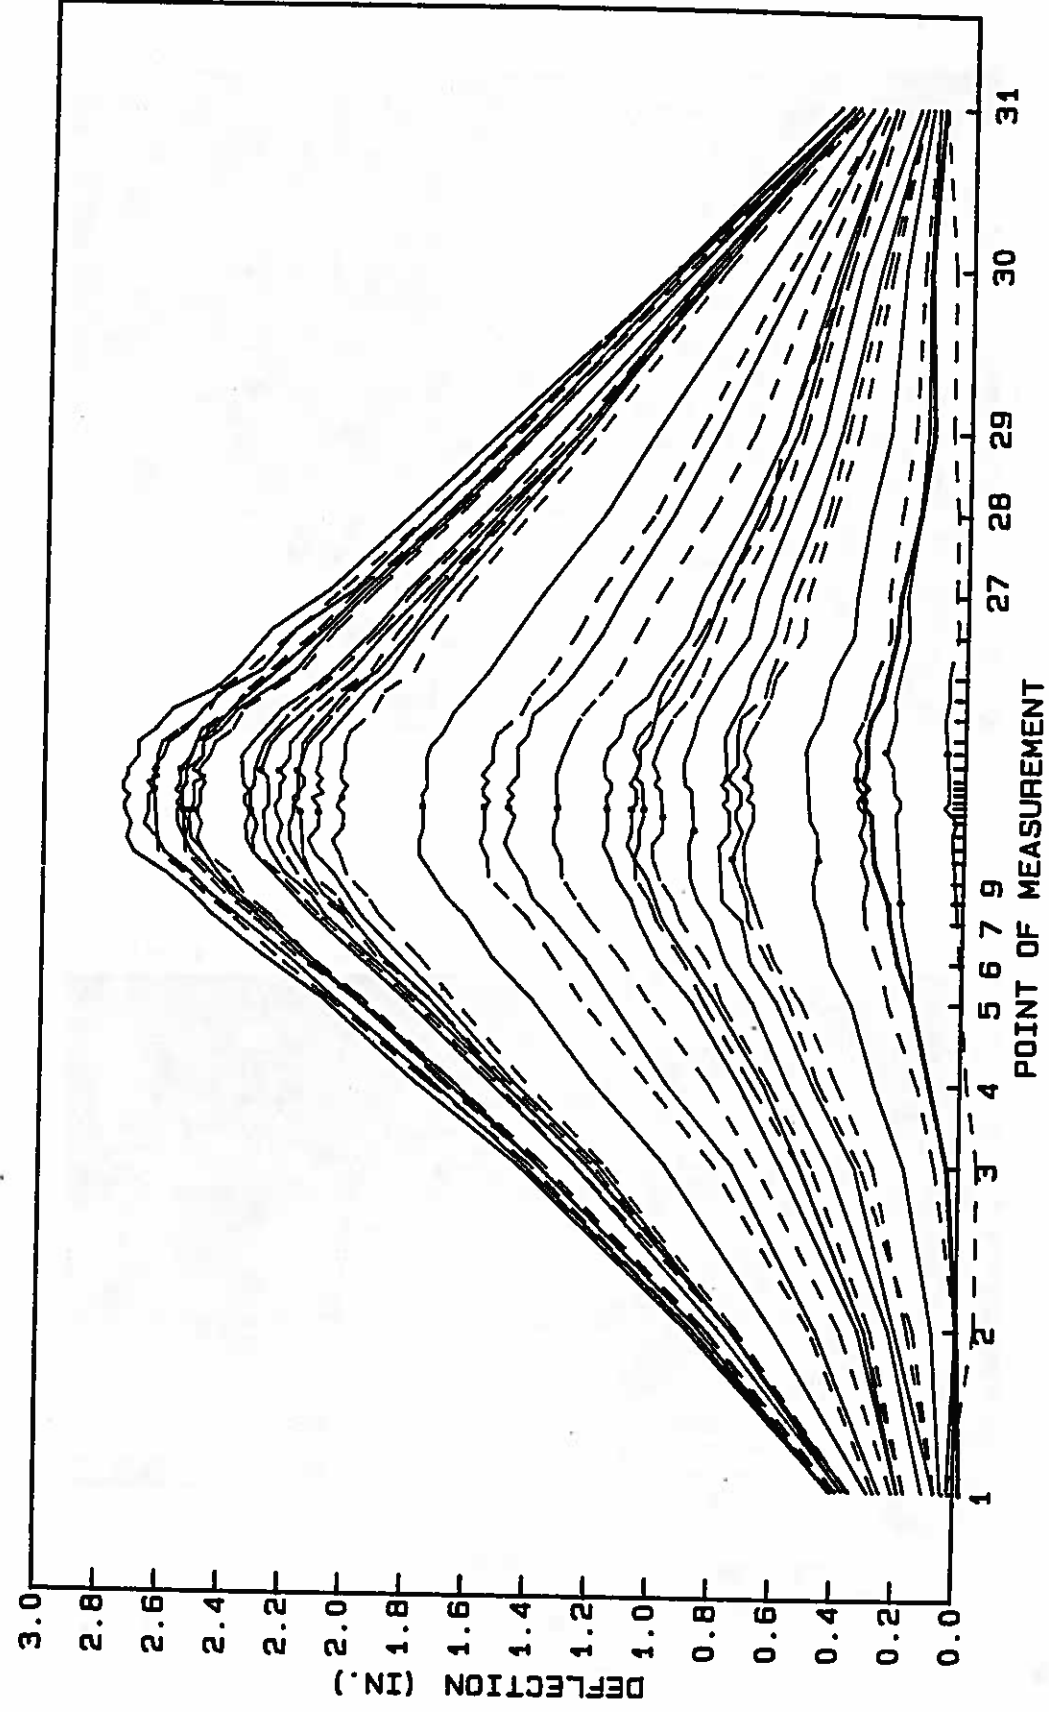
After the successful removal of this "dish-like" distortion during the seventh heating sequence, deflection measurements were again taken along the girder. As can be seen in Figure 48, after cycle 31 the bottom flange had deflected backwards (in a direction opposite to the vee direction) about 0.28 inches. During cycle 32, there was a slight forward movement (Figure 49).

Figure 48. Heat-straightening progression for the damaged girder SB-1 through the thirty-second heating cycle.

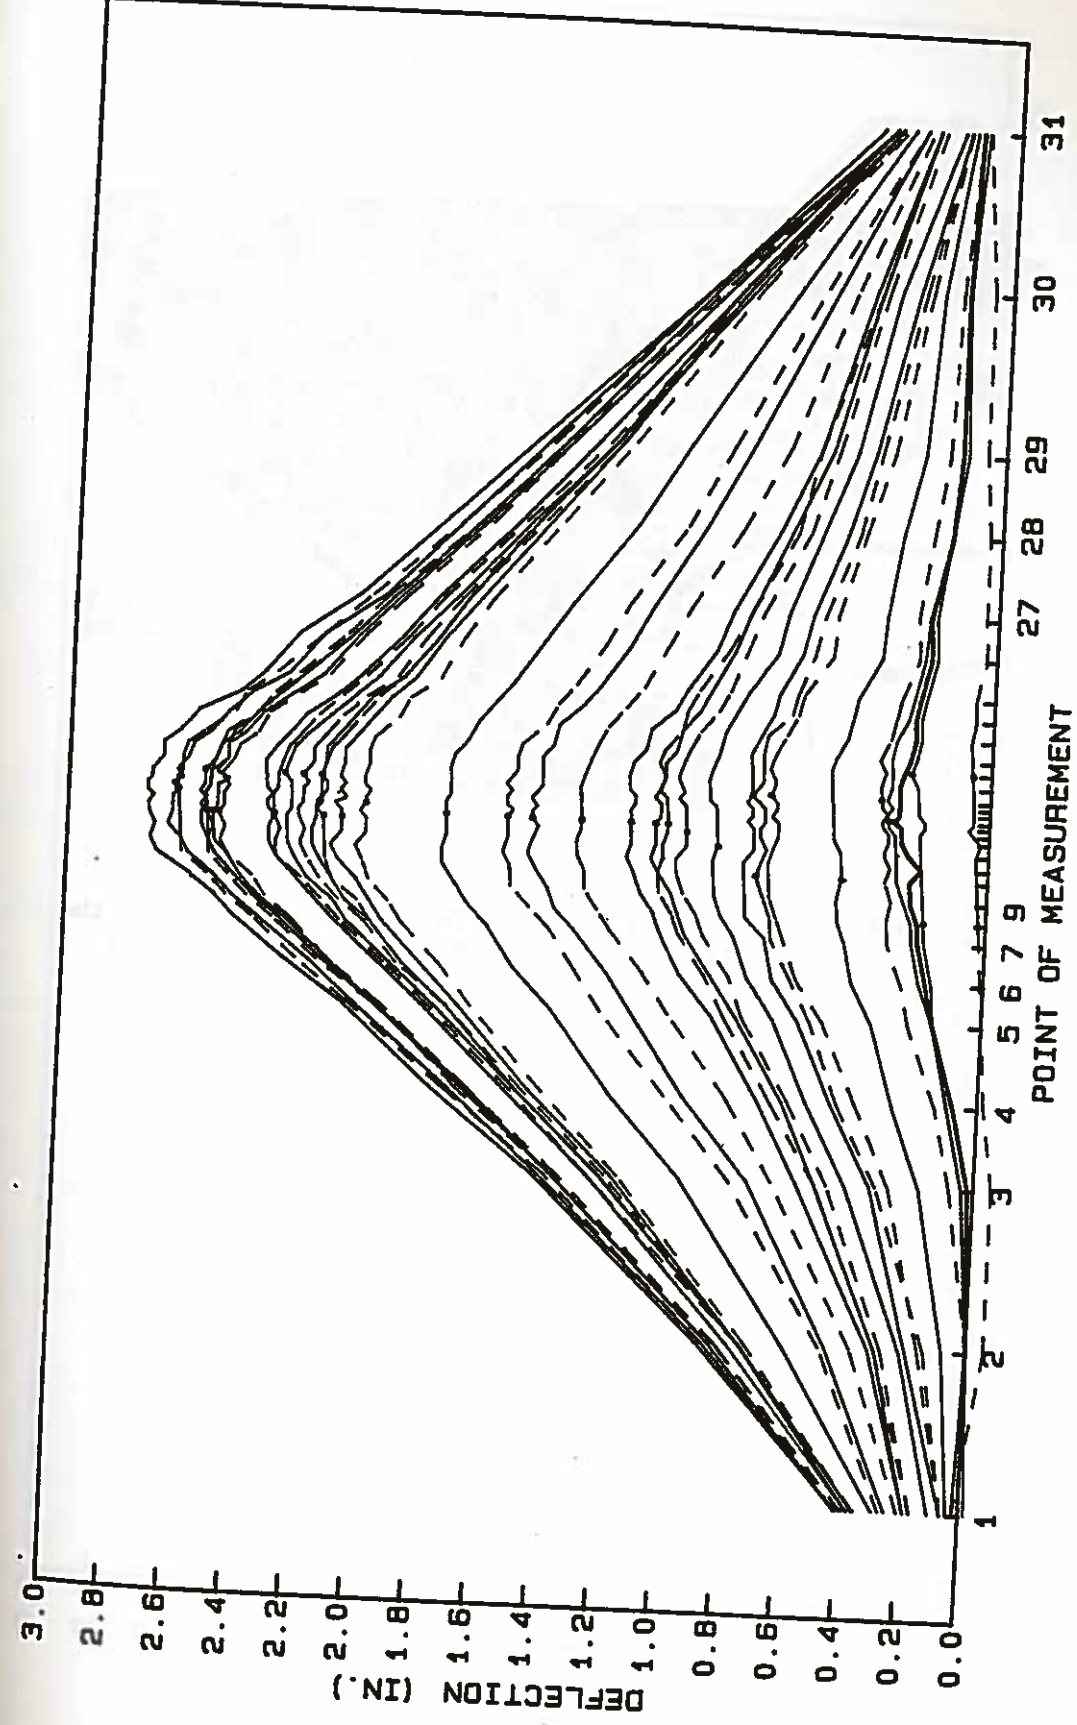
Figure 49. Heat-straightening progression for the damaged girder SB-1 through heating sequence seven (33 total heating cycles).

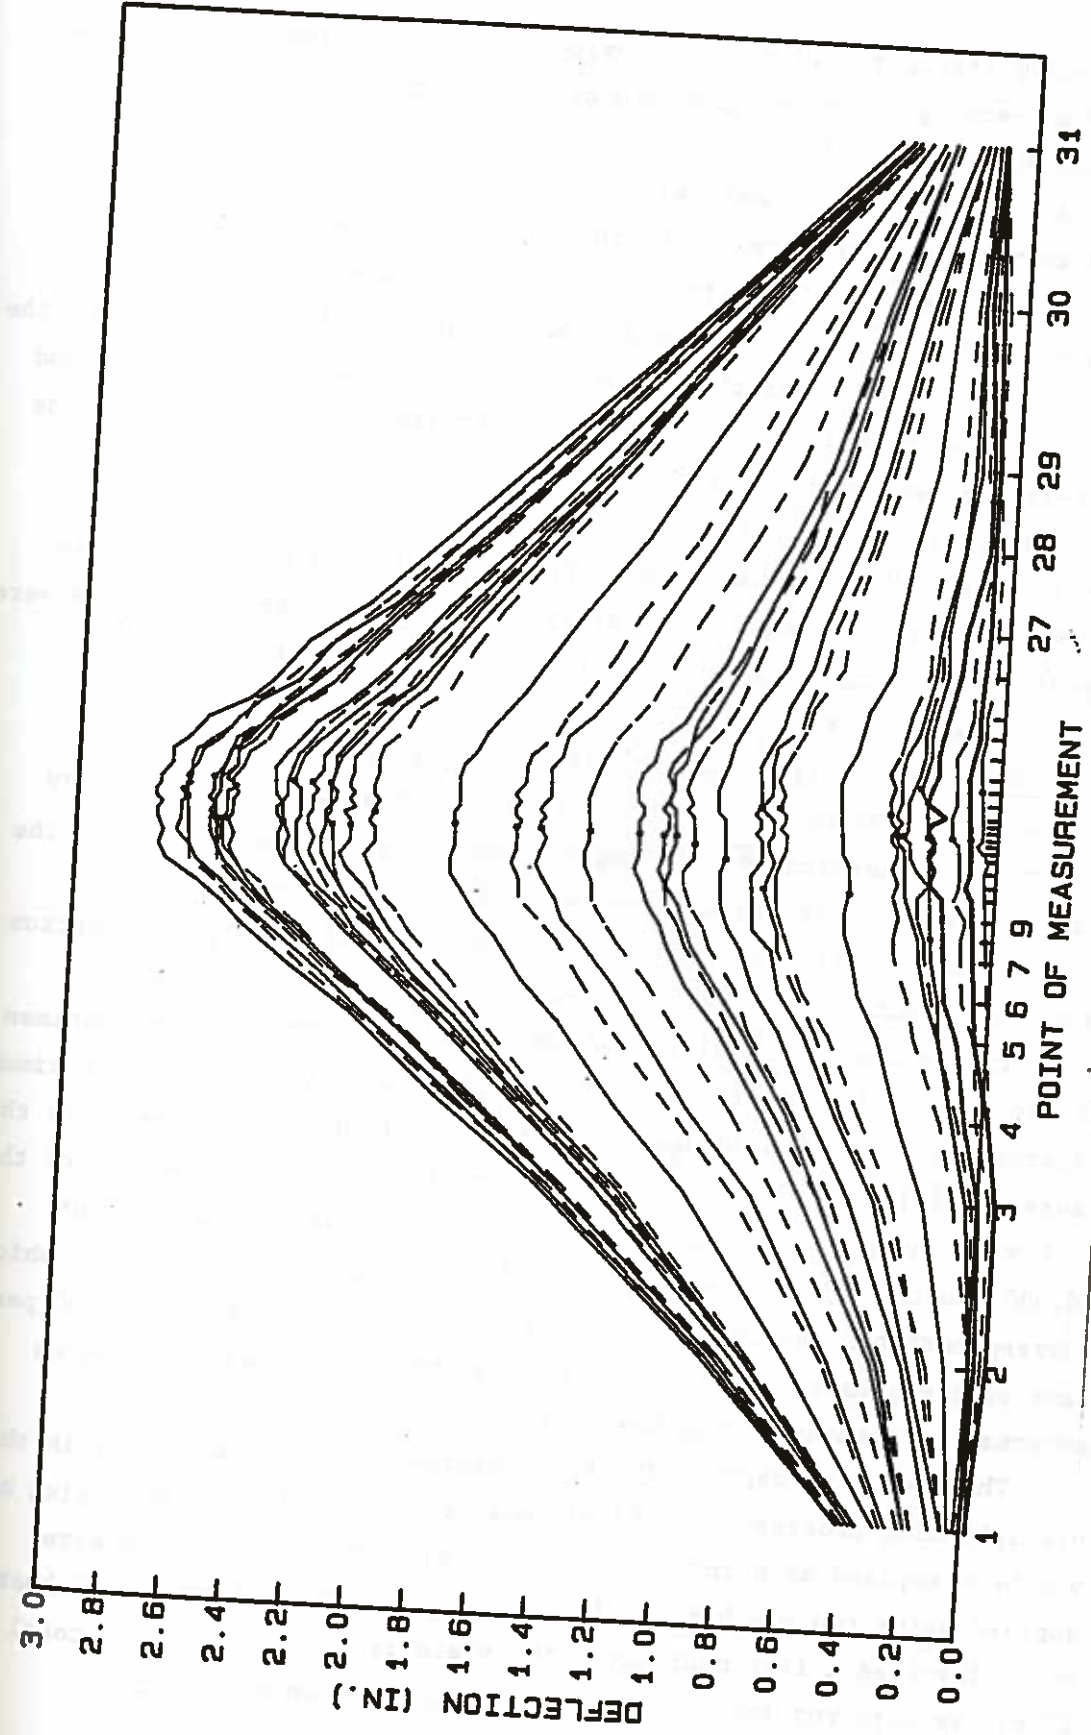
Figure 51. Heat-straightening progression for the damaged girder SB-1 through heating sequence eight (36 total heating cycles).

To remove the new lateral deflection of the bottom flange, the final heating sequence was the same procedure as used in heating sequence six. However, since the largest displacement was obtained around point 16, where most of the spot heats were applied, only one vee heat was applied at this point. Again, a 112 percent jacking force was exerted on the bottom flange. The final undeflected shape of the test girder is shown in Figure 50.

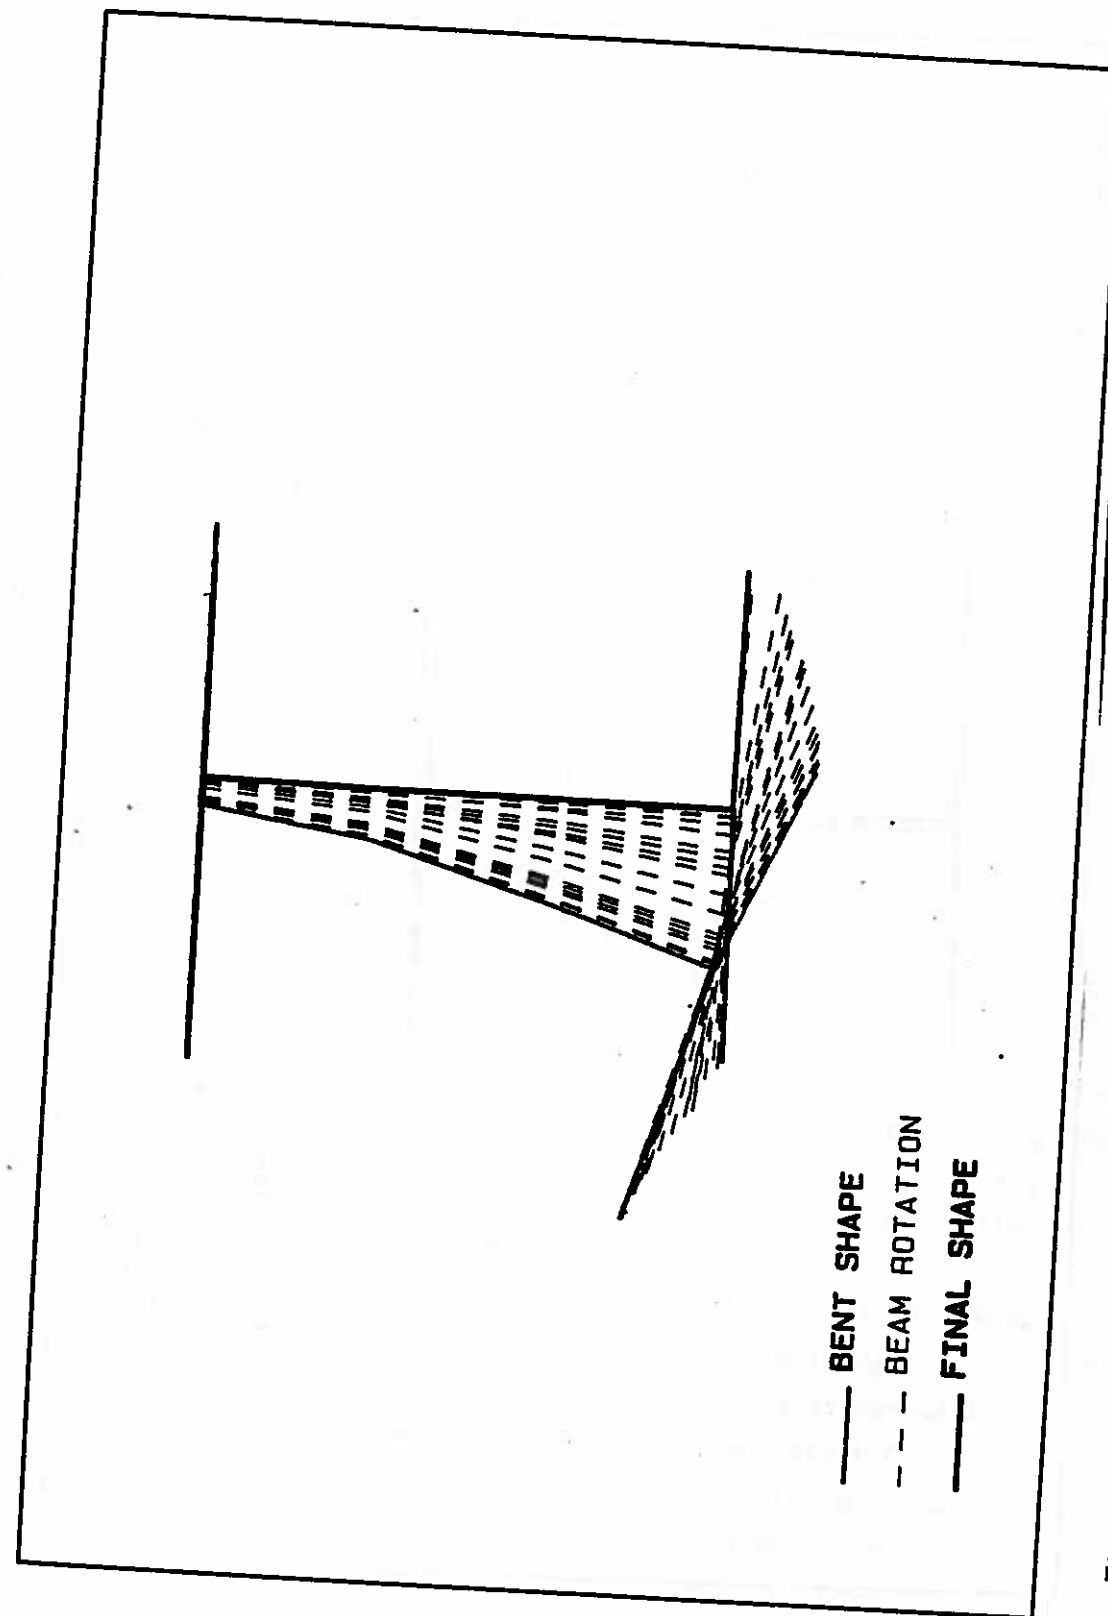
perfectly straight. Figure 52 provides a cross-sectional view showing the heat-straightening progression on the rotational behavior of the girder about point 16.

Figure 52. Rotational heat-straightening progression of the damaged girder specimen SB-1 (section at point 16).

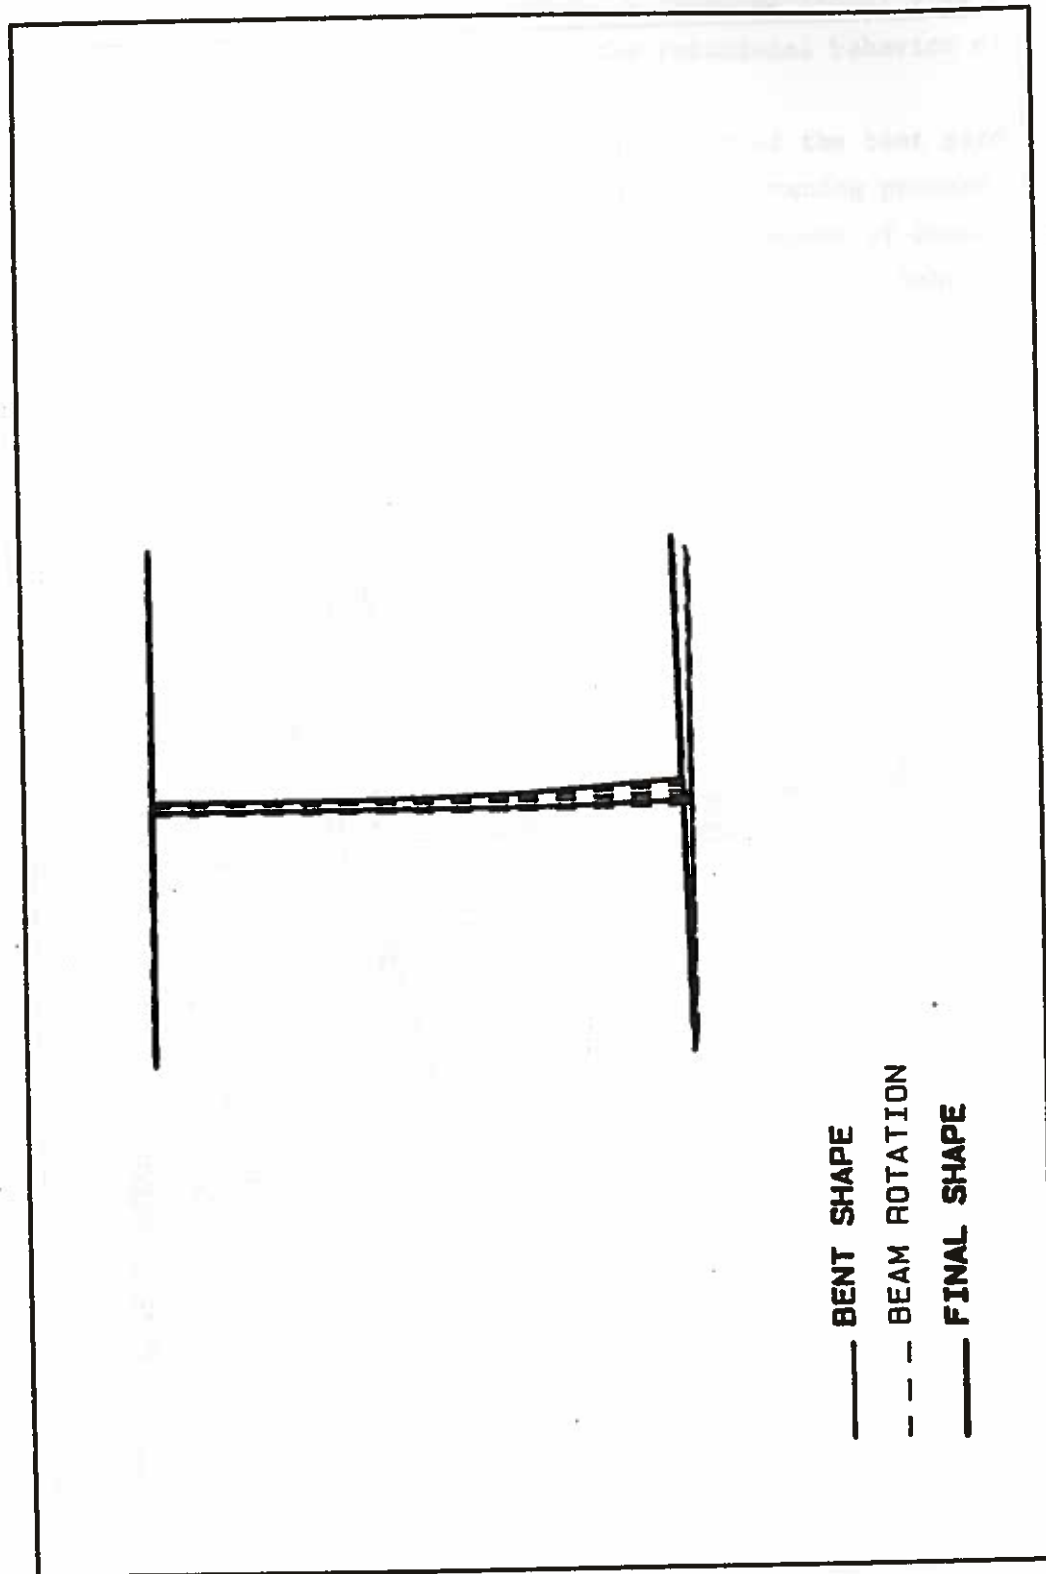
A slight curvature existed at the left end of the test girder. That curvature was not caused by the heat-straightening process, but rather was present in the girder before the inducement of damage. Figure 53 shows a cross-sectional view of the rotational behavior of the girder at point 1. When the girder was damaged, the bottom flange and web deflected elastically and assumed a straight position. During the heat-straightening process, those elements tended to return to their original deflected positions. Thus, when the heated portions were straightened, the original bend in the girder became evident. These curvatures were very small and barely seen. Since these curvatures were a part of the original shape of the girder, no attempt was made to heat-straighten that portion.

Figure 53. Rotational heat-straightening progression of the damaged girder specimen SB-1 (section at point 1).

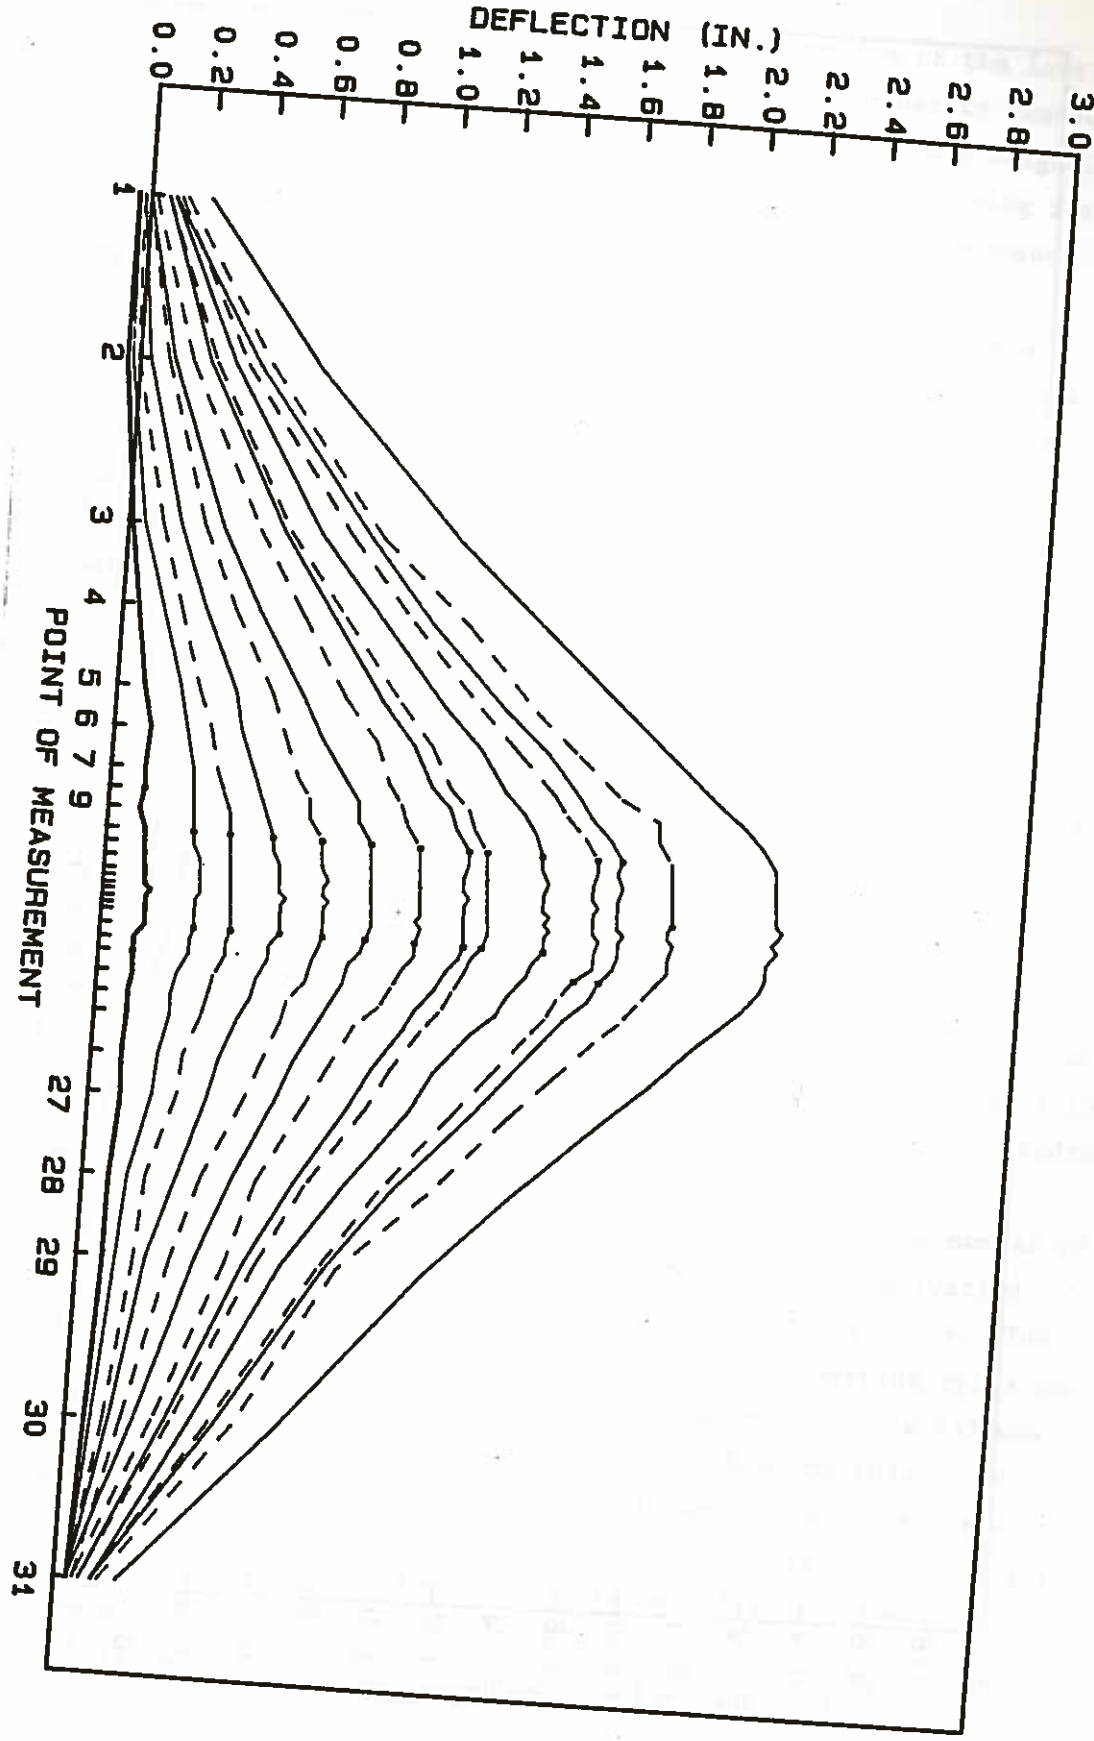
The values of the plastic rotation angles obtained during each heating cycle are shown in Table 7. Figure 58 shows a plot of the progressive effect of heats on the behavior of the girder up to the thirteenth heating cycle. After the application of the thirteenth heating cycle, the lateral displacement of the girder was eliminated. However, the "dish-like" distortion was still present in the bottom flange.

As can be seen in Figure 58, the deformation obtained after the completion of the first heating cycle was greater than that obtained after subsequent heat applications. This phenomenon was also observed during the SB-1 heat-straightening repair of this girder. Although the residual stresses are suspected of being the primary cause of this phenomenon, a residual stress analysis was not conducted during this phase of the project. However, residual stress tests are planned for tests on later heat-straightened girders.

Figure 58. Heat-straightening progression for the damaged girder SB-2 through the thirteen heating cycle.

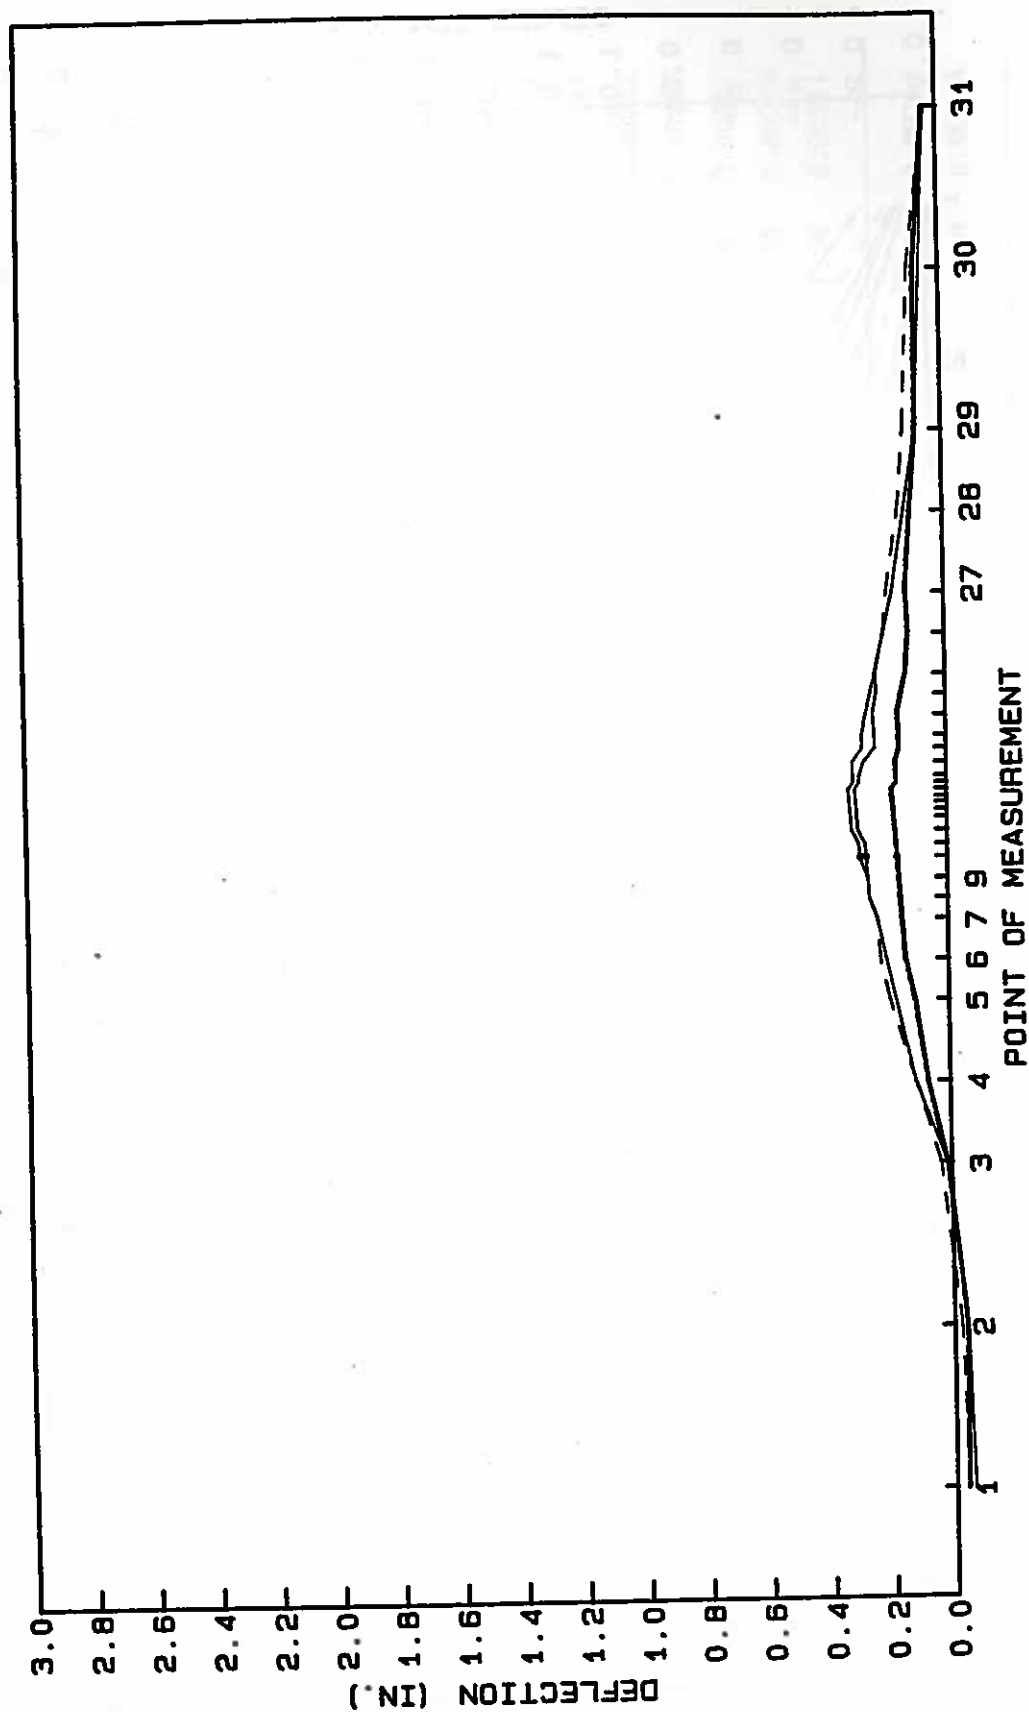
The fourteenth heating cycle was applied in order to remove the "dish-like" distortion which exists in the bottom flange. A plot of the deflections obtained during this heating cycle is presented in Figure 59. The magnitude of this deflection was about 0.18 inches in a direction opposite to the vee direction. The fifteenth heating cycle was applied to remove the slight buckles which developed in the bottom flange during the heating process. Also shown in Figure 59 is the final

Figure 59. Heat-straightening progression for the damaged girder SB-2 through the sixteenth heating cycle).

straightened shape of the girder after the application of the last heating cycle. That heating cycle was performed in order to remove most of the lateral deflection resulting from the removal of the bulges. Figure 60 provides a cross-sectional view of the girder showing its rotational behavior in response to the heat-straightening process.

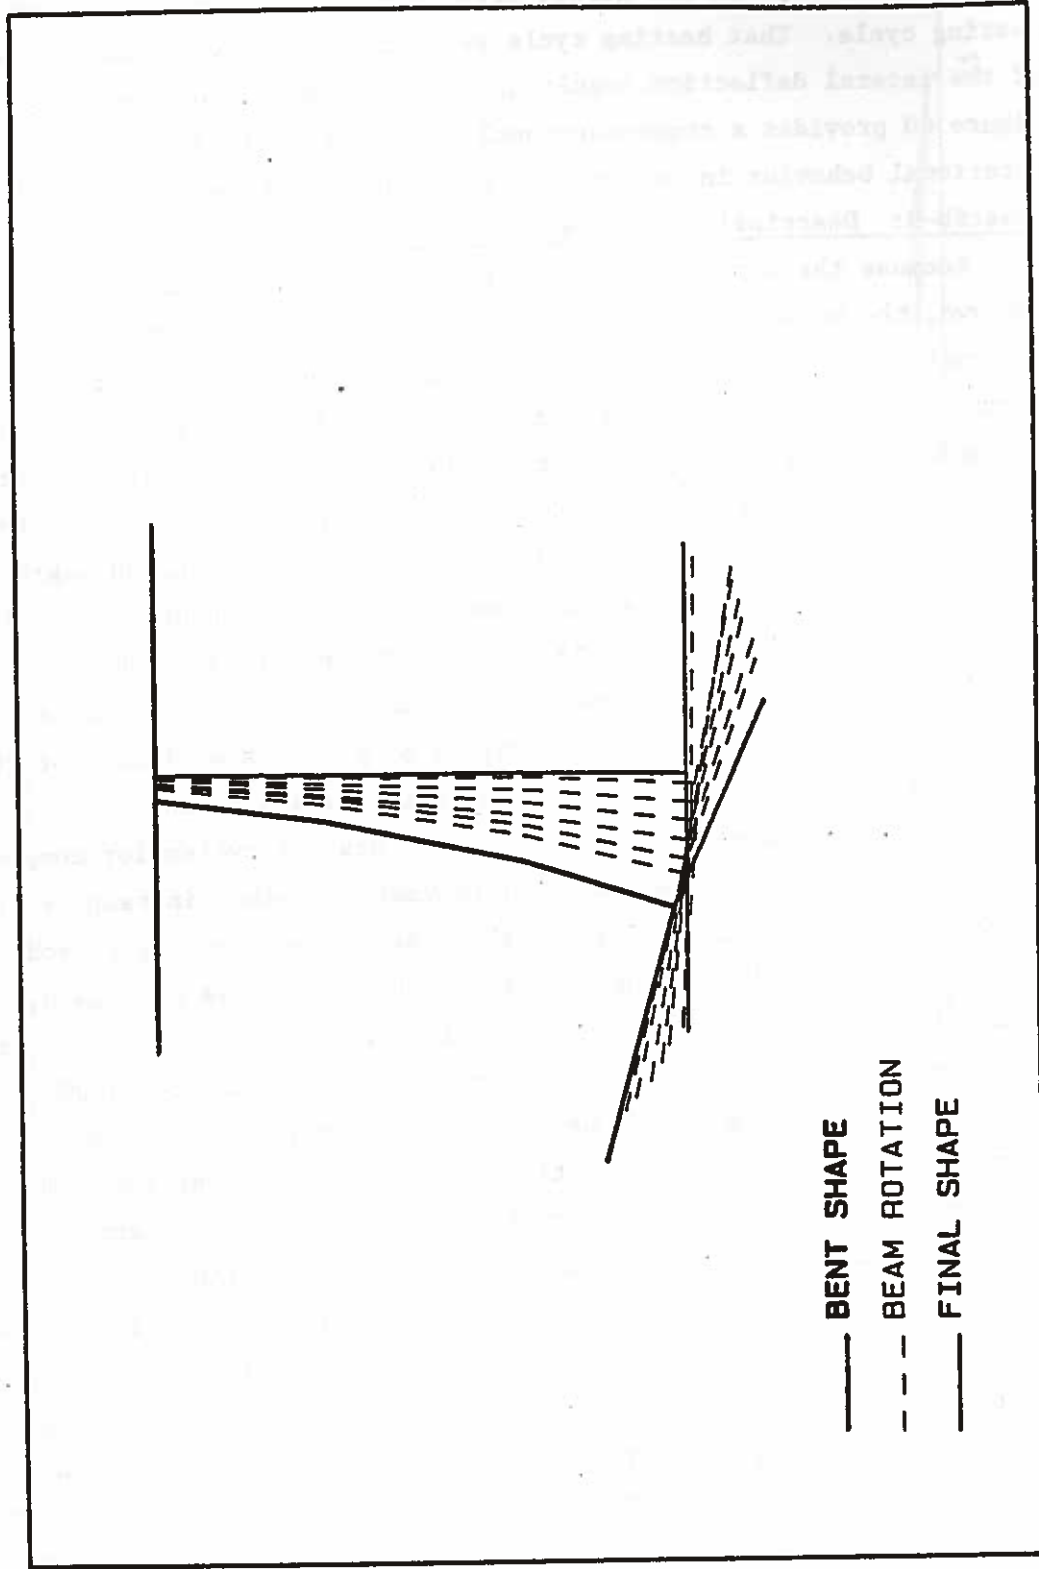
Figure 60. Rotational heat-straightening progression of the damaged girder specimen SB-2 (section at point 16).

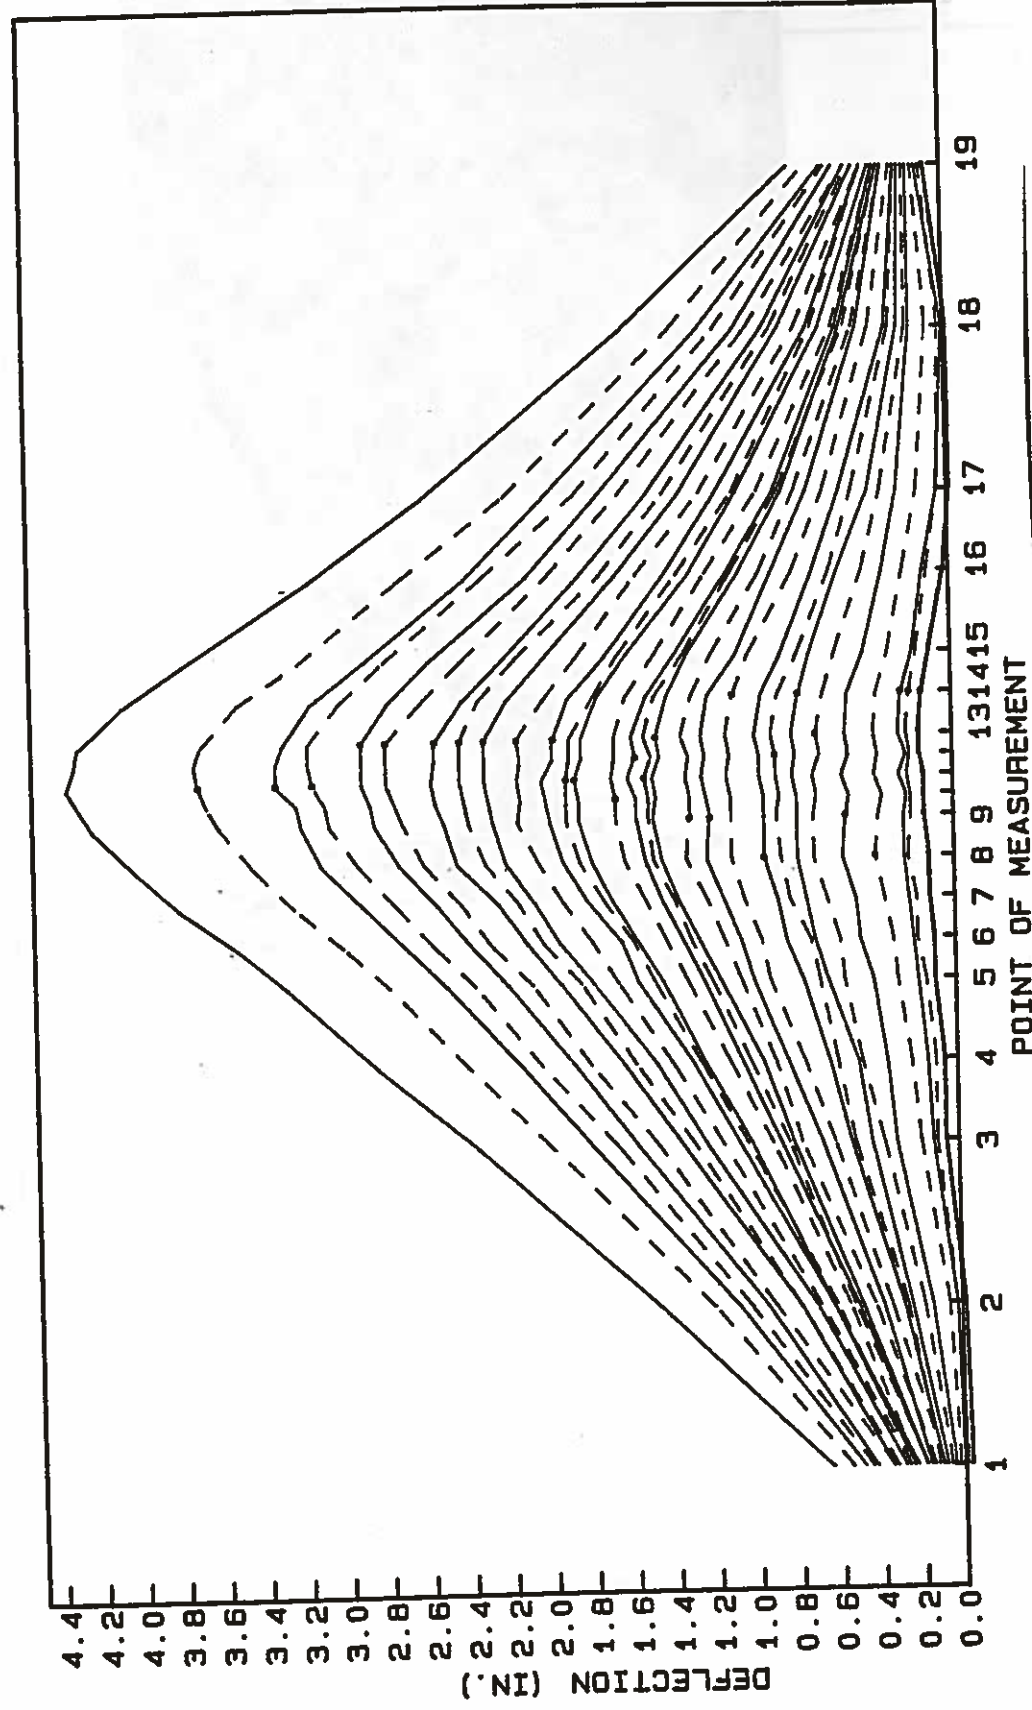
The straightening process required 28 heating cycles for completion. Figure 62 shows the amount of movement obtained in response to each heating cycle. The values of the plastic rotation angles achieved during each of the 28 heating cycles are shown in Table 8. Again, the maximum plastic rotation angle was obtained after the application of the first heating cycle. That angle was computed to be about 0.01095 radians.

During the course of the heat-straightening process, it was observed that the amount of plastic rotation decreases as the number of vee heats applied at the same location increases. That observation became clear after the application of the twelfth heating cycle. The amount of plastic rotation angle obtained during this heating cycle was 0.00102 radians. However, the following heating cycle (cycle 13) was performed by applying the vee heat to point 10. Heating this virgin location produced a plastic rotation angle of about 0.00308 radians, which is about 3 times as large as the previous plastic rotation angle. A low plastic rotation angle was again obtained after the completion of the sixteenth heating cycle. During this heating cycle, the vee heat was reapplied at point 13. The plastic rotation angle produced was

Figure 62. Heat-straightening progression for the damaged girder SB-3 up to the twenty-eighth heating cycle.
