HEAT-STRAIGHTENING EFFECTS ON THE BEHAVIOR
OF FULL-SCALE SIMULATED BRIDGE GIRDERS

VOLUME 4: FIRST INTERIM REPORT OF PHASE 2

STATE PROJECT NO. 736-10-46
FEDERAL AID PROJECT NO. HPR-0010(008)
LSU PROJECT NO. 127-15-4141

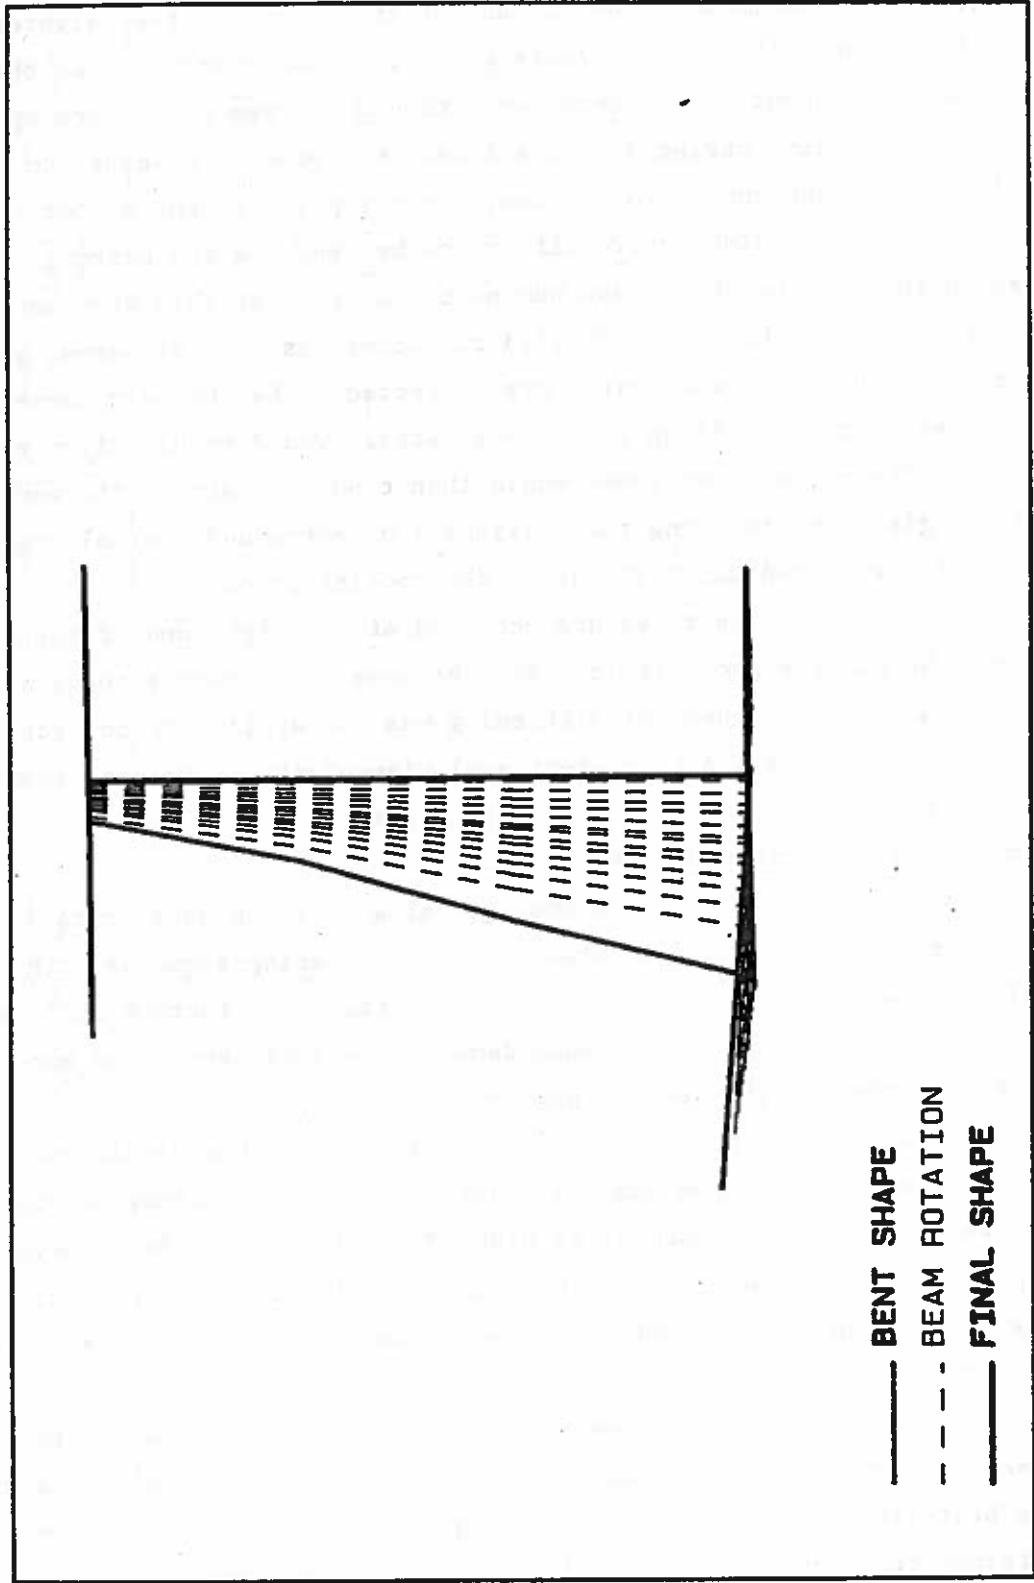
A slight reverse curvature occurred at the right end of the girder where the hinge support is located. Because this reverse curvature was small in magnitude, heat straightening was not applied to correct this over-straightening. A cross-sectional view of the rotational behavior of the girder at point 11 is shown in Figure 63.

Figure 63. Rotational heat-straightening progression of the damaged girder specimen SB-3 (section at point 11).

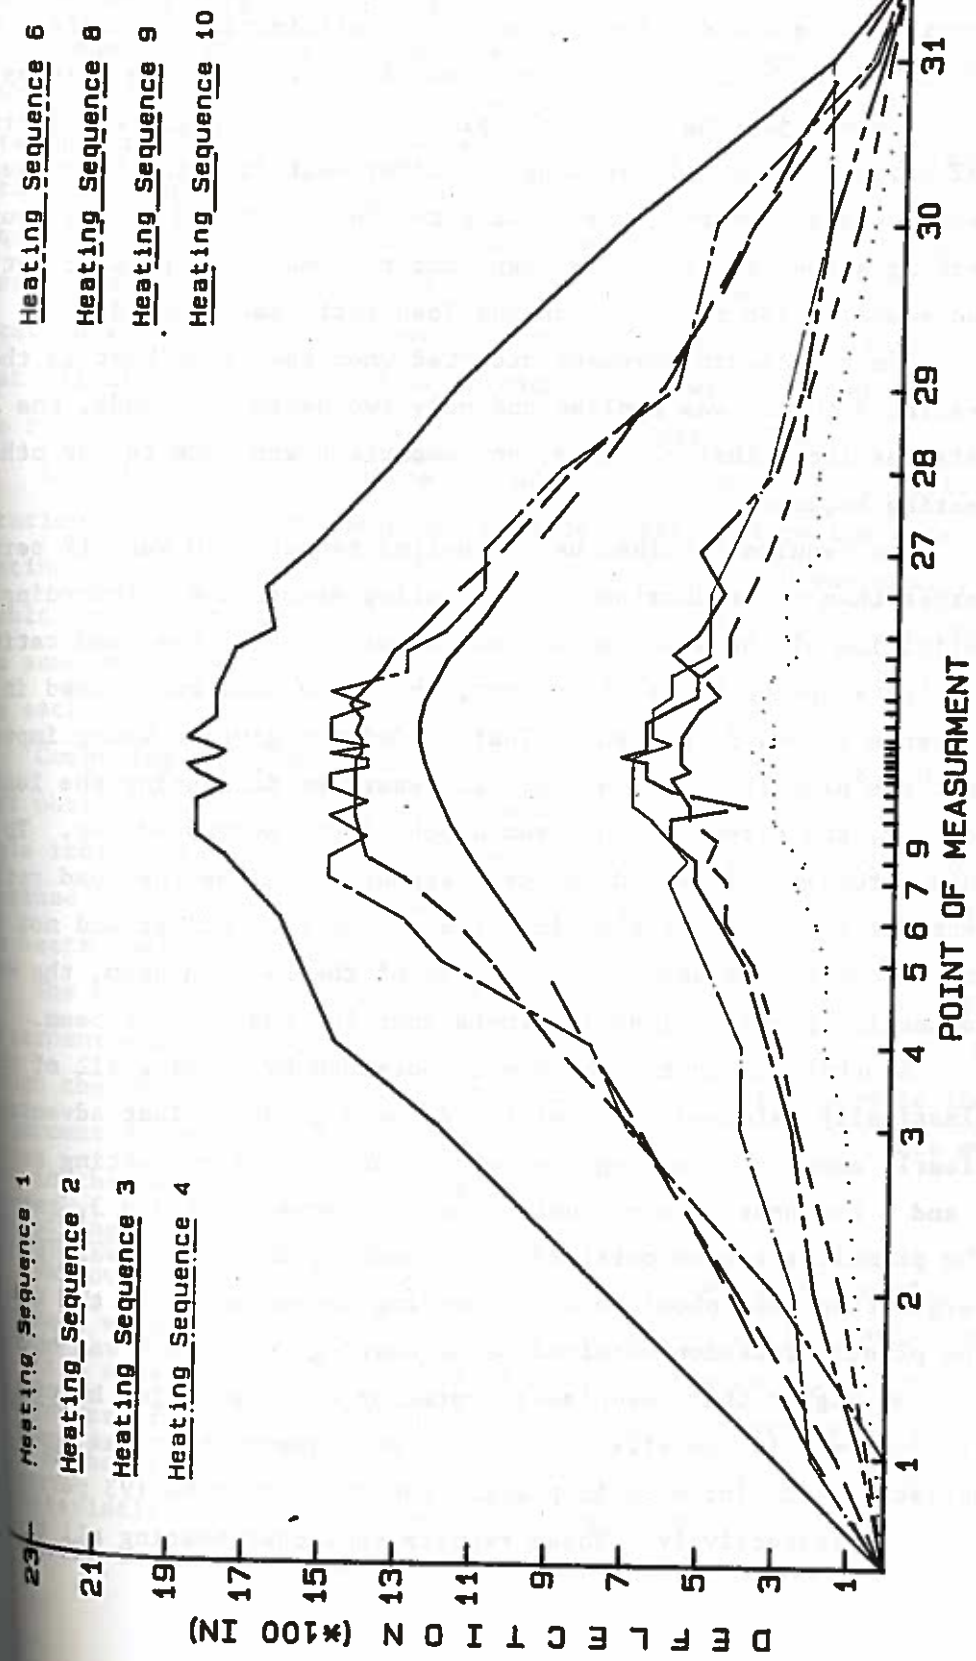
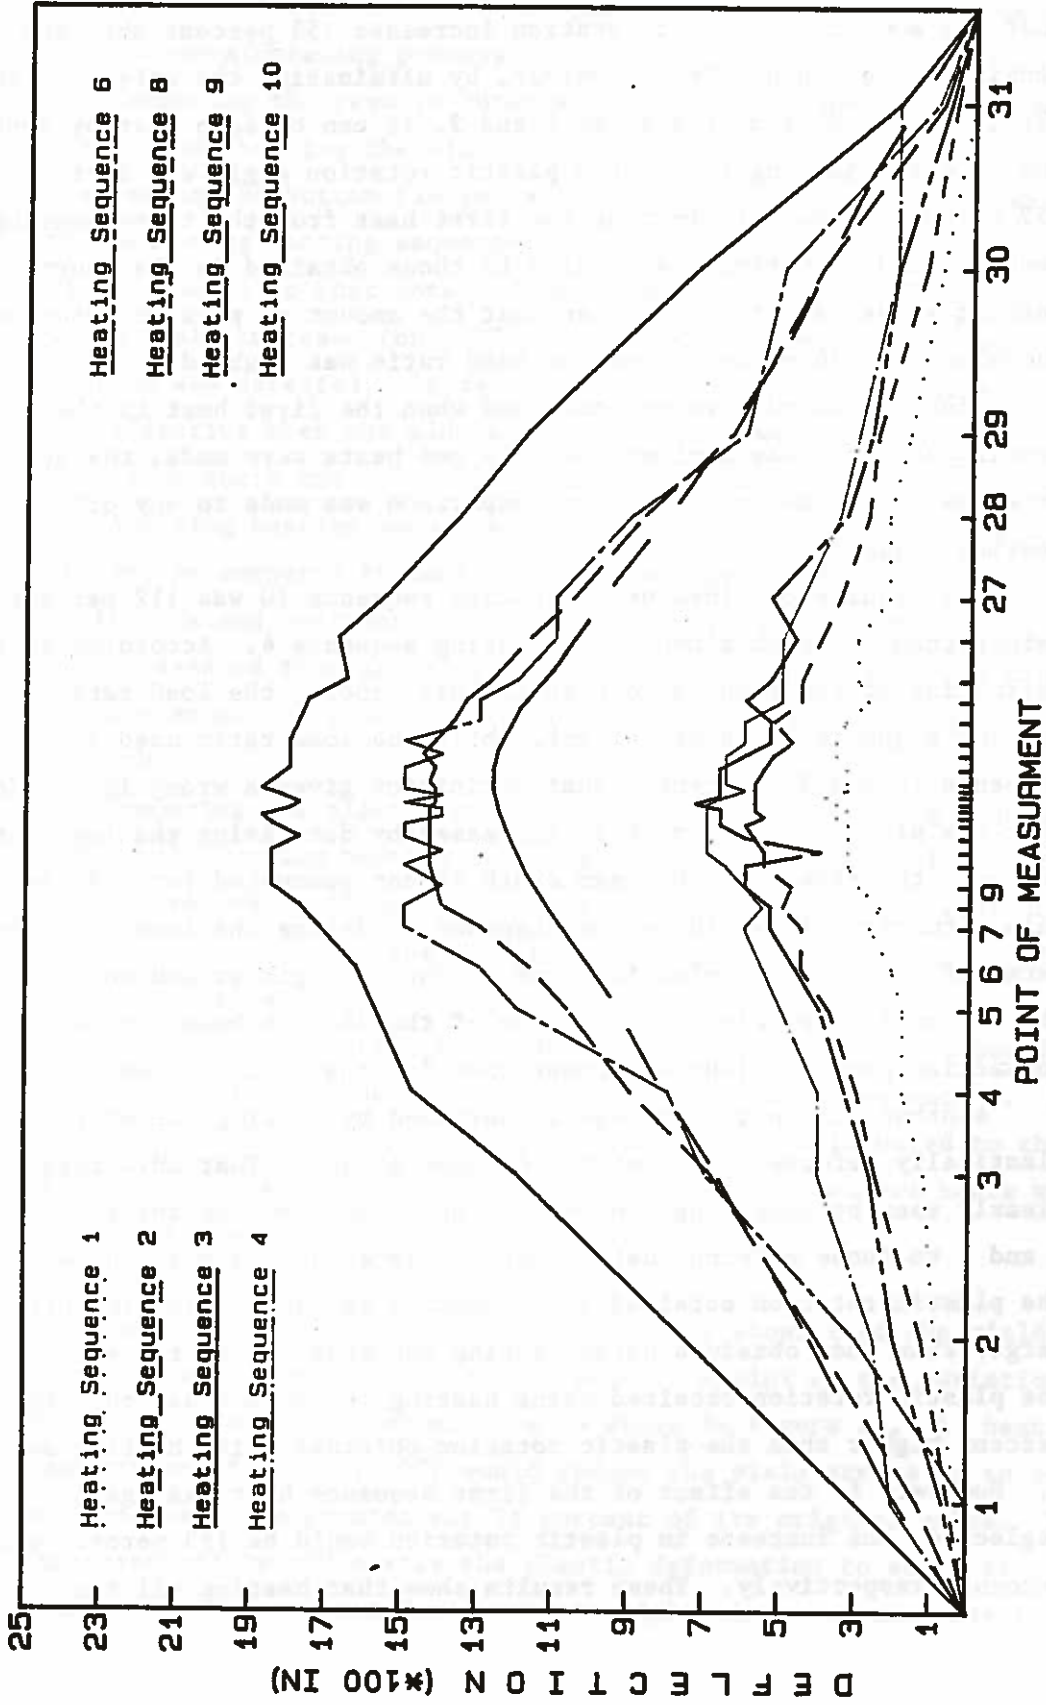
For comparison purposes, the average value of the displacement of the bottom flange of the damaged girder under the influence of each of the various heating sequences is plotted in Figure 64. Each curve represents the average of all the heating cycles in a corresponding heating sequence. For cycles with more than one vee heat, the results are divided by the number of vees.

It can be seen from these results that there exists a distinct advantage for applying an auxiliary jacking force to the girder during the heat-straightening process. A comparison between the results obtained from heating sequence 1 to those obtained from heating sequence 2 shows that the plastic rotation increased 64 percent just by doubling the jacking force. Comparing the results obtained using heating

Figure 64. Comparison of the behavior of the test girder under the influence of different sequences of heat-straightening.

sequence 3 to those obtained using heating sequence 4, it can be seen that the amount of plastic rotation increased 153 percent when the jacking force was doubled. However, by eliminating the effect of the first heat in heating sequences 1 and 2, it can be seen that by doubling the external jacking force, the plastic rotation angle was increased by 152 percent. Also, eliminating the first heat from the third heating sequence and comparing the results to those obtained in the fourth heating sequence, it can be seen that the amount of plastic rotation increased by 136 percent when the load ratio was doubled.

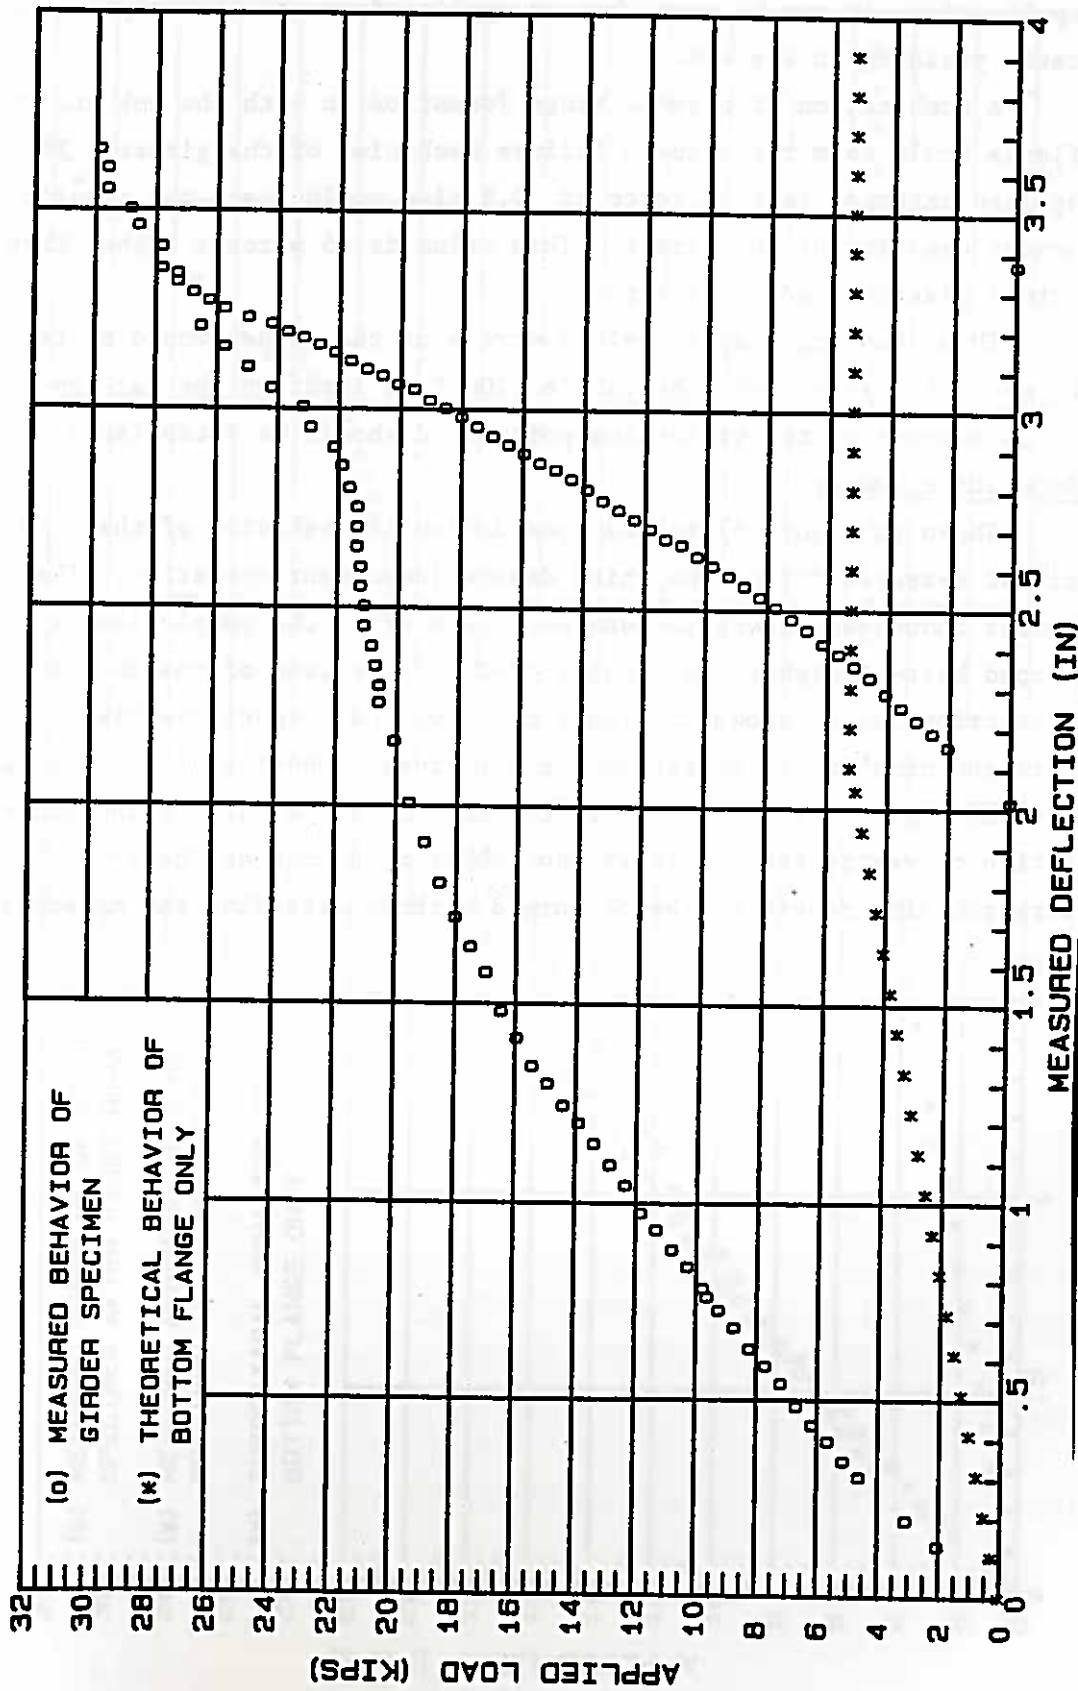
After the girder was completely repaired, it was re-damaged in an attempt to better understand the structural behavior of the girder specimen. The lateral deflection of the bottom flange was measured while loads were gradually applied. Those deflection measurements were taken at the point of load application, point 16. Figure 66 shows the experimental load-deflection behavior of the girder in comparison to the theoretical load-deflection behavior of the bottom flange only. An analysis of these results revealed that the girder specimen started to yield at an applied load of approximately 16,000 pounds. The plastic moment capacity of the girder was achieved with an applied force of about 21,000 pounds. For SB-2, the damage induced on the composite girder formed a yield line in the web that encompassed approximately a 7.5-foot span of the 19.5-foot-long specimen. The ratio of the yield line length to the entire length of the girder was 39 percent. That yield line occurred at 3.5 inches below the top flange. The ratio of this distance to the depth of the web between flanges was 38 percent. The distance between the point of load application and the yield line was about 5.625 inches. The moment capacity of the web at first yield is 10.72 k-in/ft. Assuming that the web has plastically yielded along the 7.5-foot span and varies linearly between the end points of the yield line to a zero value at both ends of the full length, the calculated yield moment capacity of the web would be approximately 142 k-in. Dividing this value by the distance to the point of load

Figure 66. Load-deflection behavior of a composite W 10 X 39 girder specimen laterally loaded to simulate impact.

application, it can be seen that an applied force of 25.3 kips would cause yielding in the web.

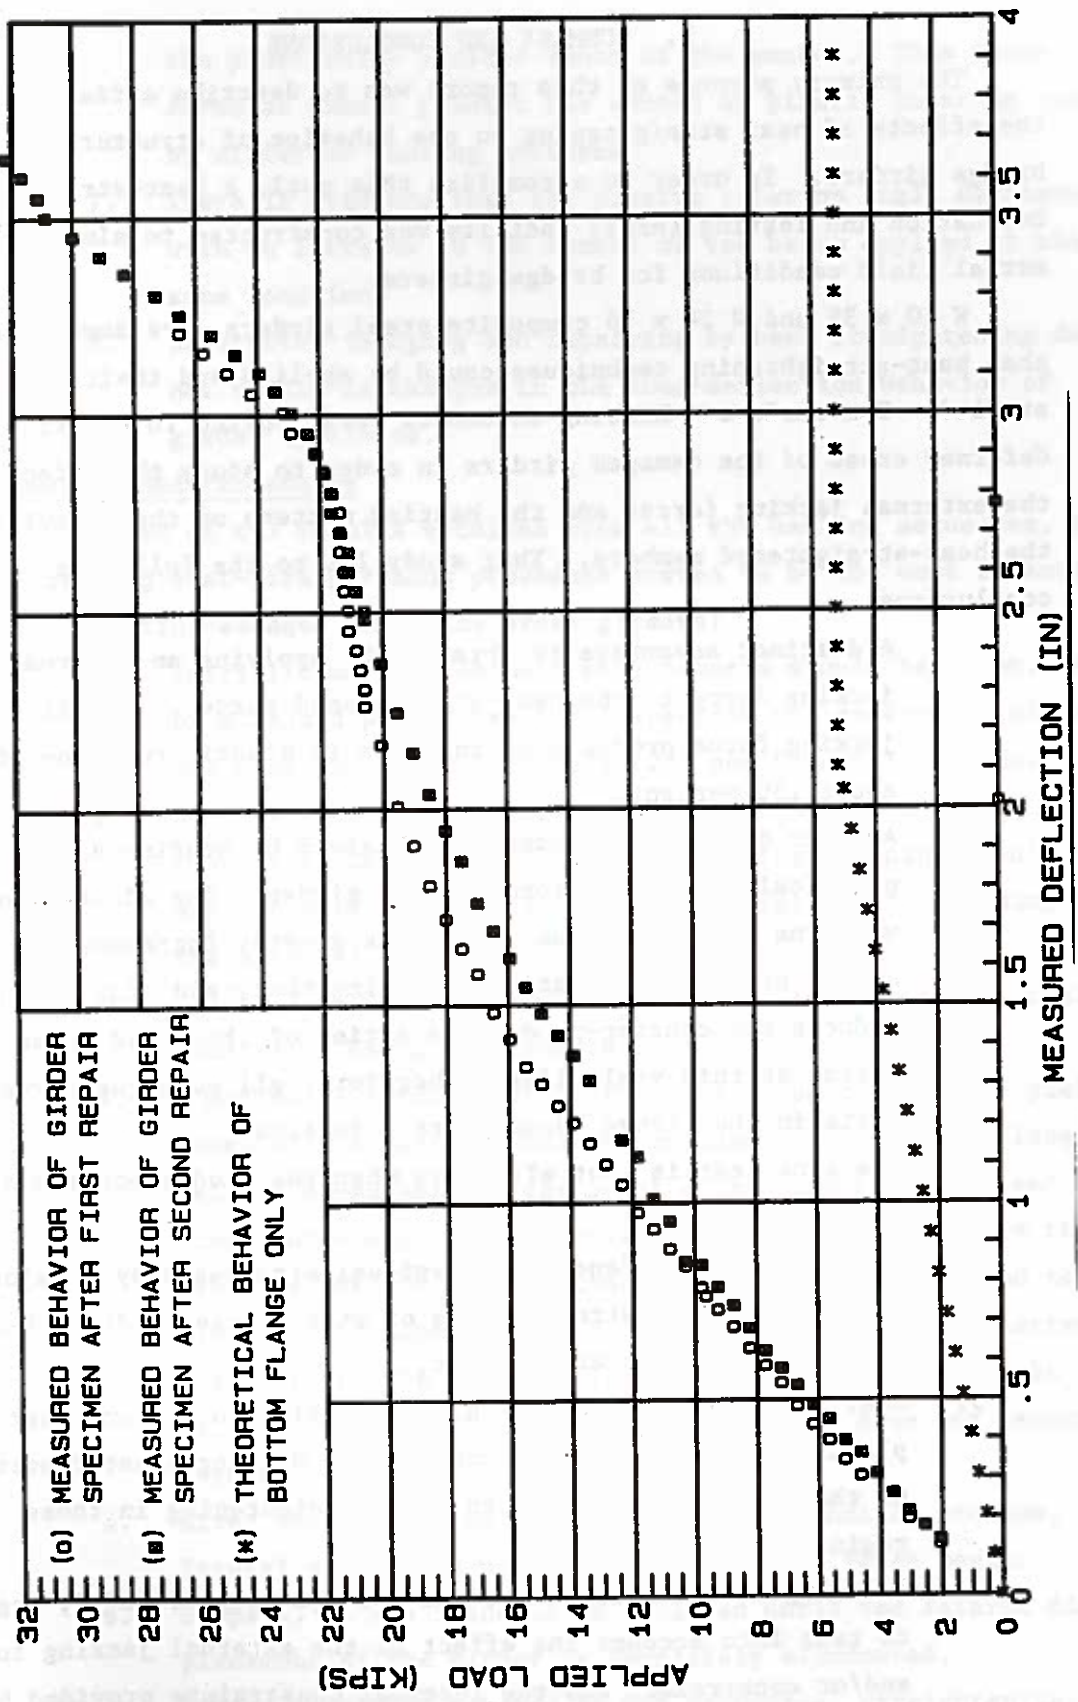
Shown in Figure 67 is the load-deflection behavior of the W 10 x 39 girder measured during the third damage inducement operation. The third damage inducement operation was performed after the completion of the second heat-straightening repair, SB-2. Comparison of the two load-deflection curves shown in Figure 67 shows that repetitive heat straightening had no effect on the structural behavior of the W 10 x 39 composite girder specimen. This comparison is the first such documentation to verify that at least two cycles of damage and heat-straightening repair can be performed without degrading the material.

Figure 67. Load-deflection behavior of a composite W 10 X 39 girder specimen laterally loaded to simulate impact.
