1. Report No. FHWA/LA-88/210		2. Government Accession No.		3. Recipient's Catalog No.	
4. Title and Subtitle Development of Design Criteria for the Prevention of Slope Failures		5. Report Date March 1990

9. Performing Organization Name and Address Dept. of Petroleum Engineering and Geosciences Louisiana Tech University Ruston, LA 71272		10. Work Unit No.

**DEVELOPMENT OF DESIGN
CRITERIA FOR PREVENTION
OF SLOPE FAILURES**

FINAL REPORT

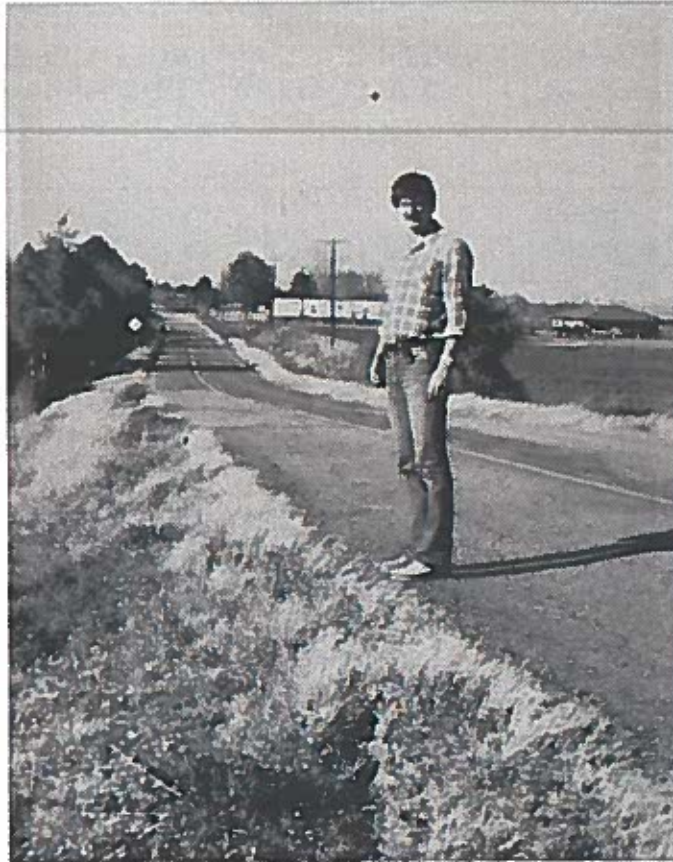
Figure 18. Upper slump scarp cutting into road in front of feet of Schaun Smith at Locality S11 (AC-1123-NW).

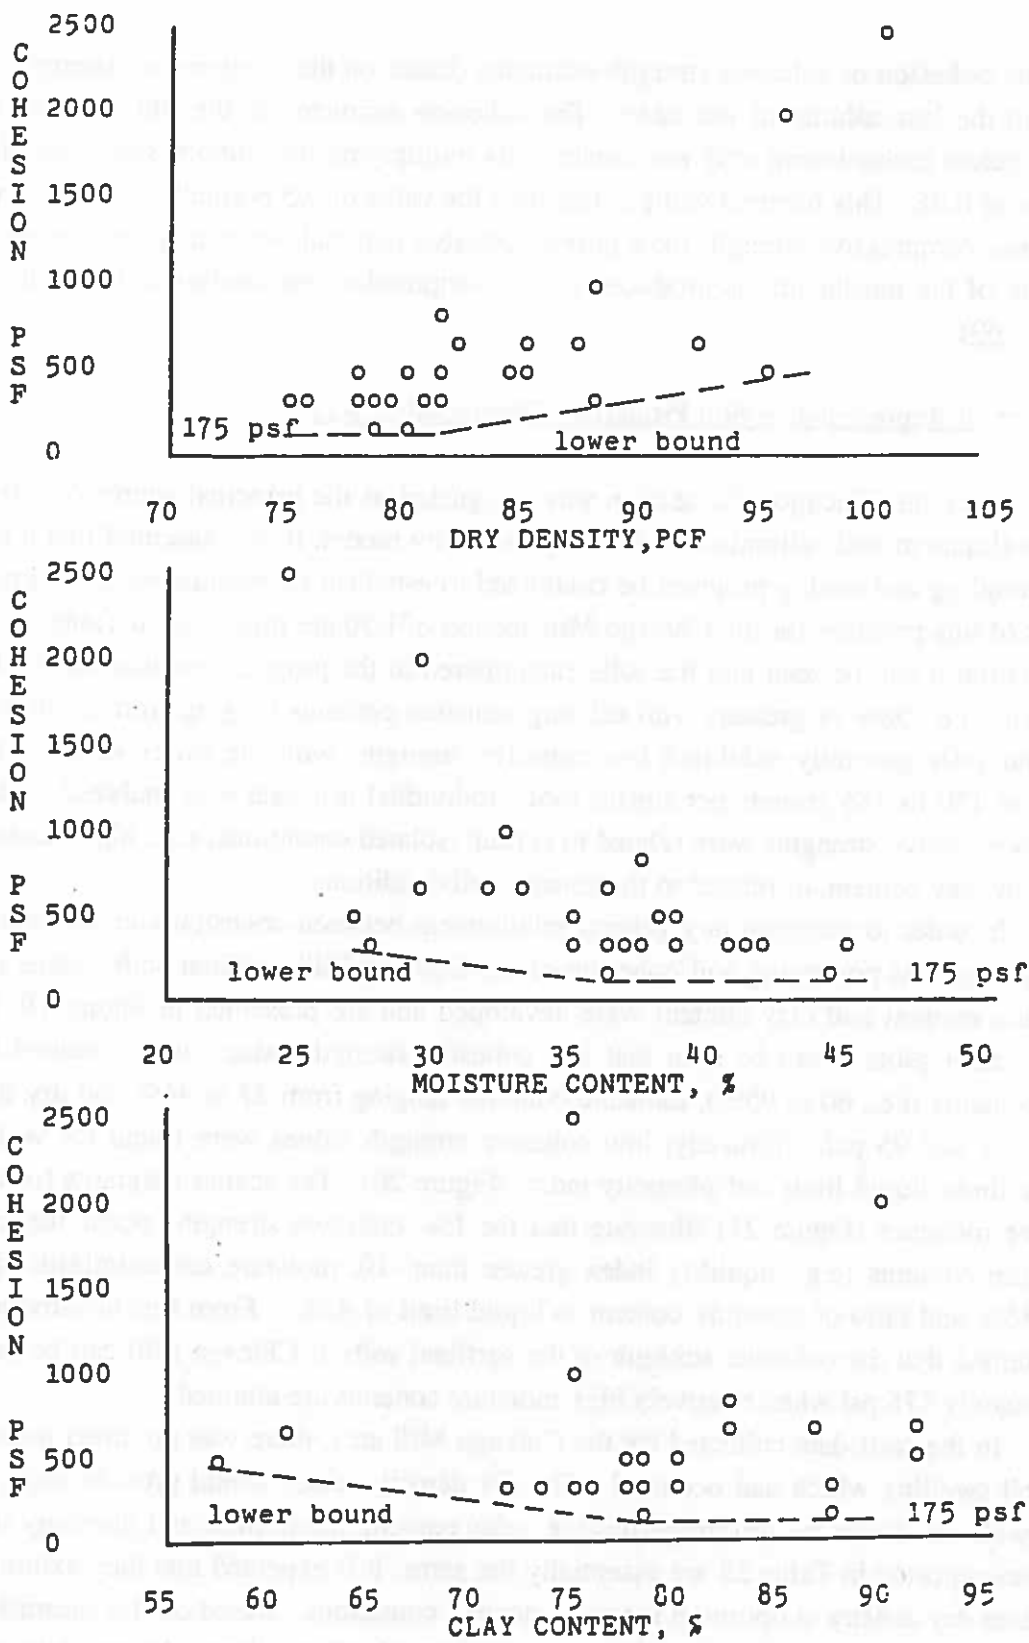
In order to ascertain any general relationship between cohesion and soil characteristics, scatter diagrams portraying soil cohesion of the Chicago Mill surficial soils versus dry density, moisture content and clay content were developed and are presented in Figure 19. From these three scatter plots it can be seen that low cohesive strength values were obtained for varying clay contents (i.e., 60 to 95%), moisture contents ranging from 27 to 46% and dry densities between 75 and 95 pcf. Similarly, low cohesive strength values were found for wide ranges in plastic limit, liquid limit and plasticity index (Figure 20). The scatter diagrams for measures of relative moisture (Figure 21) illustrate that the low cohesive strengths occur for high relative moisture contents (e.g., liquidity index greater than -10, moisture content/plastic limit greater than 85% and ratio of moisture content to liquid limit of 42%). From this information it can be ascertained that the cohesive strength of the surficial soils at Chicago Mill can be as low as approximately 175 psf when relatively high moisture contents are attained.

Figure 19. Scatter diagrams for various soil characteristics
Chicago Mill section of I-20, Madison Parish, N17.

the top section of Figure 19 where the cohesive strength values are lower for the lower dry densities. It is apparent that a majority of the surficial soil samples from the Chicago Mill area have undergone significant swelling.

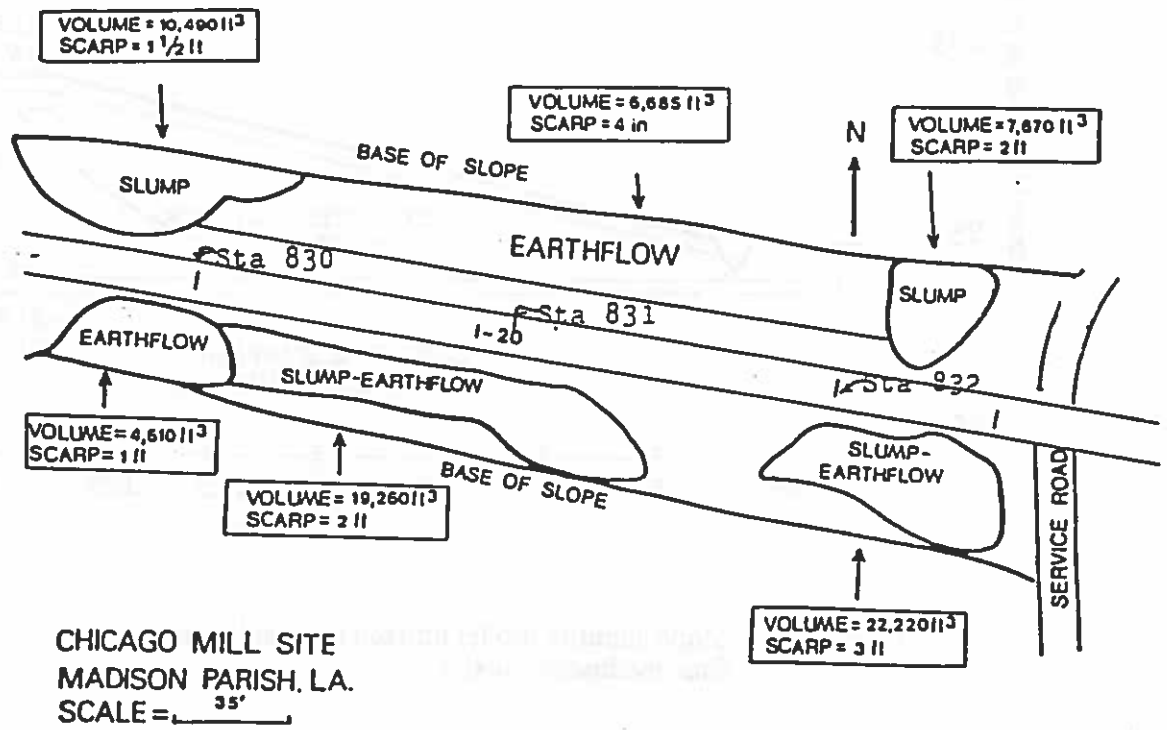
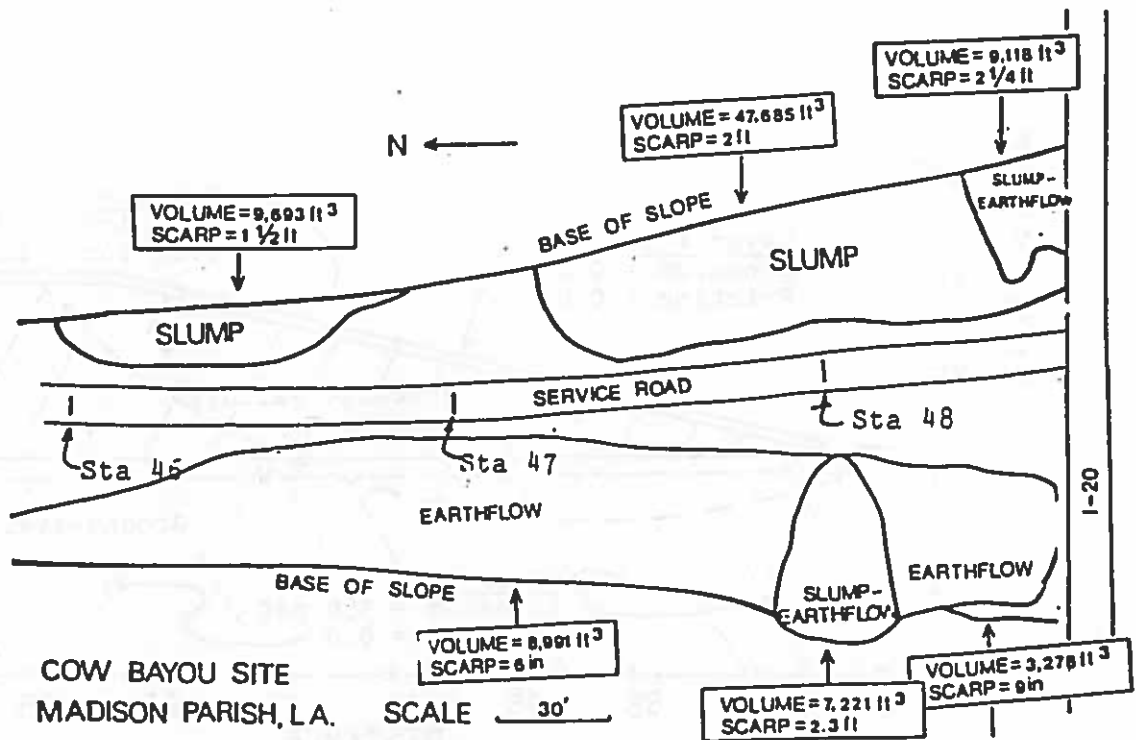
Figure 30. Embankment slope condition survey results for Chicago Mill (N17) and Cow Bayou (N13) sites.

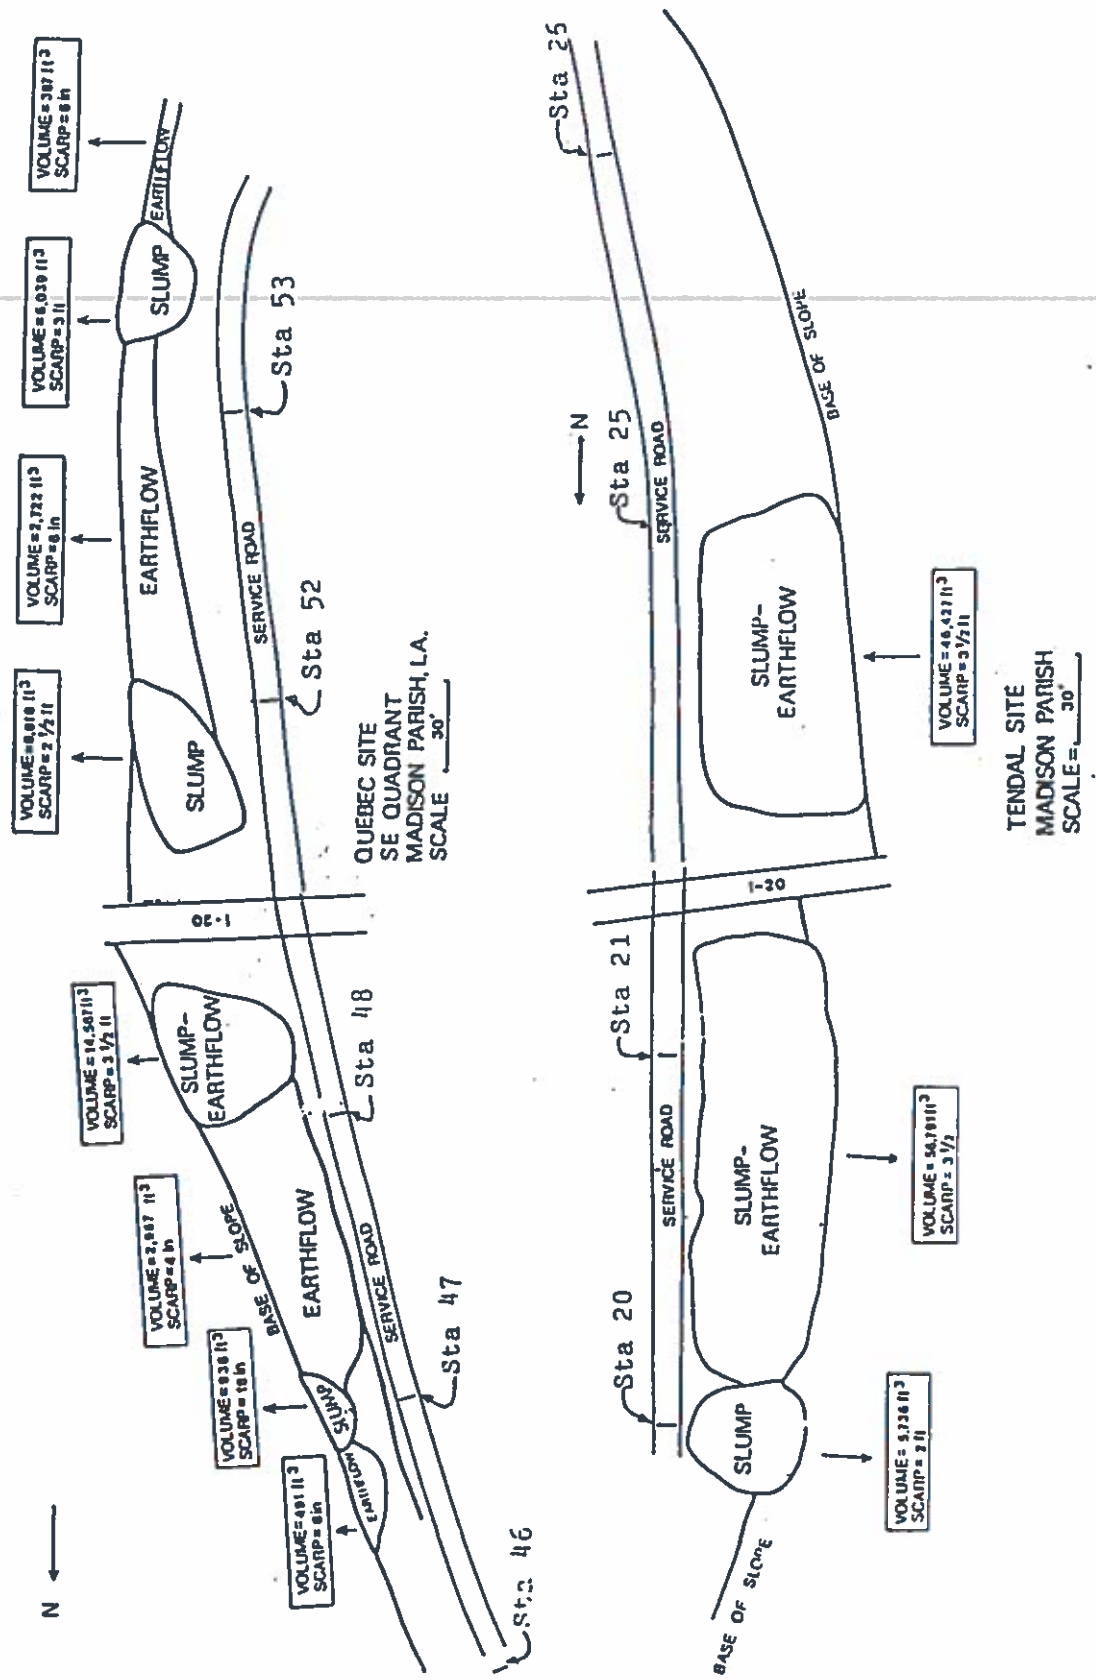
Figure 31. Embankment slope condition survey results for Quebec (N16) and Tendal (N15) sites.

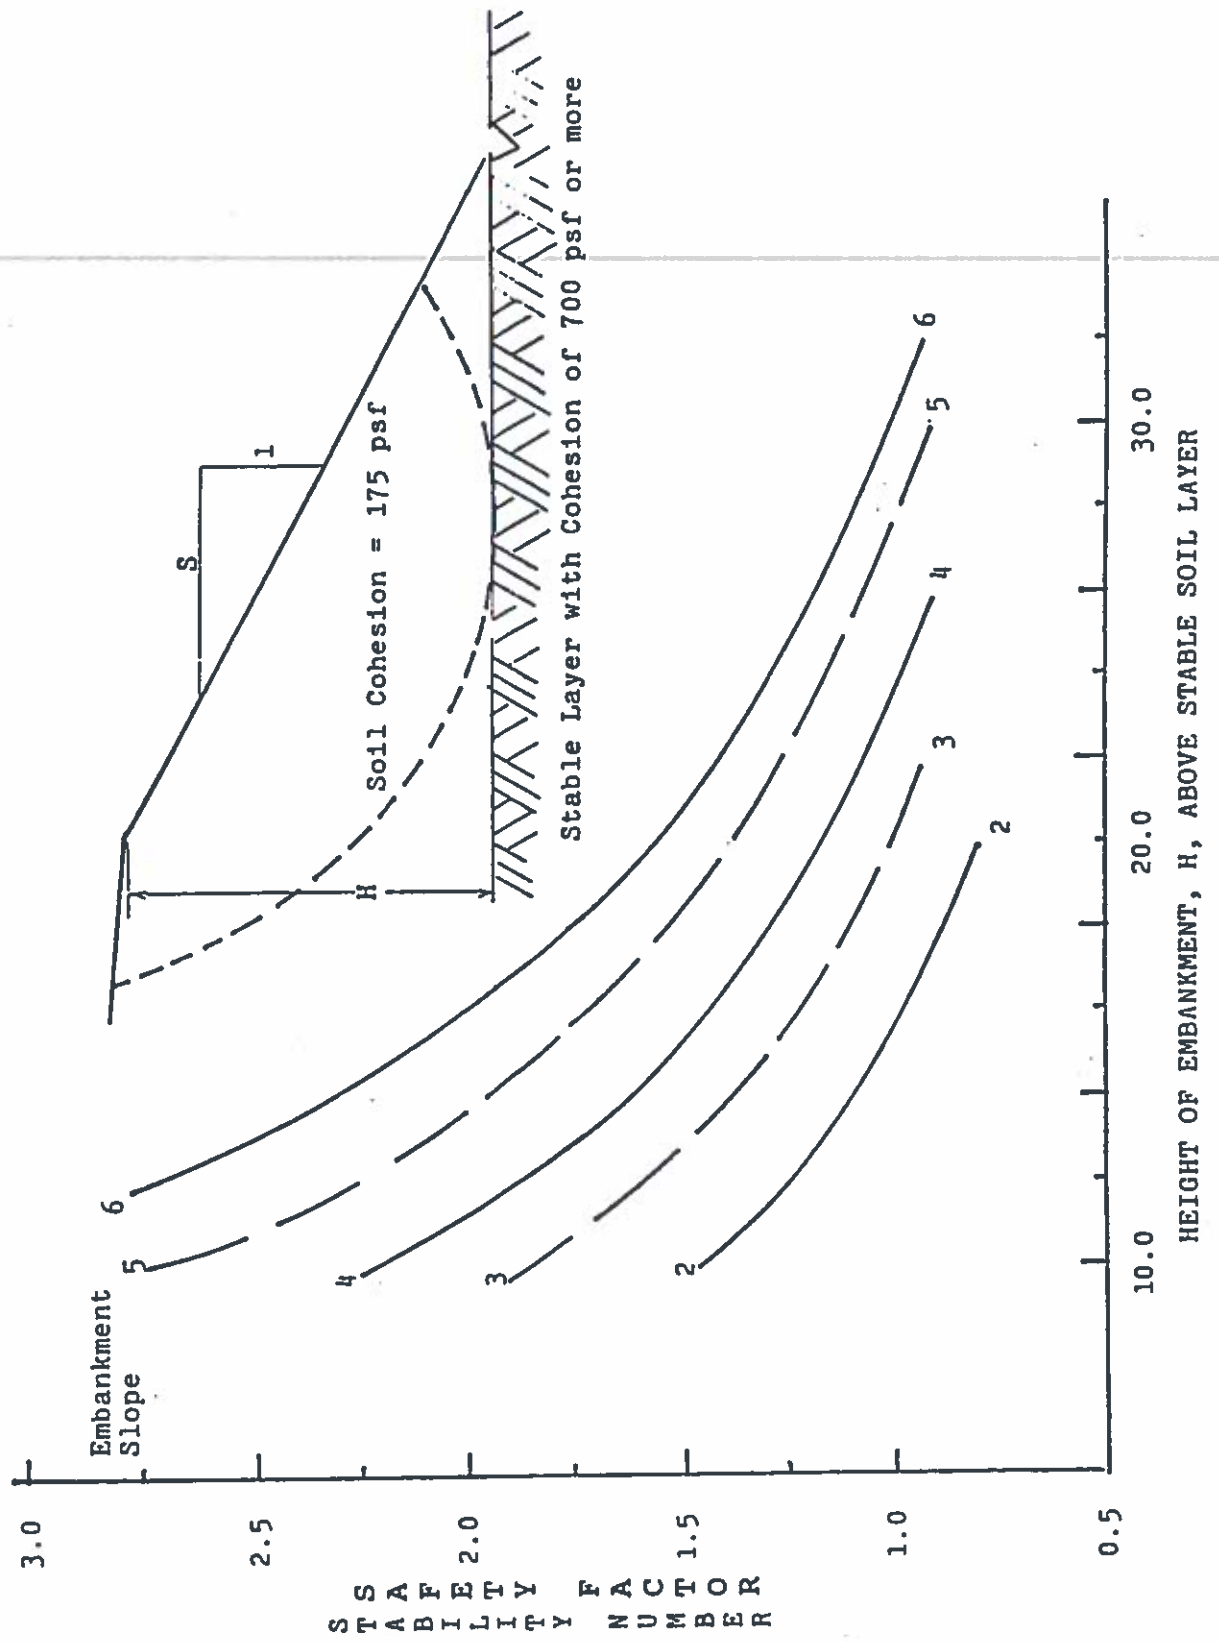
Figure 38. Stability numbers (safety factors) for embankment founded on stable subgrade. No slope design or redesign should be attempted using this method alone.

d) Constant embankment slope with a stable subgrade (Fig. 38). The low-angle embankment is built on a stable subgrade with a cohesive strength of at least 700 psf.

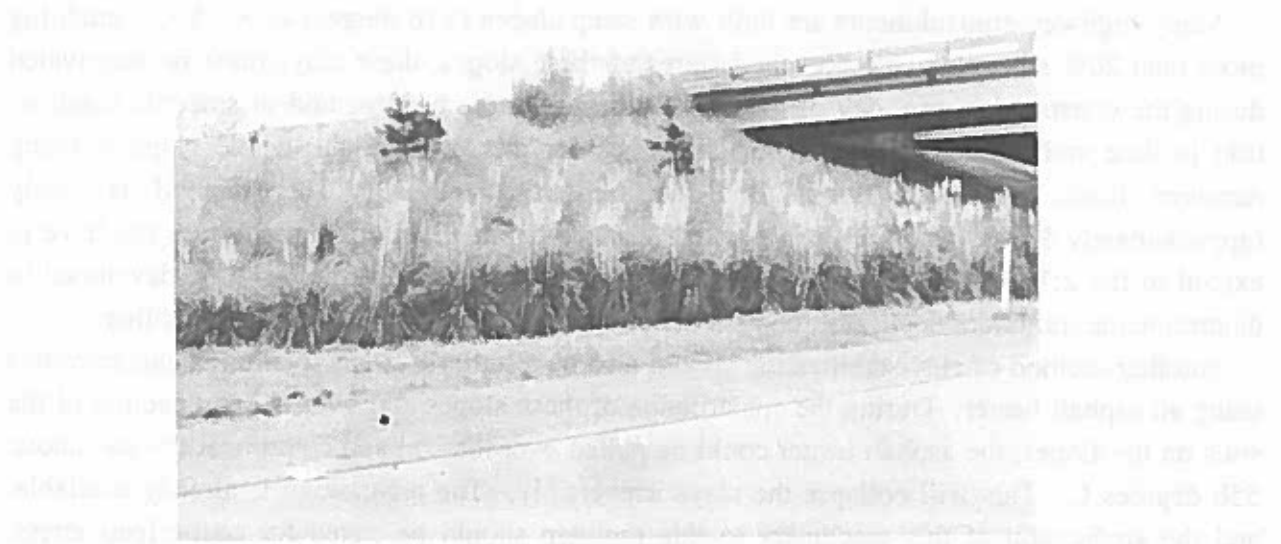
Figure 40. Slope stabilization with exotic vegetation. At this Locality S1 in Calcasieu Parish in the I-10 study area, pampas grass has been successfully used to stabilize a repaired slope.

The possibility of using a different type of vegetation on the slope should also be examined. There is a need for more biomass on the slopes for they act as pumps, and through evapotranspiration, remove water from the slopes. Pampas grass (*Cortaderia selloana*) might be the perfect alternative, for it has been used successfully in Texas and also on the repaired slope at location S1 in the I-10 study area (Fig. 40). It has deep roots and is easily transplanted. It is an aesthetically pleasing plant that would not require mowing. The constant use of heavy machinery on these embankments to mow the grass might help cause slope failures so lack of mowing might help stabilize the slopes.

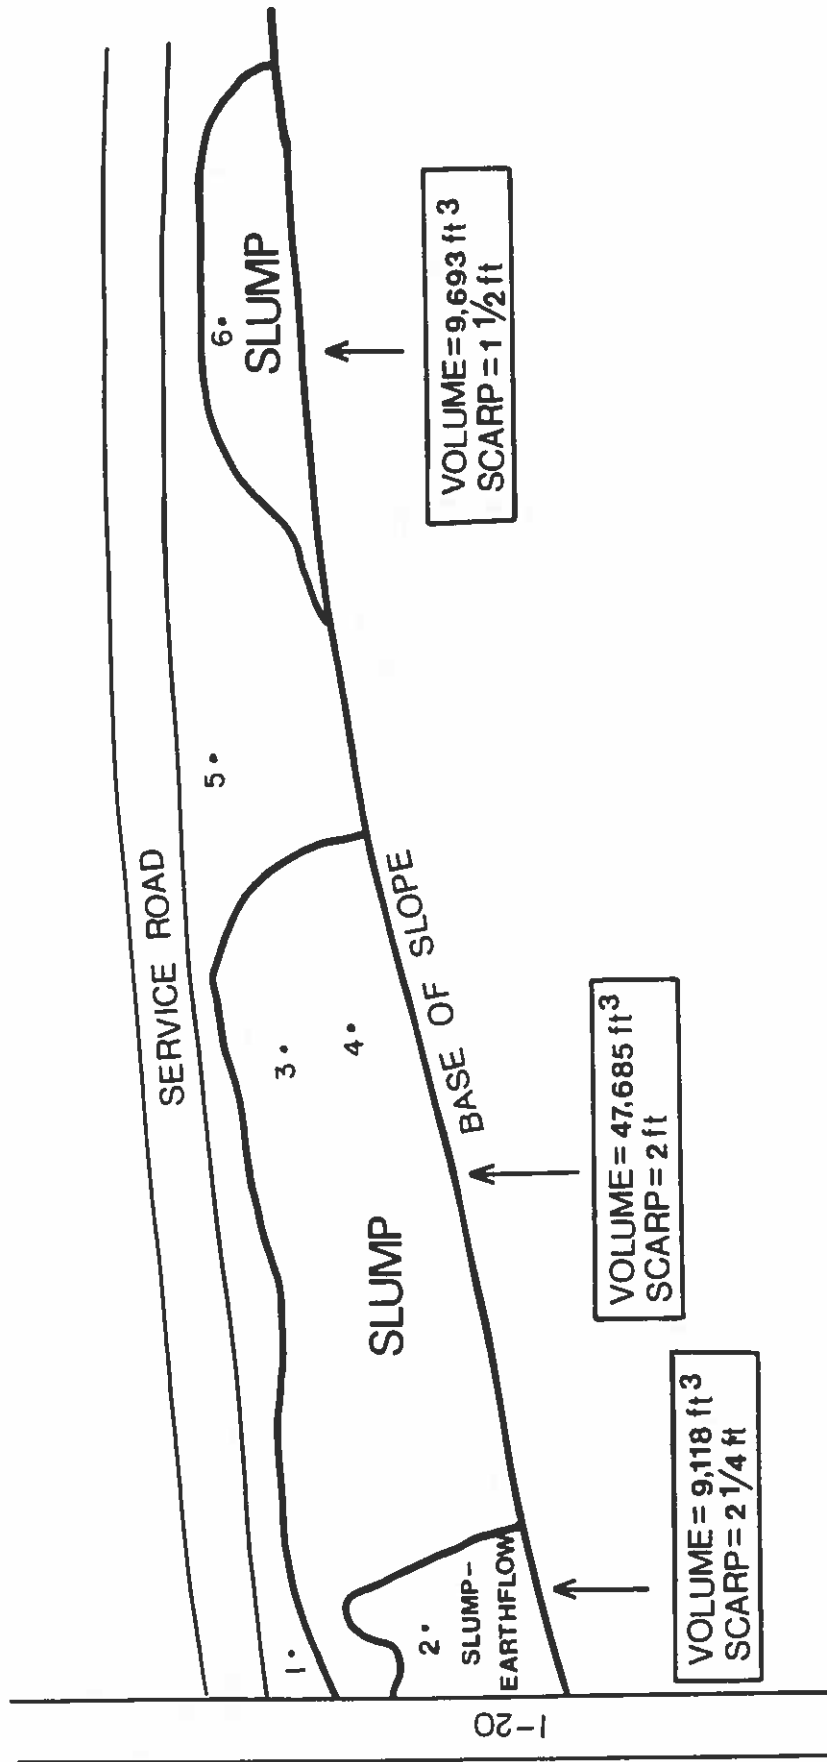
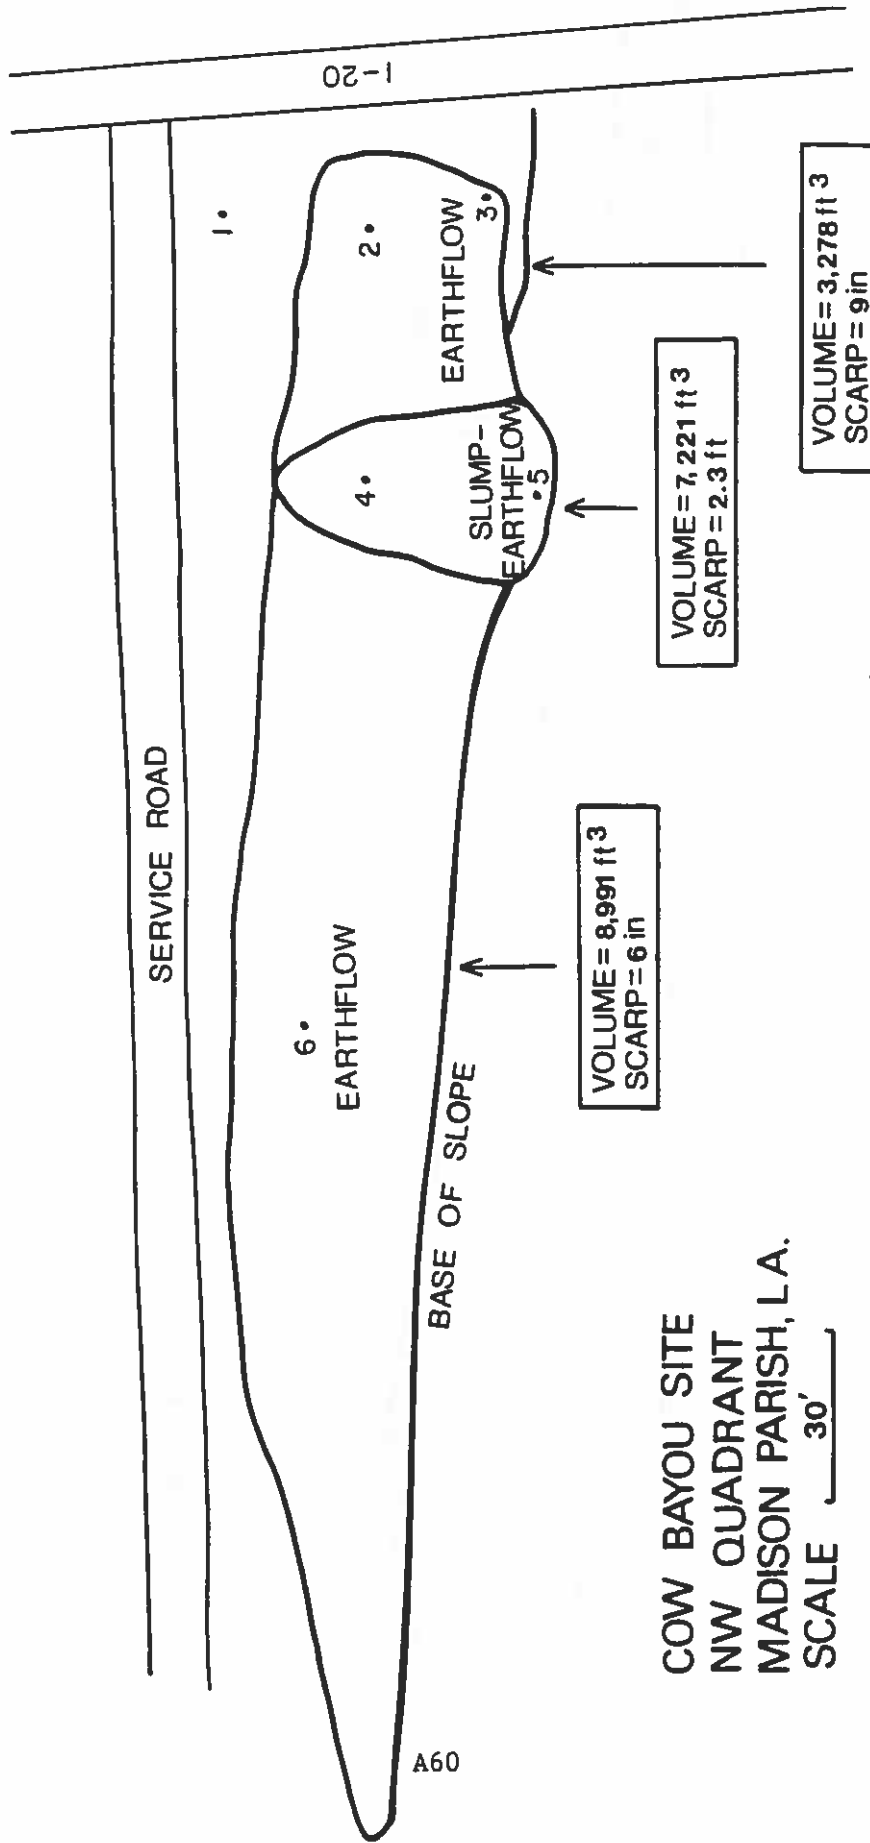
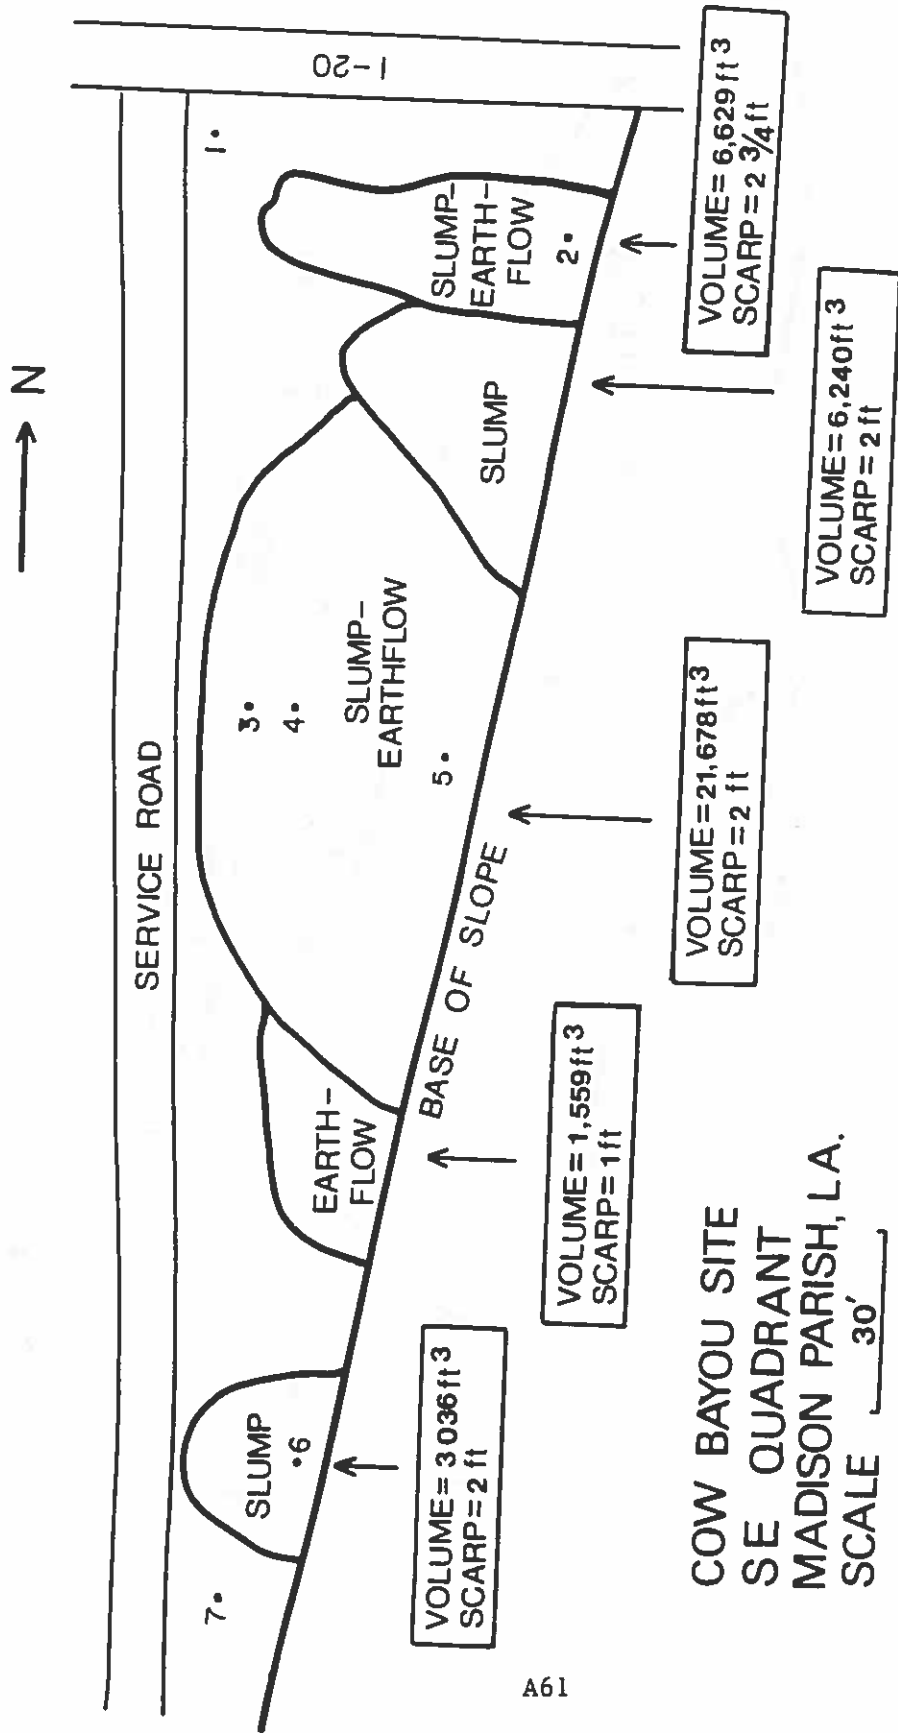
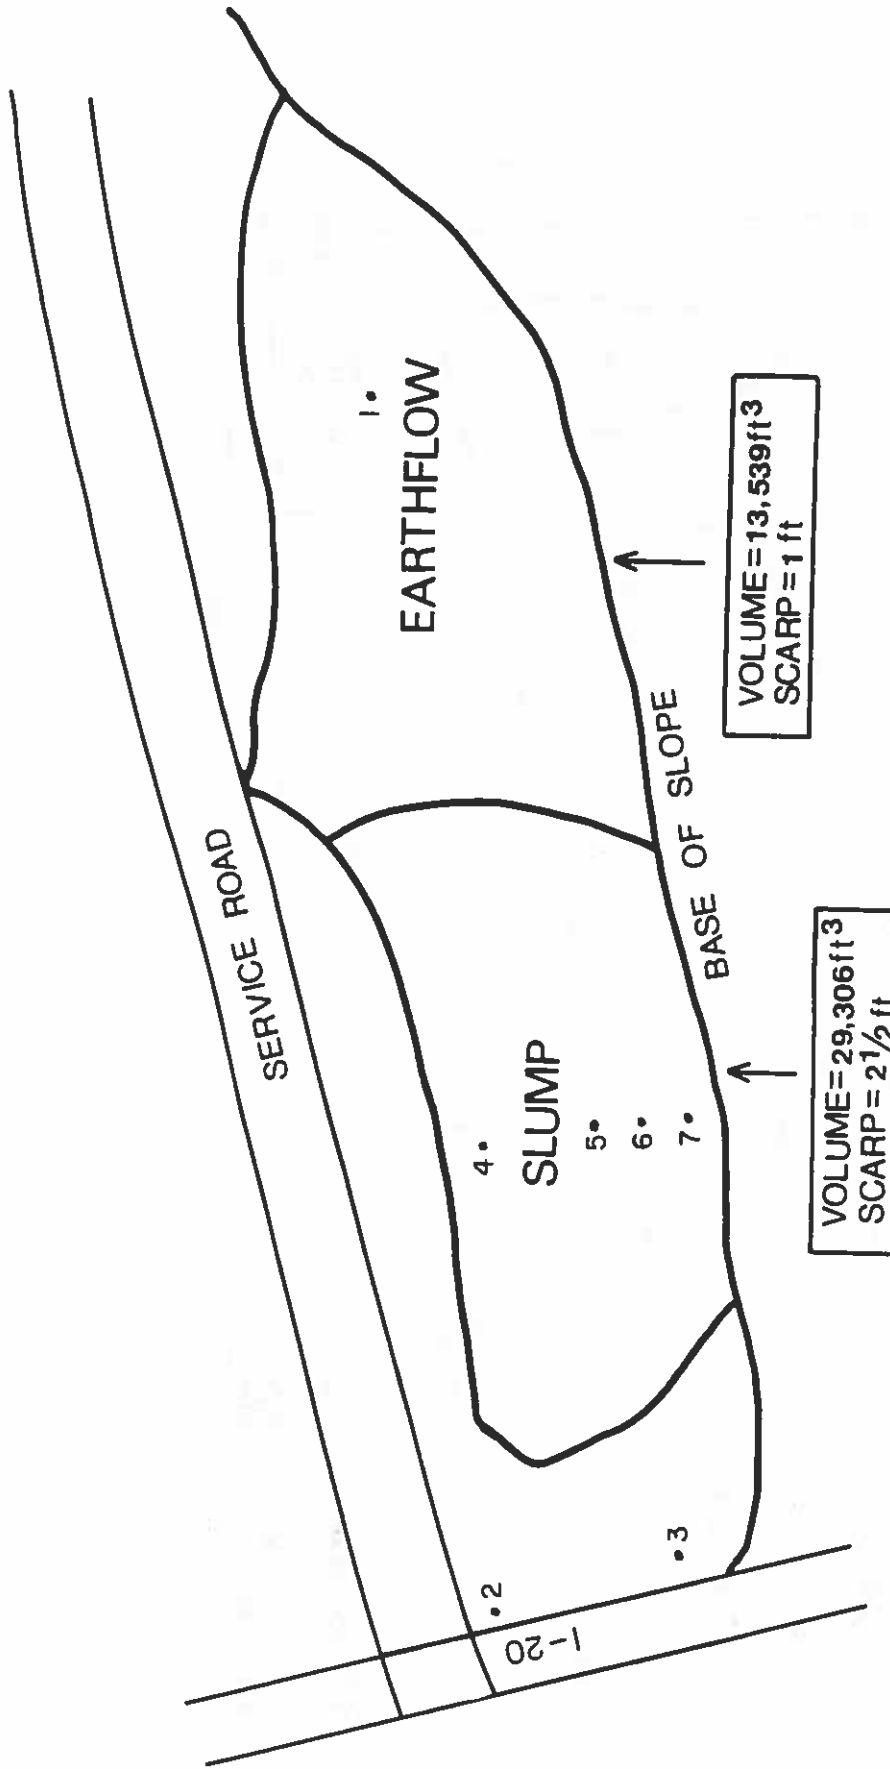
Figure A23. Locality N13, sample location and site map of Cow Bayou, northeast quadrant.

Figure A24. Locality N13, sample location and site map of Cow Bayou, northwest quadrant.

Figure A25. Locality N13, sample location and site map of Cow Bayou, southeast quadrant.

Figure A26. Locality N13, sample location and site map of Cow Bayou, southwest quadrant.

All four embankments at the Cow Bayou site have failed. The embankments at the Cow Bayou site were constructed in 1970 and failed in December, 1982, after a heavy rainfall of over 12 inches (305 mm). Slope angles vary from 16-18 degrees or 3.5:1 to 3:1 (Table A2). A total of 13 failures have occurred (Table A13). Figures A23 - A26 display the failures on the site maps for this location.

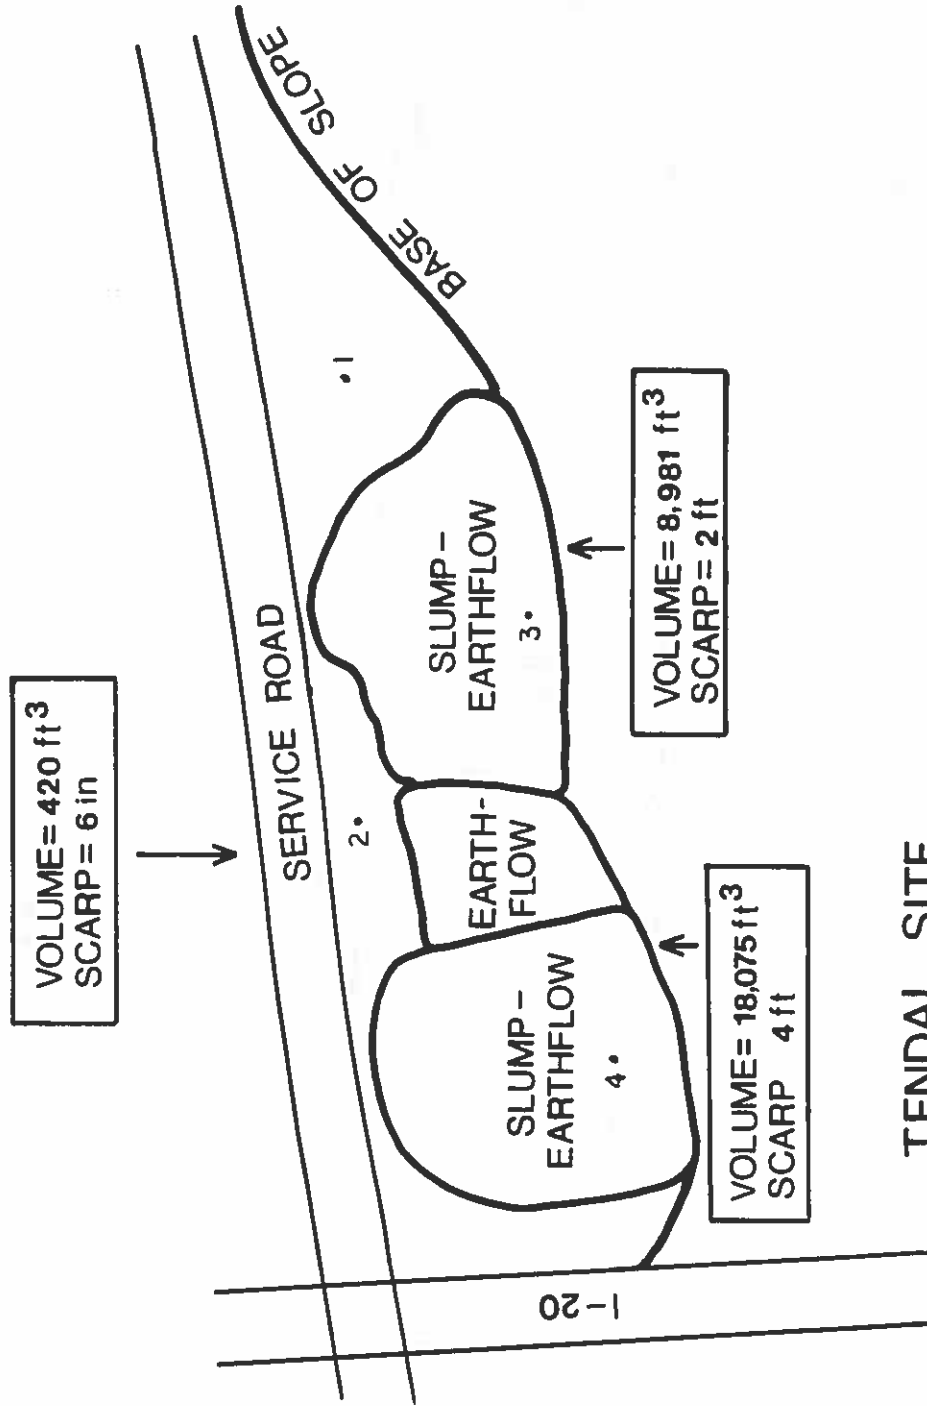
TENDAL SITE
NE QUADRANT
MADISON PARISH, LA.
SCALE = 30'

Figure A27. Locality N15, sample location and site map of Tendal, northeast quadrant.

VOLUME = 5,736 ft³
SCARP = 2 ft

VOLUME = 56,791 ft³
SCARP = 3 1/2
