CRASH TESTING OF LOUISIANA'S
3 1/2" DIAMETER MULTI-DIRECTIONAL,
SINGLE STEEL POST, SMALL SIGN SUPPORT

RESEARCH REPORT NO. 267
RESEARCH PROJECT NO. 93-1SS(B)

Conducted by
SAFETY DIVISION, TEXAS TRANSPORTATION INSTITUTE,
THE TEXAS A&M UNIVERSITY SYSTEM
COLLEGE STATION, TEXAS 77843
and
LOUISIANA TRANSPORTATION RESEARCH CENTER,
LOUISIANA DEPARTMENT OF TRANSPORTATION AND DEVELOPMENT
In Cooperation With
U.S. DEPARTMENT OF TRANSPORTATION
FEDERAL HIGHWAY ADMINISTRATION

March 1993

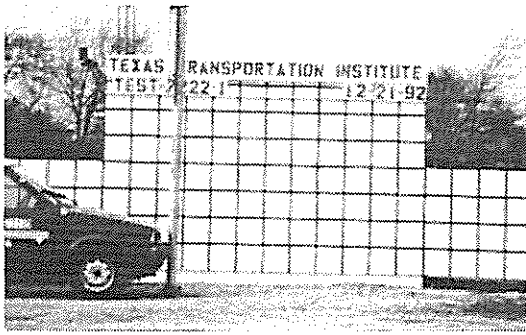
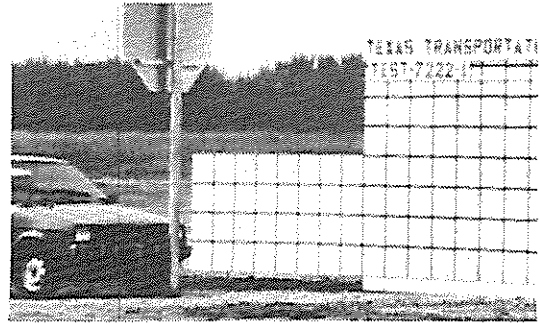
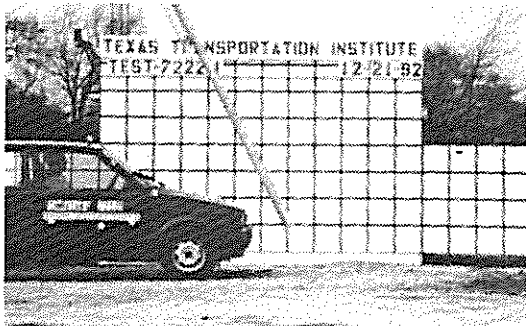
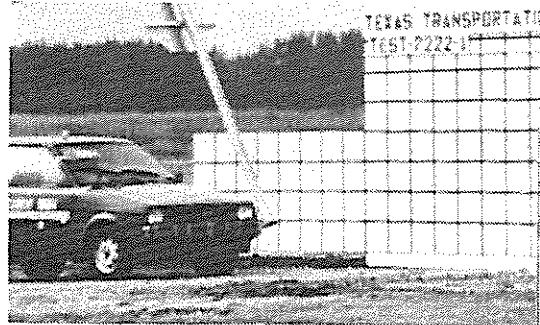
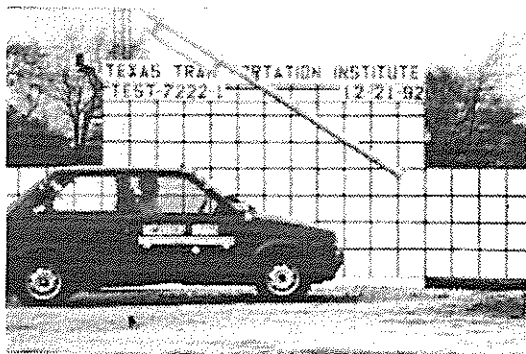
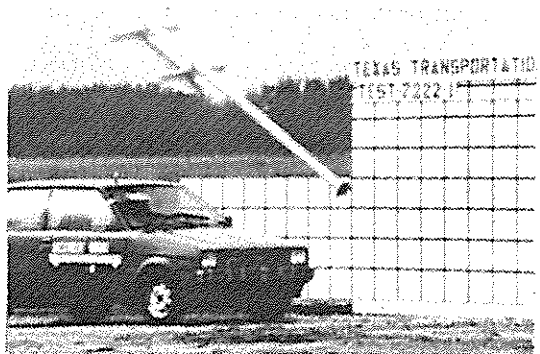
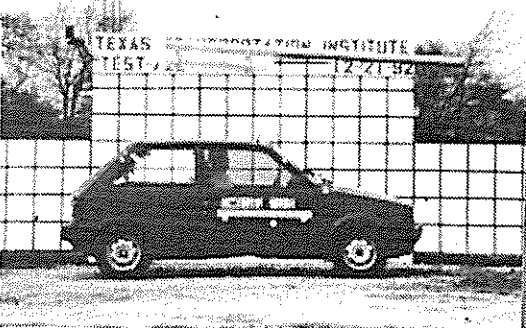
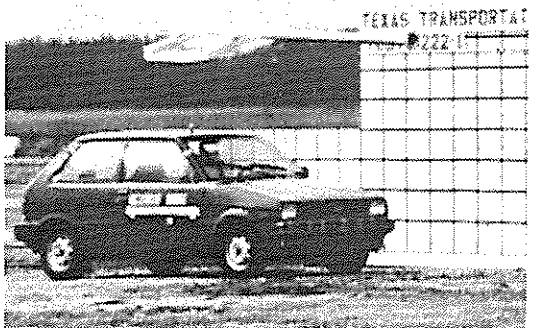
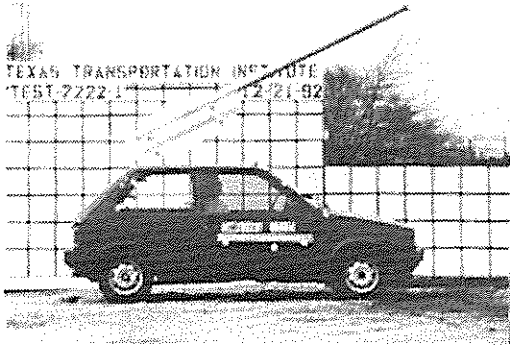
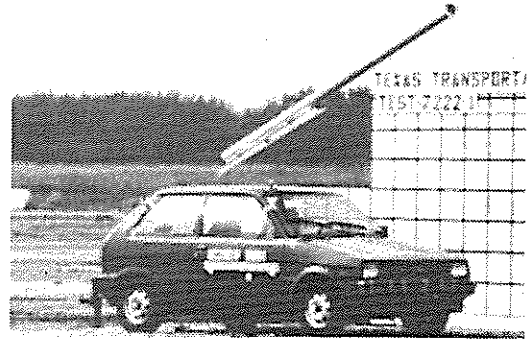
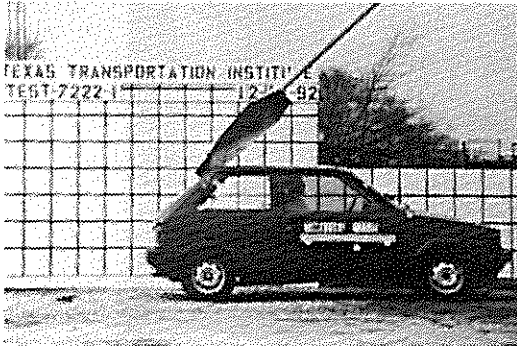
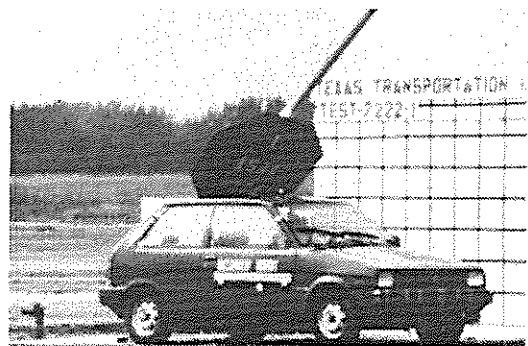
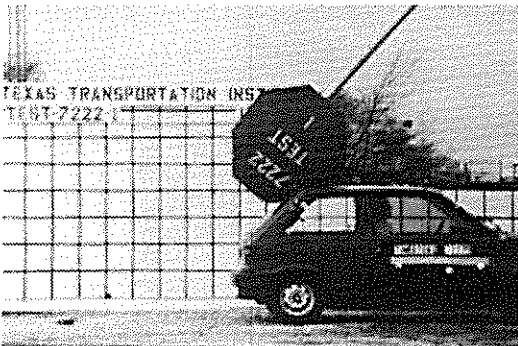
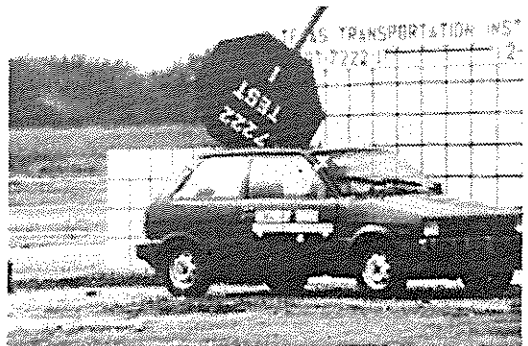
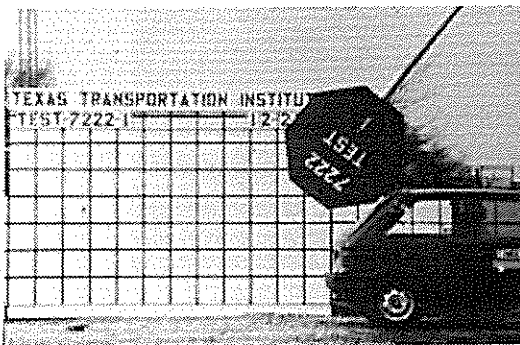
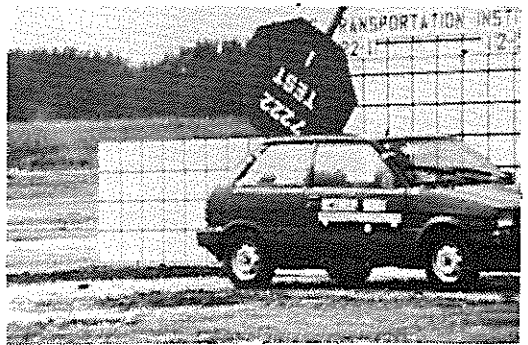
Figure 8. Sequential photographs for test 7222-1 (perpendicular and side views).

The vehicle was free wheeling and unrestrained just prior to impact. Shortly after impact, the sign support displaced the bolts in the slip-base and began to rise up off the base plate. By approximately 0.034 seconds, the vehicle had temporarily lost contact with the support. As the vehicle continued to move forward, the support was displaced over the vehicle. The sign panel and, subsequently, the end of the support impacted the roof (at the top of the rear hatchback) of the vehicle at approximately 0.408 second. The vehicle lost contact with the sign support at 0.692 second. At approximately 2.5 seconds after impact, the brakes were applied and the vehicle came to rest 24.1 m (79.0 ft) from the point of impact as shown in Figure 7. Sequential photographs of the test are shown in Figure 8.

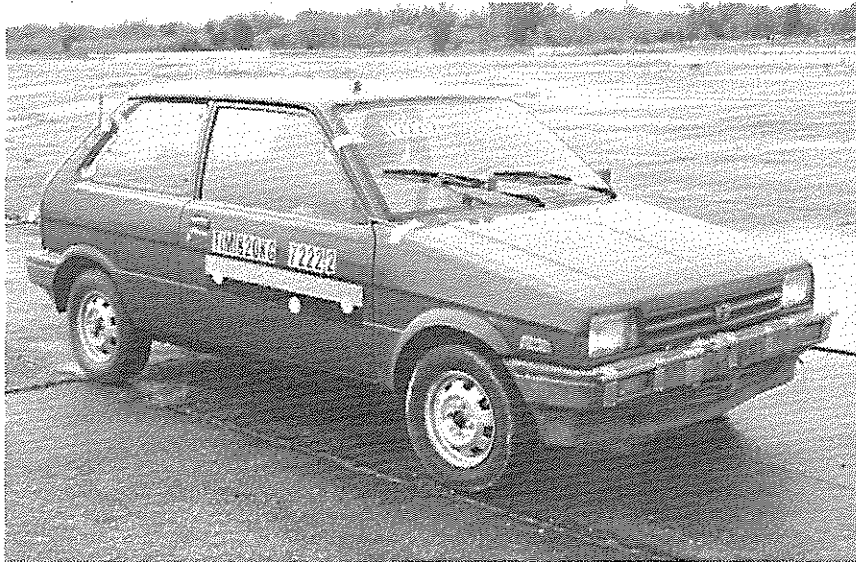
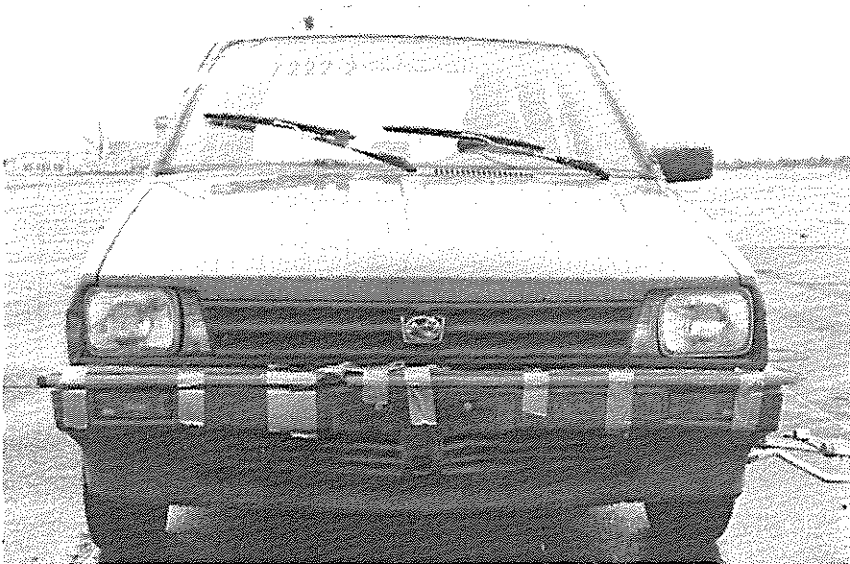
Figure 15. Vehicle prior to test 7222-2.

The same 1988 Subaru Justy used in Test No. 7222-1 (shown in Figure 15) was re-used in Test 7222-2. The sign installation was of the same type as Test No. 7222-1, a 8.9 cm (3-1/2 in) diameter steel pipe, multi-directional slip-base, sign installation in standard soil (shown in Figure 16). The impact was at 105.3 km/h (65.5 mi/h) using a cable reverse tow and guidance system. The point of impact was the front right quarter point of the vehicle bumper with the sign installation.

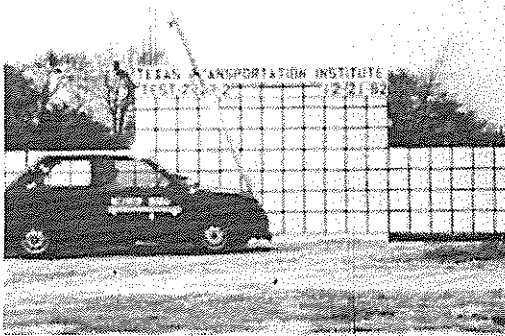
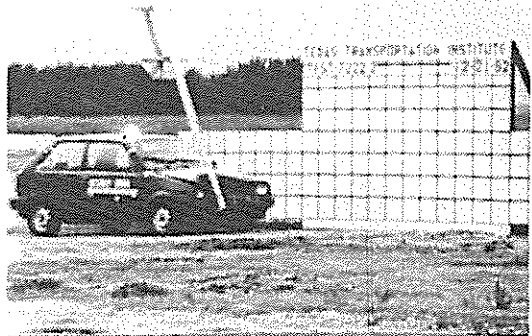
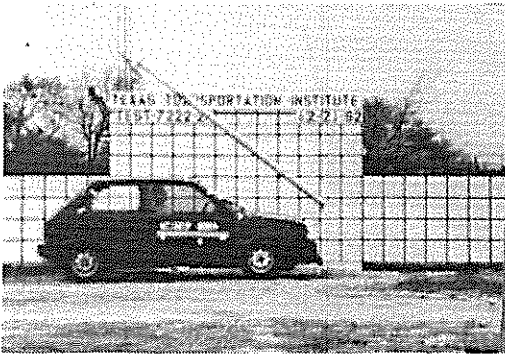
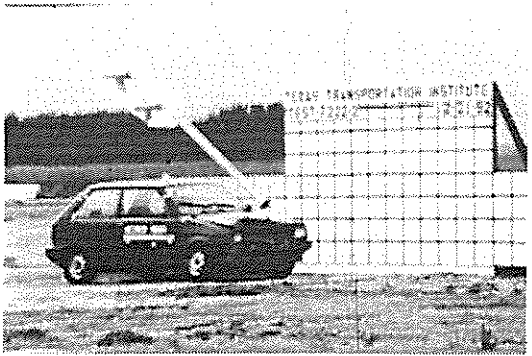
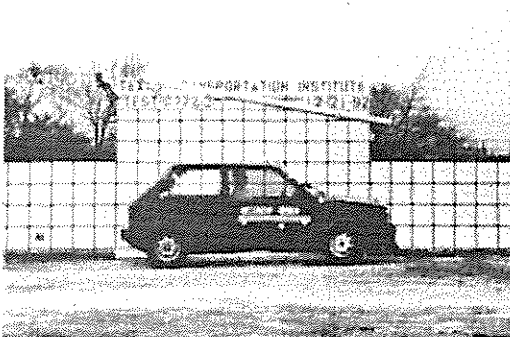
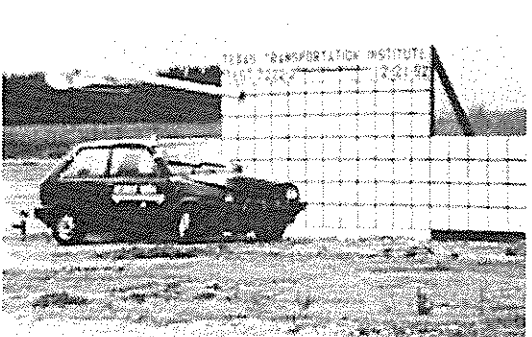
Figure 18. Sequential photographs for test 7222-2
(perpendicular and side views).

The impact force of the vehicle caused a wave motion to be transferred into the sign panel. Subsequently, at 0.126 second, the wave motion of the sign panel caused the panel to "walk" the top strap anchoring the sign panel to the support off the end of the support. Shortly thereafter, the lower strap failed. At approximately 0.45 seconds after impact, the brakes were applied and the vehicle came to rest 84 m (276.0 ft) from the point of impact as shown in Figure 17. Sequential photographs of the test are shown in Figure 18.

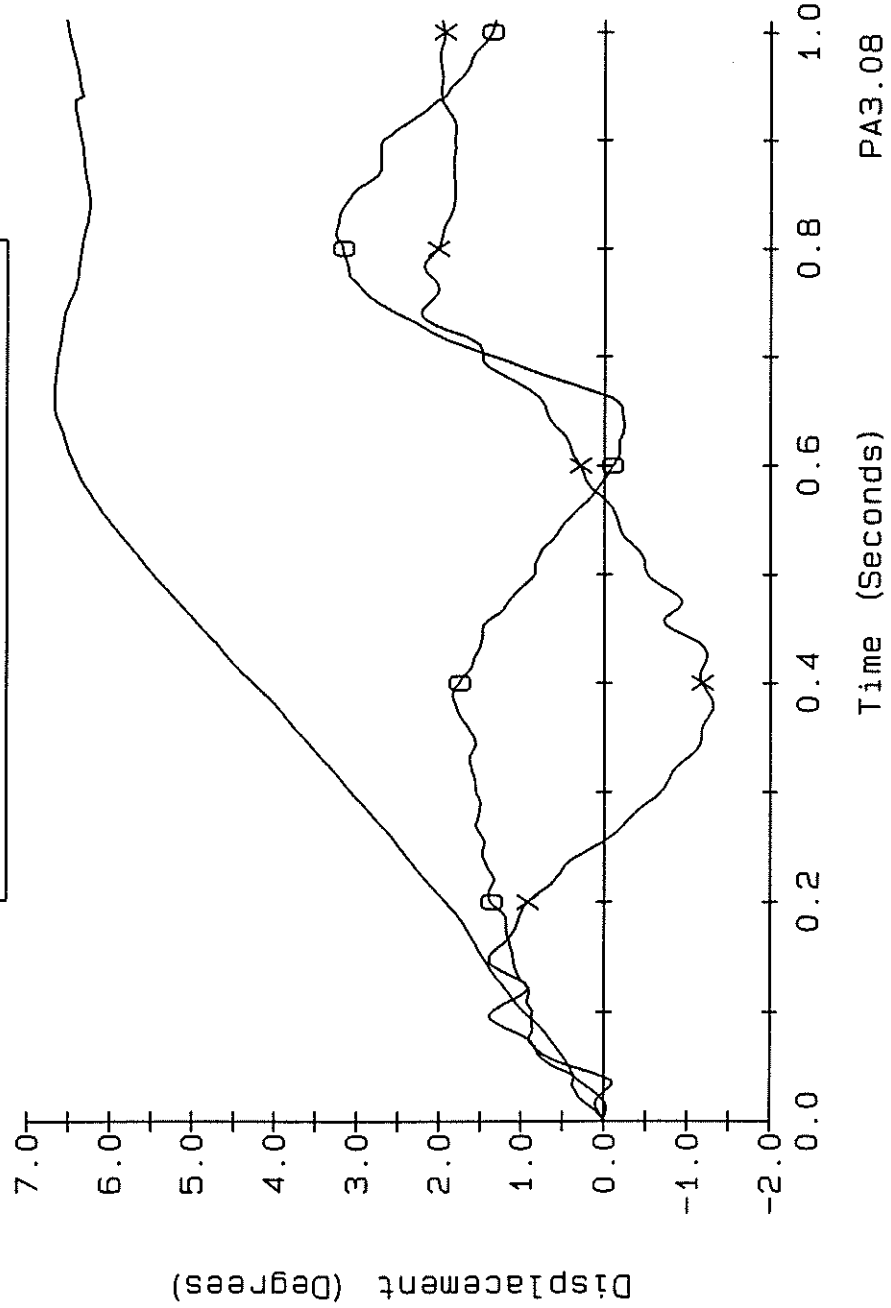
Figure 21. Vehicle angular displacements for test 7222-2.

A summary of the test results and other information pertinent to this test are given in Figure 20. The maximum 0.050 second average acceleration experienced by the vehicle was -2.3 g in the longitudinal direction and -0.8 g in the lateral direction. Vehicle angular displacements are plotted in Figure 21 and vehicle accelerometer traces are displayed in Figures 22 through 24. Occupant impact velocity in the longitudinal and lateral direction are not applicable to this test, as theoretical occupant displacement did not reach 0.6 m (2.0 ft) longitudinal or 0.3 m (1 ft) lateral. Occupant ridedown accelerations were not applicable as well because theoretical occupant contact did not occur. Change in vehicle velocity was 5.3 km/h (3.3 mi/h).
