1. Report No. State Project Number: 736-99-0680		2. Government Accession No.	3. Recipient's Catalog No.
4. Title and Subtitle Implementation of Heat-Straightening Repairs for Louisiana Bridges		5. Report Date December 1998

**IMPLEMENTATION OF HEAT-STRAIGHTENING REPAIRS
FOR
LOUISIANA BRIDGES**

LTRC PROJECT NO. 99-1C
STATE PROJECT NO. 736-99-0680

LOUISIANA DEPARTMENT OF TRANSPORTATION AND DEVELOPMENT
LOUISIANA TRANSPORTATION RESEARCH CENTER

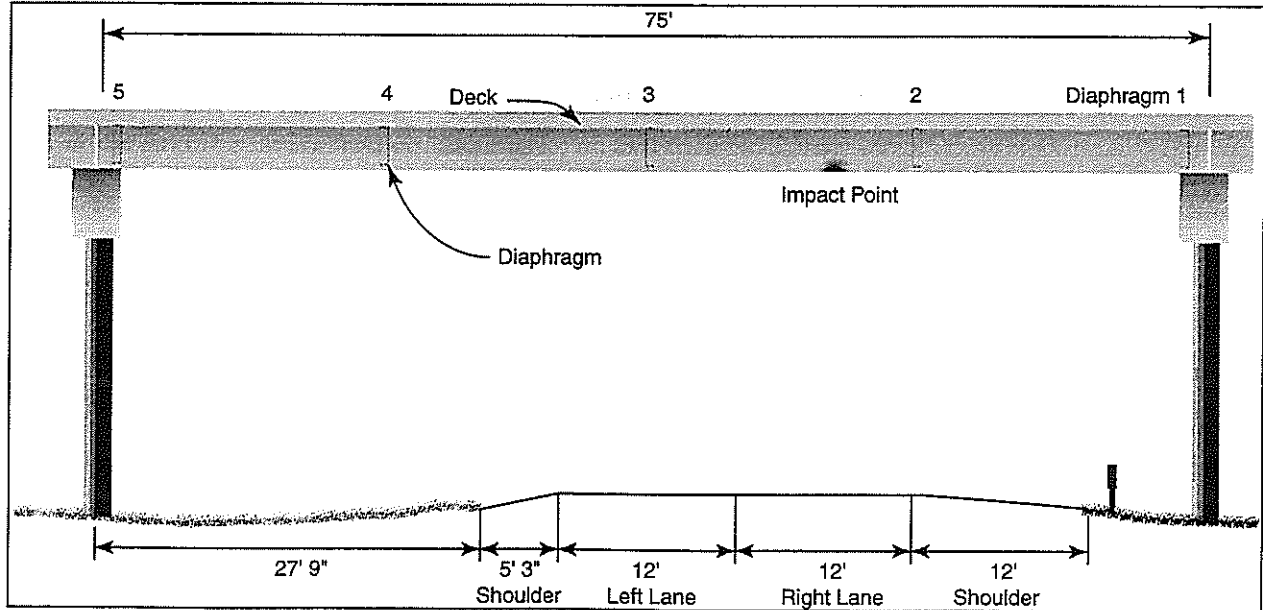
The initial inspection indicated that the bridge remained stable. The lower flange had displaced approximately 17 inches at the impact point (fig. 1). Impact occurred on the lower flange directly over the center of the right, eastbound lane (fig. 2). Located six feet to the left of diaphragm number 2, the flange had a sharp dimple where the impact occurred (fig. 3). Diaphragms 2 and 3 were partially crushed but most bolts remained intact (fig. 4). Very minor crushing was observed at diaphragm 4. No significant damage was found at the end diaphragms, 1 and 5, or at the bearing supports. The top flange had pulled out of the slot on the underside of the concrete deck and had a maximum lateral deflection of 1.5 inches (fig. 5). The concrete deck had not cracked. Since there was no immediate safety concerns and the overpass was lightly traveled by local traffic, the bridge remained open to traffic.

Figure 1
View of damaged beam at region of impact
