Technical Assistance Report 15-01TA-C

**Evaluation of Cores from I-10 between
Acadian Thruway and College Drive**

Petrographic Investigation of Concrete Cores From Cracked Pavement Slabs Located on Interstate 10 in Baton Rouge, Louisiana

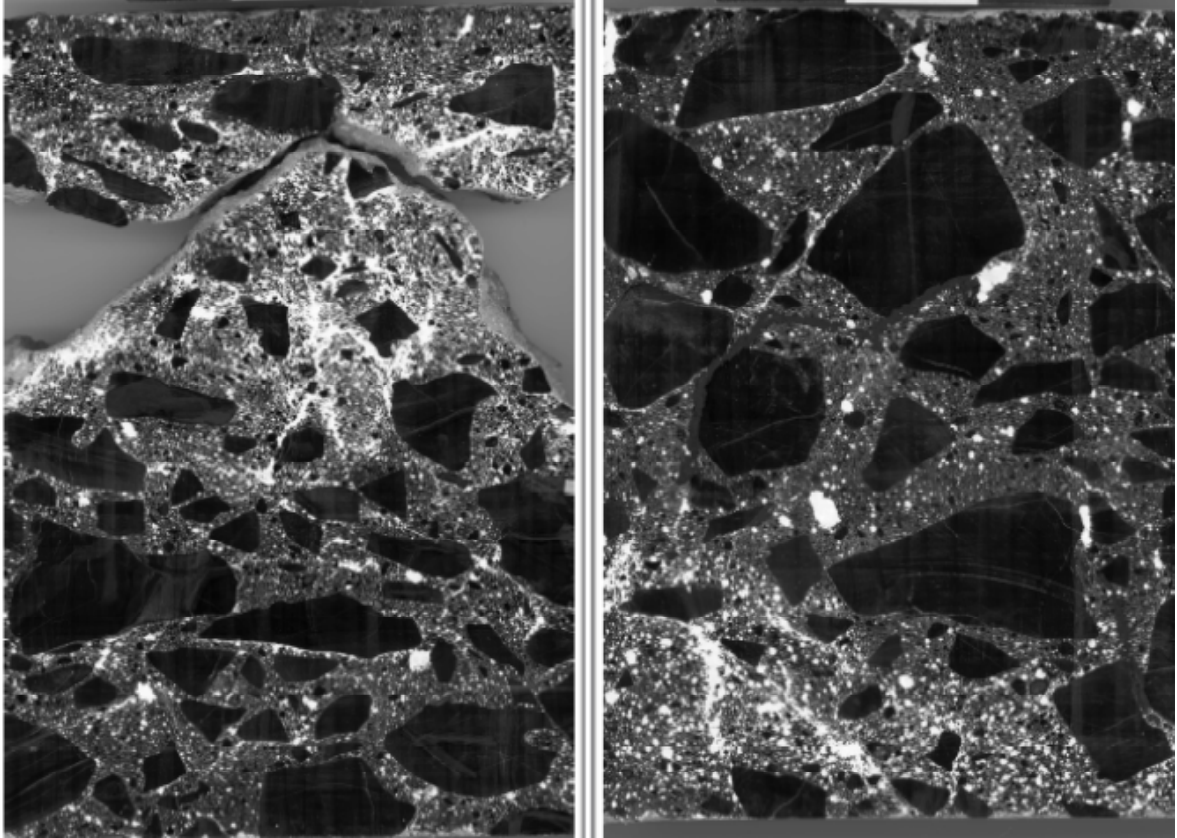
Figures 4 and 5 show the images for pavement core number 1. Note that in these images the sample is polished, colored black, and the voids are then filled with a white paste to show the contrasting air void distribution. Note that Figure 4 shows the top and bottom sections while Figure 5 shows the sections in more detail. The results show that the concentration of air is extremely high in the distressed top 5 inches of the pavement core.

Figure 4
Pavement number 1 core; Left: top, Right: bottom

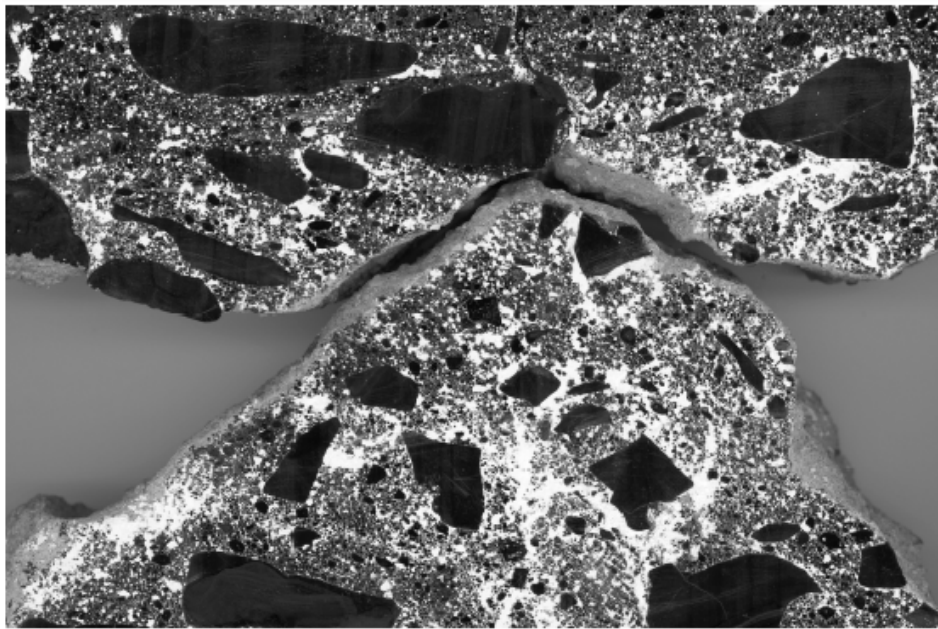
Figure 5
Top section of pavement number 1 core enhanced showing excessive air content

The excessive air content in the top sections of these cores can most likely be attributed to construction practices. If it were an admixture incompatibility issue, the authors believe that department personnel would see a far greater area in distress. It is the authors' opinion that the vibrators were set for the 14-inch thick pavement design with a certain paving speed, but the as constructed pavement thickness generally exceeds 16 inches. The combination of excess pavement thickness and vibrator settings most likely ensured that the excess air voids were not vibrated out of the pavement surface during the consolidation of the fresh concrete pavement as it was constructed.

Possible remedies for this section include partial depth patching of the affected areas, full depth patching of the affected areas, or hydroblasting the entire section to remove the top 3-4 inches and completing a bonded concrete overlay. Of the options, the most cost-effective solution is probably the full depth patching to include whole panel replacement of the affected panels.

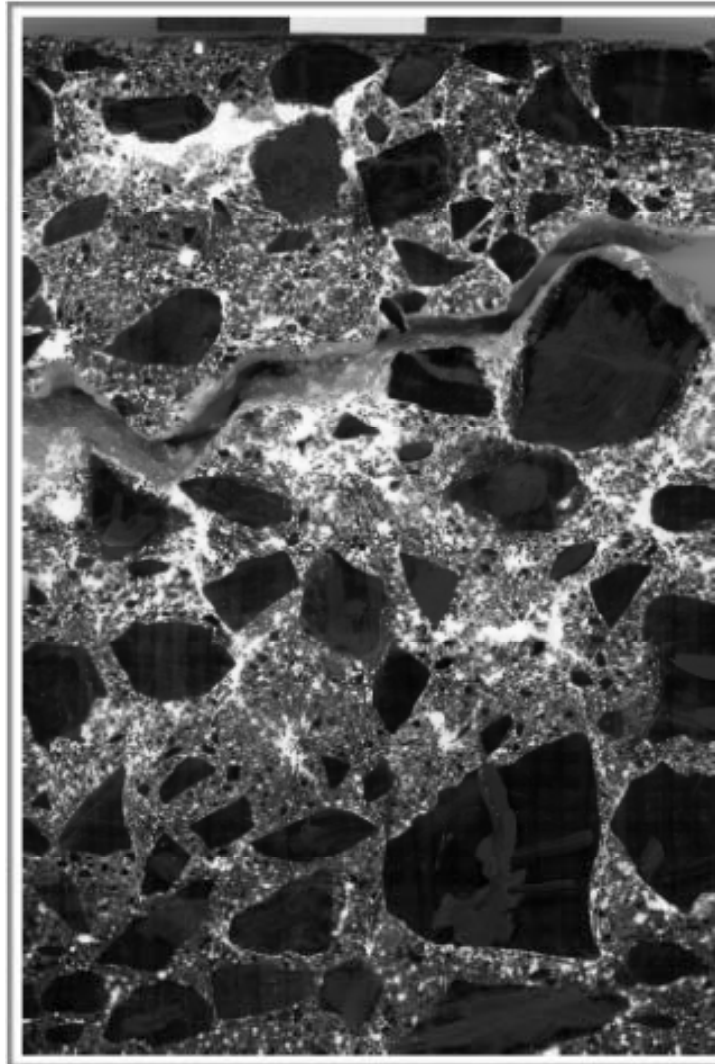
Figures 6 and 7 show the images for pavement core number 2. Note that for these images the sample is polished, colored black, and the voids are then filled with a white paste to show the contrasting air void distribution. Note that Figure 6 shows the top included with the middle section of the core, while Figure 7 shows the top distressed section in more detail. The results show that the concentration of air is extremely high in the distressed top 5 inches of the pavement core. Further elaboration on the results is included in the Appendix of this report, which contains the report from the petrographer.

Figure 6
Top and middle section of pavement core number 2

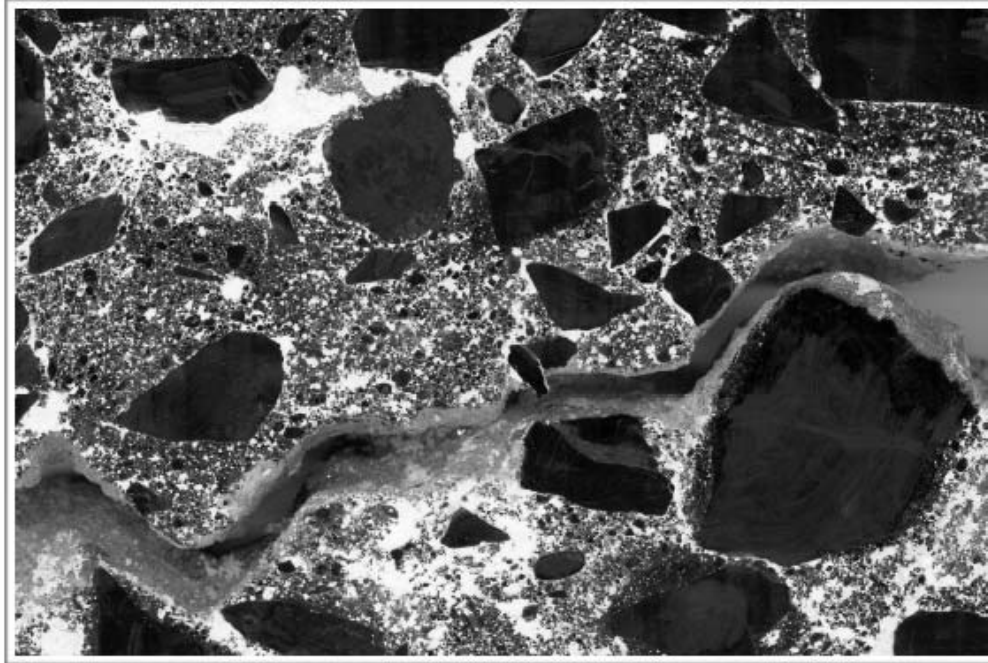
Figure 7
Top of pavement core number 2 enhanced showing excessive air void concentration

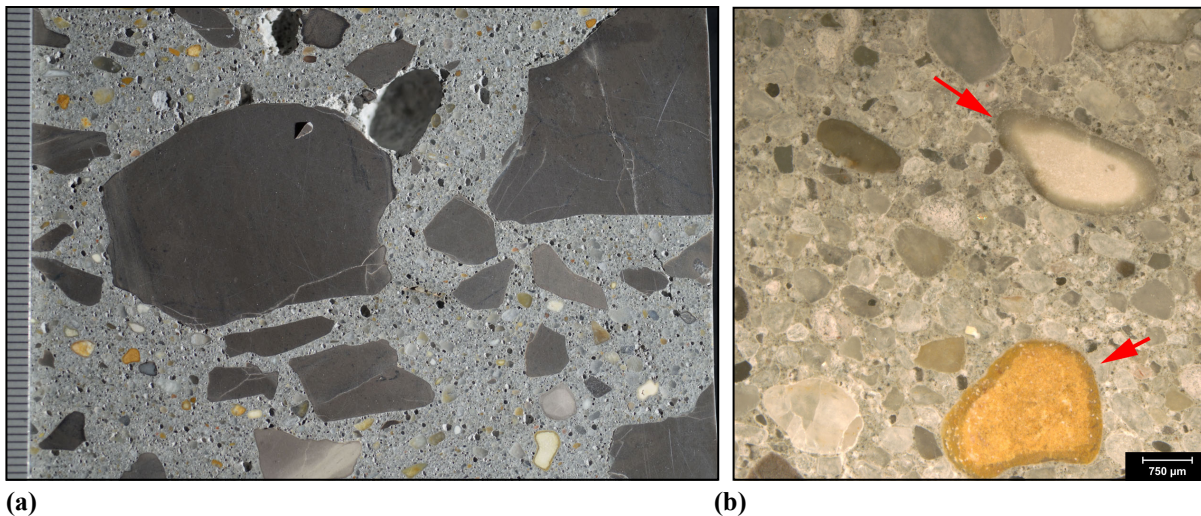
3.5 Components: Aggregates All the cores contains similar aggregates that consist of a crushed limestone coarse aggregate with a nominal top size of 38.5 mm (1 ½ in.) and fine aggregate that consists of a natural siliceous sand (**Figure 6**). The coarse aggregate is a dolomitic limestone very similar to that observed to be susceptible to ACR in previous investigations. The rocks are hard and competent. The limestone is medium brown in color with patches of euhedral dolomite rhombs and other patches of amorphous, clay-rich material. In the present cores these rocks commonly show prominent reaction rims but at most only very minor internal microcracking and no significant microcracking of the paste around the aggregate. The coarse aggregate commonly shows marked gap grading with a paucity of intermediate sized particles and an abundance of sand. The sand is siliceous in composition and consists primarily of quartz and quartzite with minor amounts of granitic rocks and chert. Many of the components present in the sand are potentially susceptible to ASR. Very minor ASR was observed in seven of the eight cores subjected to petrographic examination, as discussed in more detail below, but no evidence of cracking or distress was linked to ASR. No potentially deleterious components, such as clay lumps, friable particles, coal, lignite or excessive fines were observed.

Figure 6. (a) Photograph and (b) reflected light photomicrograph of polished surface of Core EB #3 showing coarse and fine aggregate, respectively. The scale is in millimeters in (a). The red arrows in (b) indicate particles of chert.

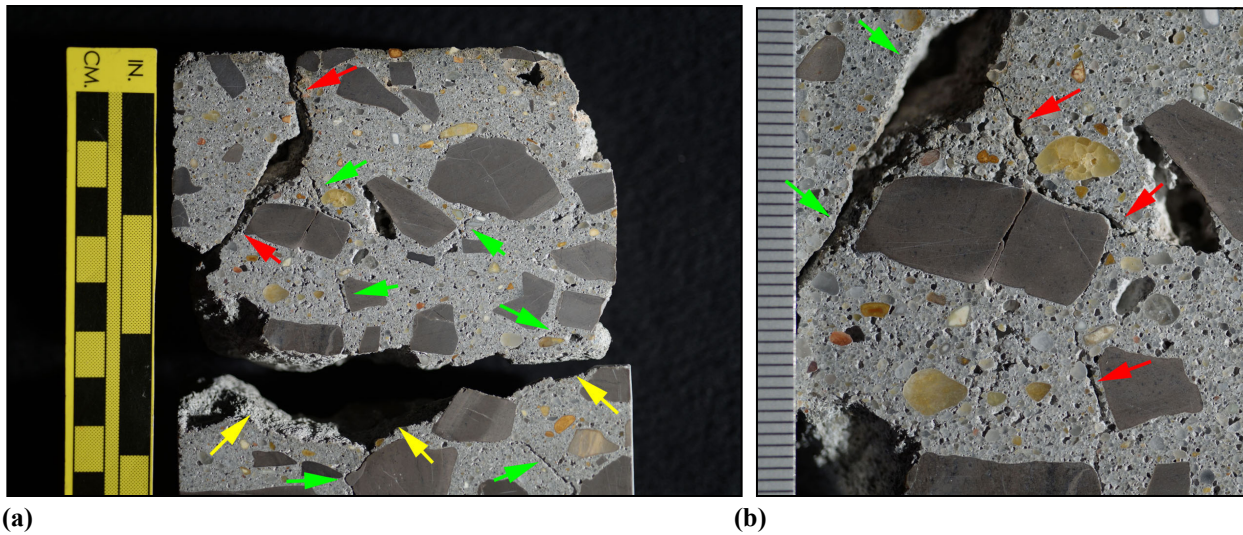
Core EB #3 Core EB #3 showed the most prominent cracking in the eight cores that were examined petrographically (**Figure 8**). The core was received with several cracks that were open when the core was received (precluding measurement of their widths). A sub-horizontal crack cut through the full width of the core at ~ 55 mm (2 1/8 in.) below the top surface. Above this sub-horizontal a complex network of cracks, hairline cracks and microcracks cut through the paste in orientations that range from sub-horizontal to oblique to sub-vertical. These cracks and microcracks cut predominantly around aggregate particles and lack secondary deposits. In Core EB #3 microcracking was observed throughout the thickness of the core. These microcracks lacked secondary deposits, were most commonly oriented obliquely and cut around aggregate particles.

Figure 8. (a) Photographs of the polished surface of Core EB #3 showing overview and detail, respectively of cracking at the top of the core. In (a) the yellow arrows indicate the main sub-horizontal crack along which the core delaminated. The red arrows in (a) indicate a sub-vertical crack which, combined with the sub-horizontal crack, cut the core into three pieces. The green arrows indicate oblique cracks that cut through the paste both above and below the sub-horizontal crack.

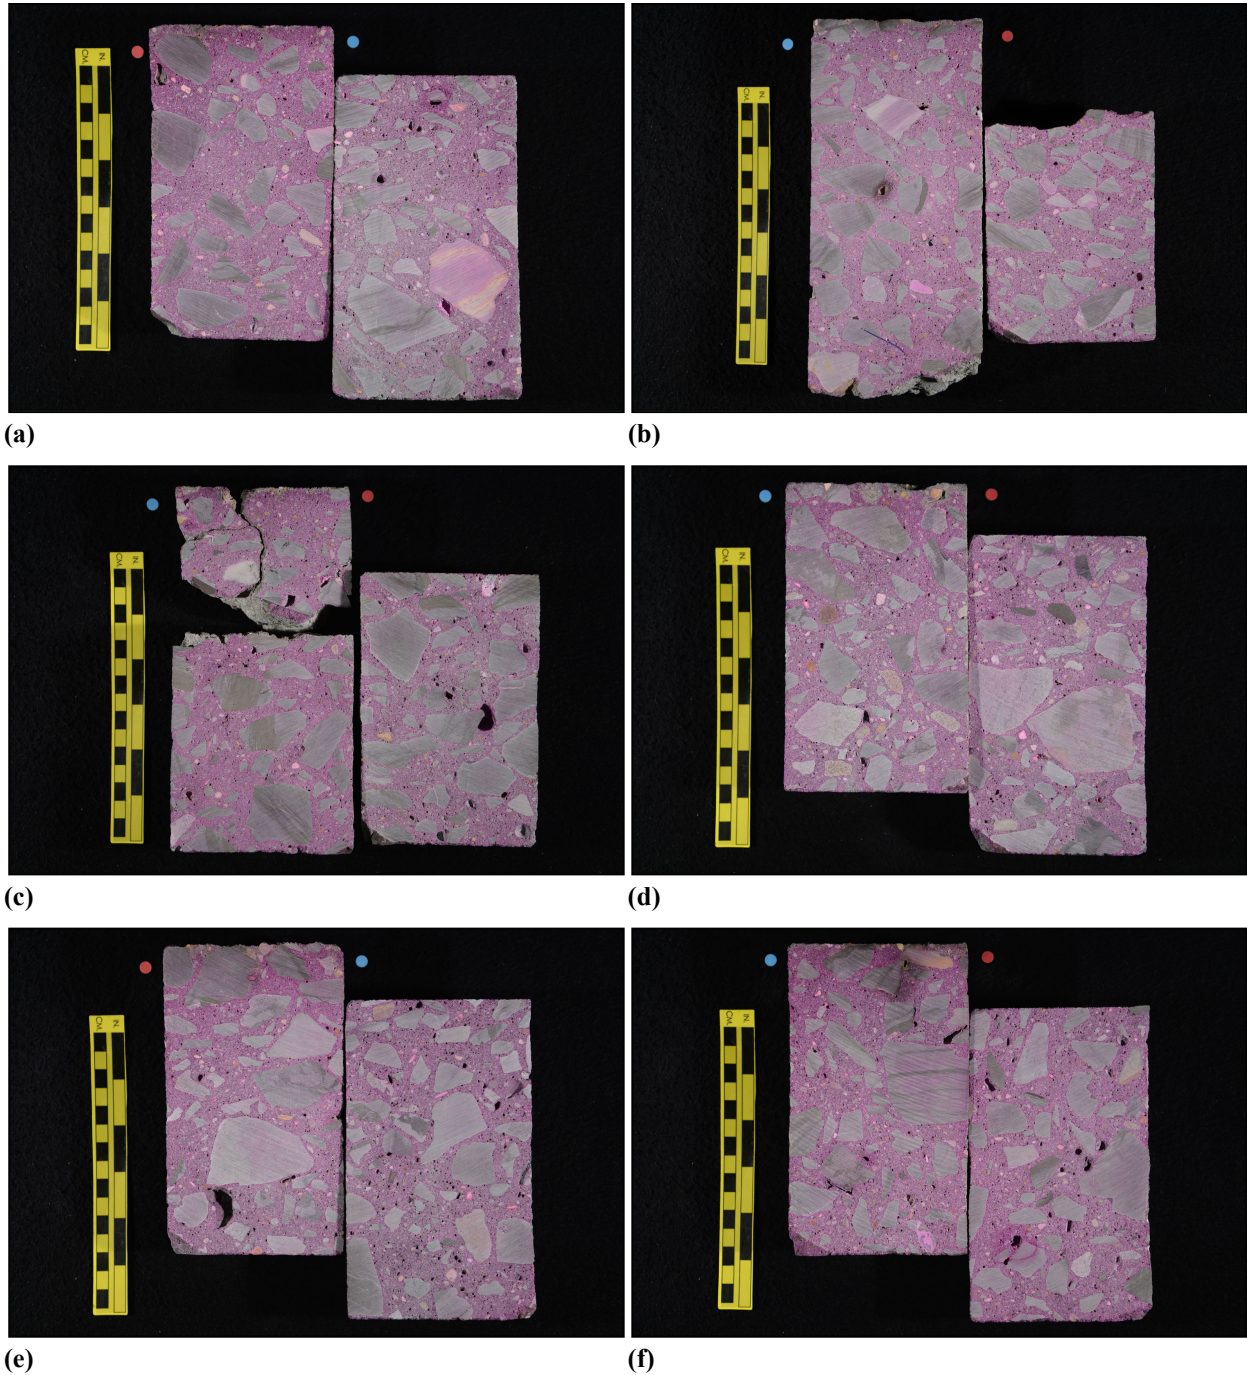
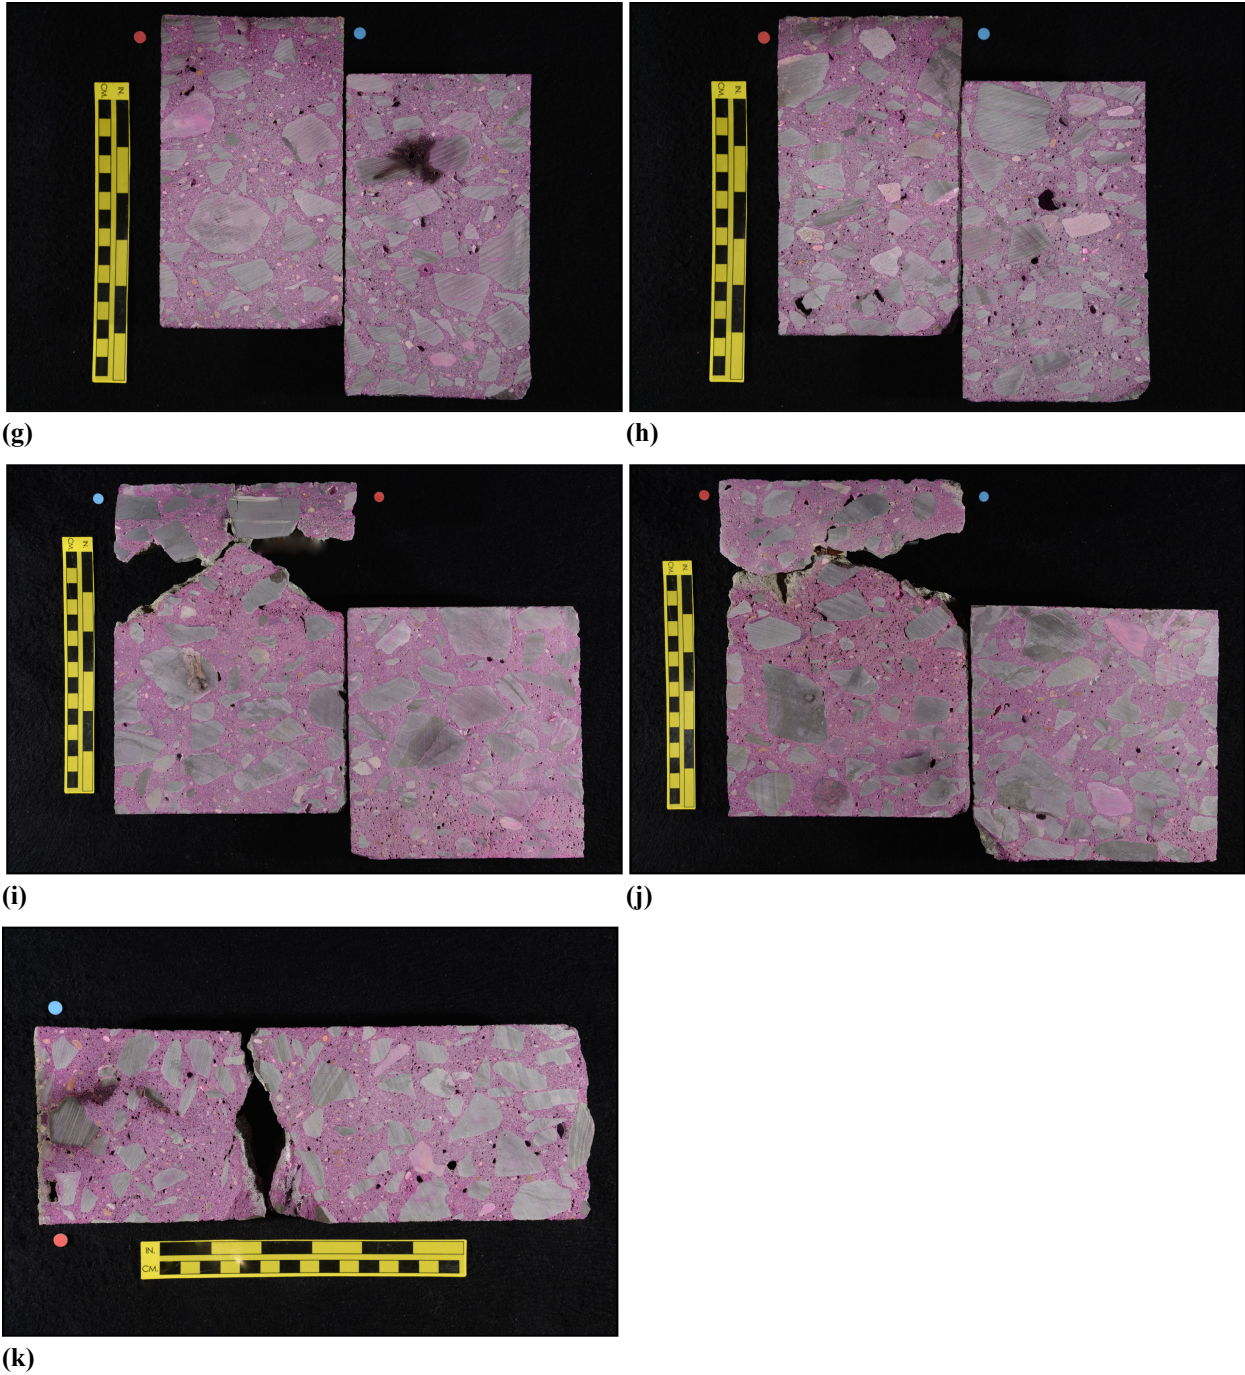
3.7 Secondary Deposits—Carbonation The cores show negligible carbonation based on phenolphthalein staining and thin section microscopy (**Figure 9**). Voids are generally free of secondary deposits.

Figure 9. Photographs of the phenolphthalein stained surfaces. (a) Core EB #1. (b) Core EB #2. (c) Core EB #3. (d) Core EB #4. (e) Core WB #1. (f) Core WB #2. The yellow scale bar is ~ 150 mm (6 in.) long.

Figure 9 (cont'd). Photographs of the phenolphthalein stained surfaces. (g) Core WB #3. (h) Core WB #4. (i) Core P#1. (j) Core P#2. (k) Core Wall #1. The yellow scale bar is ~150 mm (6 in.) long.

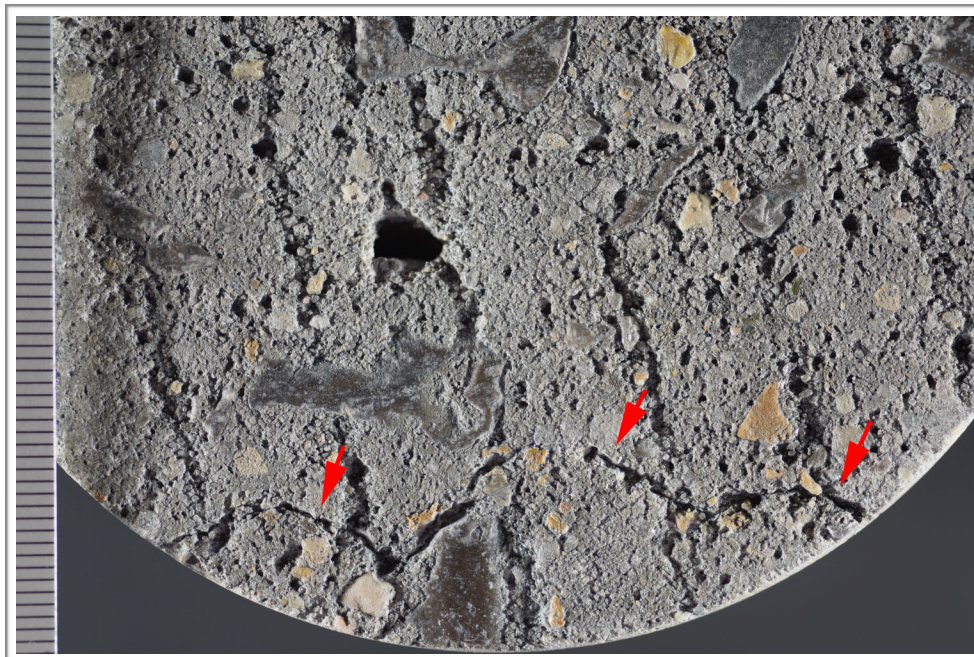
3. CRACKING	
MACROSCOPIC	A hairline crack was observed on the polished surface that cuts sub-vertically from the top of the core to ~ 25 mm (1 in.; Figure A4). The crack is free of secondary deposits and cuts around aggregate particles. Subjacent to the top surface and adjacent to a large void at the top of the core (see below) the polished surface shows a gap between a coarse aggregate particle and the paste (Figure A5). The paste along this interface is white and has a very granular texture.
MICROSCOPIC	No significant microcracking was observed.

Figure A4. Photograph showing crack (red arrows) on the top surface; scale in millimeters.

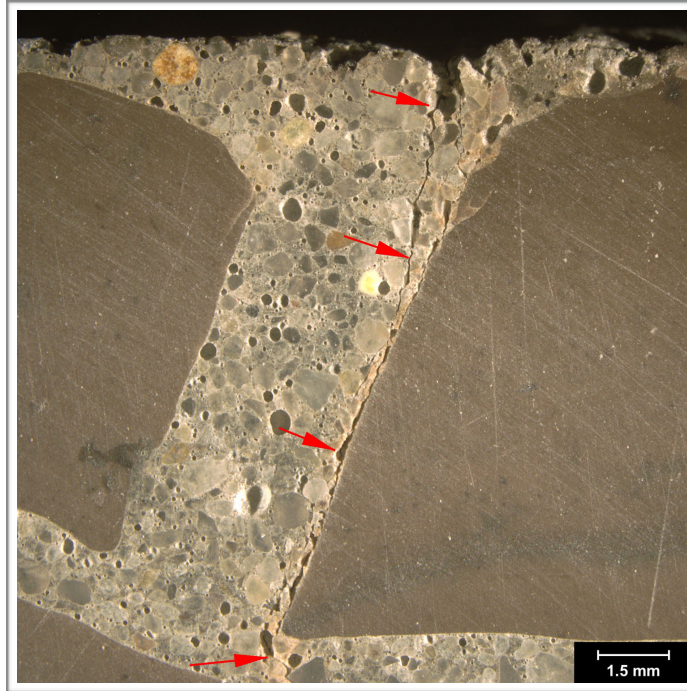
Figure A4 (cont'd). (b) Reflected light photomicrograph of the polished surface showing hairline crack (red arrows) at the top of the core.

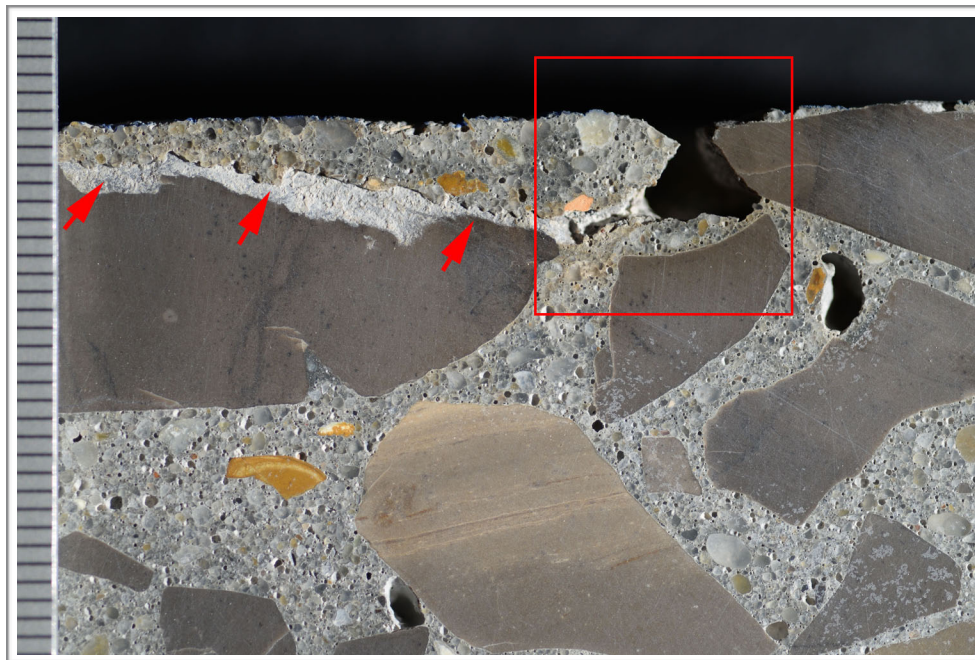
Figure A5. Reflected light photomicrograph of the polished surface showing vertical microcrack (red arrows) at the top of the core. The red box shows the approximate area of Figure A7.

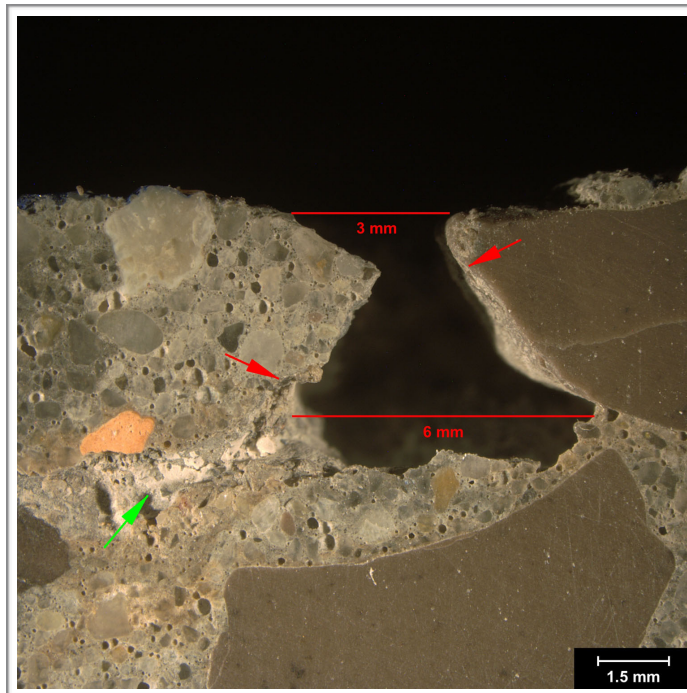
Figure A7. Reflected light photomicrograph of polished surface showing tear-drop shaped void (red arrows and bars) at the top of the core. The green arrow highlights crack.

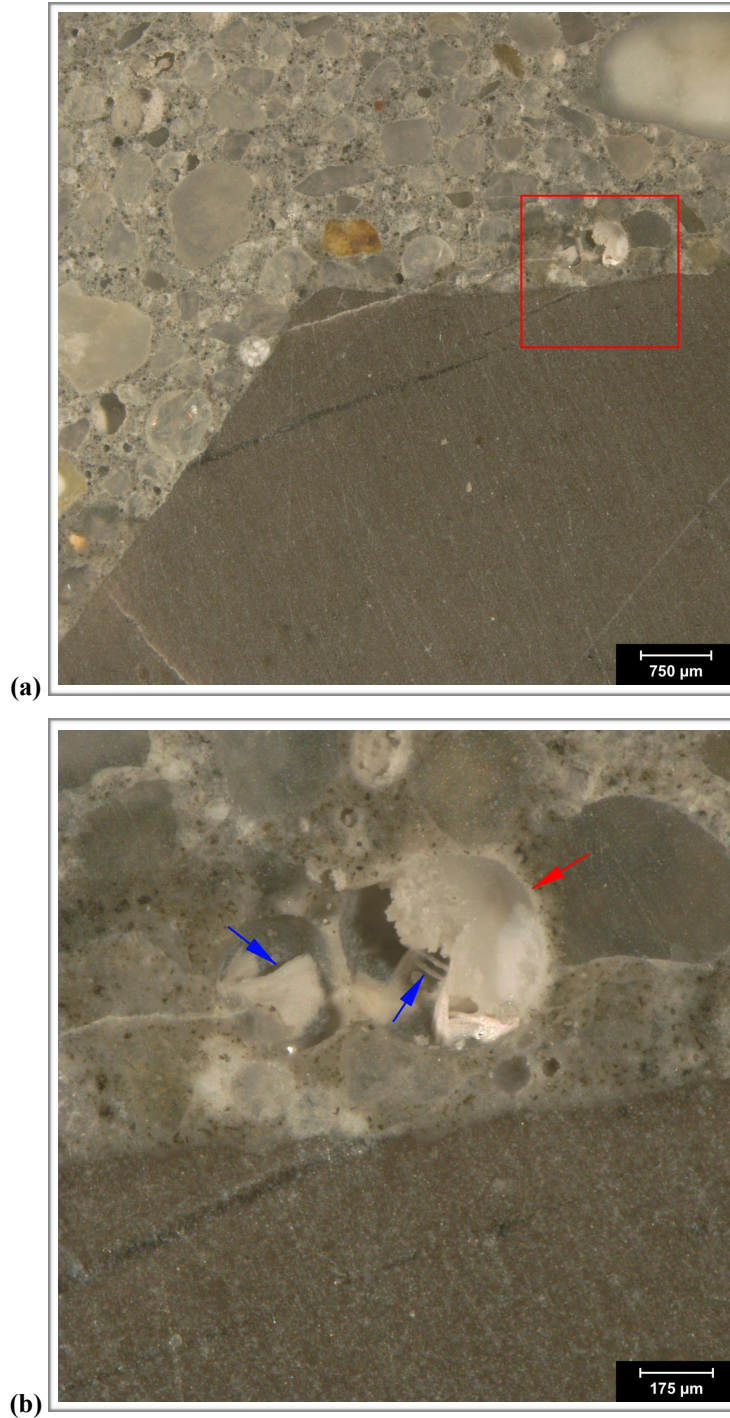
PHENOLPHTHALEIN	Entire surface stains purple (Figure A14).
DEPOSITS	Minor carbonation observed at the top of the core and in irregularly distributed zones in the paste in thin section. Minor deposits of ettringite observed in voids. Trace to minor deposits of ASR gel observed in rare voids, most commonly next to limestone particles (Figure A15).

Figure A15. Reflected light photomicrographs of polished surface showing (a) overview and (b) detail of gel deposits in void next to a coarse aggregate particle about 85 mm (3 ³/₈ in.) below the top surface. The red square in (a) shows the approximate area of (b) where the red arrow indicates a gelatinous deposit and blue arrows indicate more crystalline deposits.

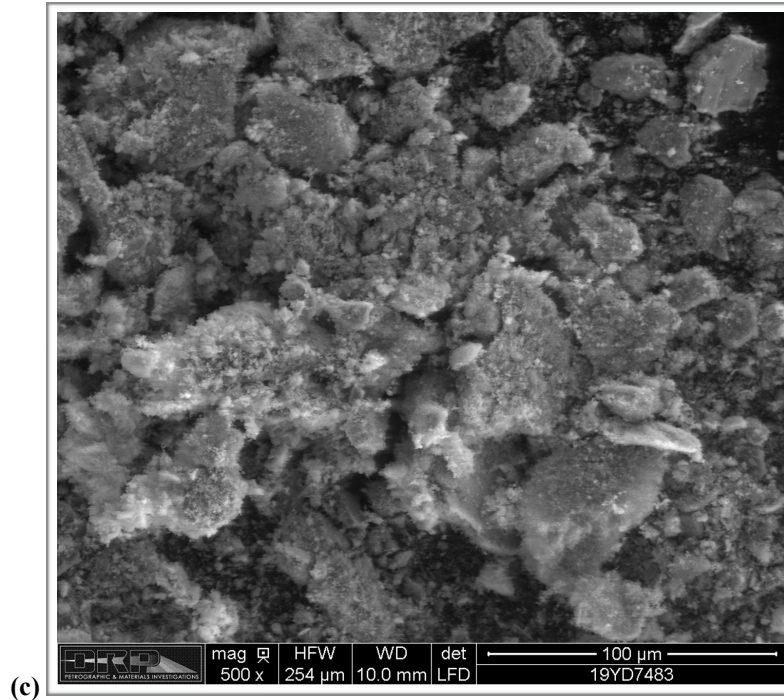
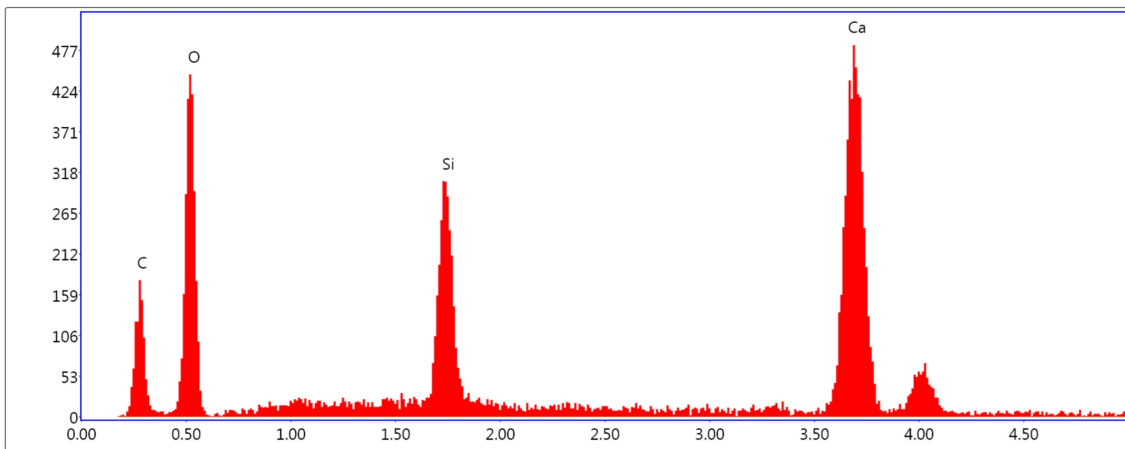
Figure A15 (cont'd). (c) Secondary electron micrograph of gel deposits scraped from voids shown in (b) and placed on carbon tape. (d) EDS spectrum of deposit indicating composition typical of ASR gel.

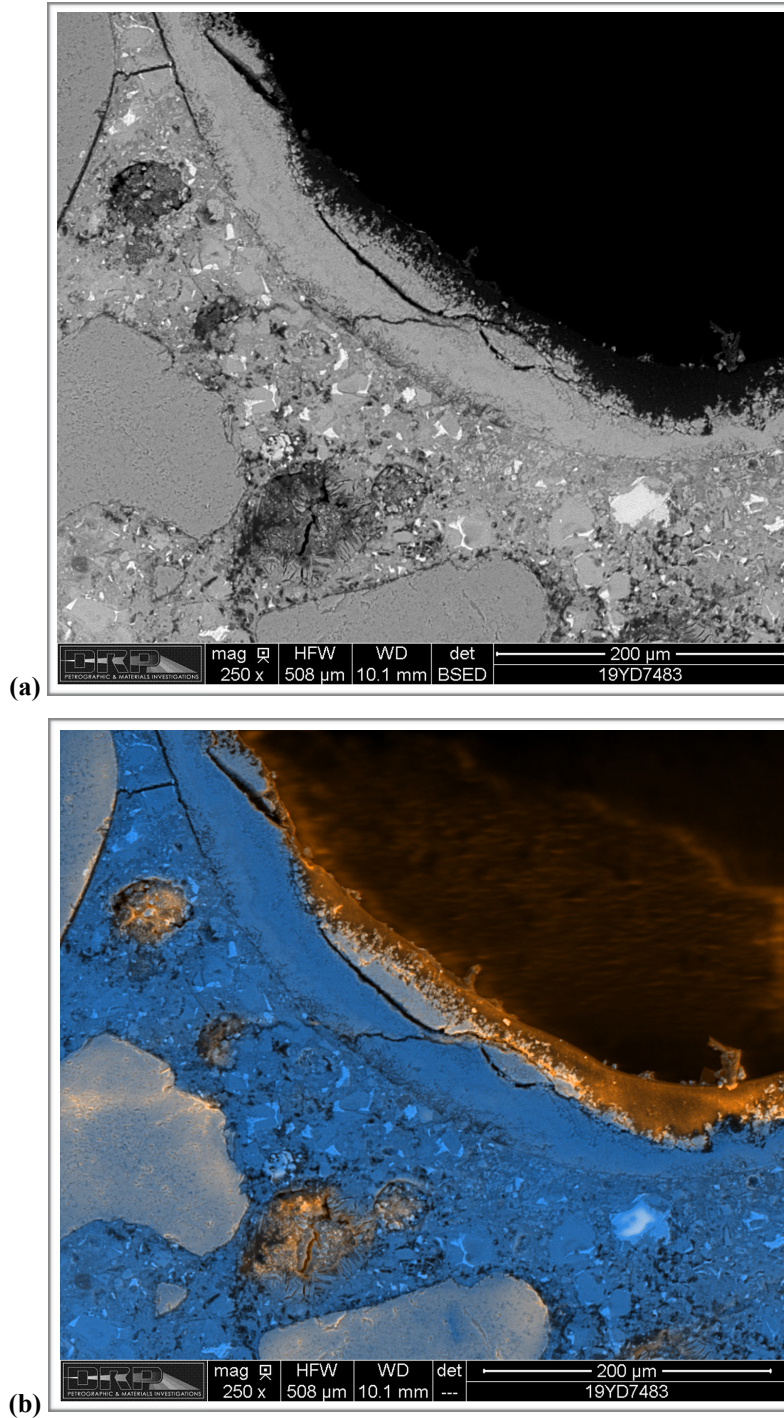
Figure A16. (a) Backscatter electron (BSE) and (b) combined backscatter/secondary electron (BSE/SE) micrograph of polished surface showing detail of void with gel.

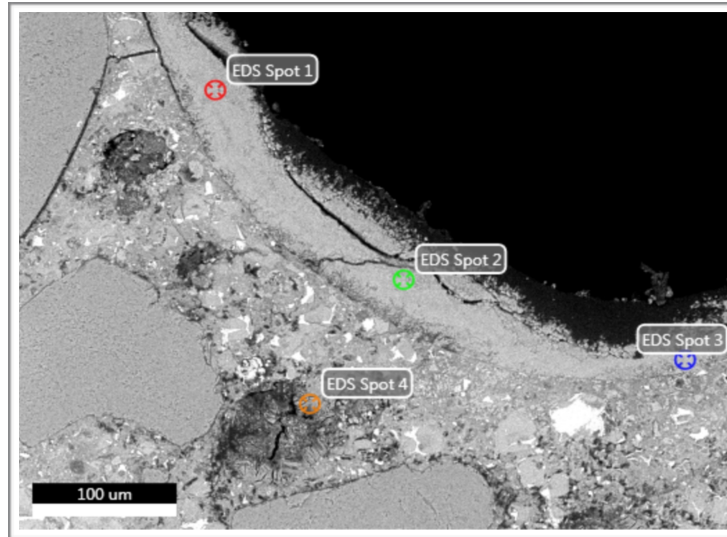
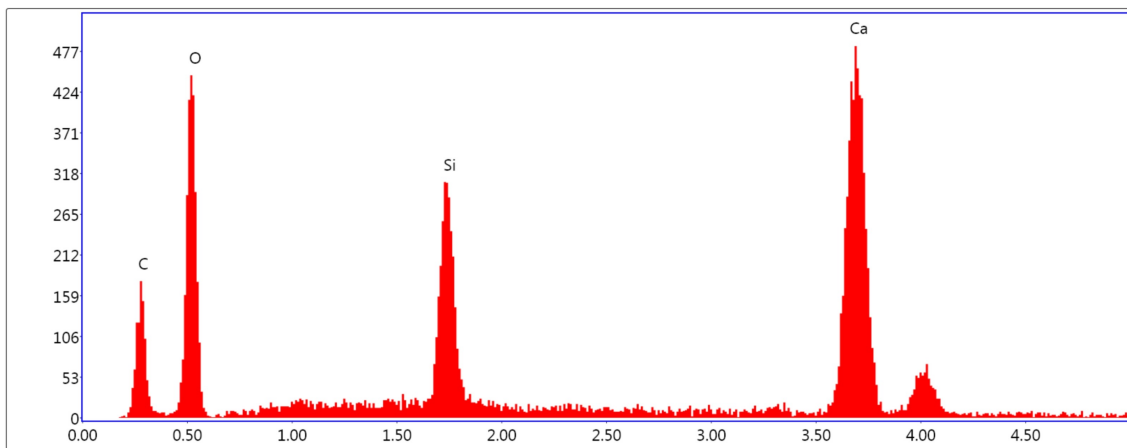
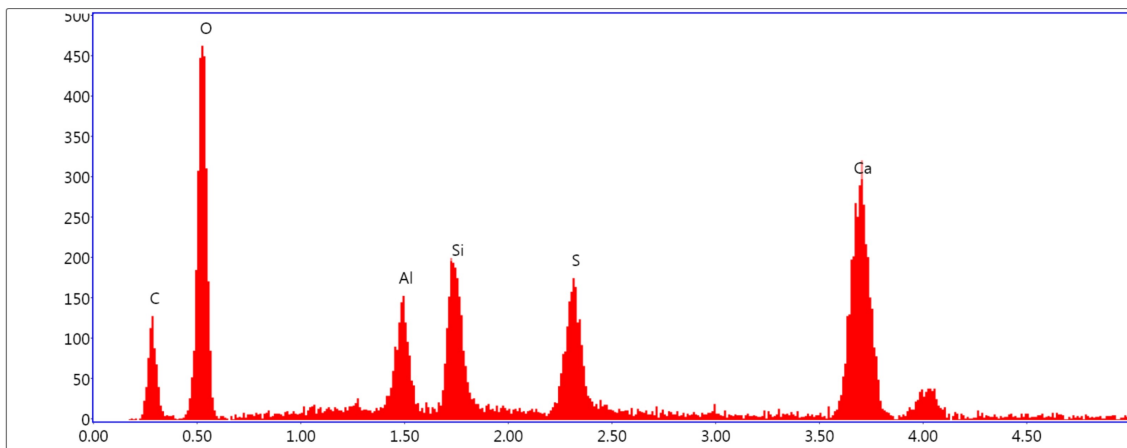
Figure A16 (cont'd). BSE micrograph showing location of EDS analyses in gel deposit shown in (a) and (b). The EDS spectrum shown in (d) is from EDS Spot 2 and is typical of ASR gel and Spots 1-3. The spectrum shown in (e) is from EDS Spot 4 and is typical of ettringite.

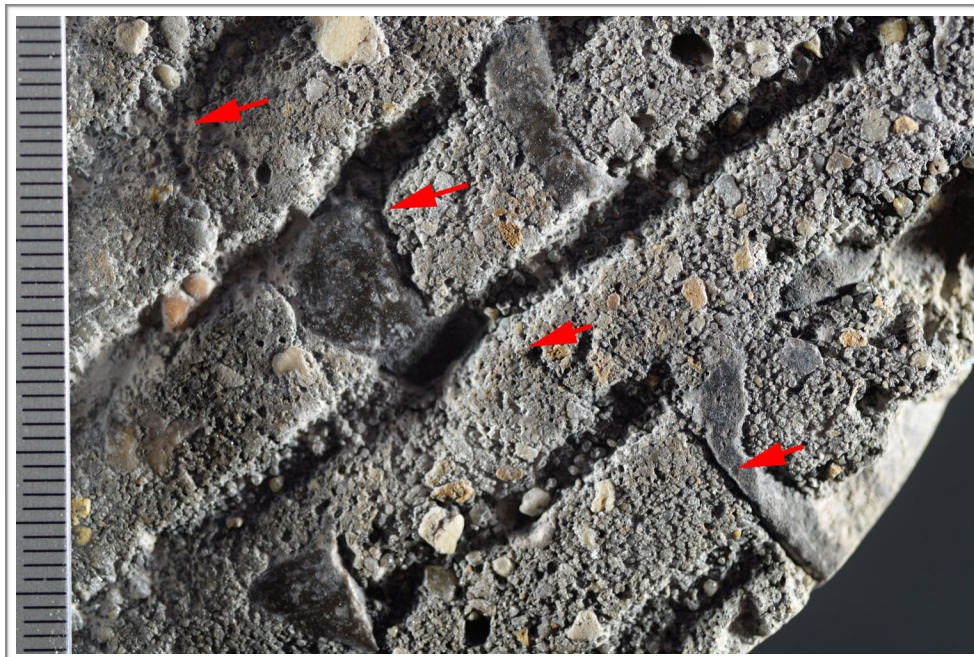
3. CRACKING	
MACROSCOPIC	A linear crack cuts across the top surface of the core; the crack is up to ~ 500 µm (20 mil) wide and has a strike length of 30 mm (1 1/8 in.) on the surface (Figure B4). On the polished surface the crack cuts sub-vertically to a depth of ~ 9.5 mm (3/8 in.). The crack cuts around aggregate particles and is free of secondary deposits. A hairline crack that is ~ 100 µm (4 mil) wide cuts obliquely through the paste for ~ 12.5 mm (1/2 in.) about 125 mm (5 in.) below the top surface (Figure B5). The crack cuts around aggregate particles and is free of secondary deposits.
MICROSCOPIC	No significant microcracking was observed.

Figure B4. Photograph showing crack (red arrows) on the top surface; scale in millimeters.

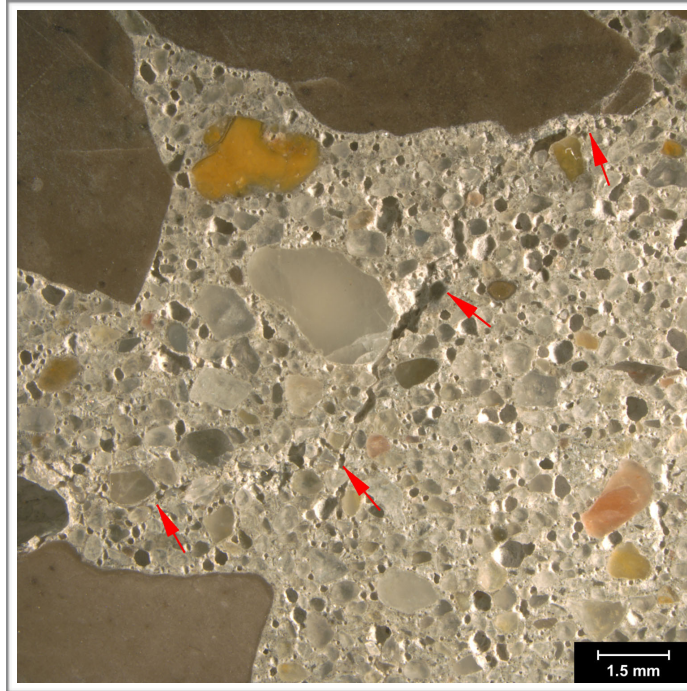
Figure B5. Reflected light photomicrograph of the polished surface showing hairline crack (red arrows) about 125 mm (5 in.) below the top surface.

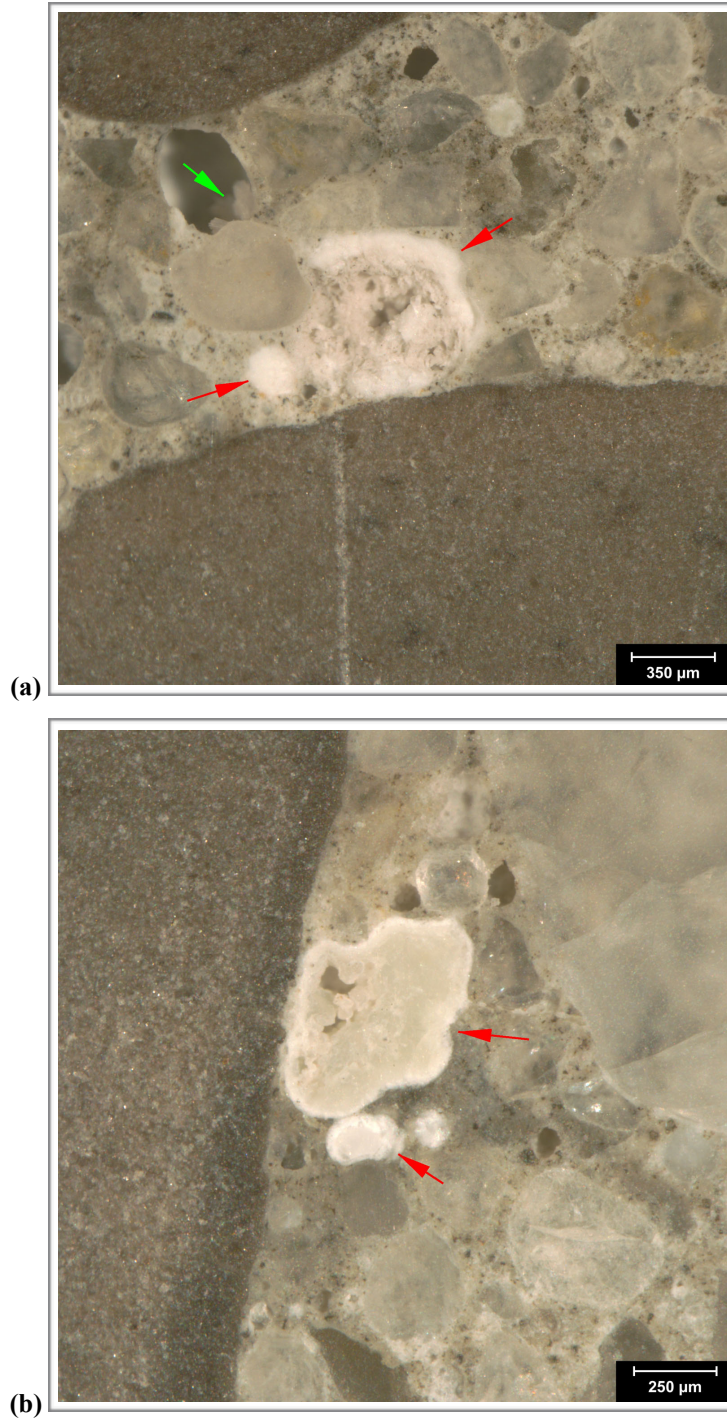
PHENOLPHTHALEIN	Entire surface stains purple (Figure B12).
DEPOSITS	Minor carbonation observed at the top of the core and in irregularly distributed zones in the paste in thin section. Minor deposits of ettringite observed in voids. Trace to minor deposits of ASR gel observed in rare voids, most commonly next to limestone particles (Figure B13 , Figure B14).

Figure B13. Reflected light photomicrographs of polished surface showing secondary deposits in voids (a) 35 mm (1 3/4 in.) and (b) 220 mm (8 5/8 in.) below the top surface. In (a) the red arrows indicate gelatinous deposits and the green arrow indicates a more crystalline deposit. In (b) the red arrow highlights a crystalline deposit.

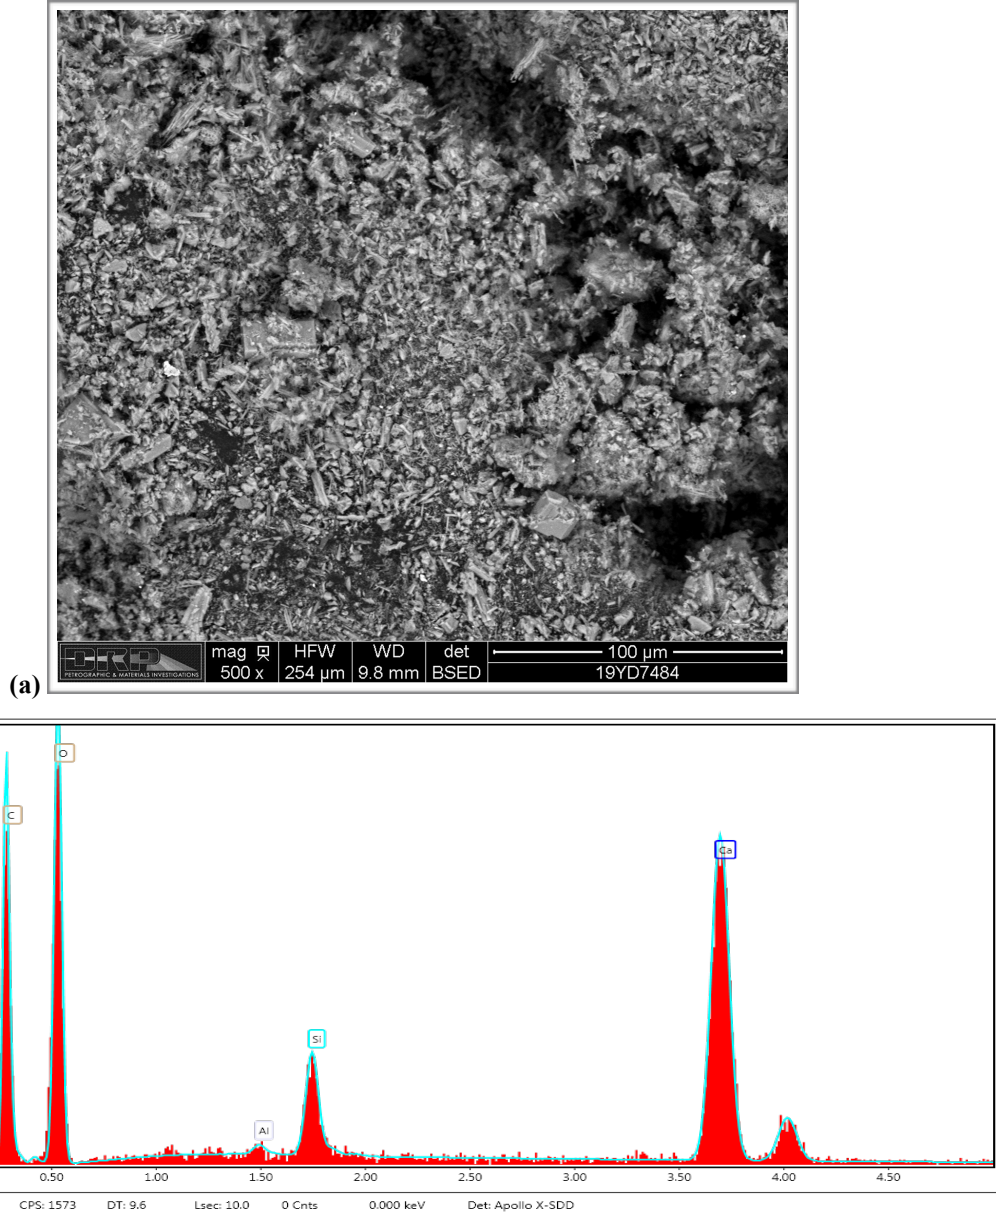
Figure B14. (a) Backscatter electron micrograph of gel deposits scraped from void shown in B13 (a) and placed on carbon tape. (b) EDS spectrum of deposit indicating composition typical of ASR gel.

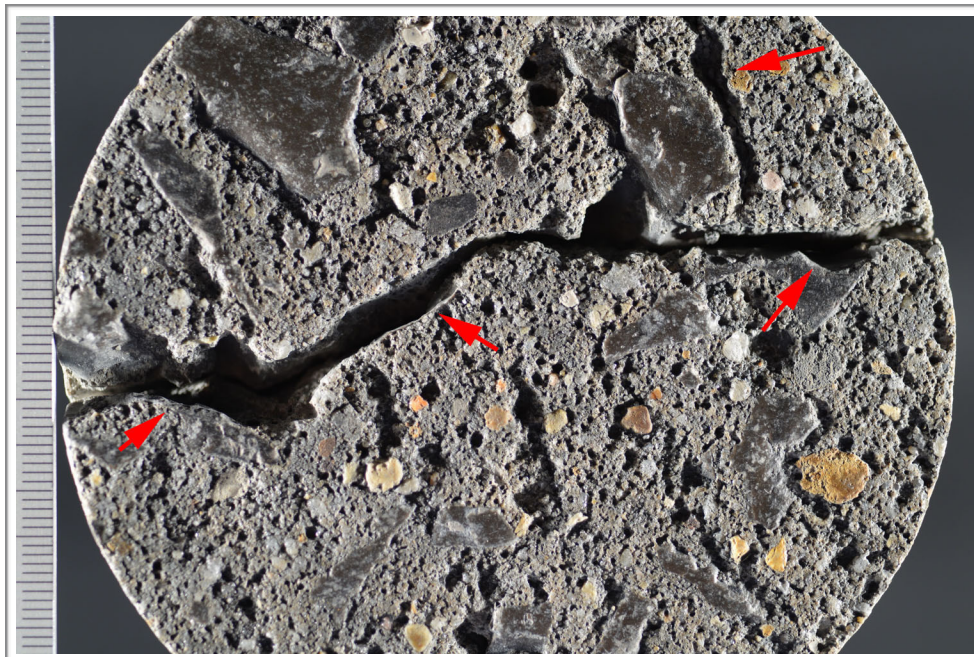
1. RECEIVED CONDITION	
ORIENTATION	Vertical core taken through highway pavement slab measures 100 mm (~ 4 in.) in diameter and 330 mm (~ 13 in.) long (Figure C1, C2).
SURFACES	The top surface has a worn tined texture and exposed coarse aggregate particles that are worn smooth (Figure C3) and the bottom surface is a saw cut such that the core represents a partial thickness of the pavement slab.
GENERAL CONDITION	The concrete is hard and compact and rings lightly when sounded with a hammer. The core was received in three pieces. There is a horizontal break that cuts cross the core in two about 55 mm (2 1/8 in.) below the top surface. The top piece is in turn cut in two by a sub-vertical crack (Figure C4).

Figure C4. Photograph showing cracks (red arrows) on the top surface; scale in millimeters.
