Technical Assistance Report 15-01TA-C

**Evaluation of Cores from I-10 between
Acadian Thruway and College Drive**

Petrographic Investigation of Concrete Cores From Cracked Pavement Slabs Located on Interstate 10 in Baton Rouge, Louisiana

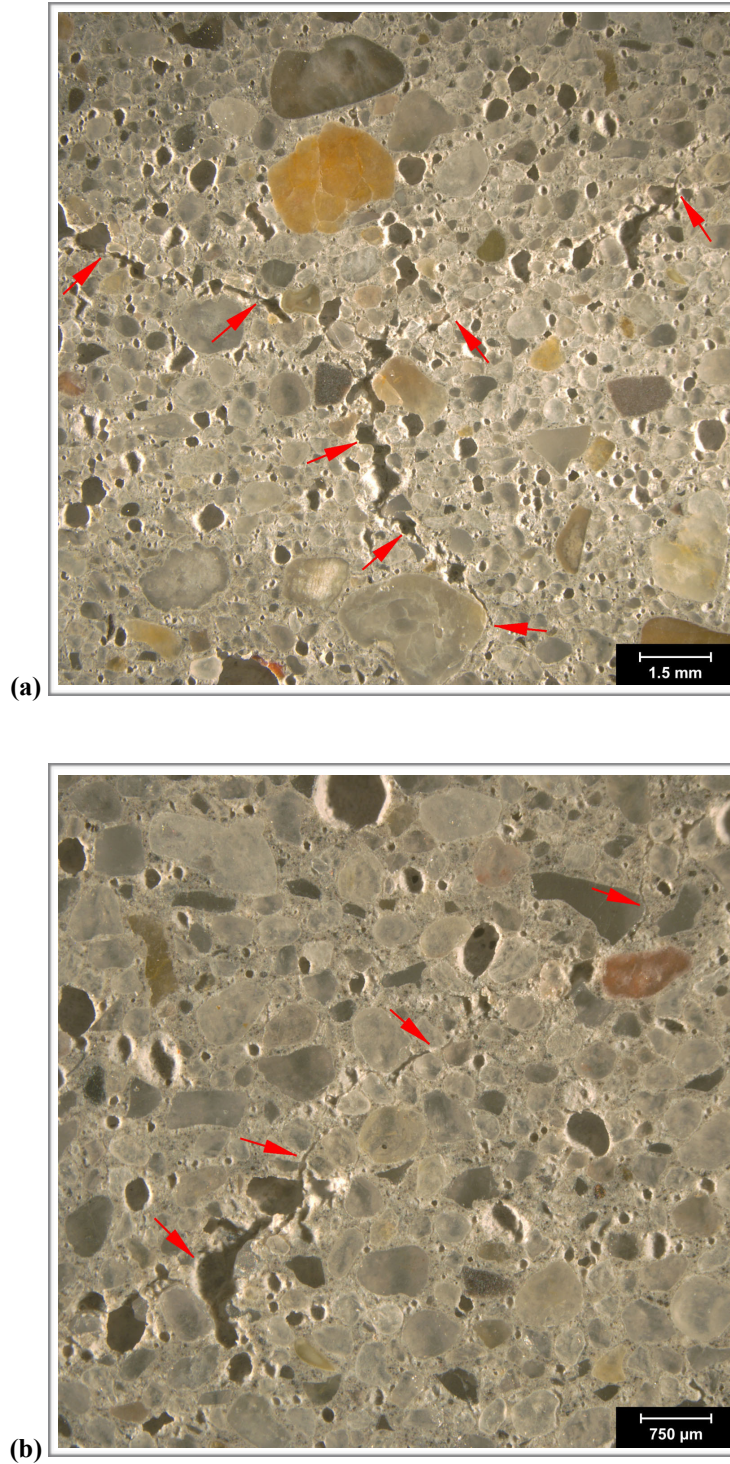
3. CRACKING	
MACROSCOPIC	Two open cracks cut the core in three pieces as described above. These cracks cut primarily around aggregate particles and lack significant secondary deposits. On the polished surface there is a complex network of cracks and hairline cracks that splay from the main vertical crack and cut obliquely through the paste from ~ 25 mm (1 in.) to 38 mm (1 1/2 in.) below the top surface where they cut sub-horizontally and then sub-vertically to the main horizontal crack (Figure C5). Numerous cracks ranging from 100-250 µm wide strike sub-horizontally to obliquely across the polished surface about 50 mm (2 in.) below the top of the core. A sub-vertical microcrack cuts from the main horizontal crack at ~ 50 mm (2 in.) depth to a depth of ~ 125 mm (5 in.). The crack cuts around aggregate particles and is free of secondary deposits (Figure C6).
MICROSCOPIC	Numerous microcracks were observed nested within the network of irregular cracking in the top 50 mm (2 in.). Some of these intersect or are next to voids with gelatinous deposits but the microcracks are free of secondary deposits (Figure C7). Occasional microcracks were observed throughout the remainder of the core; these are typically 25-100 µm (1-4 mil) wide and range up to 19 mm (3/4 in.) long (Figure C8). These cut around aggregate particles and are free of secondary deposits. Many of these microcracks have irregular, undulating walls and variable widths.

Figure C8. Reflected light photomicrographs of the polished surface showing microcracks (red arrows) about (a) 145 mm (5 ¾ in.) and (b) 150 mm (6 in.) below the top surface.

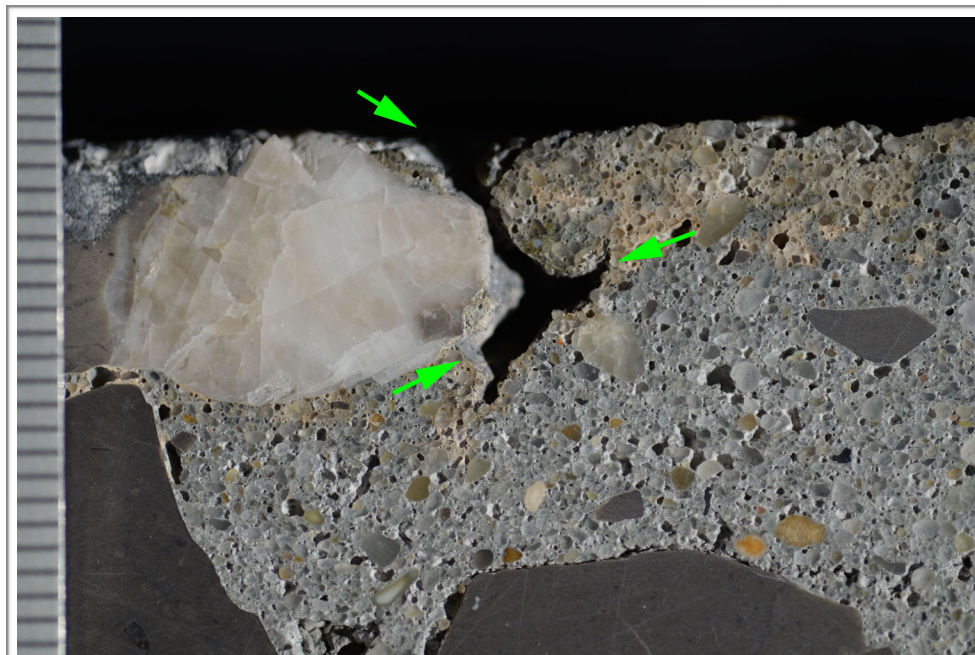
4. VOIDS	
VOID SYSTEM	Concrete is air-entrained (Figure C9) and contains 7-9% air by visual estimation (not determined following ASTM C457). The core is poorly consolidated in the top 55 mm (2 1/8 in.) where several large, irregularly shaped voids ranging from 12.5-25 mm (1/2-1 in.) across were observed (Figure C10).
VOID FILLINGS	Voids are commonly lined with ettringite. Rare voids contain gel.

Figure C10. Photograph of the polished surface showing irregular void (green arrows) at the top of the core; scale in millimeters.

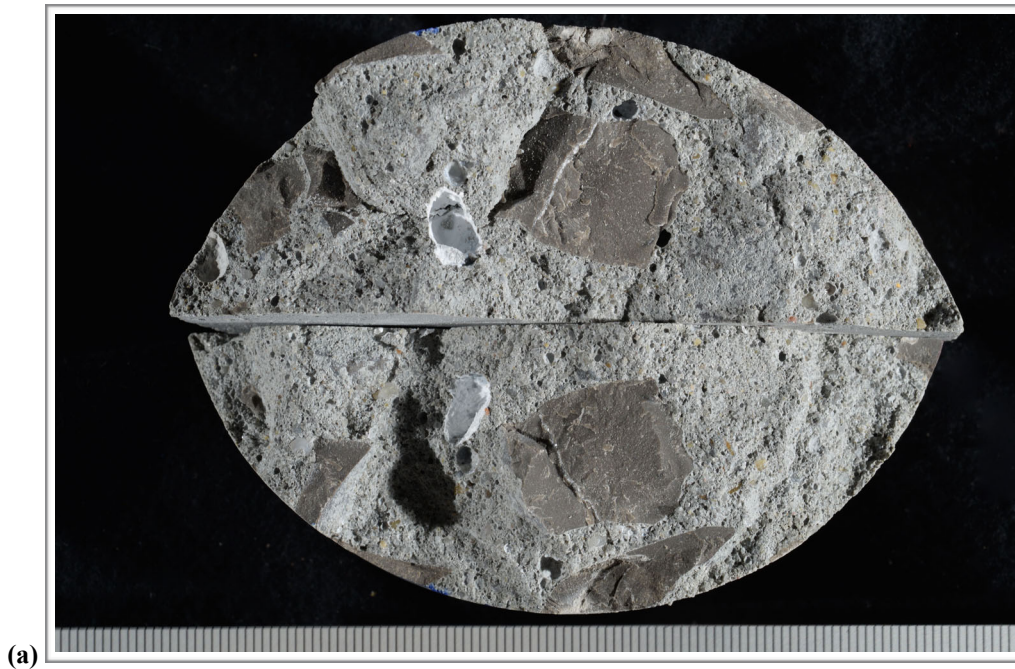
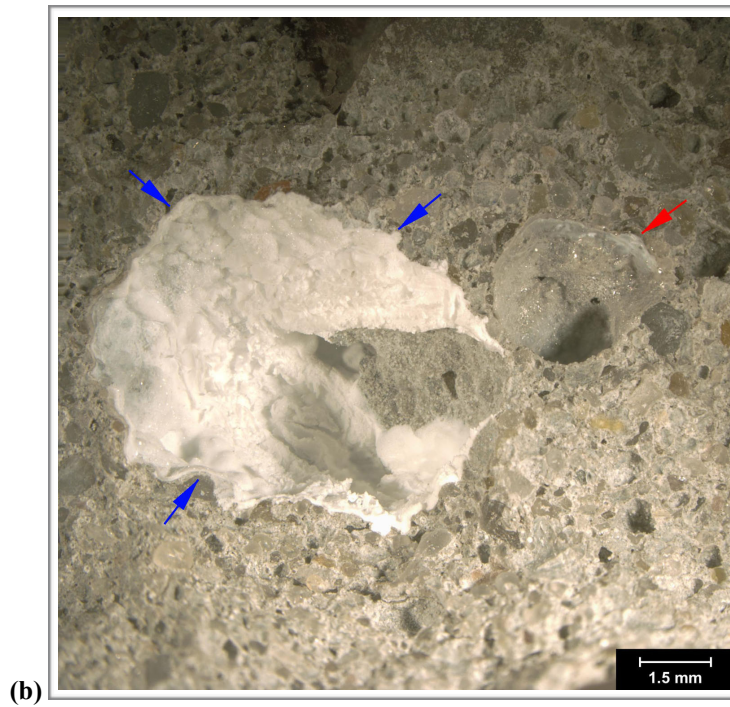
Figure C14. (a) Photograph and (b) reflected light photomicrograph of the fresh fracture surface. The scale in (a) is in millimeters. In (b) the blue arrows indicate white gelatinous deposit in a void and the red arrow indicates a clear gel.

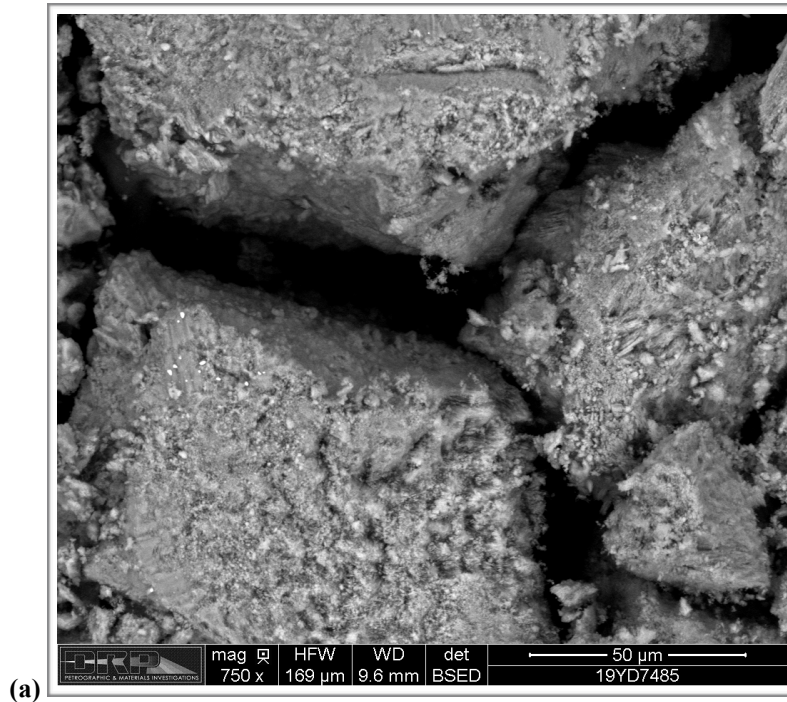
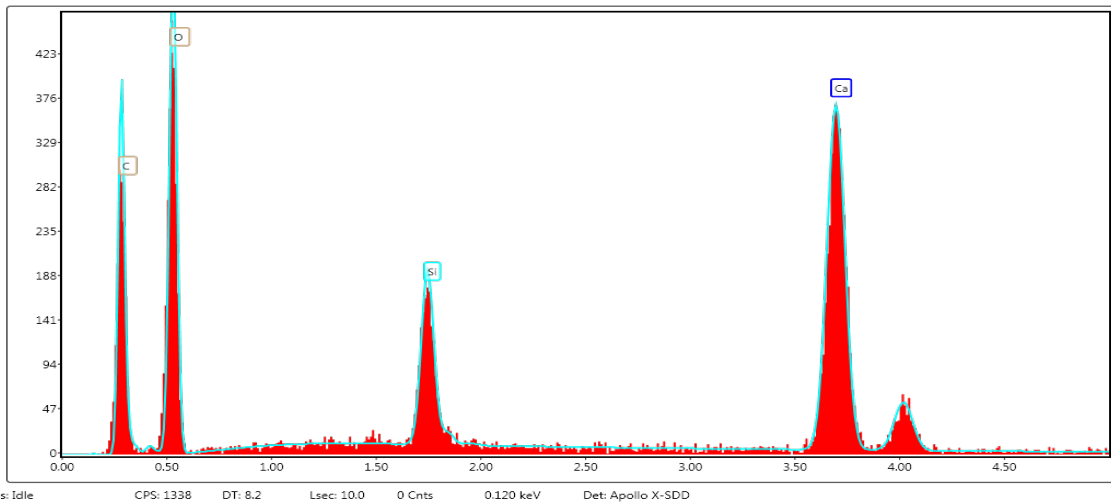
PHENOLPHTHALEIN	Entire surface stains purple (Figure C16).
DEPOSITS	Minor carbonation observed at the top of the core and in irregularly distributed zones in the paste in thin section. Minor deposits of ettringite observed commonly in voids. Minor deposits of ASR gel observed in voids (Figure C17-Figure C19). No evidence of cracking or microcracking due to ASR observed.

Figure C17. (a) Backscatter electron micrograph of gel deposits scraped from void shown in C7(b) and placed on carbon tape. (b) EDS spectrum of deposit indicating composition typical of ASR gel.

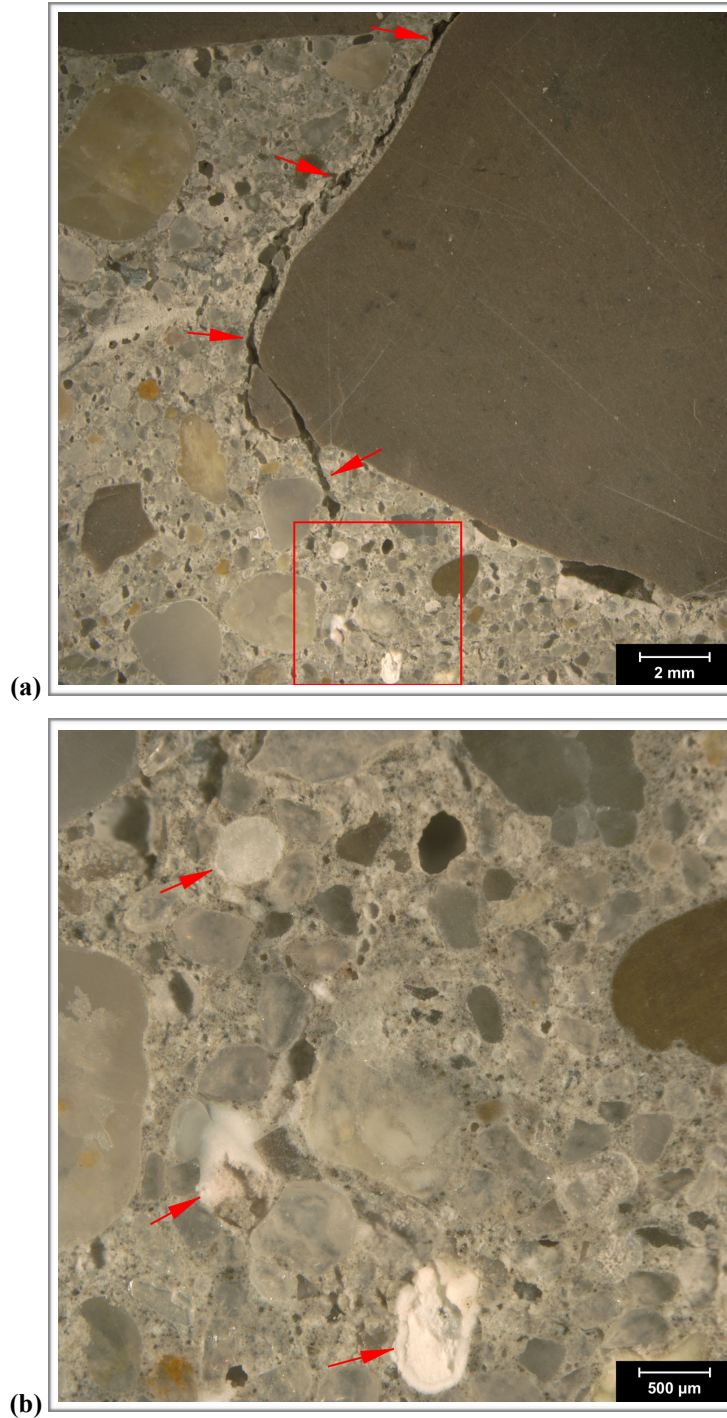
Figure C18. Reflected light photomicrographs of polished surface showing (a) overview and (b) detail of deposits in voids about 115 mm (4 ½ in.) below the top surface. In (a) the red arrows indicate cracks and the red box shows the area of (b), where the red arrow indicates gel in voids.

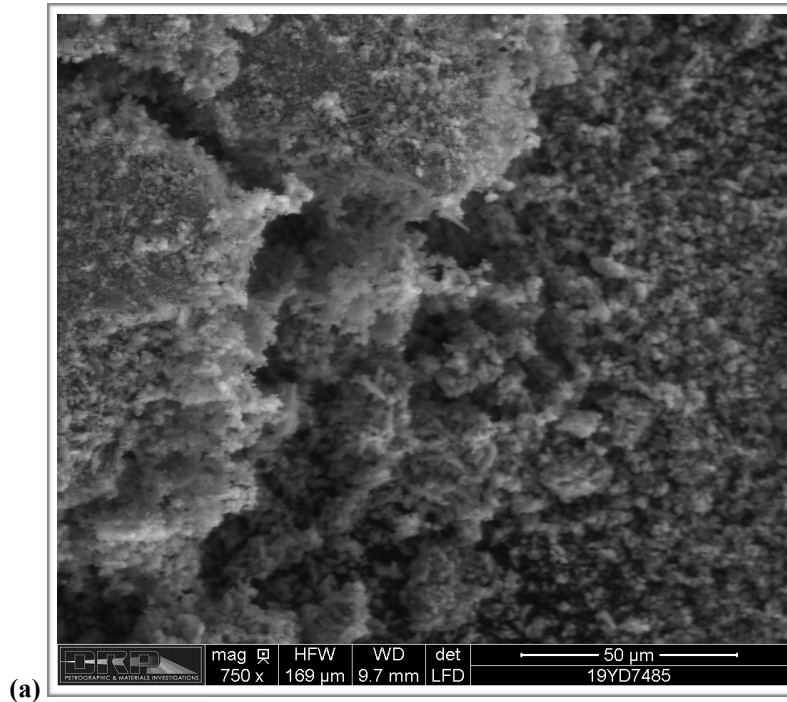
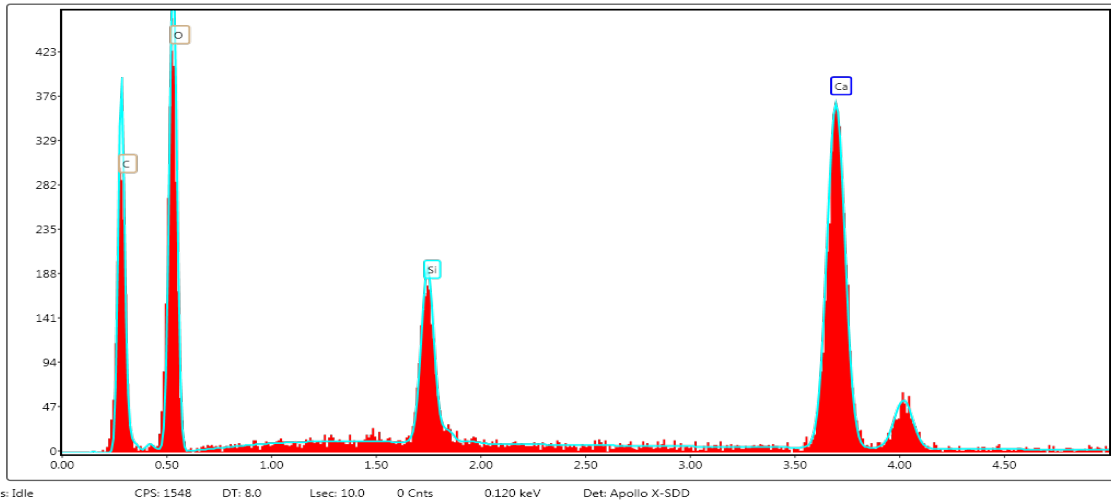
Figure C19. (a) Backscatter electron micrograph of gel deposits scraped from void shown in C18(b) and placed on carbon tape. (b) EDS spectrum of deposit indicating composition typical of ASR gel.

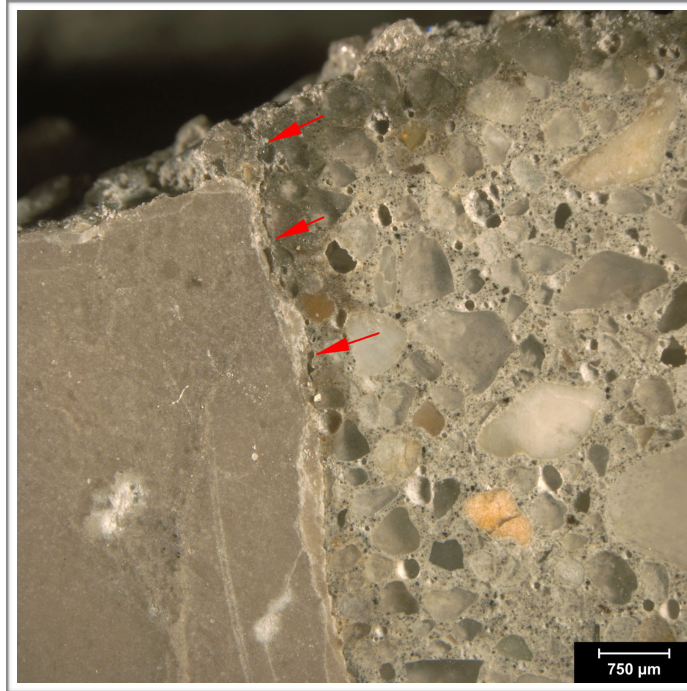
3. CRACKING	
MACROSCOPIC	None observed except for minor internal hairline cracks in coarse aggregate particles. These do not propagate into the paste.
MICROSCOPIC	A microcrack that is ~ 75 µm (3 mil) wide cuts sub-vertically from the top surface to ~ 3 mm (1/8 in.); the crack is free of secondary deposits and cuts around an aggregate particle (Figure D4). No other microcracking was observed.

Figure D4. Reflected light photomicrograph of the polished surface showing microcrack (red arrows) at the top of the core.

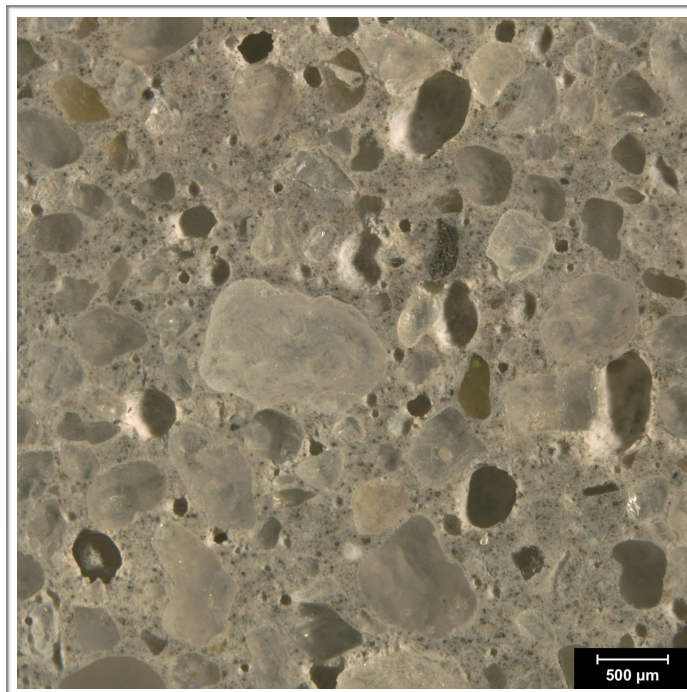
4. VOIDS	
VOID SYSTEM	Concrete is air-entrained (Figure D5) and contains 4-6% air by visual estimation (not determined following ASTM C457). The core is moderately well consolidated with only a few large voids that measure 6-9.5 mm (1/4-3/8 in.) across observed.
VOID FILLINGS	Voids are commonly lined with ettringite. Rare voids contain gel.

Figure D5. Reflected light photomicrograph of the polished surface showing entrained air voids (dark circles).

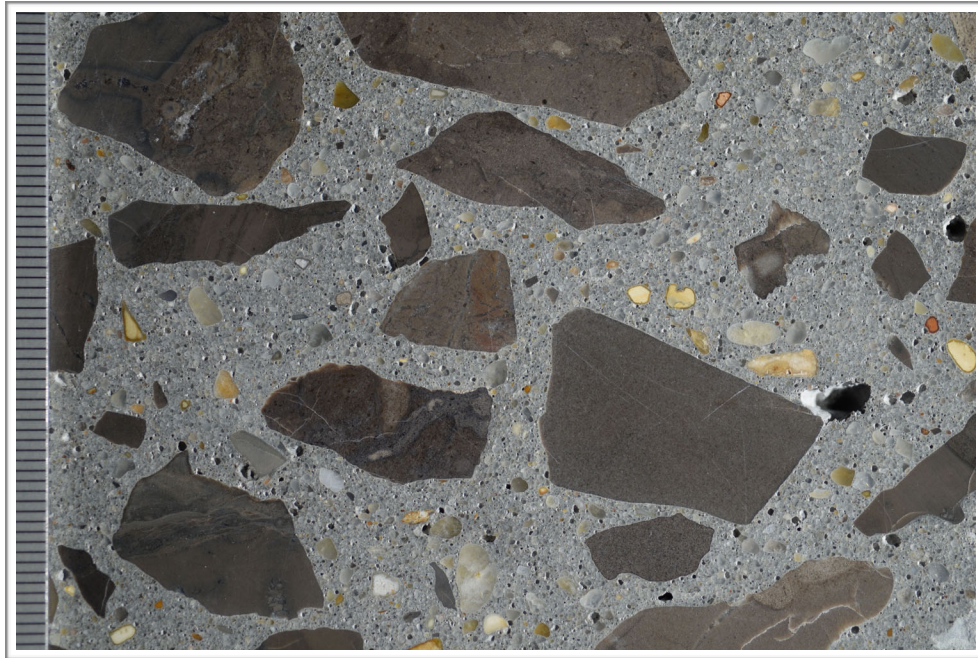
5. COARSE AGGREGATE	
PHYSICAL PROPERTIES	Crushed quarry rock with 38 mm (1 1/2 in.) nominal top size (Figure D6). The rocks are hard and competent. The particles are sub-equant to tabular in shape with sub-angular to sub-round edges. The grading and distribution are relatively even. The sand is very fine.
ROCK TYPES*	The aggregate is carbonate in composition and consists of brown dolomitic limestone as well as tan to light brown limestones that show laminations and evidence of bioturbation as well as some oolitic limestones.
OTHER FEATURES	No deleterious coatings or incrustations observed. A few minor low w/c mortar coatings observed. Occasional particles show internal cracking and microcracking; these do not propagate into the paste.

Figure D6. Photograph of the polished surface showing coarse aggregate; scale in millimeters.

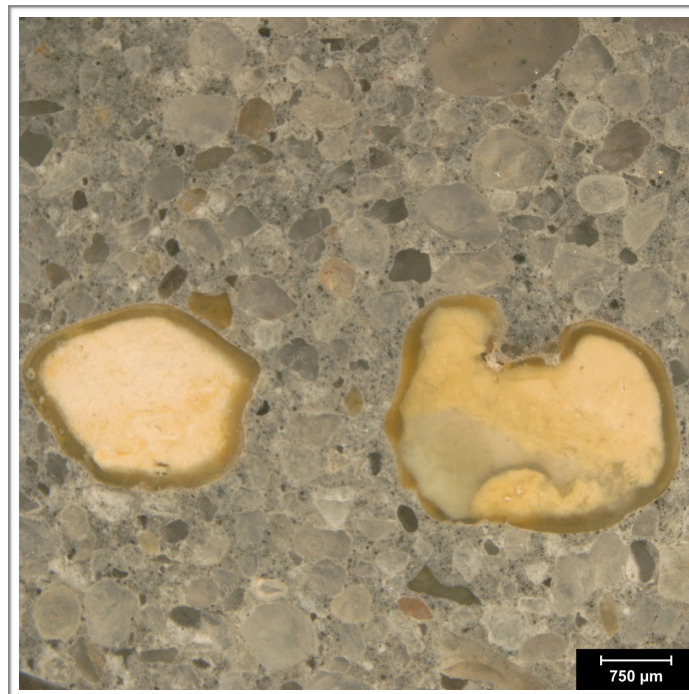
PHYSICAL PROPERTIES	Natural sand consists of rocks that are hard and competent (Figure D7). The particles are sub-equant to tabular in shape with sub-round to sub-angular edges. The grading and distribution are relatively even.
ROCK TYPES	The sand is siliceous in composition and consists primarily of quartz and quartzite with minor amounts of granitic rocks and chert.
OTHER FEATURES	No deleterious coatings or incrustations observed and no low w/c mortar coatings observed. Particles of chert typically show reaction rims but no microcracking or deposits of gel are associated with them.

Figure D7. Reflected light photomicrograph of polished surface showing the fine aggregate.

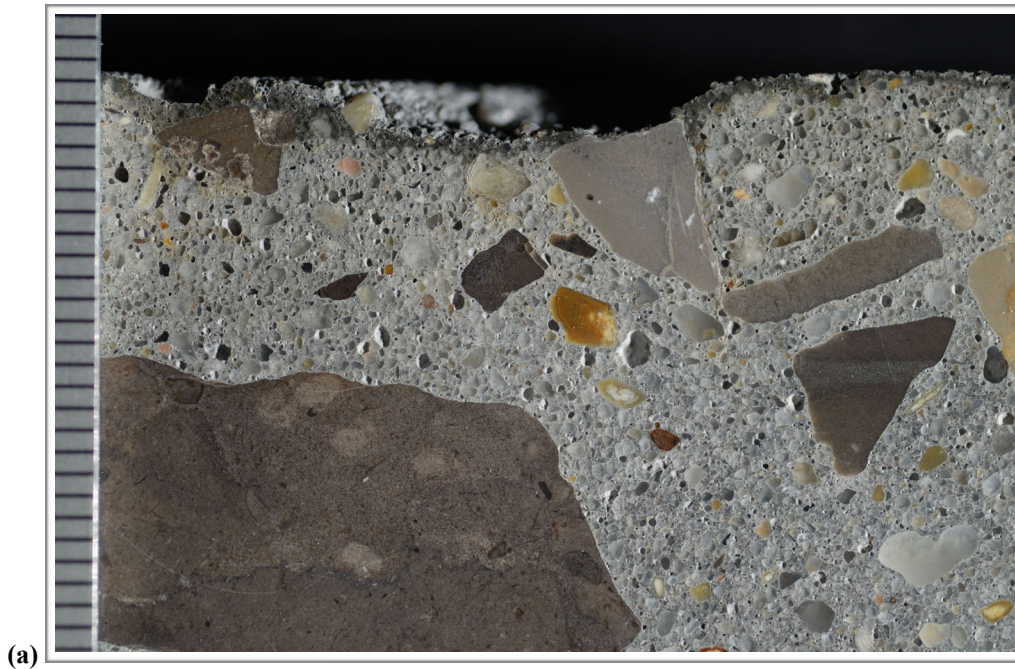
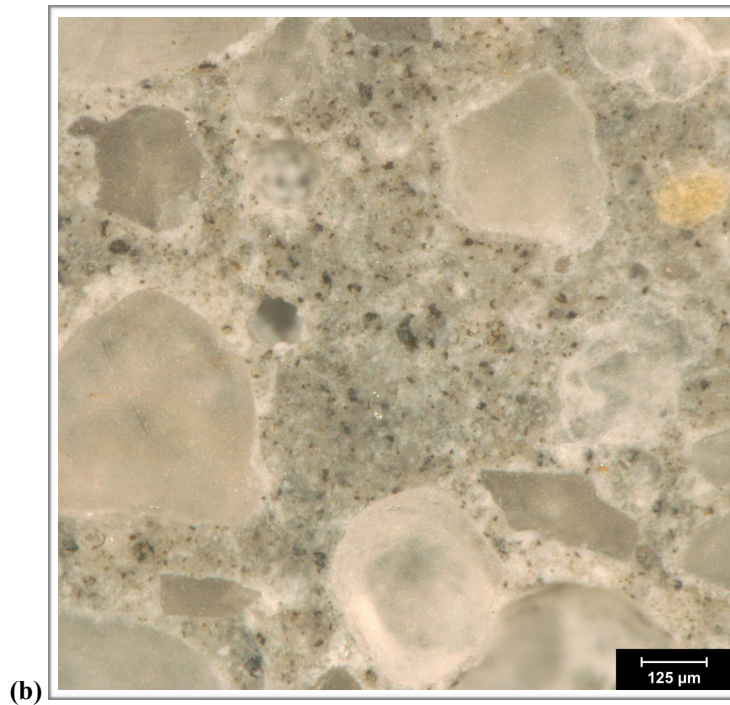
POLISHED SURFACE	Paste is gray (Munsell 2.5Y/6/1) to dark gray (2.5Y/4/1), has a smooth texture and sub-vitreous luster (Figure D8). The paste is hard (Mohs 3.5-4). The paste is dark gray for up to 3 mm ($\frac{1}{8}$ in.) from the top of the core.
FRESH FRACTURE	Fracture surface is light gray, has a hackly texture and a sub-vitreous luster. The fracture cuts primarily around aggregate particles (Figure D9). No significant secondary deposits were observed though minor deposits of ettringite commonly line voids.
THIN SECTION*	The paste contains hydrated portland cement; no fly ash, slag cement or other SCM were observed. The hydration is normal with 4-8% RRCG that consist mostly of interstitial ferrite and aluminate with occasional grains of belite (Figure D10). CH makes up 10-17% of the paste, is fine to medium-grained and evenly distributed.

Figure D8. (a) Photograph of polished surface showing overview of paste at the top of the core. The scale is in millimeters. (b) Reflected light photomicrograph showing detail of paste color, texture and luster in the middle of the core.

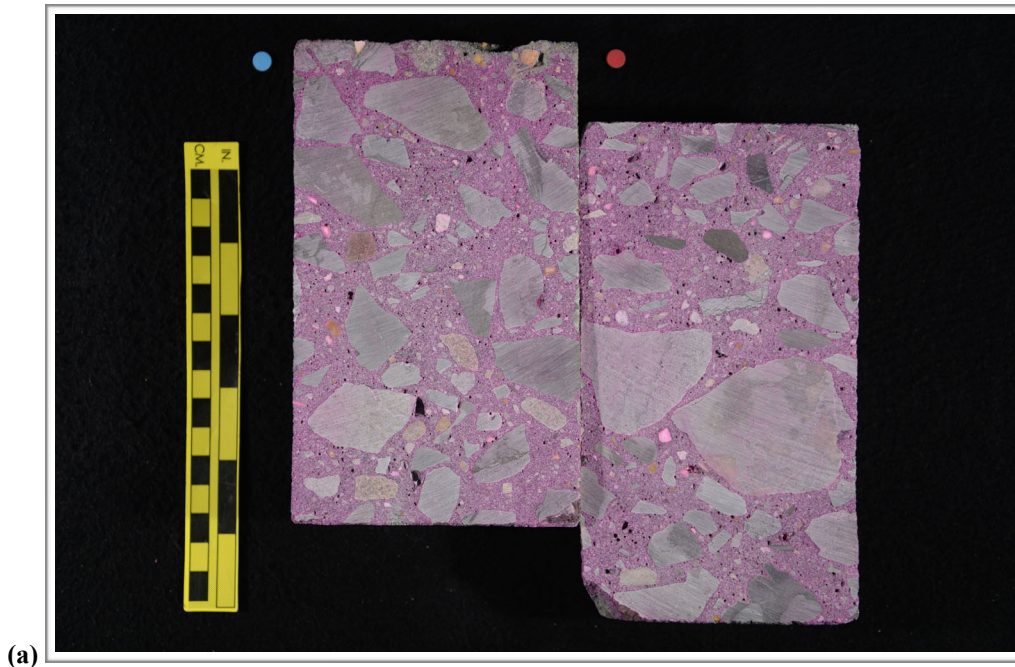
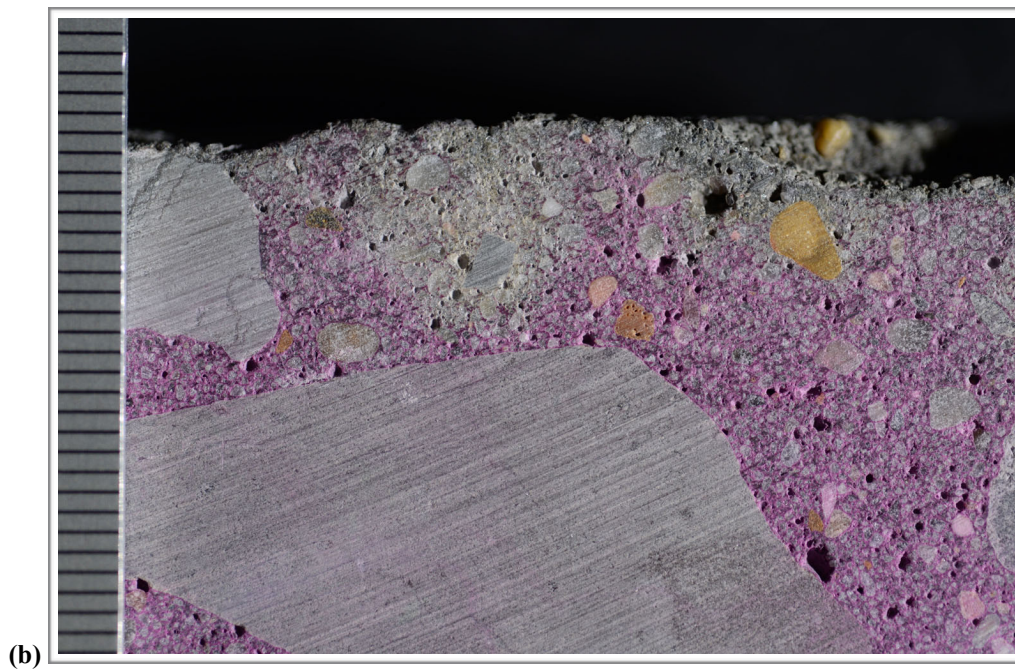
PHENOLPHTHALEIN	Entire surface stains purple (Figure D11).
DEPOSITS	Minor carbonation observed at the top of the core and in irregularly distributed zones in the paste in thin section. Minor deposits of ettringite observed commonly in voids. Minor deposits of ASR gel observed in voids (Figure D12, D13). No evidence of cracking or microcracking due to ASR observed.

Figure D11. Photographs showing (a) overview of phenolphthalein stained surface and (b) detail of surface near the top of the core. Scale in millimeters in (b).

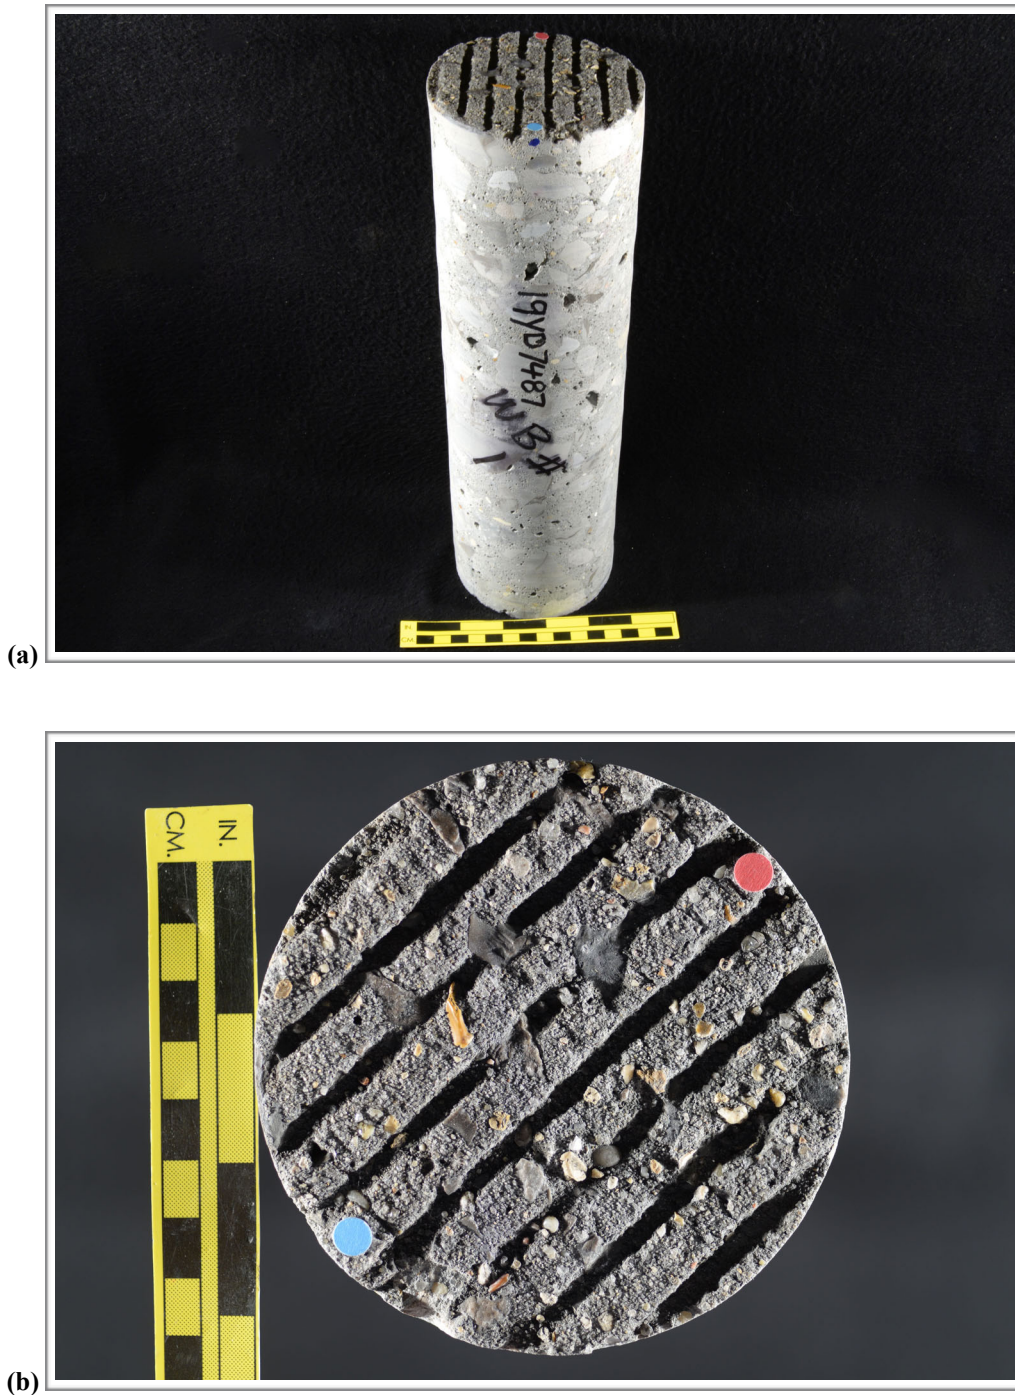
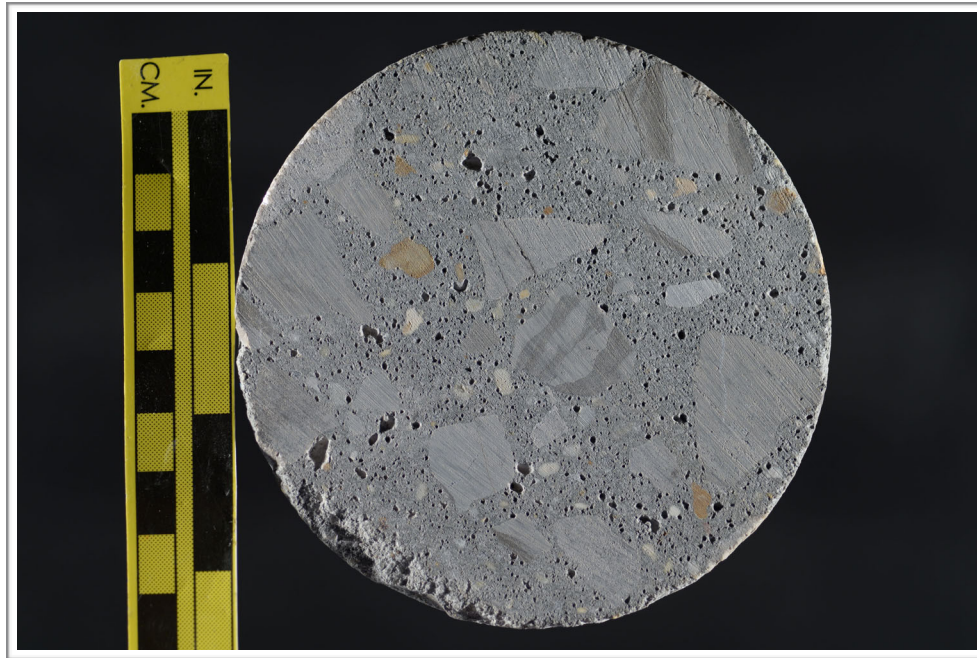
1. RECEIVED CONDITION	
ORIENTATION	Vertical core taken through highway pavement slab measures 100 mm (~ 4 in.) in diameter and 325 mm (~ 13 in.) long (Figure E1, E2).
SURFACES	The top surface shows minor wear; the tines are largely intact but numerous coarse aggregate particles are exposed and worn smooth (Figure E3a). The bottom surface is a saw cut such that the core represents a partial thickness of the pavement slab.
GENERAL CONDITION	The concrete is hard and compact and rings lightly when sounded with a hammer. The core was received intact in one piece.

Figure E1. Photographs showing (a) oblique view of the top and side of the core with identification labels and (b) the top of the core. The red and blue dots in (a) show the orientation of the saw cuts used to prepare the sample.

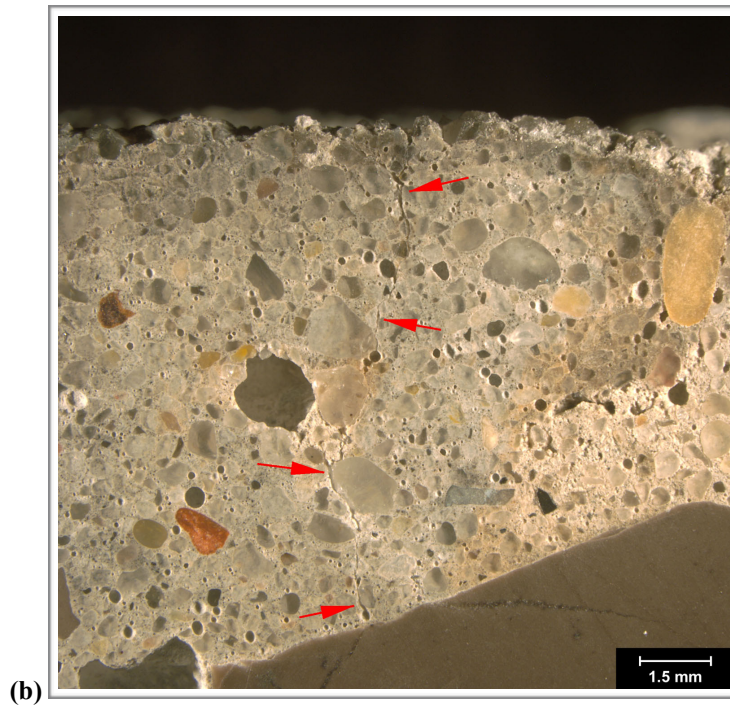
3. CRACKING	
MACROSCOPIC	Linear crack cuts 100 mm (4 in.) across the top of the core; the crack is 250 µm (10 mil) wide and cuts to ~ 9.5 mm (3/8 in.; Figure E3). The crack cuts around aggregate particles and is free of secondary deposits. Minor internal hairline cracks observed in coarse aggregate particles. These do not propagate into the paste.
MICROSCOPIC	A microcrack that is ~ 75 µm (3 mil) wide cuts sub-vertically from the top surface to ~ 5 mm (200 mil); the microcrack is free of secondary deposits and cuts around aggregate particles (Figure E4). No other microcracking was observed.

Figure E3. (a) Photograph showing crack (red arrows) on the top surface; scale in millimeters. (b) Reflected light photomicrograph showing hairline crack (red arrows) at the top of the core.

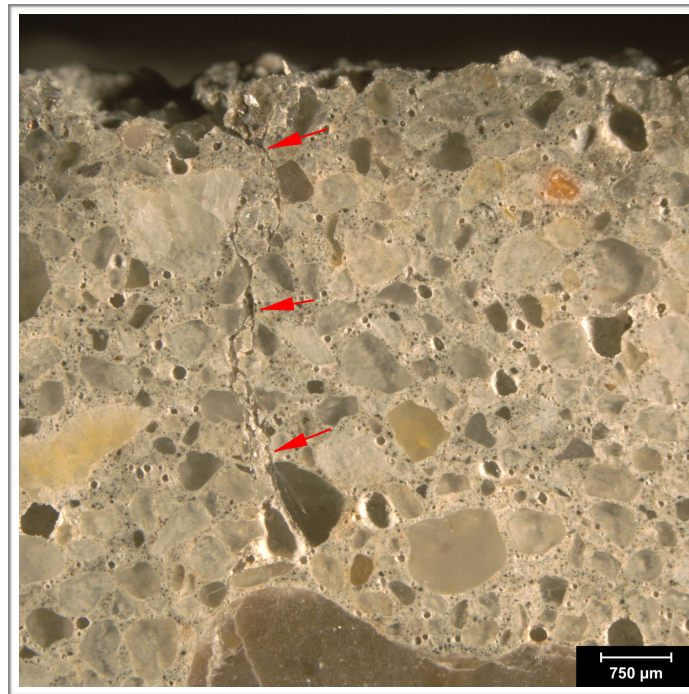
Figure E4. Reflected light photomicrograph of the polished surface showing microcrack (red arrows) at the top of the core.

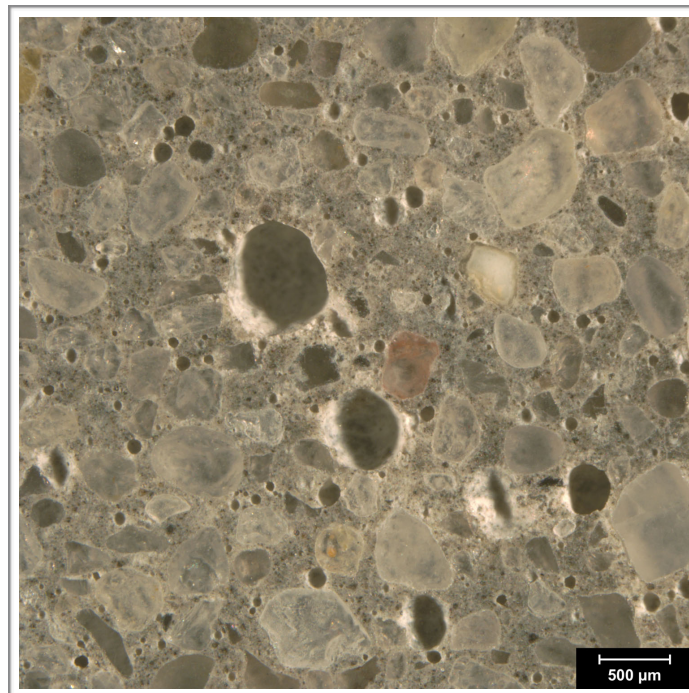
4. VOIDS	
VOID SYSTEM	Concrete is air-entrained (Figure E5) and contains 4-6% air by visual estimation (not determined following ASTM C457). The core is moderately consolidated with several larger water voids and entrapped voids that measure 6-9.5 mm (1/4-3/8 in.) across observed.
VOID FILLINGS	Voids occasionally contain minor to trace deposits of ettringite.

Figure E5. Reflected light photomicrograph of the polished surface showing entrained air voids (dark circles).

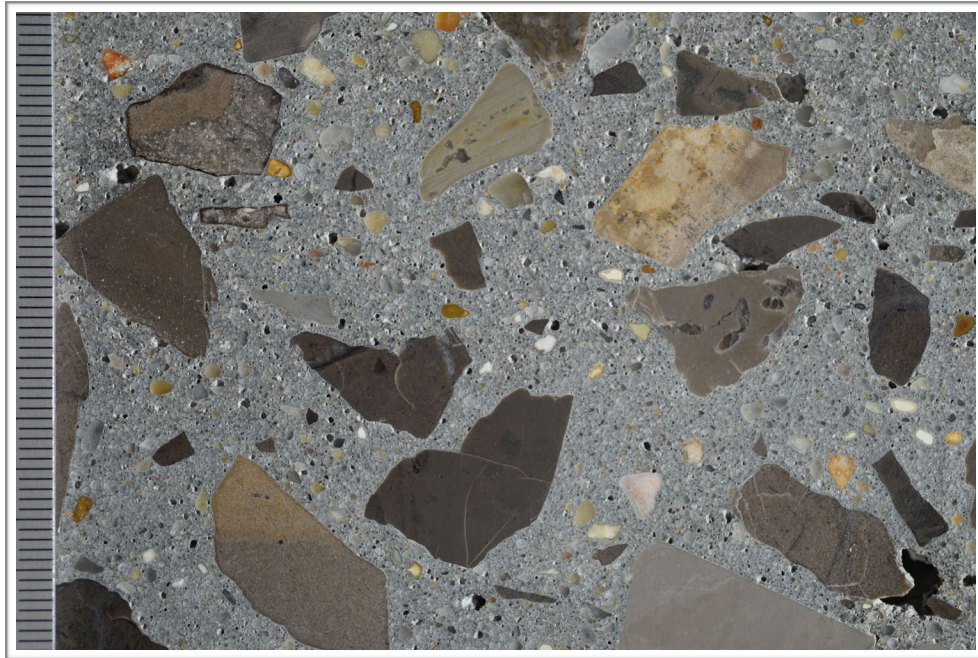
5. COARSE AGGREGATE	
PHYSICAL PROPERTIES	Crushed quarry rock with 38 mm (1 1/2 in.) nominal top size (Figure E6). The rocks are hard and competent. The particles are sub-equant to tabular in shape with sub-angular to sub-round edges. The grading and distribution are relatively even. The sand is very fine.
ROCK TYPES*	The aggregate is carbonate in composition and consists of brown dolomitic limestone as well as tan to light brown limestones that show laminations and evidence of bioturbation as well as some oolitic limestones.
OTHER FEATURES	No deleterious coatings or incrustations observed. A few minor low w/c mortar coatings observed. Occasional particles show internal cracking and microcracking; these do not propagate into the paste.

Figure E6. Photograph of the polished surface showing coarse aggregate; scale in millimeters.

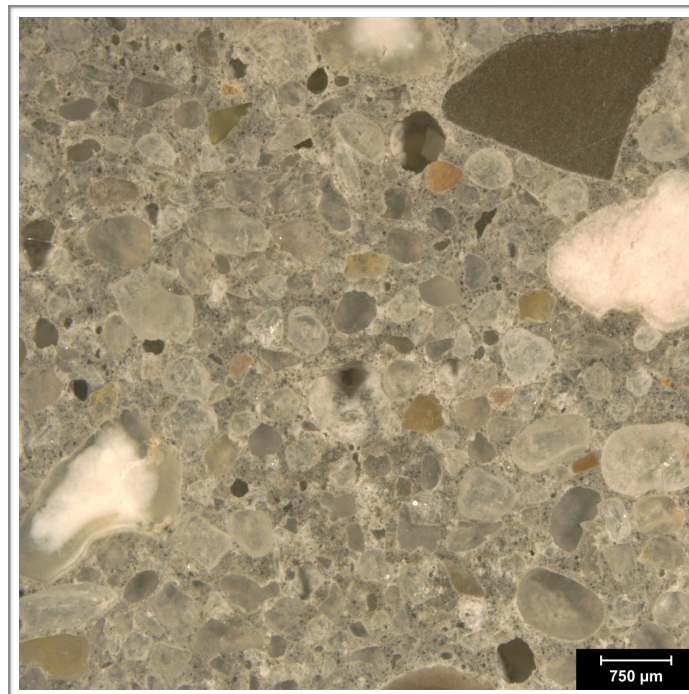
PHYSICAL PROPERTIES	Natural sand consists of rocks that are hard and competent (Figure E7). The particles are sub-equant to tabular in shape with sub-round to sub-angular edges. The grading and distribution are relatively even.
ROCK TYPES	The sand is siliceous in composition and consists primarily of quartz and quartzite with minor amounts of granitic rocks and chert.
OTHER FEATURES	No deleterious coatings or incrustations observed and no low w/c mortar coatings observed. Particles of chert typically show reaction rims but no microcracking or deposits of gel are associated with them.

Figure E7. Reflected light photomicrograph of polished surface showing the fine aggregate.

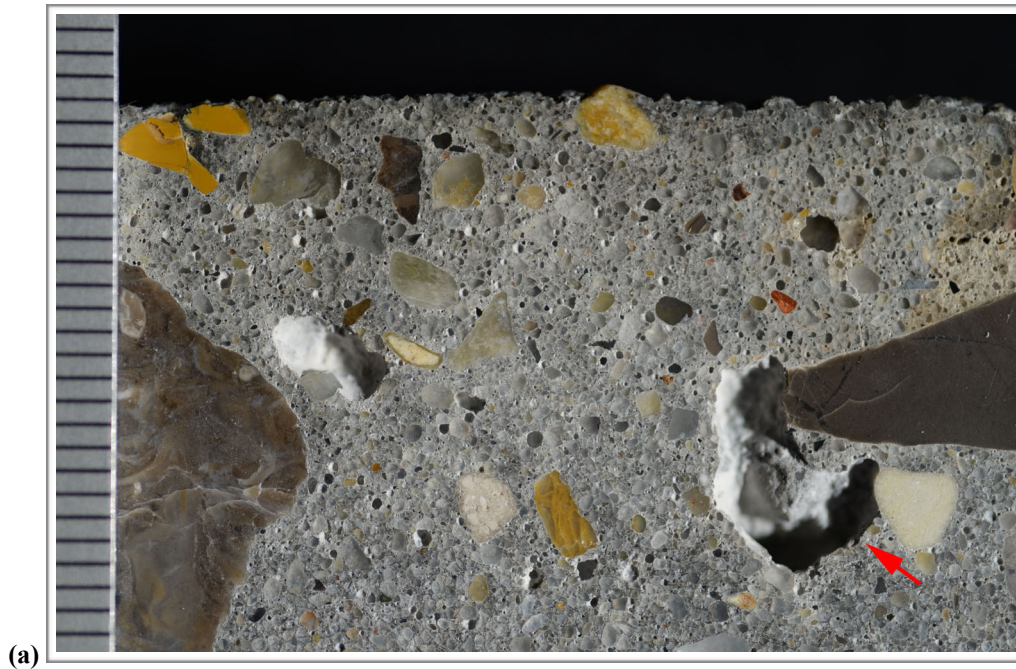
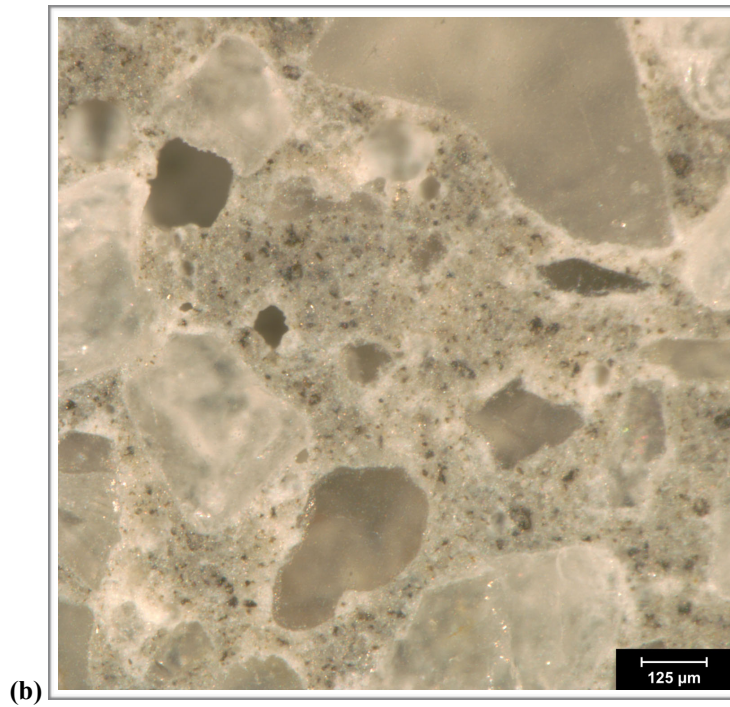
POLISHED SURFACE	Paste is gray (Munsell 2.5Y/6/1) to dark gray (2.5Y/4/1), has a smooth texture and sub-vitreous luster (Figure E8). The paste is hard (Mohs 3.5-4). The paste is dark gray for up to 3 mm ($\frac{1}{8}$ in.) from the top of the core.
FRESH FRACTURE	Fracture surface is light gray, has a hackly texture and a sub-vitreous luster. The fracture cuts primarily through aggregate particles (Figure E9). No significant secondary deposits were observed though minor deposits of ettringite commonly line voids.
THIN SECTION*	The paste contains hydrated portland cement; no fly ash, slag cement or other SCM were observed. The hydration is normal with 10-7% RRCG that consist mostly of interstitial ferrite and aluminate with occasional grains of belite (Figure E10). CH makes up 12-20% of the paste, is medium to coarse-grained and distributed somewhat unevenly.

Figure E8. (a) Photograph of polished surface showing overview of paste at the top of the core. The scale is in millimeters; the red arrows indicates a water void. (b) Reflected light photomicrograph showing detail of paste color, texture and luster in the middle of the core.

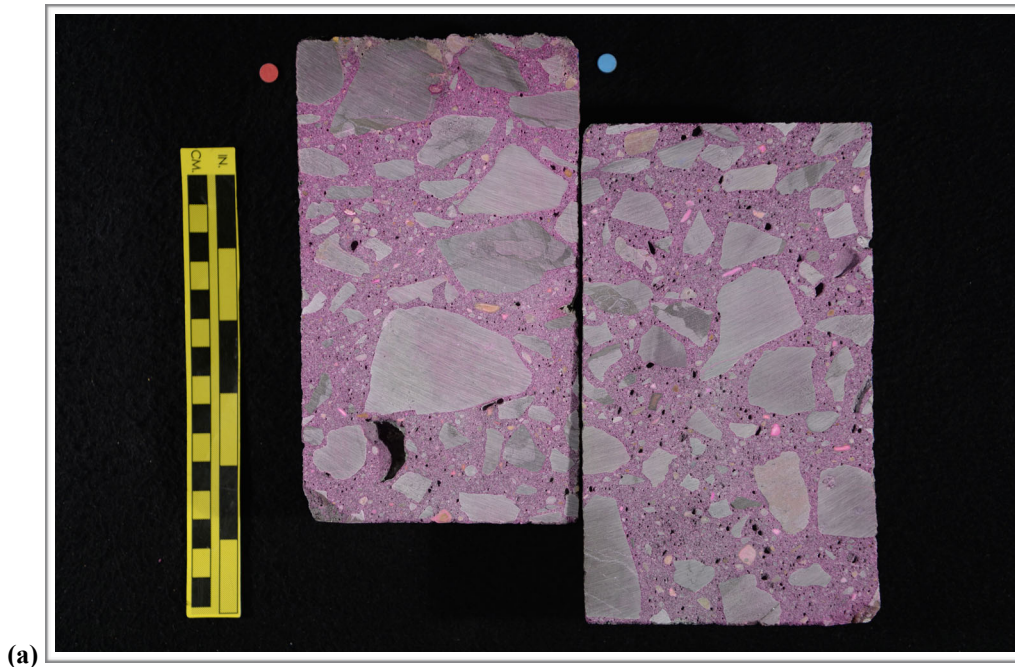
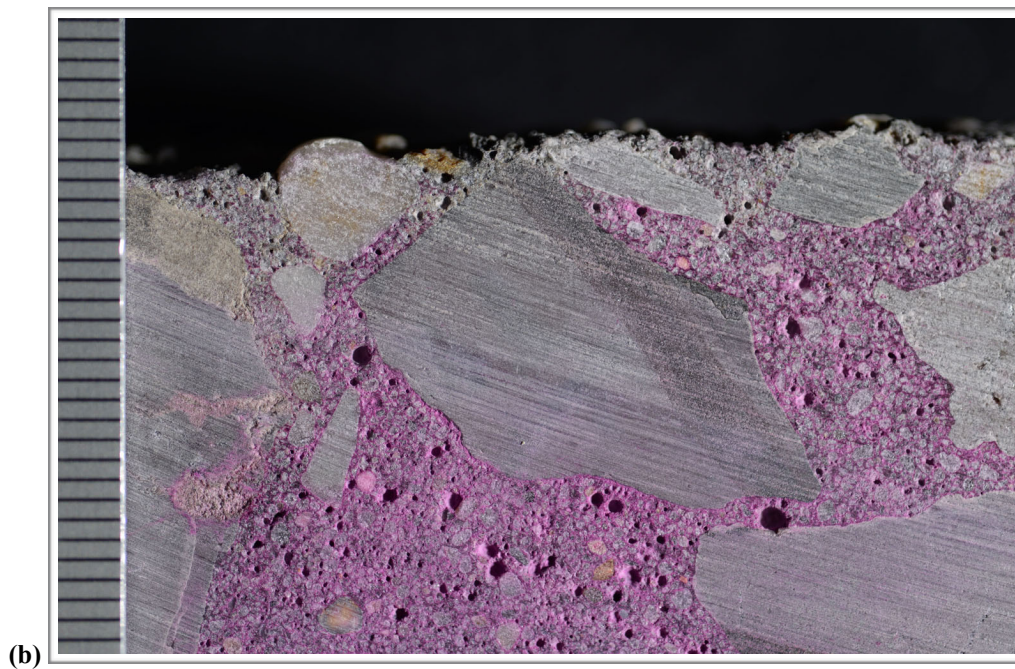
PHENOLPHTHALEIN	Entire surface stains purple (Figure E11).
DEPOSITS	Minor carbonation observed at the top of the core and in irregularly distributed zones in the paste in thin section. Minor deposits of ettringite observed commonly in voids. No deposits of gel observed.

Figure E11. Photographs showing (a) overview of phenolphthalein stained surface and (b) detail of surface near the top of the core. Scale in millimeters in (b).
