Technical Assistance Report 15-01TA-C

**Evaluation of Cores from I-10 between
Acadian Thruway and College Drive**

Petrographic Investigation of Concrete Cores From Cracked Pavement Slabs Located on Interstate 10 in Baton Rouge, Louisiana

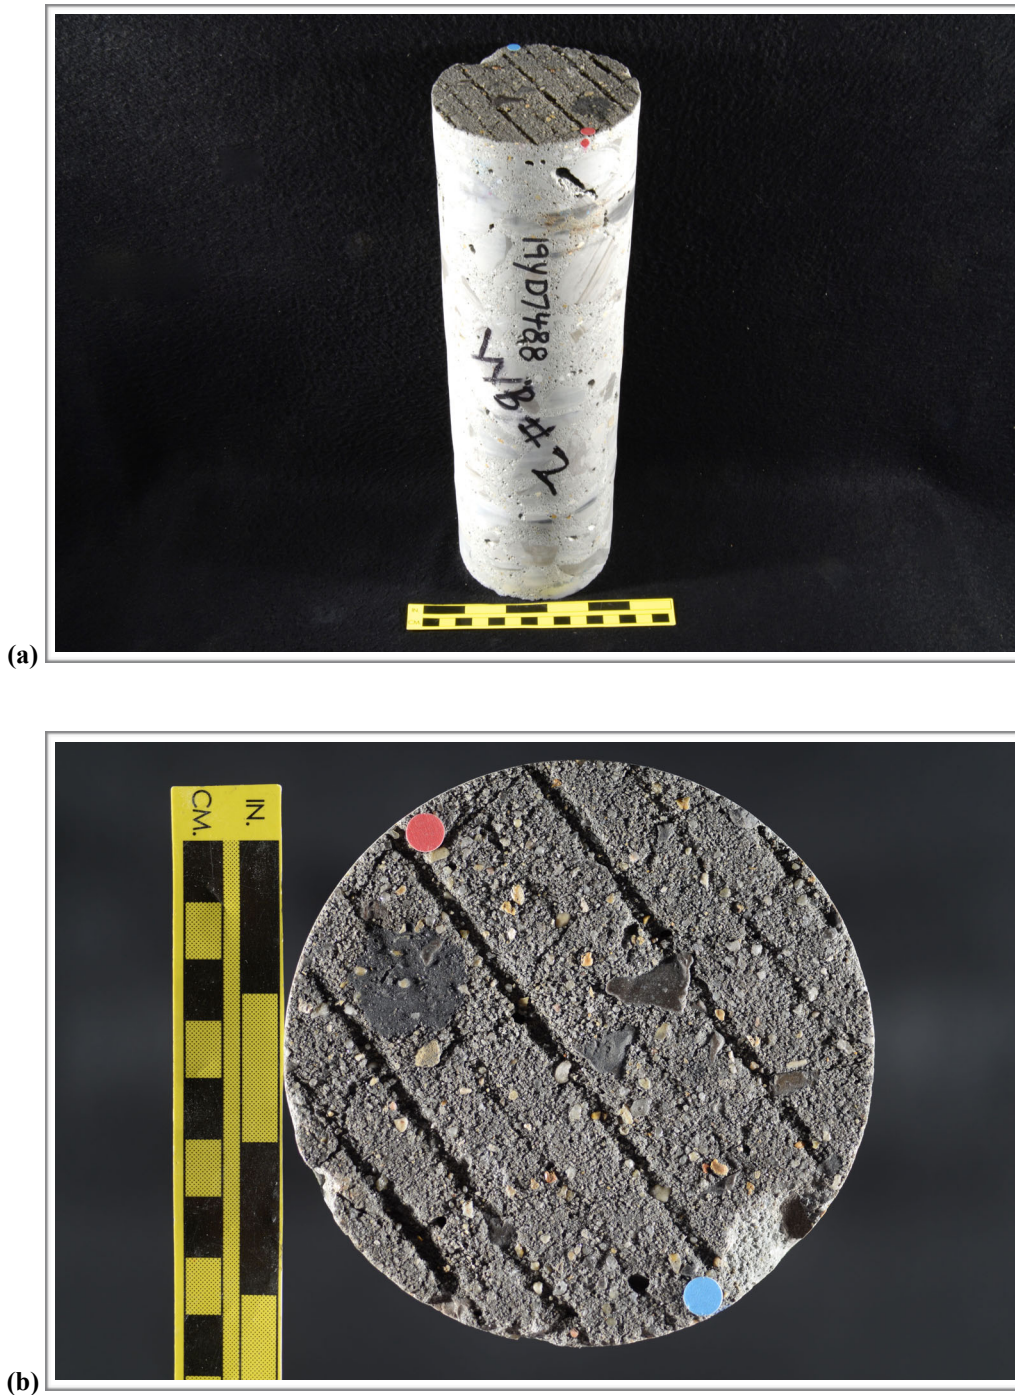
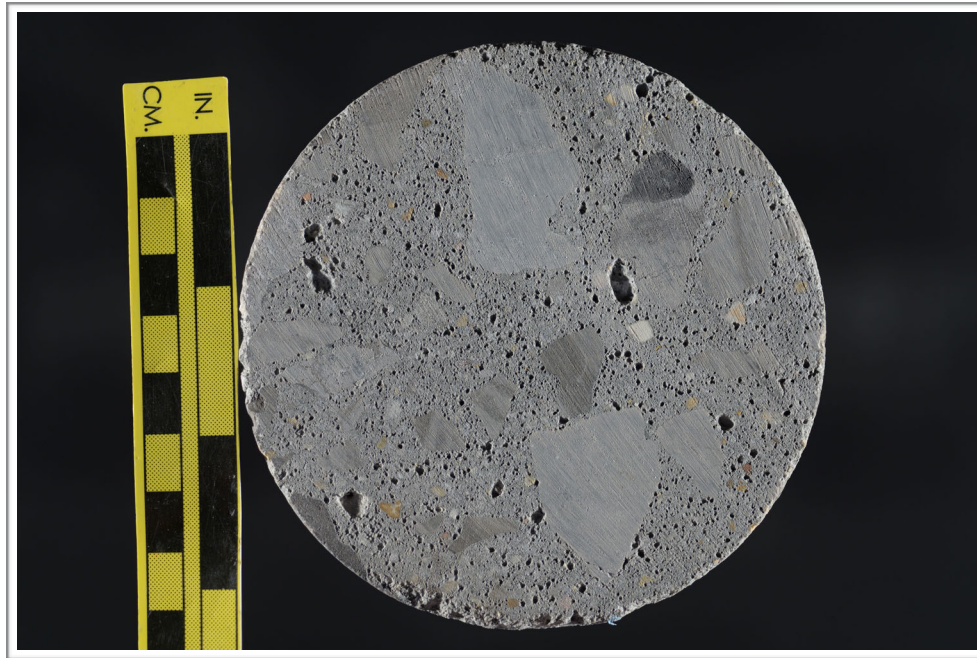
1. RECEIVED CONDITION	
ORIENTATION	Vertical core taken through highway pavement slab measures 100 mm (~ 4 in.) in diameter and 325 mm (~ 13 in.) long (Figure F1, F2).
SURFACES	The top surface shows minor wear; the tines are largely intact and a few coarse aggregate particles are exposed and worn smooth (Figure F3). The bottom surface is a saw cut such that the core represents a partial thickness of the pavement slab.
GENERAL CONDITION	The concrete is hard and compact and rings lightly when sounded with a hammer. The core was received intact in one piece.

Figure F1. Photographs showing (a) oblique view of the top and side of the core with identification labels and (b) the top of the core. The red and blue dots in (a) show the orientation of the saw cuts used to prepare the sample.

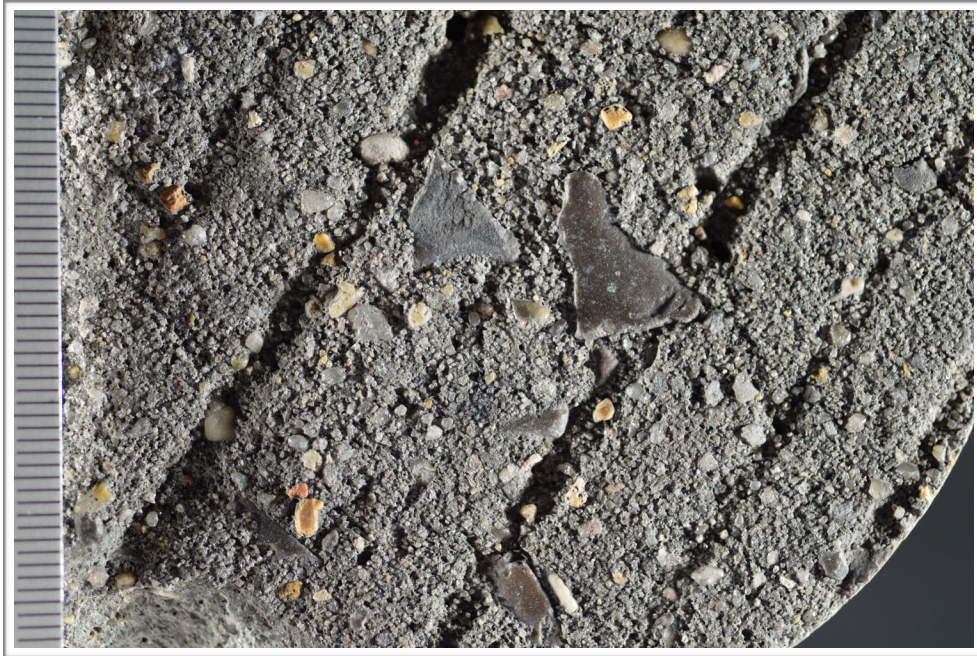
Figure F3. Photograph showing detail of the top surface of the core; scale in millimeters.

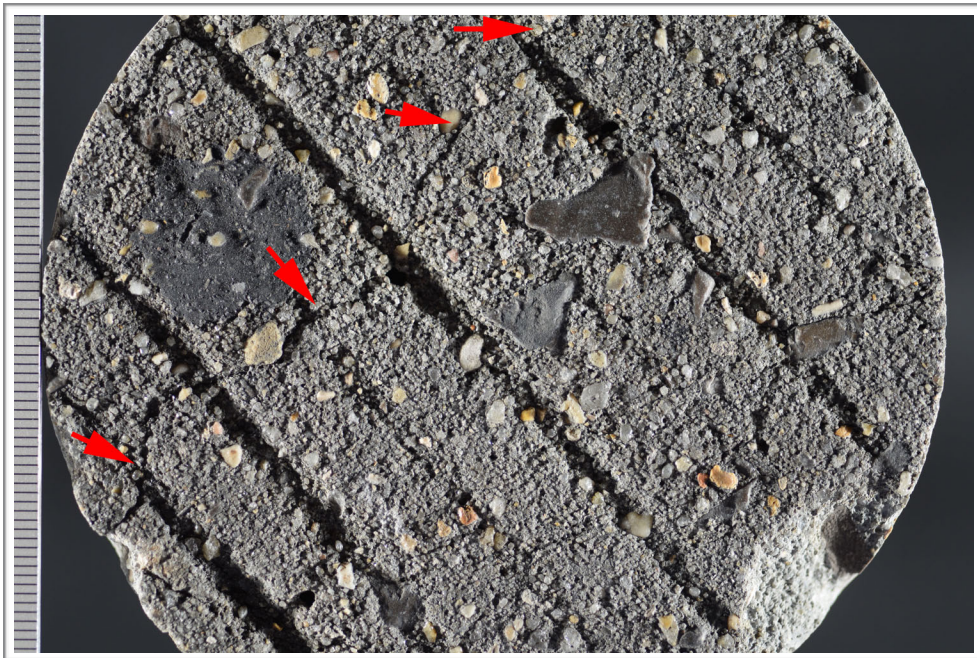
3. CRACKING	
MACROSCOPIC	Linear crack cuts 90 mm (3 ½ in.) across the top of the core; the crack is 250 µm (10 mil) wide and was not observed cutting to a significant depth on the polished surface (Figure F4). Minor internal hairline cracks observed in coarse aggregate particles. These do not propagate into the paste.
MICROSCOPIC	A microcrack that is ~ 75 µm (3 mil) wide cuts sub-vertically from the top surface to ~ 3 mm (3/8 in.); the microcrack is free of secondary deposits and cuts around aggregate particles (Figure F5). No other microcracking was observed.

Figure F4. Photographs showing crack (red arrows) on the top surface; scale in millimeters.

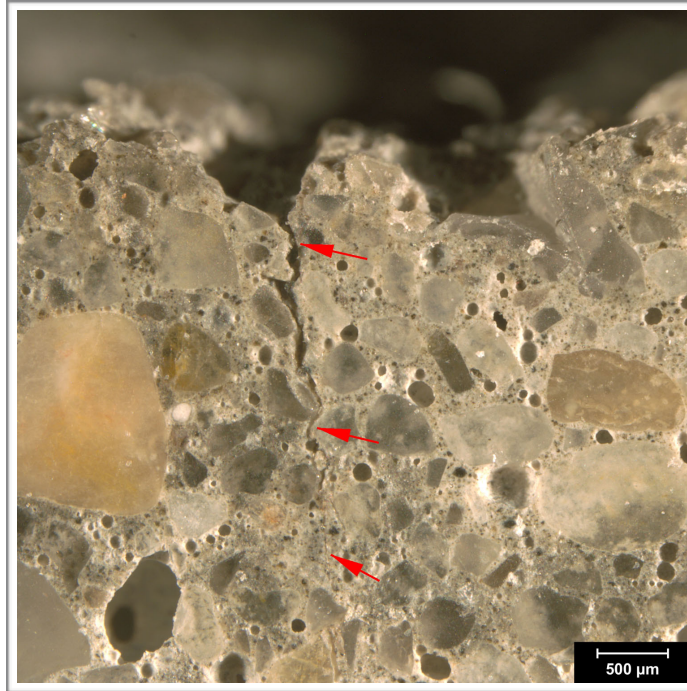
Figure F5. Reflected light photomicrograph of the polished surface showing microcrack (red arrows) at the top of the core.

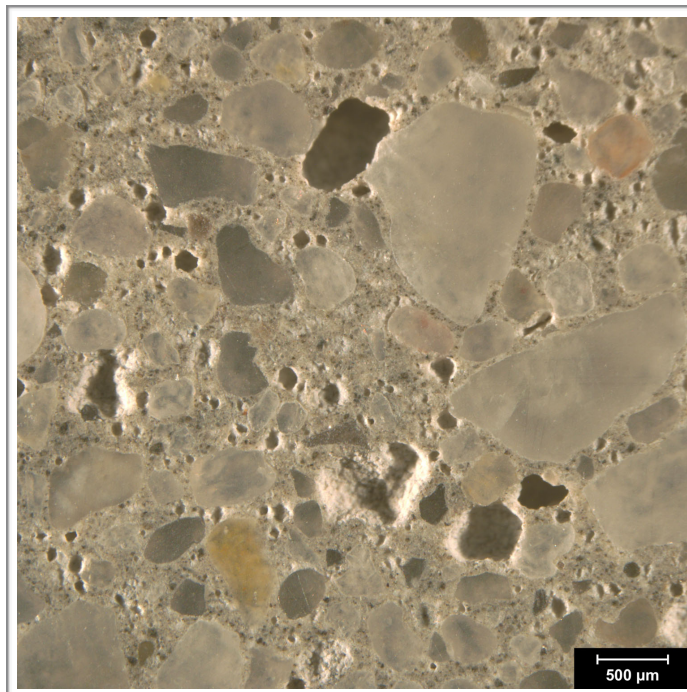
4. VOIDS	
VOID SYSTEM	Concrete is air-entrained (Figure F6) and contains 4-6% air by visual estimation (not determined following ASTM C457). The core is moderately consolidated with several larger water voids and entrapped voids that measure up to 12.5 mm (½ in.) across observed (Figure F7).
VOID FILLINGS	Voids commonly contain minor deposits of ettringite.

Figure F6. Reflected light photomicrograph of the polished surface showing entrained air voids (dark circles).

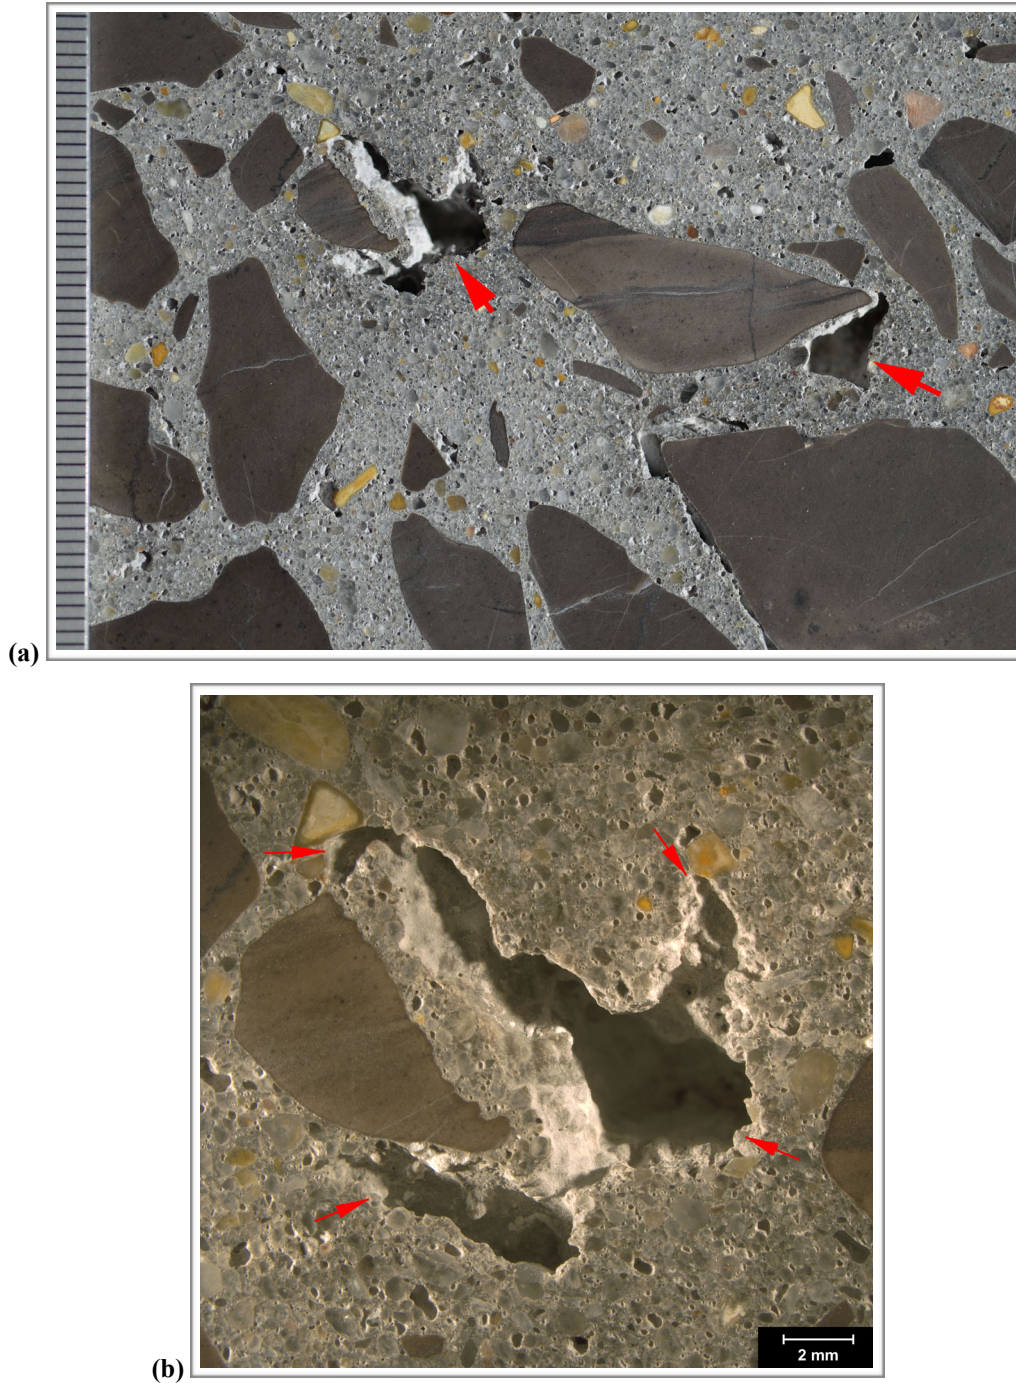
Figure F7. (a) Photograph and (b) reflected light photomicrograph of the polished surface showing overview and detail, respectively, of large entrapped voids about 50 mm (2 in.) below the polished surface.

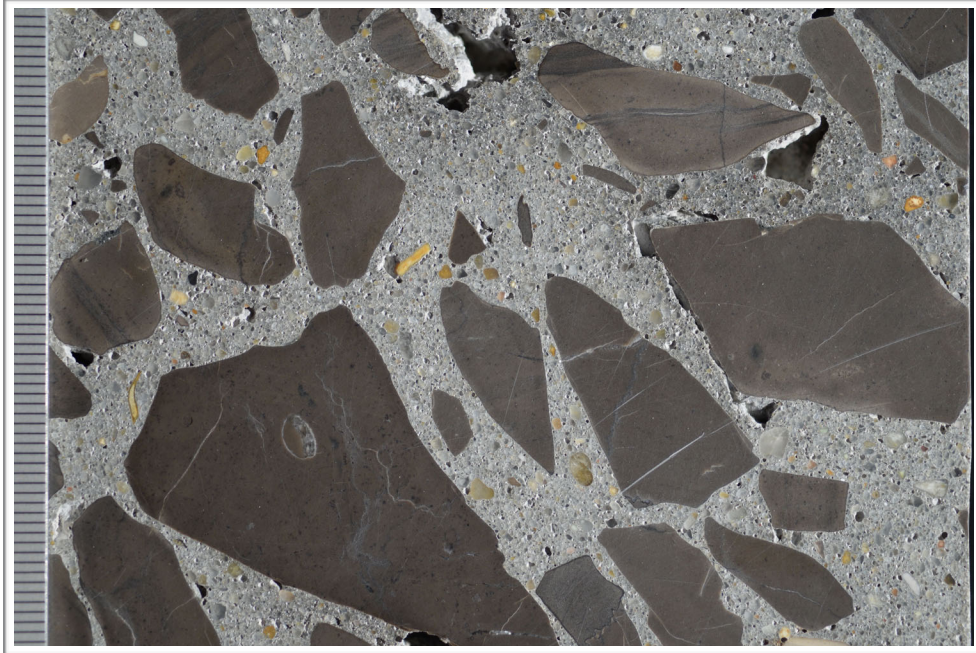
5. COARSE AGGREGATE	
PHYSICAL PROPERTIES	Crushed quarry rock with 38 mm (1 ½ in.) nominal top size (Figure F8). The rocks are hard and competent. The particles are sub-equant to tabular in shape with sub-angular to sub-round edges. The grading and distribution are relatively even. The sand is very fine.
ROCK TYPES*	The aggregate is carbonate in composition and consists of brown dolomitic limestone as well as tan to light brown limestones that show laminations and evidence of bioturbation as well as some oolitic limestones.
OTHER FEATURES	No deleterious coatings or incrustations observed. A few minor low w/c mortar coatings observed. Occasional particles show internal cracking and microcracking; these do not propagate into the paste.

Figure F8. Photograph of the polished surface showing coarse aggregate; scale in millimeters.

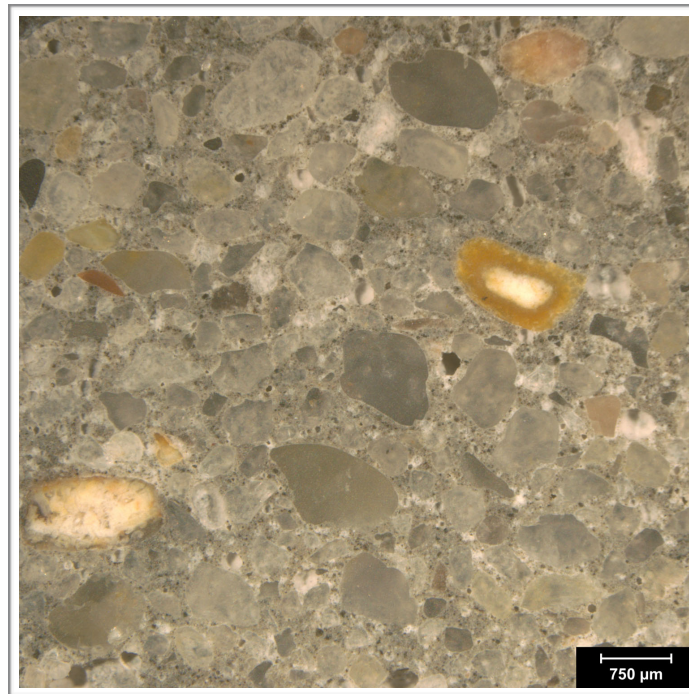
PHYSICAL PROPERTIES	Natural sand consists of rocks that are hard and competent (Figure F9). The particles are sub-equant to tabular in shape with sub-round to sub-angular edges. The grading and distribution are relatively even.
ROCK TYPES	The sand is siliceous in composition and consists primarily of quartz and quartzite with minor amounts of granitic rocks and chert.
OTHER FEATURES	No deleterious coatings or incrustations observed and no low w/c mortar coatings observed. Particles of chert typically show reaction rims but no microcracking or deposits of gel are associated with them.

Figure F9. Reflected light photomicrograph of polished surface showing the fine aggregate.

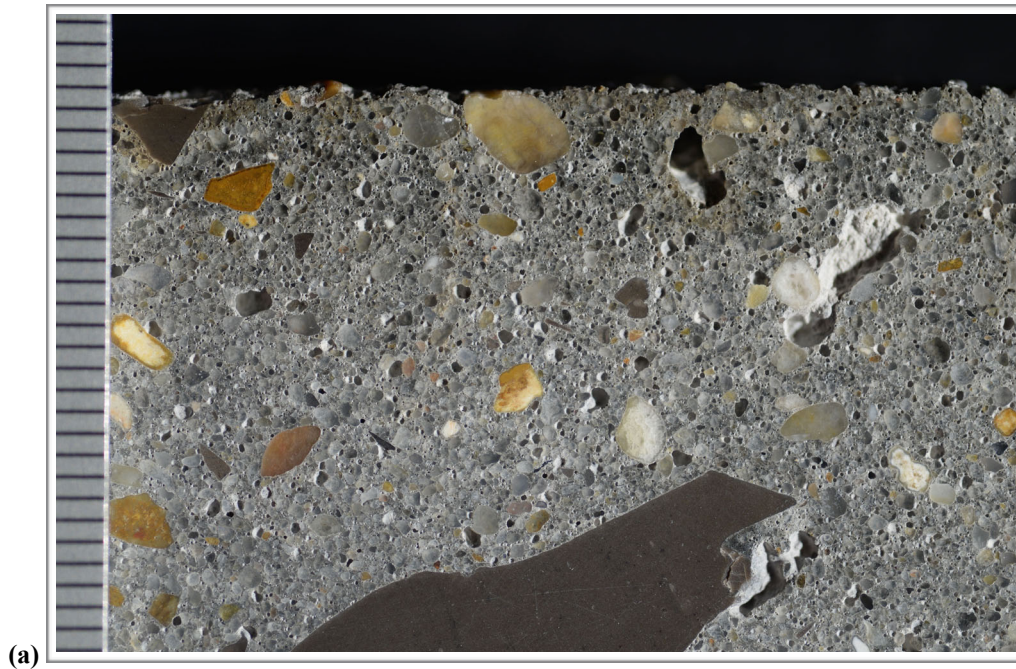
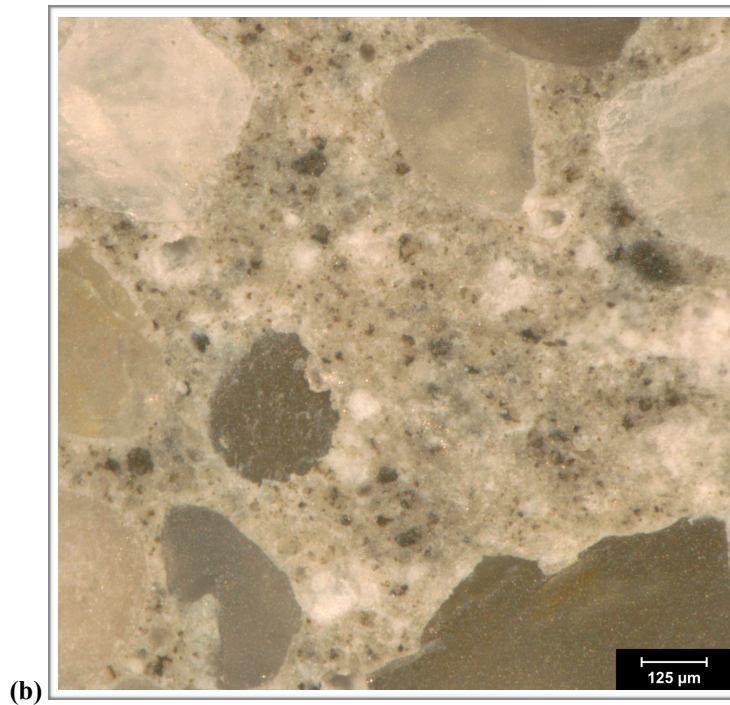
POLISHED SURFACE	Paste is gray (Munsell 2.5Y/6/1) to dark gray (2.5Y/4/1), has a smooth texture and sub-vitreous luster (Figure F10). The paste is hard (Mohs 3.5-4). The paste is dark gray for up to 3 mm ($\frac{1}{8}$ in.) from the top of the core.
FRESH FRACTURE	Fracture surface is light gray, has a hackly texture and a sub-vitreous luster. The fracture cuts primarily through aggregate particles (Figure F11). No significant secondary deposits were observed though minor deposits of ettringite commonly line voids.
THIN SECTION*	The paste contains hydrated portland cement; no fly ash, slag cement or other SCM were observed. The hydration is normal with 4-8% RRCG that consist mostly of interstitial ferrite and aluminate with occasional grains of belite (Figure F12). CH makes up 10-17% of the paste, is fine to medium-grained and evenly distributed.

Figure F10. (a) Photograph of polished surface showing overview of paste at the top of the core. The scale is in millimeters; the red arrows indicate the hairline crack that cut across the top surface. (b) Reflected light photomicrograph showing detail of paste color, texture and luster in the middle of the core.

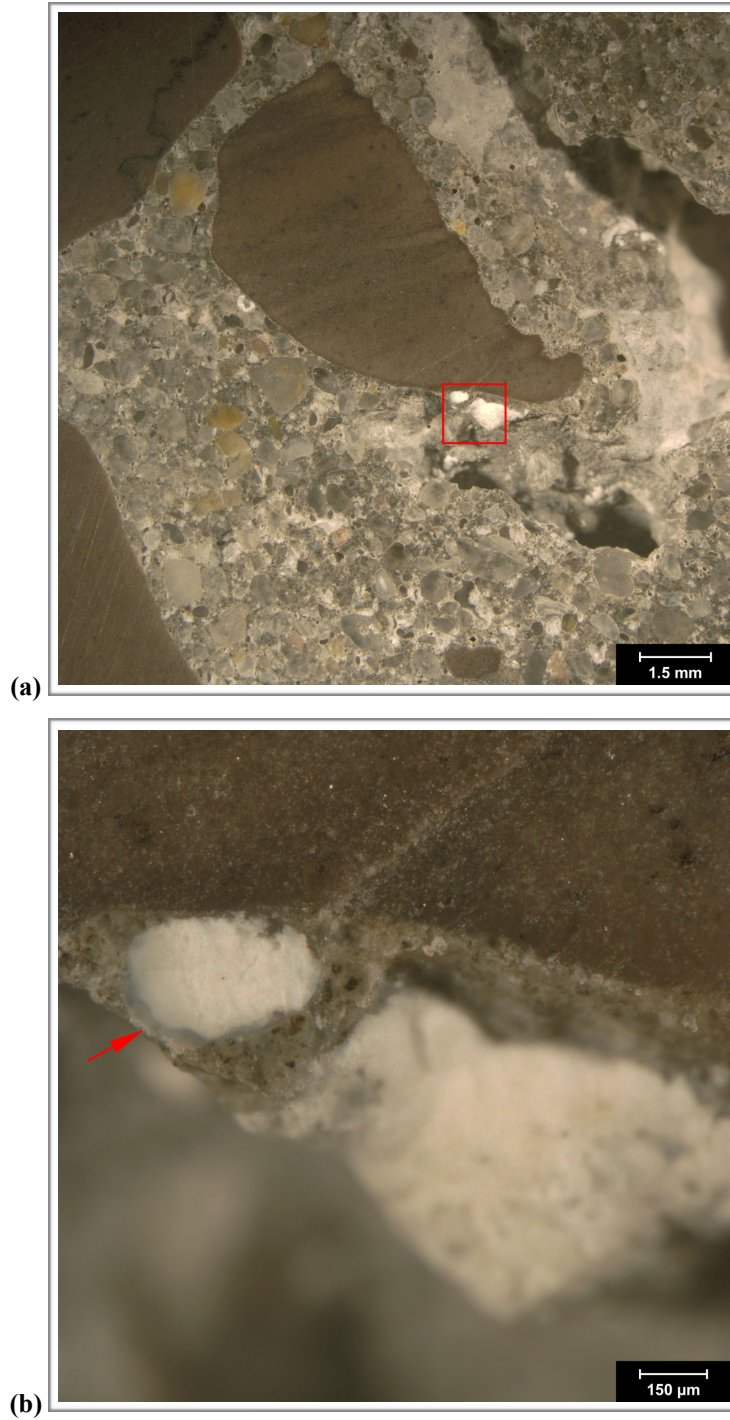
PHENOLPHTHALEIN	Entire surface stains purple (Figure F13).
DEPOSITS	Minor carbonation observed at the top of the core and in irregularly distributed zones in the paste in thin section. Minor deposits of ettringite observed commonly in voids. Deposits of gel observed in minor amounts in rare voids (Figure F14-Figure F17). No microcracking observed in association with ASR.

Figure F14. Reflected light photomicrographs of the polished surface showing a void filled with secondary deposits (red arrow in (b) about 50 mm (2 in.) below the top surface. The red square in (a) shows the approximate are of (b).

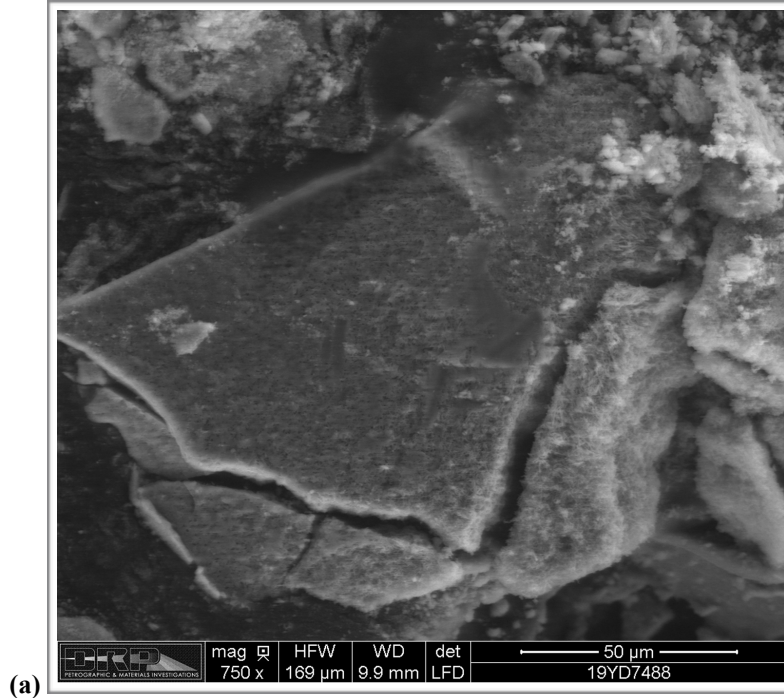
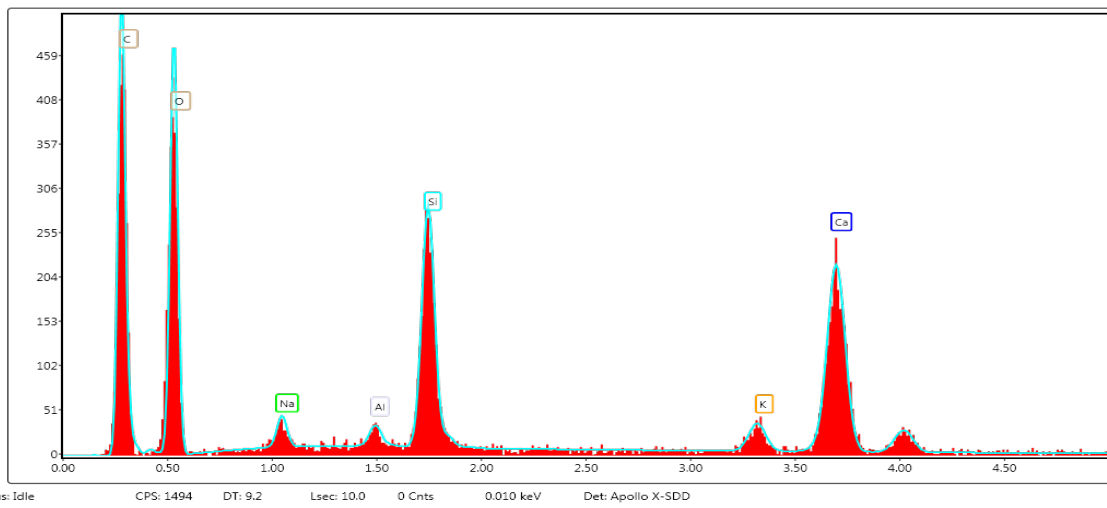
Figure F15. (a) Backscatter electron micrograph of gel deposits scraped from void shown in F12(b) and placed on carbon tape. (b) EDS spectrum of deposit indicating composition typical of ASR gel.

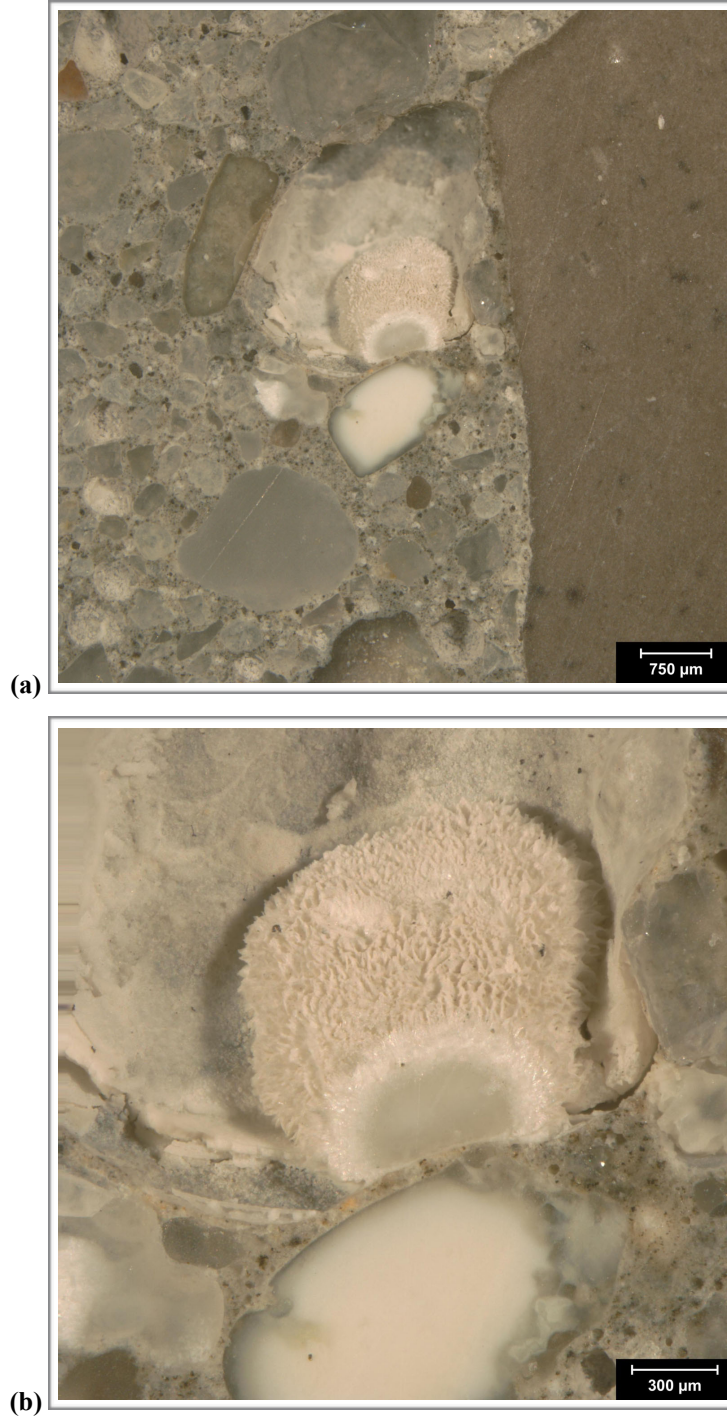
Figure F16. Reflected light photomicrographs of the polished surface showing a void filled with secondary deposits about 195 mm (7 3/4 in.) below the top surface.

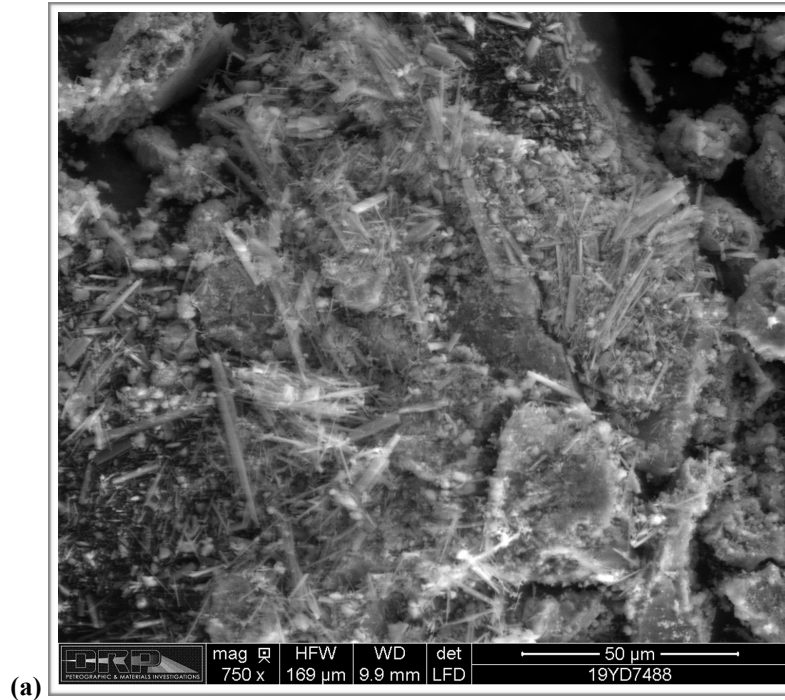
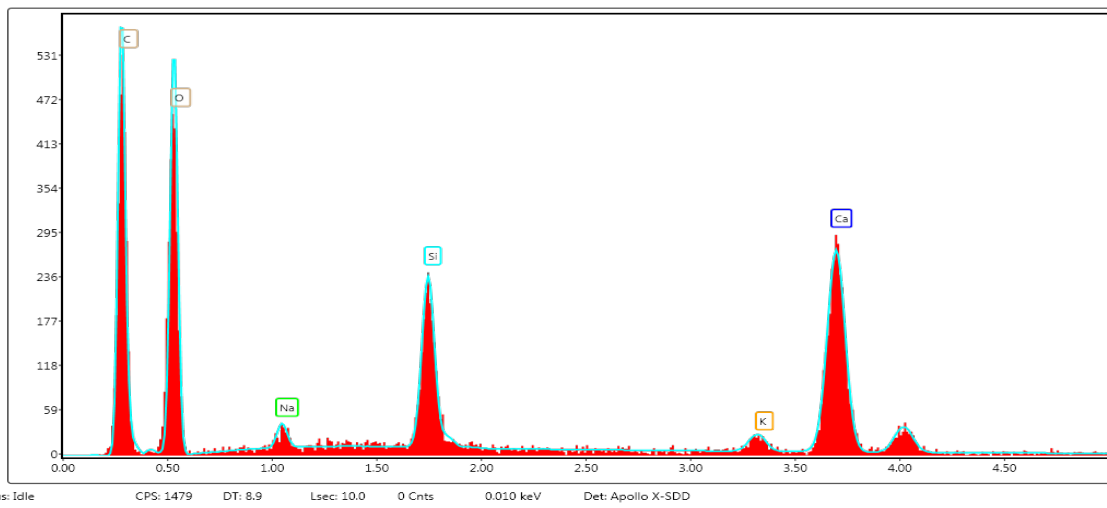
Figure F17. (a) Backscatter electron micrograph of gel deposits scraped from void shown in F14(b) and placed on carbon tape. (b) EDS spectrum of deposit indicating composition typical of ASR gel.

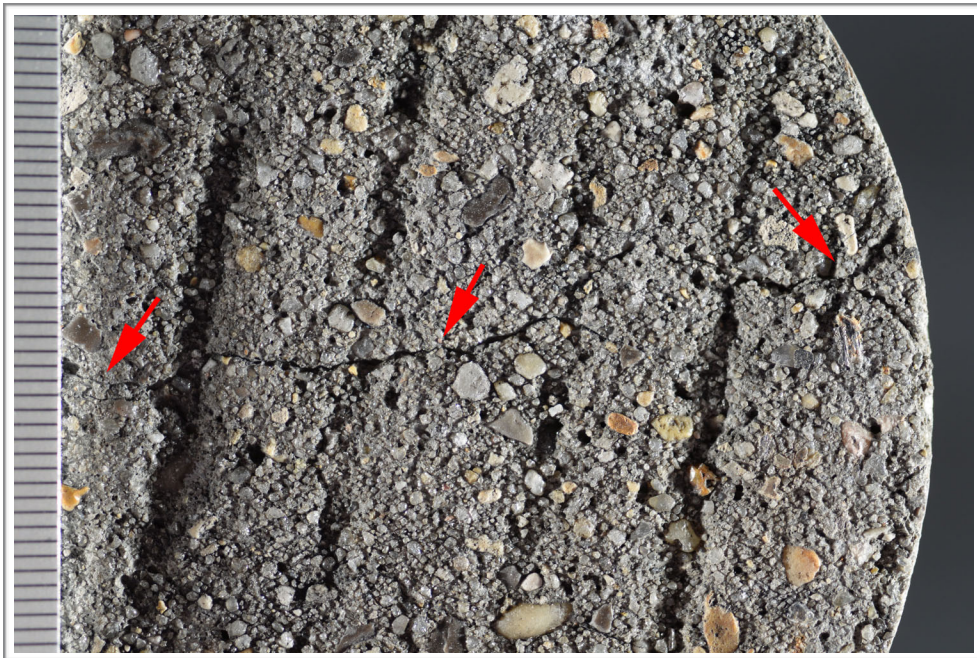
3. CRACKING	
MACROSCOPIC	Linear crack that is up to 500 µm (20 mil) wide cuts 100 mm (4 in.) across the top of the core and cuts sub-vertically ~15 mm (5/8 in.) down the side of the core (Figure G4). On the polished surface the crack cuts around aggregates to ~ 19 mm (3/4 in.) below the top surface (Figure G5). Minor internal hairline cracks observed in coarse aggregate particles. These do not propagate into the paste. No other cracks were observed.
MICROSCOPIC	No significant microcracks observed.

Figure G4. Photographs showing crack (red arrows) on the top surface; scale in millimeters.

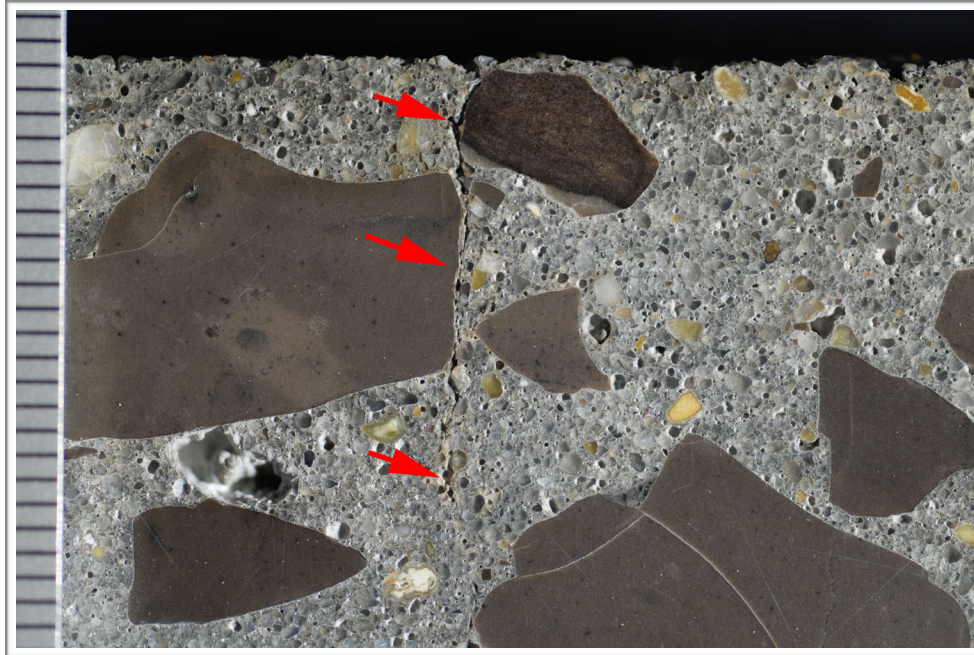
Figure G5. Reflected light photomicrograph of the polished surface showing microcrack (red arrows) at the top of the core.

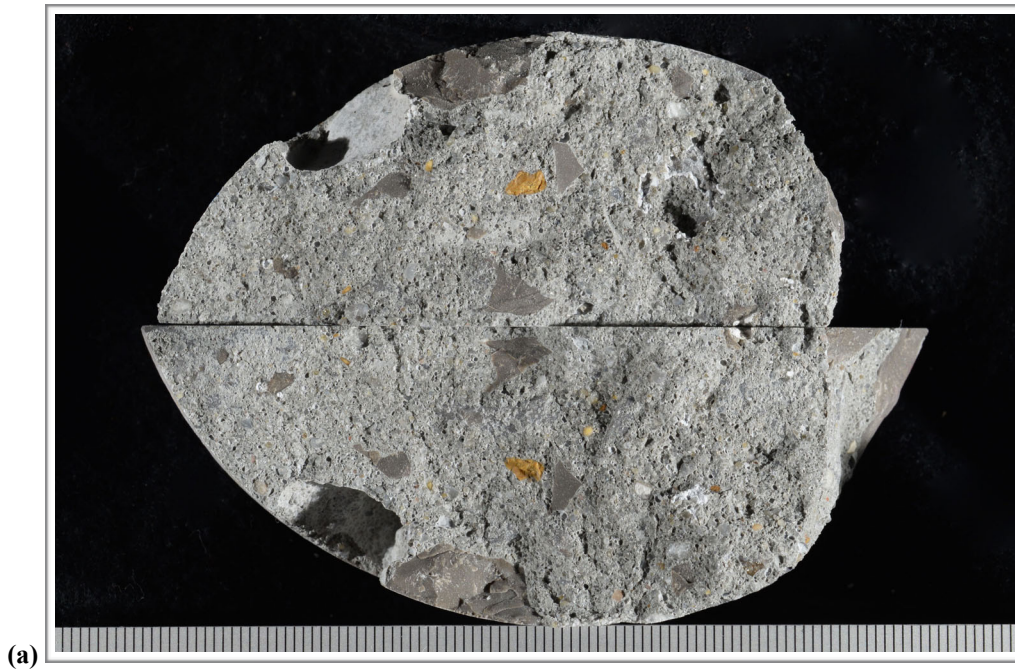
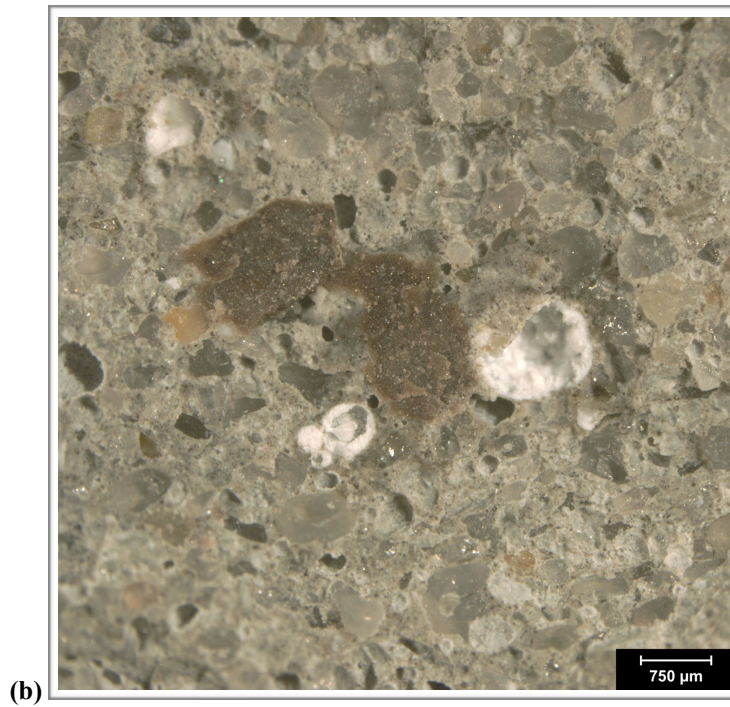
Figure G10. (a) Photograph and (b) reflected light photomicrograph of the fresh fracture surface. The scale in (a) is in millimeters. The white deposits in voids consist of ASR gel.

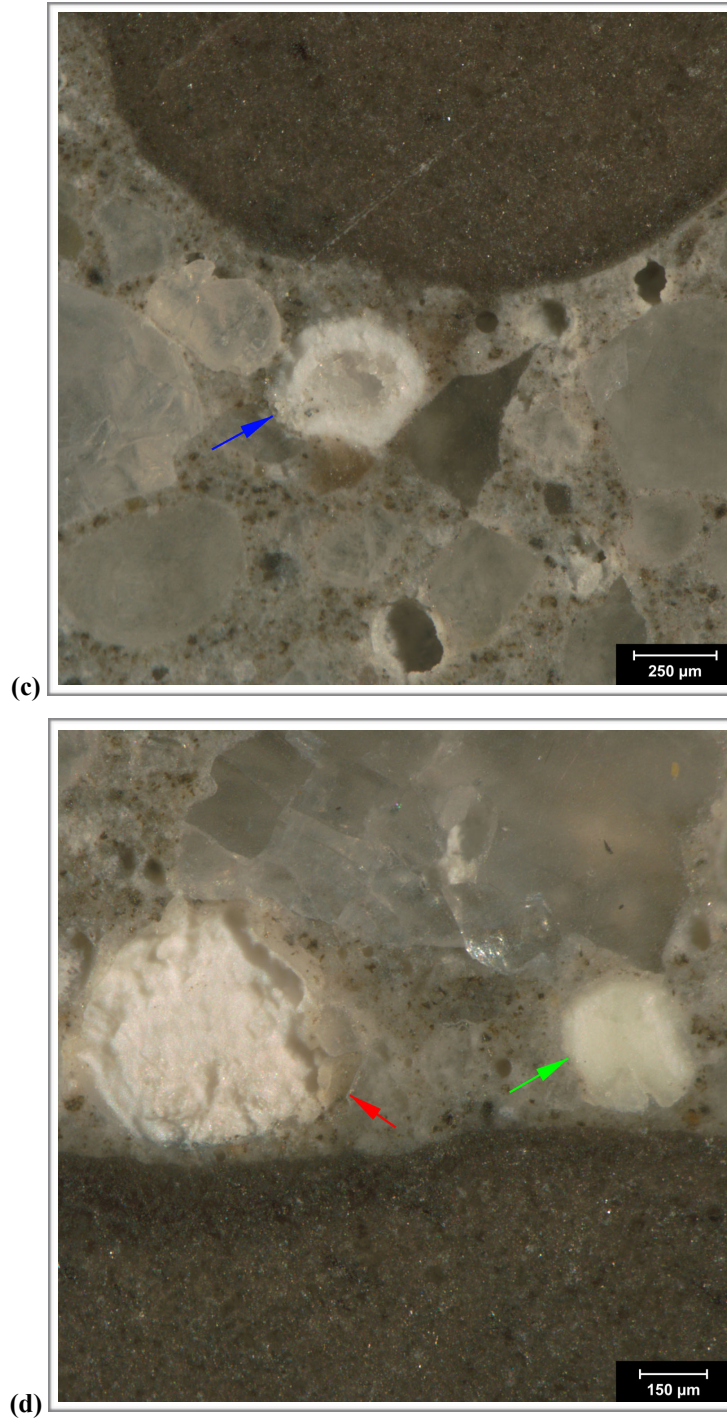
PHENOLPHTHALEIN	Entire surface stains purple (Figure G12).
DEPOSITS	Minor carbonation observed at the top of the core and in irregularly distributed zones in the paste in thin section. Minor deposits of ettringite observed commonly in voids. Deposits of gel observed in minor amounts in rare voids (Figure G13, Figure G14). No microcracking was observed in association with ASR.

Figure G13 (cont'd). Reflected light photomicrographs of the polished surface showing detail of voids filled with gel indicated by the blue and green arrows in (c) and (d), respectively. The red arrow in (d) indicates a void filled with ettringite.

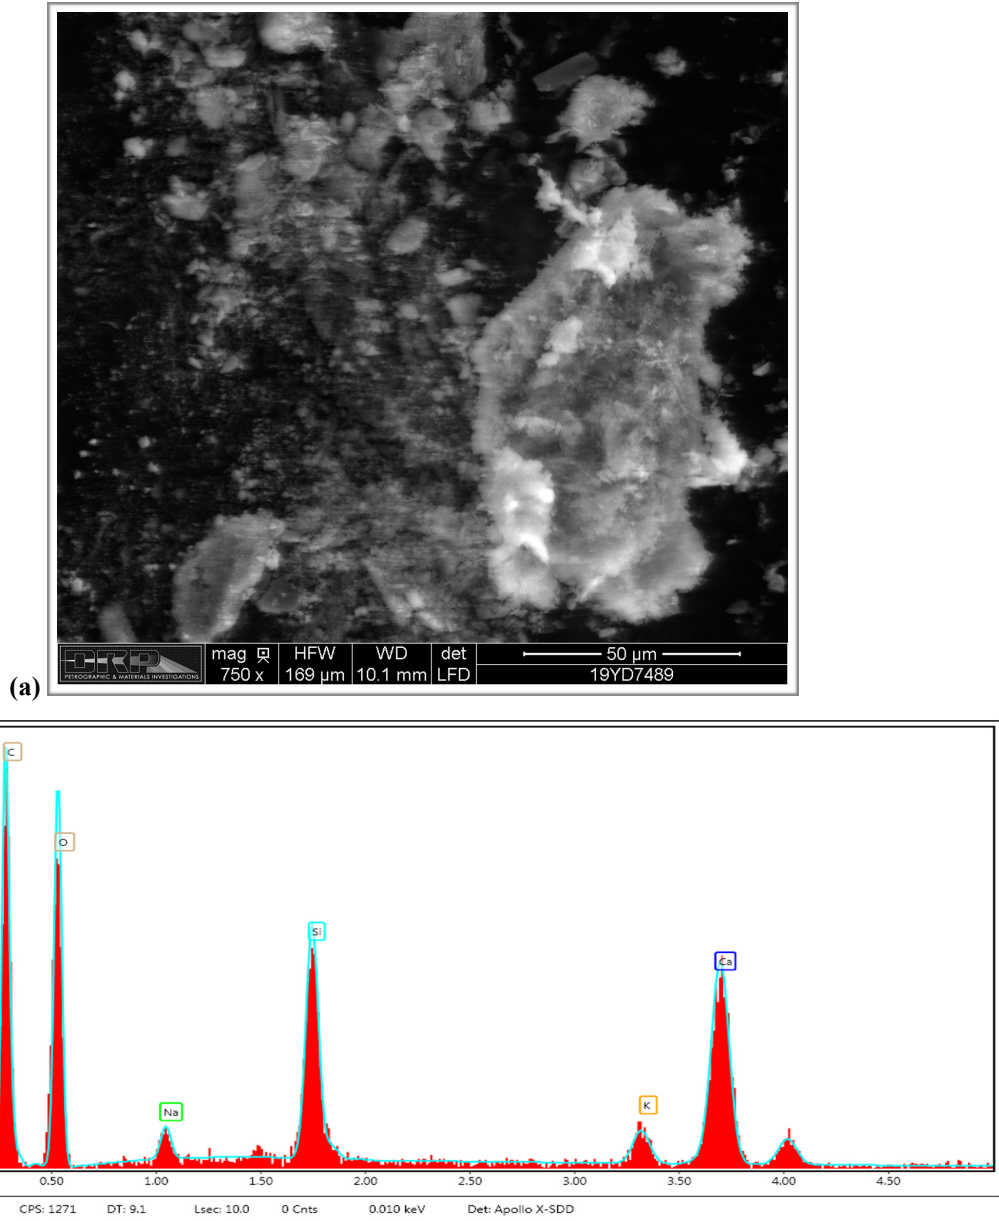
Figure G14. (a) Backscatter electron micrograph of gel deposits scraped from void shown in Figure G13(b) and placed on carbon tape. (b) EDS spectrum of deposit indicating composition typical of ASR gel.

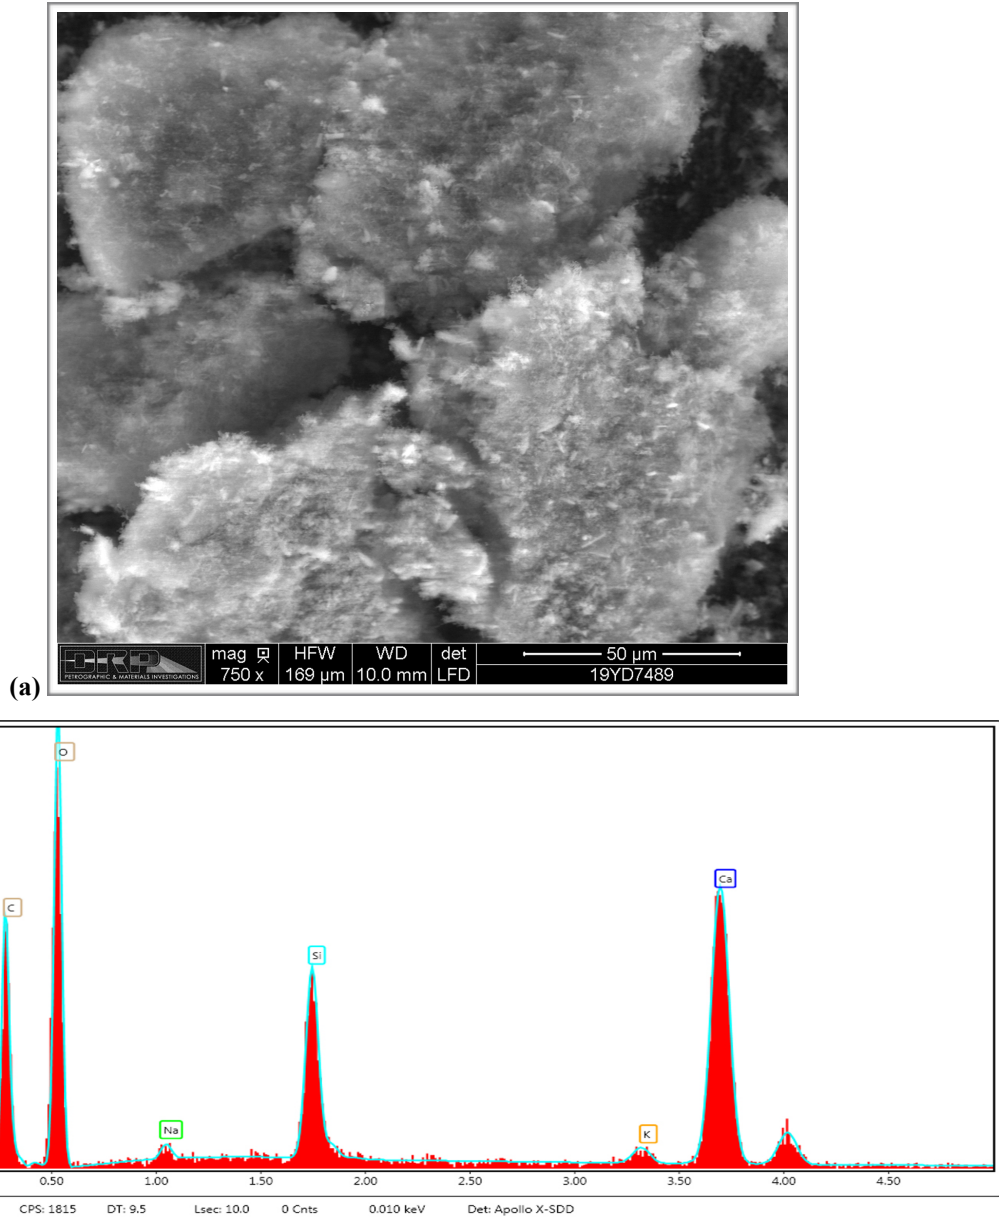
Figure G15. (a) Backscatter electron micrograph of gel deposits scraped from void on fresh fracture surface shown in G10(b) and placed on carbon tape. (b) EDS spectrum of deposit indicating composition typical of ASR gel.

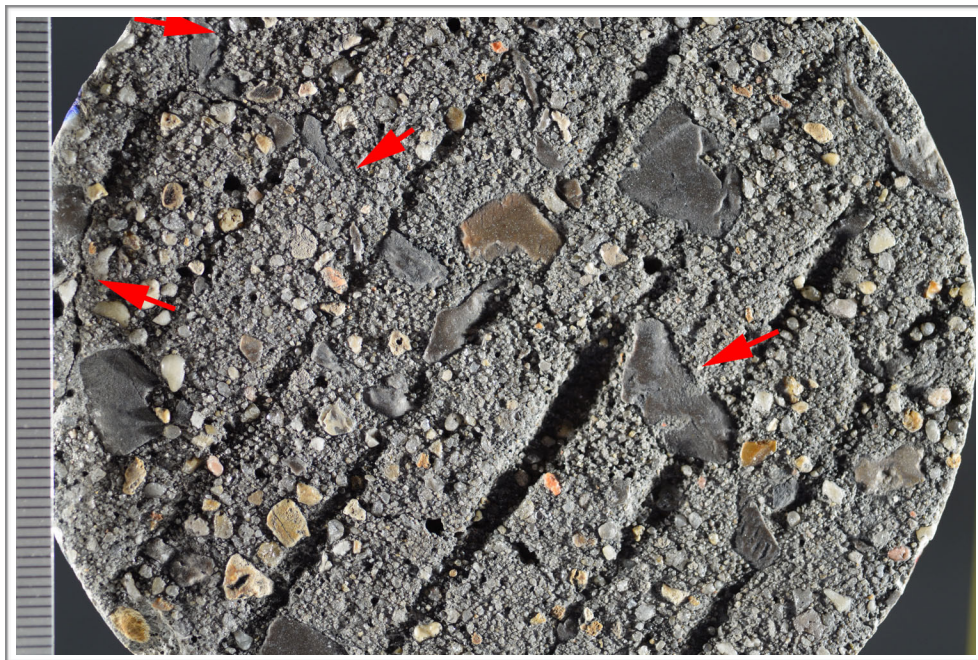
3. CRACKING	
MACROSCOPIC	A few cracks were observed on the top surface that range up to 500 µm (20 mil) wide and 70 mm (2 ¾ in.) long; these cracks form a triple point pattern (Figure H4). These cracks do not penetrate the concrete significantly. No other cracks were observed.
MICROSCOPIC	No significant microcracks observed. A couple of microcracks cut from the top surface to a depth of 1-2 mm (40-80 mil); these microcracks represent extensions of the triple point cracks described above and cut around aggregate particles and are free of secondary deposits (Figure H5).

Figure H4. Photographs showing crack (red arrows) on the top surface; scale in millimeters.

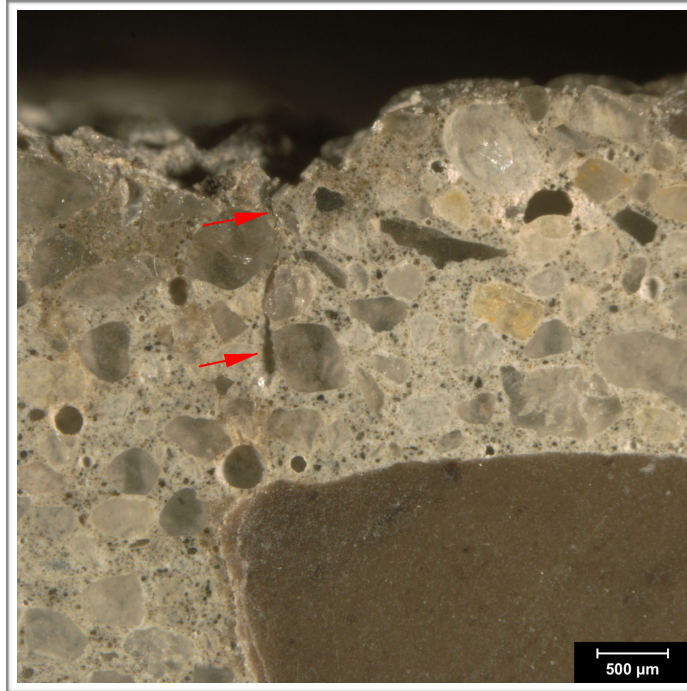
Figure H5. Reflected light photomicrograph of the polished surface showing microcrack (red arrows) at the top of the core.

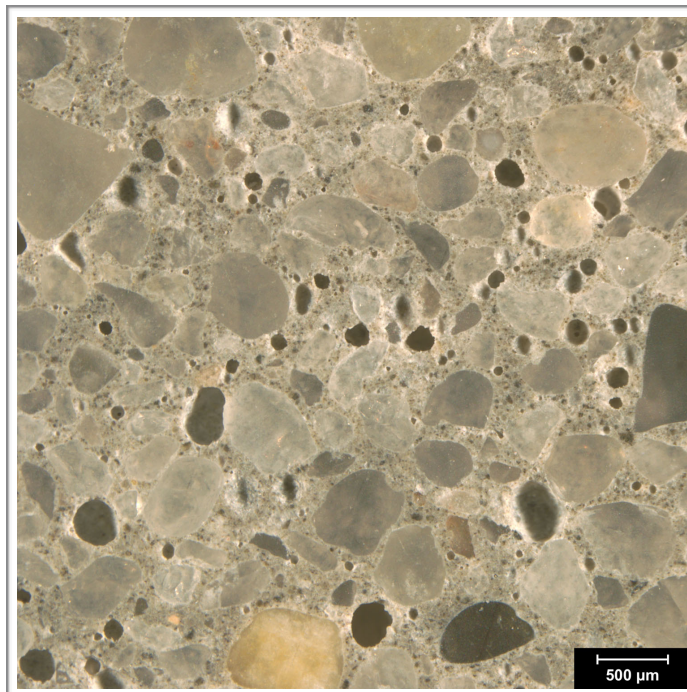
4. VOIDS	
VOID SYSTEM	Concrete is air-entrained (Figure H6) and contains 4-6% air by visual estimation (not determined following ASTM C457). The core is well consolidated with no significant entrapped voids or water voids observed.
VOID FILLINGS	Voids commonly contain minor deposits of ettringite.

Figure H6. Reflected light photomicrograph of the polished surface showing entrained air voids (dark circles).
