Technical Assistance Report 15-01TA-C

**Evaluation of Cores from I-10 between
Acadian Thruway and College Drive**

Petrographic Investigation of Concrete Cores From Cracked Pavement Slabs Located on Interstate 10 in Baton Rouge, Louisiana

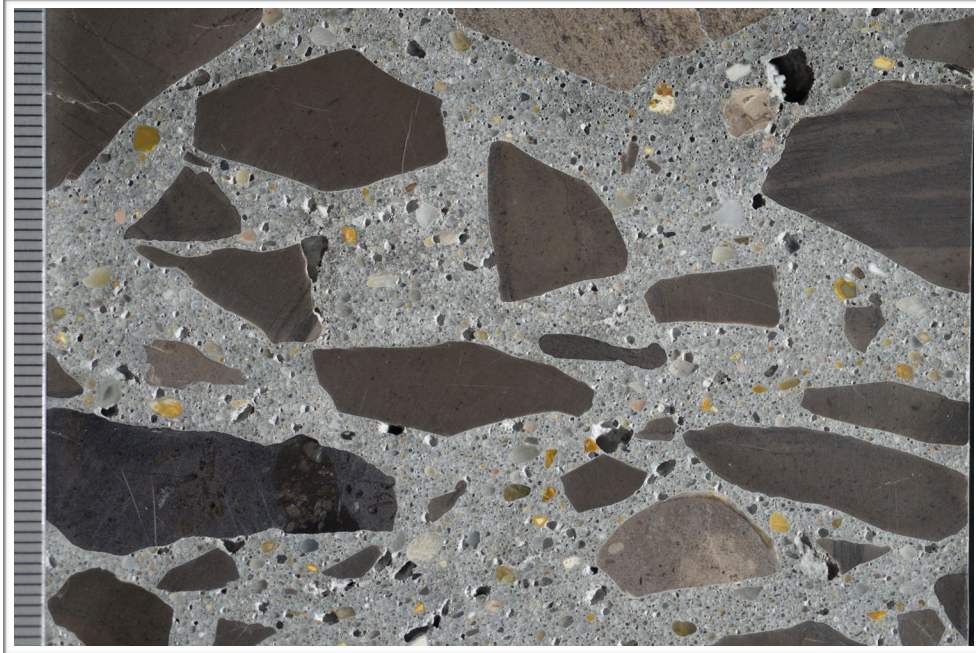
Figure H7. Photograph of the polished surface showing coarse aggregate; scale in millimeters.

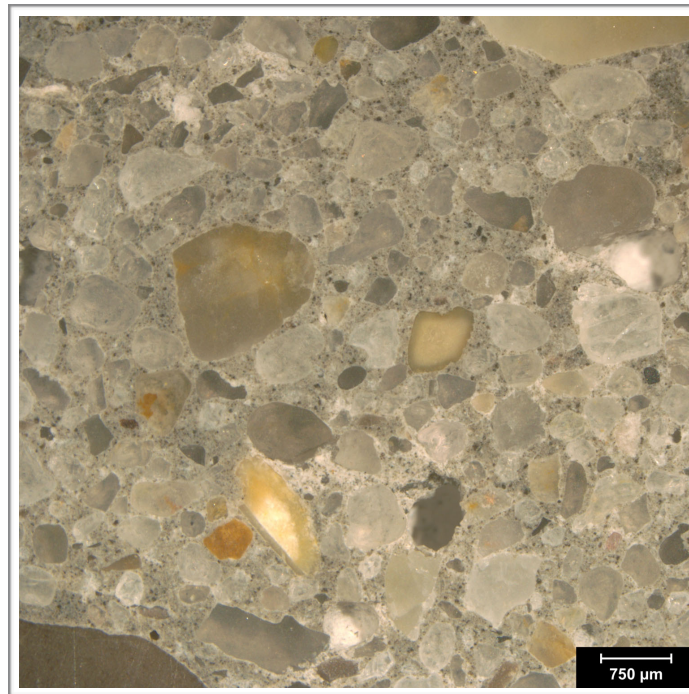
PHYSICAL PROPERTIES	Natural sand consists of rocks that are hard and competent (Figure H8). The particles are sub-equant to tabular in shape with sub-round to sub-angular edges. The grading and distribution are relatively even.
ROCK TYPES	The sand is siliceous in composition and consists primarily of quartz and quartzite with minor amounts of granitic rocks and chert.
OTHER FEATURES	No deleterious coatings or incrustations observed and no low w/c mortar coatings observed. Particles of chert typically show reaction rims but no microcracking or deposits of gel are associated with them.

Figure H8. Reflected light photomicrograph of polished surface showing the fine aggregate.

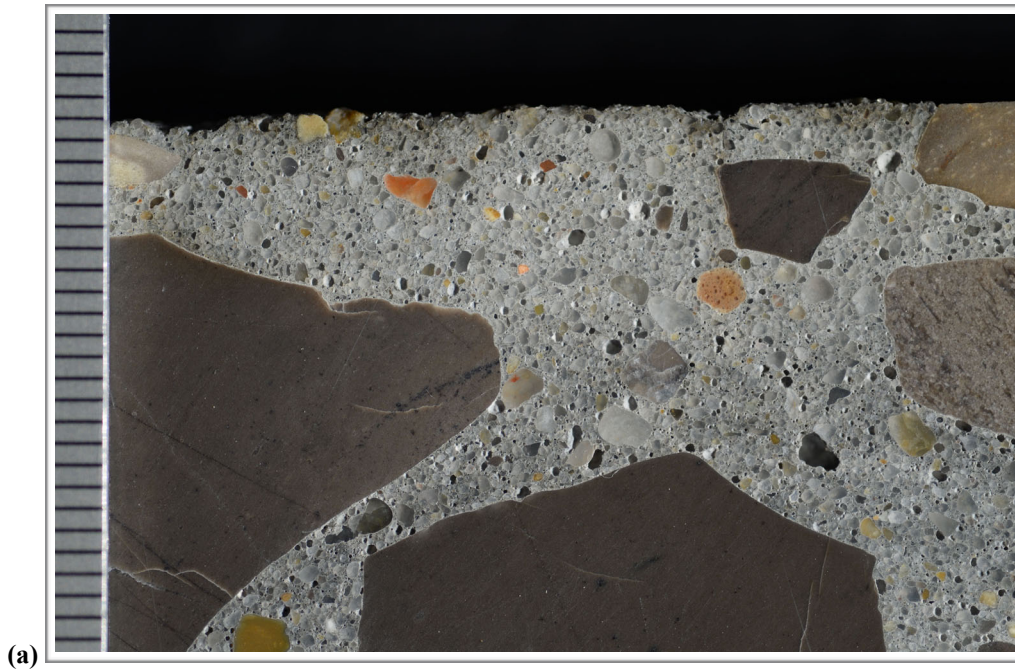
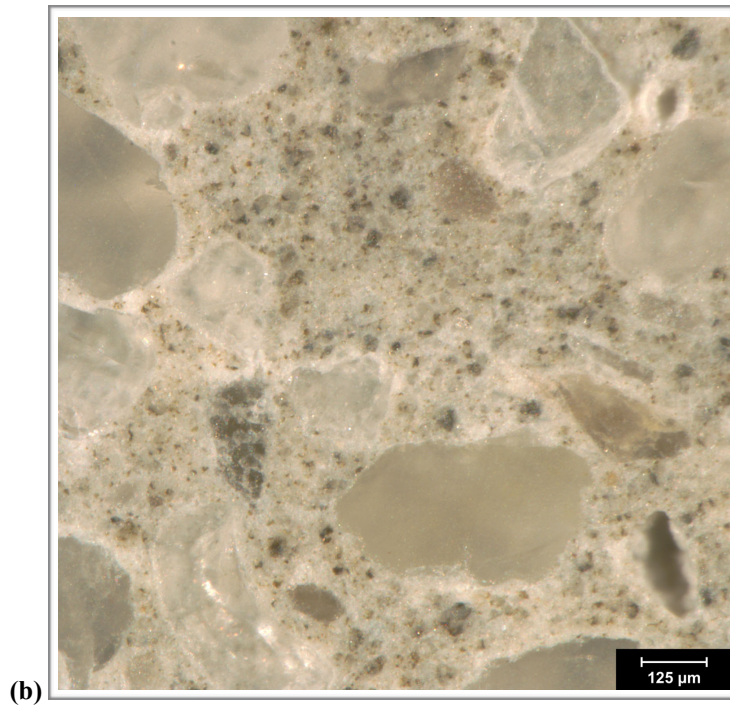
3. CRACKING	
MACROSCOPIC	A few cracks were observed on the top surface that range up to 500 µm (20 mil) wide and 70 mm (2 ¾ in.) long; these cracks form a triple point pattern (Figure H4). These cracks do not penetrate the concrete significantly. No other cracks were observed.
MICROSCOPIC	No significant microcracks observed. A couple of microcracks cut from the top surface to a depth of 1-2 mm (40-80 mil); these microcracks represent extensions of the triple point cracks described above and cut around aggregate particles and are free of secondary deposits (Figure H5).

Figure H9. (a) Photograph of polished surface showing overview of paste at the top of the core. The scale is in millimeters; the red arrows indicate the hairline crack that cut across the top surface. (b) Reflected light photomicrograph showing detail of paste color, texture and luster in the middle of the core.

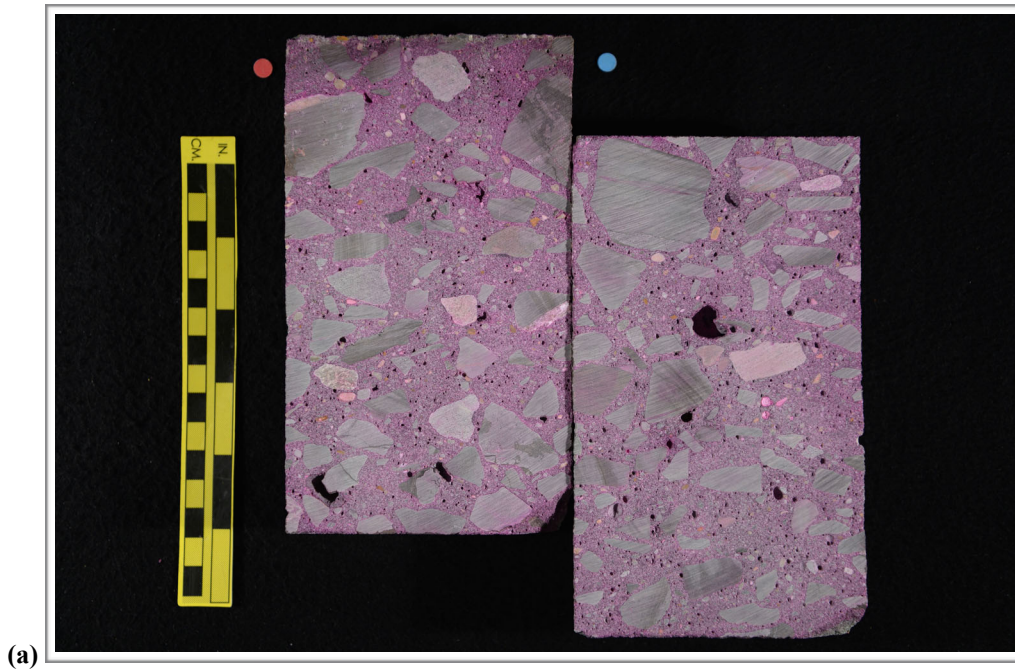
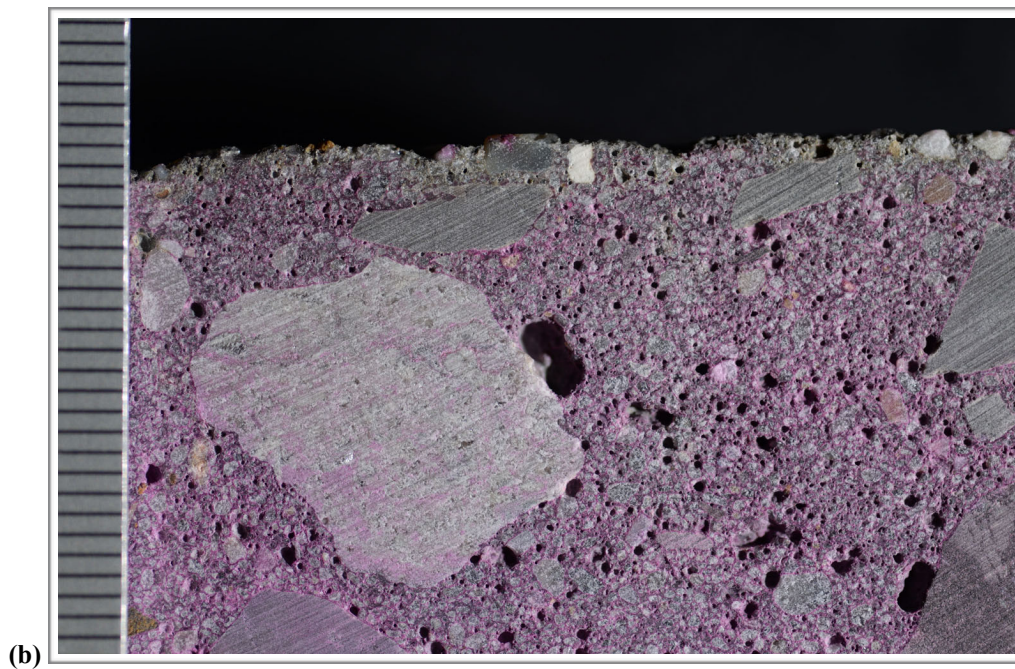
PHENOLPHTHALEIN	Entire surface stains purple (Figure H12).
DEPOSITS	Minor carbonation observed at the top of the core and in irregularly distributed zones in the paste in thin section. Minor deposits of ettringite observed commonly in voids. Deposits of gel observed in minor amounts in rare voids (Figure H13-Figure H15).

Figure H12. Photographs showing (a) overview of phenolphthalein stained surface and (b) detail of surface near the top of the core. Scale in millimeters in (b).

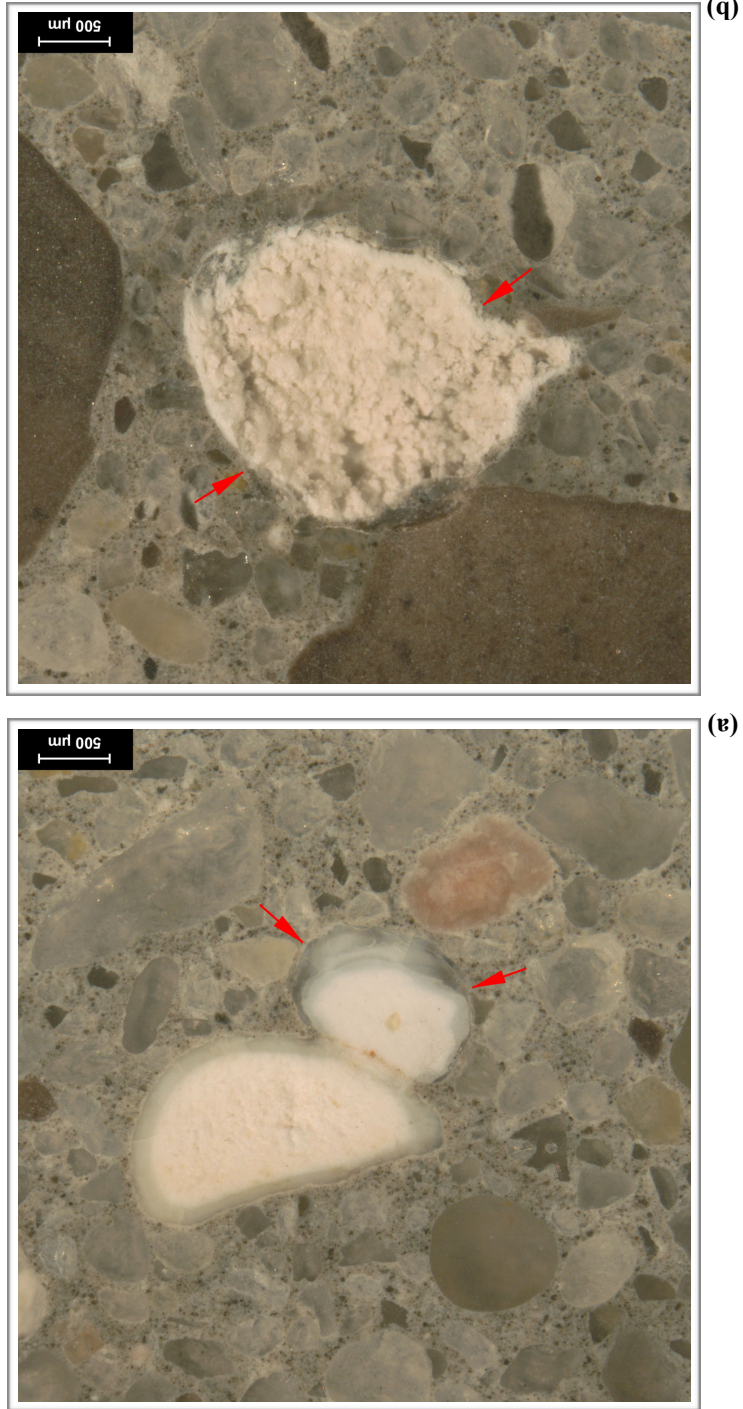
Figure H13. Reflected light photomicrographs of the polished surface showing voids filled with gel (red arrows) about (a) 220 mm (8 3/4 in.) and (b) 225 mm (9 in.) below the top surface.

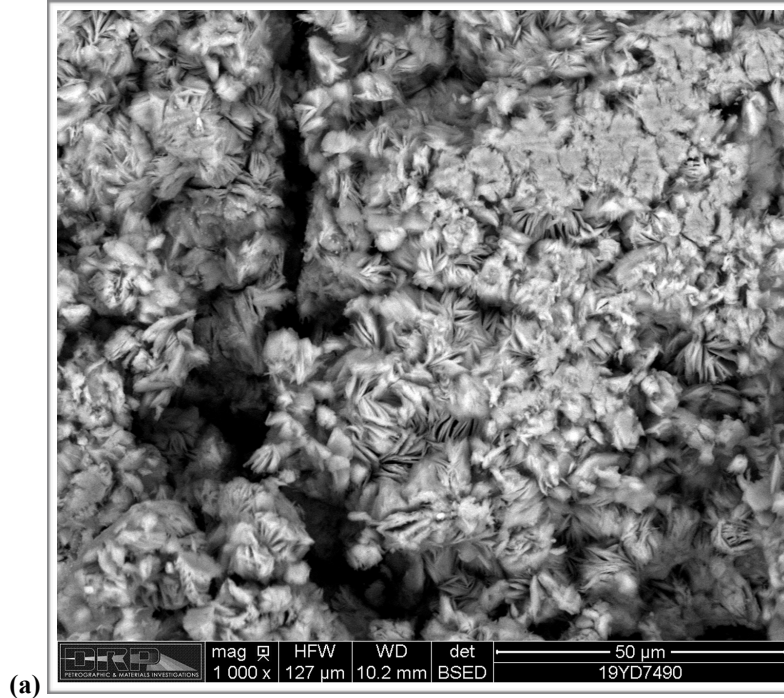
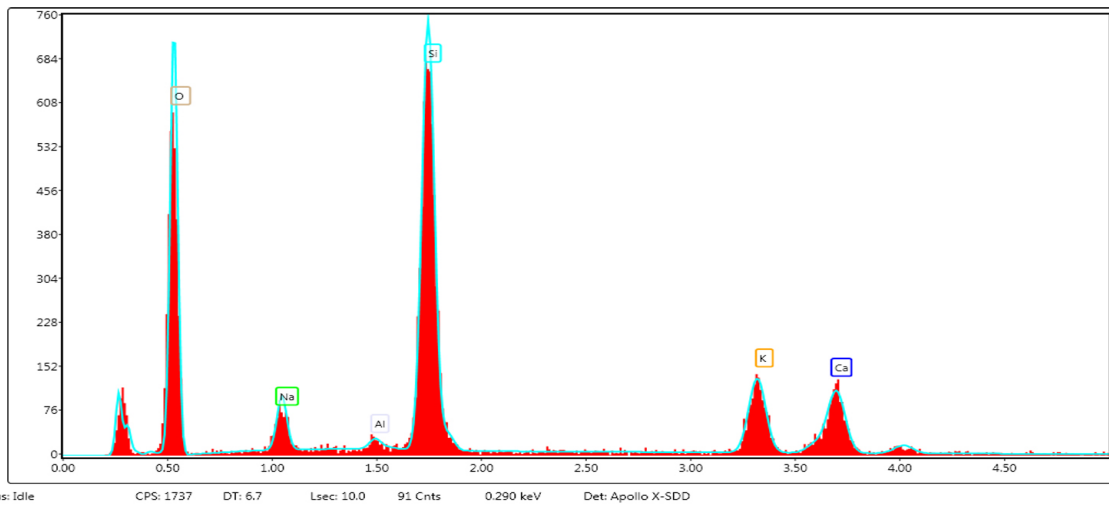
Figure H14. (a) Backscatter electron micrograph of gel deposits scraped from void shown in H13(a) and placed on carbon tape. (b) EDS spectrum of deposit indicating composition typical of ASR gel.

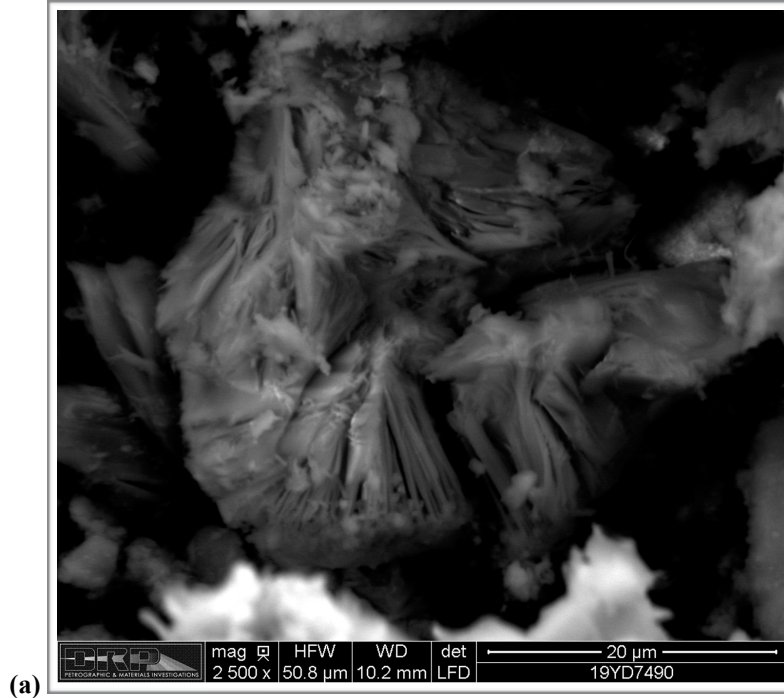
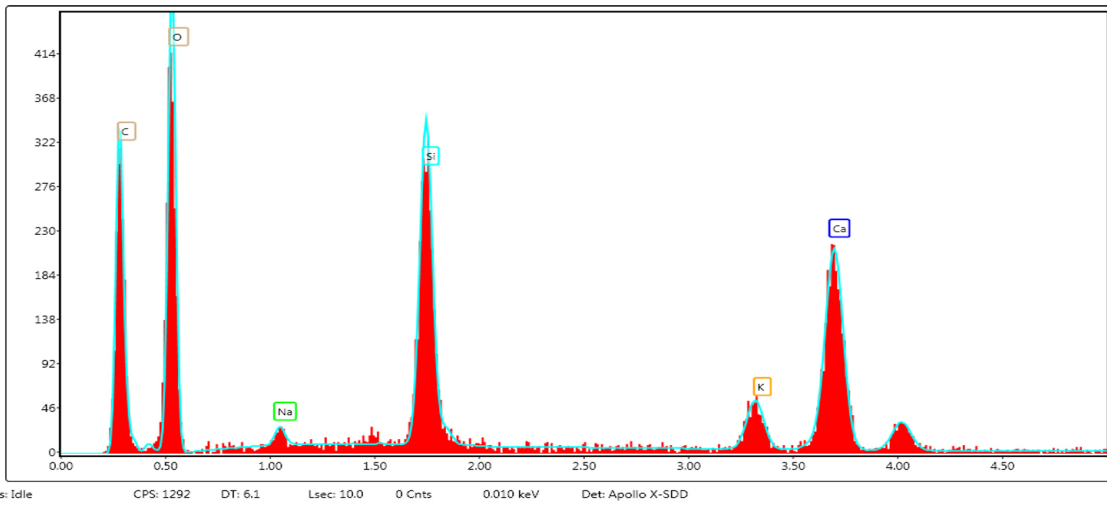
Figure H15. (a) Backscatter electron micrograph of gel deposits scraped from void shown in H13(b) and placed on carbon tape. (b) EDS spectrum of deposit indicating composition typical of ASR gel.

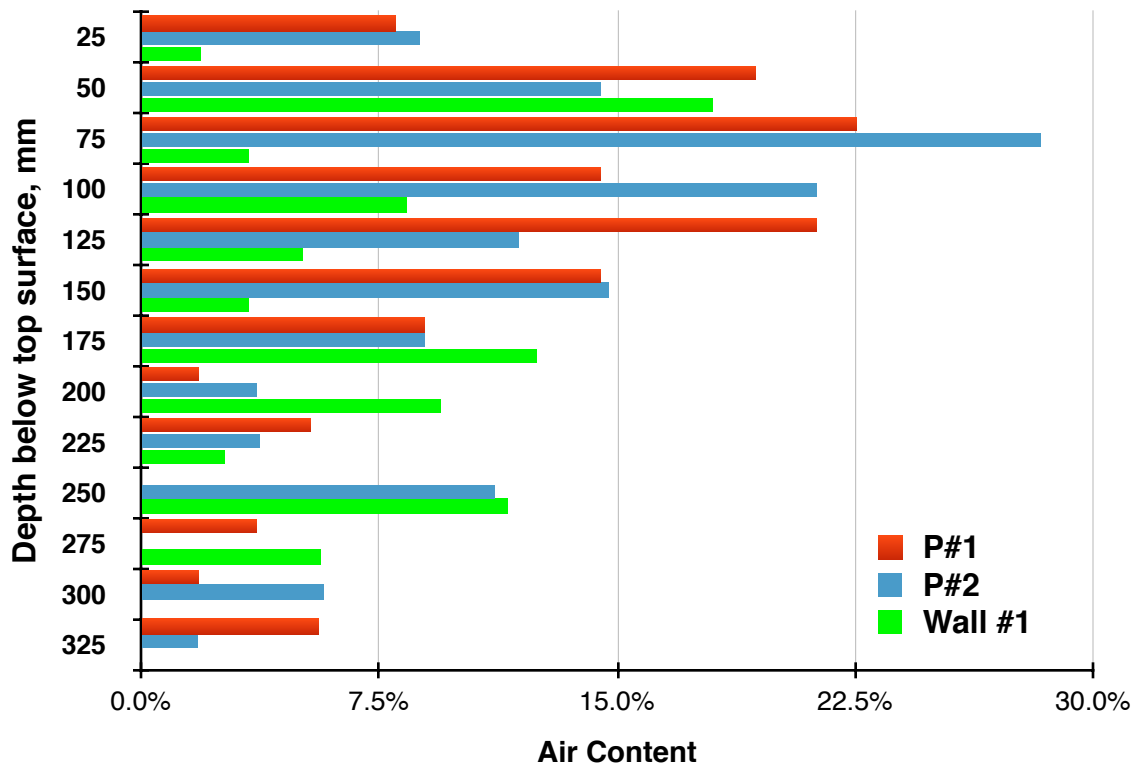
Chart 1. Summary of air content data for cores determined from point count analysis. Note that 0% air was measured at 275 mm in Core P#2.

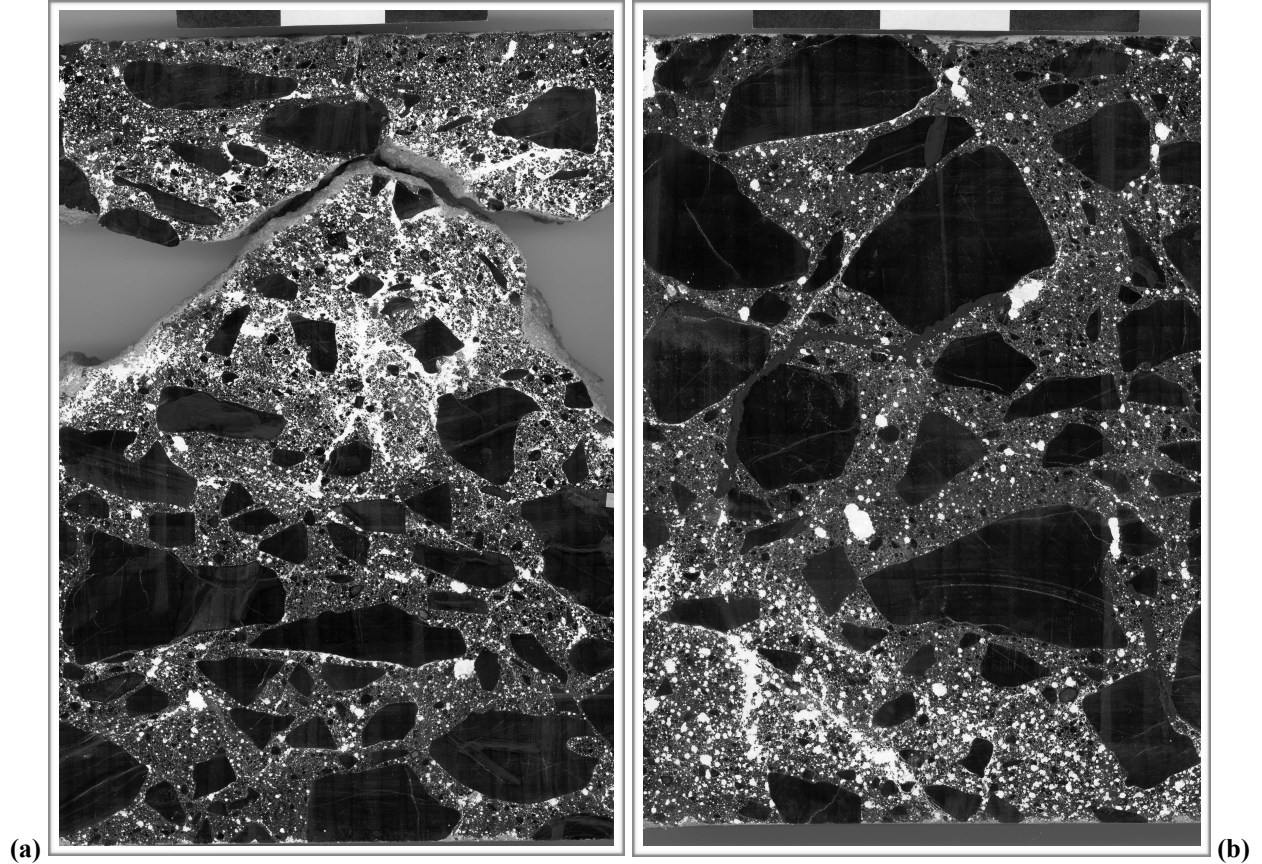
Figure I7. Scanned images of polished surface of Core P#1 after slab was prepared for enhanced contrast image analysis. The images represent areas at the (a) top of the core and (b) at the bottom of the core. In these images white areas represent voids and black areas represent paste and aggregate. The black and white bars at the top of each image are 75 mm (3 in.) across. Note that near the bottom of (a) the abundance of voids (white areas) is markedly lower than at the top. Also note that at the bottom of (b) there is a zone of high void content.

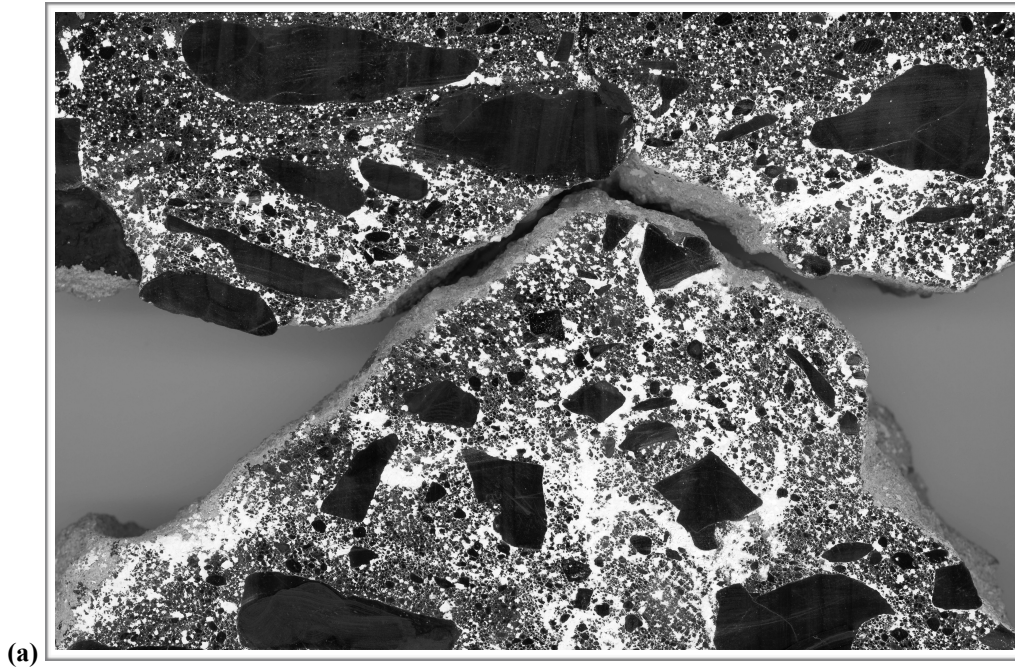
(a)
Figure I8. Cropped scanned image of enhanced contrast slab at the top of Core P#1 showing detail of area with high air content. The horizontal field width (HFW) is ~ 135 mm (5 ¼ in.).

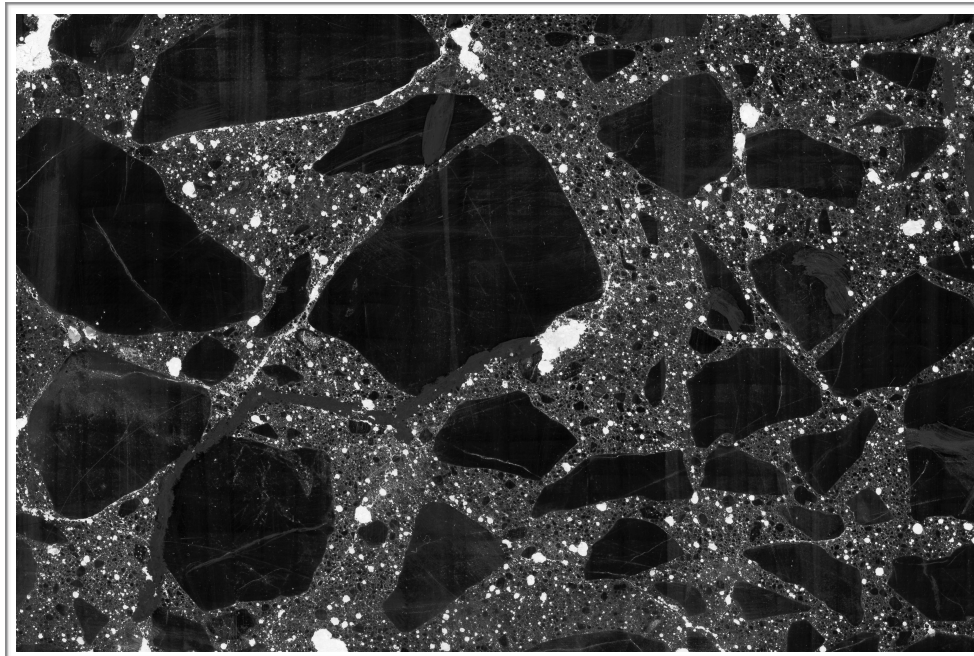
Figure I9. Cropped scanned image of enhanced contrast slab at the bottom of Core P#1 showing detail of area with low air content. The HFW is ~ 135 mm (5 ¼ in.).

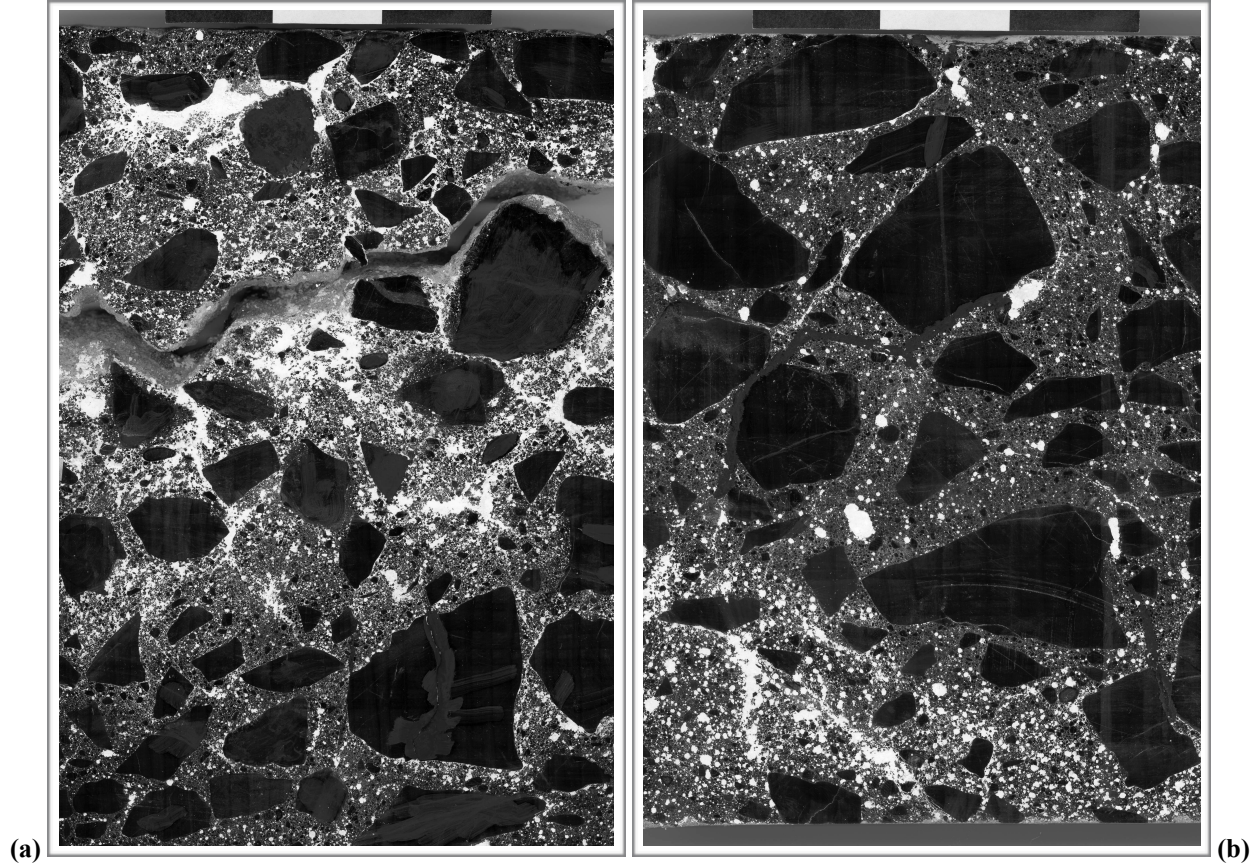
Figure I16. Scanned images of polished surface Core P#2 after slab was prepared for enhanced contrast image analysis. The images represent areas at the (a) top of the core and (b) at the bottom of the core. In these images white areas represent voids and black areas represent paste and aggregate. The black and white bars at the top of each image are 75 mm (3 in.) across. Note that near the bottom of (a) the abundance of voids (white areas) is markedly lower than at the top. Also note that at the bottom of (b) there is a zone of high void content.

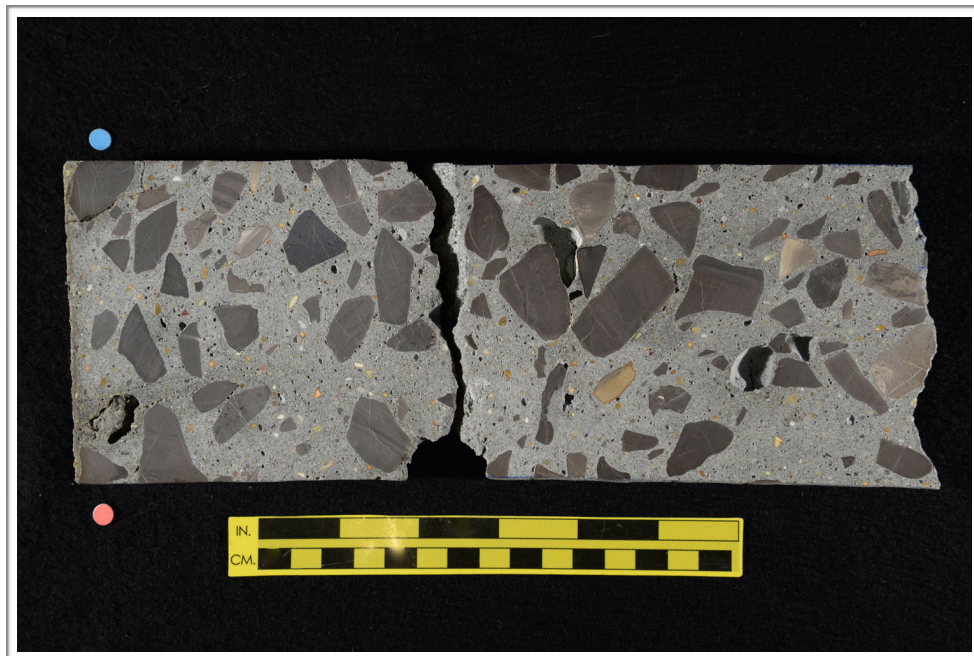
Figure I19. Photograph showing the polished surface of Core Wall #1.

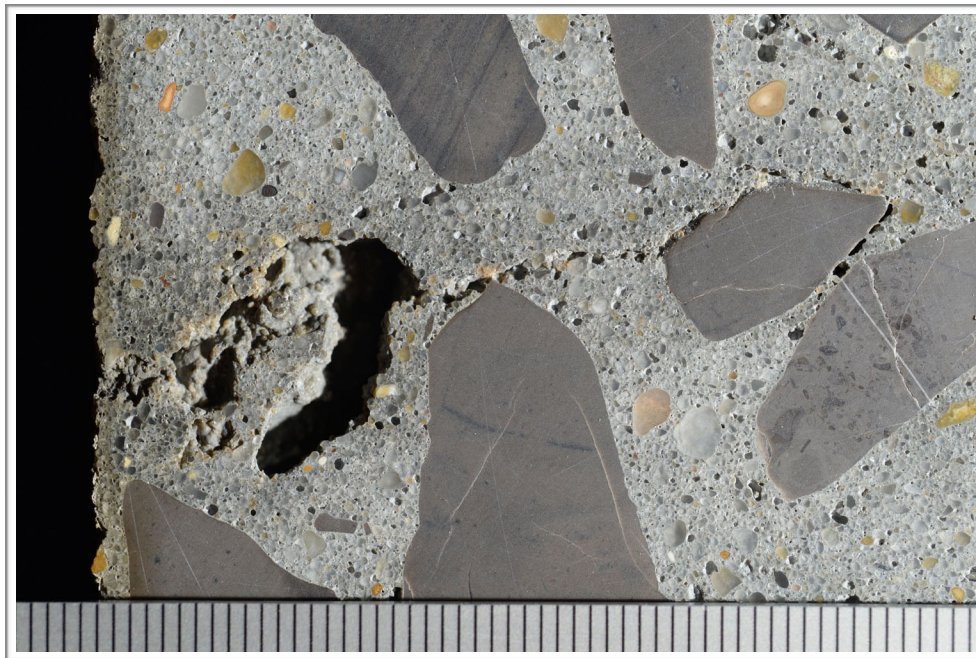
Figure I20. Photograph showing overview of polished surface at the outer end of Core Wall #1; scale in millimeters.

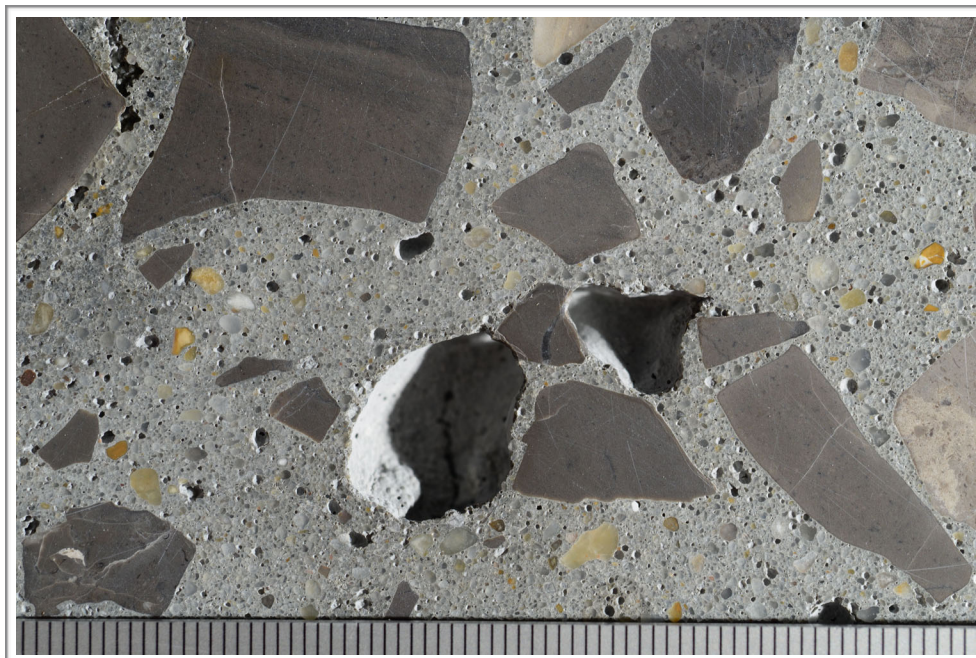
Figure I21. Photographs showing overview of polished surface in the middle of Core Wall #1; scale in millimeters.

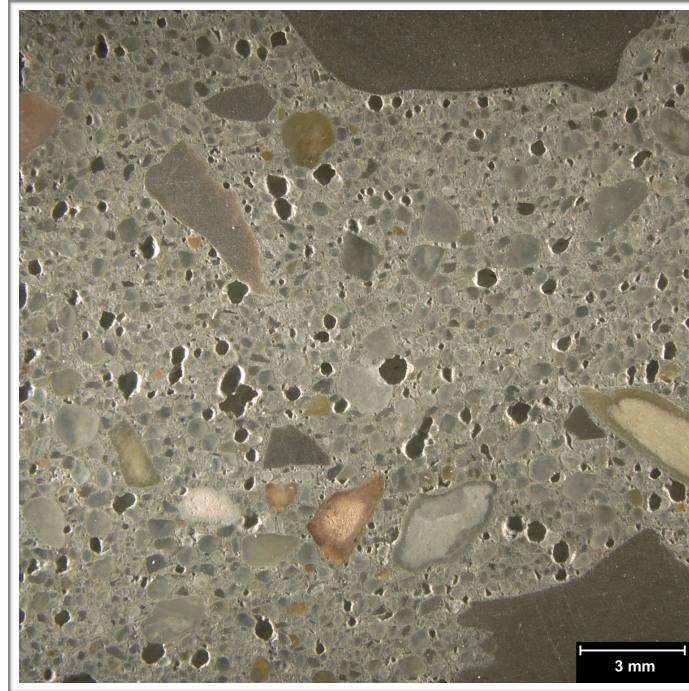
Figure I22. Reflected light photomicrograph of the polished surface showing voids and smooth texture of the polished surface at the outer end of Core Wall #1.

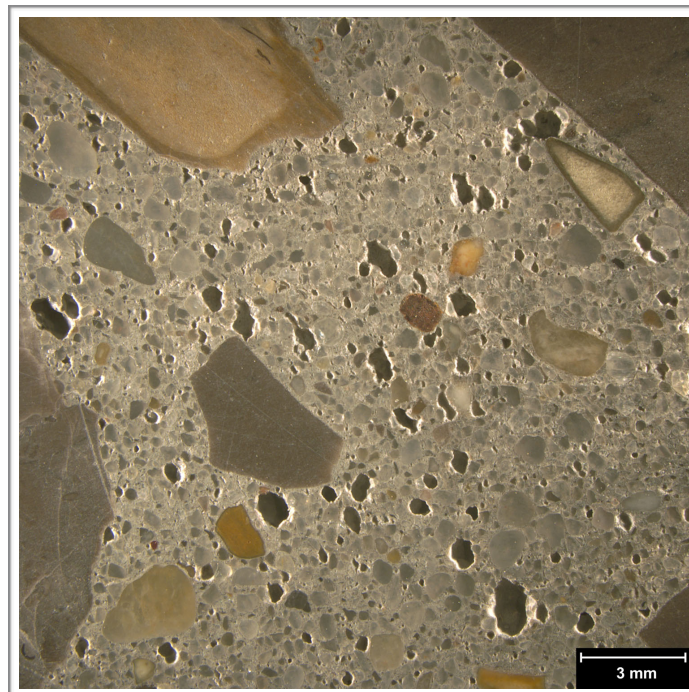
Figure I23. Reflected light photomicrograph of the polished surface showing voids and smooth texture of the polished surface in the middle of Core Wall #1.

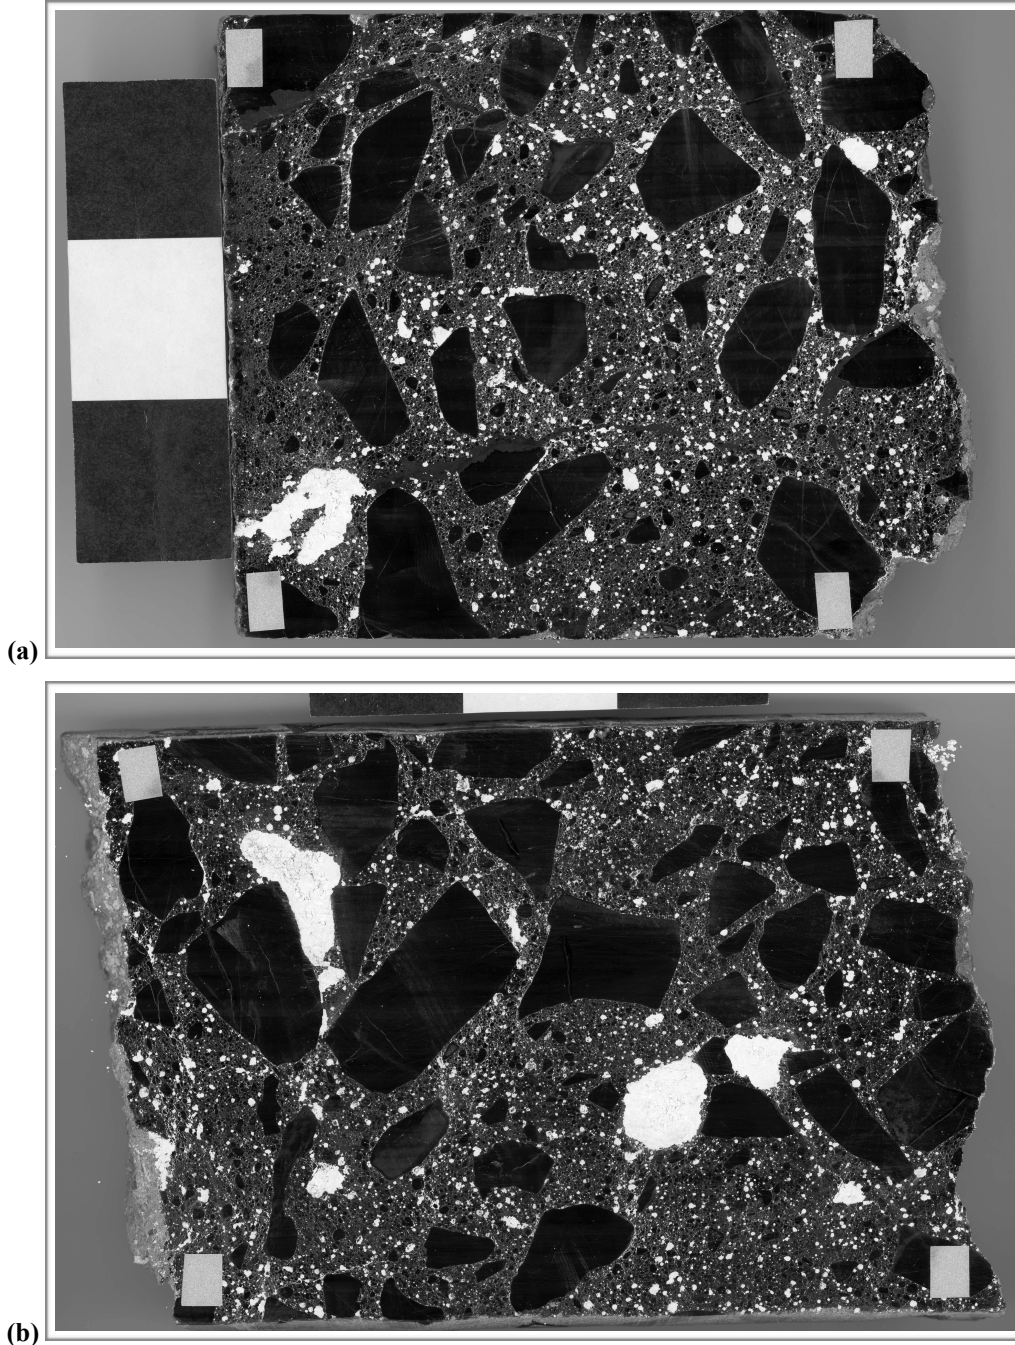
Figure I24. Scanned images of polished surface Core Wall #1 after slab was prepared for enhanced contrast image analysis. The images represent areas at the (a) outer end of the core and (b) at the middle of the core. In these images white areas represent voids and black areas represent paste and aggregate. The black and white bars shown in each image are 75 mm (3 in.) long.

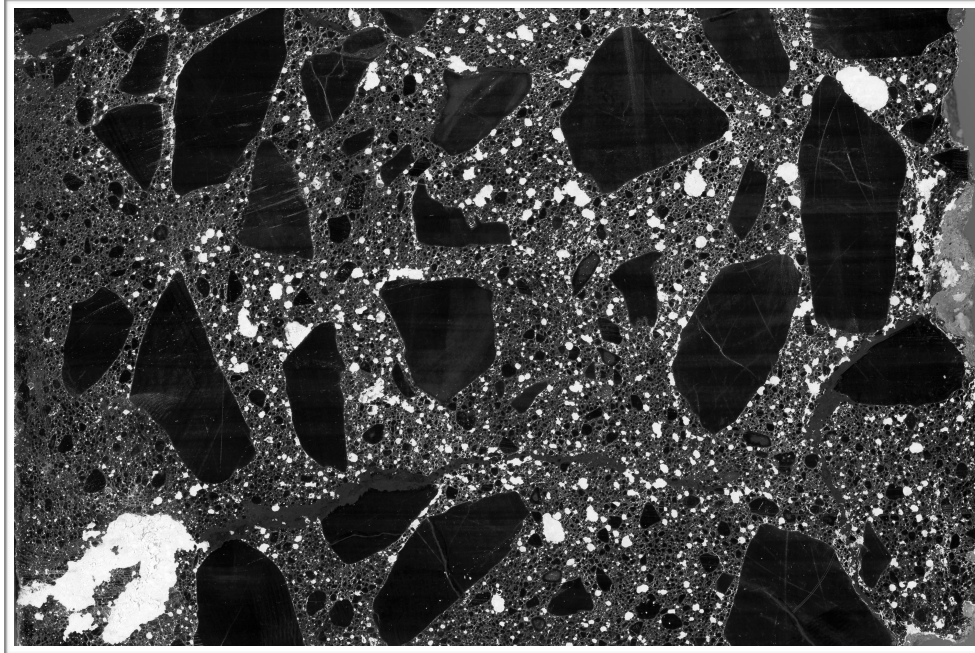
Figure I25. Cropped scanned image of enhanced contrast slab at the outer end of Core wall #1. The HFW is ~ 115 mm (4 ½ in.).

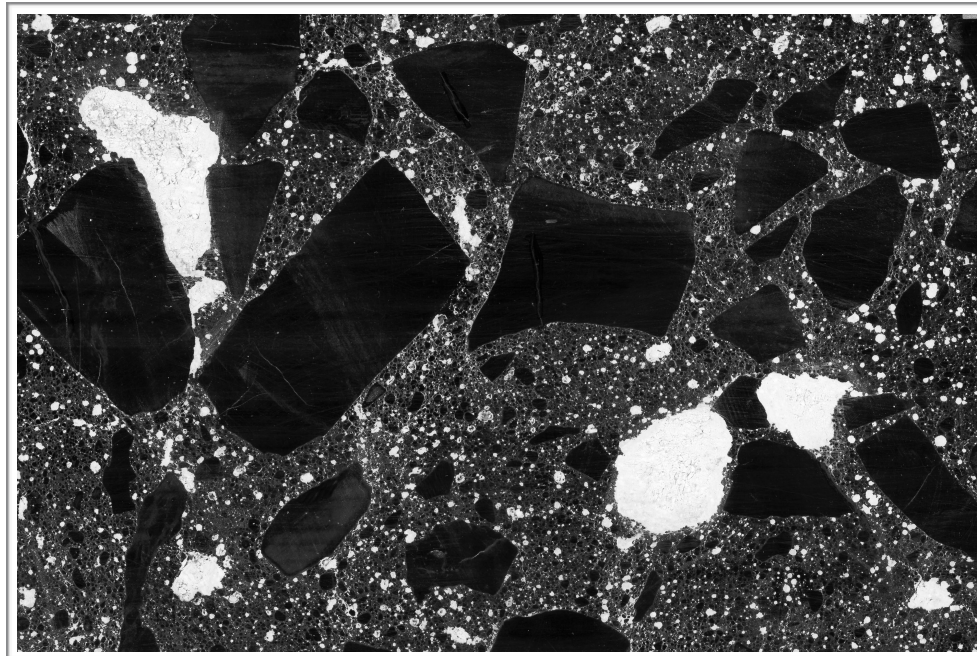
Figure I26. Cropped scanned image of enhanced contrast slab at the bottom of Core P#2. The HFW is ~ 100 mm (4 in.).
