# Louisiana Transportation Research Center

Final Report 579

## **I-10 Girder Repair Using Post-Tensioned Steel Rods and Carbon Fiber Composite Cables (CFCC)**

Ching Tsai, Ph.D., P.E.  
Walid Alaywan, Ph.D., P.E.

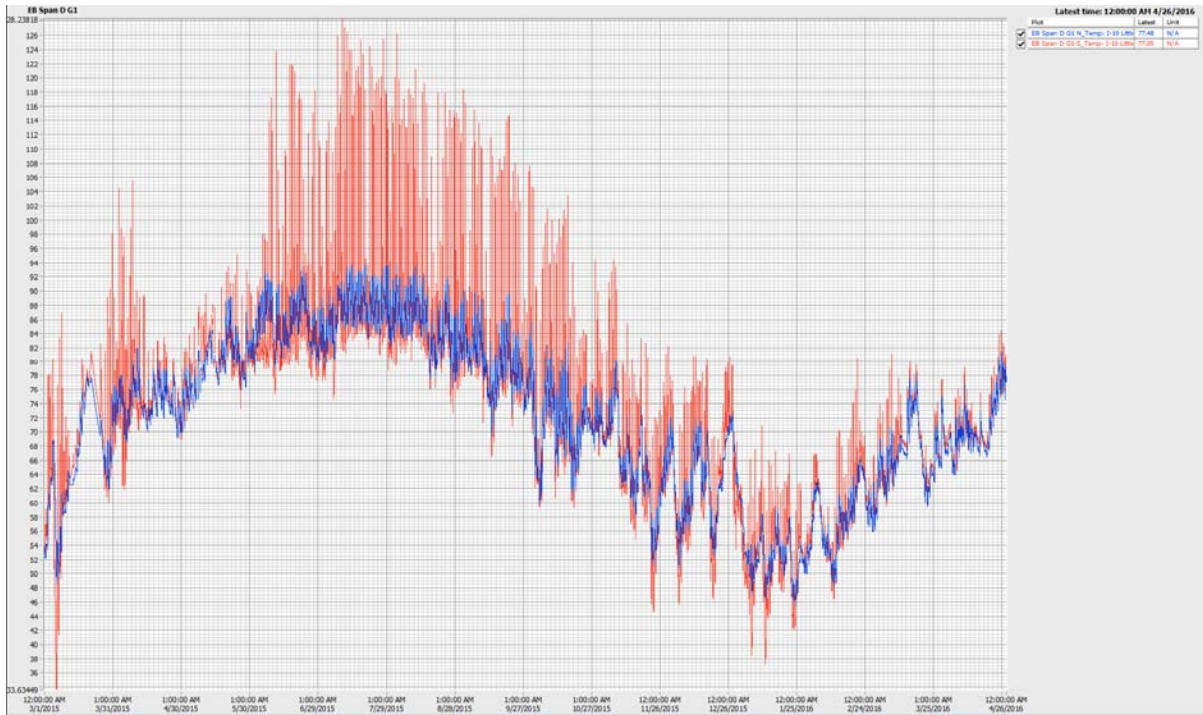
**Figure 11**  
**Temperature of the external steel rods for girder 1 (Span D) eastbound**

The temperatures of the external reinforcing elements measured during the same period are presented in Figures 11 through 14. Note that all temperature readings are taken from Span D of the eastbound bridge. Figure 11 shows the temperature of the steel rods on the two sides of Girder 1. The red line represents the temperatures at the south side of the girder and the blue line represents temperatures at the north side. Since Girder 1 is the southernmost girder, the south side is exposed to ambient conditions or under a few inches of water, while the north side is either under constant shade or underwater. During the summer months, the south side

of the girder experienced higher temperature fluctuations and the north side remains in a narrow band of fluctuation. The temperature differential between the two sides can reach as high as 35°F from June to October. It is suspected that the high temperature fluctuations were the results of the lower water level during the summer and the temperatures measured reflected the true ambient conditions. Detail discussions of the water level effect are presented later in this report. Based on the temperature difference between the two sides of the girder, it appears that the temperatures of unexposed reinforcement roughly near the daily lows in the summer. The night time temperatures in December, on the other hand, appeared to be near the daily highs. The temperature effect can have a significant impact on the girder behavior since the differential temperature between the two sides of the same girder can cause the girder to bend along the weak axis. Depending upon the magnitude of stresses resulting from the differential temperatures, it is possible that deterioration rate of the concrete can be significantly impacted.

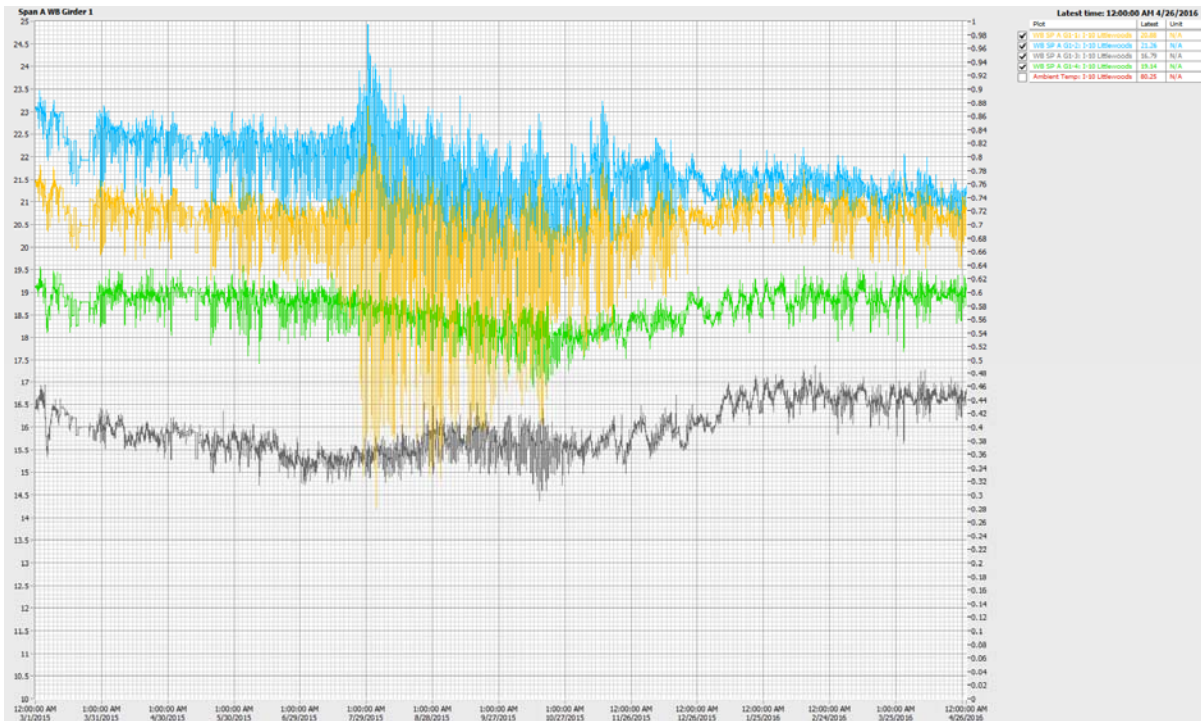
**Figure 15**  
**Tensions of the reinforcing steel rods for girder 1 Span A westbound**

Figure 15 shows the tensile force measurements of the Girder 1 Span A (westbound) from March 1, 2015, to April 26, 2016, the same period used for temperature comparison. The yellow and blue lines represent the tensile forces measured from the two strain gages on the steel reinforcing bar at the south side of the girder and the other two lines are the forces recorded from the reinforcement at the north side of the girder. It is clear that the tension forces of the steel bar at the south side are strongly influenced by the ambient conditions similar to the temperature fluctuations (black line) presented in Figure 14(a). The range of the tension force swing within a 24-hour period reaches 7.0 kips, about 30% of the applied tension. Another interesting observation is that the observed tension forces from these two gages converges with time. The tension force difference in early March 2015 was about 1.5 kips. By the end of April in 2016, the gap had narrowed to about 0.5 kips. The north side reinforcing rod was never exposed to the ambient conditions. As such, the temperature

fluctuations thus the daily tension force swings measured are much smaller, mostly fluctuating within a range of about 1 kip.

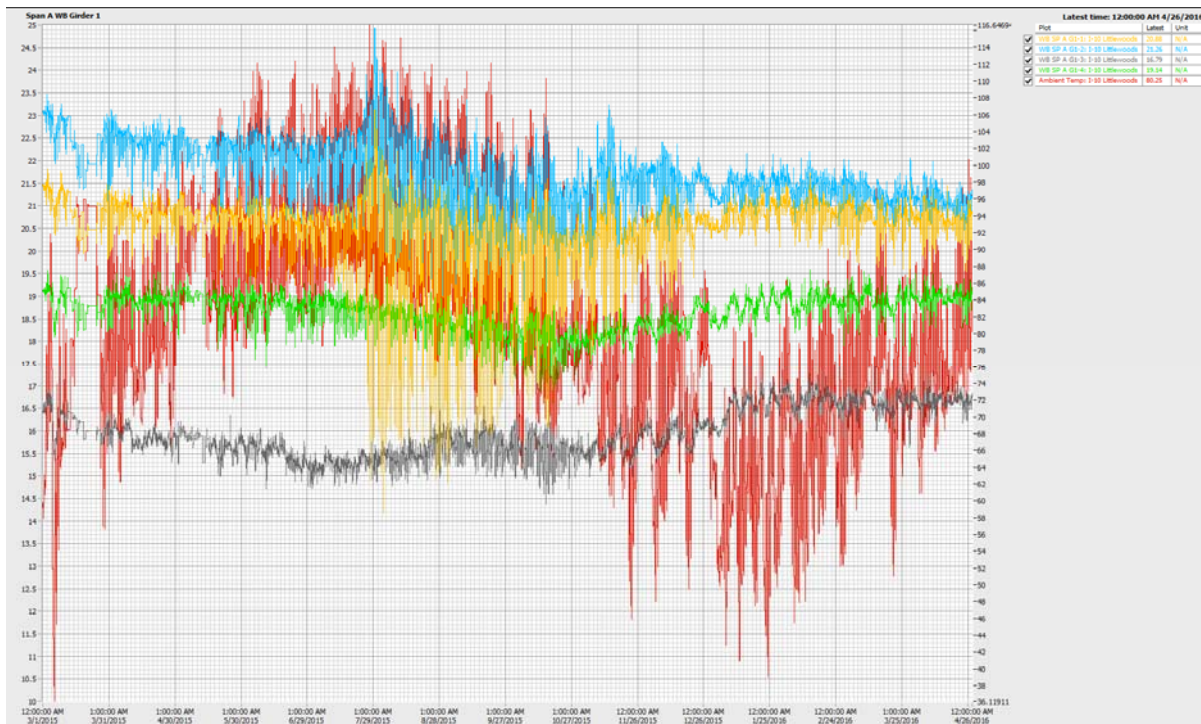
**Figure 16**  
**Tensions and temperature of the reinforcing steel rods for girder 1 Span A westbound**

To further enhance the understanding of the structural response to temperature, the ambient temperatures are superimposed on Figure 15 with the ambient temperatures. The red line presented in Figure 16 shows the ambient temperatures during the monitoring period. It appears that during the first few months of observations (March 2015 to July 2015) the tension forces were relatively stable with only slight daily fluctuations. A sudden increase in tensions was observed on the south reinforcing rod in late July 2015. The tension increase coincided with the water level drop in the Lake Pontchartrain (Figure 17). It is suspected that the water level at the site dropped below the external reinforcing rods and exposed the outside reinforcement to the ambient conditions that in turn caused the large fluctuations of the tension forces as well as the spike in the tension observed in late July 2015. Once exposed, the observed tension forces steadily declined until late September 2016. This period coincides with the water level drop perfectly. Note that the exposure affected the south side of the girder much stronger than the north side. The hypothesis is that the lowering of the water level exposed the girder to the environment and cause the girder bend along the weak axis slightly. Some of this bending recovered once the girder became submerged again as evident by the tension recovery of the south reinforcement. Only small fluctuations were

observed on the north side of the girder. The small fluctuation is likely due to the reinforcing rod being under the shade of the bridge deck and experiencing only minimum effect from the ambient temperatures. Based on the Lake Pontchartrain water level observations by the US Army Corps of Engineer at the Lakefront Airport in New Orleans, a portion of the girders submerged again in the water after later September 2015 [6]. The time-history plot (Figure 16) of the tensions reflected that change. There were two short periods that the water level dropped to below the girders in February and March 2016. The durations of these two periods appear to be too short to cause significant changes the temperature responses of the girders.

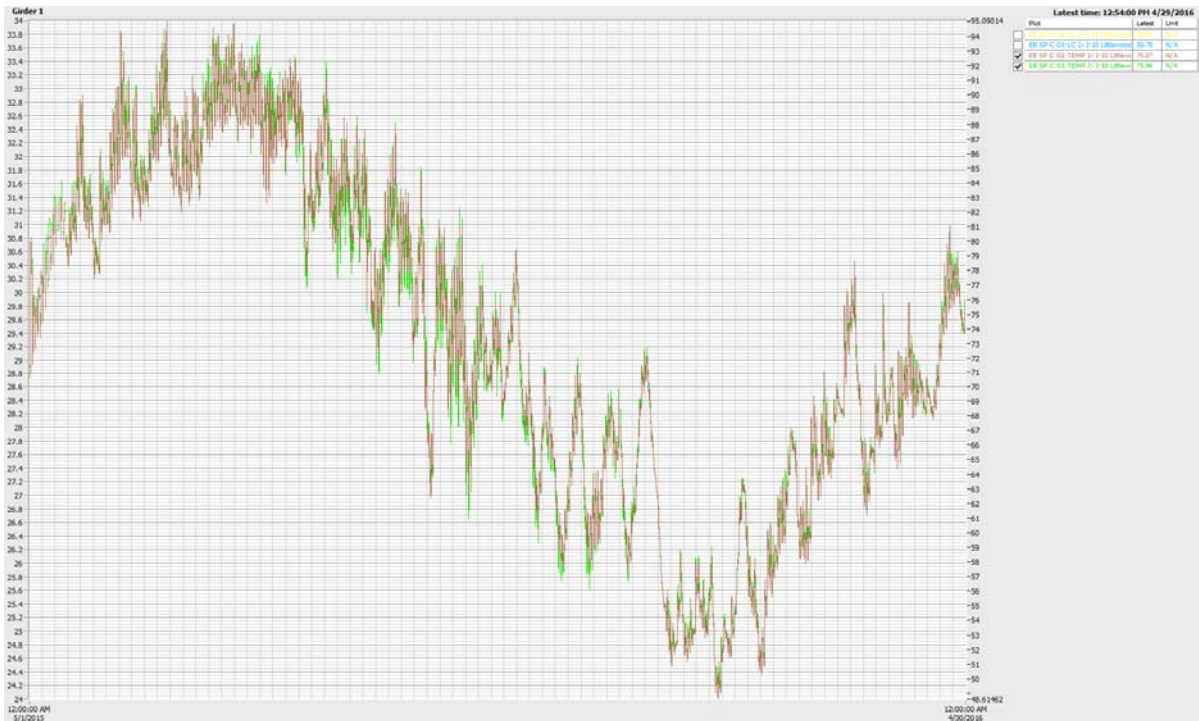
**Figure 22**  
**Temperature of CFCC for girder 1, Span C eastbound**

It should be noted that the tension force and temperatures measurements were made from the load cells installed at the east end of the girders only. In addition, the CFCCs are insulated from the ambient conditions and are less susceptible to temperature changes even for the exterior girders. This phenomenon can be illustrated by comparing the temperatures at the load cell locations of the exterior girder in Figure 22. It is very clear that the temperature of the CFCCs on both sides of the girders were almost identical even though the outside of the girder was exposed to the ambient conditions when water level dropped below the CFCC during the summer months. Another interesting fact is that, while the CFCCs are insulated, the load cells that measure the tension forces and temperatures are not. Even with the exposure, both the temperature and tension force fluctuations are much smaller than those observed from steel. Note that the small temperature effect on the CFCCs does not mean the temperature responses of the concrete girders would also be small. In fact, the differential thermal responses between the CFCCs and concrete could in theory generate stresses in the girders that are totally different from steel reinforcement. Unfortunately, the uncertainties of the structure conditions made the comparison difficult to positively identify the causations of

The daily maximum tension force fluctuation was only about 0.4 kips. This is in contrast to the 7 kips daily fluctuation of the steel rods. The long-term rate of tension increase on an annual basis is about 2 kips. This is very significant. The implication that the internal prestressed tendons are transferring equivalent of the 2 kips of prestress force to the external reinforcement every year. The force transferring could be the result of bonding loss of the prestressed strands due to concrete deterioration or steel corrosion.
