Louisiana Transportation Research Center

Final Report 626

Evaluating Louisiana New Continuity Detail for Girder Bridges

1. Title and Subtitle
**Evaluating Louisiana New Continuity Detail for Girder
Bridges**
2. Author(s)
Ayman M. Okeil, Ph.D., P.E. (FL)
Marco Canales, M.Sc.
3. Performing Organization Name and Address
Department of Civil and Environmental Engineering
3255 P.F. Taylor Hall
Louisiana State University
Baton Rouge, LA 70803

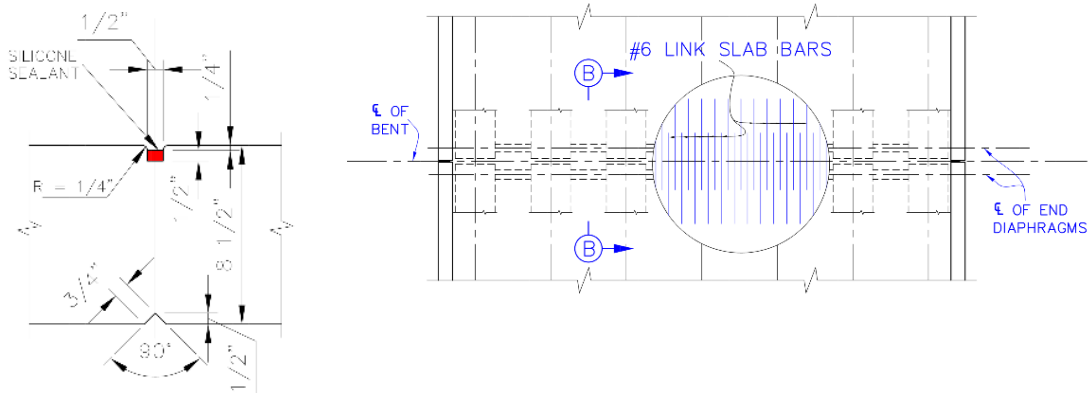
Figure 15. Link slab details

2. The transverse crack control detail (groove) at the center of link slab was not effective in arresting expected transverse cracks at the joint. Therefore, it is not deemed a necessary detail, especially that the crack widths are not alarming and do not require intervention.

For the cases where link slabs were used; i.e., jointless deck, a crack control detail was provided for some link slabs to assess its efficiency in arresting transverse crack over the supports. The crack control detail (see Figure 15(a)) consisted of a 0.5 in. x 0.5 in. groove that was filled with a silicone sealant. Two meshes of steel reinforcement (top and bottom) were provided as can be seen in Figure 15(b). For the Ouachita Bridge, the longitudinal reinforcement consisted of #6 bars spaced at 7 in., which were 10-ft. long and were staggered by alternating a 2 ft.-6in. shift as shown to cover a total length of 15 ft. in the longitudinal direction. For some of the link slabs, stainless steel bars were used instead of typical black bars to assess if their performance will be different in the case of corrosion initiation. Finally, the link slab #6 bars (Figure 15(b)) were added to the

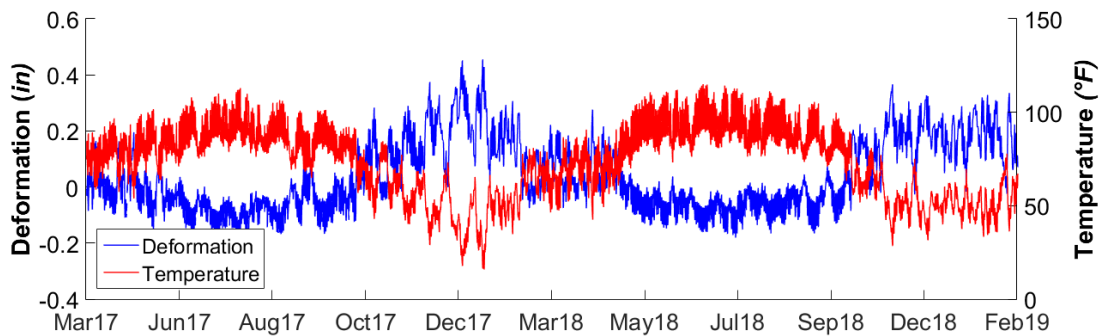
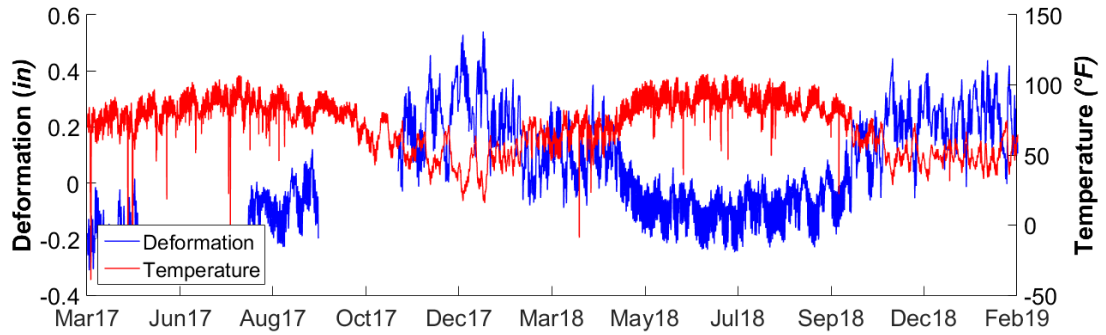
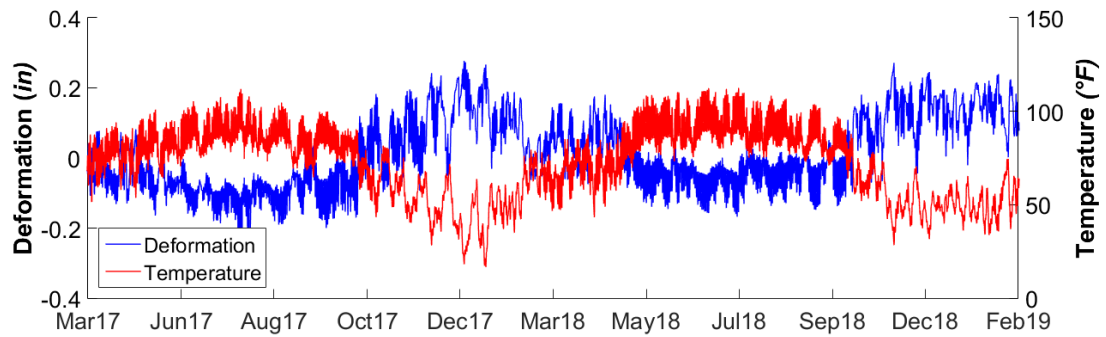
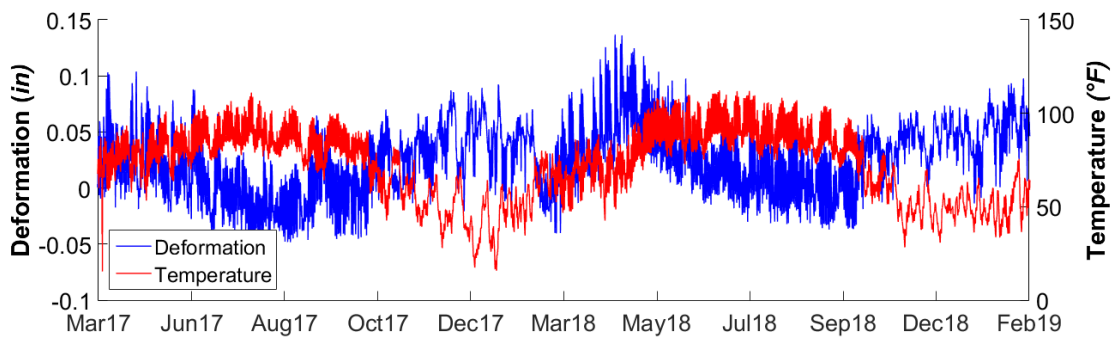
The plotted results are for a period of about two years from March 2017 to February 2019. It can be seen that seasonal and daily temperature changes are directly correlated to the plotted relative girder end movements. This is expected as seasonal changes cause a uniform elongation, or shortening, of the entire segment, which daily temperature changes are more affected by the temperature gradient, which causes girder camber leading to end rotations. In all cases, the girder end movements did not exceed 0.5 in. It can also be stated that floating segments experience smaller girder end movements (~ 0.2 in.) compared to anchored segments. This is true for all but one 2-span floating segment, which could be attributed to locking of girder bottom flanges with surrounding shear keys. The observed results indicate that anchoring diaphragms, whether by design or due to unforeseen locking, leads to more demands on the bearings.

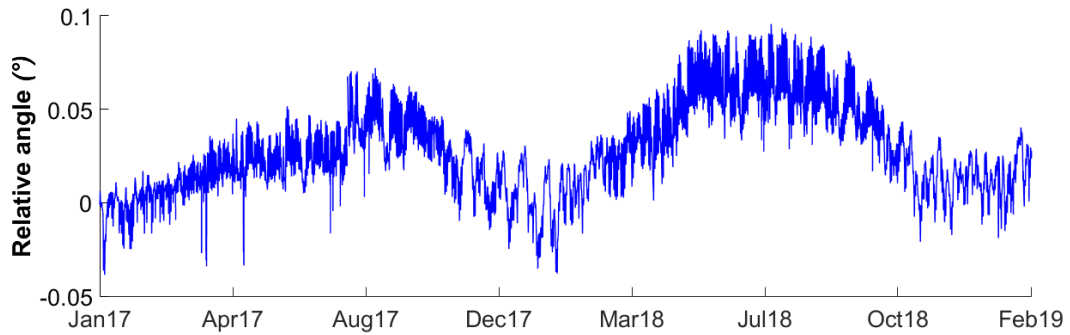
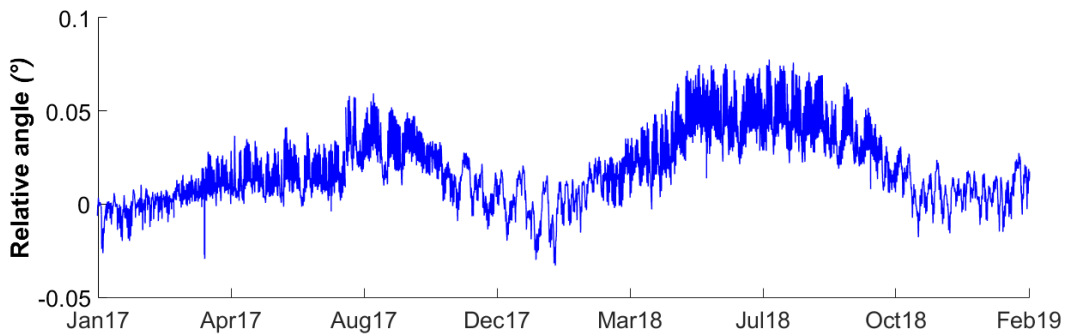
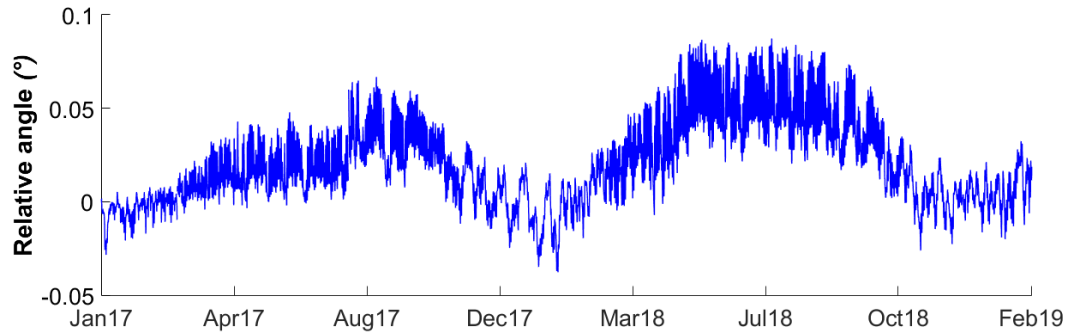
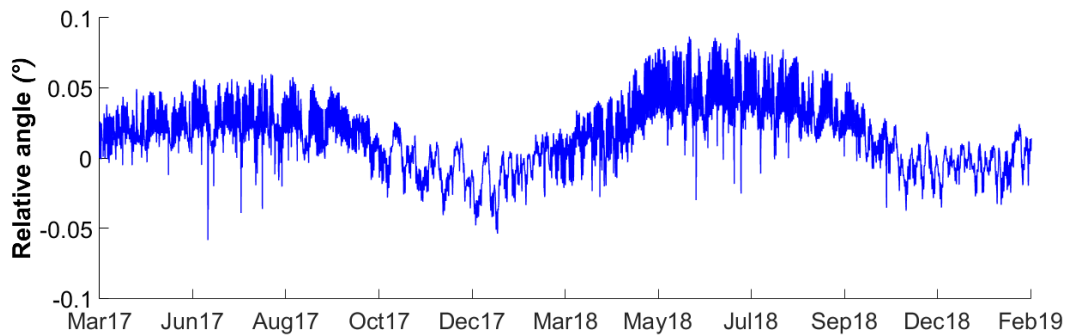
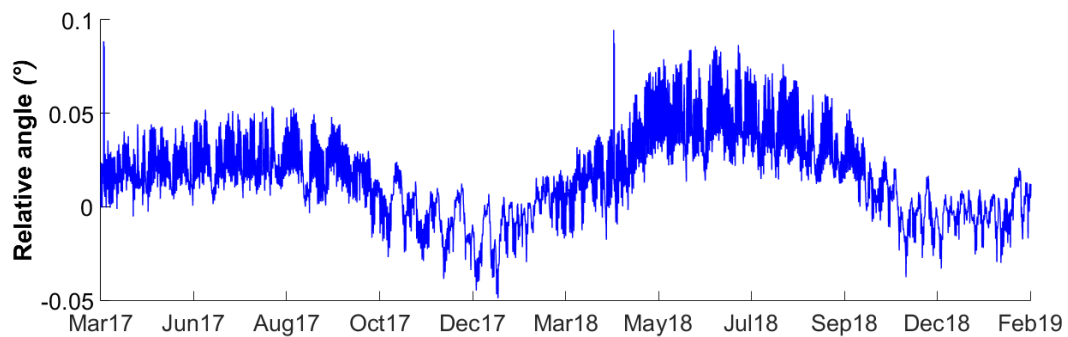
Figure 29 through Figure 33 show the relative angle between girder ends as calculated using the aforementioned procedure. It is clear that the relative angle between girder ends at bents with link slabs varies daily and seasonally following the ambient temperature variations (see Figure 28). The magnitude of the relative angle is limited, however, its effect on other bridge elements (e.g. bearings and shear keys) may still need to be assessed.

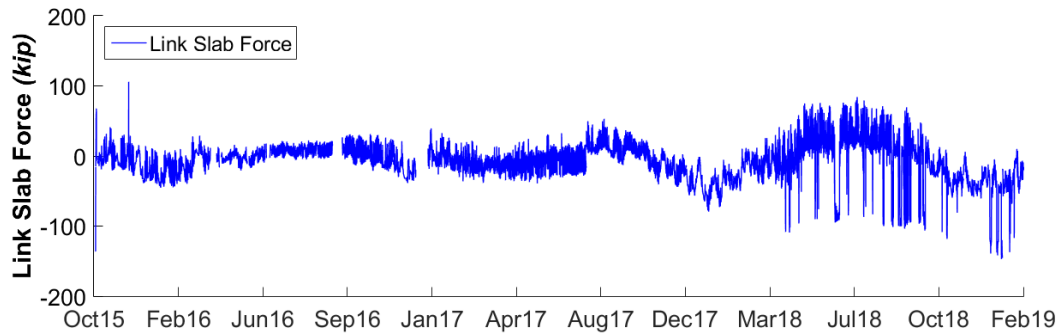
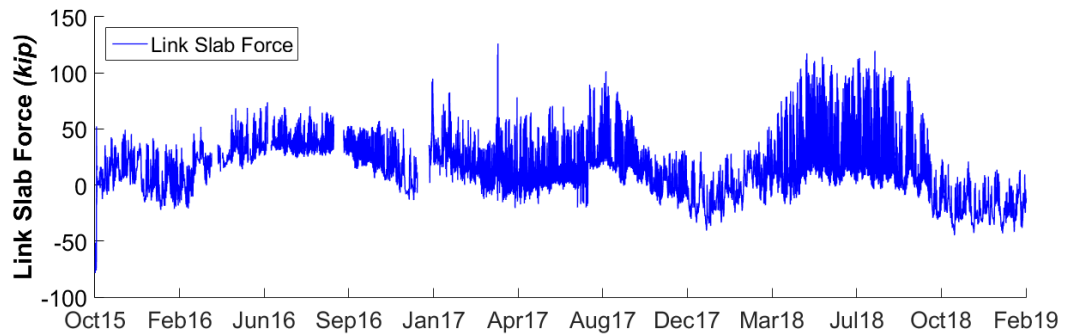
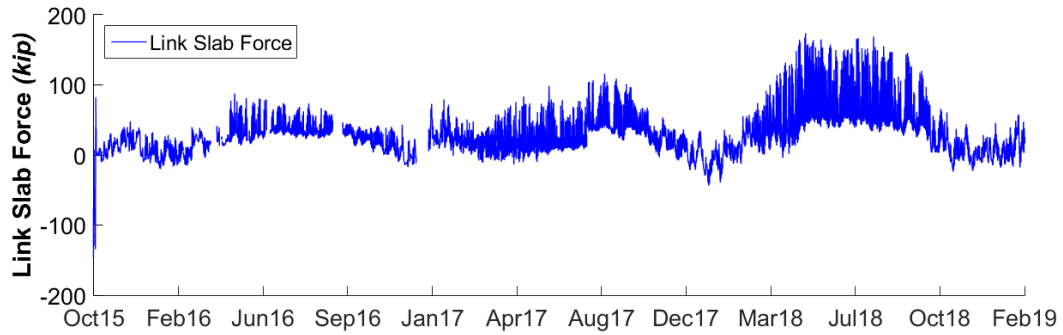
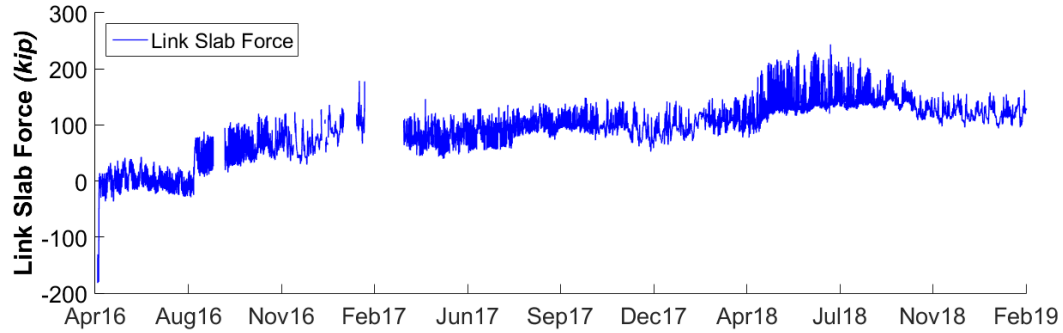
Figure 36 through Figure 40 show plots of the link slab forces based on the measured readings as interpreted using the aforementioned approach. Figure 35 shows the corresponding temperatures during the same monitoring period. The plots show that the link slab forces vary daily and are also affected by seasonal temperature changes. This can be attributed to the fact that seasonal temperature changes contribute to crack opening, or closure, which is superimposed on the temperature gradient effect that leads to relative girder end rotations as described in the previous section. The magnitude of the link slab forces can increase beyond what is expected for a link slab system. This may be attributed to the fact that shear keys provide additional stiffness that far exceeds the stiffness of bearing pads.
