LIME TREATMENT AT DEPTH

FINAL REPORT

Research Report No. 41

Conducted by
LOUISIANA DEPARTMENT OF HIGHWAYS
Research and Development Section
In Cooperation with
U. S. Department of Transportation
Federal Highway Administration
BUREAU OF PUBLIC ROADS

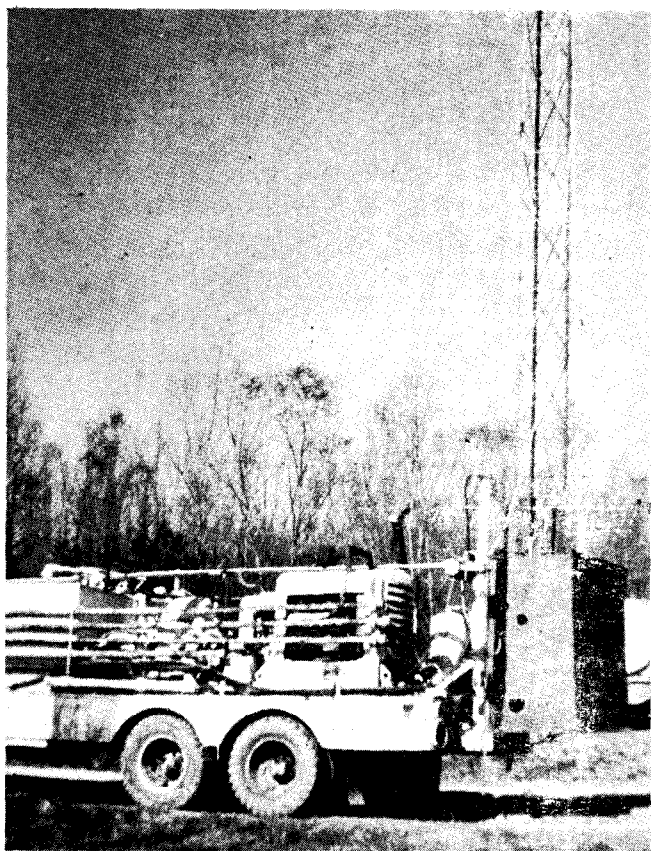
Figure 1

1. The Injection Process: The problems encountered during placement with loss of slurry to the surface were discussed in the previous report. A picture of the injection apparatus with the boom required for the 20 foot injections is shown in Figure 1.

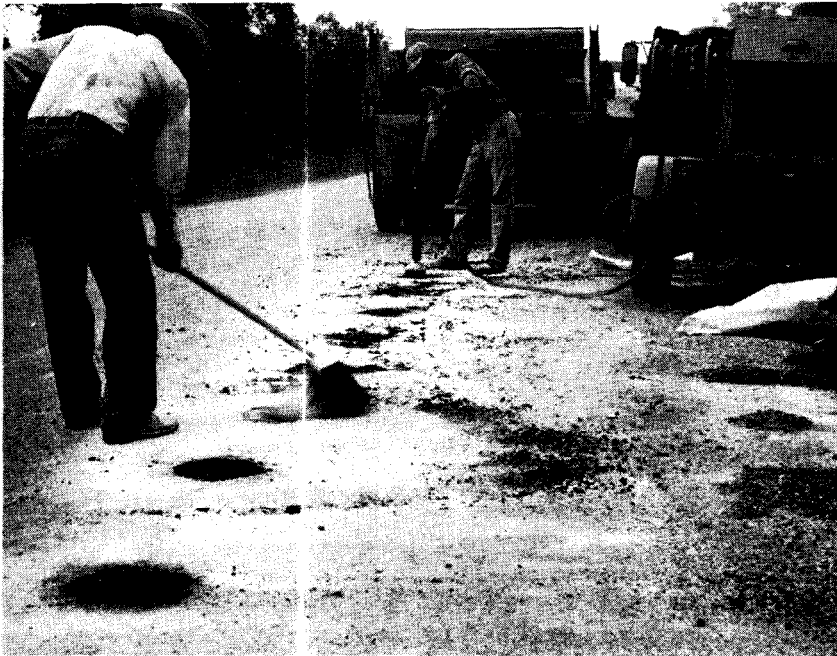
Figure 7

One half bag of lime (25 pounds) was placed in the 18 inch and 24 inch holes while one bag (50 pounds) was placed in the 36 inch and 48 inch holes. Water was added to the lime where sufficient water was not evident in the holes. Gravel was mixed with the lime and water to the level of the base and compacted as much as possible. The remainder of the hole was filled with a cold-laid asphaltic mix and compacted thoroughly (Figure 7).
