DESIGN CRITERIA FOR PREVENTION OF SLOPE FAILURES

It was determined that failures occurred most often in slopes constructed of soils high in smectite (shrink-swell clays previously known as montmorillonite). Therefore, control of slope stability depends upon control of these clays.

This report summarizes the method of determining if there is a problem soil, and also provides two alternatives to slope construction. One method is lime stabilization of the problem soil to inactivate the shrink-swell clays. The second method is to redesign the slope and use the natural soil material without lime stabilization. Four methods of redesign are noted.

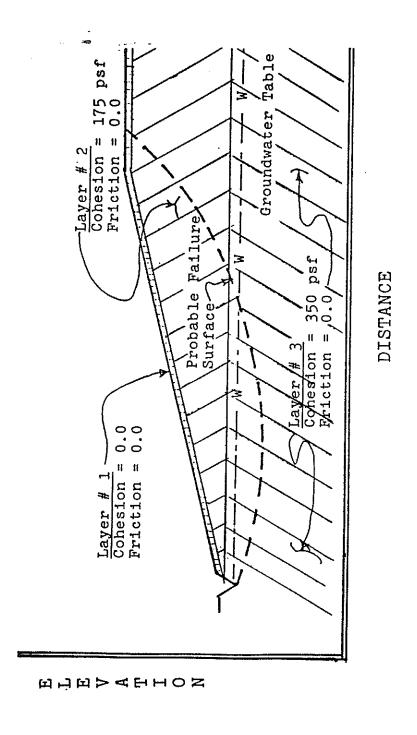
Figure 2. General soil-embankment conditions and slope stability model cross section.

The slope stability model developed in this project (Figure 2) adequately characterizes the embankment cross sections and more importantly, accurately predicts embankment slope stability. The model, when applied to slopes in the I-20 study area, predicted slope failures in all of the 11 slopes used as examples. When applied to 20 stable slopes in the same area, it predicted stability in 17 of the examples. The three examples where failure was predicted had safety factors just below 1.0, and so were very close.

The slope stability model cross section (Fig. 2) is composed of three distinct soil layers. The top layer consists of vegetation covering the embankment top and sides, is approximately one foot thick, and provides no structural support. Soil layer 2 consists of the embankment fill material and is considered cohesive clay with a cohesive strength of 175 psf. Layer 3 is the natural soil surface upon which the embankment has been constructed and is primarily cohesive clay with a cohesion of 350 psf.

Two important conclusions were made from computer characterizations of the I-20 slopes. About two-thirds of the cases investigated resulted in failure surfaces extending well below the surrounding ground surface (deep-seated failures). Also, the predicted failure surface originated well back of the top of the embankment slope (i.e., approximately 6 - 8 feet from the top of the slope in the direction of the pavement edge) and approached the edge of the pavement shoulder. This information leads one to conclude that repair and rehabilitation schemes which only designate improvements above the existing ground elevations and from the top of the slope to the toe of the embankment slope may not alleviate the slope stability problem since deep-seated failures could possibly develop behind and underneath the improved embankment. In the field no evidence of this deep-seated failure mechanism has been located as of yet.

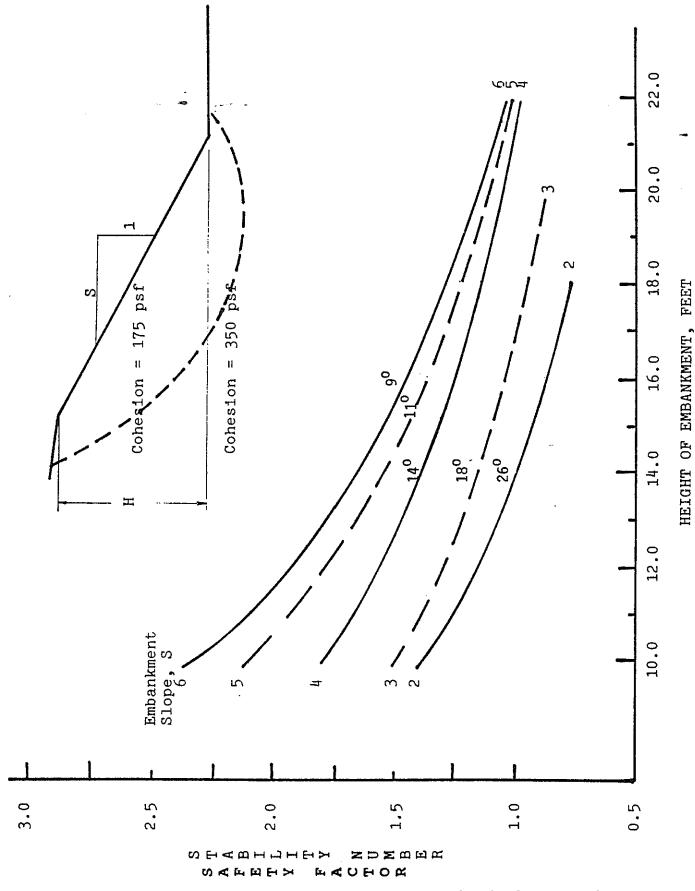
Figure 3. Stability numbers (safety factors) for constant slope of embankments and embankment height. No slope design or redesign should be attempted using this method alone.

The design nomograph for constant embankment slope is presented in Figure 3. This configuration would be utilized in those situations where acquisition of right-of-way is not a problem and where low slope angles can be used. This method would be cheaper than the lime stabilization method as the natural soils would only be compacted, not limed.

For those cases where soil moisture movements can be controlled and soil cohesive strength is estimated from either Figure 7 or 8, these four nomographs presented in Figures 3-6 can also be used in establishing minimum embankment slopes. The correction for the effect of increased cohesion would be handled by adjustments to desired stability number (safety factor), since an increase in soil cohesive strength would yield higher stability numbers. Consequently, the nomographs could be used in the present form by multiplying the desired stability number by the ratio of 175 to the estimated cohesive strength.

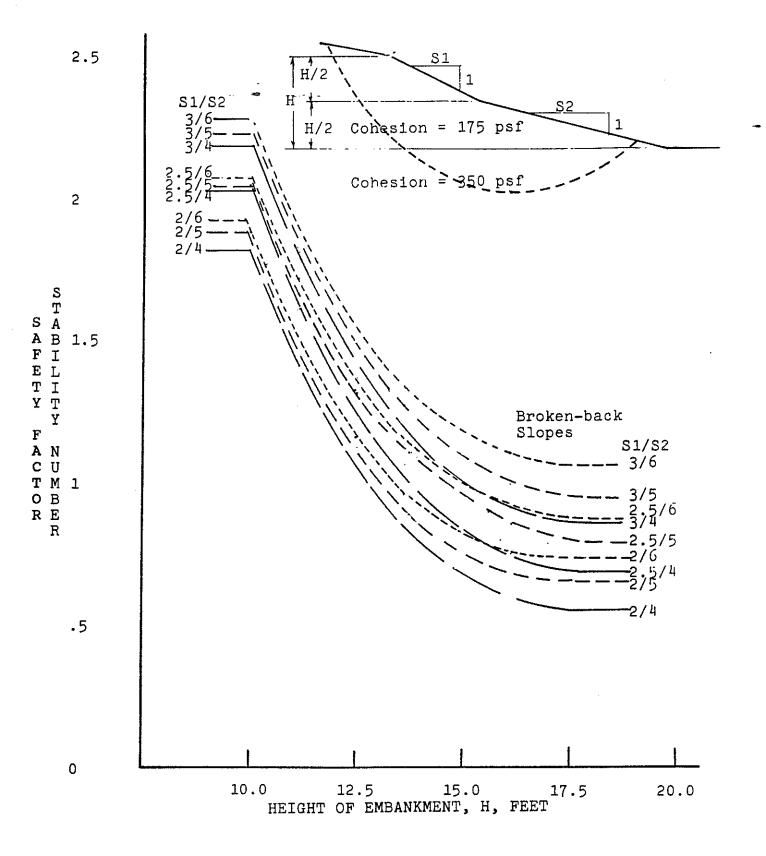
Figure 4. Stability numbers (safety factors) for broken back embankment configuration with varying heights and slopes. No slope design or redesign should be attempted using this method alone.

This configuration (Figure 4) was developed for the case of limited right-of-way or reconstruction of an existing embankment where lime stabilization is not wanted. The broken-back term describes an embankment configuration consisting of two different slopes. The upper slope is the steeper of the two. This configuration was selected because it represented an opportunity to reduce the mass of earth captured within the failure surface and should result in a lesser driving force and corresponding higher stability number.

The nomograph (Figure 4) is used in a fashion similar to that described in the constant slope configuration case above. A vertical line would be constructed from the height of embankment, H, while a horizontal line would be constructed from the desired stability number (safety factor). The intersection of these two lines would yield the combination of slopes S1 and S2, which meets the stability requirement.

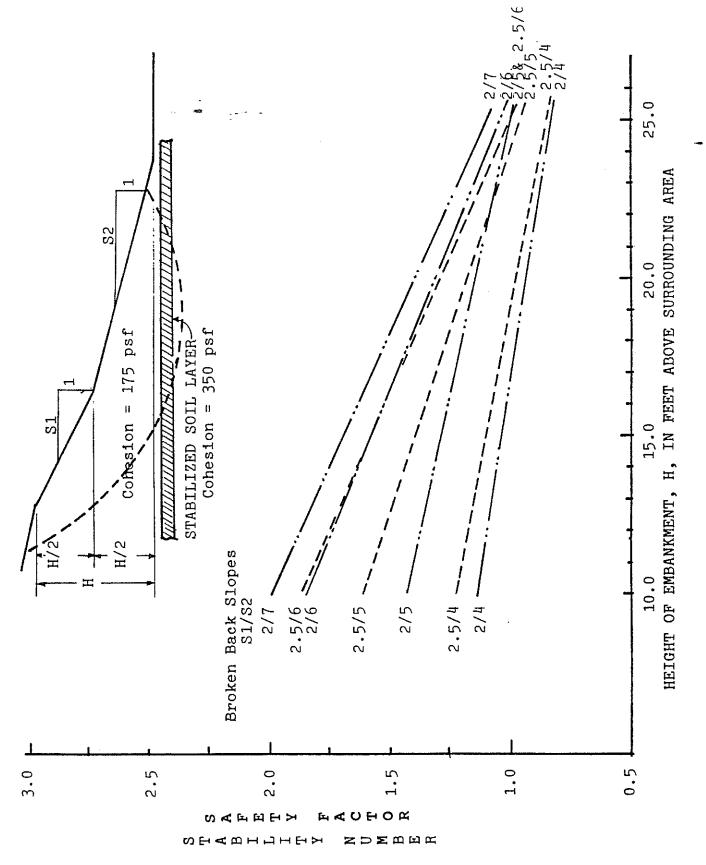
Figure 5. Stability numbers (safety factors) for broken back embankment configuration and stabilized soil layer at toe of slope; consideration of height, H, and slopes, S1 and S2. No slope design or redesign should be attempted using this method alone.

In the two previous design configurations, the failure surface dipped quite a bit down into the subgrade or third soil layer. This third configuration was established to create a situation in which a stabilized soil layer would limit the intrusion of the predicted failure surface into the subgrade or bottom soil layer. The stabilized layer would offer an additional advantage in that it would substantially reduce the movement of soil moisture from the subgrade or bottom layer to the upper embankment layer. It is more expensive than the above two methods and would require stabilization of the lower soil layer, probably by lime stabilization.

The nomograph (Figure 5) is used in the same fashion as the preceding one. The stabilized soil layer would have to have a minimum thickness of 18 inches. Economics would, of course, play a major role in evaluating this option.

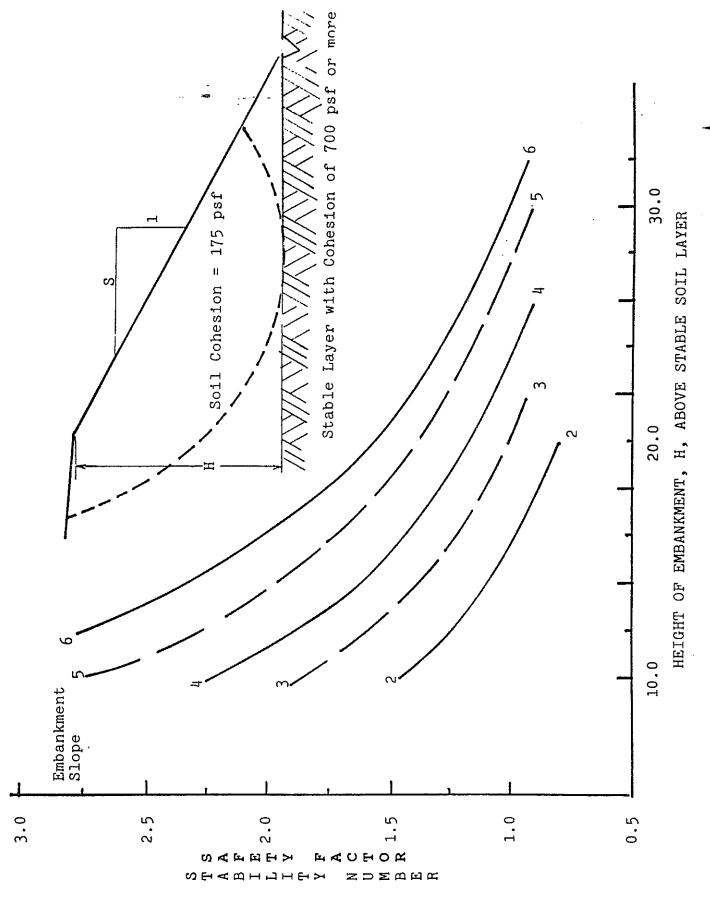
Figure 6. Stability numbers (safety factors) for embankment founded on stable subgrade. No slope design or redesign should be attempted using this method alone.

Minimum embankment slopes for this situation can be obtained by the appropriate entry of the nomograph (Figure 6) with embankment height, H, and desired stability number (safety factor).

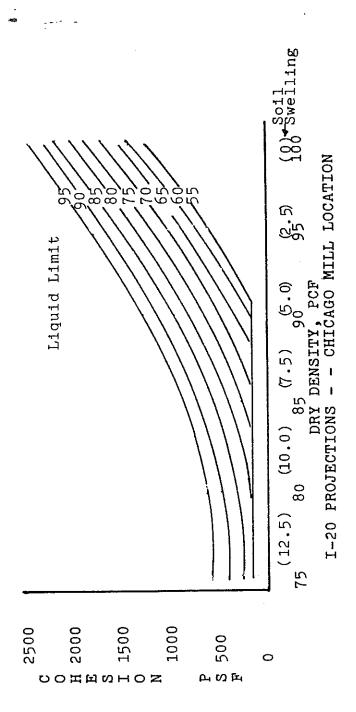
Figure 7. Soil cohesion estimates for high plasticity clays (CH) for varying density and liquid limits. No slope design or redesign should be attempted using this method alone.

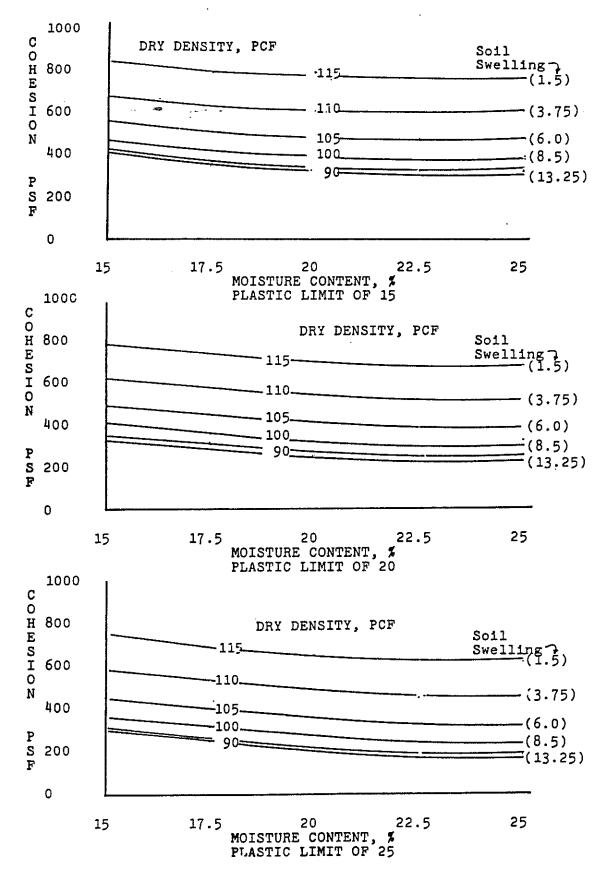
Figure 8. Soil cohesion estimates for low and medium plasticity clays (CL) for varying moisture, density and plastic limits. No slope design or redesign should be attempted using this method alone.

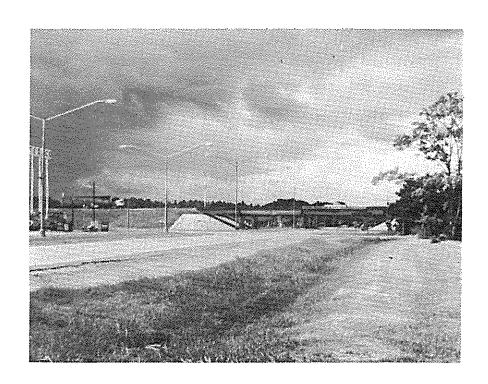
Figure 9. Wrap-around aprons on the revetments. This site has not failed and is located at the interchange at Rayne in the I-10 study area. This design is recommended to reduce the large number of header failures.

- 1) Do not use pilings to repair slopes that are constructed of high- or intermediate-risk soils. They merely become conduits for moisture to enter the slope and actually increase the chances of slope instability.
- 2) Extend the revetment of overpasses around the sides of the embankment (Figure 9).
- 3) Provide ample drainage to keep water off of the slope.
- 4) Vegetate the slope not with grass, but with pampas grass (<u>Cortaderia selloana</u>) if it is available (Figure 10). Unlike grass, pampas grass will not require mowing and thus will further stabilize the slope.

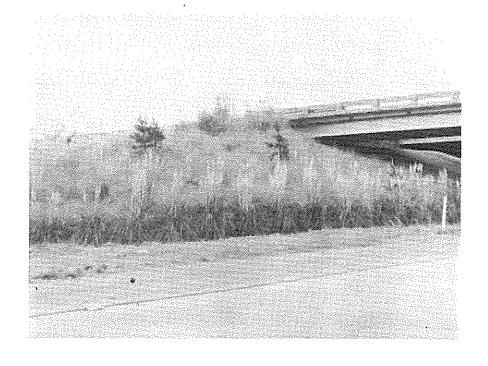
Figure 10. Slope stabilization with exotic vegetation. At this locality S1 in Calcasieu Parish in the I-10 study area, pampas grass has been successfully used to stabilize a repaired slope.
