1. Report No. LA-99 / 324		2. Government Accession No.	3. Recipient's Catalog No.
4. Title and Subtitle Cathodic Protection of Culverts – Field Application and Expert System		5. Report Date June 1999

**Cathodic Protection of Culverts
Field Application and Expert System**

Final Report

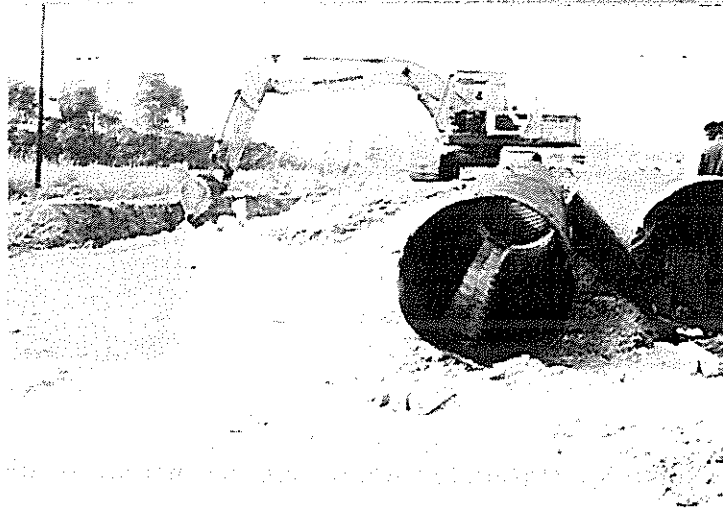
Figure 8
Trench being dug for installation of new culvert at Hwy 757

Figure 8 shows the trench being dug for the culverts that are shown on the right side of the photograph. The two four-foot diameter bituminous-coated steel culverts were 30 feet long each. Before the internal anode could be physically attached, an electric hand grinder was used to remove the bituminous coating away from the bottom portion of the culvert where the connections were to be made. The anodes could then be welded to provide an electrical connection. The six internal anodes used had dimensions of four inch by four inch by 1.5 foot long. In case of corrugated pipes, welding can be difficult and care must be taken

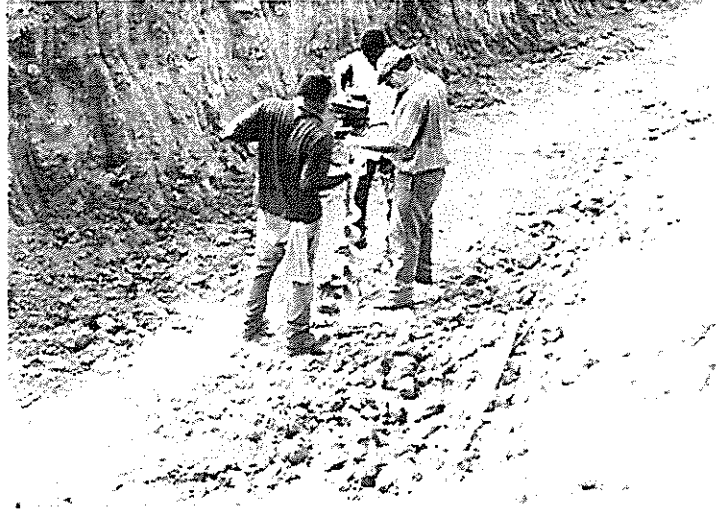
Figure 10
Manual digging of holes for installation of external anodes.

After the internal anodes were installed, the next step was to dig holes at the bottom of the site on which the coated culvert was about to be laid for the purpose of installing the external anodes. Three holes about 32 inches deep and eight inches in diameter were dug. Figure 10 shows the manual digging of the holes for the external anode installation. Each hole was filled with a 32-pound magnesium anode packed with gypsum. Water was placed in the hole to increase conductivity. The leads from all of the external anodes were connected to a single lead wire that was then connected to both ends of the culvert.

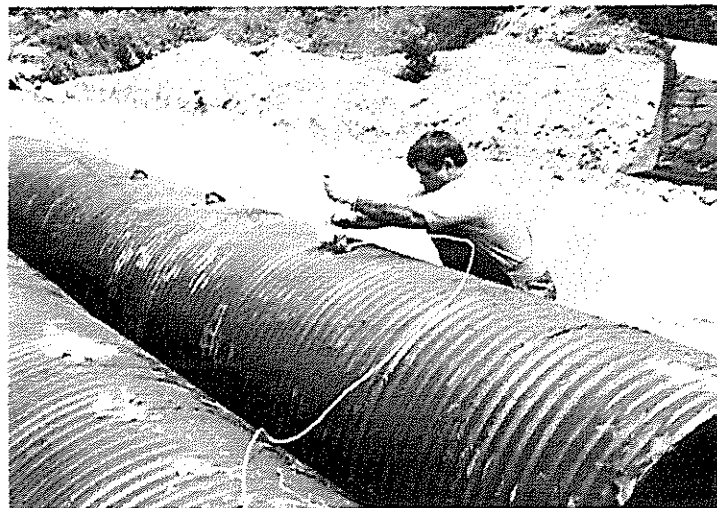
Figure 11
Electrical connection is being made to a section of culvert.

Figure 11 shows the electrical sections being made to each section of the culvert. The culvert was then lifted and placed in the trench.

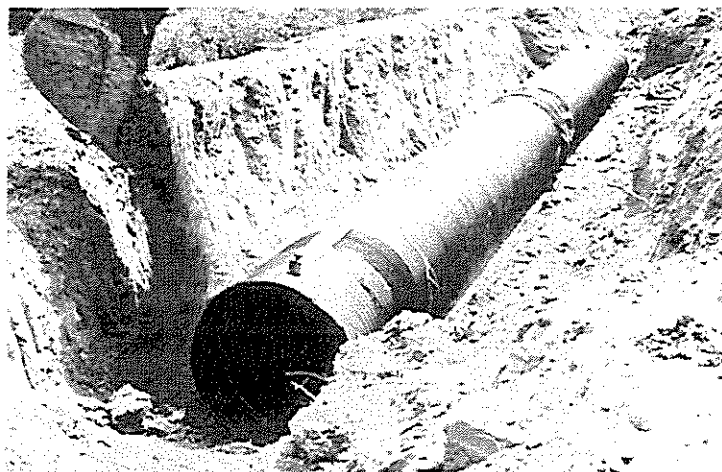
The culvert is being buried with dirt.

Once the culvert was in place, dirt was added on both sides of the culvert to bury it. Figure 13 shows the culvert being buried with dirt. A copper wire was welded to the top of both ends of the culvert. A test station on each end of the culvert connected the two copper wires from the anode bed and the culvert through a 0.01Ω shunt resistor.

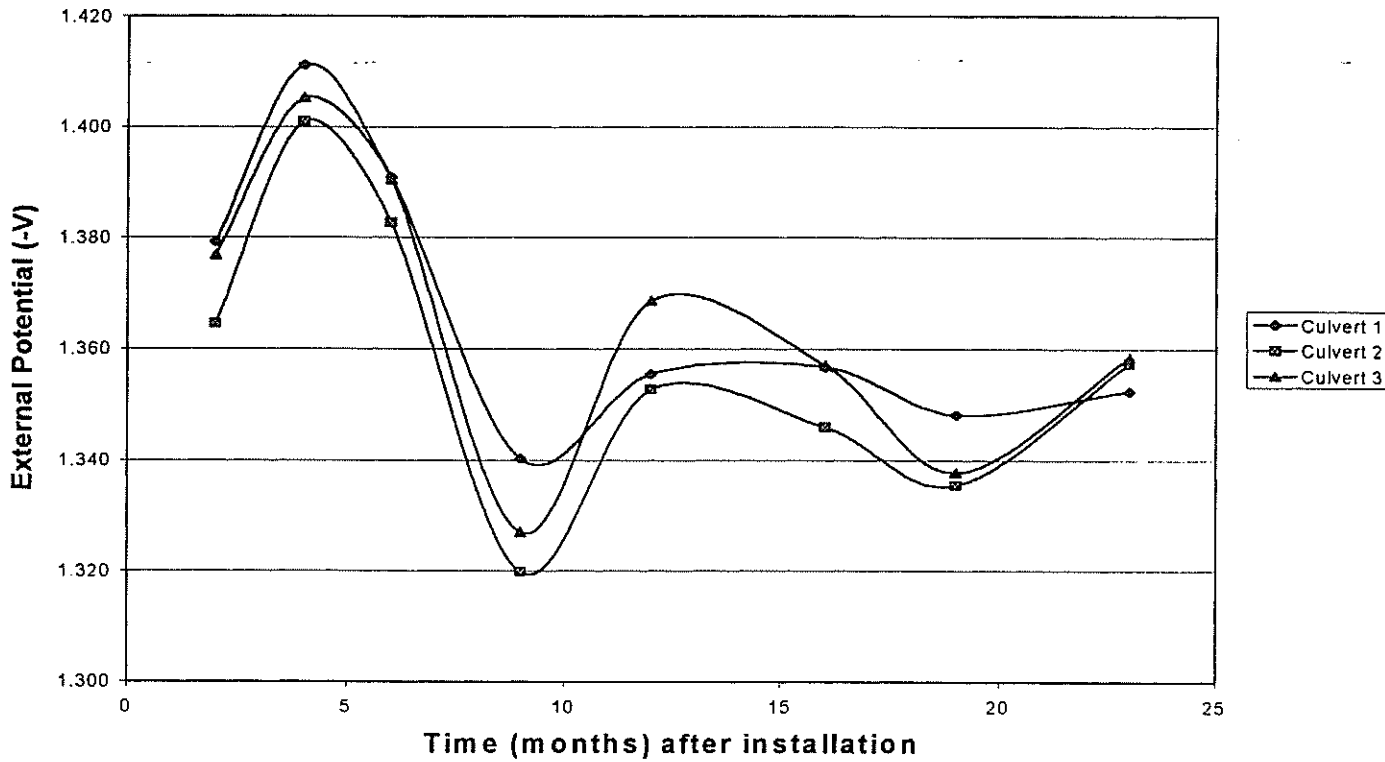
Figure 17
Potential of each culvert versus time (culverts at I-49)

Proof that the external current is protecting the culverts can be seen in Figure 17. All three culverts are well above the -1.1 V value that is needed to protect the zinc and steel of the culverts. The system is operating equally well for all three of the culverts. The cyclic nature of the data is likely due to the seasonal condition around the culverts.
