TECHSUMMARY *September 2018*

State Project No. 30001020 / LTRC Project No. 13-4ST

I-10 Girder Repair Using Post-Tensioned Steel Rods and Carbon Fiber Composite Cables (CFCC)

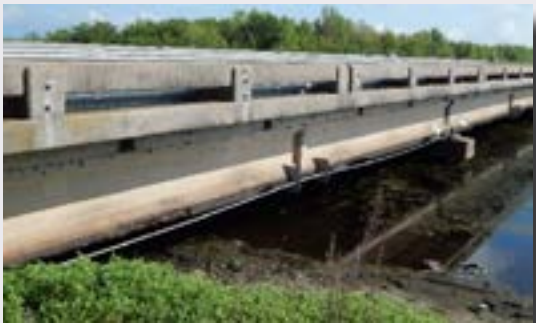
Figure 1
Distance view of the eastbound bridge
